PRICASTON FARM CASTLEMARTIN STANDING BUILDING RECORDING

RHIF YR ADRODDIAD / REPORT NO. 2009/4
RHIF Y PROSIECT / PROJECT RECORD NO. 94314

January 2009

PRICASTON FARM, CASTLEMARTIN STANDING BUILDING RECORDING

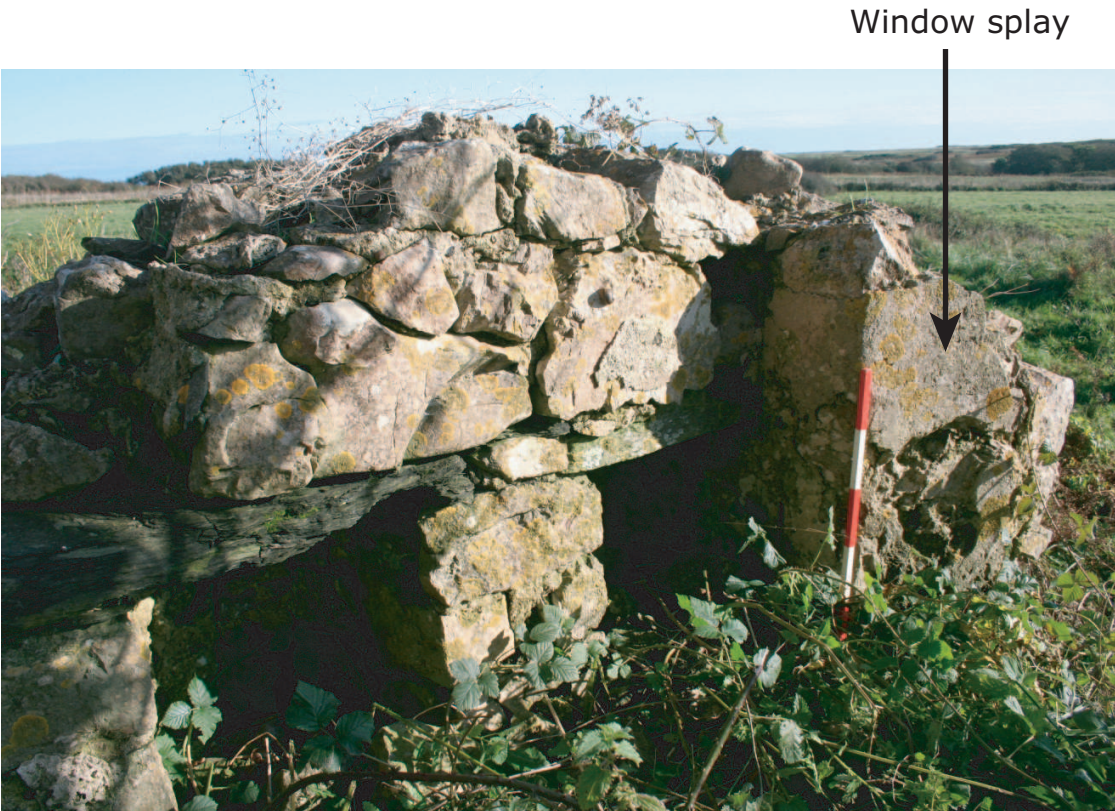
To the south of the complex, lying just outside the southern boundary of the current enclosure stands the ruins of a structure which incorporates two rows of nesting boxes. An arch of masonry represents the remains of a gateway, though none of the jambs or dressings survive (Plate 63). To the east, and projecting to the south is a small building with the remains of a window splay in the south wall and a doorway in the corner of the east wall. Along the internal faces of the east and west walls are nesting boxes; 0.35m wide, 0.4m deep and 0.4m high, constructed with a slate capping stone over (Plate 64).

Plate 64: Nest boxes in the east wall of gatehouse
