PHILBEACH FARMHOUSE, DALE, PEMBROKESHIRE: BUILDING RECORDING AND ARCHAEOLOGICAL WATCHING BRIEF

RHIF YR ADRODDIAD / REPORT NO. 2011/28
RHIF Y PROSIECT / PROJECT RECORD NO. 94527

**PHILBEACH FARMHOUSE, DALE, PEMBROKESHIRE:
BUILDING RECORDING AND ARCHAEOLOGICAL
WATCHING BRIEF**

Simon Ratty

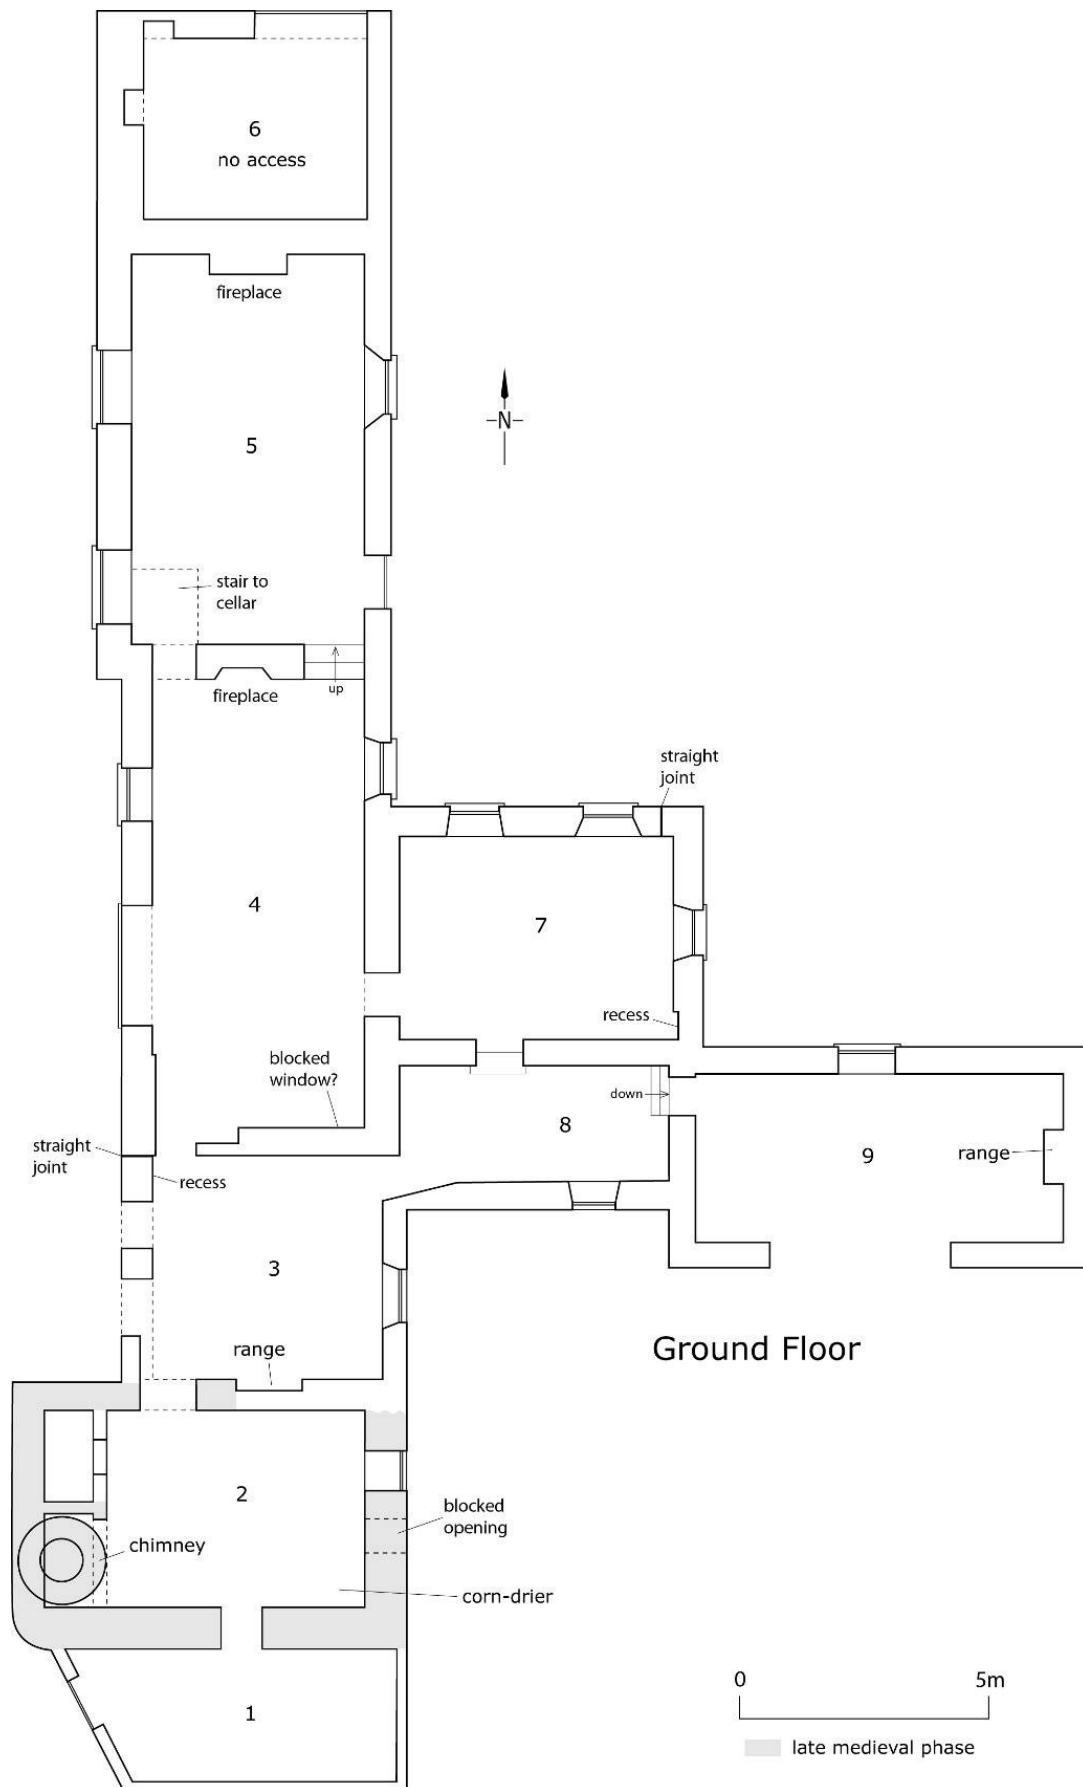
Figure 4: Ground floor plan of Philbeach Farmhouse.

3.1.2 The internal recording of the building commenced within the cellar before moving to the ground floor level and working northwards. The first floor was recorded using the same method. Each room on the ground and first floor has been numbered for ease of reference (see Figures 4 – 5).
