# A Survey of Garn Fawr Hillfort, Pembrokeshire

Prepared by Dyfed Archaeological Trust  
For: The National Trust and  
Pembrokeshire Coast National Park  
Authority

RHIF YR ADRODDIAD / REPORT NO. 2009/34  
RHIF Y PROSIECT / PROJECT RECORD NO. 94874

June 2009

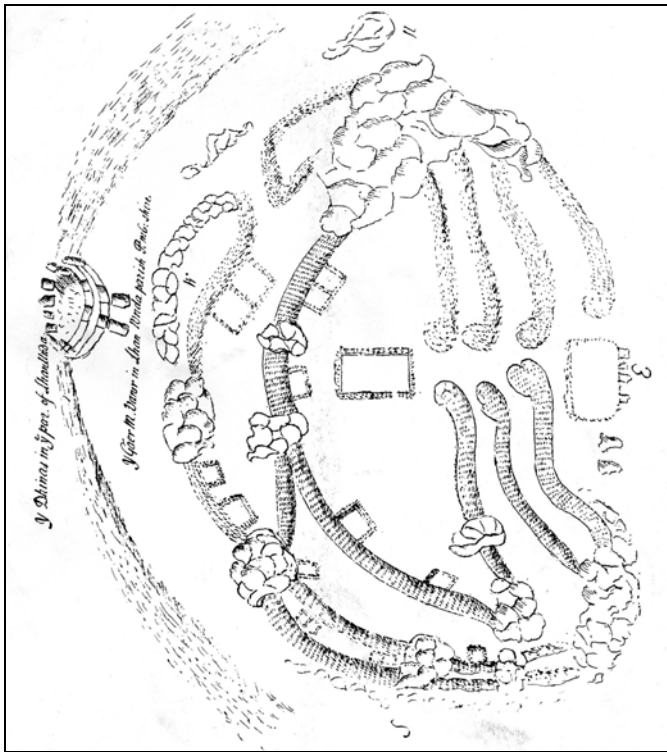
Figure 4: extract from the survey showing the shapes of ramparts A and B, probably parts of the original entrance into the hillfort.

This survey generally agrees with Hogg in considering the east side to be the original entranceway, as illustrated in figure 4, below. Although the modern pathway has indeed caused damage to the ramparts, the shape of rampart A, in particular, suggests an original entrance. Where most of the ramparts have clearly been truncated by the path and the stone field walls, rampart A appears to still have an original form, curving inwards (westwards) and being matched in shape on the opposite side of the path by the remains of a stone (or stone-faced?) rampart (labeled B, see figure 4). This impression is strengthened if Edward Lhuyd's sketch is also considered (see figure 5), which appears to show a clear entrance on the east side.

However, immediately to the west, the path breaks through a rampart formed largely by a stone spread, (visible on fig 4, above) and here the path and the wall clearly truncate the rubble spread. It is not clear exactly what the relationship is between the path / wall and the earth bank at this point, but it is worth noting that the stone spread appears to overlie, and therefore post-date, the earth bank. This may indicate that the substantial stone defences at this site are, in fact, a re-modeling of earlier earth banks.

The vehicle track, which can just be seen at the top of Fig. 4 is, presumably, later in date than 1973 as Hogg's detailed descriptions make no mention of it. The way in which this modern track breaks through the earthworks provides a useful comparison for other areas where paths and tracks cross the earthworks, note in Fig. 3 the "clean" nature of the track's passage through the northern parts of the earthworks, the banks are clearly and squarely truncated. This is in contrast to the pathway which runs between ramparts A and B, further giving the impression that this pathway in fact utilized an original entrance.

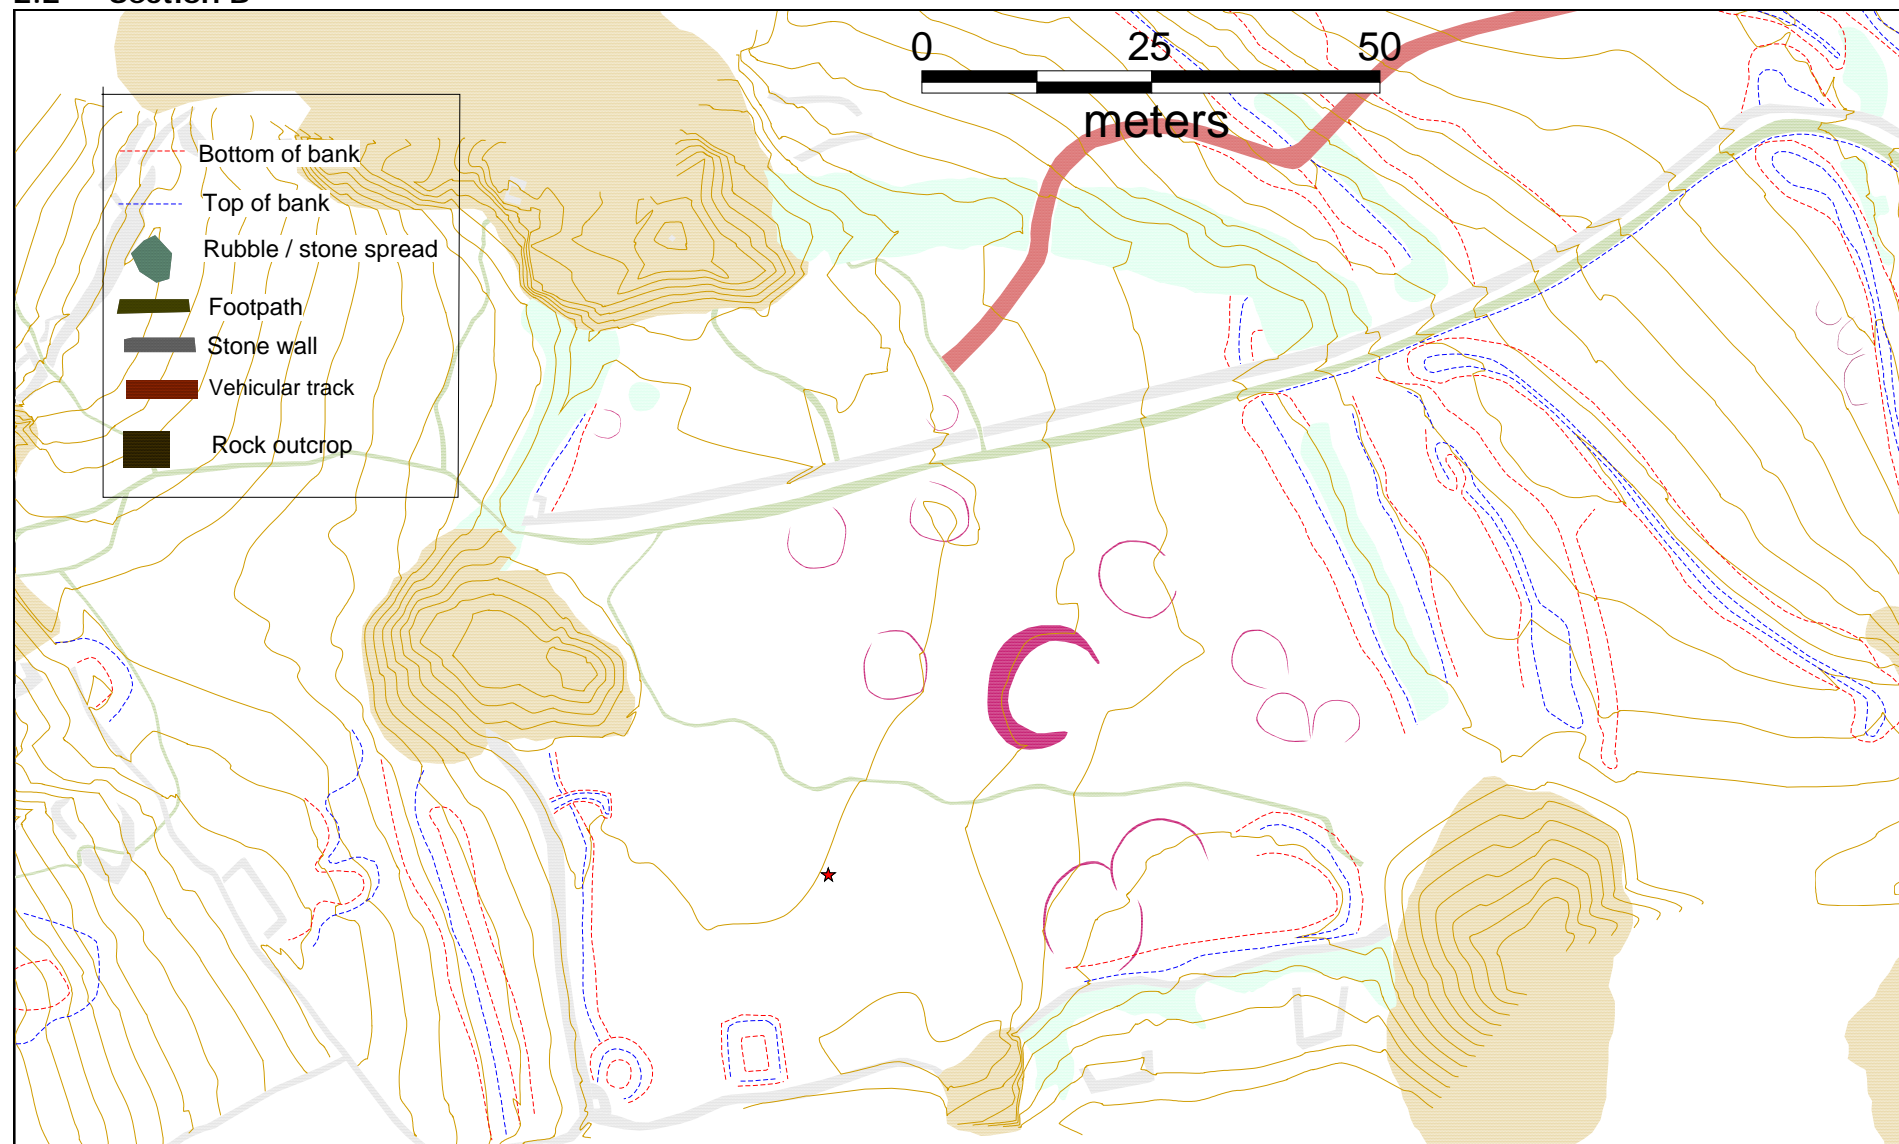
Figure 7: Section B, the interior of the hillfort of Garn Fawr

This, the 'inner' section of the hillfort, contains abundant evidence for hut platforms as well as for later agricultural use. This survey identified at least 11 probable hut circles as well as a central circular feature. This feature is a very pronounced depression, terraced into the slope on its western side and commanding what appears, on the ground, to be a central location (though, as the survey shows, it is not truly central). Lhuyd's drawing (see fig 5) shows this as a rectangular building standing on its own. Hogg also subscribed to the idea of this feature being an isolated hut platform and described it as follows:

The hut circles are generally only preserved as earthworks, showing up as more-or-less clear circular depressions with raised 'ridges' around the edges. However in some cases there appear to be traces of surviving stonework, particularly noticeable in the case of the largest, central feature which has a few individual stones protruding out above the grass cover. The hut circles vary in diameter from approx 3m to approx 10m. Unlike the three hut circles to the east (see section A of the survey and Fig. 6), none of the hut circles in this section of the hillfort appear to be overlain by either earth or stone banks.

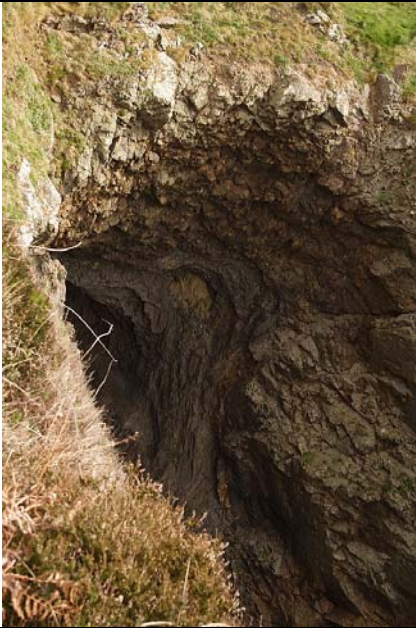
<p><i>View NE looking at the mouth of Ogof March, taken from the interior of Dinas Mawr hillfort</i></p>				
<b>Description</b>				
OGOF MARCH				
A large sea cave called Ogof March in the cliffs below Dinas Mawr hillfort, and extending under the promontory. The cave is inaccessible and sea-washed making it unlikely to hold any archaeological remains but this has not been examined closely.				
<b>Condition</b>				
The cave was not examined in any detail, but lies in an area of gradually eroding sea cliffs.				
<b>Management Recommendations</b>				
No specific recommendations
