ROCH CASTLE, PEMBROKESHIRE (SM 8803 2121)

ARCHAEOLOGICAL DESK- BASED ASSESSMENT AND BUILDING APPRAISAL

Prepared by Dyfed Archaeological Trust
For: Acanthus Holden Architects

RHIF YR ADRODDIAD / REPORT NO. 2009/36
RHIF Y PROSIECT / PROJECT RECORD NO. 95174

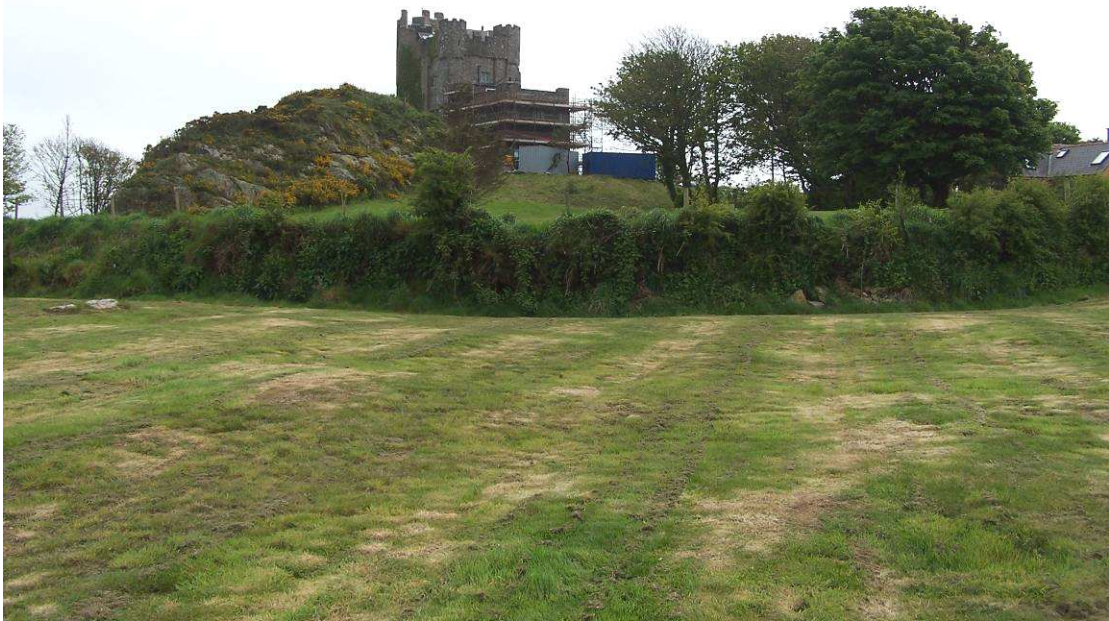
- 3.3.7 A change in ground level is present to the northwest of the castle (dropping own from the castle), following roughly the line of the ditch marked on the earlier OS maps which suggests the line of this feature is still visible, although possibly slightly further to the north than shown on the maps) (Photo 2 and 3). Stone work is present within this change in level, which may indicate a stone wall was formerly present, although the remains do not suggest a very substantial wall (ie. not a massive curtain wall that formerly surrounded the castle, but perhaps a revetment wall) (Photo 4). A breach is present through this area associated with a modern vehicle access track (Photo 2). It is understood that the land to the north and east of this ground level change is outside of the property boundary of the castle (as sold in 2009).

Photo 2: View south towards castle, showing change in ground level

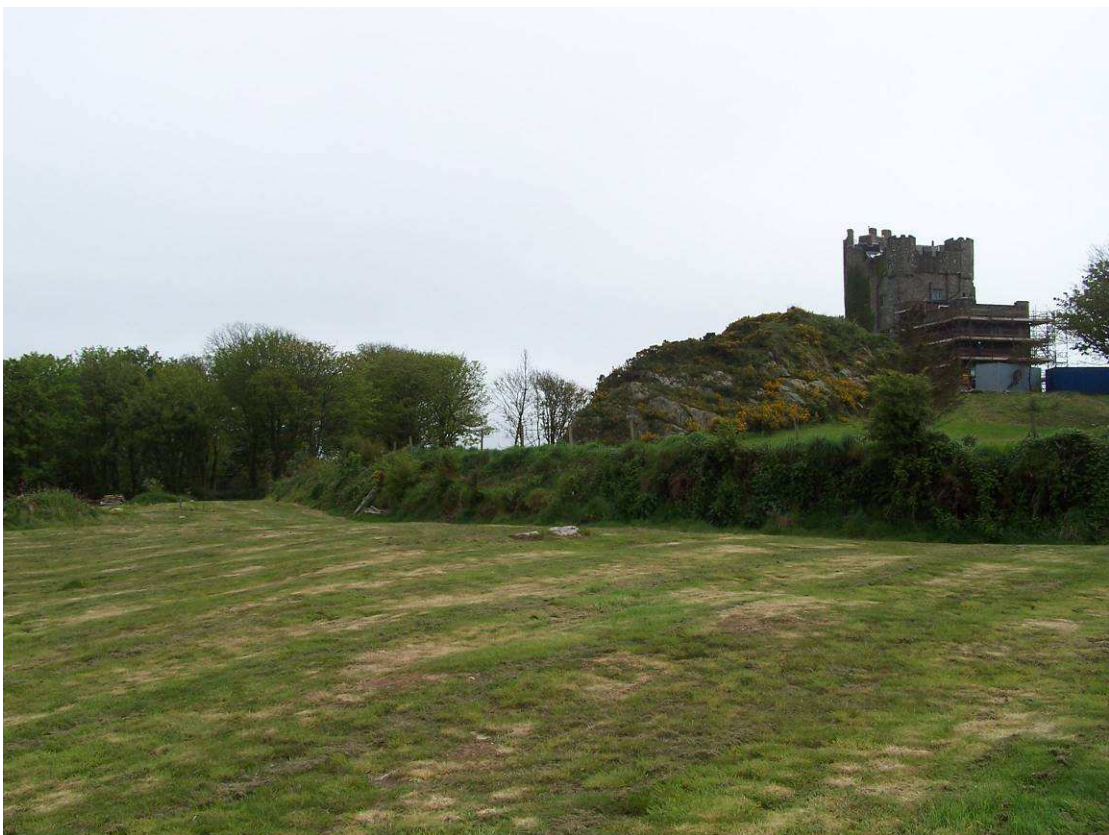
Photo 3: View southeast, showing change in ground level

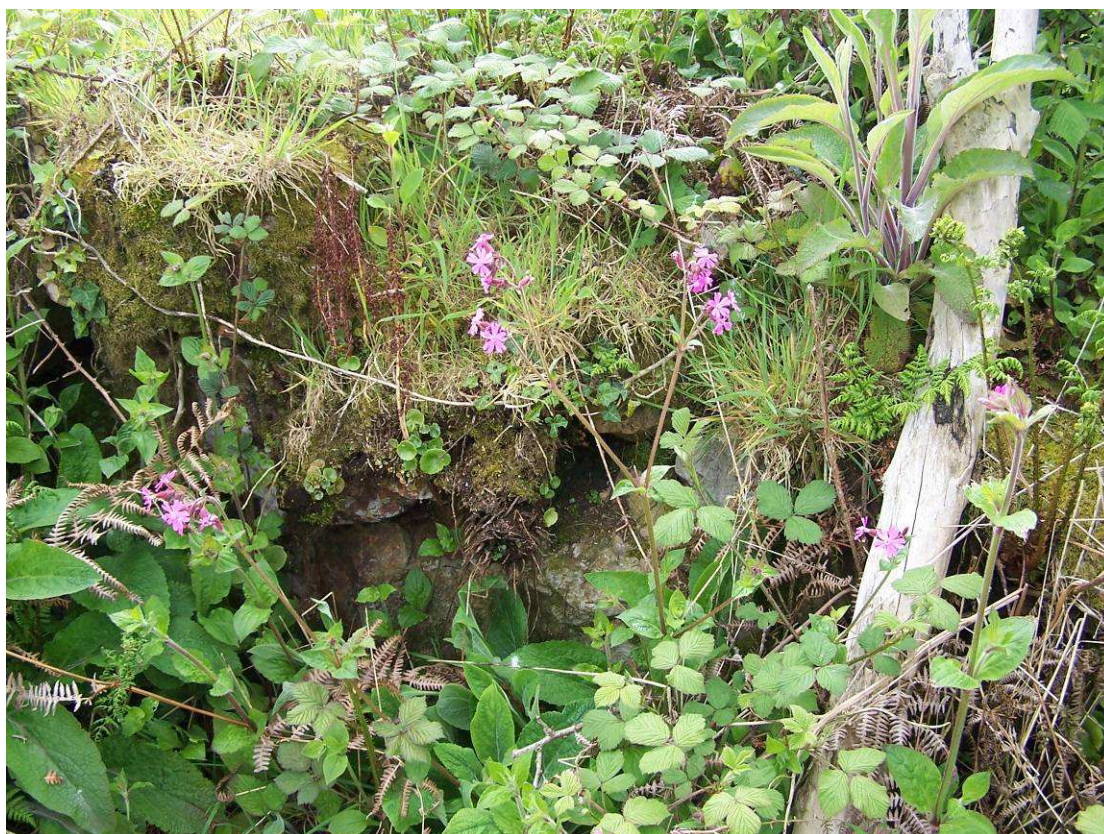
Photo 4: Stone wall along edge of change in ground level to the north of castle

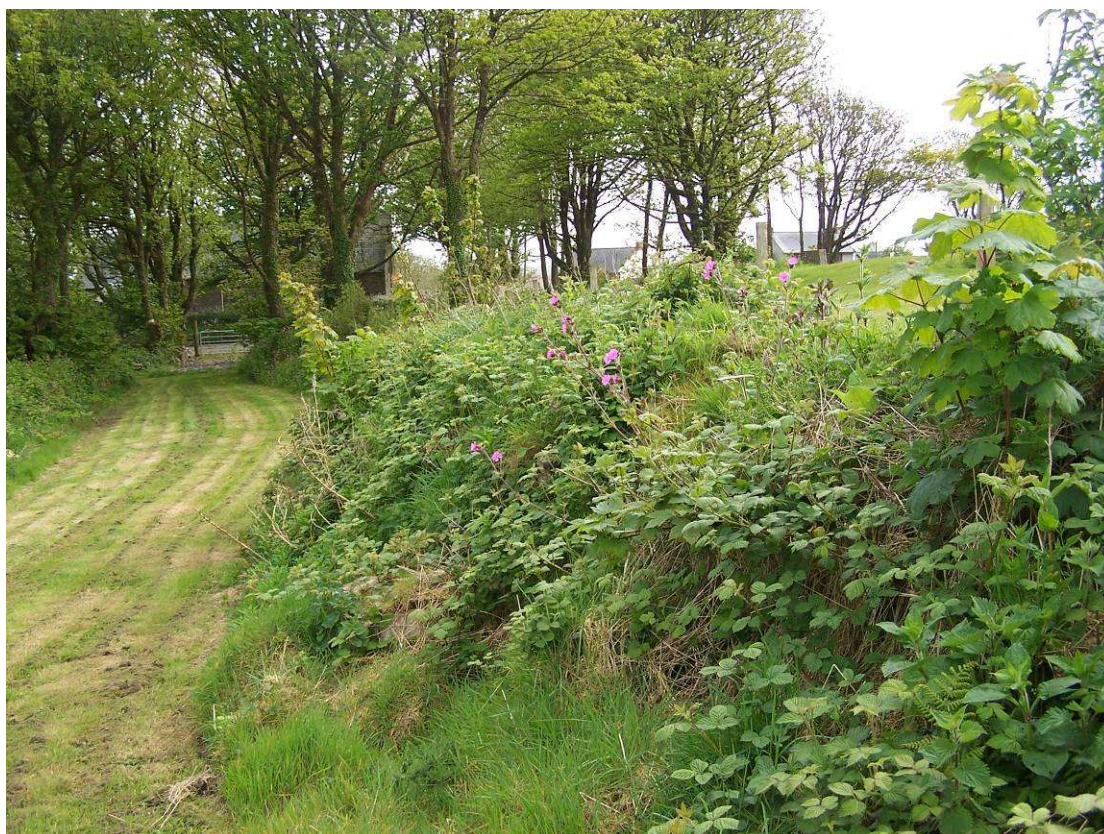
- 3.3.8 To the northeast of this level change is a short stretch of a former road or trackway (Photo 5), which has been leveled and improved in more recent years (Dave Berry pers. comm., 06/05/09). The trackway is shown on all of the earlier maps, running from opposite the church, heading north around the outside of the 'moat'. The 1748 and 1839 maps show that the road ran around the perimeter of the castle enclosure, with building present on its northern/eastern side. The stone footings of some of these buildings are still visible, although are in a poor state of repair and have been affected by more recent clearance activities (Photo 6 and 7). The original dates of these structures is uncertain, but none except the cottage directly opposite the church are shown on the second edition OS map.

Photo 5: View southwards along trackway towards church, also showing raised ground associated with wall

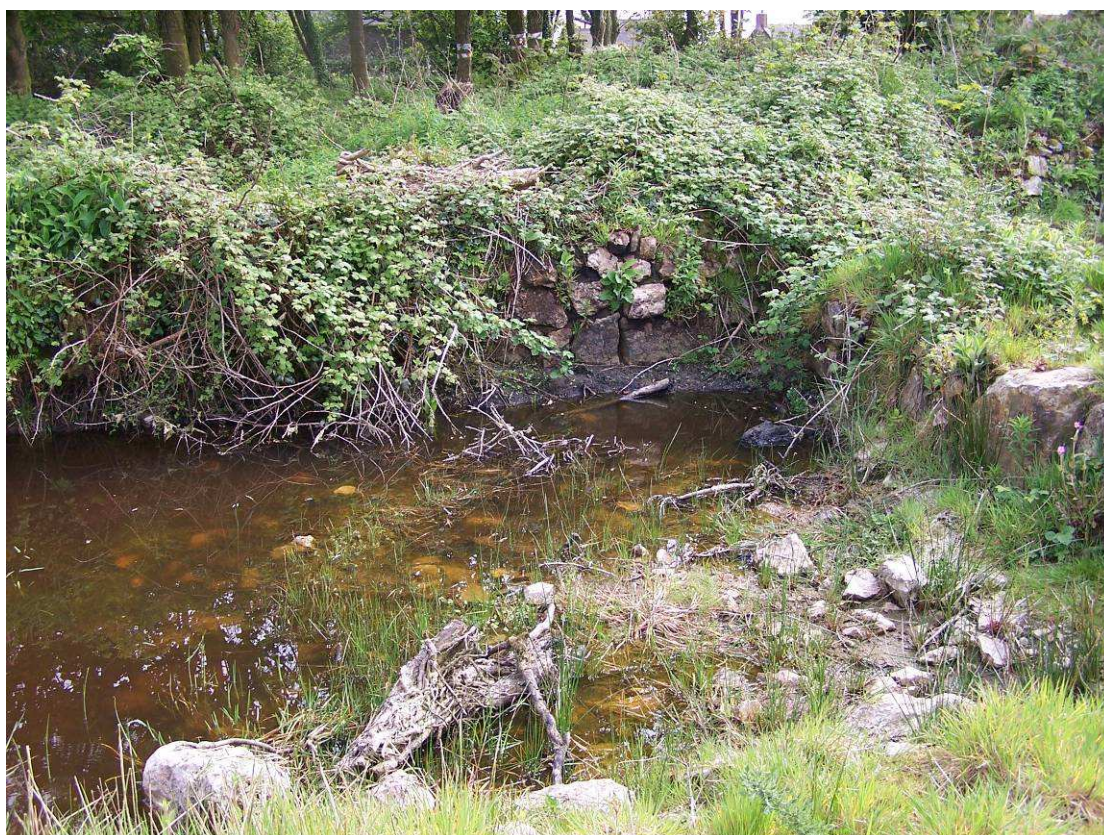
Photo 6: Stone walls of former building on northeastern side of castle enclosure, of uncertain date and function (view south)

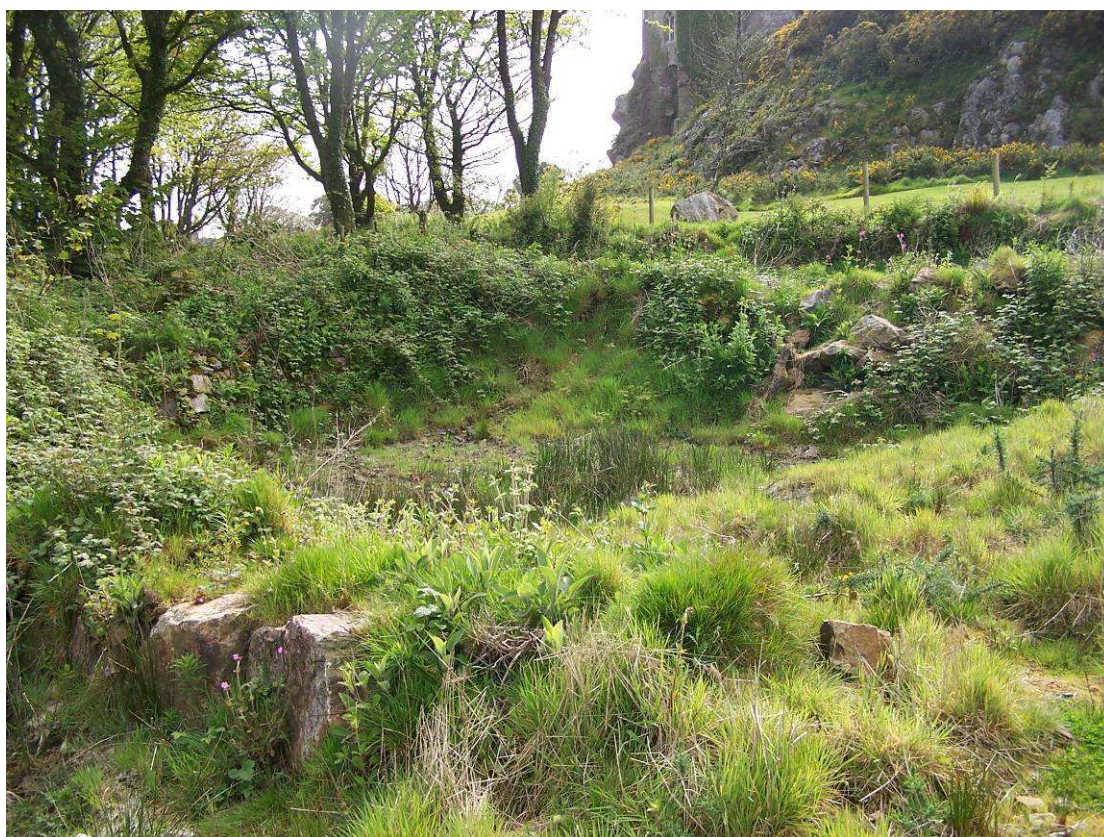
Photo 7: Stone walls of former building on northeastern side of castle enclosure, of uncertain date and function (view west)

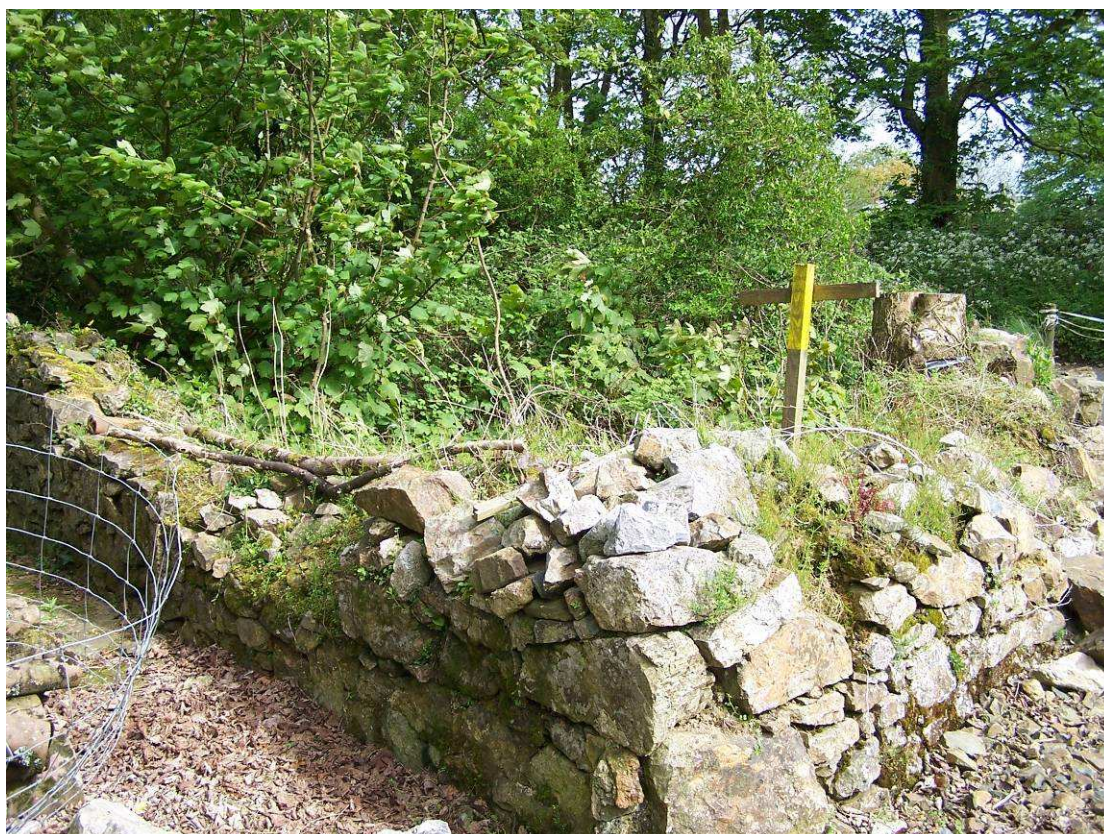
Photo 8: Stone walls associated with former cottage directly opposite the church

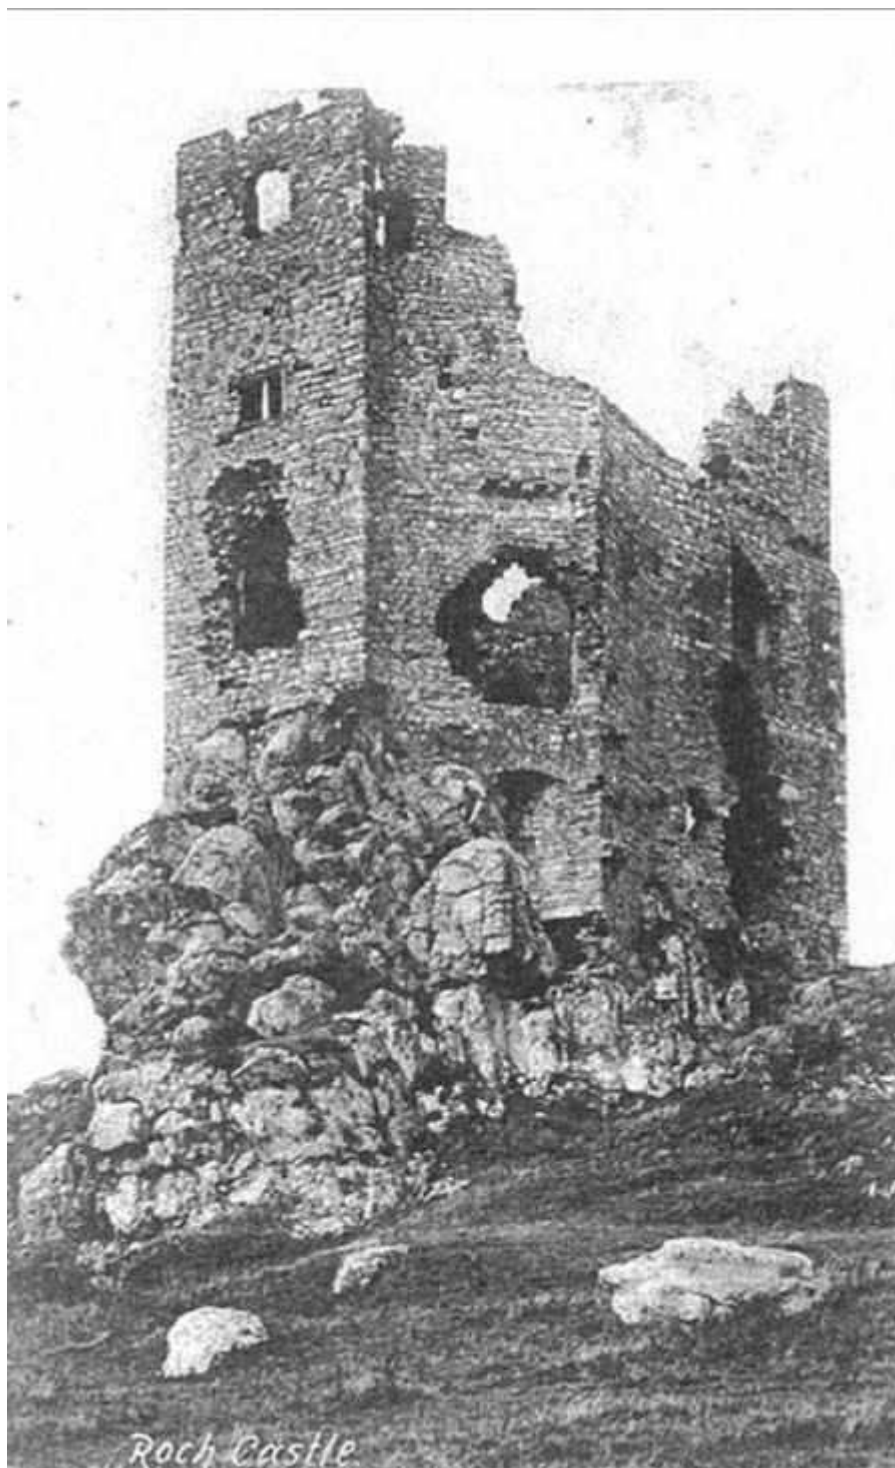
Photo 9: View of Roch Castle from Southeast Pre-1900 (reproduced from Acanthus Holden Design and Conservation Statement 2008)

- 4.2.9 Photo 8 closely follows the information shown on the 1865 illustrations, although it can be seen that the arched window within the southern square tower projection is far less intact than previously illustrated, with only a hint of the arched opening visible back from the damaged façade. The void in the wall on the eastern façade is clearly shown, as is a void in the south-eastern façade in the location of the Room 4 at first floor level. The photograph confirms the survival of much of the fabric of the Eastern Turret. The southern square tower projection is shown to survive relatively intact to the upper crenellations. A relieving arch is shown at

the base of Room 4, to join the wall sitting directly on the upper part of the rock outcrop with the lower stone built wall to the north. This arch is still visible today (see Photo 38).

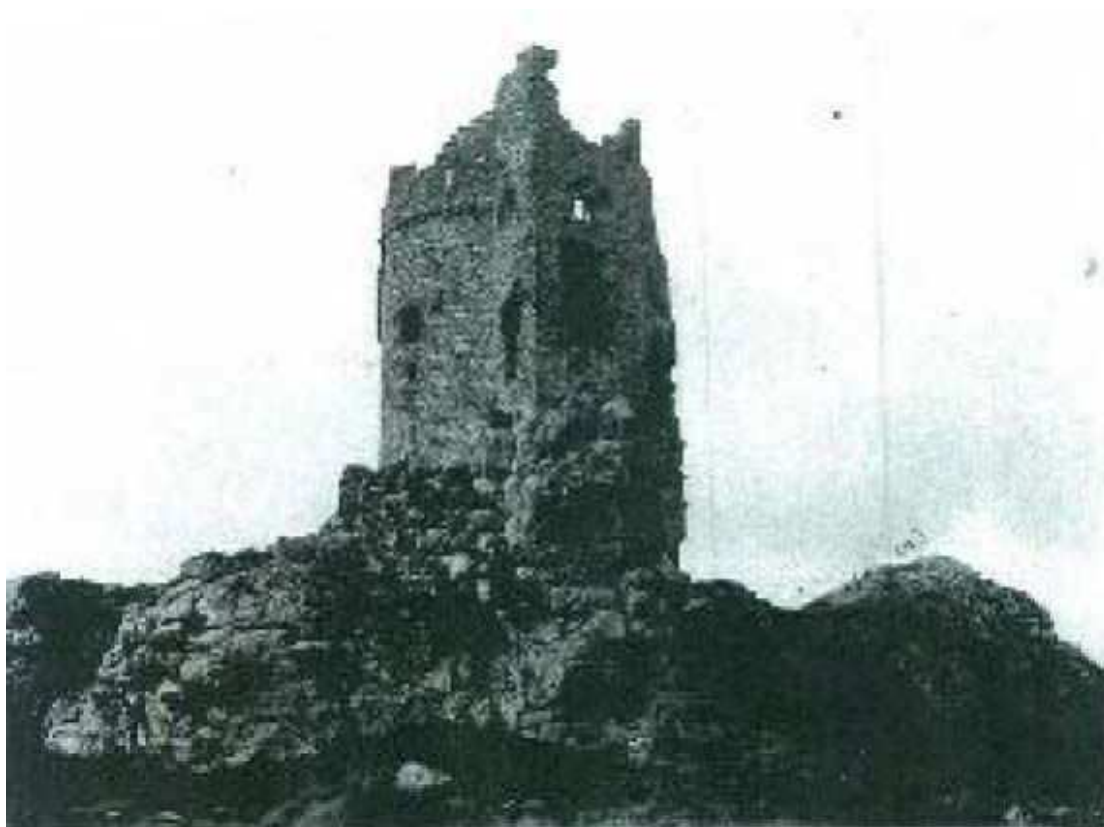
Photo 10: Southwestern view of Roch Castle taken pre-1900 (reproduced from Acanthus Holden Design and Conservation Statement 2008)

4.2.10 Photo 10 also dates from pre-1900, showing a view of the southern façade, but is notable as it indicates that the top part of the southern square projecting tower must have collapsed or the photograph has been altered (although this is considered unlikely).

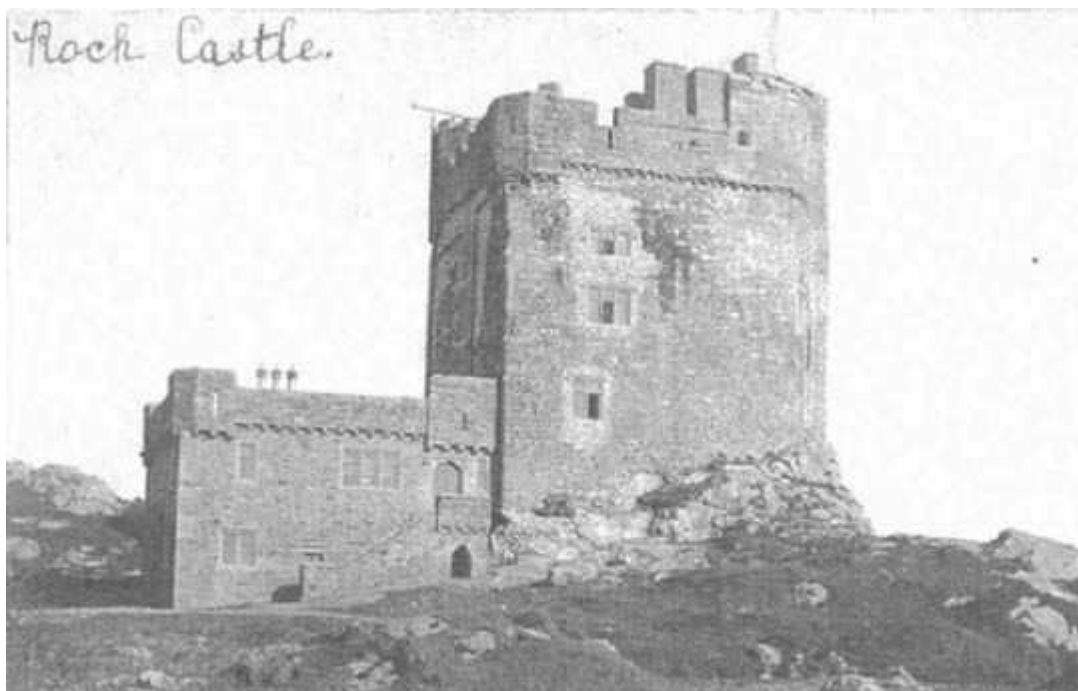
Photo 11: Western view of Roch Castle taken pre-1922, after first phase of restoration showing two storey northern extension (reproduced from Acanthus Holden Design and Conservation Statement 2008)

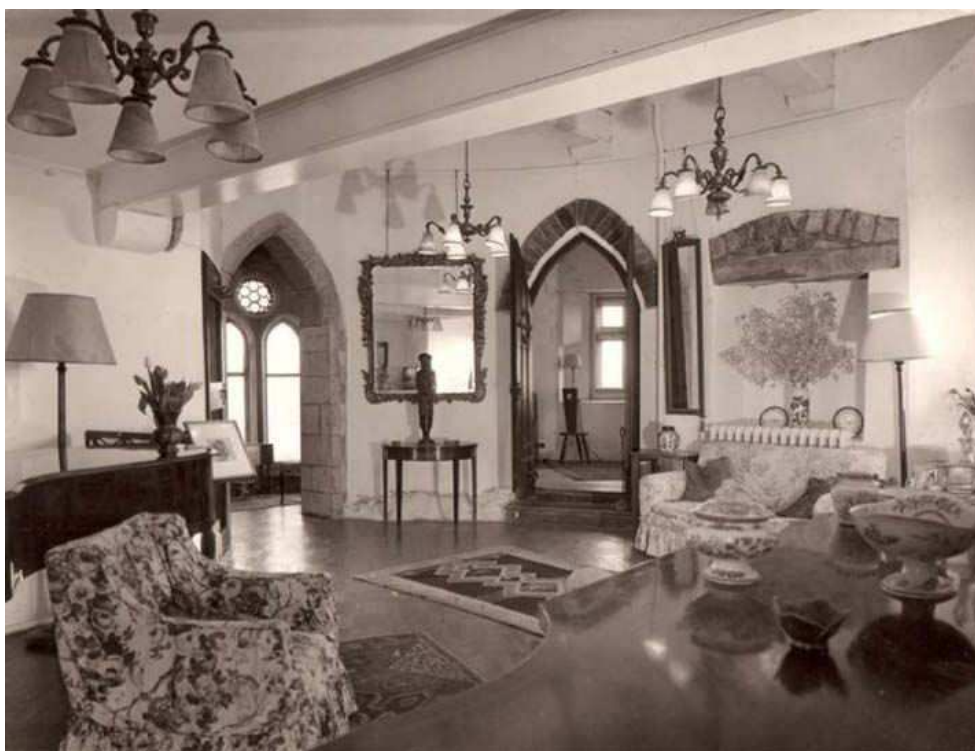
Photo 15: The Court Room (Room 3) looking southeast towards Room 4 (study, left hand side doorway) and Room 5 (Chapel) (centre doorway), taken during the 1950s (reproduced from Acanthus Holden Design and Conservation Statement 2008). The left hand wall before the arched doorway to Room 4 is a modern insertion.

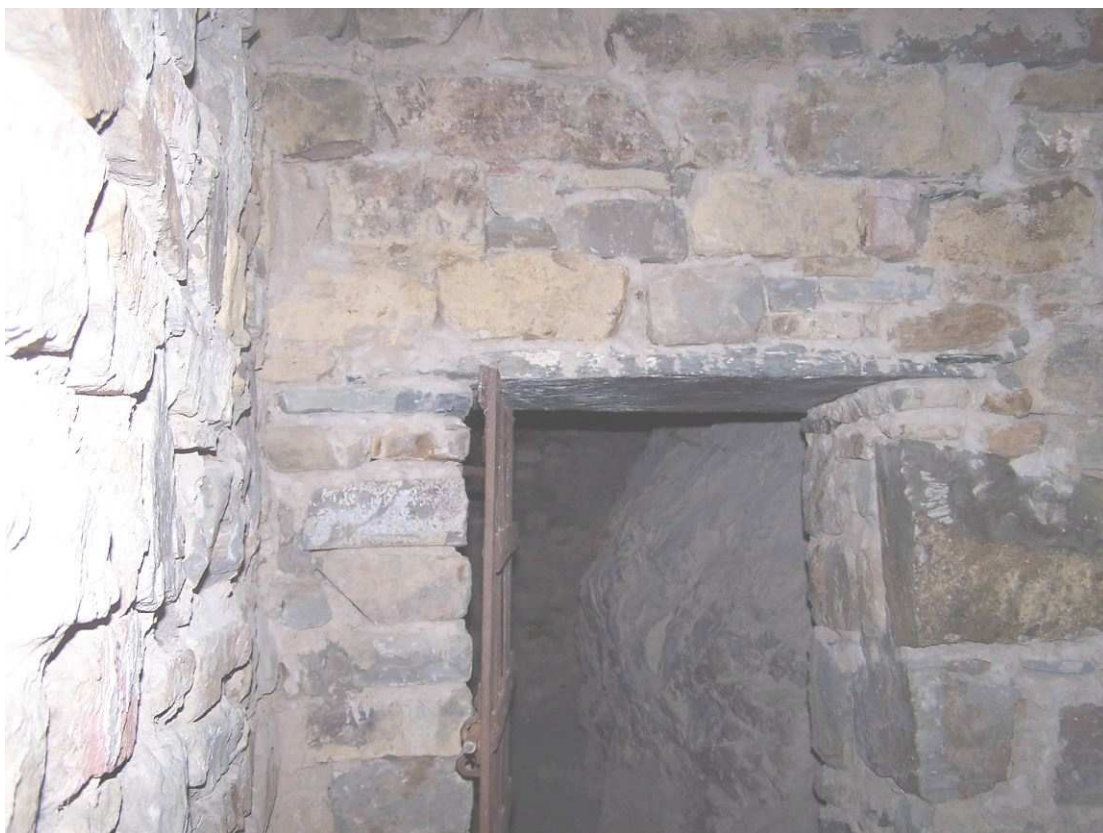
Photo 17: View east within Room 2 towards adjacent corridor running along northern edge of rock outcrop

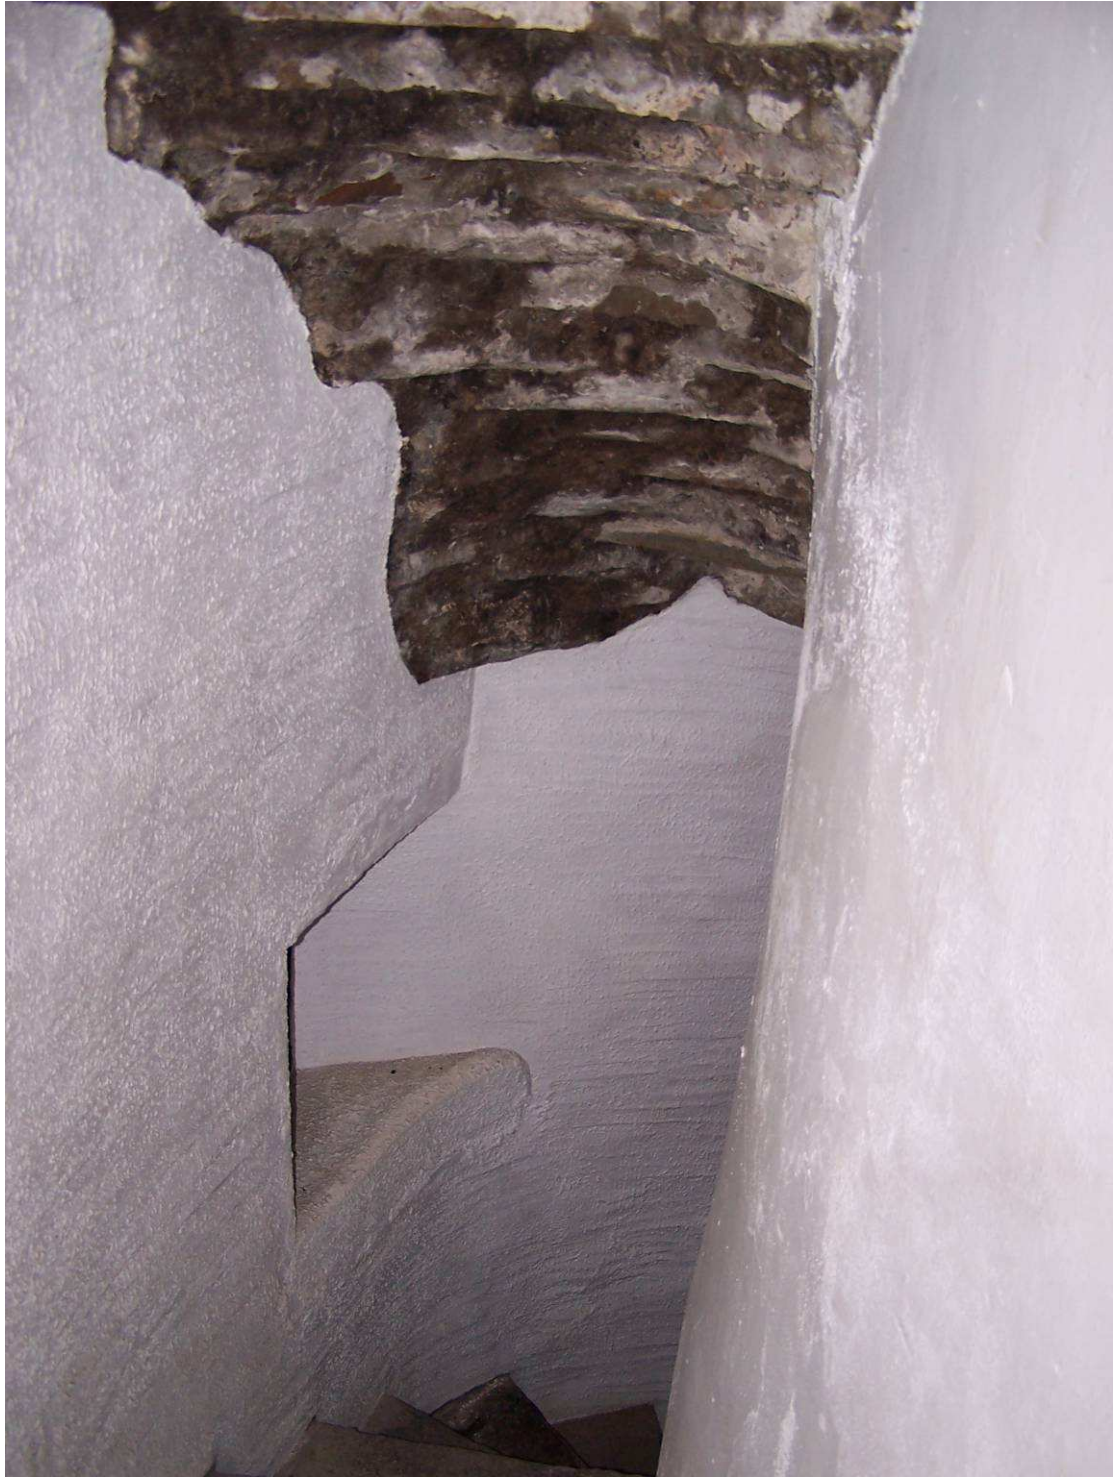
Photo 24: View south down staircase on southeastern part of castle, showing underside of original staircase above

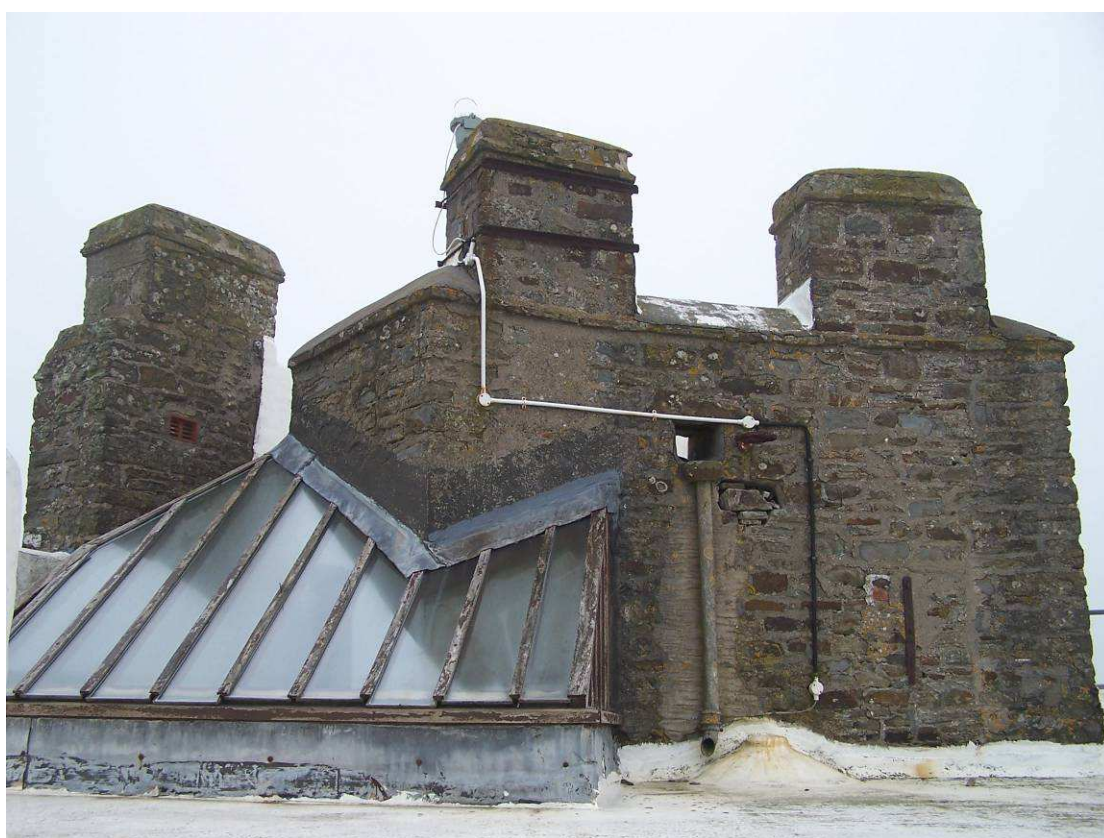
Photo 28: View towards roof of southern projecting square tower above Room 13
(modern glass addition covers the staircase area to the north of Room 13)

Following the removal of asphalt and other roof coverings a photographic record should be carried out, to include description and drawings where original fabric is revealed within the crenellations and any features that may come to light. The aim of this work will be to establish whether any original fabric survives at roof level. Only a photographic record would be needed of the remainder of the room. Investigation should be made of the curving inner wall of the southern projecting square tower to establish whether the wall represents part of an earlier wall (pre-dating the tower) or is merely a cosmetic feature mirroring the overall D-shape of the castle.

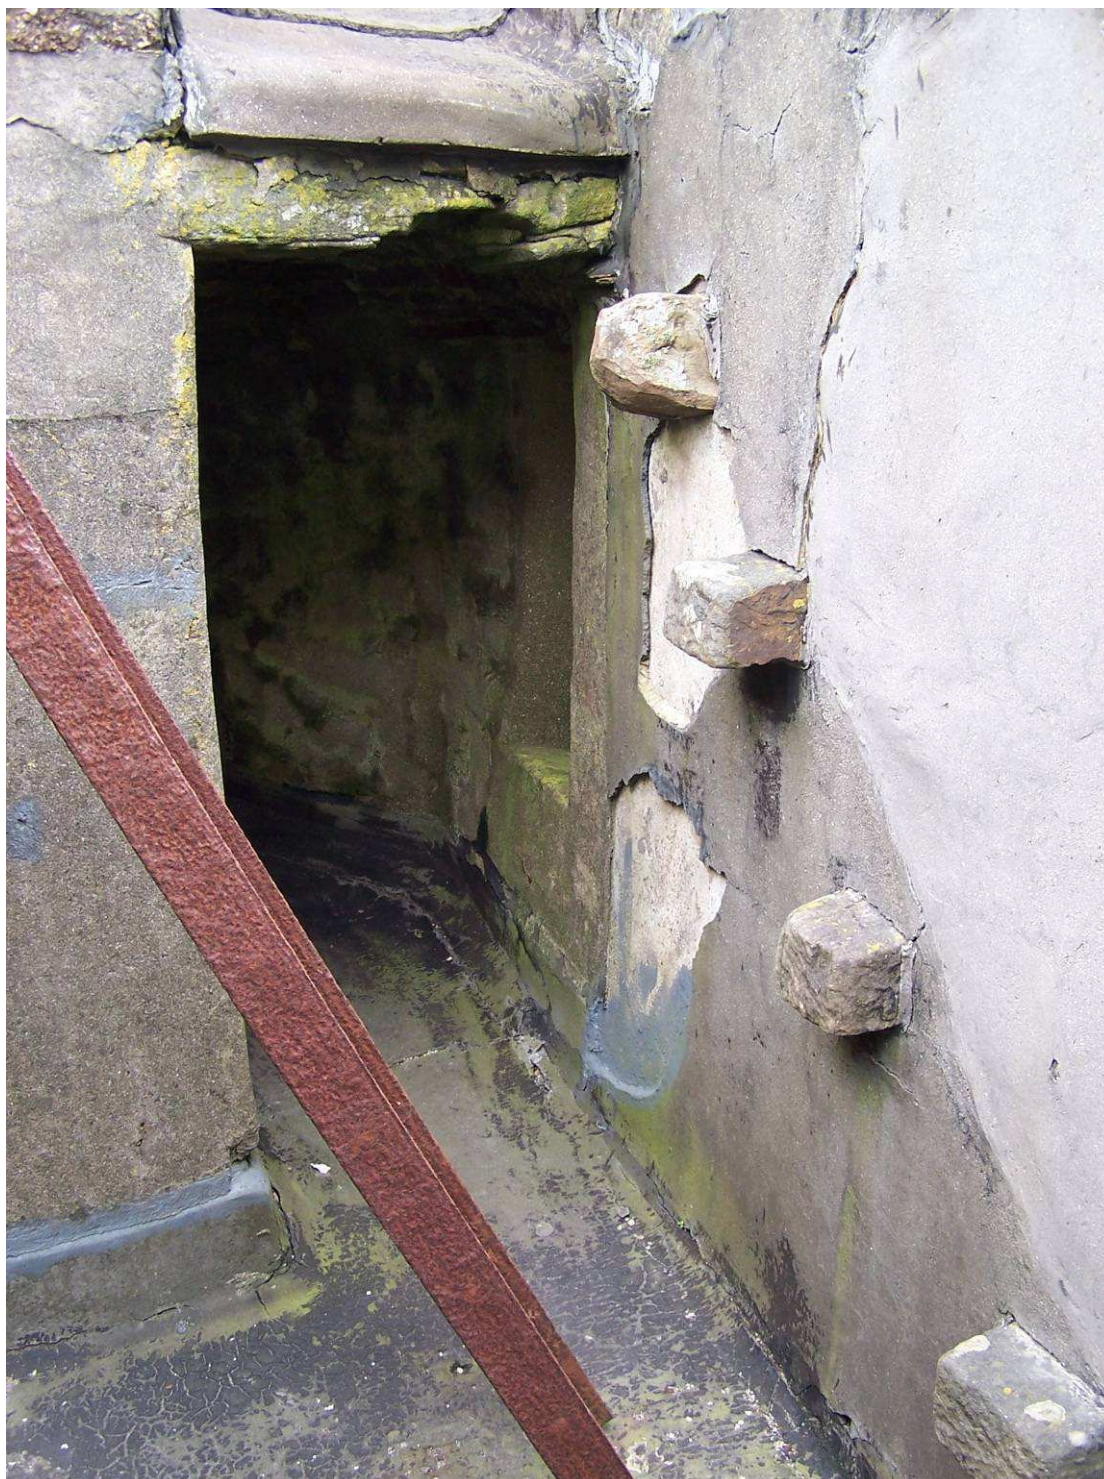
Photo 30: Projecting stones on the eastern side of the castle to carry steps to allow access to the turret floor.

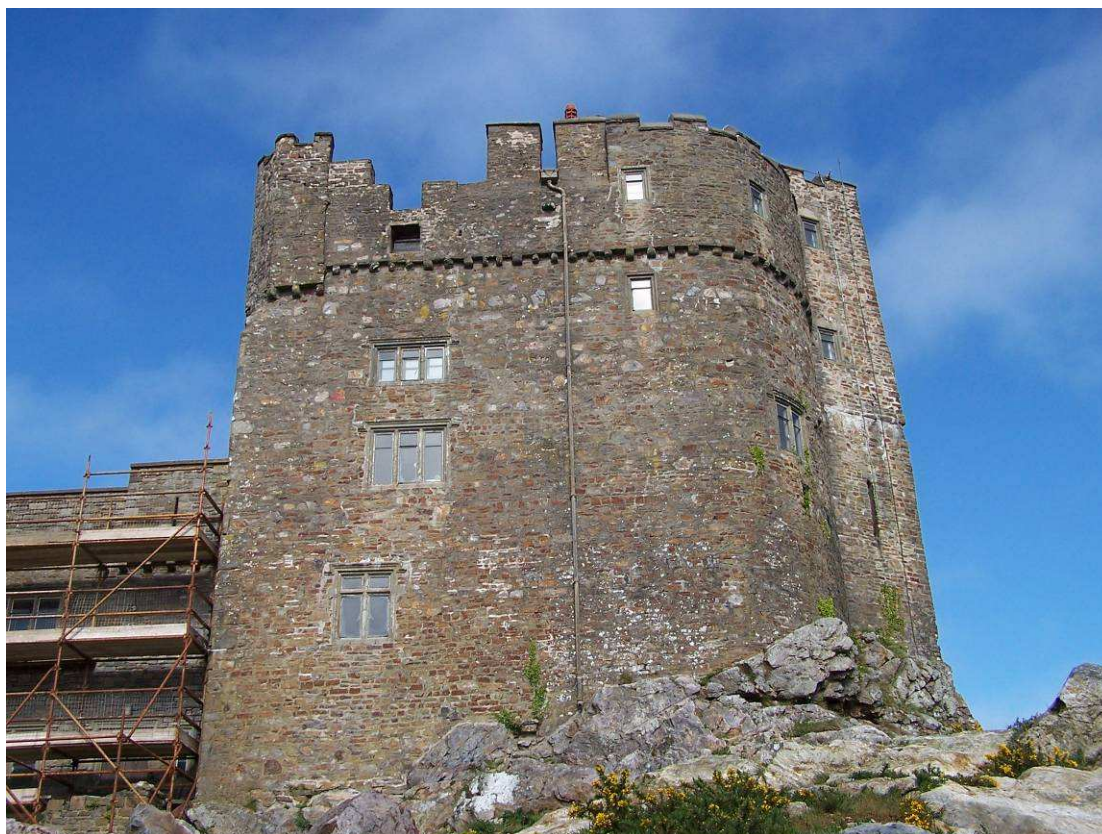
Photo 31: Western Elevation of Roch Castle

- 4.5.4 Based on internal layout it is considered that the windows on the northern part of the façade are replacement windows but in original window locations. The small window in the upper centre part of the elevation,

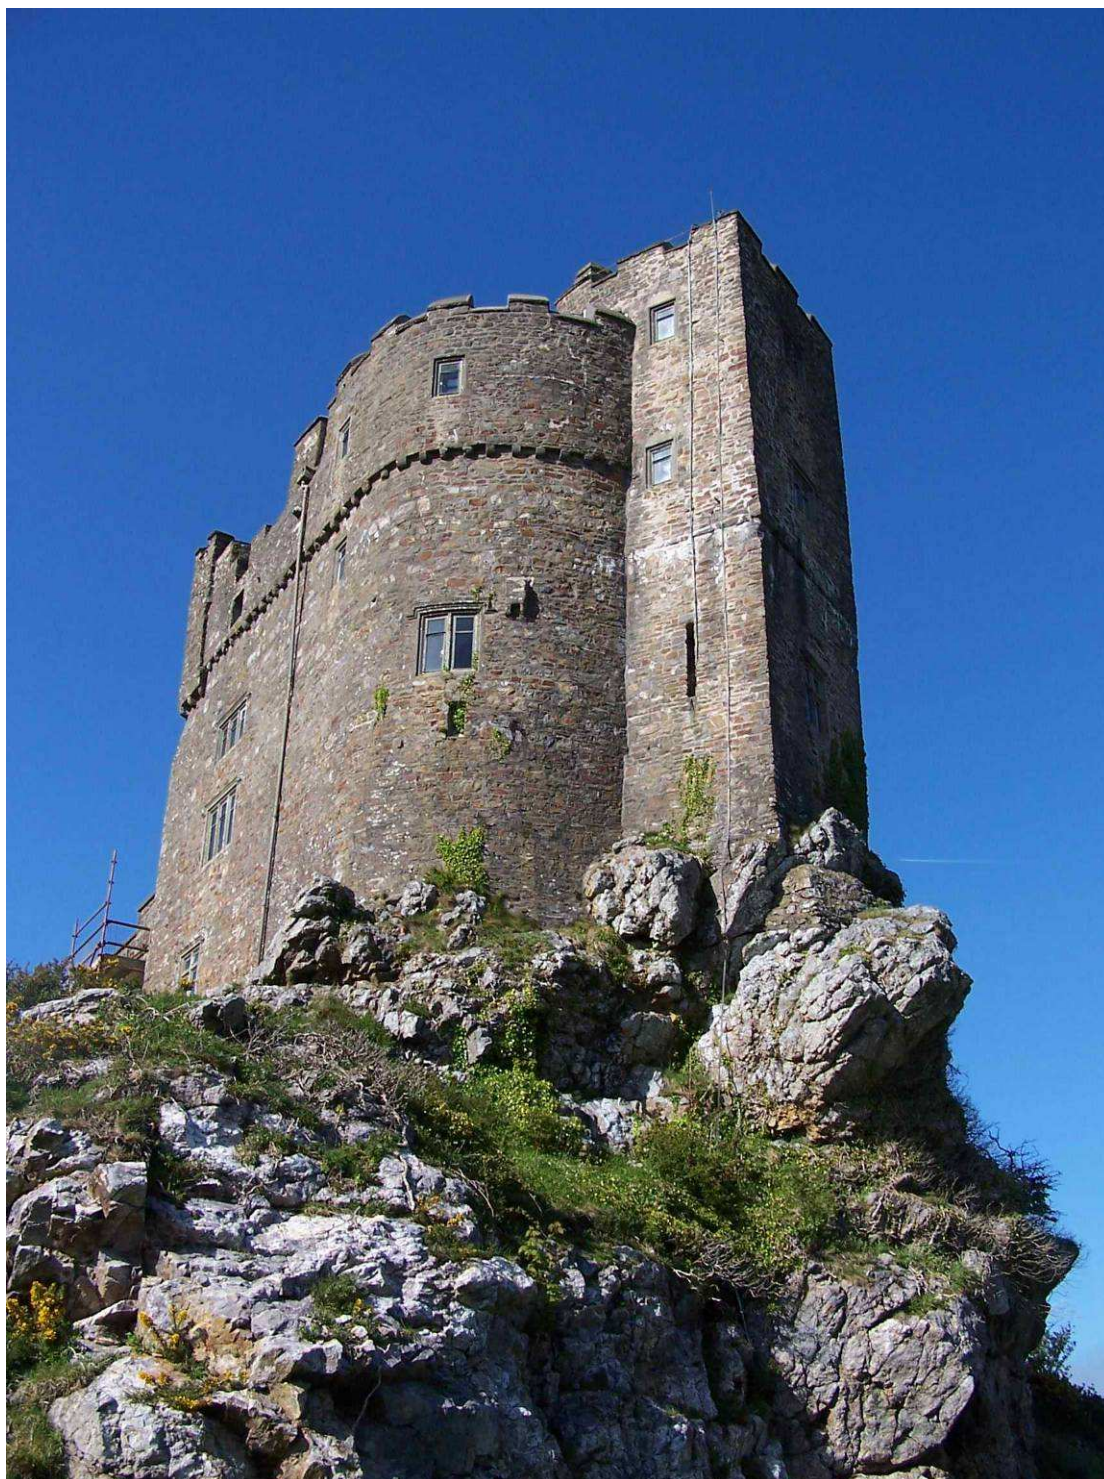
Photo 34: Southwestern elevation of Roch Castle

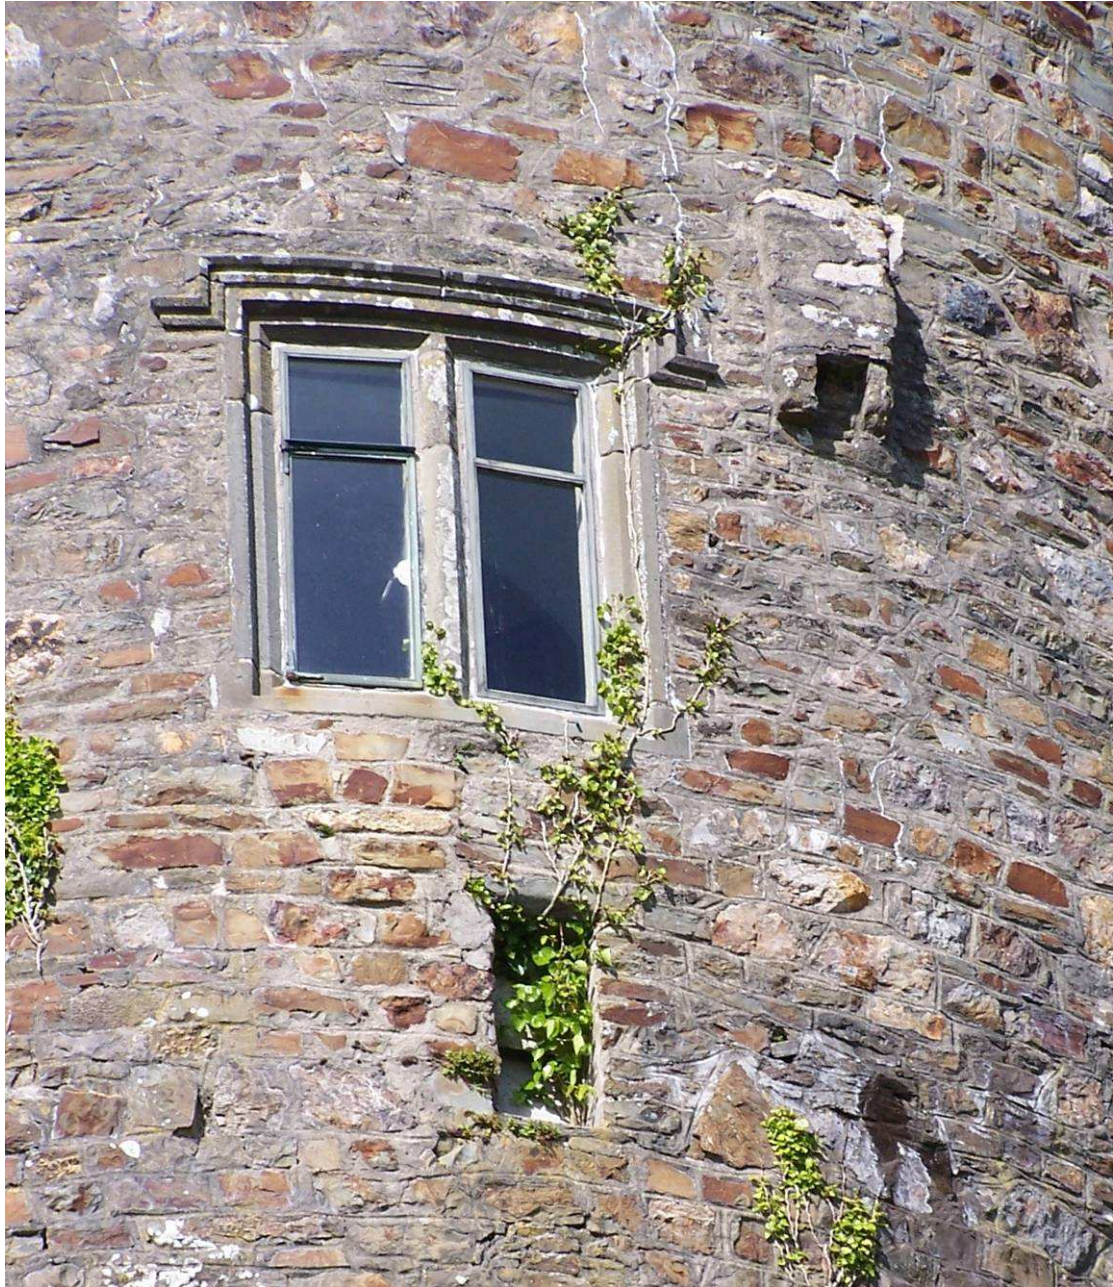
- 4.5.11 Two features are also visible on the curving wall of this elevation, including a small light just below the larger window and also a stone projecting feature located to the right of this window (Photo 35). It is assumed that these are original features. The stone light beneath the inserted window would be that which the lower part is visible within Room 2 (Photo 16). The relationship between the two windows and original floor levels needs further analysis.

Photo 35: Southwestern elevation of Roch Castle showing original features either side of window into Room 3

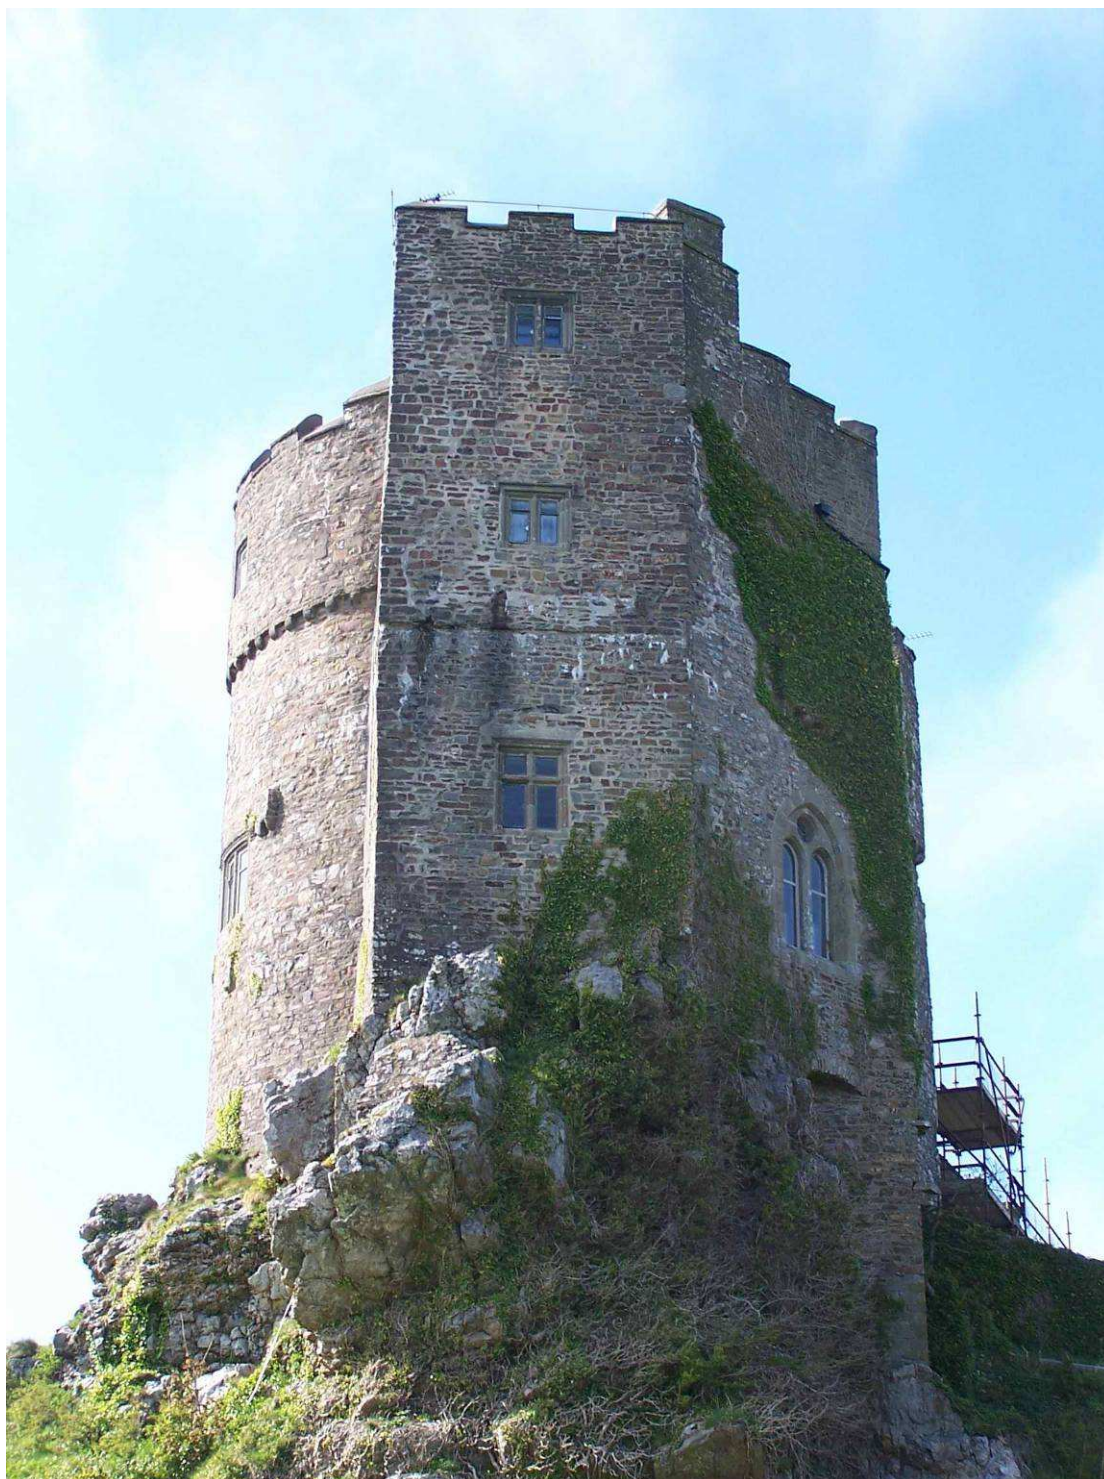
- 4.5.13 The southern and southeastern elevations (Photo 37) comprises the projecting square tower and the adjacent projection carrying stairways and possible garderobes on the upper floors of the castle.

Photo 37: Southern / Southeastern of elevation of Roch Castle
