ROCH CASTLE, PEMBROKESHIRE (SM 8803 2121)

ARCHAEOLOGICAL DESK- BASED ASSESSMENT AND BUILDING APPRAISAL

Prepared by Dyfed Archaeological Trust
For: Acanthus Holden Architects

RHIF YR ADRODDIAD / REPORT NO. 2009/36
RHIF Y PROSIECT / PROJECT RECORD NO. 95174

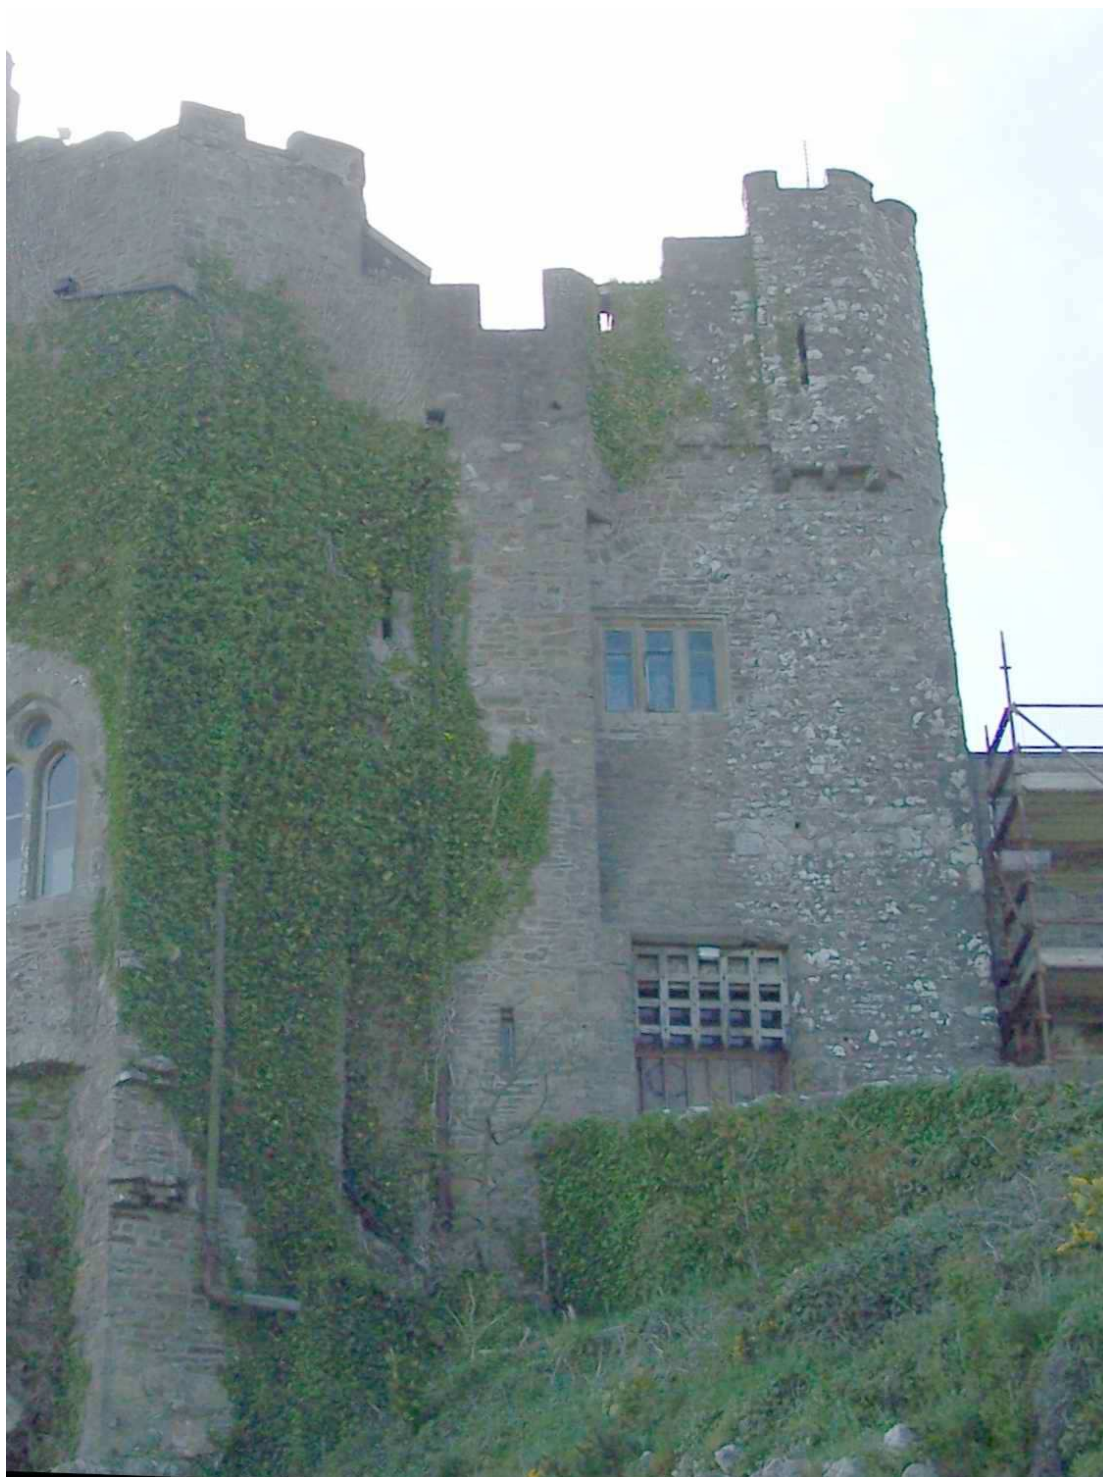
- 4.5.17 Also present on this elevation (Photo 38 and Photo 39) are three sets of projecting stones to the right of the relieving arch which are those as described by Clarke in 1864 which indicate the intention of a further wall coming off from the main castle, although no further evidence for this ever having been completed exists.

4.5.18 The eastern elevation has also been substantially rebuilt during the first phase of restoration. The early photographs and illustrations indicate a large void running down a sizeable portion of the wall, with the upper levels of the castle and crenellations also missing.

Photo 39: Eastern elevation of Roch Castle

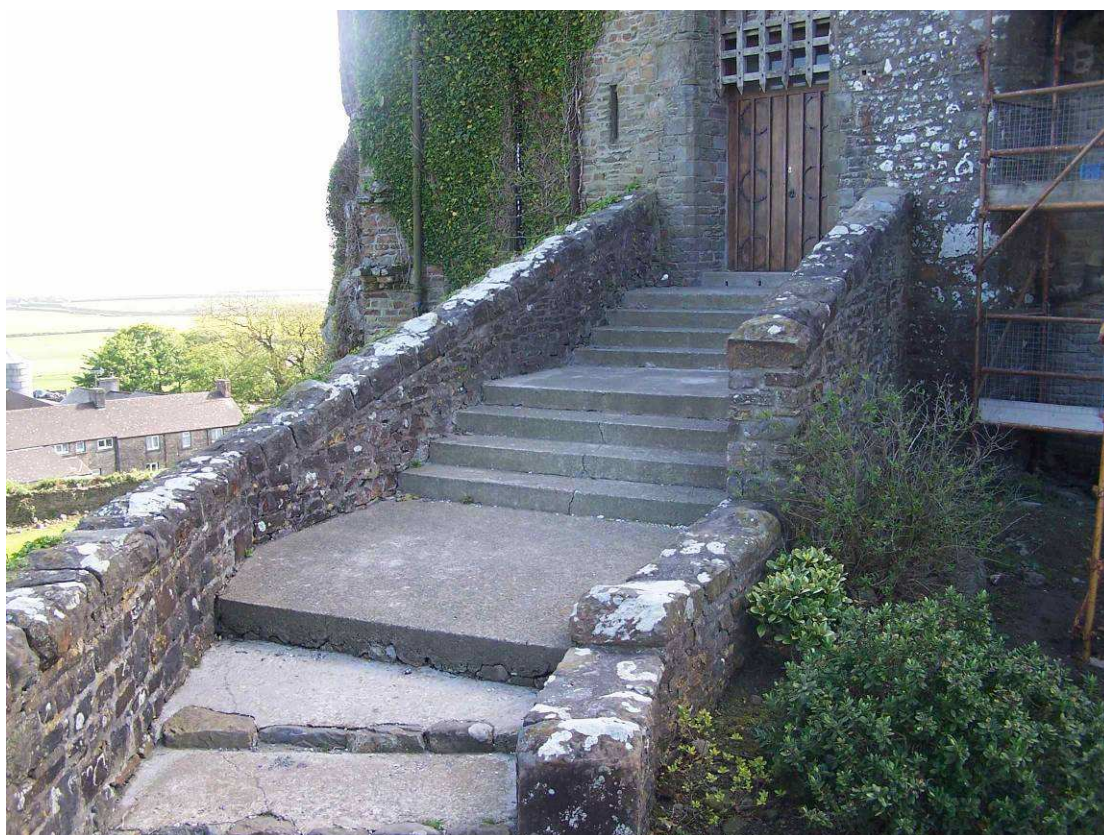
4.5.20 The main entrance into the castle is through the eastern façade, and has been substantially rebuilt and remodelled. This was inserted through an existing void in the fabric of the wall, as shown on earlier photographs and illustrations, although elements of a possible earlier doorway internally which suggest this was the original entrance (and as indicated on Illustration 2). The doorway was originally set fairly high within the wall of the building, and access was improved in the first phased of restoration with the construction of a stone stairway up to the doorway (Photo 41).

An arrow slit to the south of the doorway may be an original feature (as shown on Illustration 2).

Photo 41: Main doorway in eastern façade

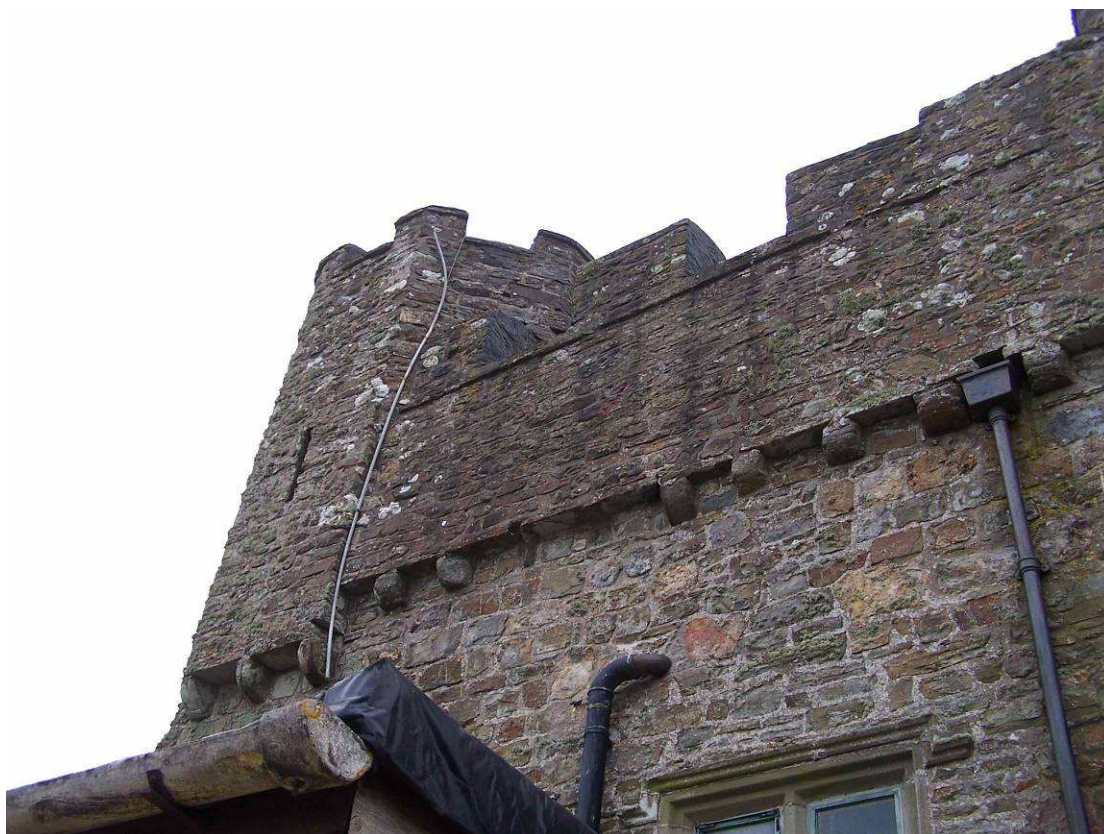
- 4.5.22 The majority of the northern elevation has been completely remodelled with the construction of the northern extension during the first and second phases of renovation. The only part of this elevation still exposed is that above the extension (Second and Third Floors). A central window is present on the Second Floor which is in an original location (as shown on Illustration 2) (Photo 42). The only other features on this wall are the entire stretch of the course of corbels, and the Eastern and Western Turrets (the corbel course beneath both of these may also be original).

Photo 42: Eastern side of Northern elevation, showing Eastern Turret, part of central window and corbel course

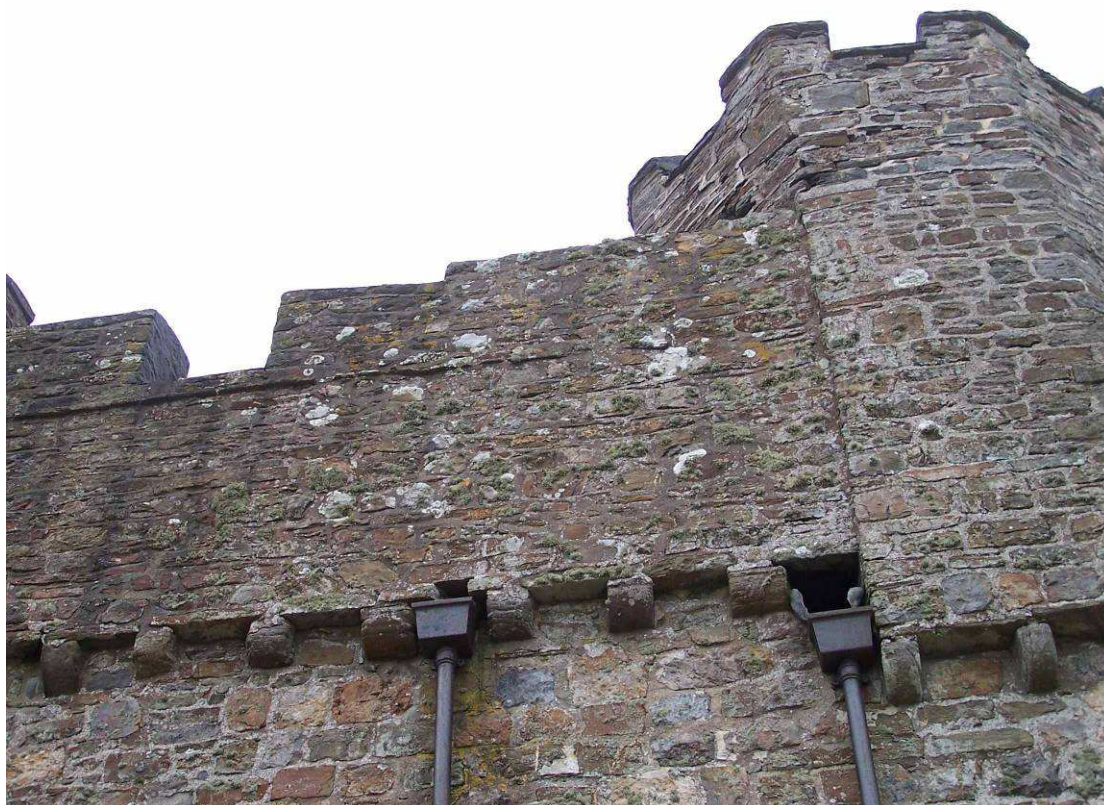
Photo 43: Western side of Northern elevation, showing Western Turret and corbel course

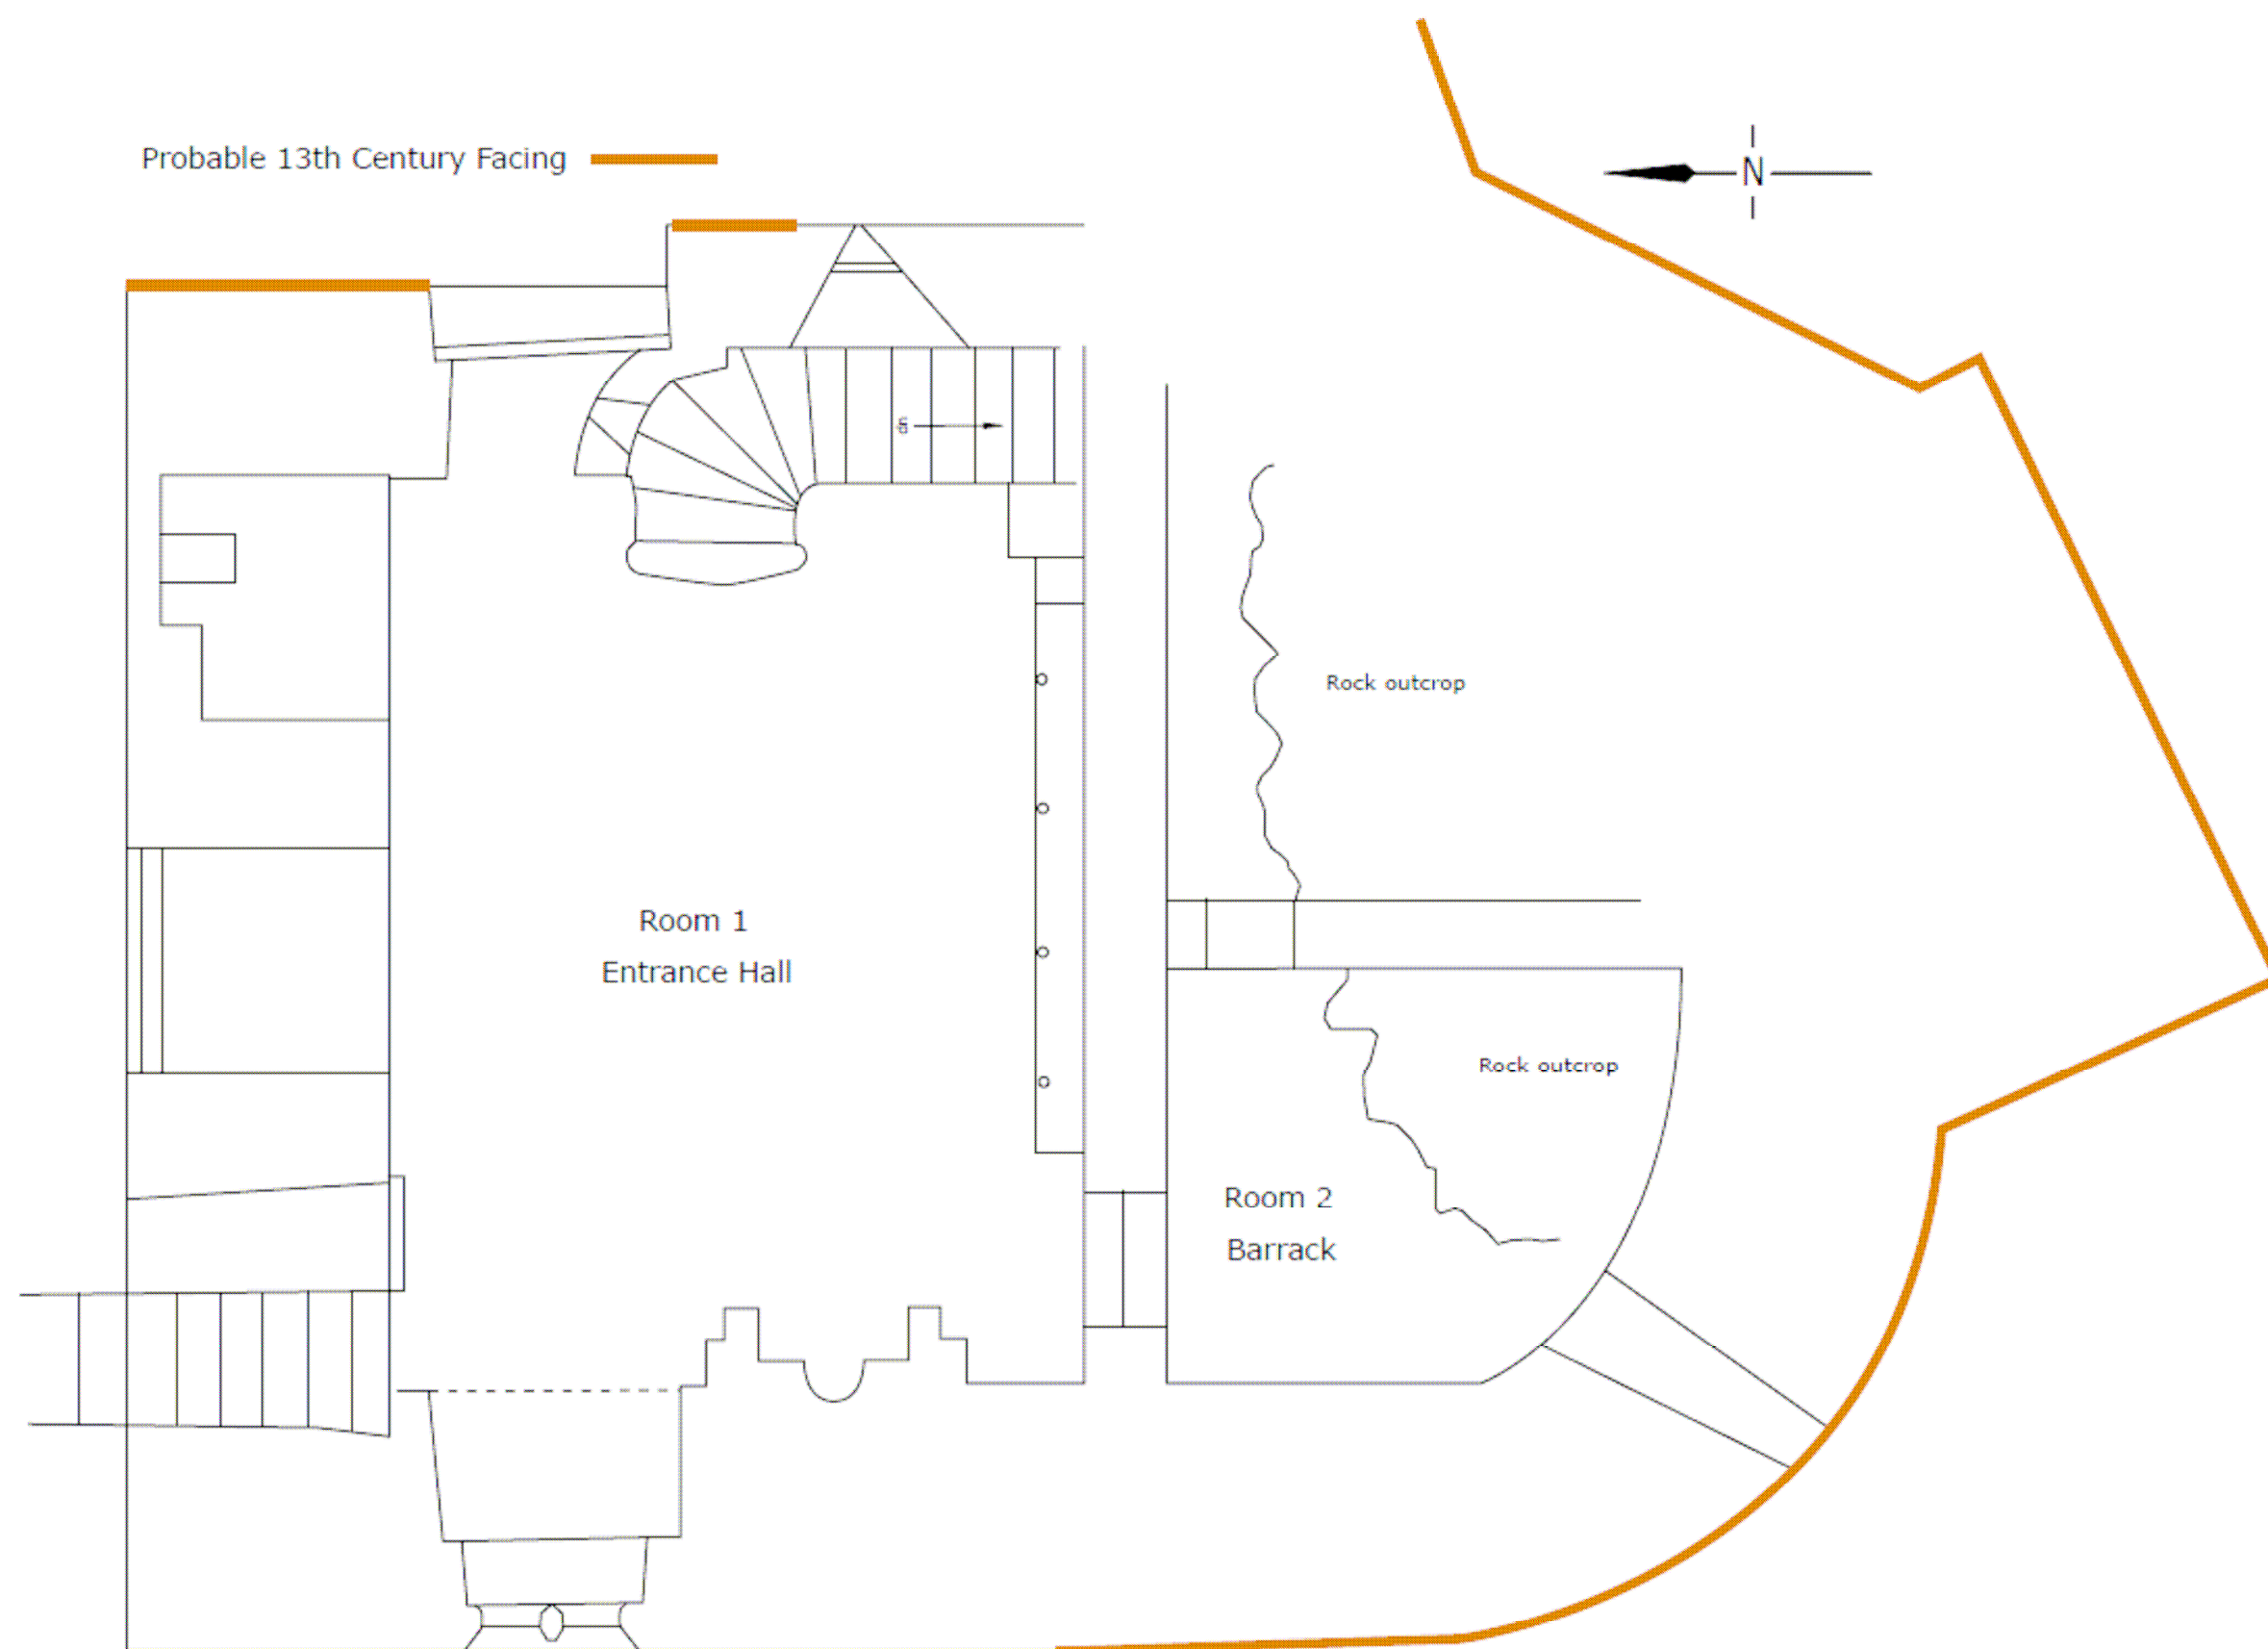
Figure 6: Ground Floor Plan of Roch Castle (based on RCAHMW survey)

- Ground Floor (Figure 6)
 - Room 1: Entrance Hall
 - Room 2: Barrack (room mostly occupied by stone outcrop)
 - Stairs to first floor (partially built in thickness of wall)

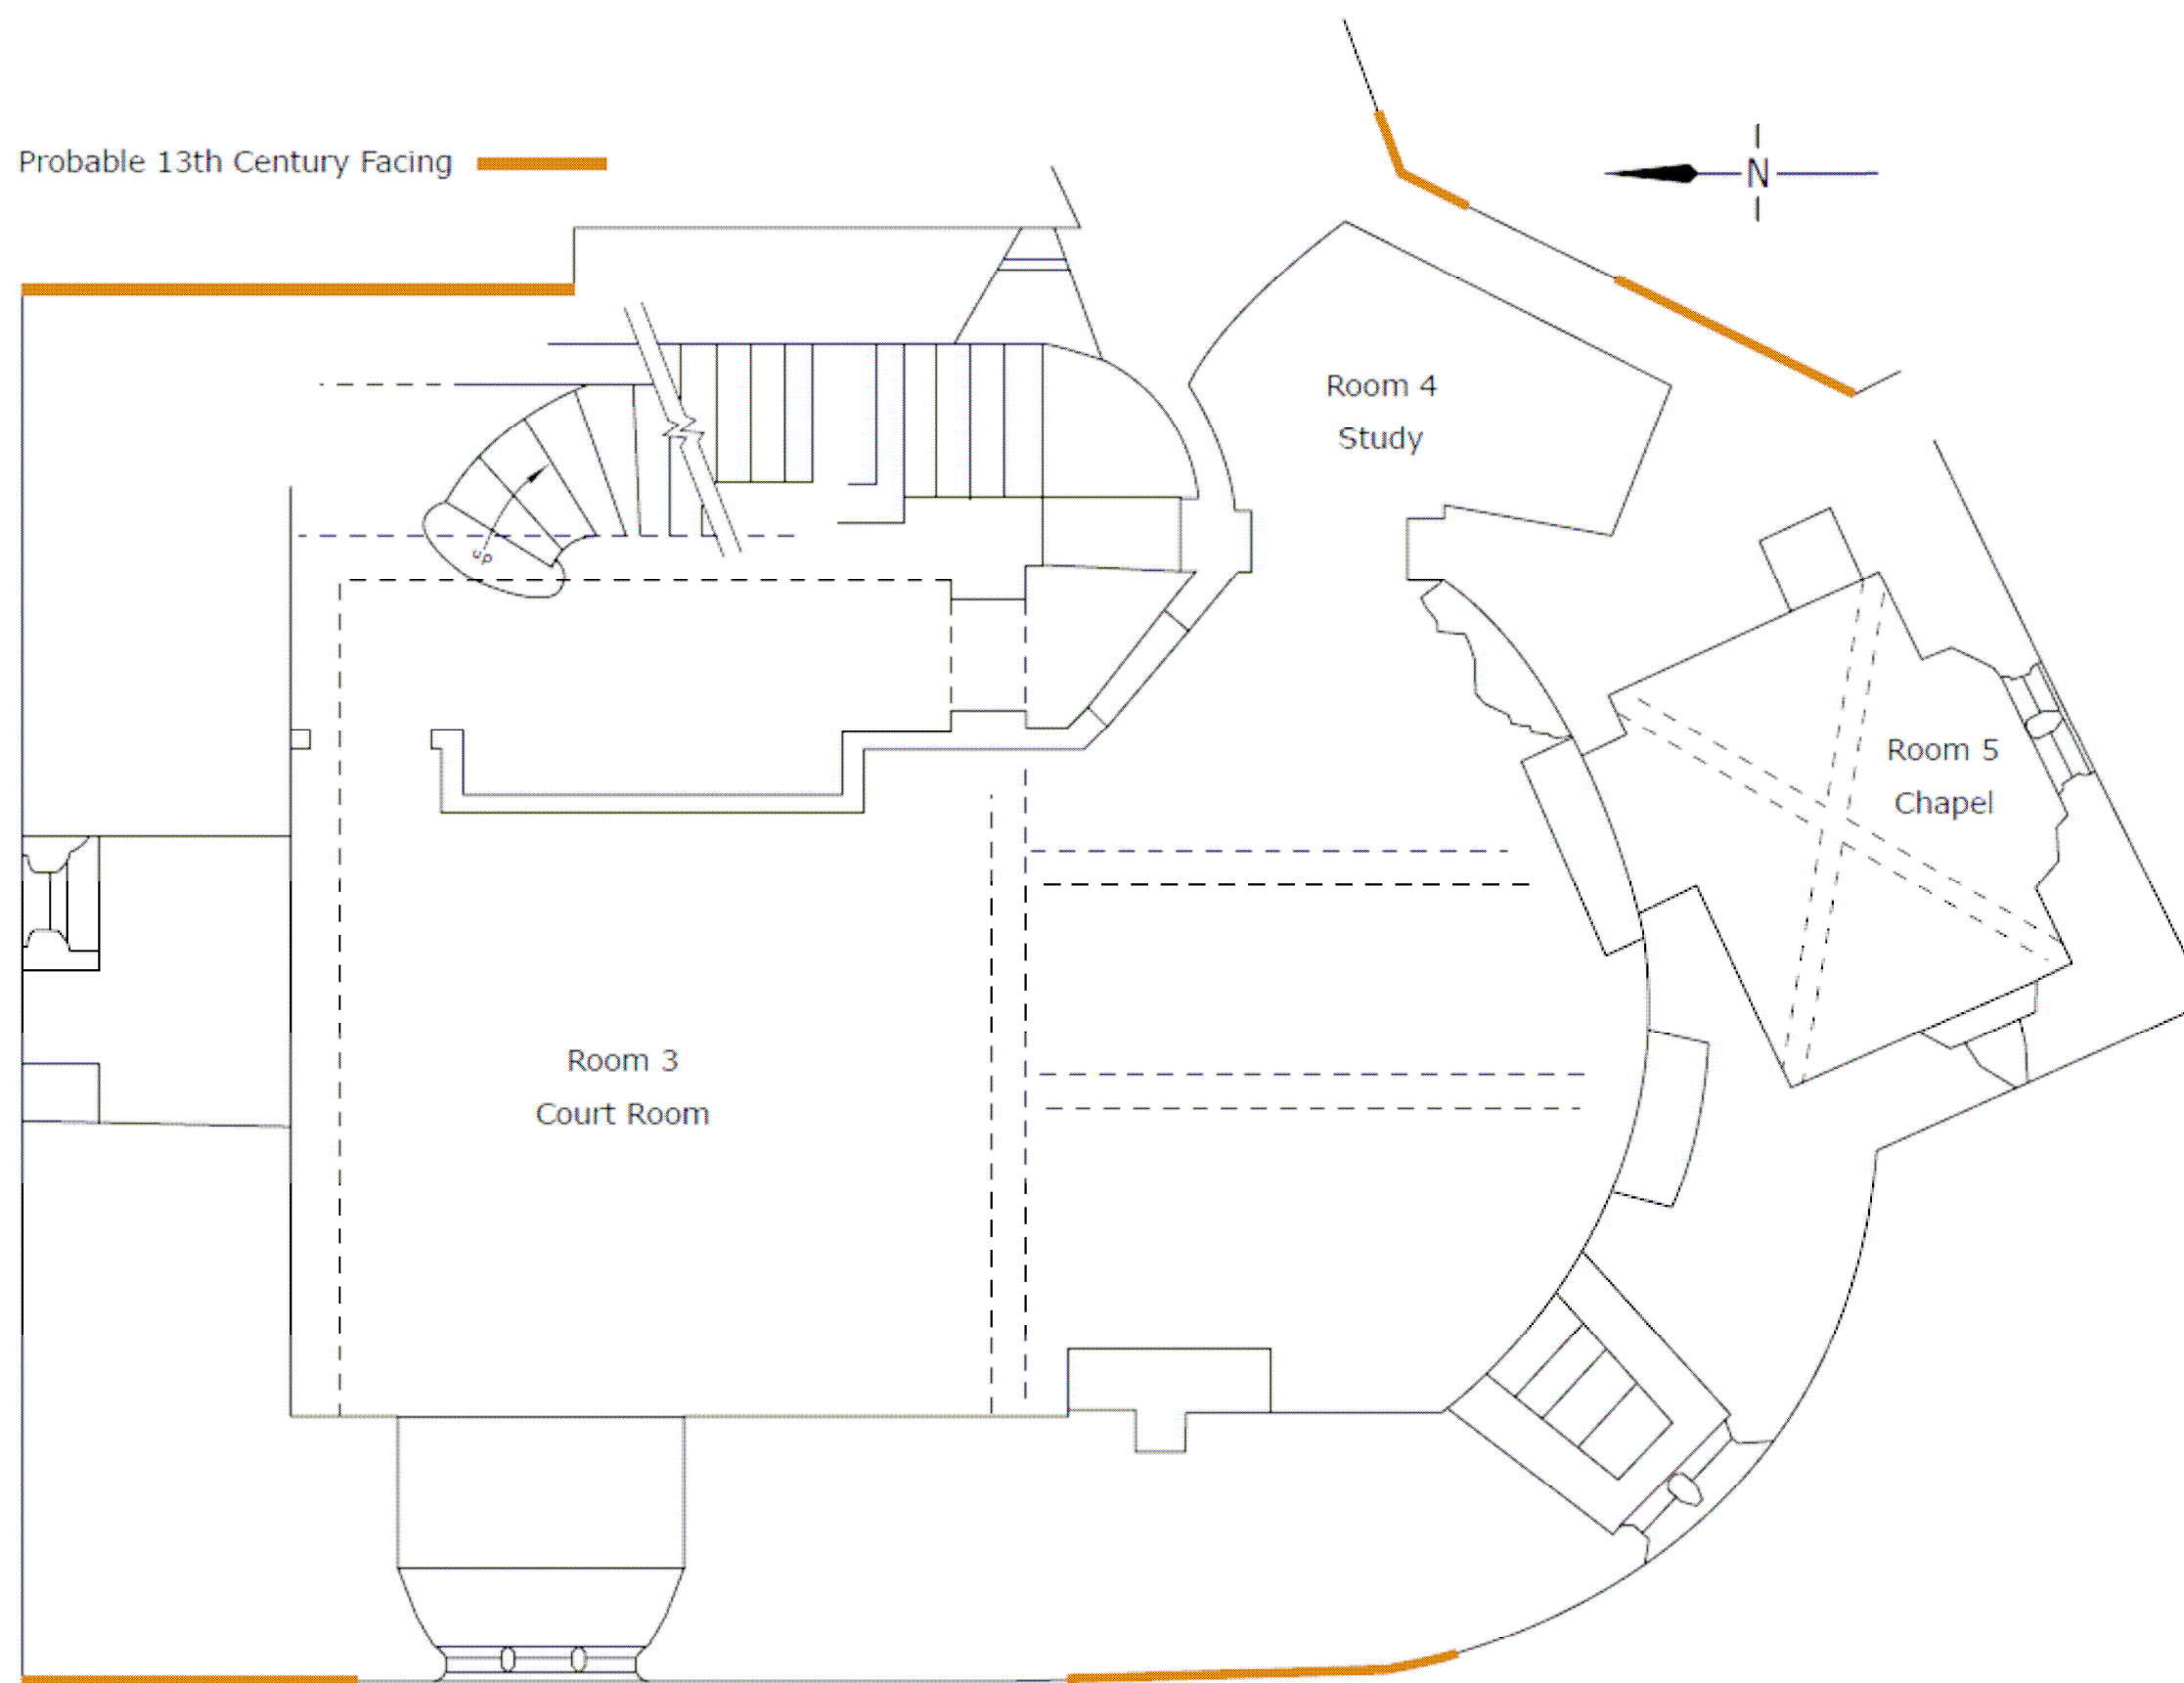
Figure 7: First Floor Plan of Roch Castle (based on RCAHMW survey)

- First Floor (Figure 7)
 - Room 3: The Court Room (main room, southern half lying on bedrock)
 - Room 4: Study (small room to south-east lying on bedrock)
