ST. DAVID'S CHURCH, MEIDRIM, CARMARTHENSHIRE (SN 2891 2086) ARCHAEOLOGICAL WATCHING BRIEF

RHIF YR ADRODDIAD / REPORT NO. 2009/84
RHIF Y PROSIECT / PROJECT RECORD NO. 98516

James Meek

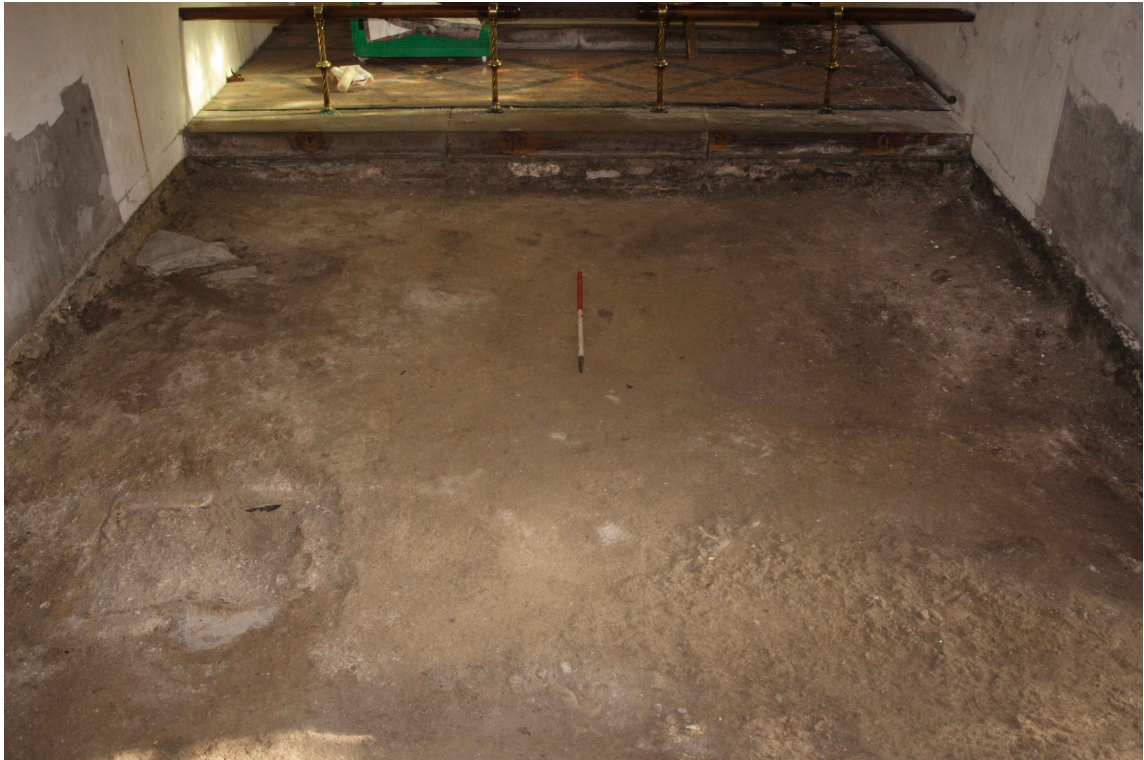
- 3.2.6 Following removal of the concrete and rubble from the entire area of the chancel, the earlier clay and mortar floor was found to be present across almost the entire area of the floor (fig. 3) except in one or two places where it had been previously disturbed.

Photo 6: Eastern half of chancel floor following removal of concrete and rubble levelling

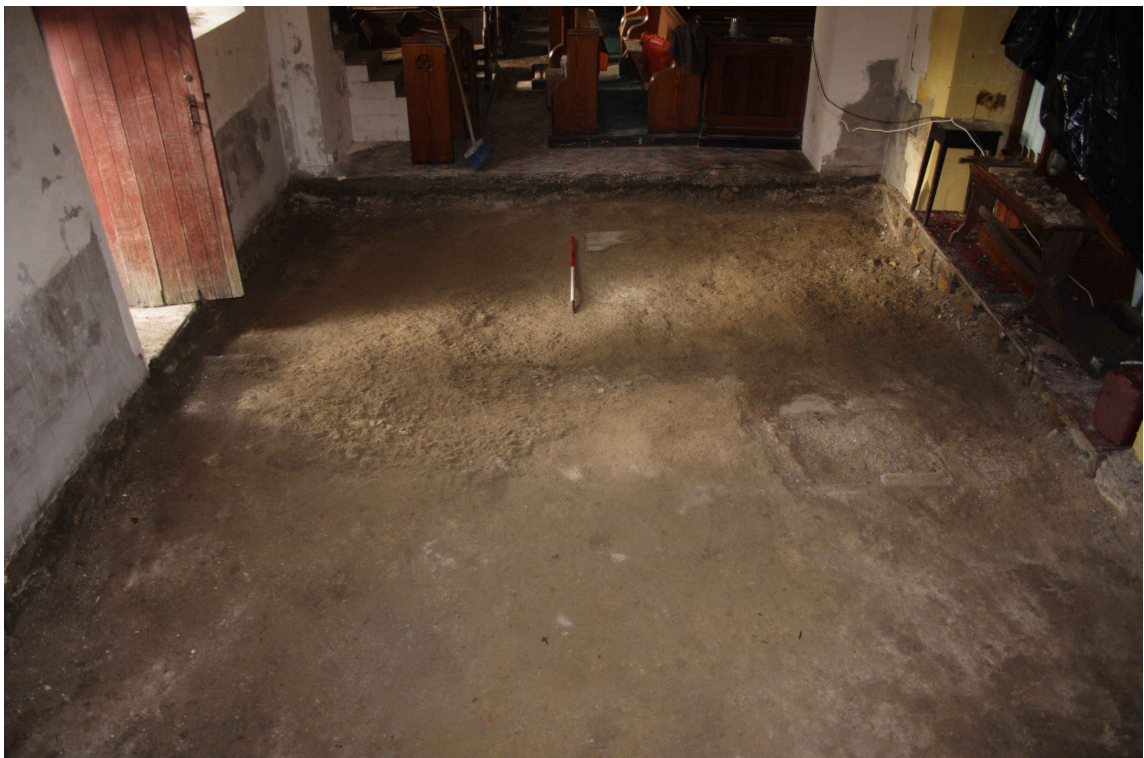
Photo 7: Western half of chancel floor following removal of concrete and rubble levelling
