ARFORDIR COASTAL HERITAGE 2009-2010

RHIF YR ADRODDIAD / REPORT NO. 2010/23 RHIF Y PROSIECT / PROJECT RECORD NO. 99087

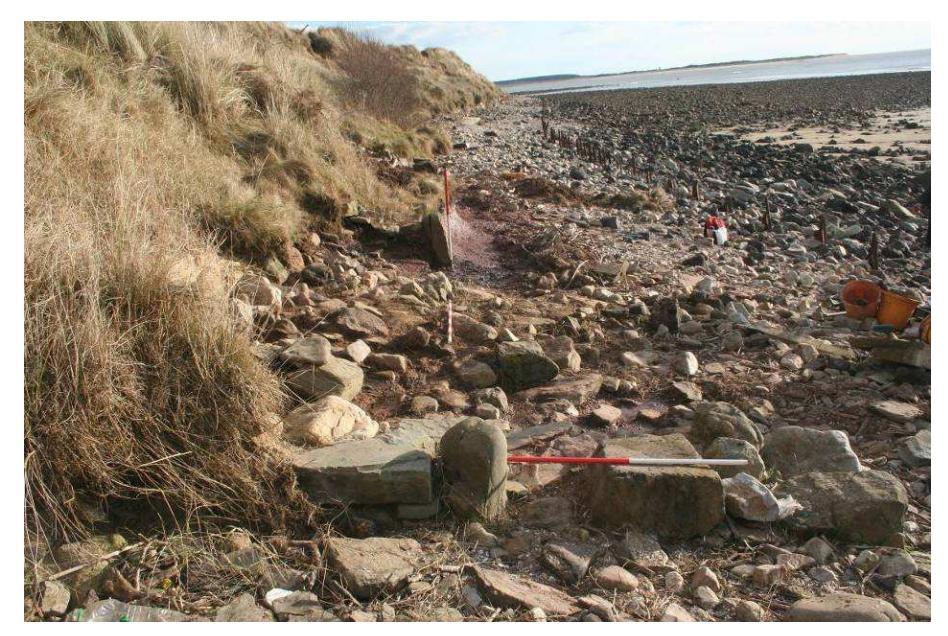
Photo 9: St Ishmaels Deserted Medieval Village

Deserted Medieval Village, St Ishmael, Carmarthenshire – PRN 2113, 99091, 99092, 99093 and 99094. The village site is discussed further in Appendix II. During spring tides and during storm surges the sand dunes which cover the site are eroded. It contains substantial stone buildings of probable 13th and 14th century date.

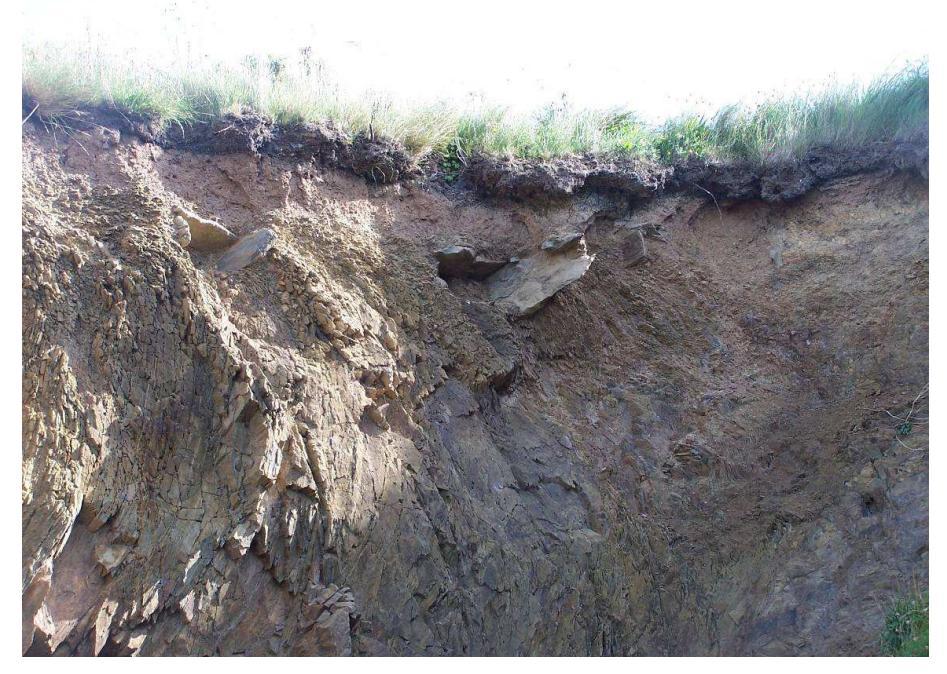
Photo 10: West Angle Bay cist graves

iii) Early medieval cist grave cemetery, West Angle Bay, Pembrokeshire, PRN 3092, 7595 and 35095, SAM PE 554. An area of cist graves are eroding from the cliffs on the northern edge of the scheduled area. This has been known about for many years, but over the course of the summer of 2009 into January 2010 a new cist grave has been revealed, and a previously known cist grave has completely collapsed from the cliff edge.

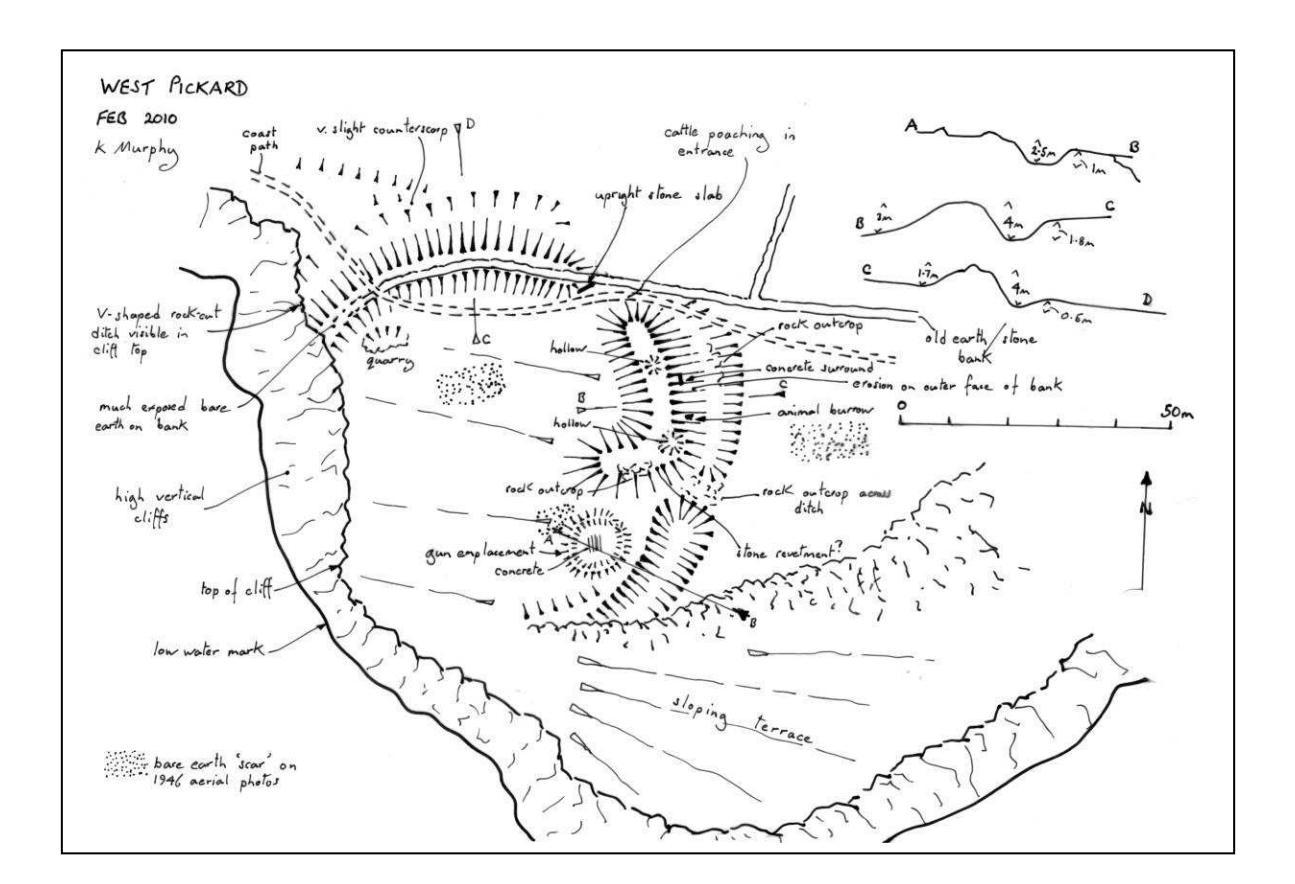
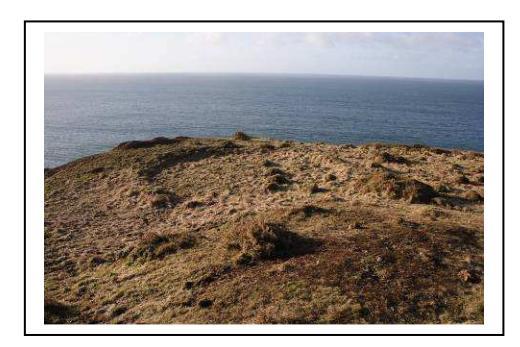
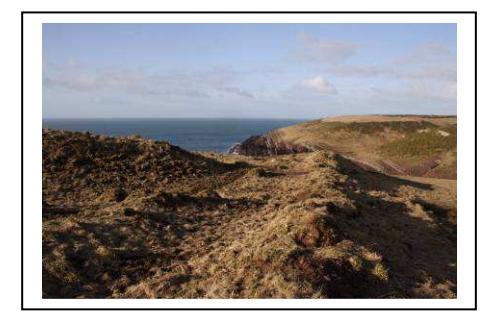
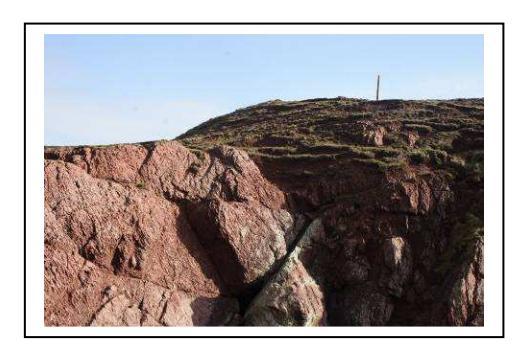
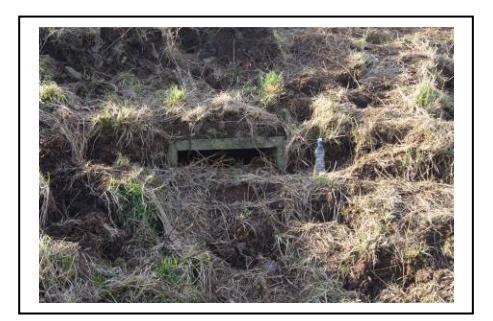
Coastal erosion is not a big problem at this site. Clearly the high sea cliffs are eroding along the west and southwest of the camp, but this does not appear to be very active erosion as there are no exposures of soil on the cliff top and no sign of new rock falls. There is some soil erosion on the banks caused by visitors and cattle, exacerbated by sea spray. There is also a fresh animal (badger?) burrow on the outer face of the defensive bank on the east side. The main area of concern is cattle poaching through the entrance, which maybe disturbing underlying archaeological deposits.

West Pickard Camp. Top: sketch plan. Upper left: WW2 gun position in fort. Upper right: looking through the entrance. Bottom right: possible WW2 emplacement dug into defensive bank. Bottom left: defensive ditch exposed in cliff face.

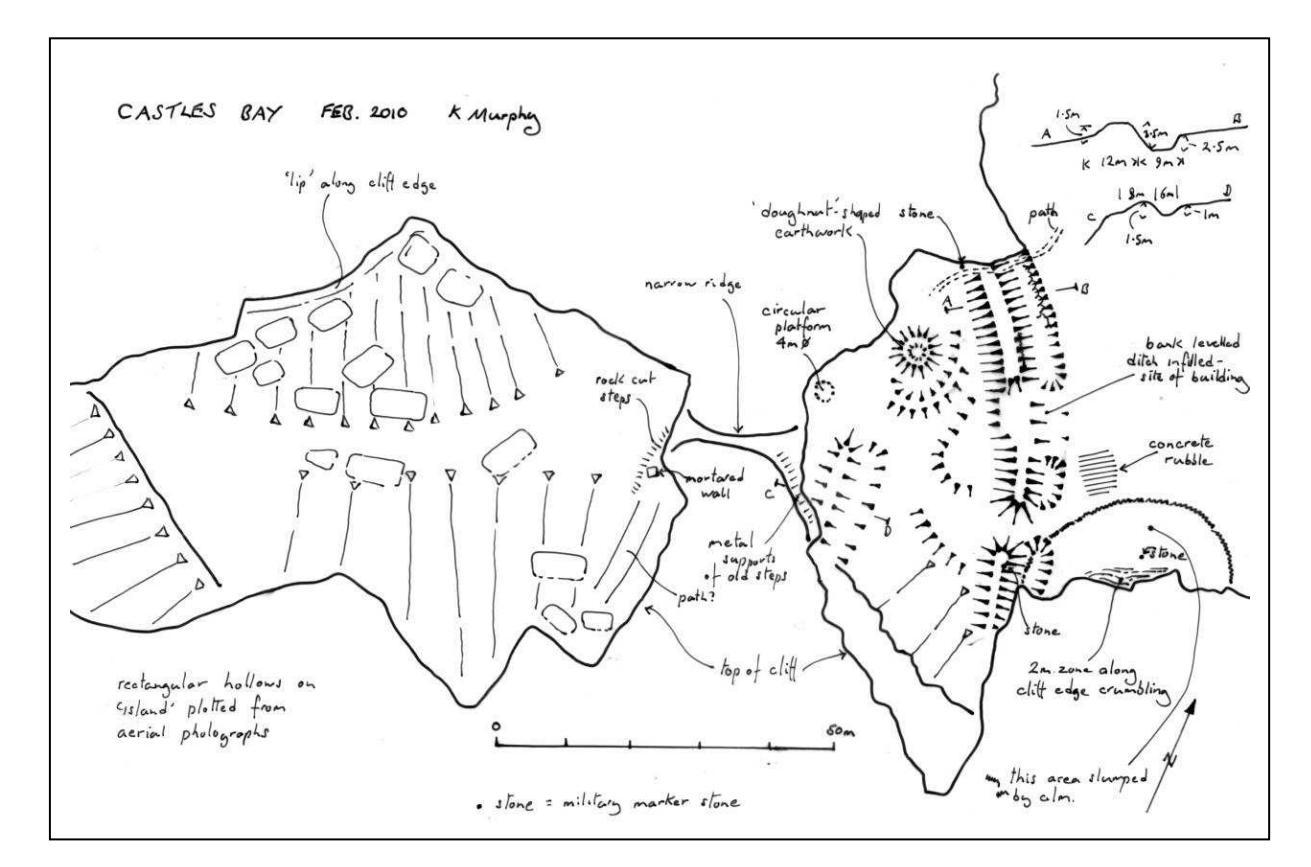
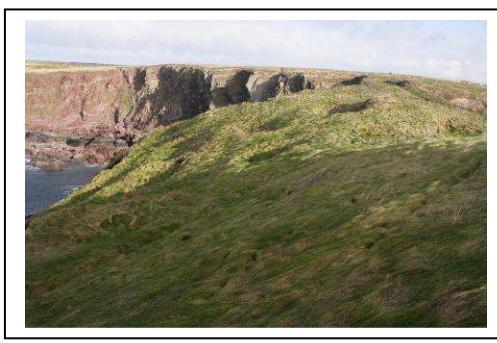
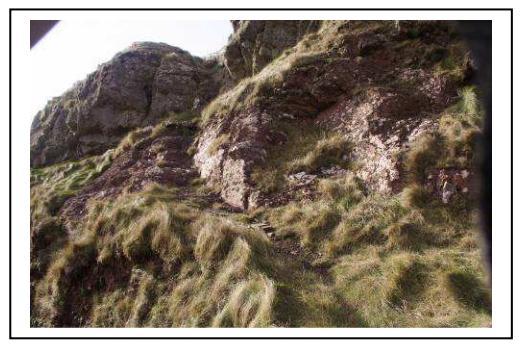
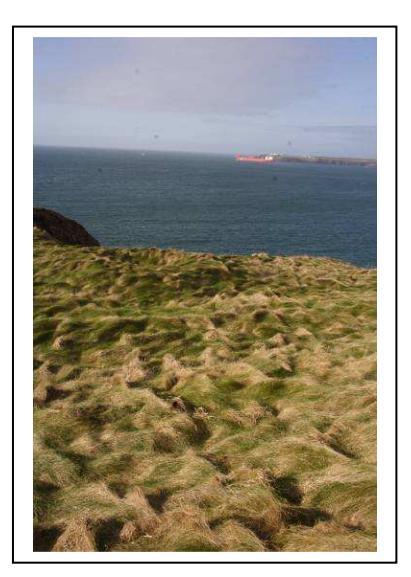
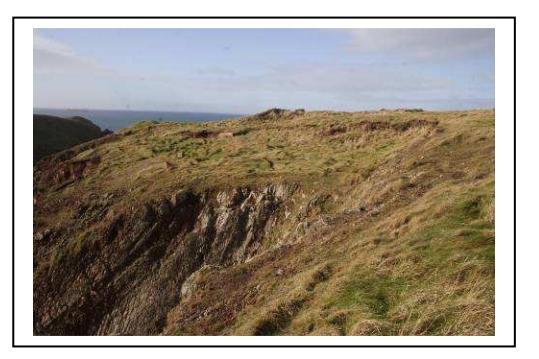
In addition to the damage caused by recent military activity, the site is suffering some coastal erosion. This is almost exclusively confined to Zone 1, and is to some extent quantifiable owing to the military marker stones of the late $19^{\text{th}}/\text{early }20^{\text{th}}$ century. For instance the stone placed at the northern end of the outer defensive bank is shown on the 1907 Ordnance Survey map right on the cliff edge – it is still on the cliff edge. Likewise, the stone towards the southern end of the defensive bank is the same distance from the cliff edge as it was in 1907. The stone to the east of the promontory fort entrance is an area of slumping – a block of land c. 30m by 15m has dropped by about 1m. This slumping was observed in the mid 1990s and does not seem to have increased since then, but the cliff edge is now crumbling. George Owen's 1660 description of the gully between Zone 1 and 2 is recognisable today, indicating minimal loss since then. However, the presumed Iron Age inner defensive bank and ditch now (and in 1660 as well as the medieval period) does not enclose any interior area. The conclusion must be that much of the original area of the Iron Age fort has been lost; the deep gully formed between the Iron Age and the medieval period, and the originally Zone 2 and Zone 1 were contiguous.

Castles Bay. Top: sketch plan. Upper left: hollows in Zone 2. Upper right: stone cut steps leading into Zone 2. Bottom left: doughnut shaped military earthwork. Bottom right: slumping immediately outside fort.

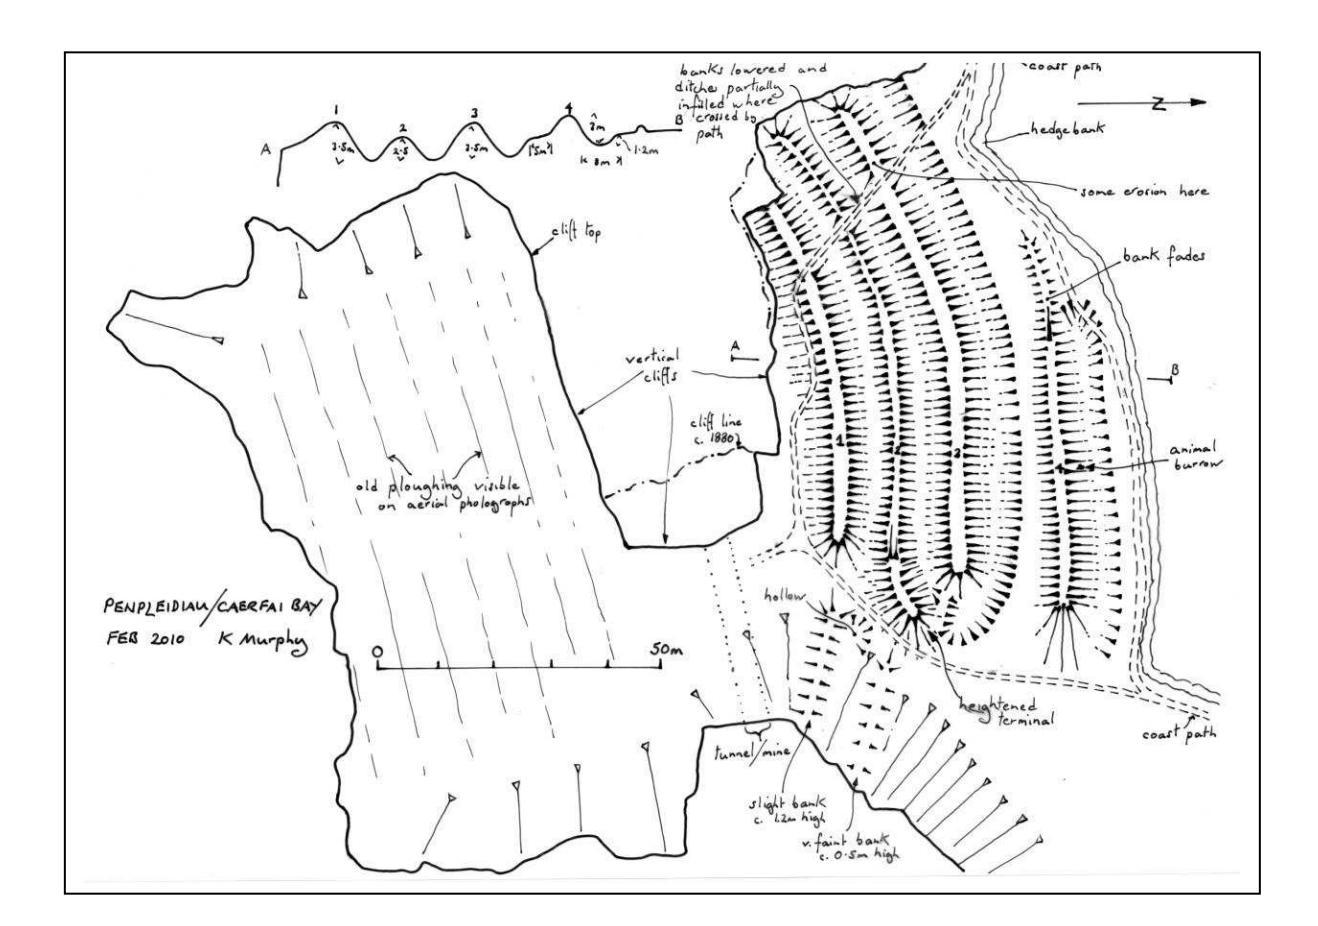
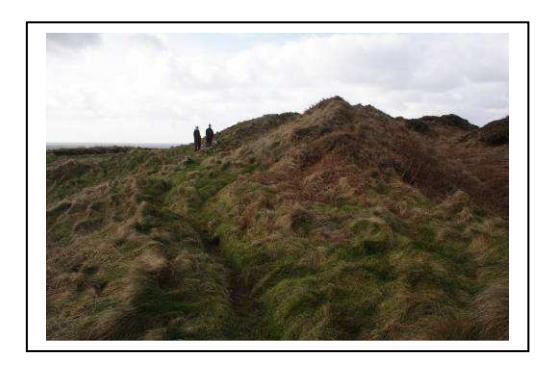
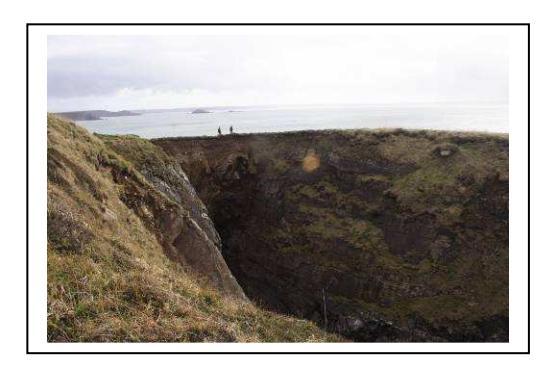
Apart from the major loss caused by the gully there are few other problems associated with this fort. There has been loss above the high cliffs at the western end of the defences, but the banks here are covered with vegetation and apparently stable. Bank 2 is beginning to curve to the south at its western end as though to meet a cliff edge, and so loss here may have been only a few metres. Visitors following a path over the western end of the ramparts are causing some erosion, but this is not severe and is long standing, the path having been in use since the 1880s.

Penpleidiau. Top: sketch plan. Above left: the out-turned and heightened terminal of bank 2. Above right: the massive gully eroded into the interior of the fort.

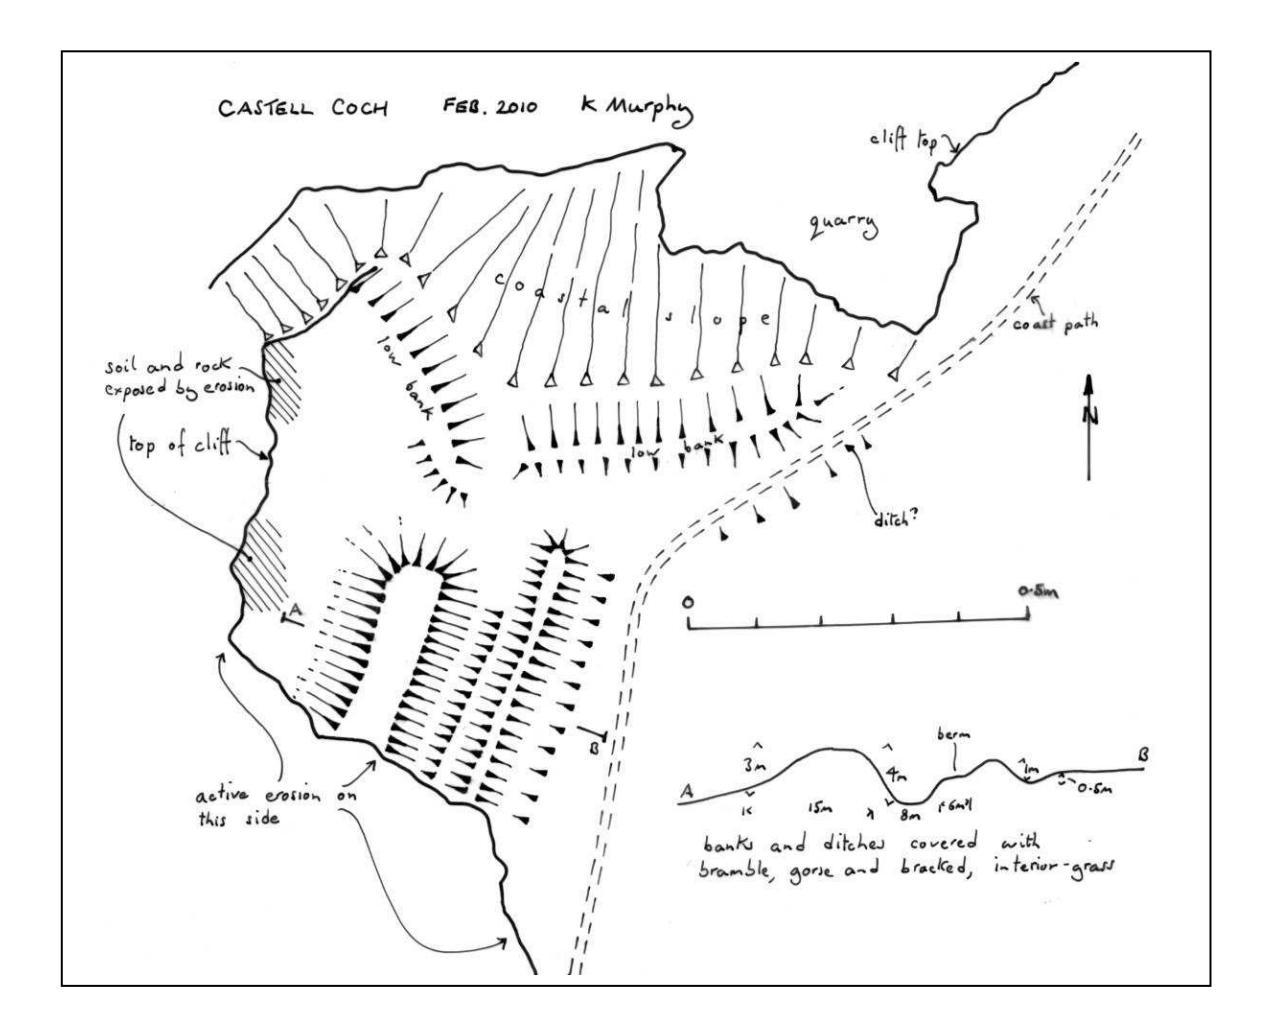
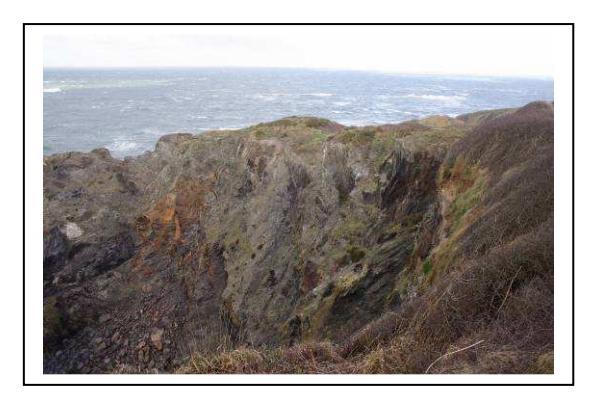
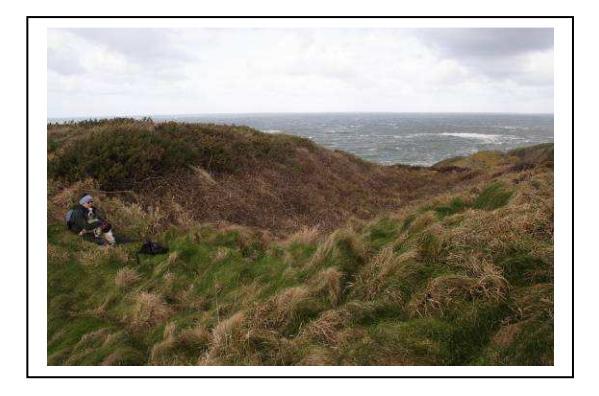
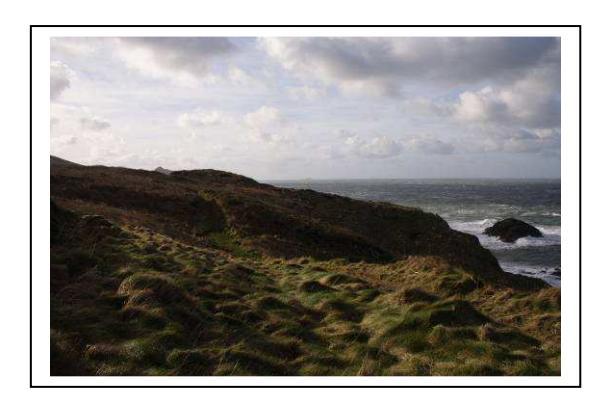
It is likely that part (most?) of the fort's interior has been lost to the sea. The promontory continues to the west as sea-washed rock; this may represent the original area of the fort.

Castell Coch. Top: sketch plan. Upper left: the fort from the south showing eroding cliff. Upper right: the inner bank and ditch. Right: the fort from the northeast.

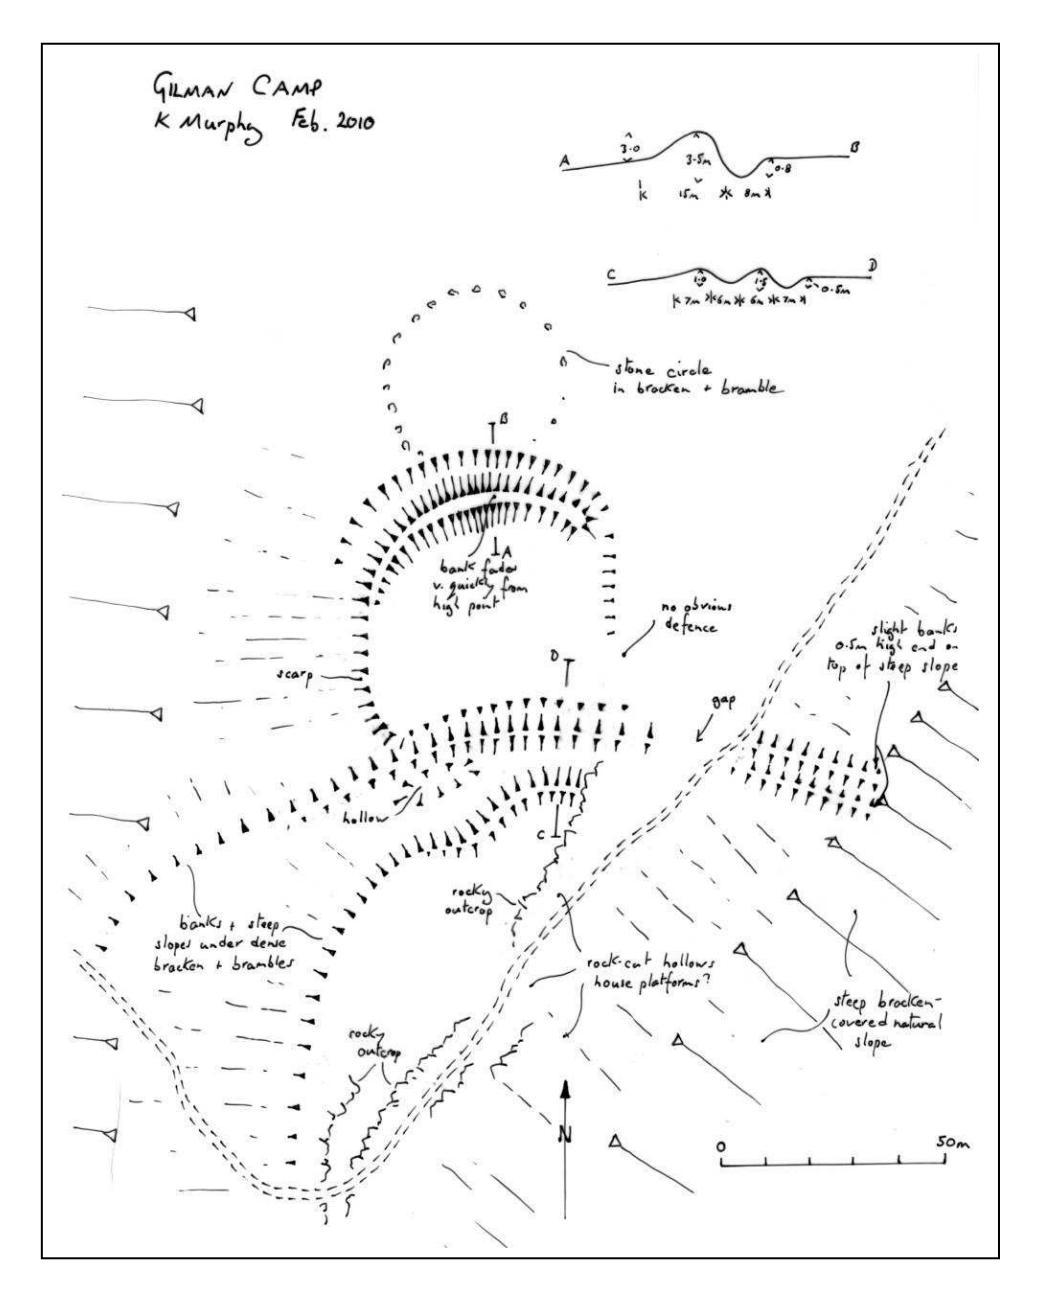
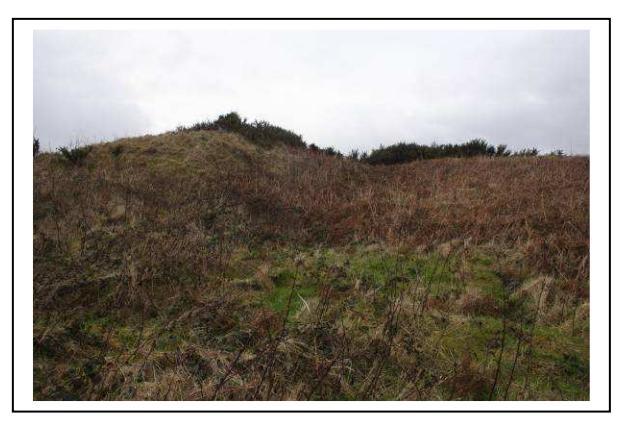
The site is in good condition with little damage. It is, however, becoming very overgrown with bracken, bramble and gorse, with only the interior of Zone 2 and the ridge top in Zone 1 relatively free.

Gilman Camp. Above: sketch plan. Right: the outer bank and ditch.

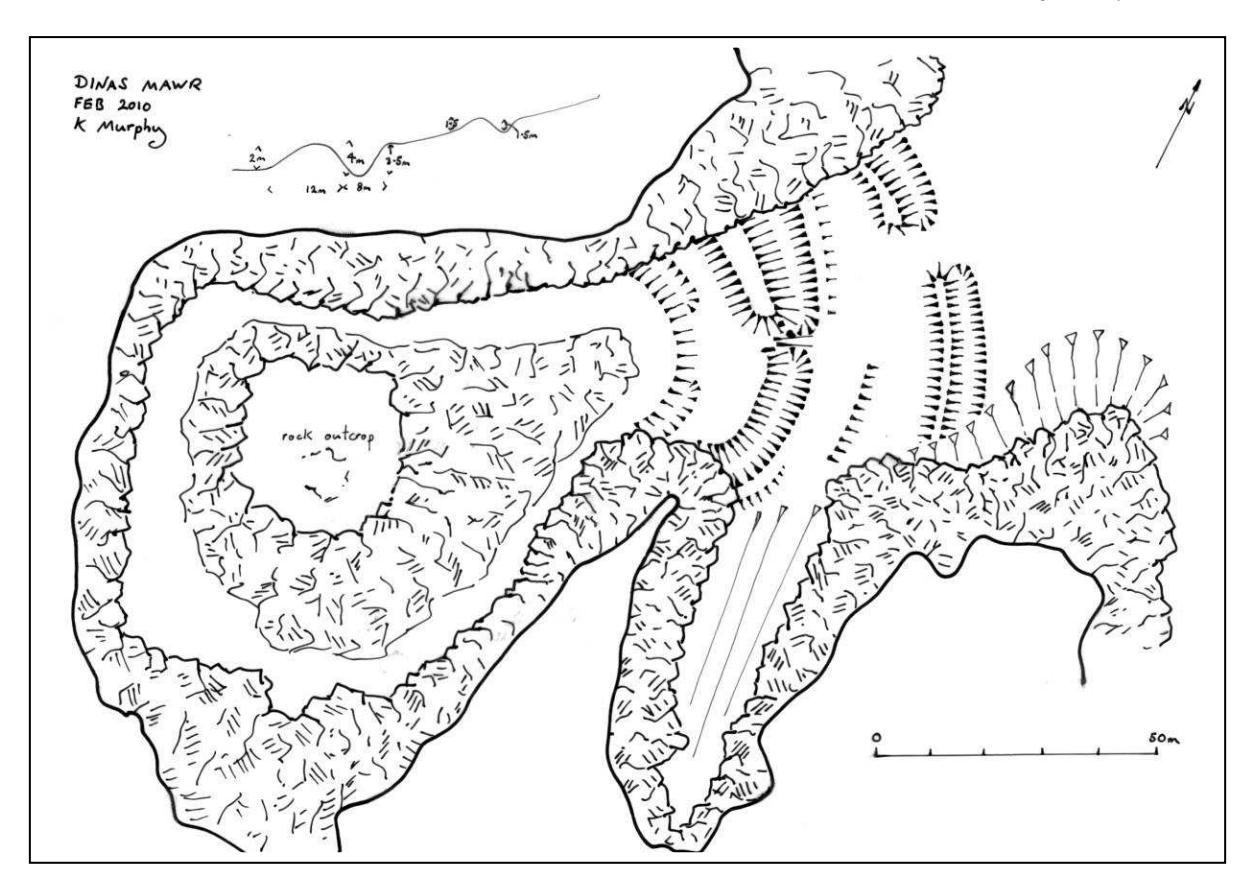
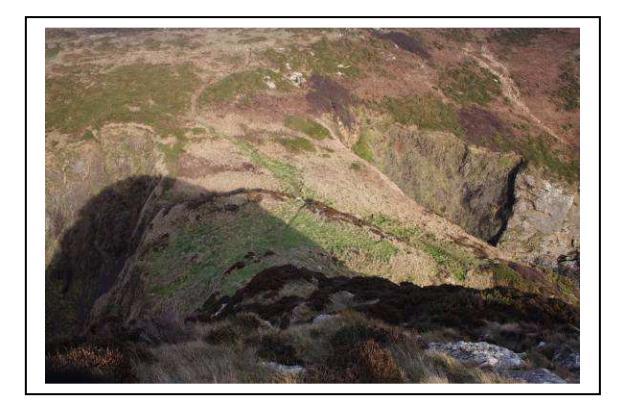
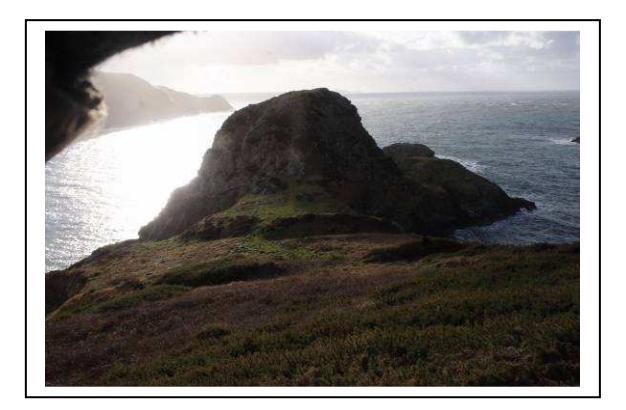
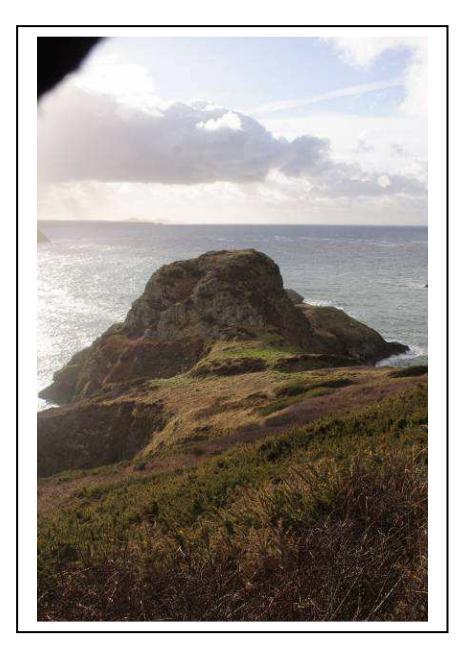
This fort seems to be in a stable condition, with little evidence of erosion. The cliffs on the south side of the fort in particular appear not to be suffering, whilst those to the north are vertical and probably more susceptible, although no new rock falls or fresh scarring was noted in 2010. The outer defences are heavily cloaked with gorse, bramble and bracken, the inner one less so. Elsewhere grass with some bracken dominates.

Dinas Mawr. Top: sketch plan. Above left: view over the fort from the rock outcrop. Above: the fort from the east. Left: the fort from the east.

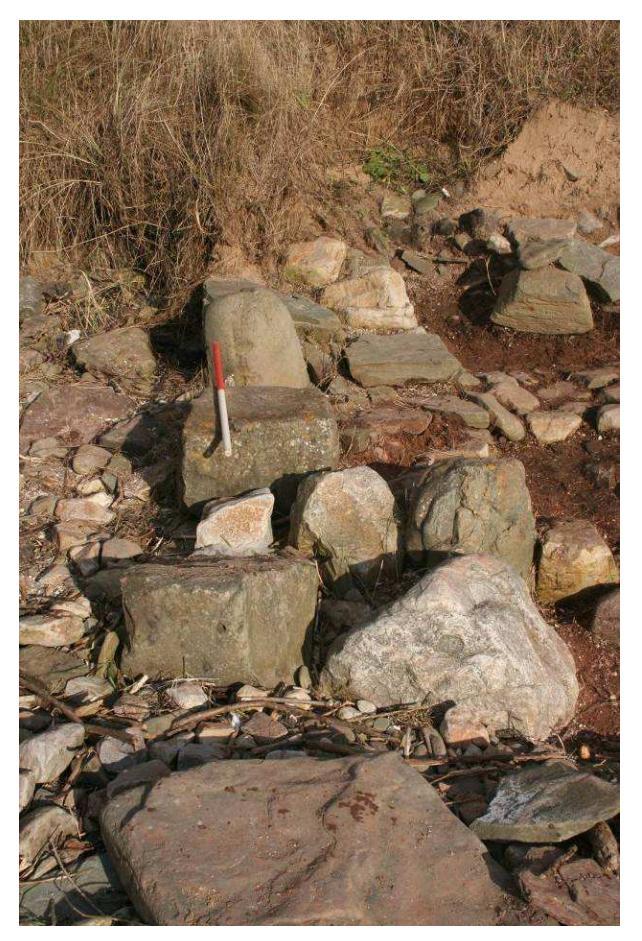
Photo 2: Wall (102) facing southeast

The northern most wall of (102) was aligned southwest to northeast and was partially concealed beneath beach stone further into the sand dunes. It comprised semi-dressed laid stone blocks, some of substantial size ($0.4 \times 0.4 \times 0.3$ m), and measured 3.16m in exposed length,0.94m in width and survived to a maximum height of 0.75m. The wall was neatly faced, with a rubble core. Erosion had removed most of the rubble core of the wall, and some smaller facing stones. Patches of clay visible where the wall entered the sand dunes suggest the wall had been clay bonded. One upright water worn stone within the wall, which may have been eroded in-situ by tidal action.

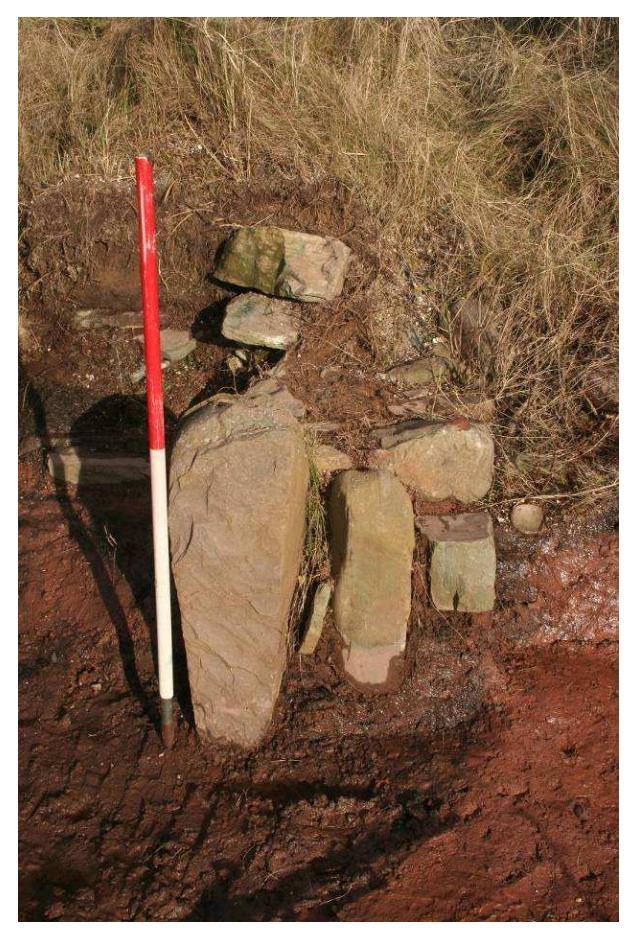
A 1.1m length of a second northwest to southeast aligned wall (103) was clearly visible 5.3m to the south of (102). Together, these walls appeared to define the area of a room. Wall (103) was narrower, measuring 0.59m in width. It comprised roughly dressed stone blocks on the outer faces, with a rubble core. It

was laid directly onto the natural clays and was either drystone or clay bonded. A number of stones laid on end at its western end of the wall perhaps marking one side of a door way.

Photo 3: Wall (103) showing upright stones at the northwestern end of the wall, facing southeast (Pit [109] visible beneath)

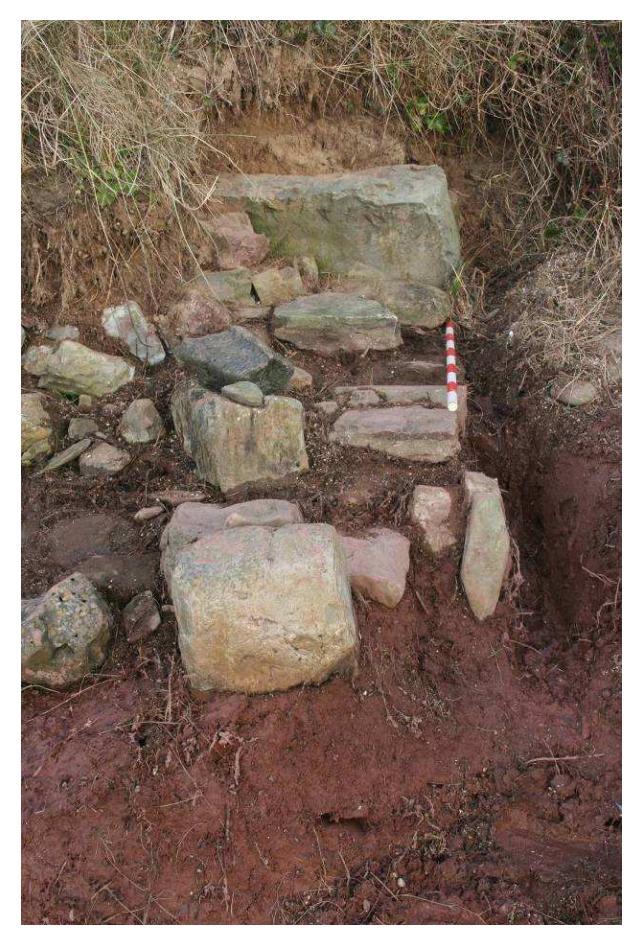
9.03m to the south of wall (103), a 2m length of Wall (104) forming the south wall of Building 1 was visible protruding from the base of the dune. The wall measured 0.60m in width. As with wall 103 it comprised larger roughly dressed facing stones, with smaller packing and rubble between and was either drystone or clay bonded.

Photo 6: Wall (104) facing northwest

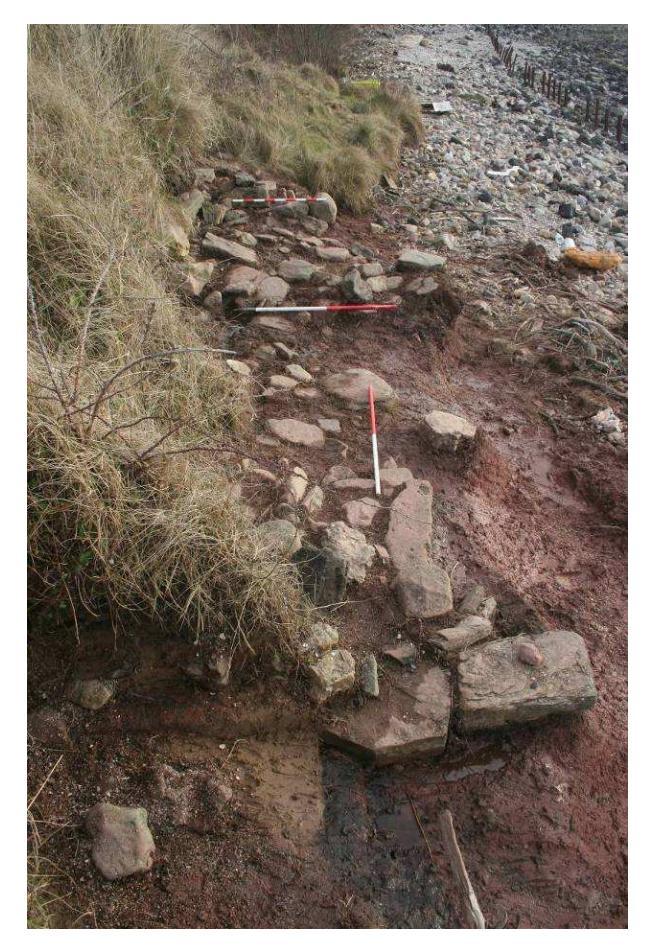
Two possible floor surfaces were located within the second room of the building. The most northerly (111), measured approximately 1.2m x 0.23m and was visible as a layer of fairly large and flat stones set into the natural clays. The majority of the floor appeared to consist of disturbed cobbles. A straight edge formed by larger flatter blocks was clearly visible in the northern part of the room. This edge, an apparent break in the floor, may suggest the presence of a drain, or may be the surviving base of a wall dividing the room into two parts. There was no evidence for any floor in the northern part of this room.

The second floor (112) is likely to have been the same as (111), but was no longer physically connected due to later disturbance and erosion. This floor was made of rough cobbles set into the natural clays, measuring roughly $1.01m \times 0.35m$, but heavily disturbed.

Photo 7: Showing edge of floor (111). The remainder of the room is visible to the rear, with floor (112). South wall (104) is located adjacent to the far scale

A second small feature was noted in the exposed section of the natural clay beneath floor (111). It comprised a small cut [114] and single dark brown clayey fill (113), measuring 0.40m in width and 0.3m in depth in section (it was not seen in plan as the floor surface was not removed). No finds were recovered from the fill and it was not investigated further.

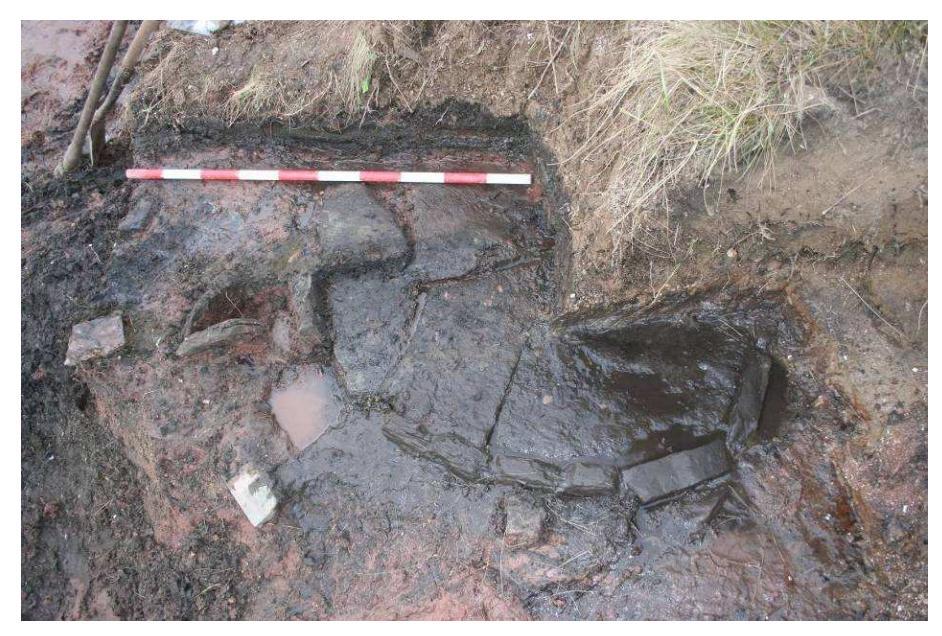
Further investigation to the south of wall (102) and floor (111) revealed a an oval hearth made neatly cut and fitted flat stone slabs (117), edged by smaller stones set on end (118). The hearth measured approximately 1.05m along its longest length (northwest to southeast), and with a visible width of 0.7m. The hearth was located at a very similar level to the floor (111), but there was no physical connection between this or any other visible floor surface. The hearth had evidently been subjected to heat and directly above it was a compacted burnt layer (119/123) around 2cm in depth and containing charcoal and fragments of shells. To the west of the hearth two stones had been placed edge-on, forming a triangle, with the pointed end pointing away from the hearth. They had evidently been specifically placed, but their function is unclear. Perhaps with others on other side of the hearth (not excavated), they may have held a wooden or metal post from which skillets could be suspended.

Photo 8: Hearth within Building 1, flat slabs (117) and edge stones (118).

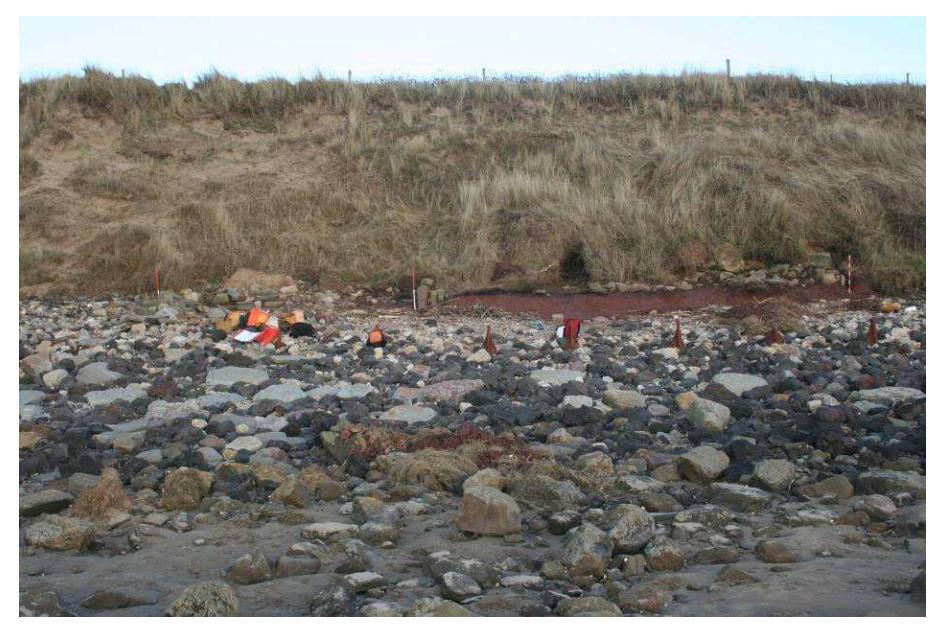
Due to the natural ground levels and patterns of erosion, the majority of the northern room of Building 1 was at a similar level to the surrounding beach level. Far more small stones were present on the beach to the north covering the underlying clay natural geology. Moving south along the building, the height of exposed clay at the base of the sand dune increases. All of the archaeological remains seen within the site were set upon, or cut into this clay (Photos 9 & 10).

Photo 9: View east of Building 1 showing increase in depth of exposed clay natural at base of sand dune, walls (1002), (103) and (104) are marked with vertical ranging rods.

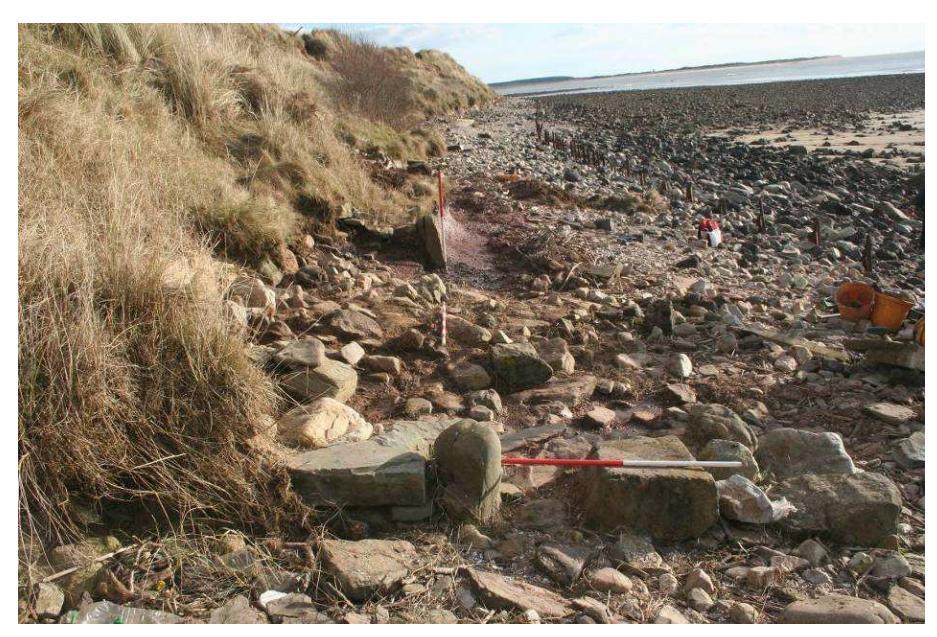
Photo 10: Overview of Building 1, with wall (102) in foreground, wall (103) by next scale bar and wall (104) beyond

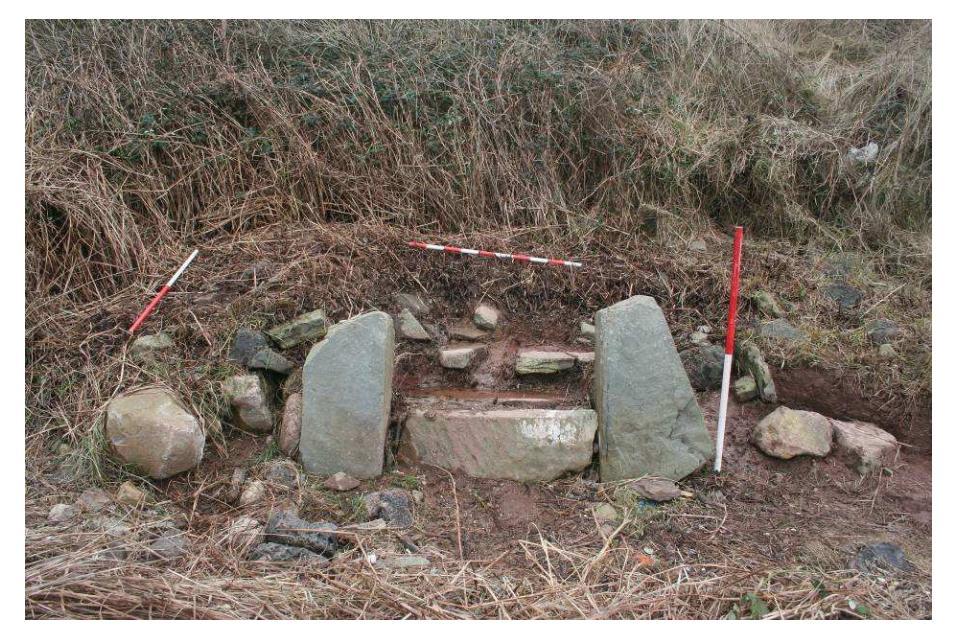
The most obvious feature at the northern end of the building comprised two upright stones spaced 0.83m apart, with a flat stone lying between them. This arrangement (201) seemingly forms a doorway into the building (photo 11 & 12).

Photo 11: Wall (200) to left, with doorway (201) visible in centre of photo

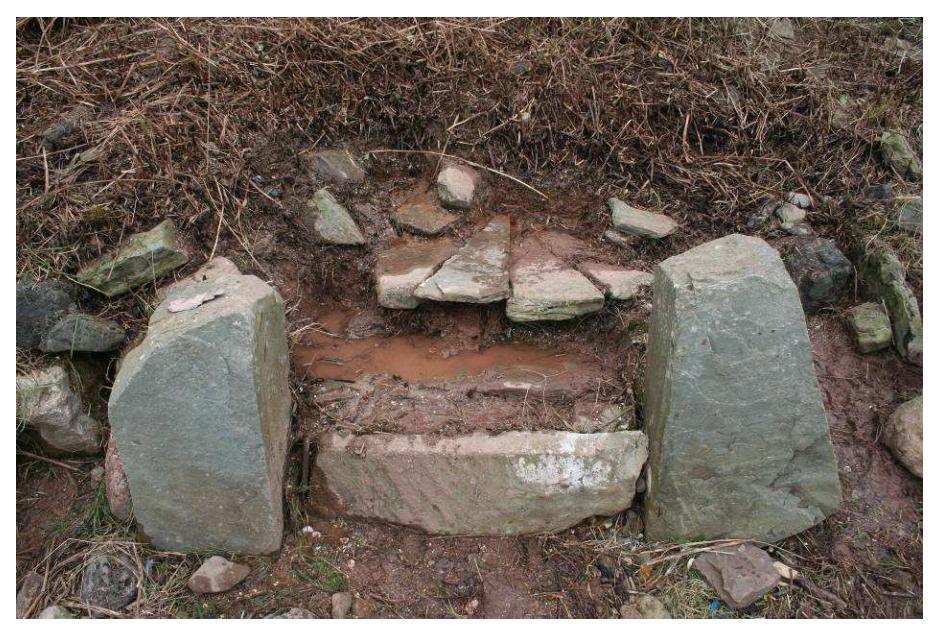
The level of the threshold stone corresponded with a flat stone lying behind it and presumably within the building. Behind this was a step up to four flat stones that had been laid to form a rectangular surface (one stone had been removed in the past, but could be fitted back into the missing location easily; photo 12).

Photo 12: View of doorway (201), with missing stone of second step replaced.

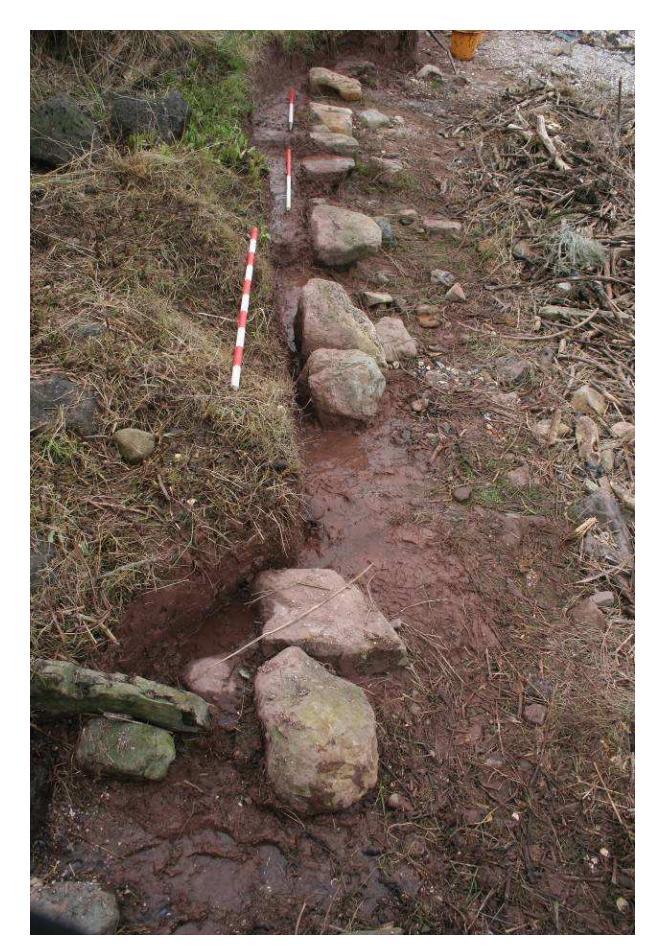
Photo 13: Wall (205)

Doorway (201) was apparently located on the western side of the building, set within wall (205). This wall survived south of the doorway, for a length of 6.8m. It comprised a single length of medium sized stone blocks set into the natural clay (photo 13). It would appear that only the internal facing stones of the wall survived, a single course in height, with all bonding stones, rubble core and outer facing stones having been previously eroded away. At the southern end of the wall all evidence of the relationship between this and the two southern walls of the building have been lost to erosion.

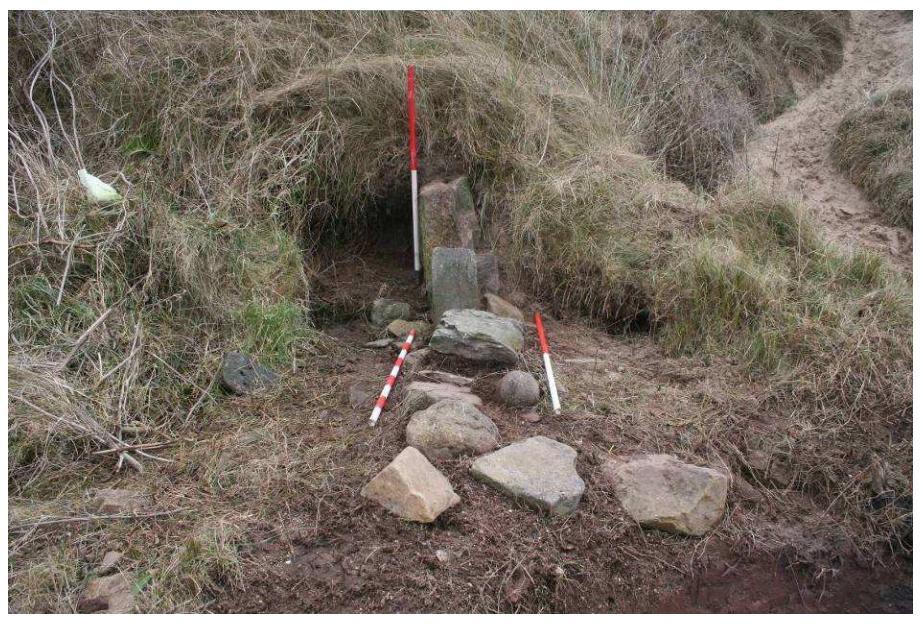
Wall (202) protruded from the sand dunes 9.65m to the south of wall (200). It measured 2.5m in exposed length, with a width of 0.6m. The wall was badly eroded at the western end, but some large upright blocks were present nearer the sand dune (photo 14). The wall was either drystone or clay bonded, comprising larger blocks, roughly dressed on the outer faces, with a rubble core. A number of large water worn stones were also present in the wall.

Photo 14: Wall (202)

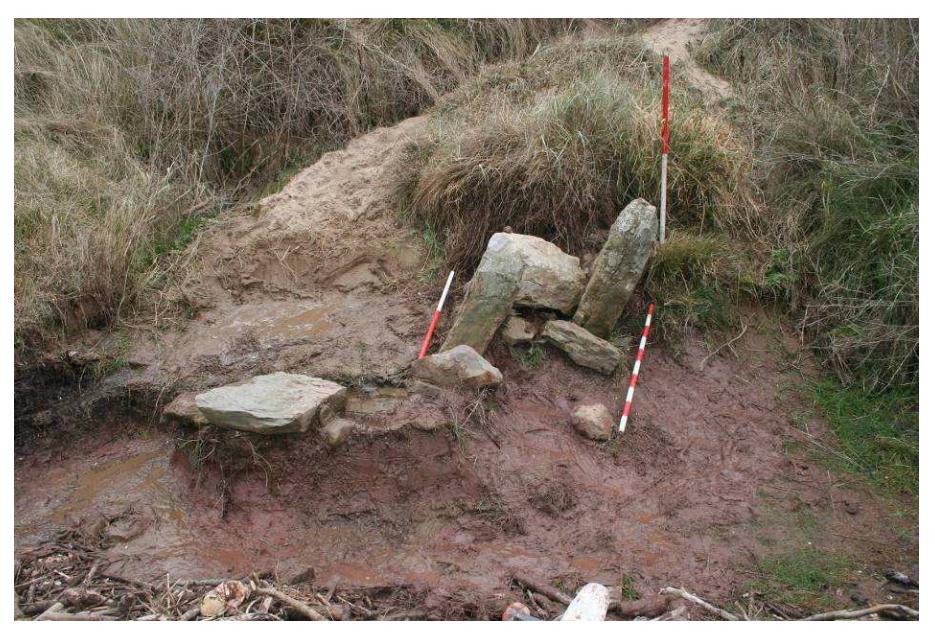
The southernmost wall of the building was (203), consisting of a 1.55m length of wall protruding from the dunes, of around 0.65m width (photo 15). The wall lay 3.7m to the south of (202, and was similar in construction as it comprised a number of large upright blocks on the outer faces of the wall. The upright stones were noticeably leaning over towards the south, presumably as a result of pressure from movement within the sand dunes (an area of sand slip is evident directly adjacent to the wall).

Photo 15: Wall (203), showing outward lean of stones
