ARFORDIR COASTAL HERITAGE 2009-2010

RHIF YR ADRODDIAD / REPORT NO. 2010/23 RHIF Y PROSIECT / PROJECT RECORD NO. 99087

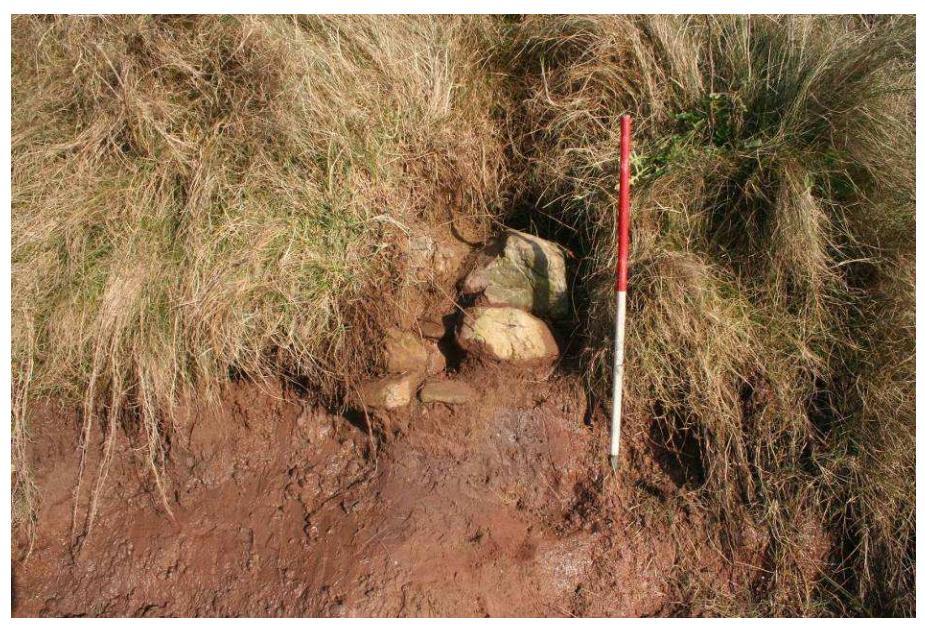
The probable northern wall of the building (300) was comprised of medium sized stones, roughly coursed, surviving to a height of 0.55m. The wall was around 0.5m in width. The stones included angular blocks and water worn stones. No bonding material could be discerned.

Photo 16: Wall (300)

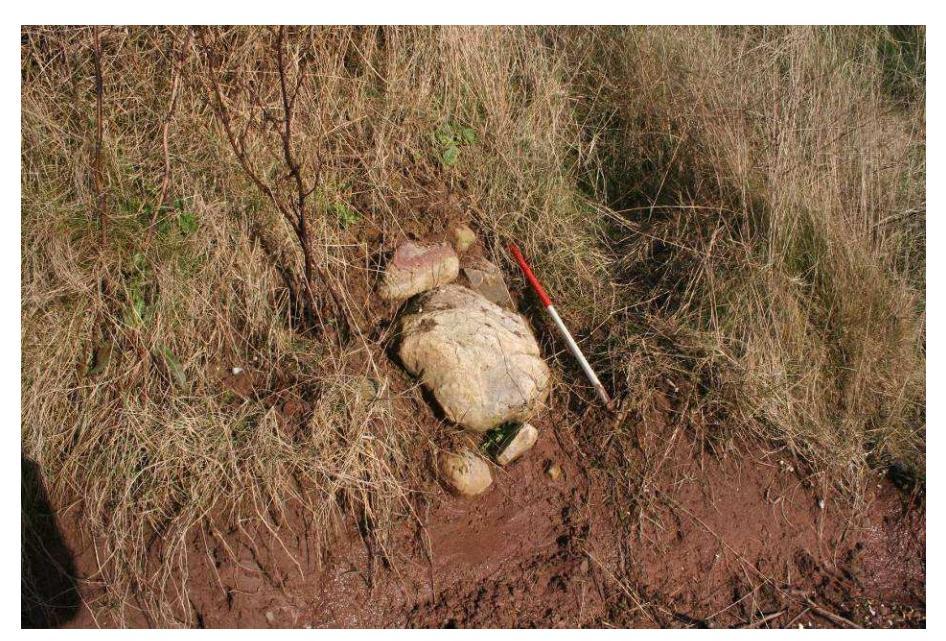
Wall, (301) was located around 15.6m to the south of wall (301), and survived to a similar extent. The wall was roughly two courses in height, and was exposed to a length of around 0.7m. The stones included angular blocks and water worn stones. No bonding material could be discerned.

Photo 17: Wall (302)

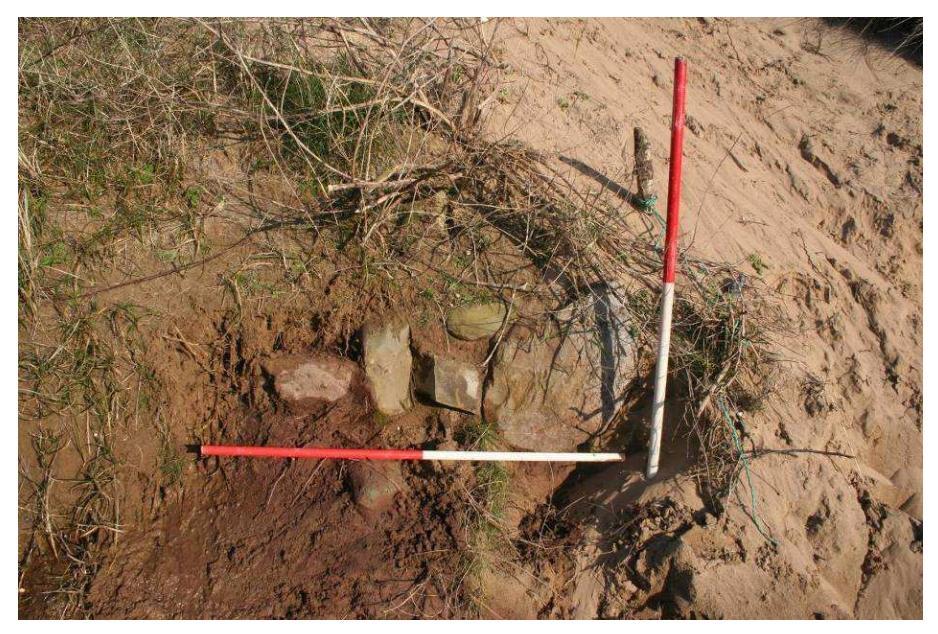
This building is the only one where a standing stretch of an eastern wall has been revealed. The side walls of the structure (400) and (401) comprised roughly coursed angular blocks of medium and small sizes. The eastern wall of the structure, comprising medium and large stones was also roughly coursed using the varying sized blocks. Again the walls were set upon or into the underlying natural clay. This building was narrow, *c*.3m wide and only survived to a length of 1m into the dunes. No floor surface was revealed in the building, although it is possible that the floor was directly upon the underlying natural clays.

Photo 18: Wall (400) and adjacent collapse of sand dune

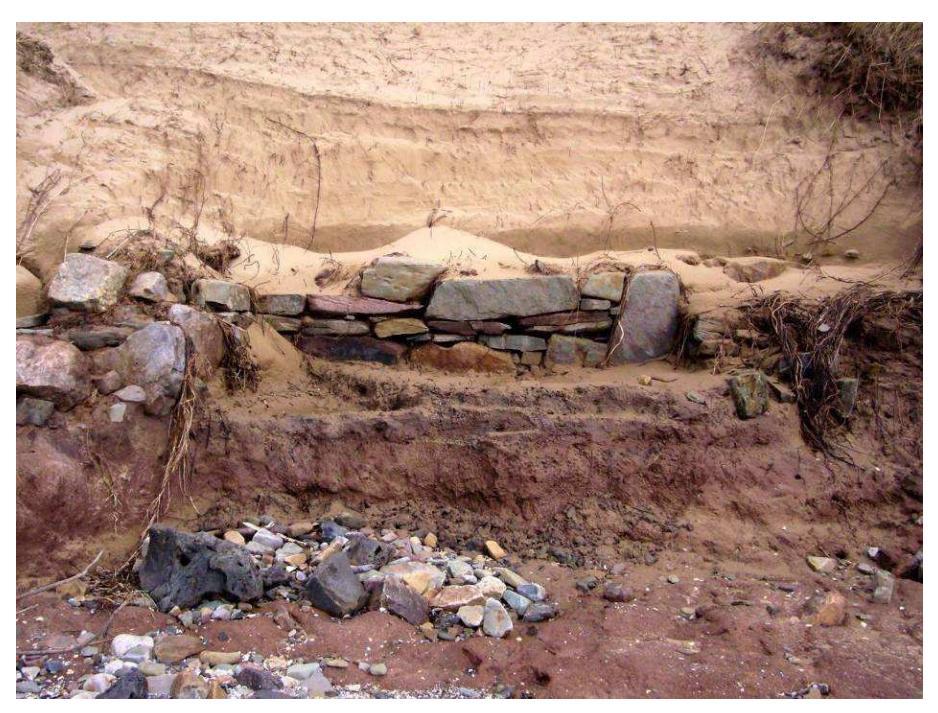
Building 4 was located some 10m to the south of Building 3. During the investigations, only one wall of the structure could be seen, although it is known from previous monitoring and recording by Owen Harris that two walls connected by a wall to the west were present, but now lie buried under a collapsed part of the sand dune.

Photo 19: Previous photograph of area, with wall (400) to left, wall (401) to right (hidden by vegetation) and wall (402) to rear. (Owen Harris photograph)

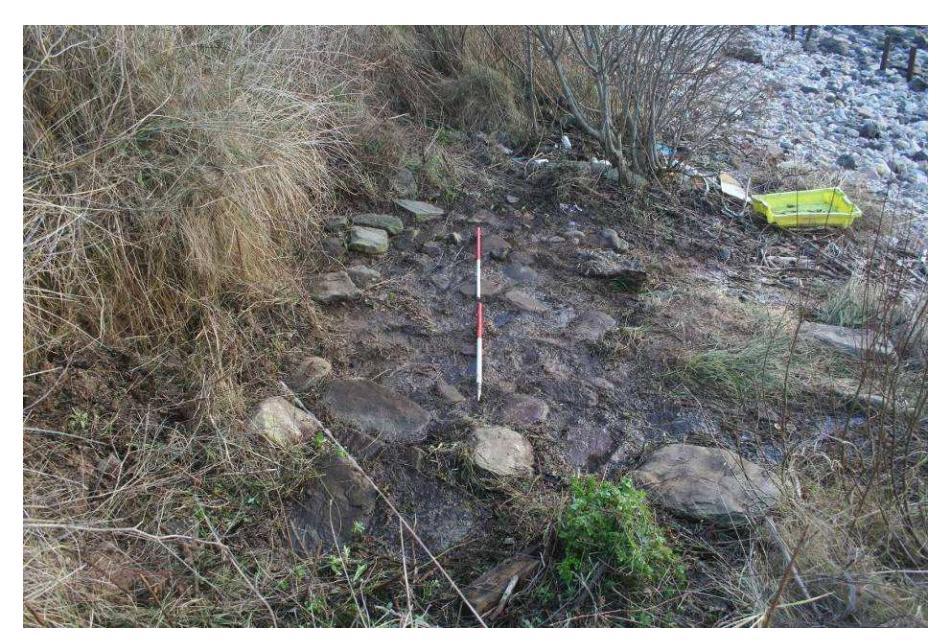
The areas visible between Buildings 1 and 2 and between Buildings 3 and 4 are considered to represent yards, as there is no evidence of walls around them. The first yard area lies around 10m to the south of Building 1 (photo 20). It comprises a number of flat sandstone slabs laid on the natural clay to form a rough surface. An area of the surface approximately $3.5m \times 1.6m$ is exposed, with more likely to be buried beneath the dunes to the north, south and east.

Photo 20: Yard surface between buildings 1 and 2

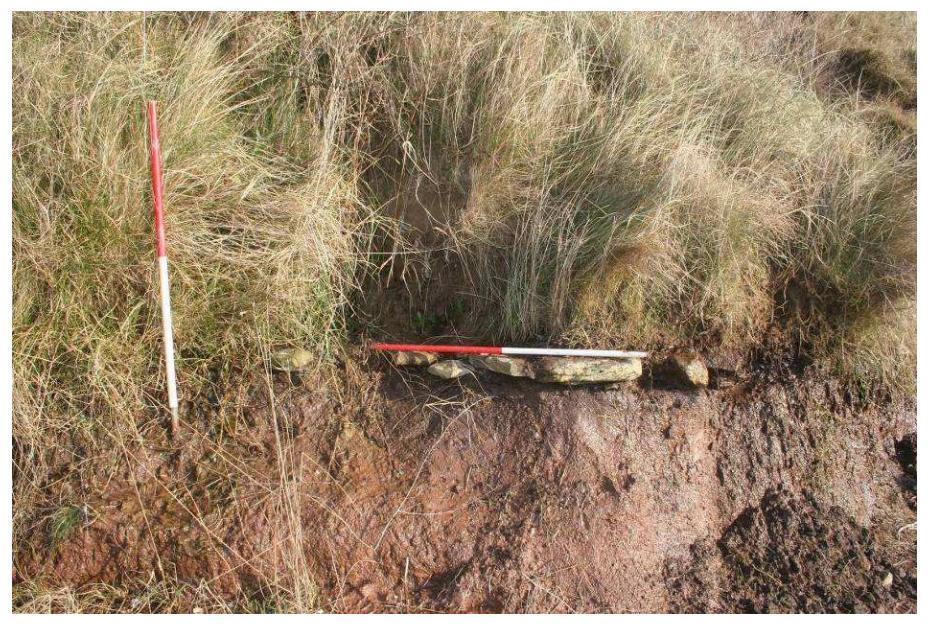
The second yard area lies 4m to the south of Building 3, visible as a small stretch of stones 2m in length sitting on top of the clay within the sand dune face. The top of the surface was only partially exposed. The stones in the floor were smaller (most around 0.15m square), and well laid to form a fairly level surface. The surface had been visible on previous visits, when a possible feature was also noted underneath cutting through the clay in the exposed section. This feature was not clearly identified during these investigations and not yet been recorded further.

Photo 21: Yard surface between Buildings 3 and 4

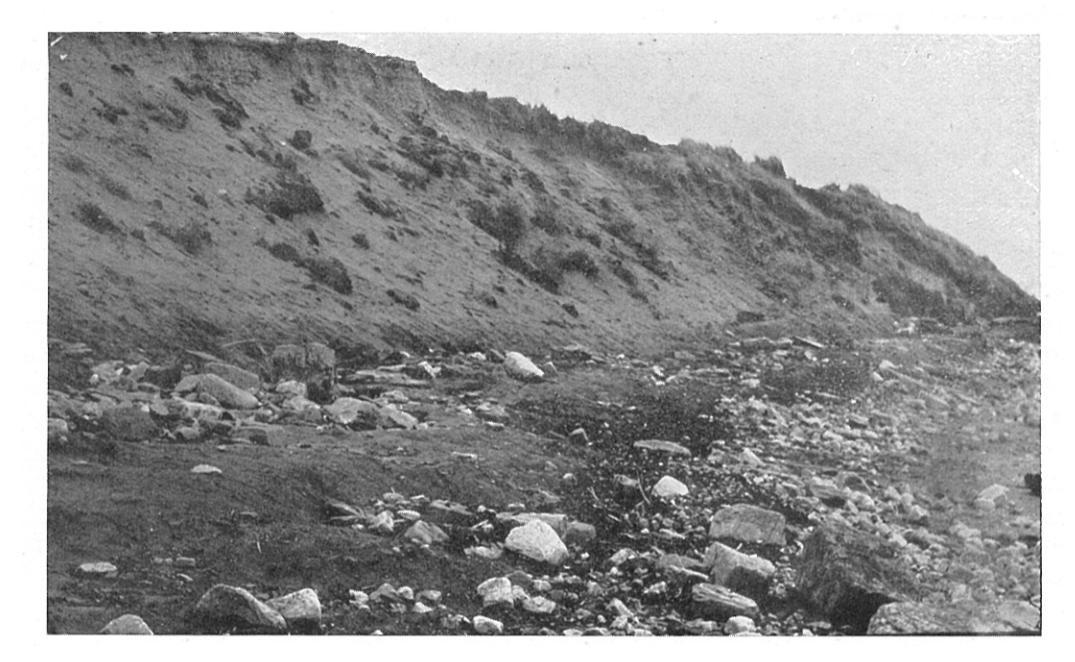
The RCAHMW survey of 1912 includes a description based on the earlier account as well as two photos of the site (photos 22 and 23). These show the dunes, with stone work exposed at the base on top of the same clay natural as was seen during the recent investigations. What is most evident in the two photos is the extent of clay natural exposed (possibly around a 3 or 4m band), with the sand dune set much further back in relative terms to how it lies at present. Vegetation is only just growing back on the edge of the dunes in the photos, indicating that a substantial part of the sand dune must have been stripped way in 1896.

Photo 22: RCAHMW photograph from 1912 visit to the site (RCAHMW 1917)

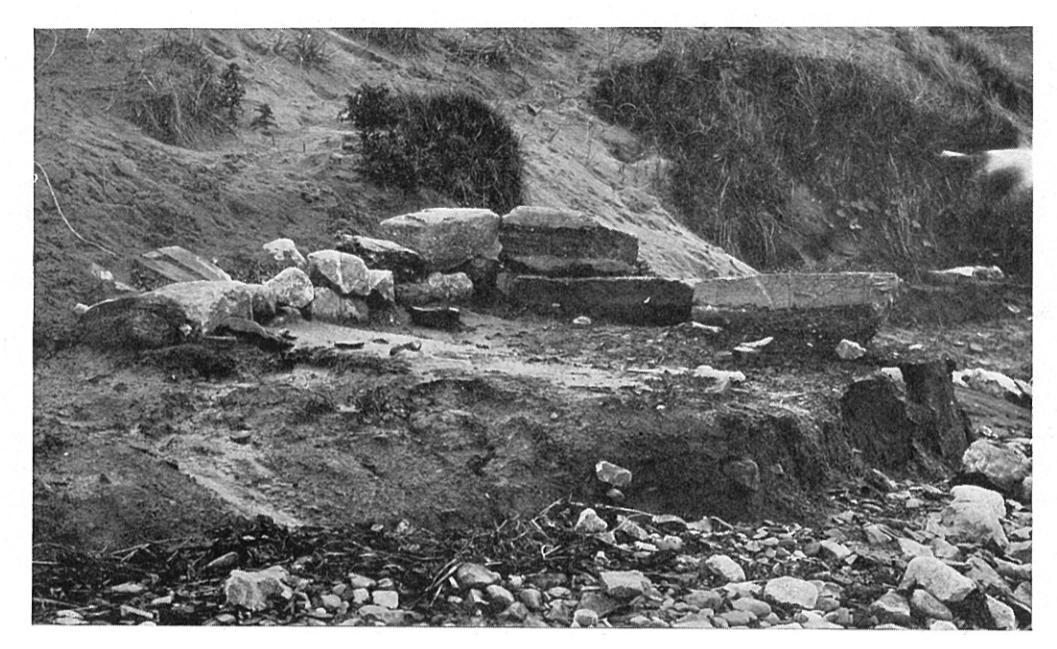
Although no clear remains are visible in the first photograph, the extent of stone work at the bottom of the dune is indicative of former structures. In the second photograph a substantial part of a building is visible exposed on top of the clay natural. The building appears to be short-end-on to the sand dune (similar to Building 4 of these excavations) with a substantial part of the southern and eastern walls exposed. The coastline has changed considerably since this time, and certainly the building in photo 23 has been completely eroded by now. Both photographs were taken over 10 years after the removal of the 40 to 50 cart loads of stone, and subsequent episodes of erosion over those years. The relative lack of stone across the clays in photo 20 may be indicative of this stone removal and erosion. The implication is that the stone of the building in photo 21 would have been removed if it had been exposed in 1896.

Photo 23: RCAHMW photograph from 1912 visit to the site (RCAHMW 1917)

Other drawings in the collection are labelled as "*the corner of a building*" and "*an erect dressed stone with hole*". The corner of the building may well be that seen in photo 23. The dressed stone with a hole appeared to have been over 1m in height and presumably the hole would have once housed a door or gate hinge. Such a stone is visible in 2010 lying below the high tide mark. The final sketch is of a stone well head described as being sand filled, but unfortunately this was inadequately located and has not subsequently come to light (although local residents do claim to have seen something similar quite far out on the adjacent scar). It is thought that all of the remains seen in 1912 have now eroded away, so it is possible that a number of the larger seemingly dressed sandstones that lie below the high tide line may be some of those recorded in 1912.

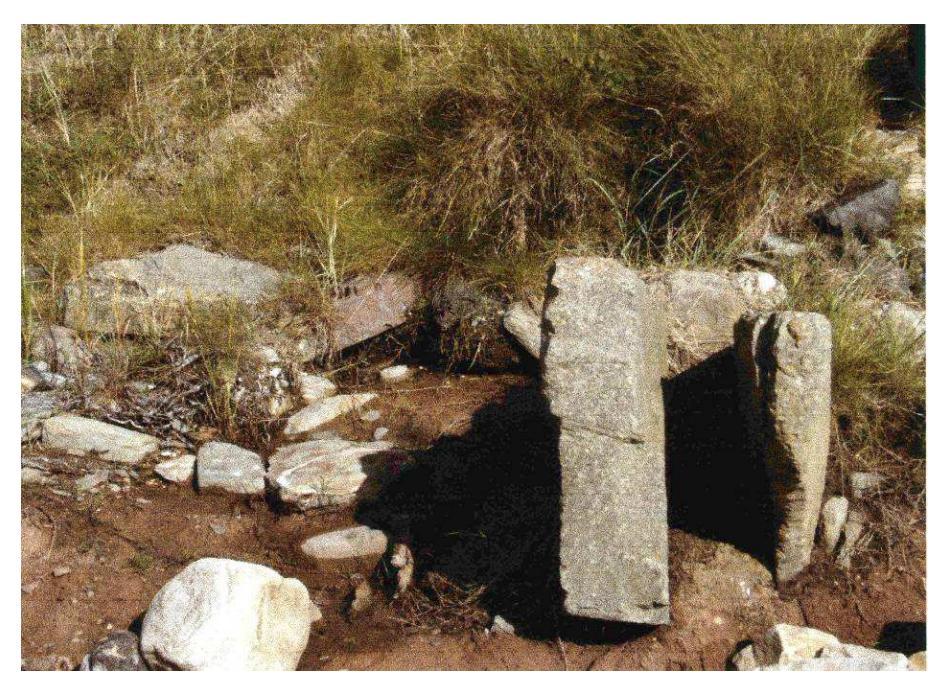
In 2007 one of the walls within Building 1 had two large upright stones at its western end. Neither of the stones now survive, but they may be present on the beach in front. It is unclear which wall these stones were associated with, or whether they were actually part of a western wall that has since been eroded.

Photo 26: Upright stones seen in 2007 within Building 1 (Owen Harris)

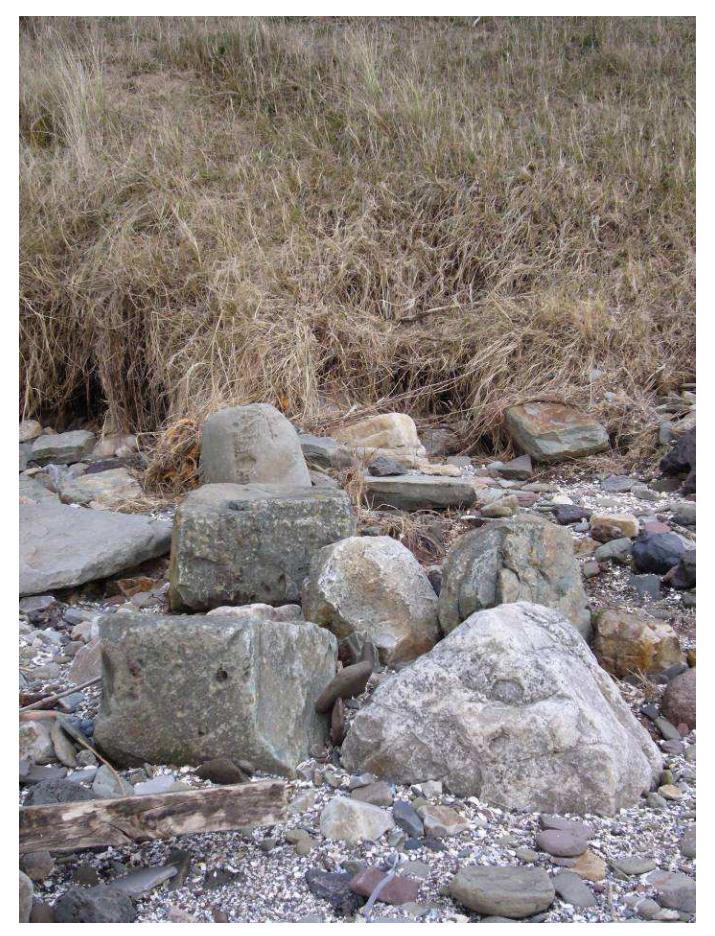
More large stones were present within the northern wall of Building 1 in May 2008, which have again since been eroded.

Photo 27: Wall (102) Building 1 in May 2007 (Owen Harris)

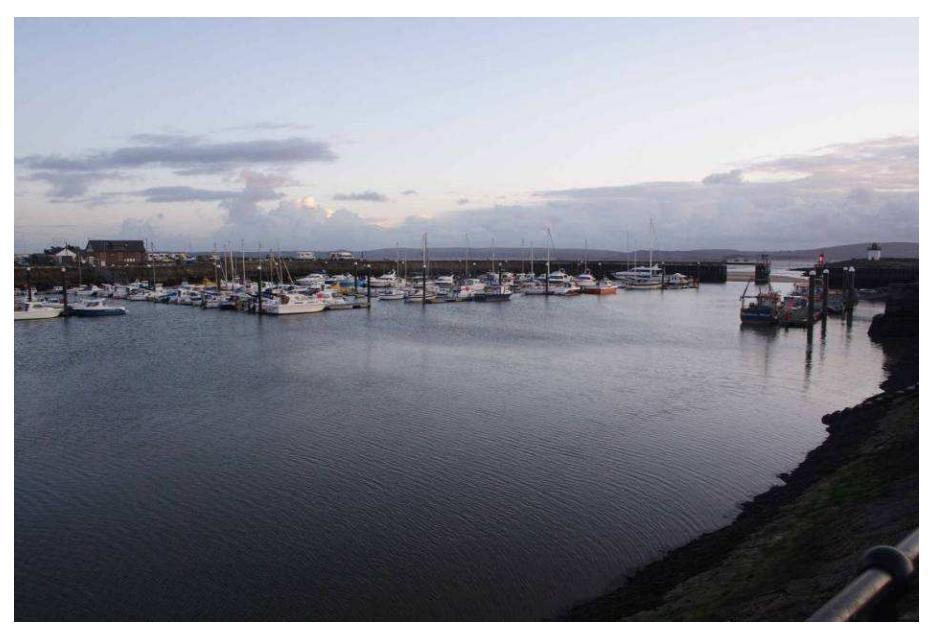
The outer harbour is a restored 19th century harbour currently used as moorings for small recreational boats (photo 1). The site is well protected from coastal erosion by breakwaters and modern dock gates, however, a sand bar is forming across the entrance of the harbour and is beginning to be problematic for users of the harbour. It is considered likely that the harbour area could eventually end up inundated with sand and silt, as happened at Pembrey Harbour.

The outer breakwaters of the harbour are formed from rubble and industrial waste (slag etc). These have been renovated fairly recently and in a stable condition.

Photo 1: Burry Port Outer Harbour

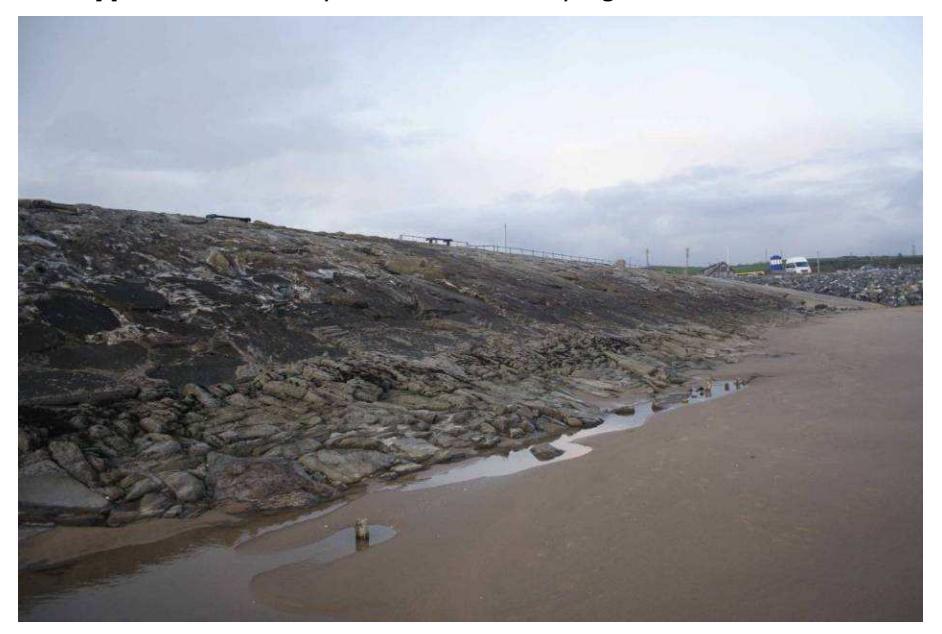
Photo 2: Area of former coal tubs, with single iron rib visible in foreground

On the seaward side of the eastern breakwater a series of iron former coal tub boats were laid to strengthen the wall (PRN 61059). The boats are a rare survival of iron constructed coal tubs and hence why they have been designated as a Scheduled Ancient Monument (SAM). The tubs were said to be visible up until quite recently, but at present only a few iron uprights were visible (forming the

ribs of the tubs, photo 2), with the remainder buried by sand. The condition of the boats is at present unclear, but whilst buried in the sand would be considered stable.

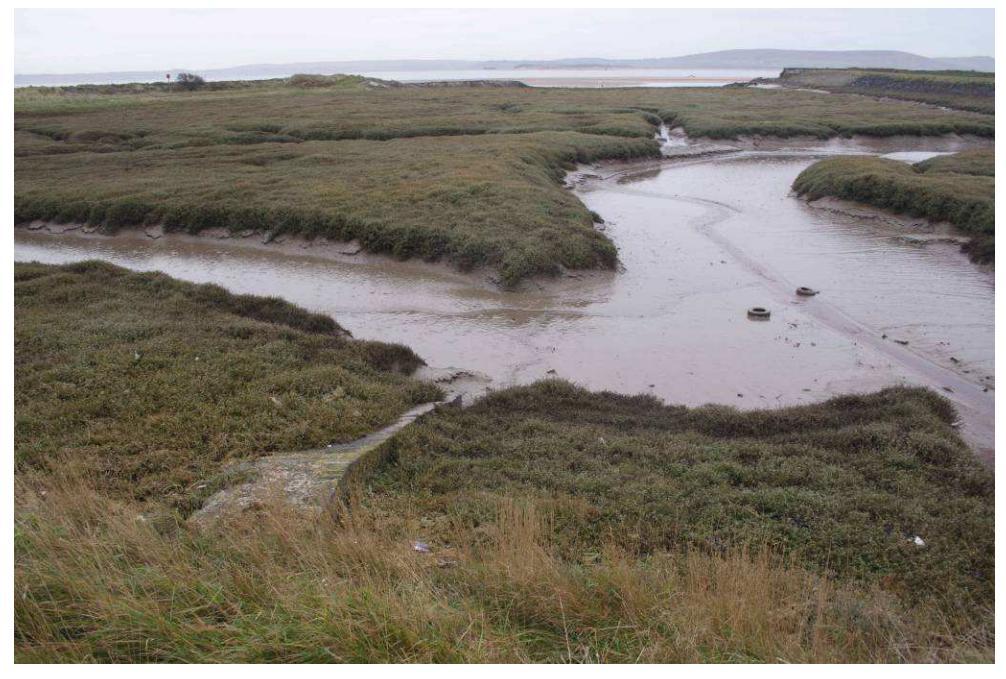
The former harbour was abandoned and replaced by that at Burry Port in the 19th century. The harbour area is now filled with sand and silt (photo 4). The harbour walls were constructed of slag block. The eastern wall appears to be in a state of decay, suffering from tidal erosion with a considerable amount of the outer skin of slag block having been ripped from the wall and is now lying scattered inside the harbour (photo 5).

Photo 4: Silted up internal area off harbour

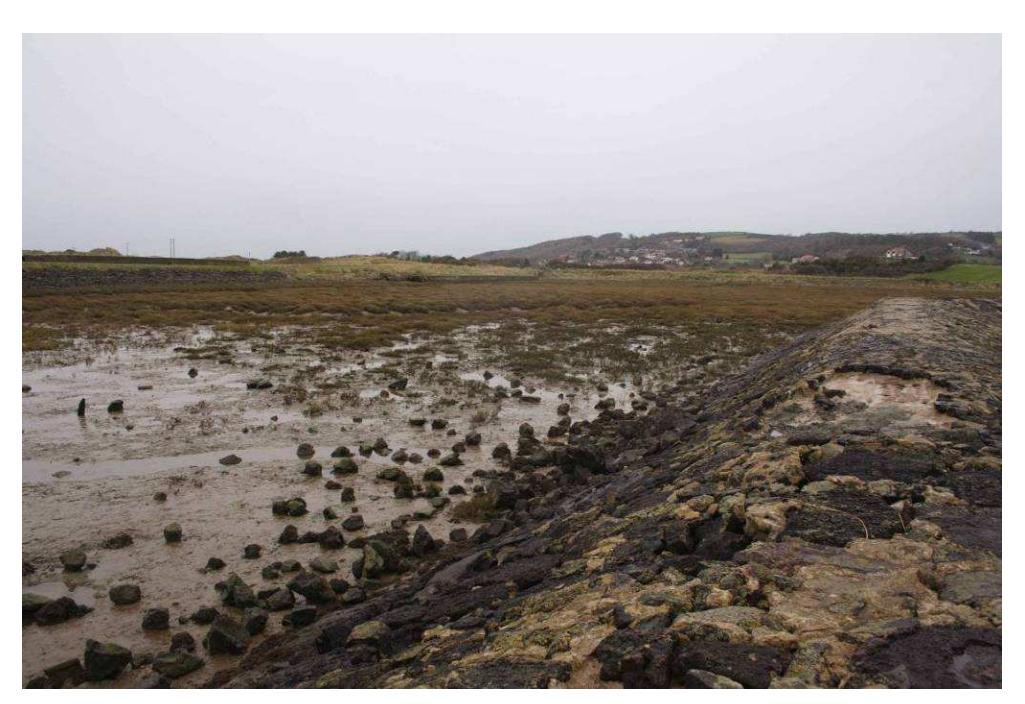
Photo 5: Pembrey Harbour, eastern breakwater also visible

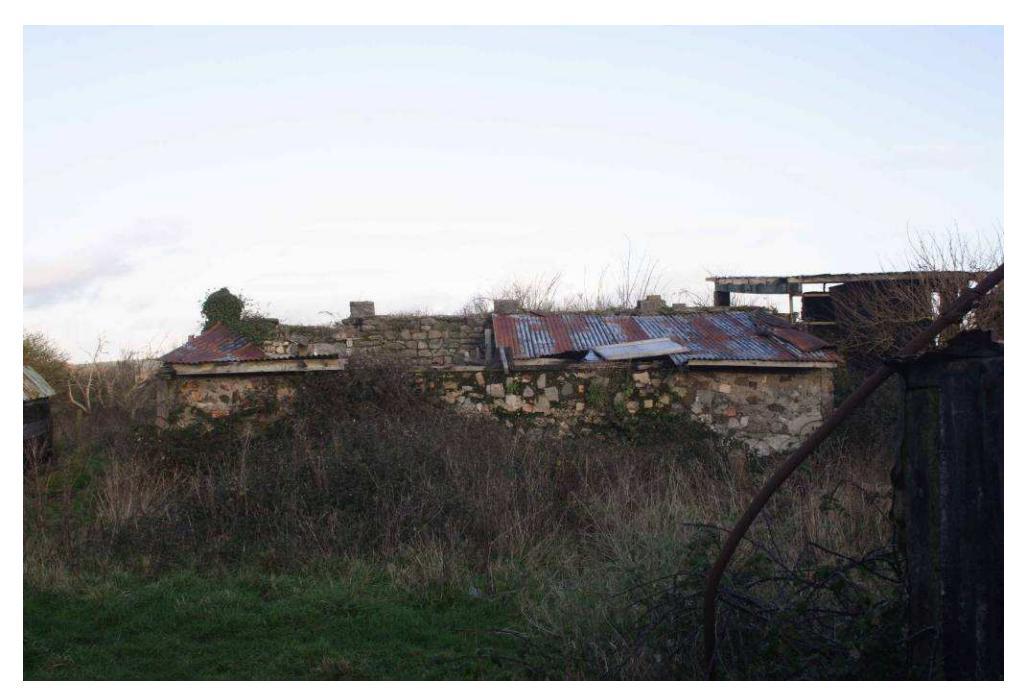
The site is located to the east of Kidwelly Quay and consists of a complex of buildings that appear to have been last used for agricultural purposes. The structures were seen to be of stone with later railway sleeper and corrugated iron additions present across the site (photos 10 & 11). The site is currently derelict with some of the buildings open to the elements and decaying. A small stone structure at the entrance to the complex has been re-roofed with ply wood and partially covered in roofing felt but this too appears also to be decaying. The small building contains a fire place (photo 12).

The site area has not been subject to previous record. The site is decaying.

Photo 10: Building remains of former Gwendraeth Valley Saw Mill (PRN 99089)

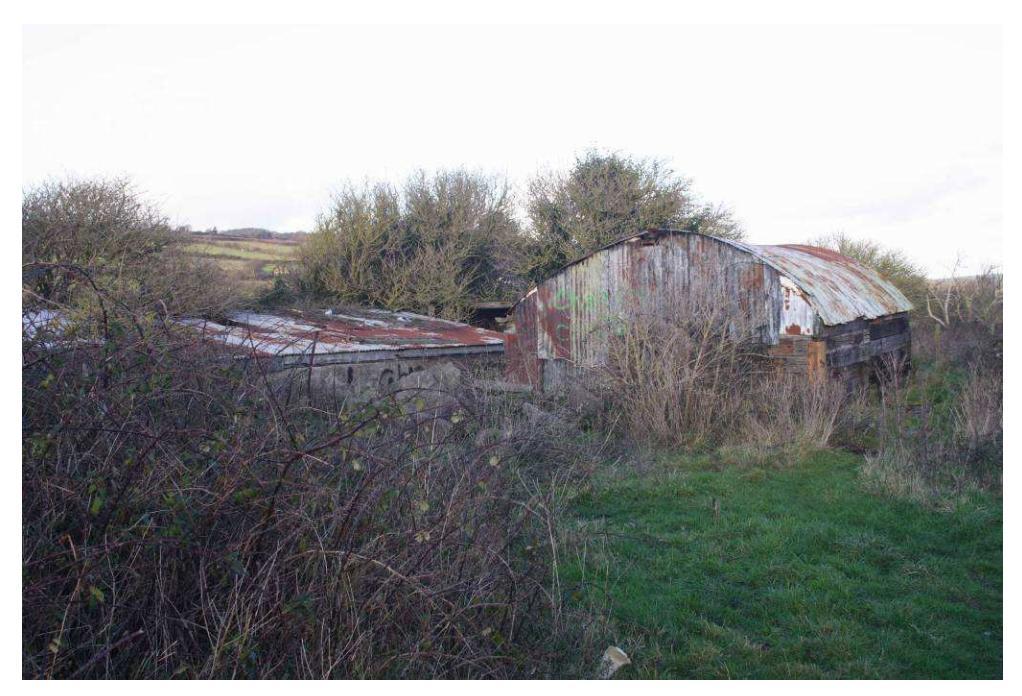
Photo 11: Building remains of former Gwendraeth Valley Saw Mill (PRN 99089)

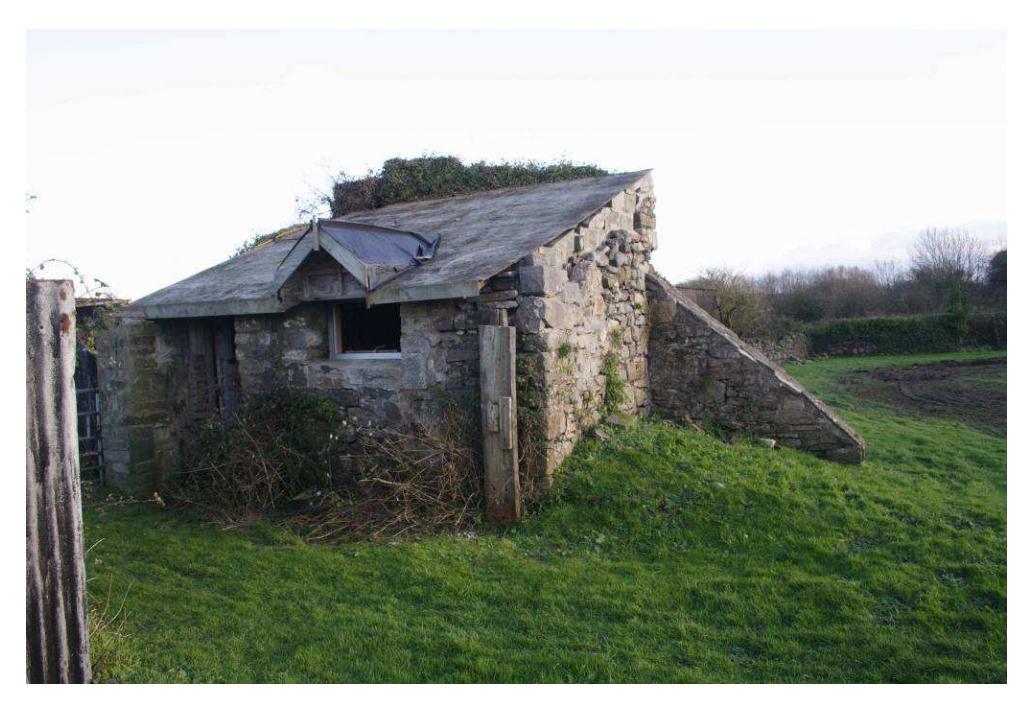
Photo 12: Building remains of small stone structure on edge of Gwendraeth Valley Saw Mill (PRN 99089)

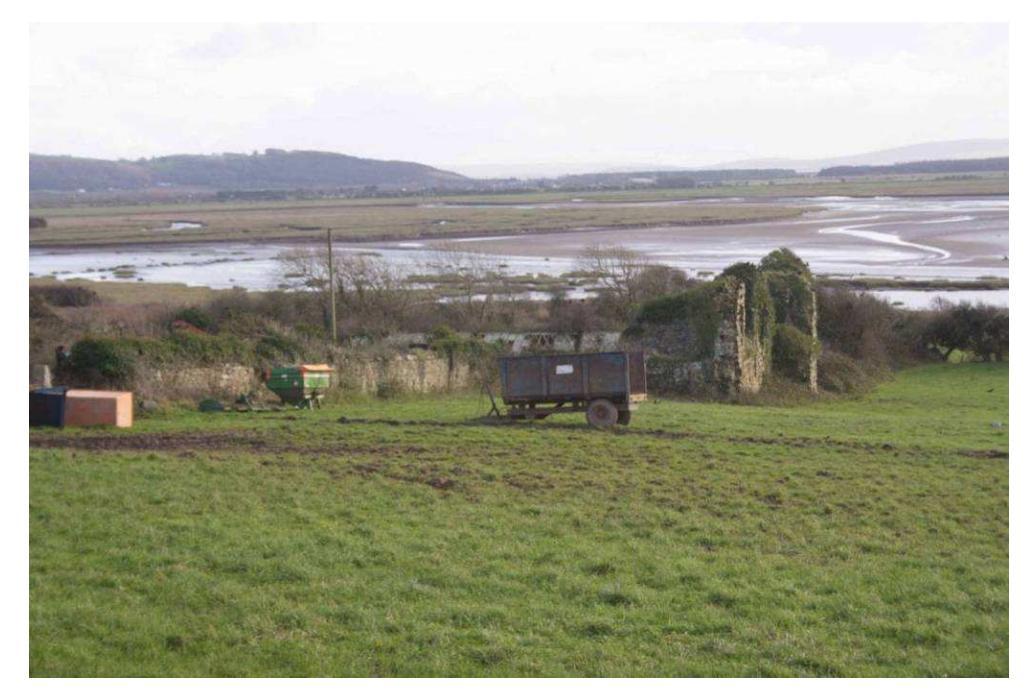
Photo 13: Penallt Priory

Permission to access the site could not be obtained, and it was therefore viewed from a distance on the adjacent road (photo 13). The site appears to be in a poor state of repair and is thickly covered in vegetation. The site may require attention to prevent any further decay. Further buried archaeological remains will be present around the site within the farmyard.

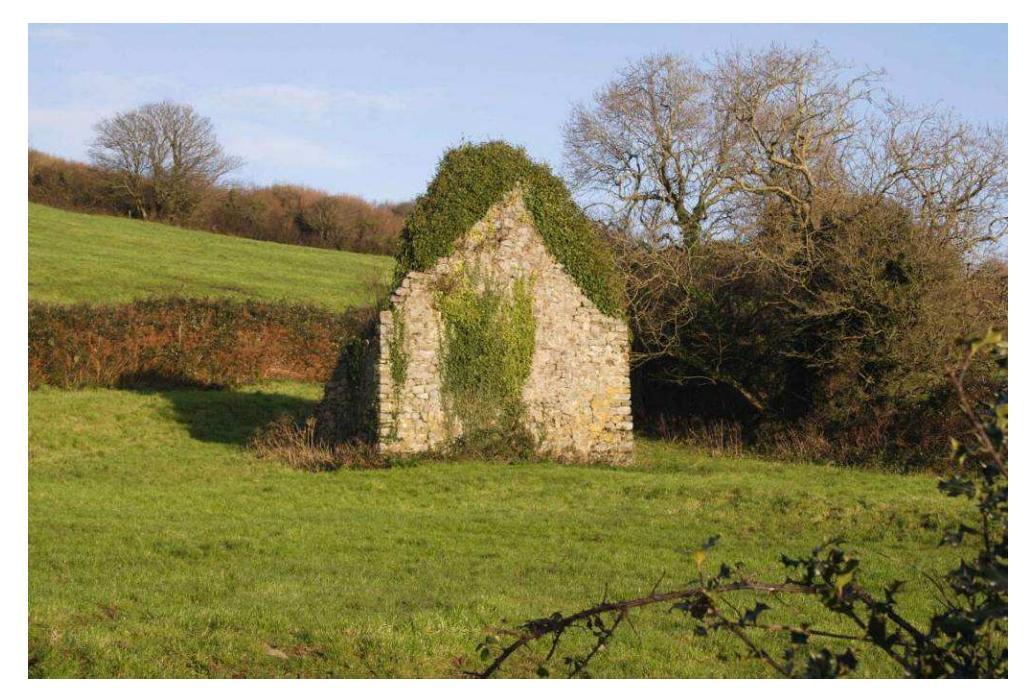
It comprises an unrecorded masonry structure surviving as substantial gable wall standing to full height with remains of masonry side walls (or buttresses; photo 14). The surviving structure is cloaked in ivy but appears to be relatively stable.

Photo 14: Penallt II Building, surviving gable end of large building and earthwork platform (PRN 99090)

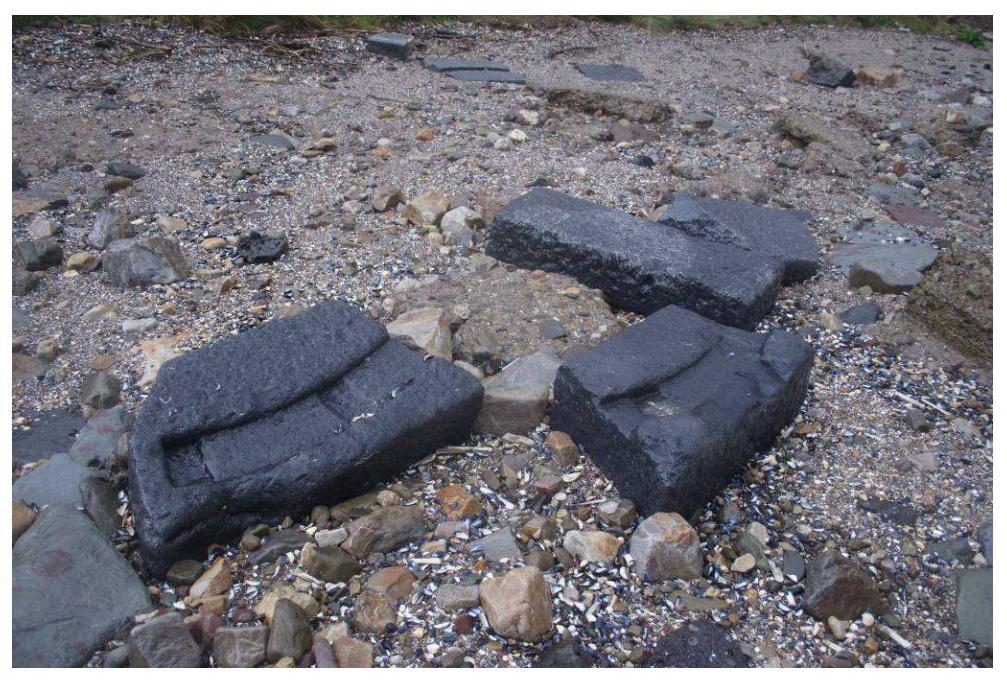
Gwelfro (PRN 7826) and the Old Gun Battery (PRN 23600) appear to refer to the same site (photo 16 & 17). The structure was originally located at the top of the sand dunes and was probably first constructed in the early part of the 19th century. Although some remains are still present on top of the dunes, substantial fragments of masonry have collapsed onto the shore line. The area surrounding the structure is littered with concrete fragments and large rectangular stone blocks with curving recesses that are considered to be the remains of a gun track. Coastal erosion will eventually lead to the destruction of the remainder of the site.

Photo 17: Stone blocks with curved recess for gun tracks on fore shore

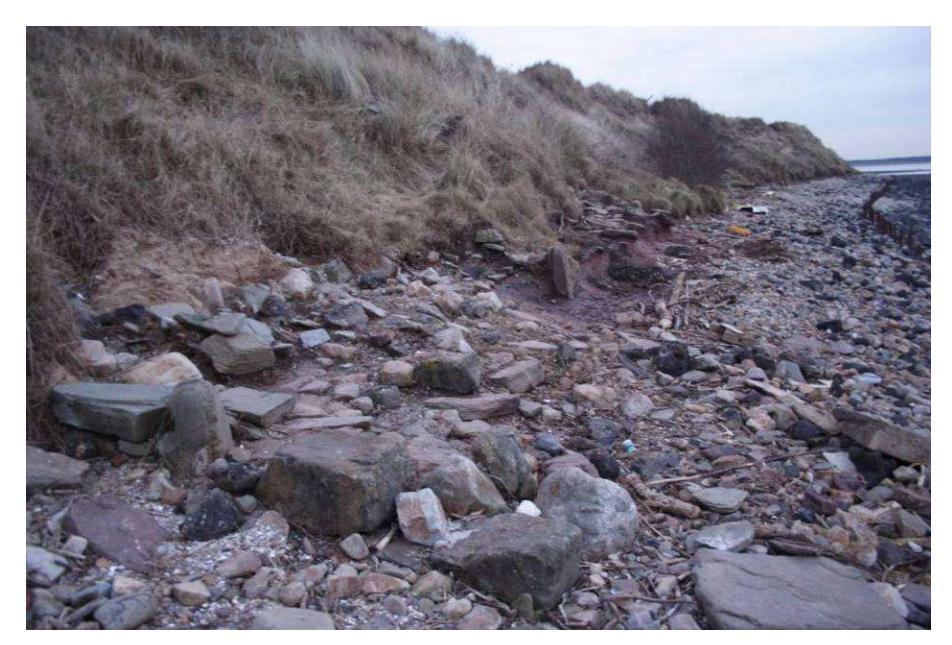
The site of the deserted medieval village near St Ishmael in Carmarthenshire is mis-located on the HER, which places it to the south of its actual location and quite far out into Carmarthen Bay. The correct grid reference is used for this description (photo 18). The actual name of the settlement is unclear and is debated. The site has been subject to a number of visits during the year. During February the site was subject to a 5 day long investigation which is reported on in **Appendix II**.

Photo 18: View along exposed remains of medieval village at St. Ishmael

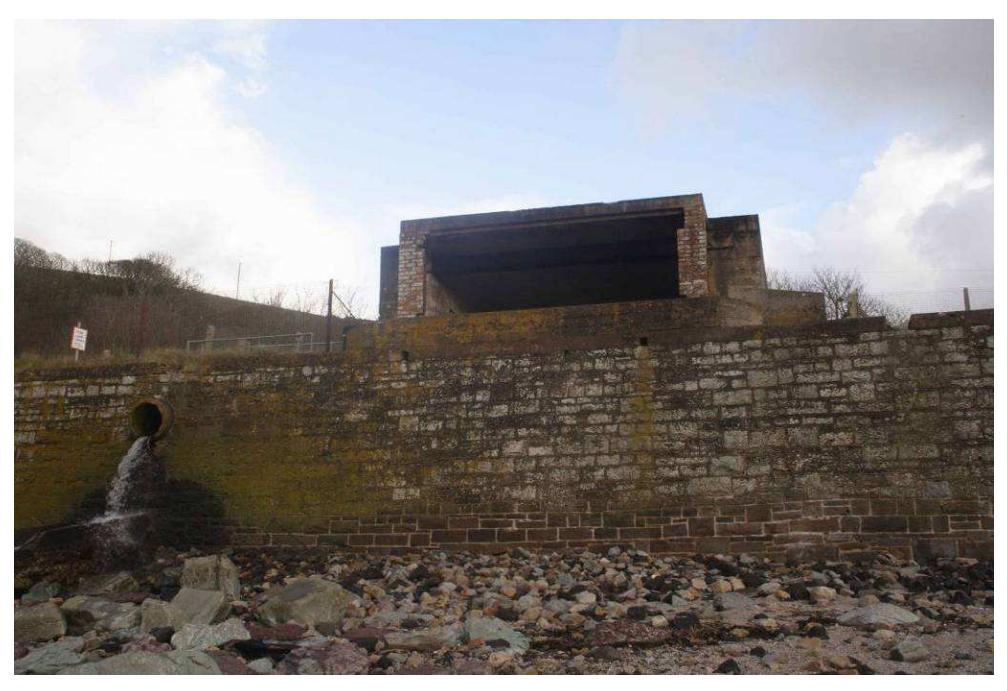
The site is located on a 19th century sea wall constructed to as part of the Great Central Railway line that crosses immediately to the rear of the site and marks the beginning of the Carmarthen Stop Line (photo 19). The concrete and brick structure has been vandalised and graffiti covers much of the internal walls with bottles, cans and other debris littering the floor.

The brick piers supporting the concrete roof have a number of missing bricks. If this gets worse, it is likely to lead to the eventual collapse of the roof. The site is afforded Scheduled Ancient Monument status. The remainder of the structure appears sound.

Photo 19: St Ishmael WWII Lookout

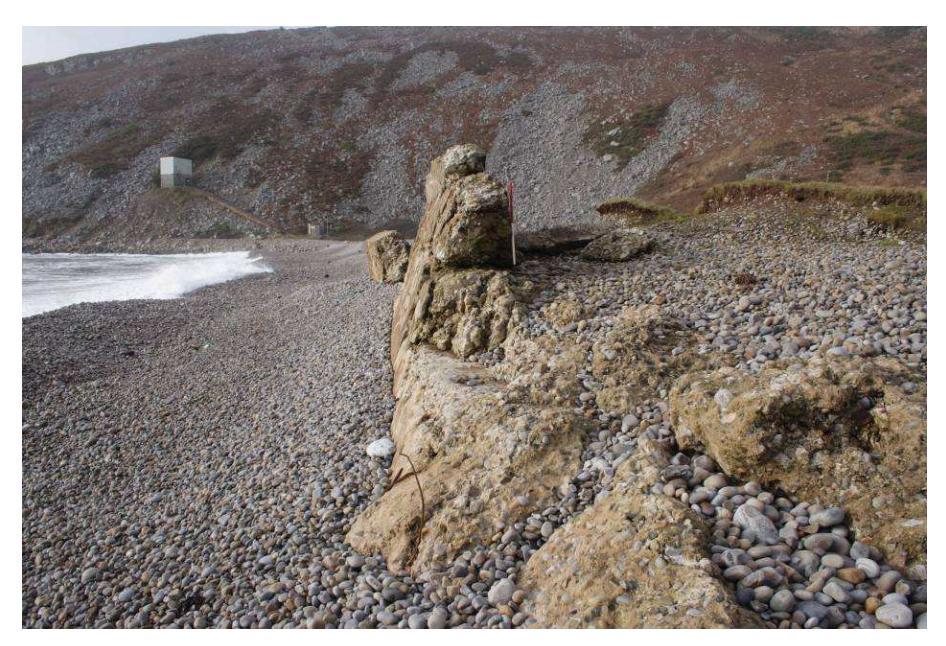
The concrete structure is located on the sea edge of the beach, on a pebble bar (photo 20). The HER description states near intact, and has evidently got this site mixed with the one set back from the beach. This structure is almost completely destroyed, most recently from erosion, but mainly during training manoeuvres during World War II. The structure has craters from shells and bullets. The structure only covers a small part of the beach front and it is considered unlikely that it was a tank trap and most likely a structure associated with training exercises, possibly used as a climbing wall to mimic German coastal defences in France or alternatively the structure was used a ranging target for ships.

Photo 20: Concrete tank trap? PRN 33466

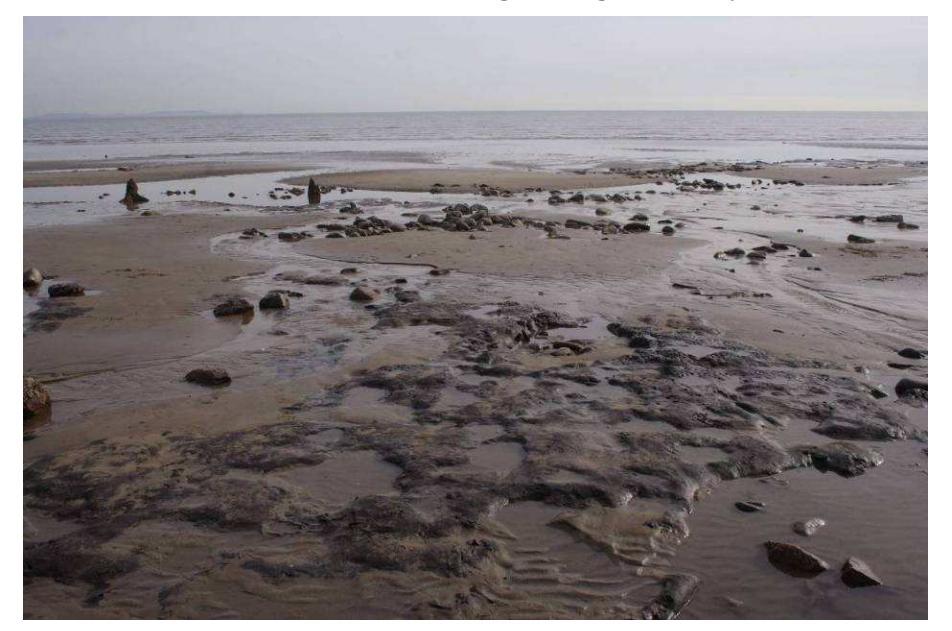
The site visit to Wiseman's Bridge was undertaken at low tide on a Spring Tide in order to view the maximum area of the submerged forest (photos 22 & 23). The conditions were good and a fairly large area of clays and wood was visible showing through the sand. Tidal action is certainly altering the surviving area of the forest as channels could be seen cutting through the clays.

Photo 22: Patches of submerged clays showing through sands with two upright stumps in distance, of submerged forest PRN 7994 looking sea ward

The recorded extents of the visible clays covered an area of around 8056 sq m. Regular monitoring of the exposed surfaces, using reference points, such as the two upright stumps, and some of the horizontal timbers could be undertaken. Changes in tidal action will cover and uncover the site with sand, so the full extent is never likely to be revealed. Monitoring at low Spring Tides could provide further evidence for the extent of the forest and provide the potential for recovery of any artefacts that may be present.

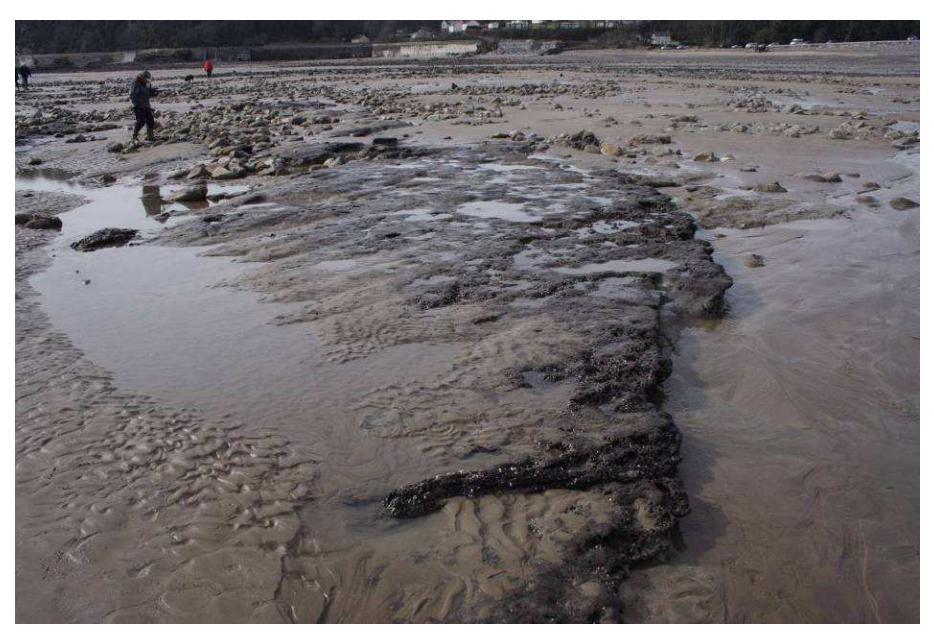
Photo 23: Further patches of submerged clays showing through sands associated with submerged forest PRN 7994 looking towards land

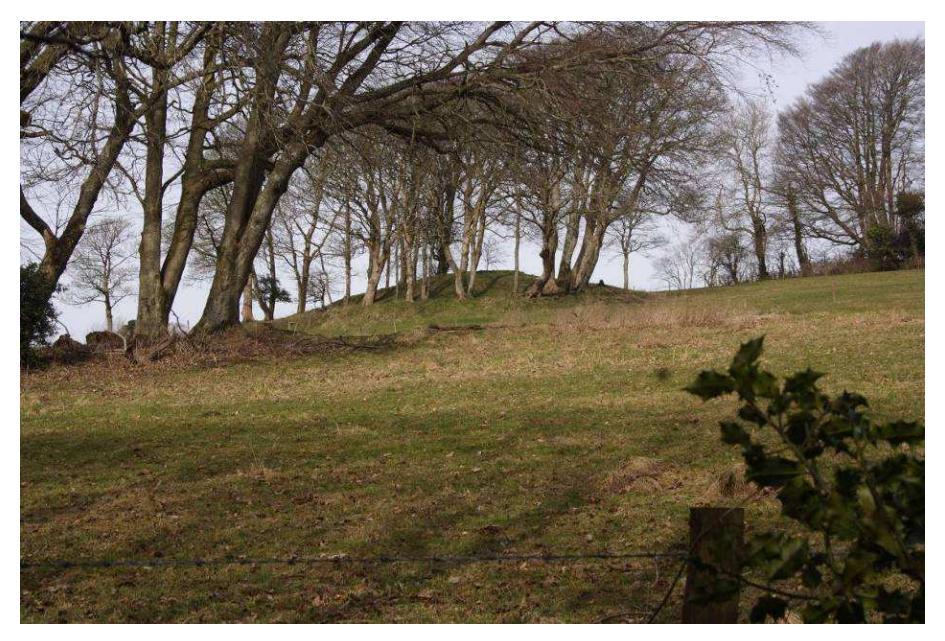
A large mound is visible within the Hean Estate land from the coastal path (over the higher ground) Coppet Hall and Wiseman's Bridge (photo 24). The mound is covered with mature trees, implying it is earlier than an industrial spoil tip. It is fairly sizable, and shows on aerial photographs of the area. It was not possible to access the site and it was viewed from some 200m away. The mound is situated on a high point of land, and (assuming no tree cover), would be visible from the promontory on the western side of Morfa Bychan to Monkstone Point. It is unclear what the site represents, though would appear to be worthy of further investigation.

It does not appear that the mound is under any threat from erosion or agricultural activity, but could represent an archaeological monument of high significance.

Photo 24: Earthwork mound within the Hean Castle Estate (PRN 99095)

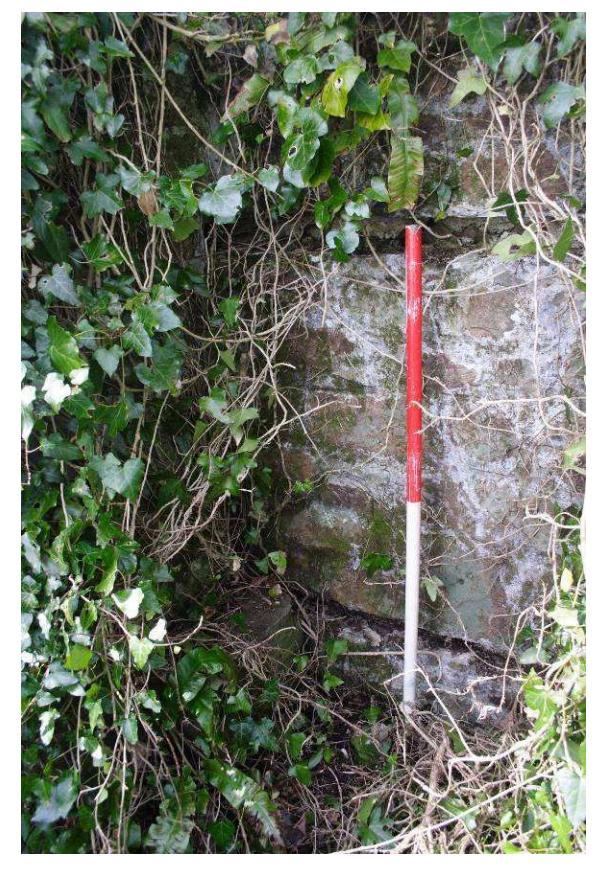
Photo 25: Southern wall of Hean Castle Summerhouse or Gazebo, showing stone plinth and recesses

A stone built structure is visible on the coastal path, at the edge of the Hean Castle estate on the cliff top. The structure comprises a straight rear wall *c*.4m in length, with two side walls projecting to the south. The structure is 1.7m in height. Three stone plinths are present on the inside of the wall, and presumably supported a wooden bench. Two horizontal recesses are also present on the southern side running the whole length of the structure. It is assumed that these held wooden battens onto which wooden slats were fitted to create a timber backrest for the seat (photo 25). Rather than a summerhouse, the structure would appear to be a seating area with clear views across Carmarthen Bay.

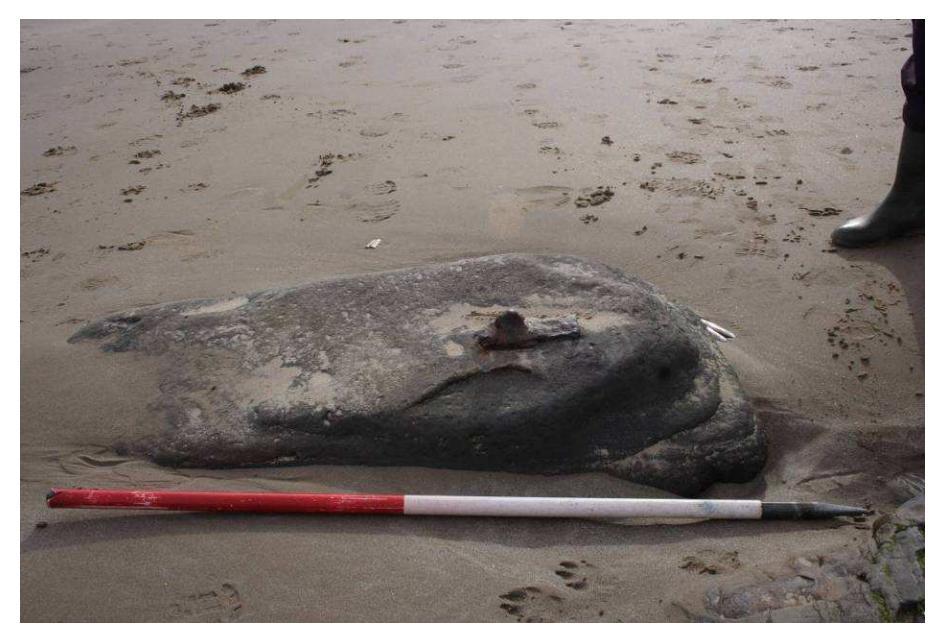
A small metal mooring point is visible within the rocks on the promontory on the western side of Coppet Hall beach (photo 26). The object is of iron and well secured in the bedrock, although the entire area is badly eroded. No remains of the original shape of the fixing is visible. It was presumably used as a mooring point for boats at high tide, connected with the transportation of goods. It is located around 18m from the cliff face.

Photo 26: Iron fixing in rock on eastern side of Coppet Hall beach, PRN 99096
