ARFORDIR COASTAL HERITAGE 2009-2010

RHIF YR ADRODDIAD / REPORT NO. 2010/23 RHIF Y PROSIECT / PROJECT RECORD NO. 99087

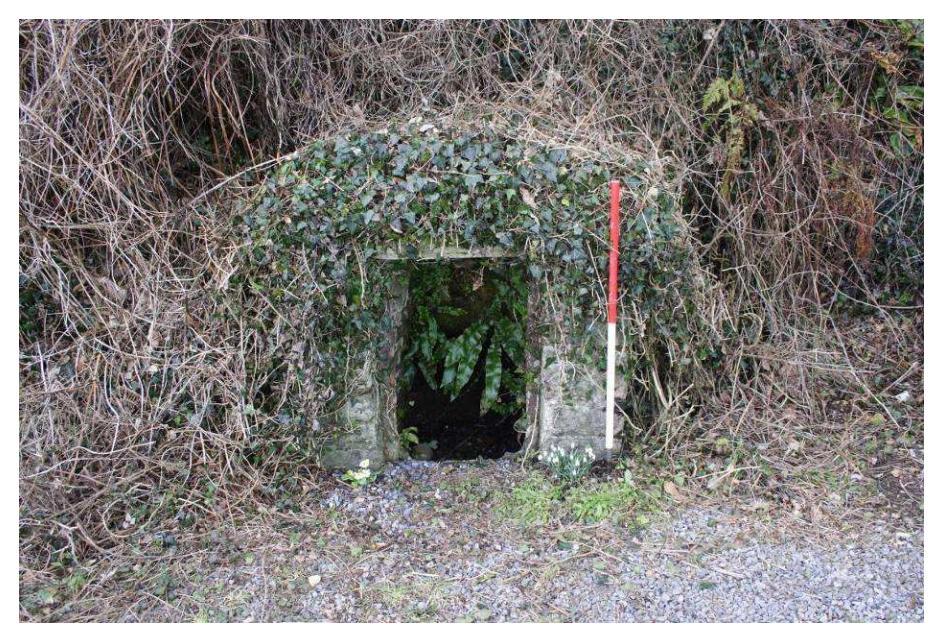
The structure comprises a small stone built structure measuring 1.2m in width, 1.25m in height and 1.3m deep (photo 27). Possibly situated over a natural spring at the base of the cliff. Iron grill present at front (badly eroded) and small drain passage visible on rear wall. Presumably of 19th century date.

Photo 27: Possible waterpoint for steam trains on edge of railway near Wiseman's Bridge PRN 99097

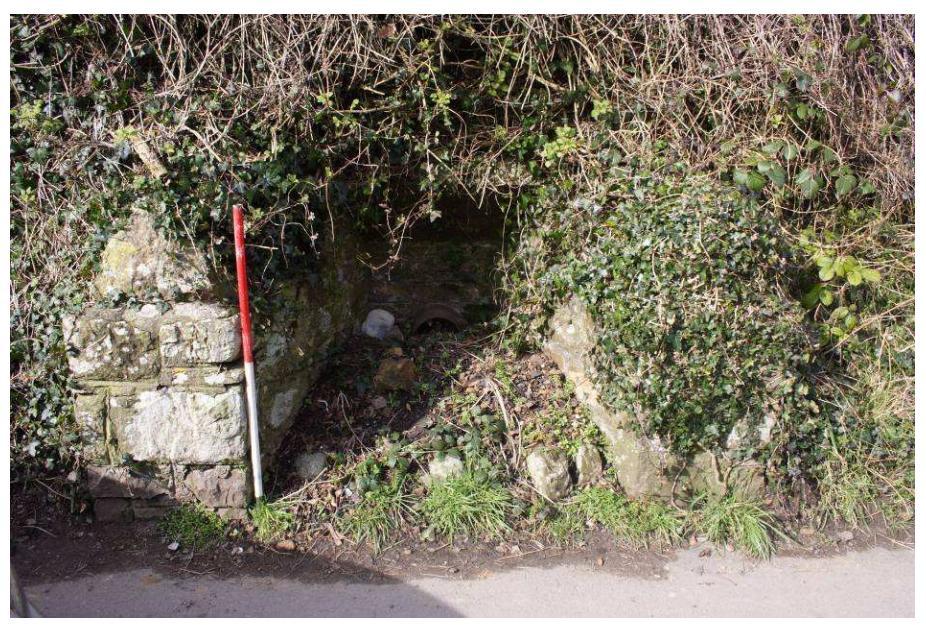
The structure comprises a small stone built structure measuring 2.7m in width, 1.2m in height and 1.4m deep (photo 28). Possibly situated over a natural spring at the base of cliff. There is no cover to the feature. A pipe is visible at the rear of the feature. Presumably of 19^{th} century date.

Photo 28: Possible waterpoint for steam trains on edge of The Strand, Saundersfoot PRN 99098

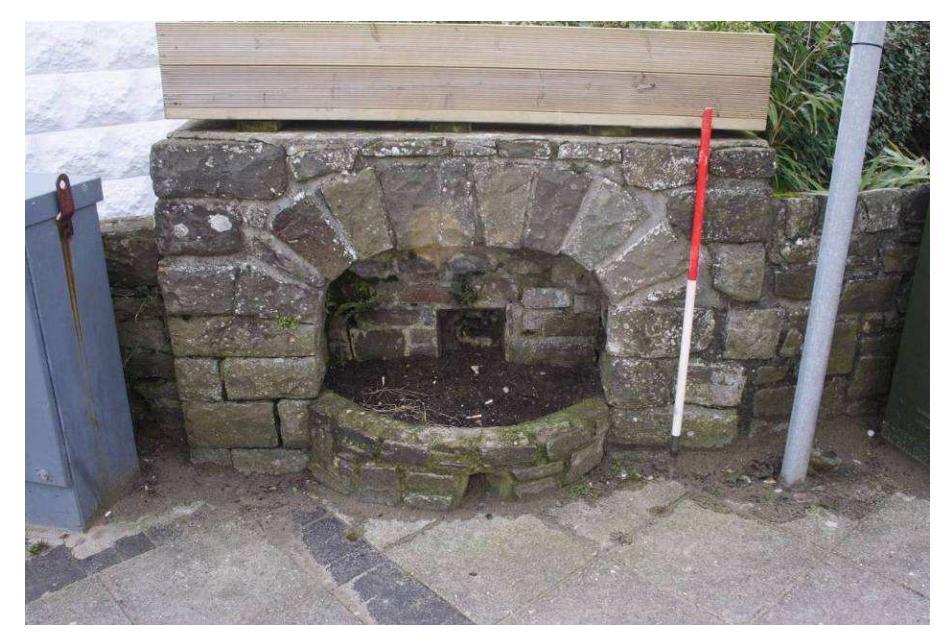
The original waterspout has been incorporated into a more decorative stone built surround in recent years (presumably at the same time as the Sensory Gardens were laid out, photo 29). The feature comprises a square iron pipe seating set in a stone wall. No remains of the external spout are present. Is likely to have been one of the five drinking water spouts that are known to have been present around Saundersfoot. Presumably of 19th century date.

Photo 29: Possible water spout at southern end of High Street, Saundersfoot PRN 99099

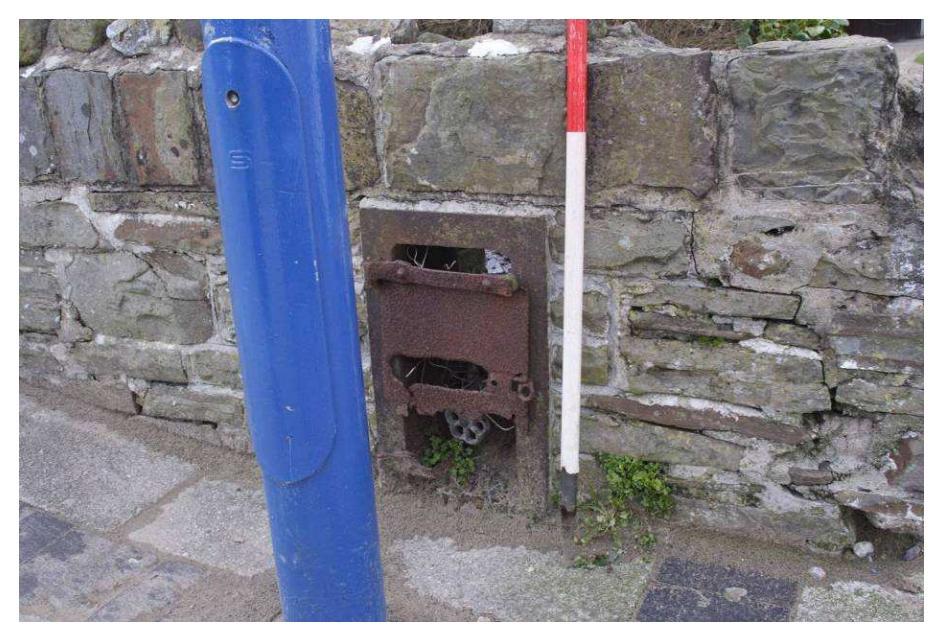
A second water feature is present close to PRN 99099 above (photo 30). This feature is different as it comprises a small metal door (the frame is $0.3m \times 0.5m$ in size) with a standpipe enclosed within. The metal door is badly rusted. The standpipe is still in use. It is unclear if this was another drinking water spout or merely part of the water feeding system. Presumably of 19th century date.

Photo 30: Metal door and standpipe, southern end of High Street, Saundersfoot PRN 99100

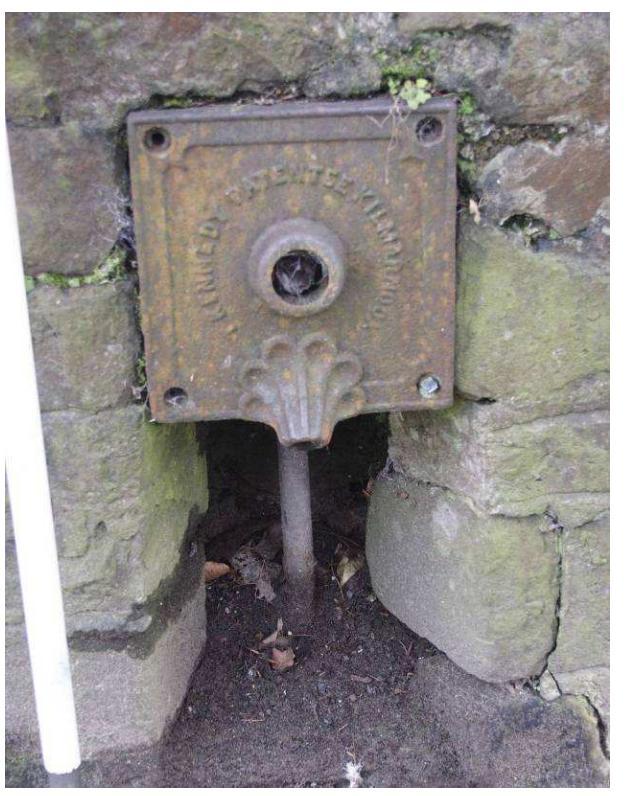
Photo 31: Water spout at east end of Milford Street on the south side, Saundersfoot PRN 99101

The original waterspout cover is still present within the wall. The cover is fairly ornate and the makers name is cast in the cover – 'Kennedy Patentee Kilmarnook' (it is assumed that earlier casts would have said Kilmarnock, but over the years the mould became abraded; photo 31). The cover was cast by the Glenfield & Kennedy Ltd Ironworks in Kilmarnock, and the water spout is model G & K No D19, self closing drinking fountain (http://www.scottishironwork.org). It is unclear if all of the water spout / drinking fountains would have been the same within Saundersfoot, as mentioned above five others were known to have been present in the town. It is also unclear why a Scottish made drinking fountain cover would have been used in West Wales. Presumably of 19th century date.

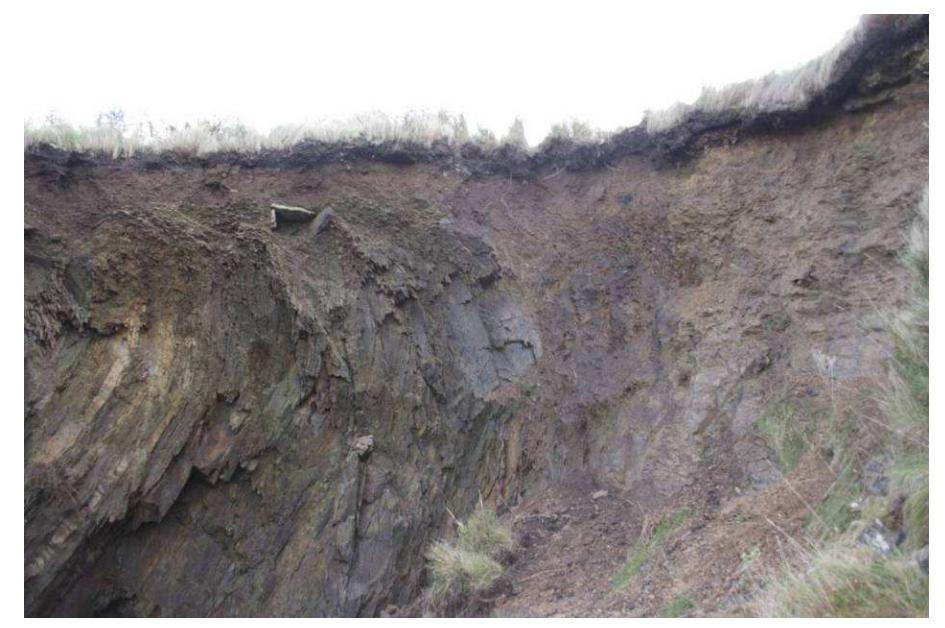
Further information regarding the site was given in January 2010, when following bad weather, the central cist grave collapsed from the cliff face (photo 34). A site visit was undertaken and a brief search of the collapsed material was made (although this could not be done in any detail, due to its location beneath the unstable cliff face). The slabs of the grave were present but no further bone or any other artefacts were recovered.

The presence of the third burial and the evident instability of the cliff, suggest that further burials are likely to be present within the Scheduled area adjacent to the cliff face. Scheduled Monument Consent has been granted for further archaeological works to be undertaken at the site, as part of the Arfordir project, to further investigate the areas close to the cliff edge.

Photo 34: West Angle Bay early medieval cemetery in January 2010, where one cist grave has collapsed from the cliff face (compare with photo 40 above)

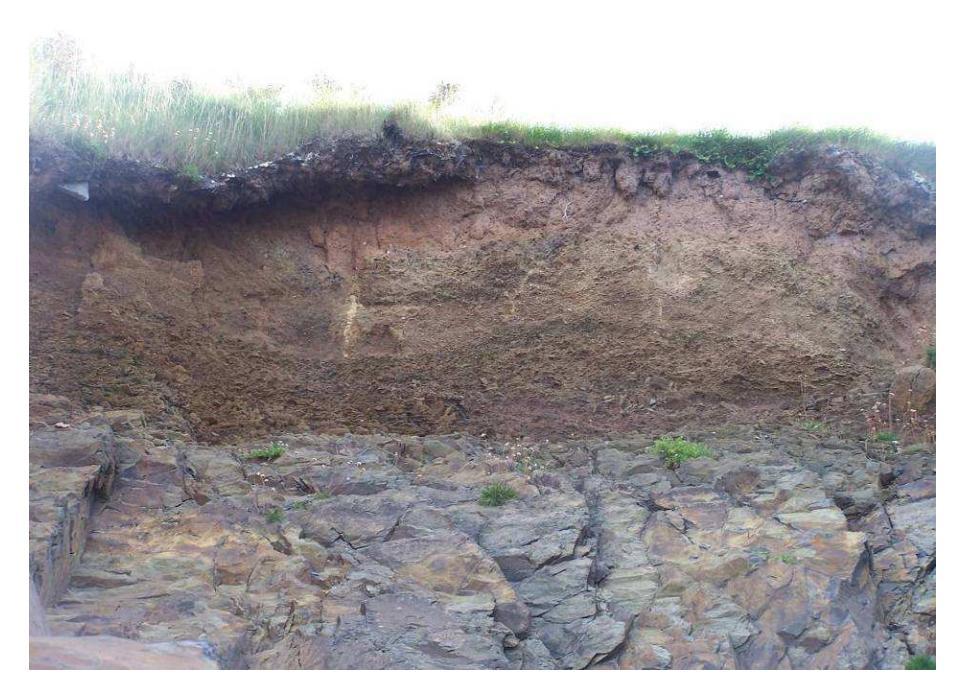
During a site visit to West Angle Bay, a possible ditch was seen eroding from the cliff to the west of the cemetery site (photo 35). The ditch was visible as a darker band of soil in a shallow U shape. The possible feature measured around 3m in width and around 1.2m in depth. Further investigation of the feature on a subsequent visit with a geologist (Arfordir volunteer) indicated that the feature may be substantially natural (formed by mineralisation), but that a definite smaller cut feature was visible above (with a further feature also situated to the west). No further investigation has been undertaken of this feature.

Photo 35: Possible ditch feature (PRN 99102) visible in eroding cliff face located to the west of the cemetery site

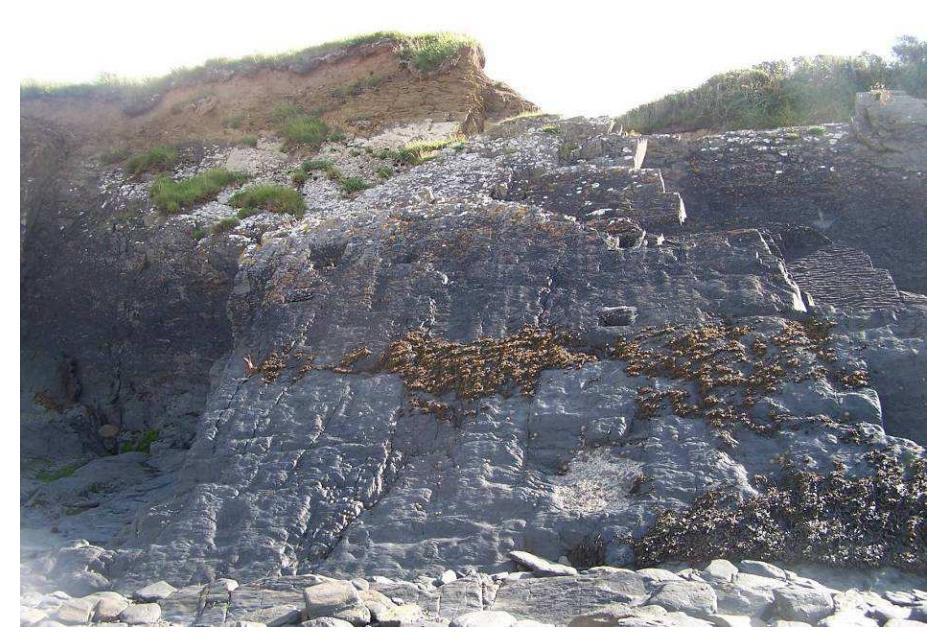
A number of square rock cut hollows were noted in a sloping cliff face adjacent to the medieval cemetery site. These are evidently of post-medieval date, and probably represent mooring points for boats possibly used for transportation of brick from the nearby brickworks (at a time before the small harbour was built on the north side of the bay. The mooring points are on three levels in the rock face, presumably so that different ones could be used depending on the height of the tides. A number contained mortar within the hollows (photo 37), and a few with iron fixings within the mortar. Other mortar/concrete features are also present in the area nearby.

Photo 36: Rock cut holes for mooring points in the cliff face adjacent to early medieval cemetery (PRN 99103)

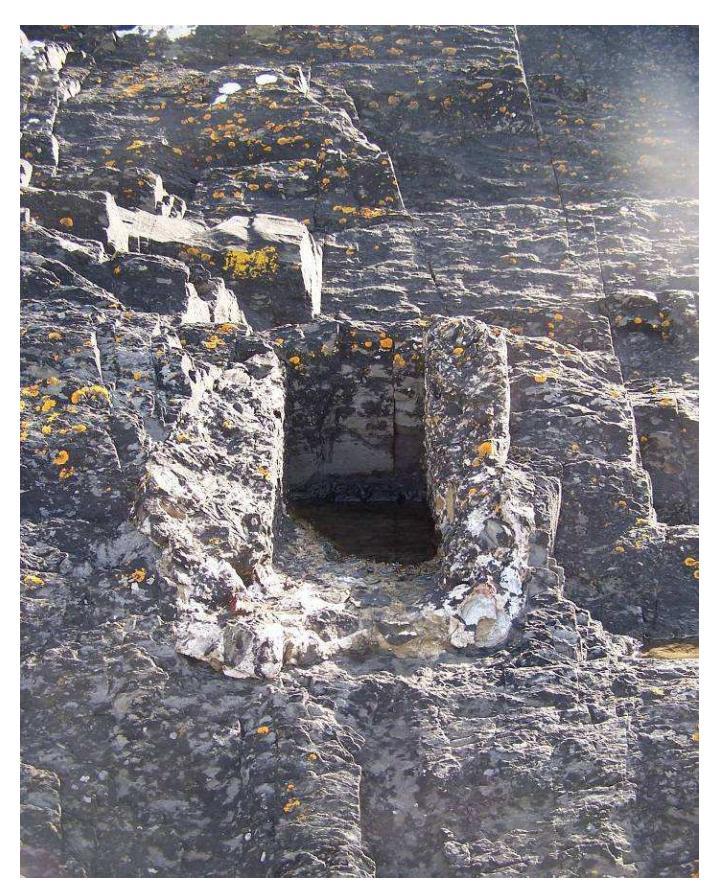
Photo 37: detail of one of the rock cut mooring point holes in the cliff showing remaining mortar seating for presumed post (PRN 99103)

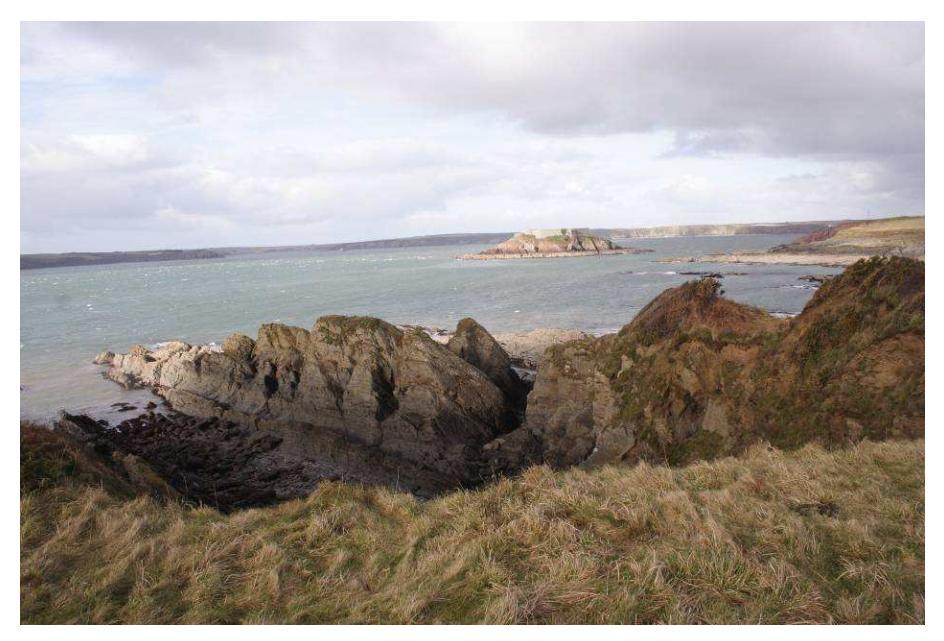
During the site visit in early 2010, an Arfordir volunteer pointed out the banks present on a small promontory at the end of the bay. The features appear to represent a substantial outer bank, and a slightly smaller inner bank with a ditch between (photo 38 & 39). Although the promontory is significantly eroded, the features would appear to be the classic remains of a former Iron Age promontory fort. The site area is quite difficult to access so detailed recording was not undertaken. The site is considered to be of high archaeological importance and worthy of further recording. The site is visibly eroding, with exposed areas of soil on the edges of the bank and ditch, presumably from recent collapse (photo 39).

Photo 38: View west along remaining promontory at West Angle Bay, with bank and ditch earthworks on right hand side of photograph (PRN 99104)

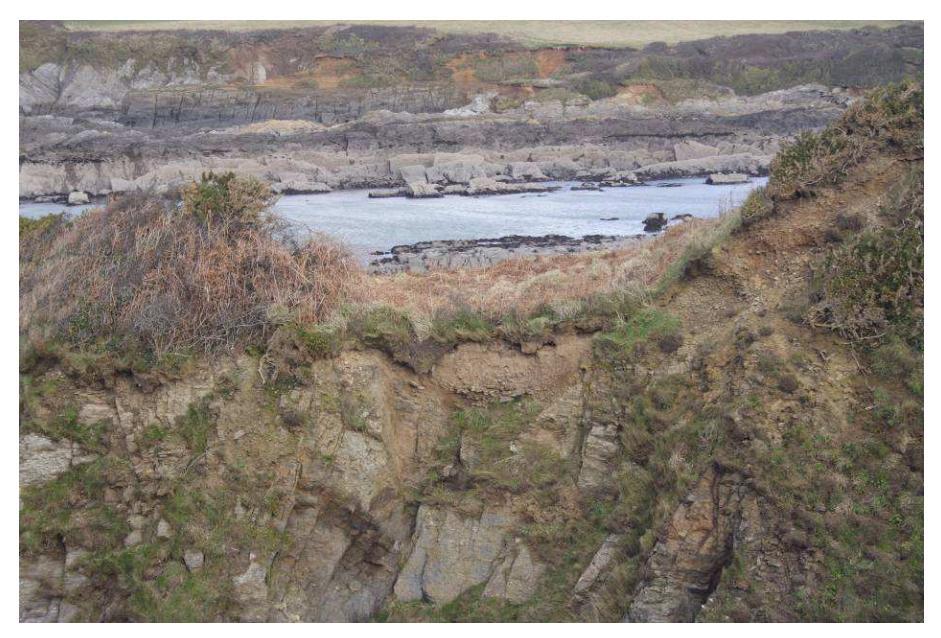
Photo 39: Profile view of banks and ditch of Iron Age promontory fort at West Angle (PRN 99104)

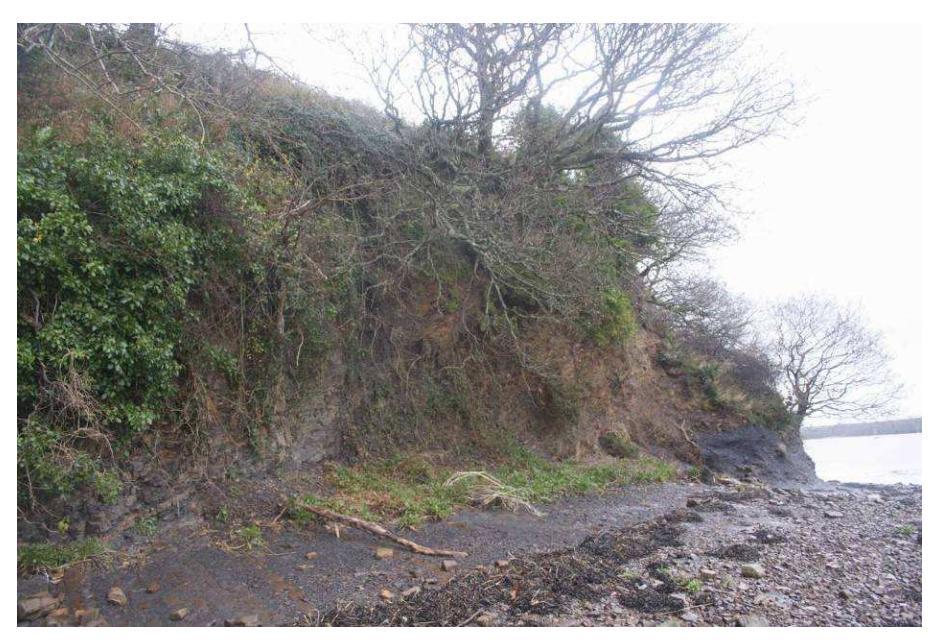
Photo 40: View of area of Picton Point promontory fort showing vegetation covering cliff face

The fort site would appear fairly stable, sitting on hard rock outcrop covered with vegetation (photo 40). There is evidence of past subsidence which has subsequently been well covered in vegetation. There is very soft geology to the east of the site along the coastline which shows clear signs of recent erosion, but this lies some distance from the site.

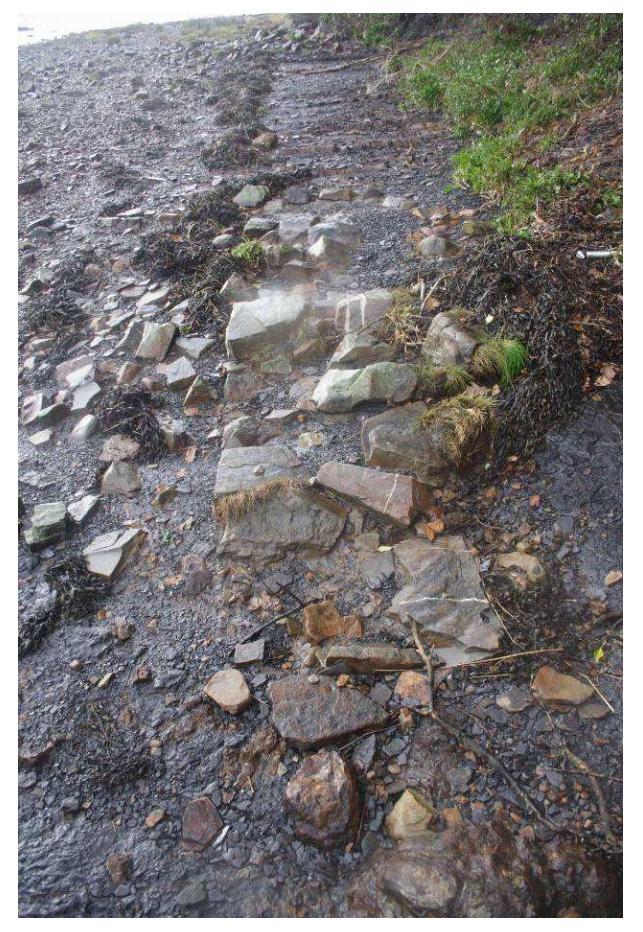
During the site visit to Picton Point stone walls were noted on the shore line, visible as clear walls set into the underlying beach deposits. The walls were constructed of small to medium sized stones with good faces. The walls indicated a right angle with one wall roughly east-west with a short north-south return. The walls only survived a few courses in height and had been substantially eroded to the south by tidal action. The first edition Ordnance Survey map indicates a rectangular building roughly in this location with 'Old Culm Pit' written adjacent to it. The building was noted, but not recorded in any detail. The building or culm pit is not shown on the second edition Ordnance survey map.

Photo 41: Part of stone wall identified on shore at Picton Point

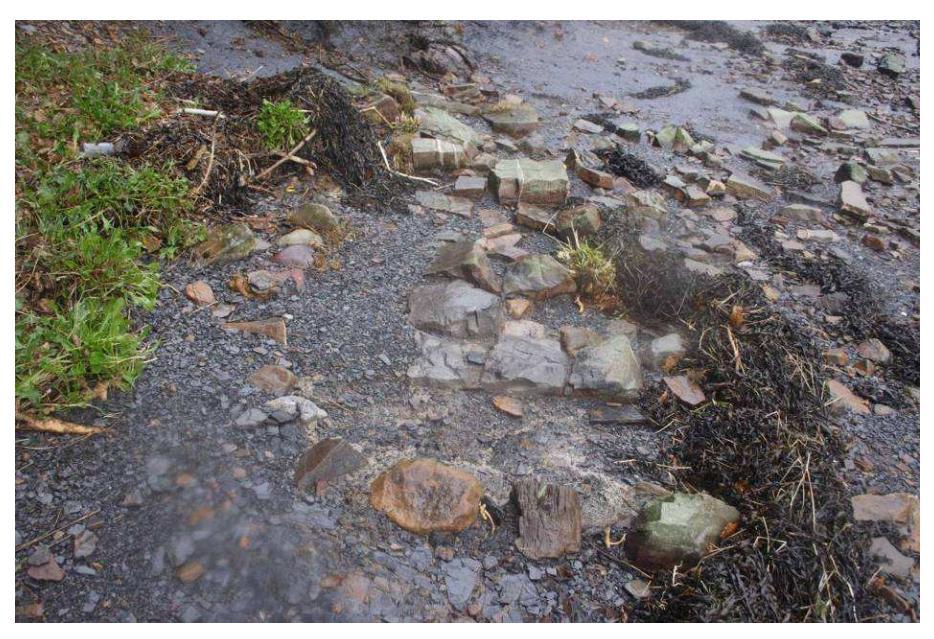
Photo 42: Corner of stone wall identified on shore at Picton Point

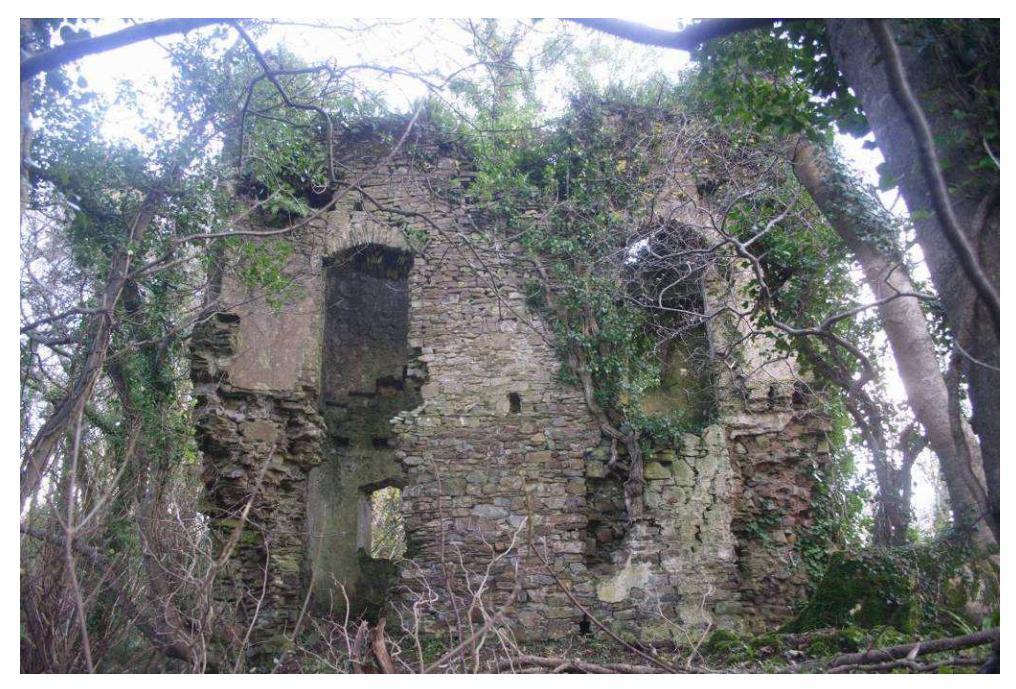
Photo 43: Eastern masonry block, stair tower indicating a former three storey structure with undercroft

The site is situated in woodland which has encroached over much of the ruins. Ivy has taken root over areas of the main surviving masonry blocks and appears to be forcing apart the stonework. Tree root damage is also apparent. At the base of the east wall of the eastern tower structure a substantial hole is present (photo 45). The eastern tower represents a stair tower used to access the former three storey building above the undercrofts (photo 43). Should the undercroft be allowed to collapse, as noted above the roof is beginning to subside (photo 46), it is possible that this will also weaken the remains of the eastern tower, as they are directly connected.

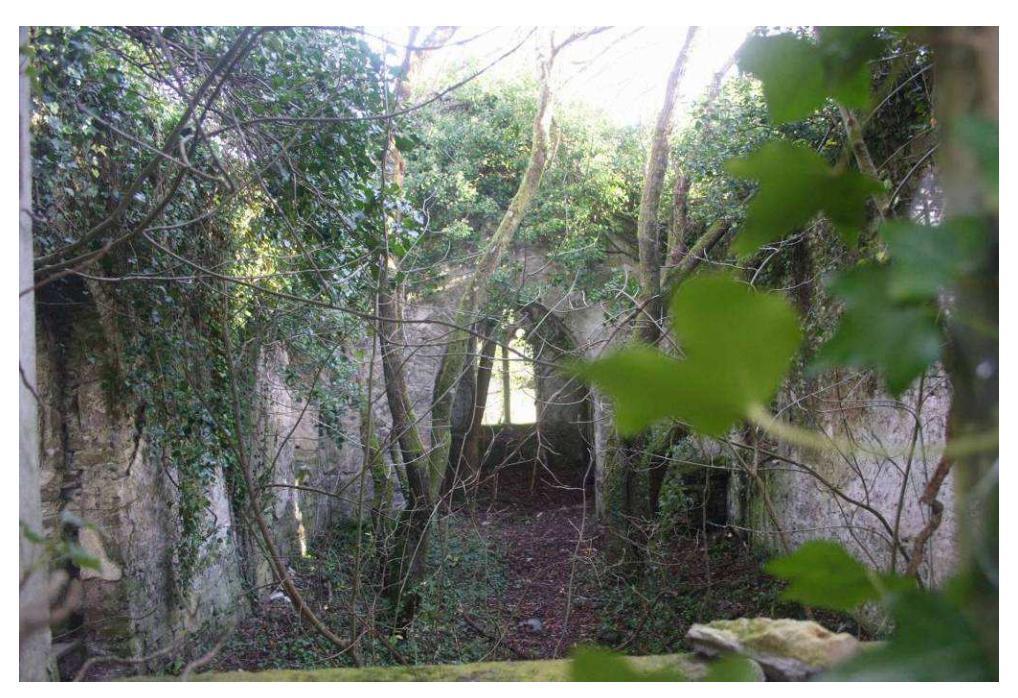
The church at Boulston was constructed in the 19^{th} century but occupies the site of a medieval church that is known to have been in existence since the 12^{th} century. The church is roofless and in a state of advanced decay with ivy and semi mature trees growing within the ruins (photo 49). Within the church are located the remains of an armorial slab and 17^{th} century tomb.

Given the church is relatively isolated and located away from any through roads vandalism does not appear to have been a problem. The biggest problem noted was the vegetation that chokes much of the site that will continue to degrade the structure. With rising sea levels, the church wall facing the estuary will be under threat from erosion, and thus the churchyard itself will also become exposed.

Photo 49: Boulston Church, internal view east

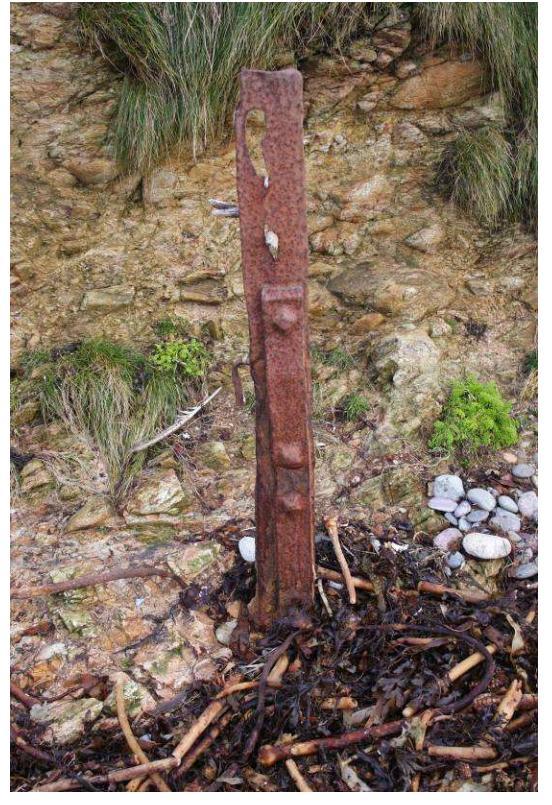
Photo 50: Iron mooring post at Porthlysgi Bay (PRN 99106)

At the edge of Portlysgi Bay, close to the enmd cliff, an upright metal post is visible. The post measures 1.20m in height ad 7.5m in width. It is L shaped in profile, with riveted metal plates near its base. The metal is rusted and corroded. The feature is isolated and thus interpreted as a mooring post, although could conceivably have been attached to other posts nearby, perhaps acting as a water break.

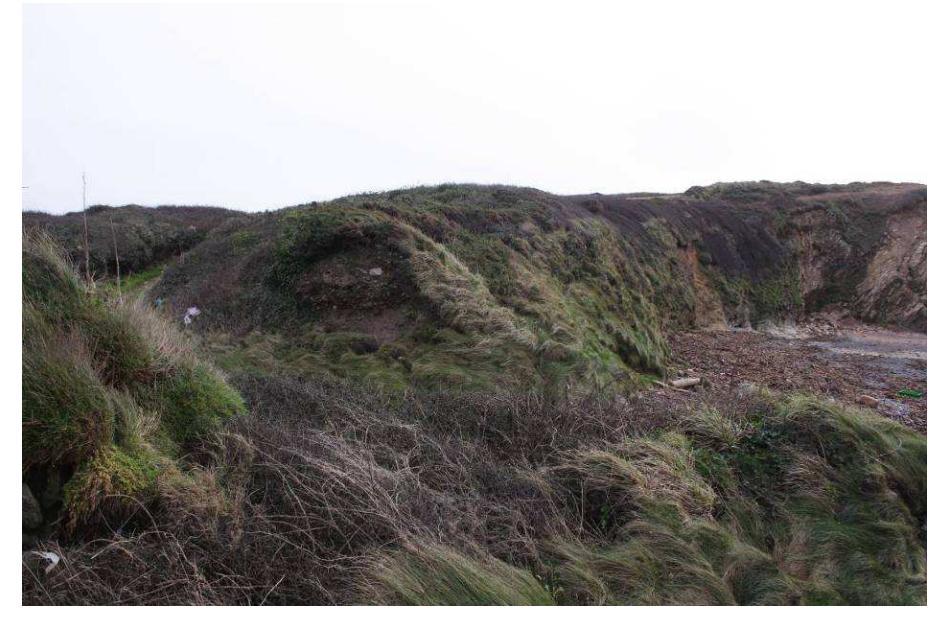
A site visit to Portlysgi Bay noted a large man made earth bank present around the northern edge of the bay. The bank was cut through by a stream course, and potentially carries on to the west. The bank is likely to have been used to shelter the buildings and farm land to the north of the Bay (similar banks have been noted at other bay sites, such as Nolton Haven). The bank could be as much as 3m in height and about 5m in width.

Photo 51: Substantial earth bank around edge of Porthlysgi Bay (PRN 99107)

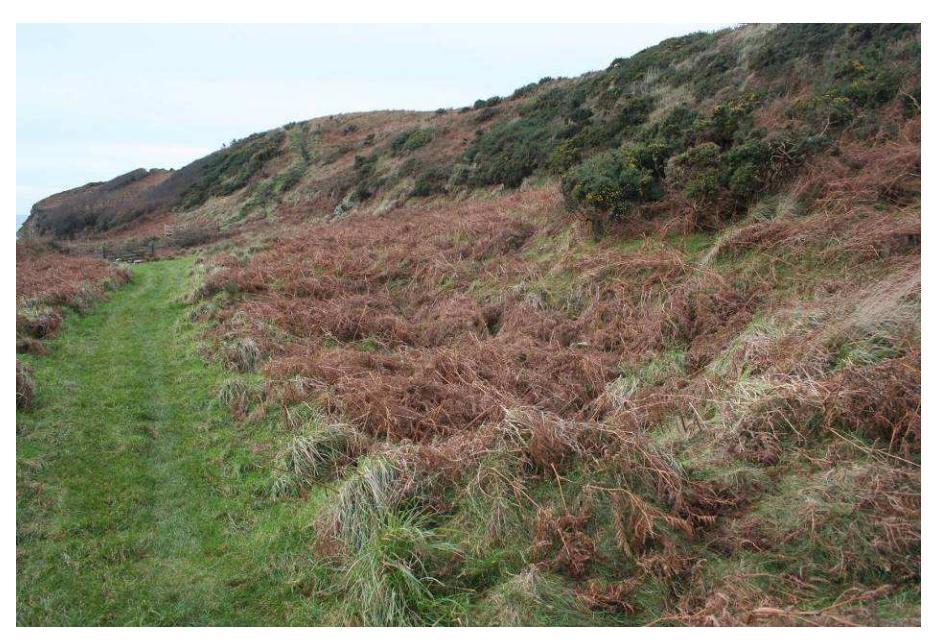
Three rectangular buildings are recorded at Porthlysgi Bay to the north of the beach (PRNs 32615, 32616 and 32635). A further building was noted during the site visit, surviving as low earthworks on the northern side of the trackway leading from the beach. The external walls of the structure, measuring $c.18m \times 5m$, are visible as low banks around the perimeter of the structure. No entrance

way or internal divisions were apparent. The building is presumably of a similar date to the other known structures, of post-medieval date associated with a small former settlement.

Photo 52: Remains of building to north of track way at Porthlysgi Bay (PRN 99108)
