YNYSLAS HULKS, YNYSLAS, CEREDIGION: ARCHAEOLOGICAL INVESTIGATIONS 2016 - 2017 INTERIM REPORT

RHIF YR ADRODDIAD / REPORT NO. 2016/15
RHIF Y DIGWYLLIAD / PROJECT RECORD NO. 107509
Cadw Project No. DAT 135

Mawrth 2017
March 2017

James Meek MCIfA

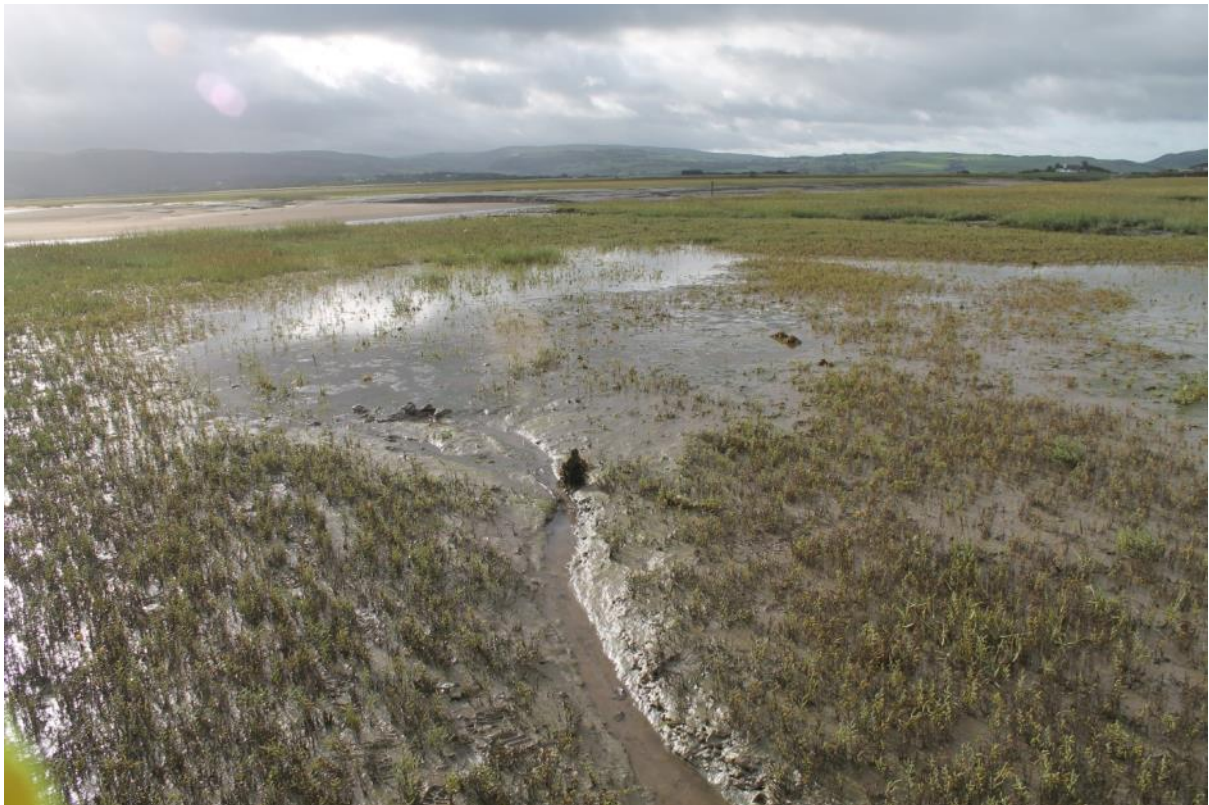
Photo 3: Wreck 2, facing south-southeast – 08/09/2016

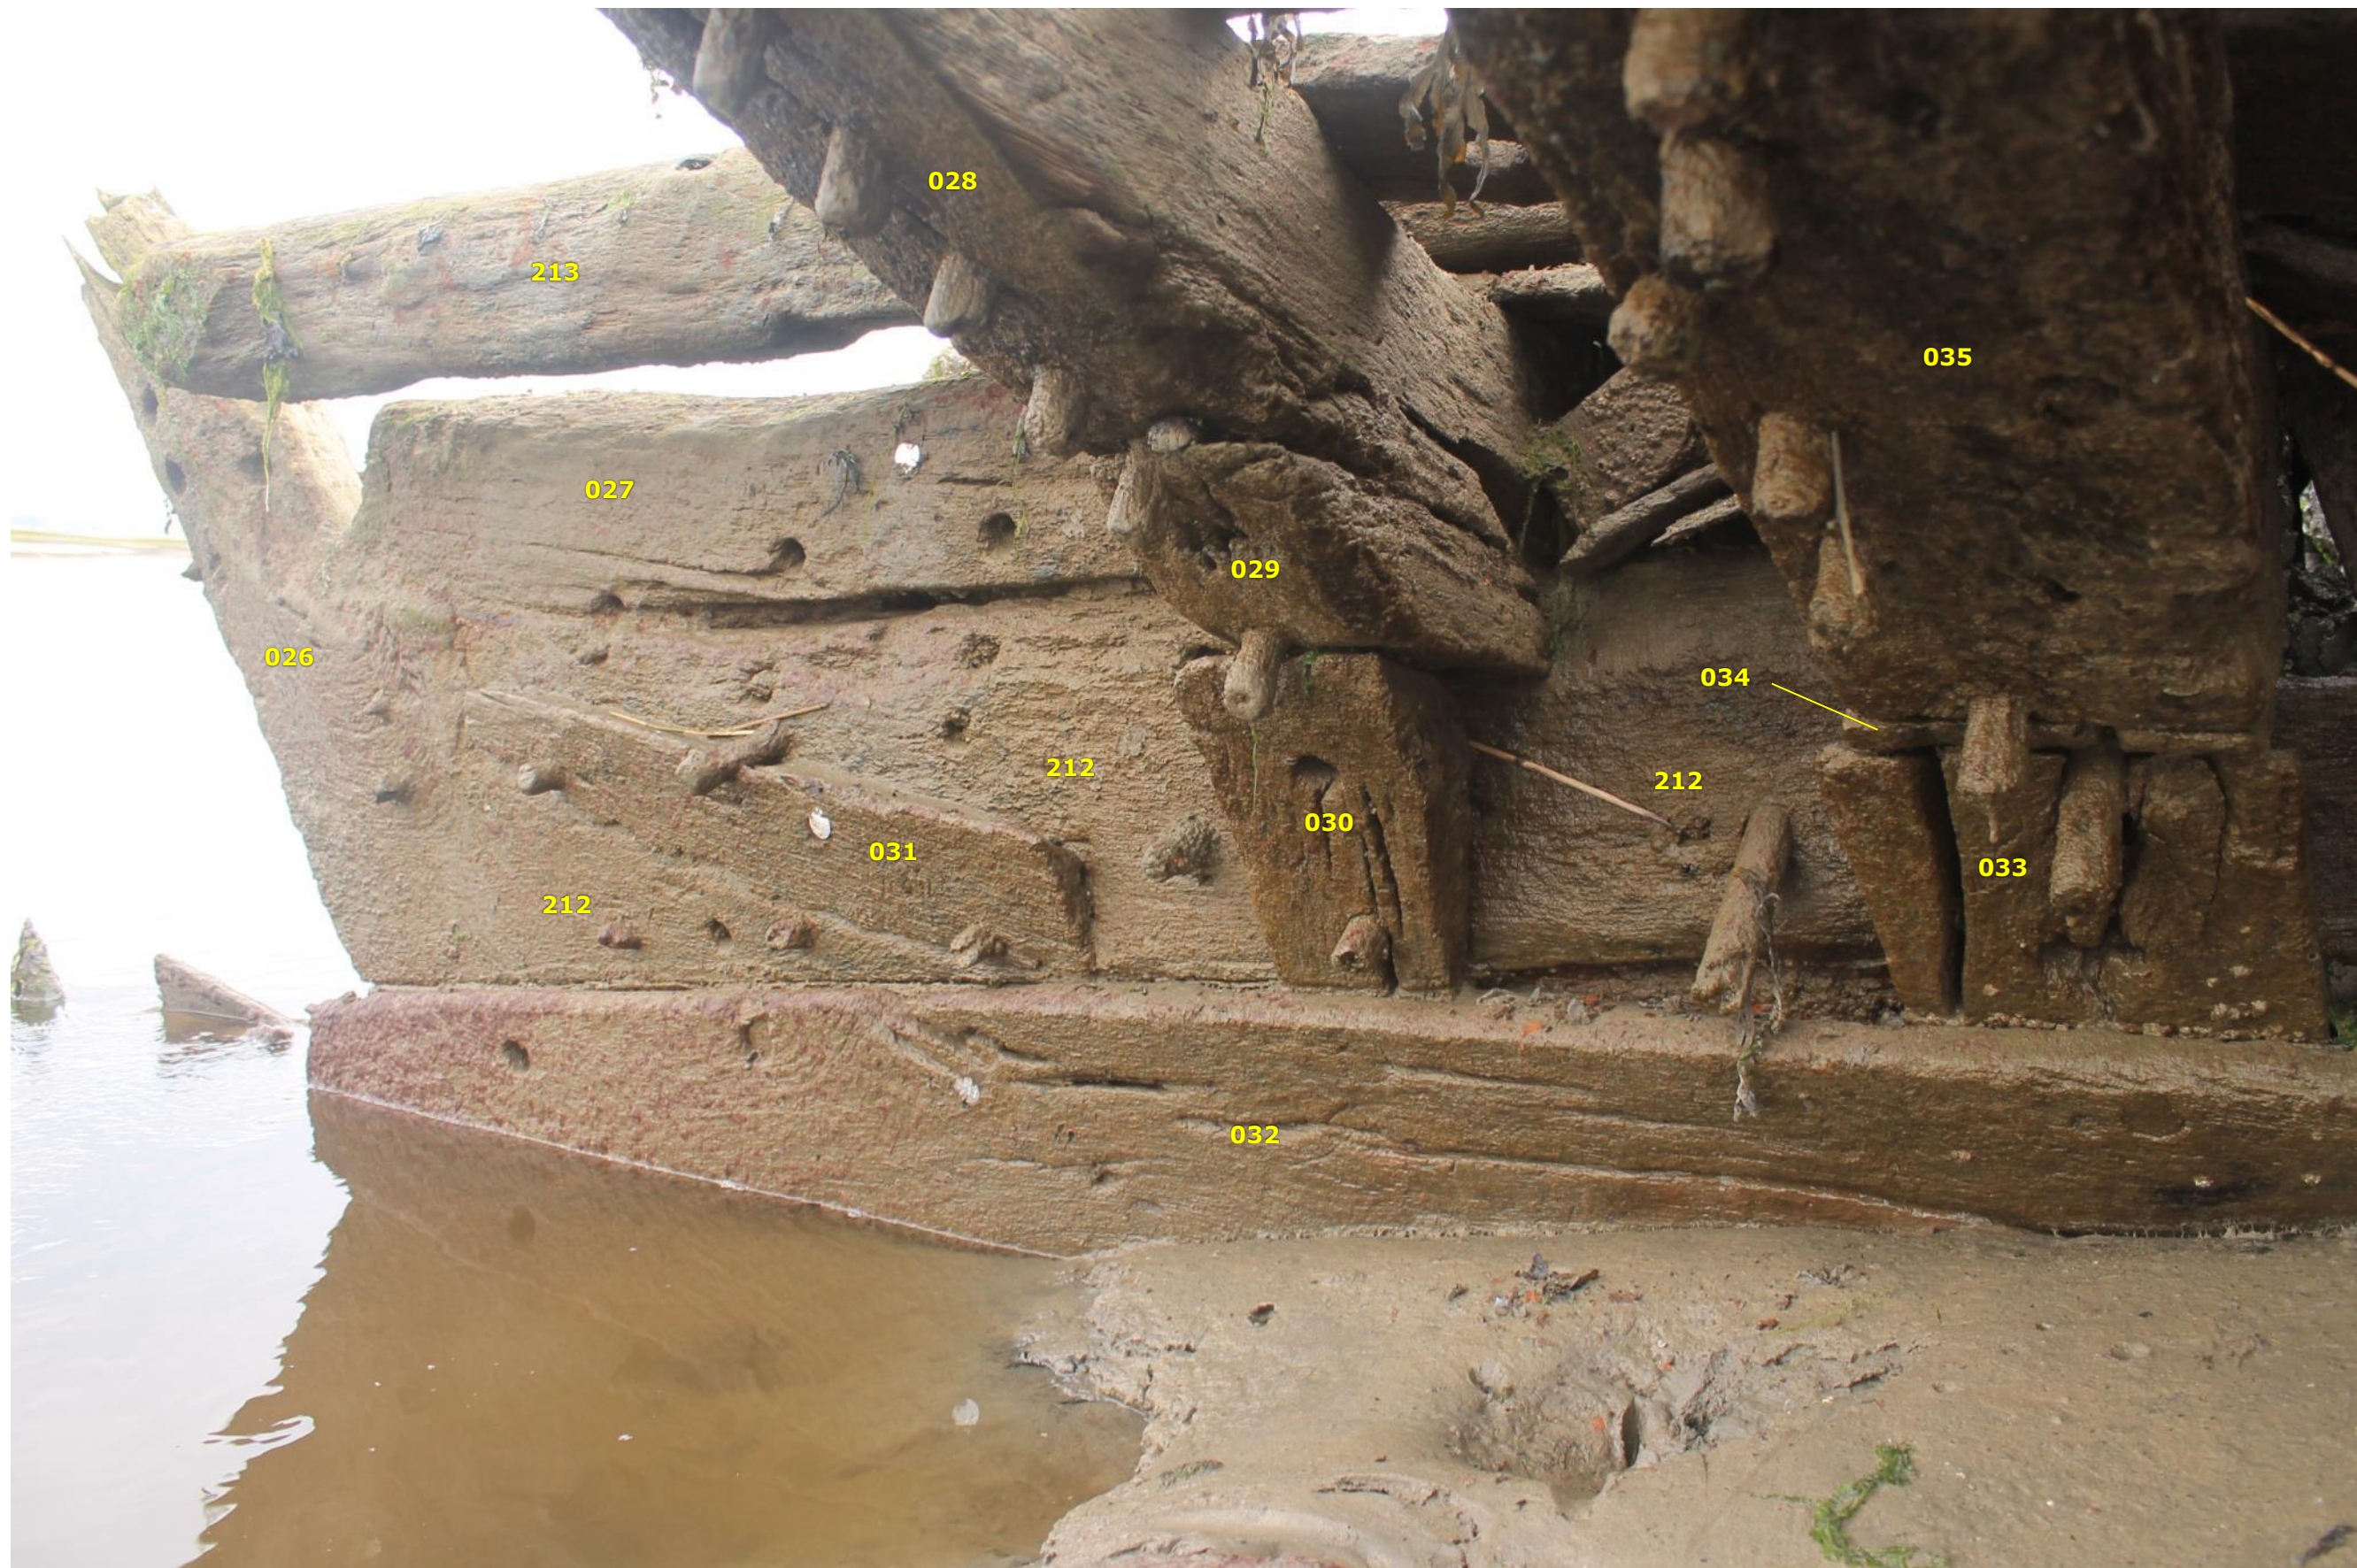
Photo 9 shows the main timber elements of the starboard side of the stern. The stern post, 026 is clearly visible with deadwood fillers between it and the first of the floor frames, 028. The first frame lies on top of a deadwood piece, 212. The next frame, 035, is also located on top of this piece of deadwood, although it has been located into a rebate half way through the timber. The next frames, 066, 065 and 064 would appear to lie directly on the underlying keel which was not visible (other than its upper surface) due to being buried in the silts. The two end floor frames were both attached to two additional filler pieces (029 & 030; 034 & 033) evidently being used to create the shape of the stern of the vessel to which outer planking was formerly attached. Only the lowest outer plank was survived at the stern, 032. This was partially attached to a further shaping filler piece attached to 212, which was an elongated wedge.

Photo 9: Timbers forming the stern on the starboard side (June 2015)

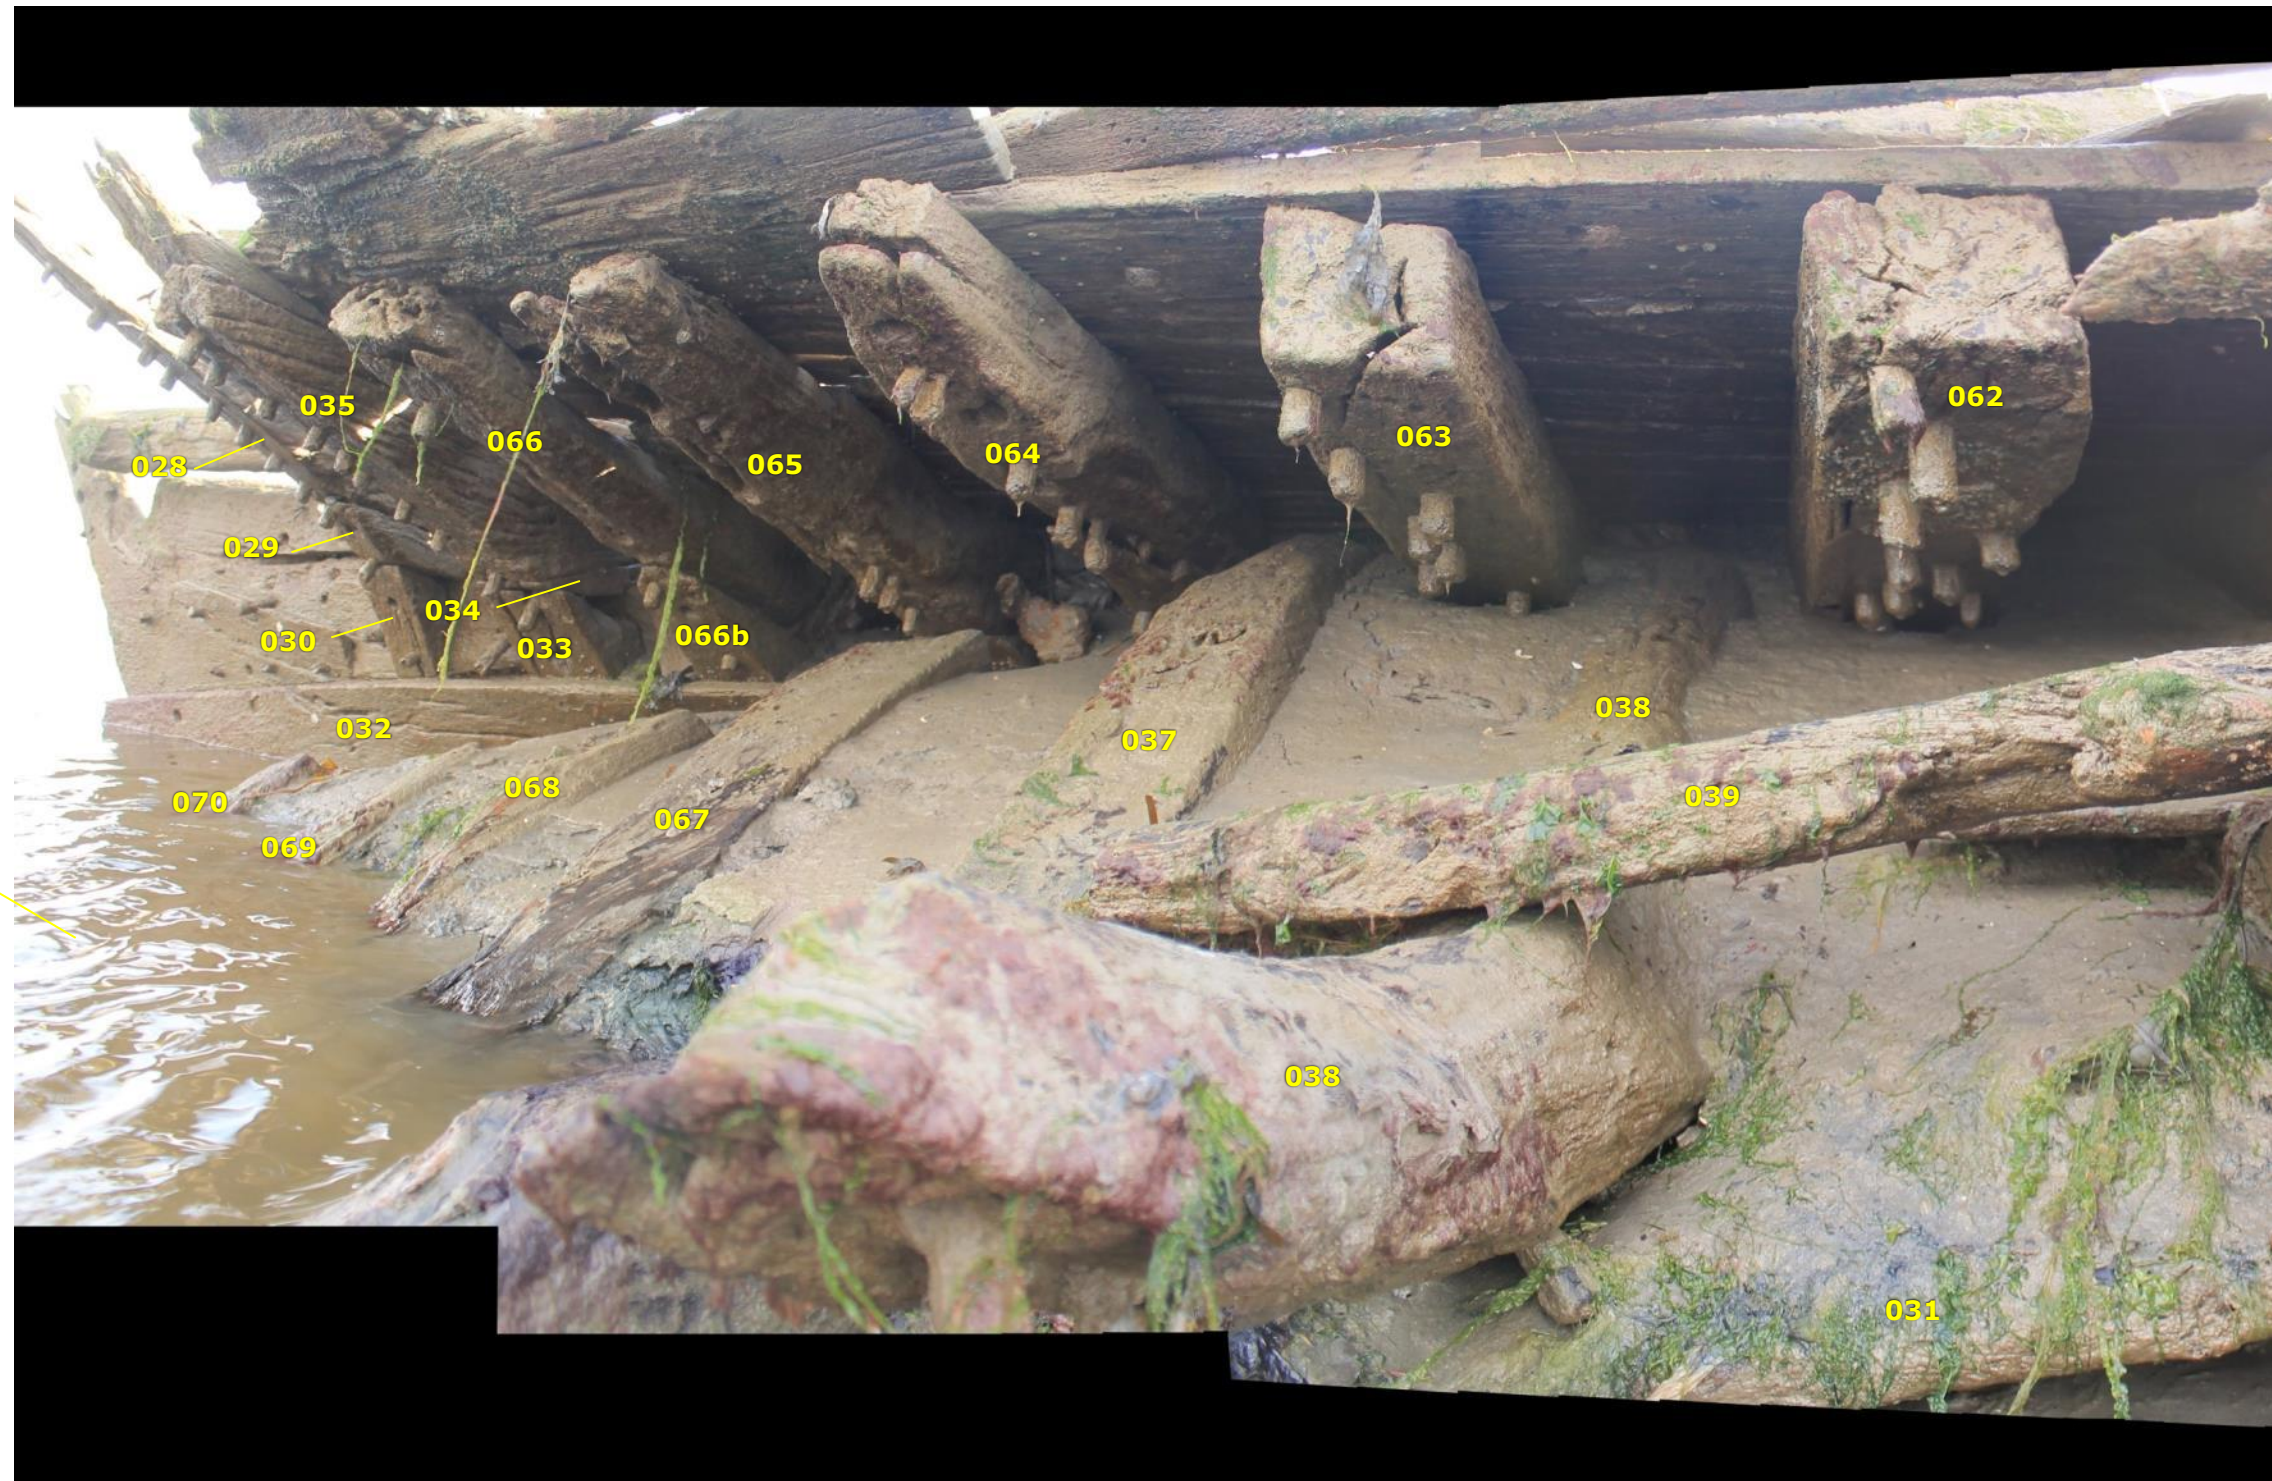
Photos 10 and 11 show the majority of the remainder of the starboard side. Although the ends of floor frames could be identified along the rest of the starboard side, it was not possible to see these attached to the keel which was hidden below silt and other timbers. Collapsed 1st futtocks could be seen, many still attached by treenails to underlying outer planking. Simple scarf joints had been used to join these to the floor frames. Filler frames remained in-situ.

Photo 10: Frames on the starboard side (between Photo 11 and stern, Photo 9)
(merged photographs from June 2015)

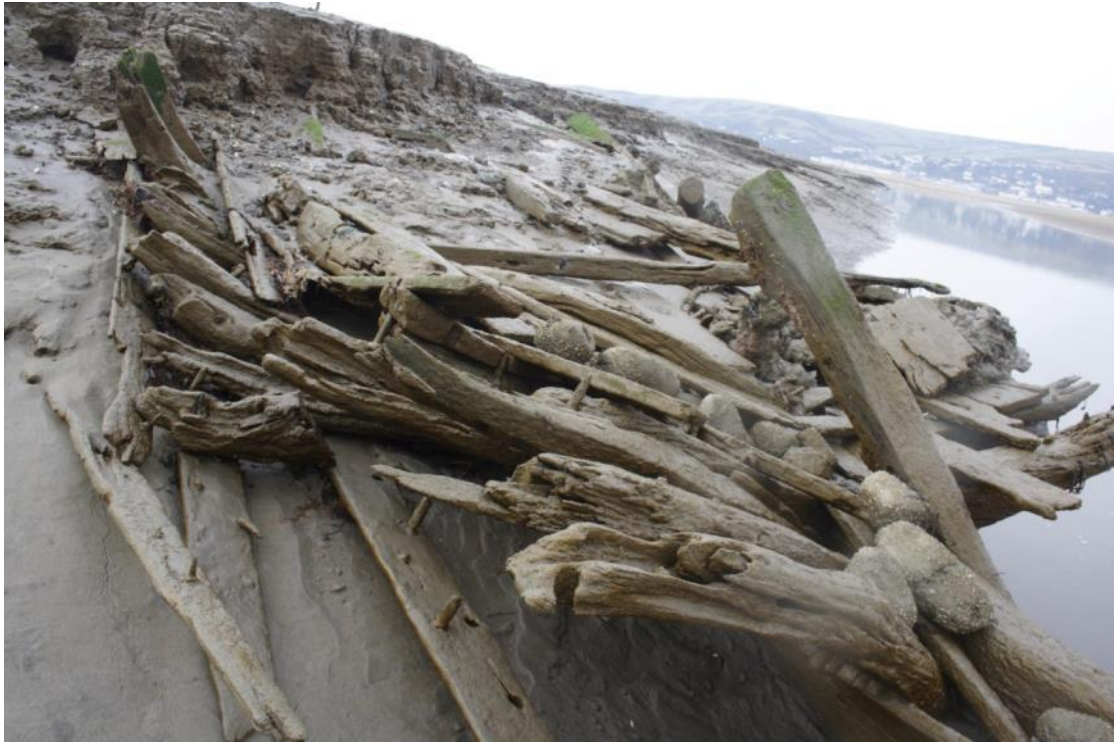
Photo 13: View along the port side of the wreck from the stern, showing the longer surviving frames still roughly in situ towards the river edge

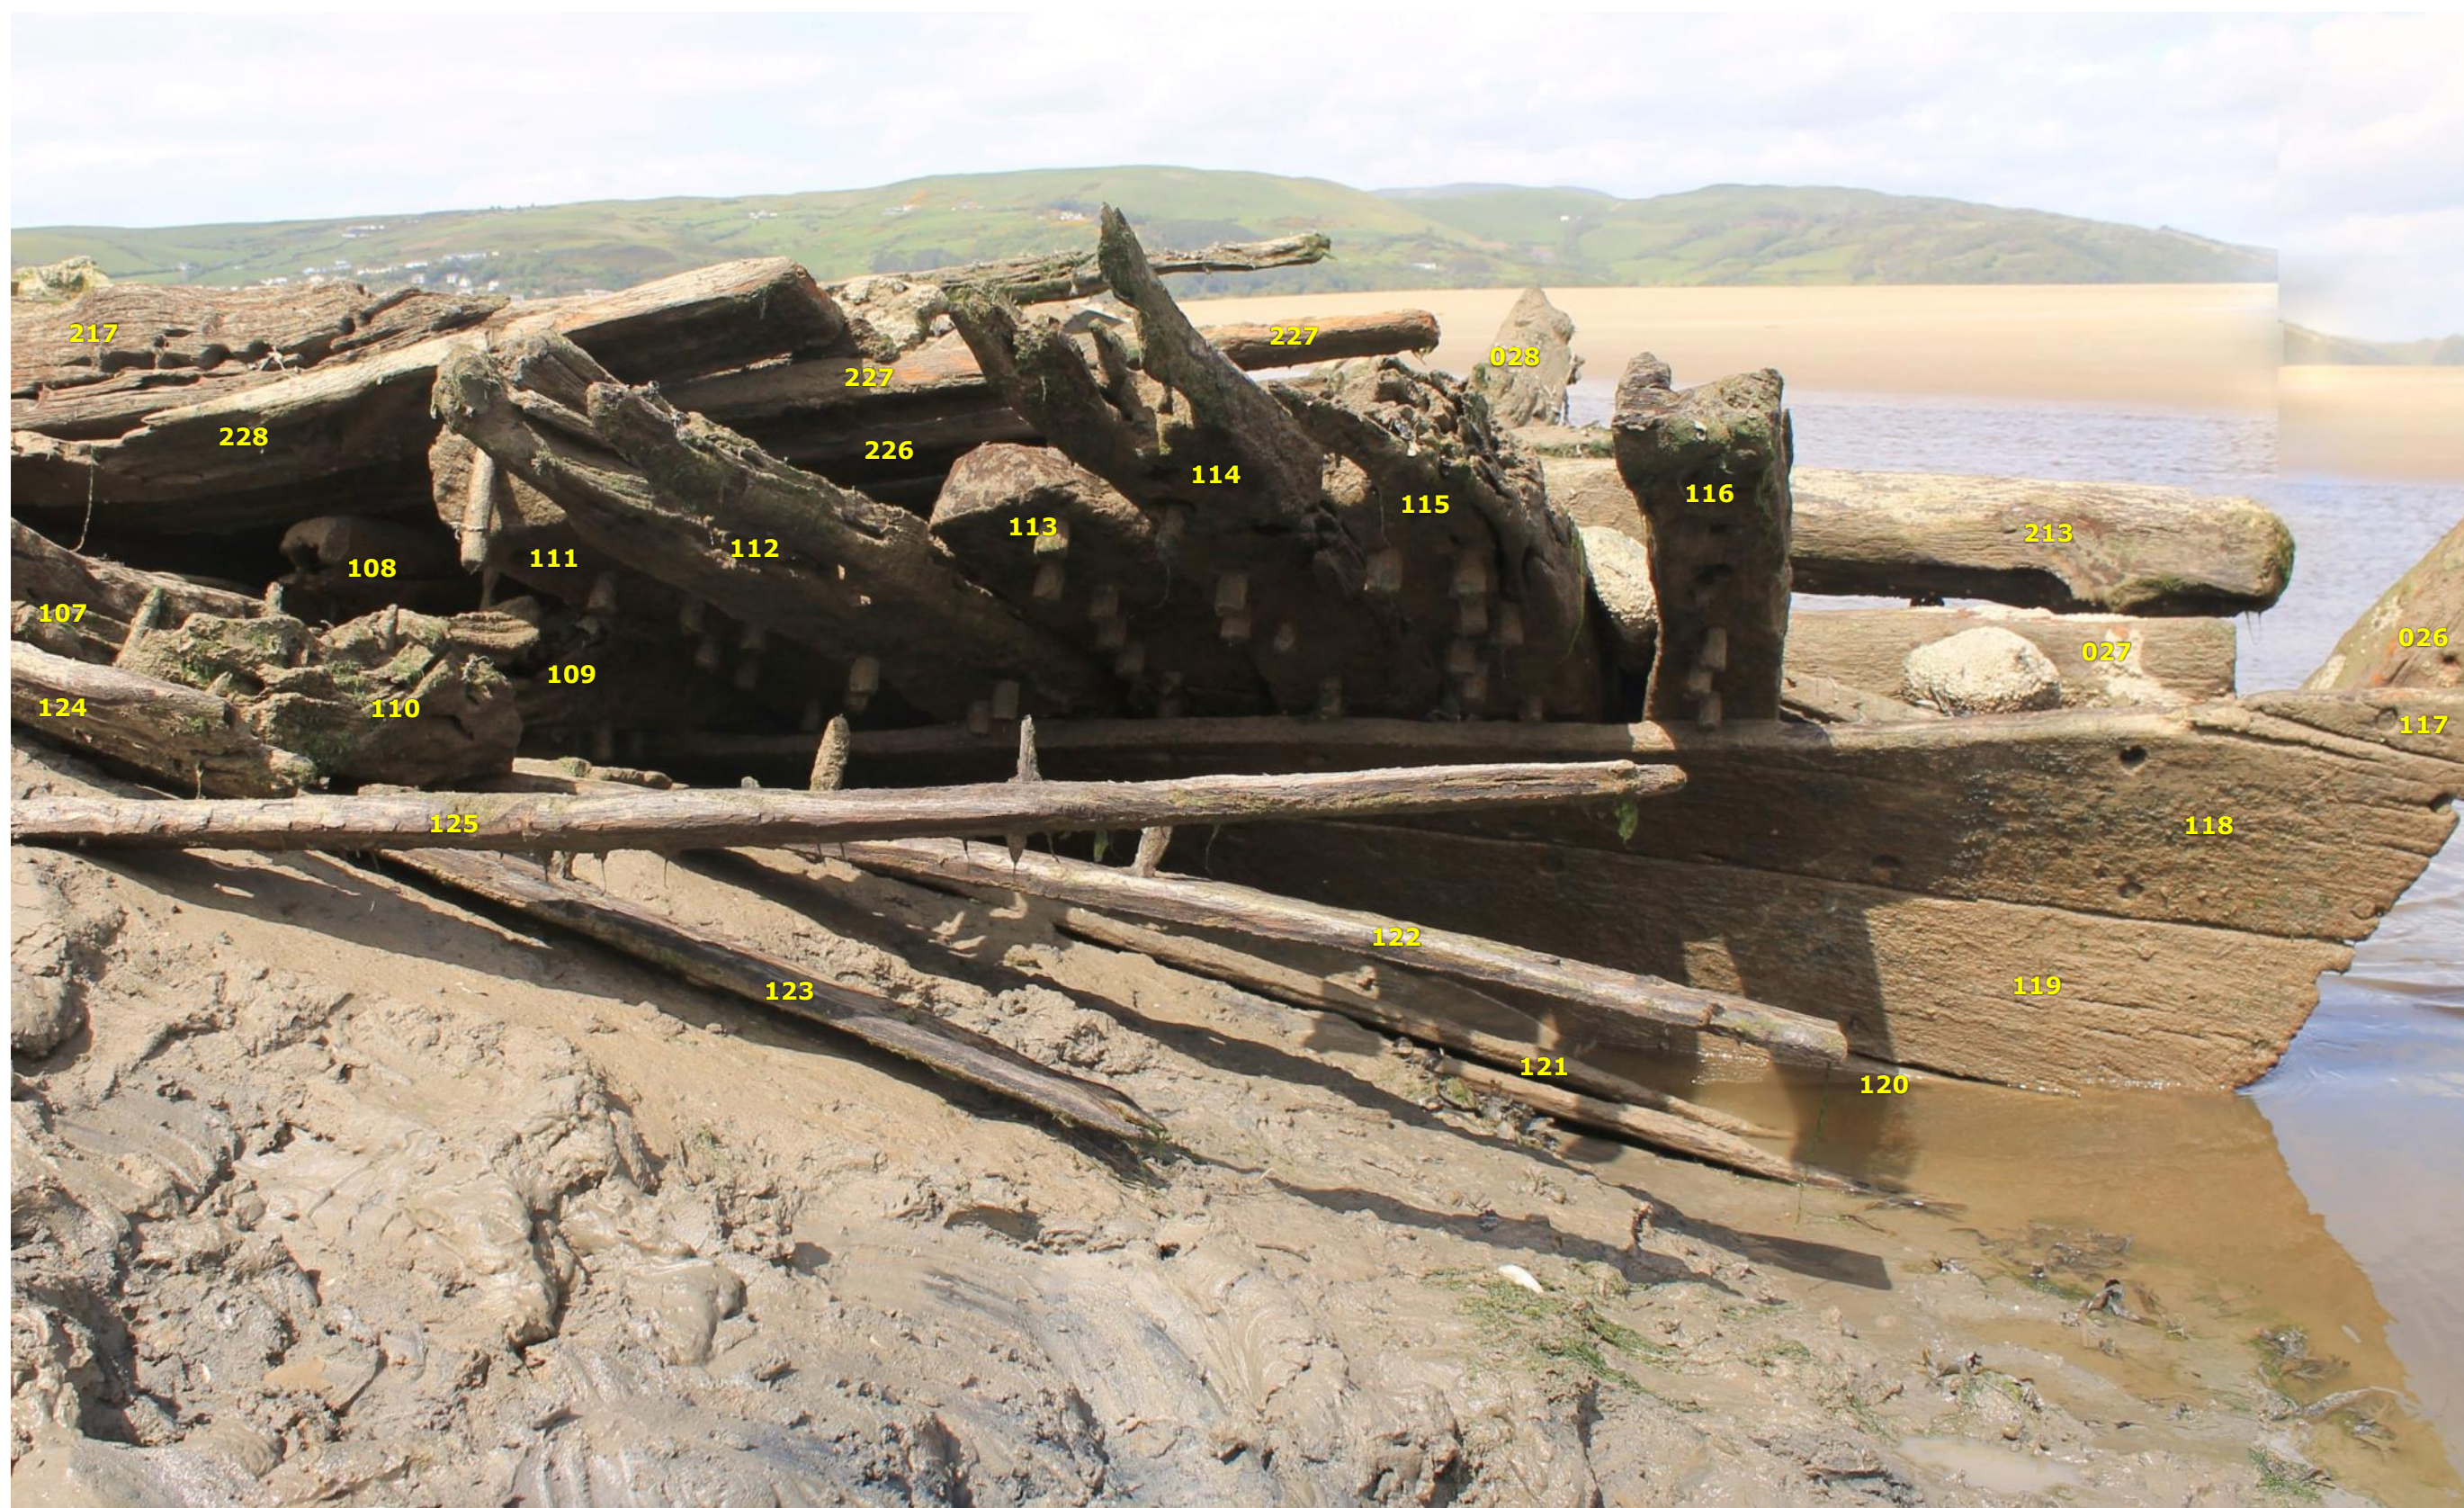
Labelled timbers are shown on photo 15. The end three frames, 116, 115 and 114, are still roughly in-situ, being attached to both the inner planking of the hold and the outer planking, four of which still remain attached to the vessel (217, 218, 219 and 220). These planks have evidently been shaped to fit the vessel to create a streamlined stern as can be seen in Photo 14. Collapsed outer planking is also present, which has become detached from the frames, but is still trapped in the silts to the northwest.

Photo 15: Port side of wreck showing frames and outer planking towards the stern
(merged photographs from June 2015)

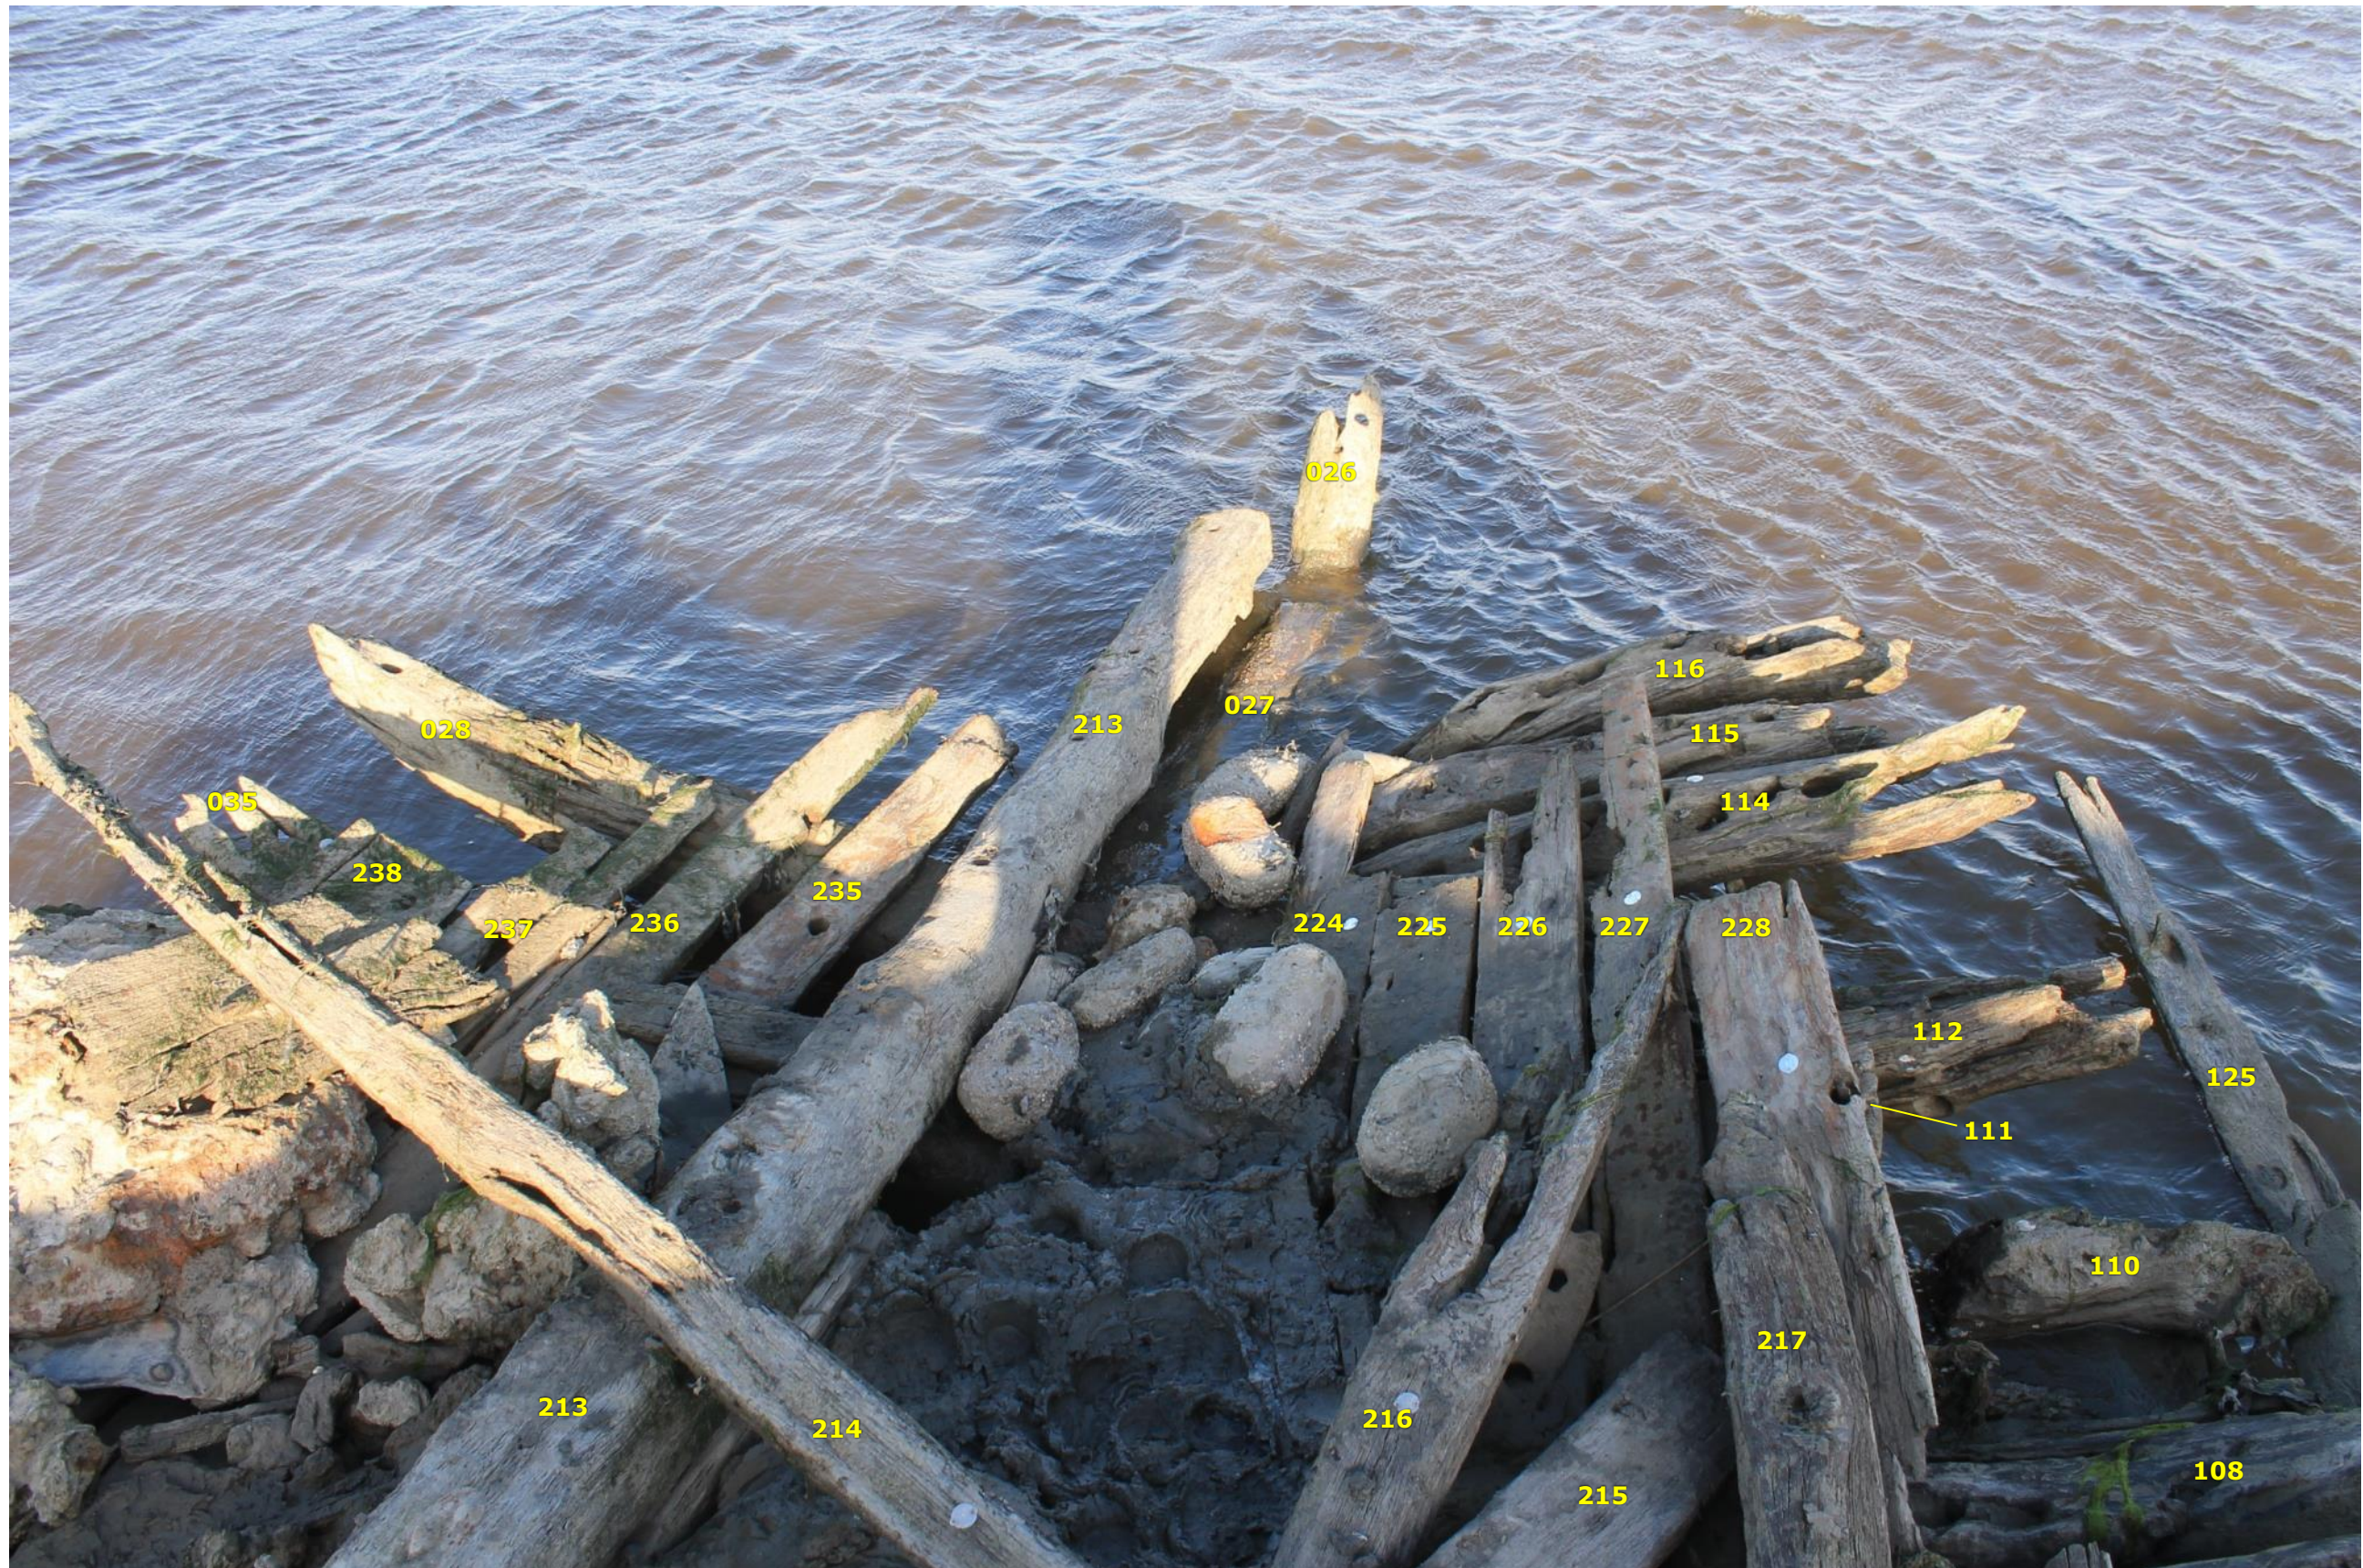
Numerous timbers, iron objects and ballast lie on the upper surface of the wreck. Many of the timbers do not seem to form part of the surviving structure, although the majority are likely to have formerly been elements of the wreck, now collapsed. At the stern end of the vessel inner planking for the hold and elements of the keel (possible keelson and deadwood) could be seen and are shown on Photo 16.

This photo also includes loose timber elements such as 213, which could possibly be a former boom from its shape. It has been seen lying almost directly on top of and parallel with elements of the keel (deadwood 212) since 2010, but has become looser with more and more erosion. It was still in-situ during the work in 2014 and 2015, but could be seen to move slightly as the water rose back into the Afon Leri channel and its movement was exacerbated when boats using the channel passed and their wake hit the wreck. In March 2016 timber 213 had moved and now lies at an angle over the starboard side with its end sticking into the silts of the river channel. It is possible that the timber was deliberately moved rather than it being caused by tidal movement of wakes from motor boats.

Inner planking of the hold includes timbers 225, 226, 227 and 228 on the starboard side and timbers 235, 236, 237 and 238 on the port side. Timbers 214, 215 and 216 appear to be collapsed elements from the former structure above. A number of large rounded pebbles remain in the hold and represent ballast. A large coil of corroded iron chain is still present on the starboard side. Within the corrosion of the chain are fragments of broken roofing slate, presumably former cargo, and also smaller pieces of timber which may include the lid a small wooden box, part of which was recovered in 2014. A number of small copper or brass pipes are also present the function of which is uncertain. These were visible in September 2014 when the Royal Navy Bomb Disposal Squad looked over the wreck to check for ordnance, so it is assumed they are associated with the wreck (although have not been removed).

Photo 16: Stern end of exposed hold showing inner planking and other main surface timbers (September 2015)

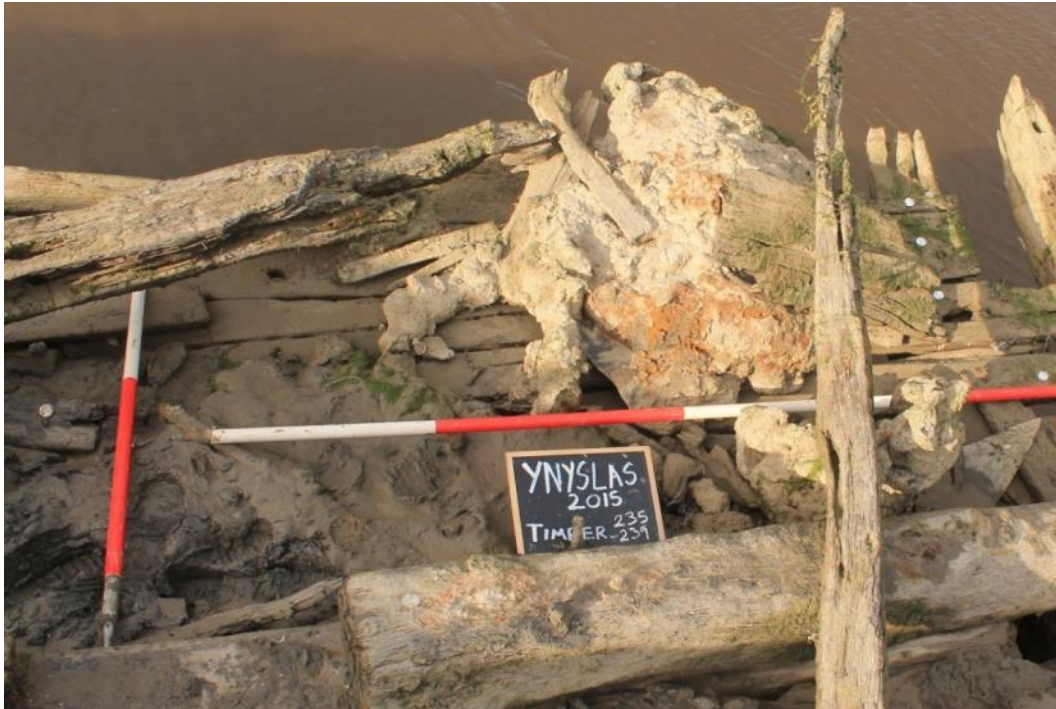
Changes had also occurred to the upper surface of the wreck where objects were quite well embedded in silts during the survey in June 2015 (Photo 23), but by September much of the silt had been washed away and the objects looser and under far greater threat of being lost through tidal movement (Photo 24).

Photo 23: Showing the starboard side of the upper part of the wreck, the hold, showing silts below the photo board (loose timbers 235 and 239 recorded)

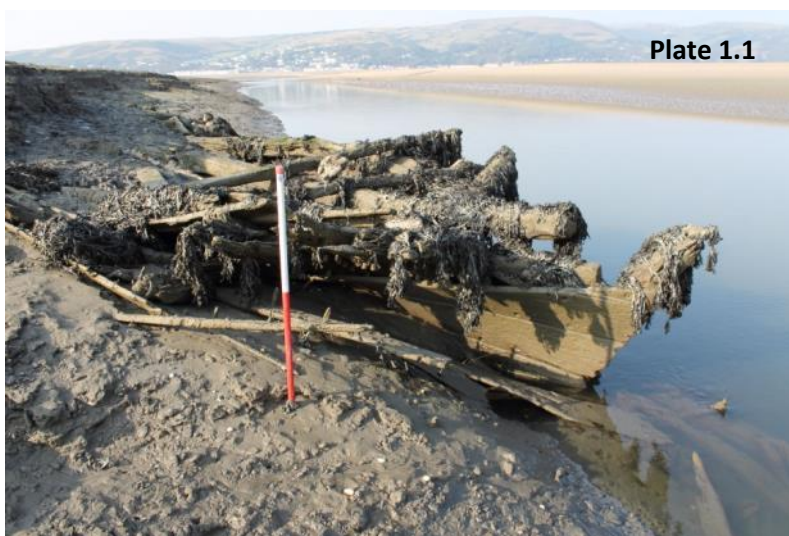
Plate 1.1

As indicated in Figure 1.2, the erosion has occurred as a result of the change in the alignment of the Leri. There have been changes at the local scale, impacting directly on Wreck 3 (Plate 1.1) but these local changes are also influenced by, or even driven by, more significant changes that have occurred in relation to the broader scale estuary shape.
