YNYSLAS HULKS, YNYSLAS, CEREDIGION: ARCHAEOLOGICAL INVESTIGATIONS 2016 - 2017 INTERIM REPORT

RHIF YR ADRODDIAD / REPORT NO. 2016/15
RHIF Y DIGWYLLIAD / PROJECT RECORD NO. 107509
Cadw Project No. DAT 135

Mawrth 2017
March 2017

James Meek MCIfA

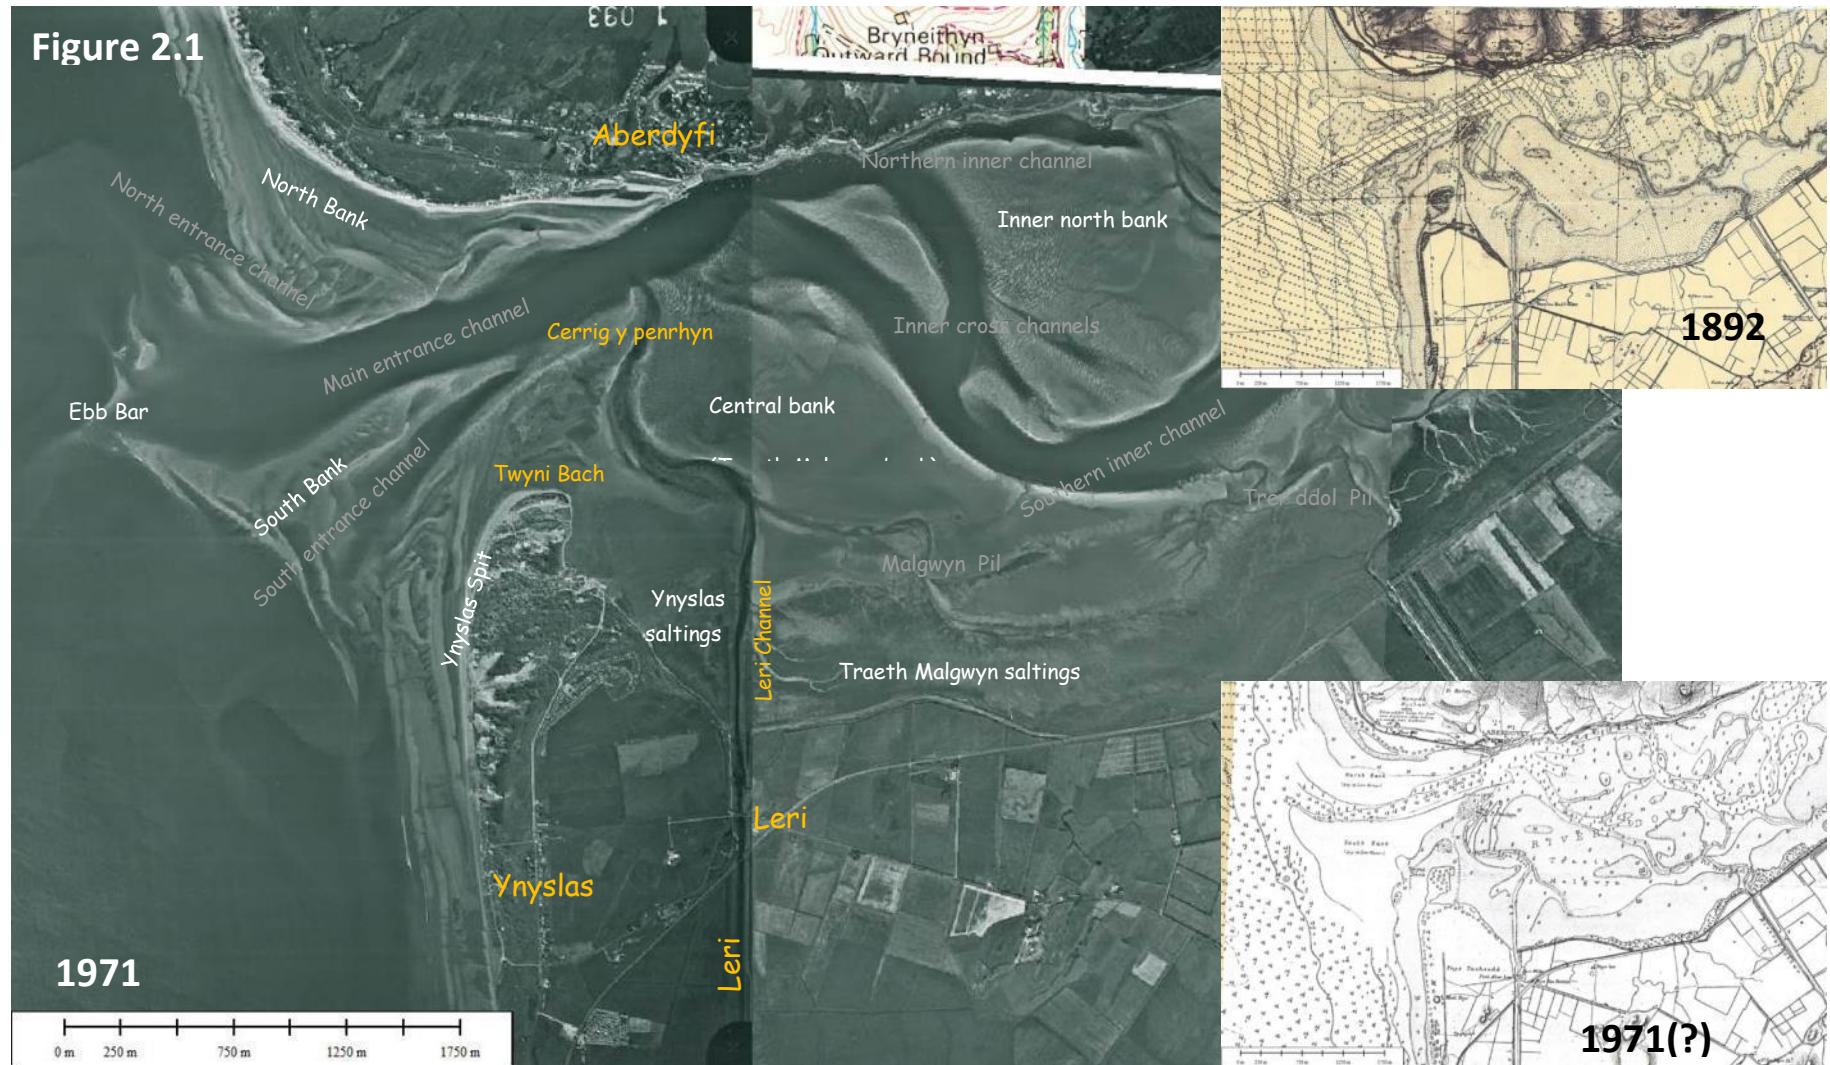
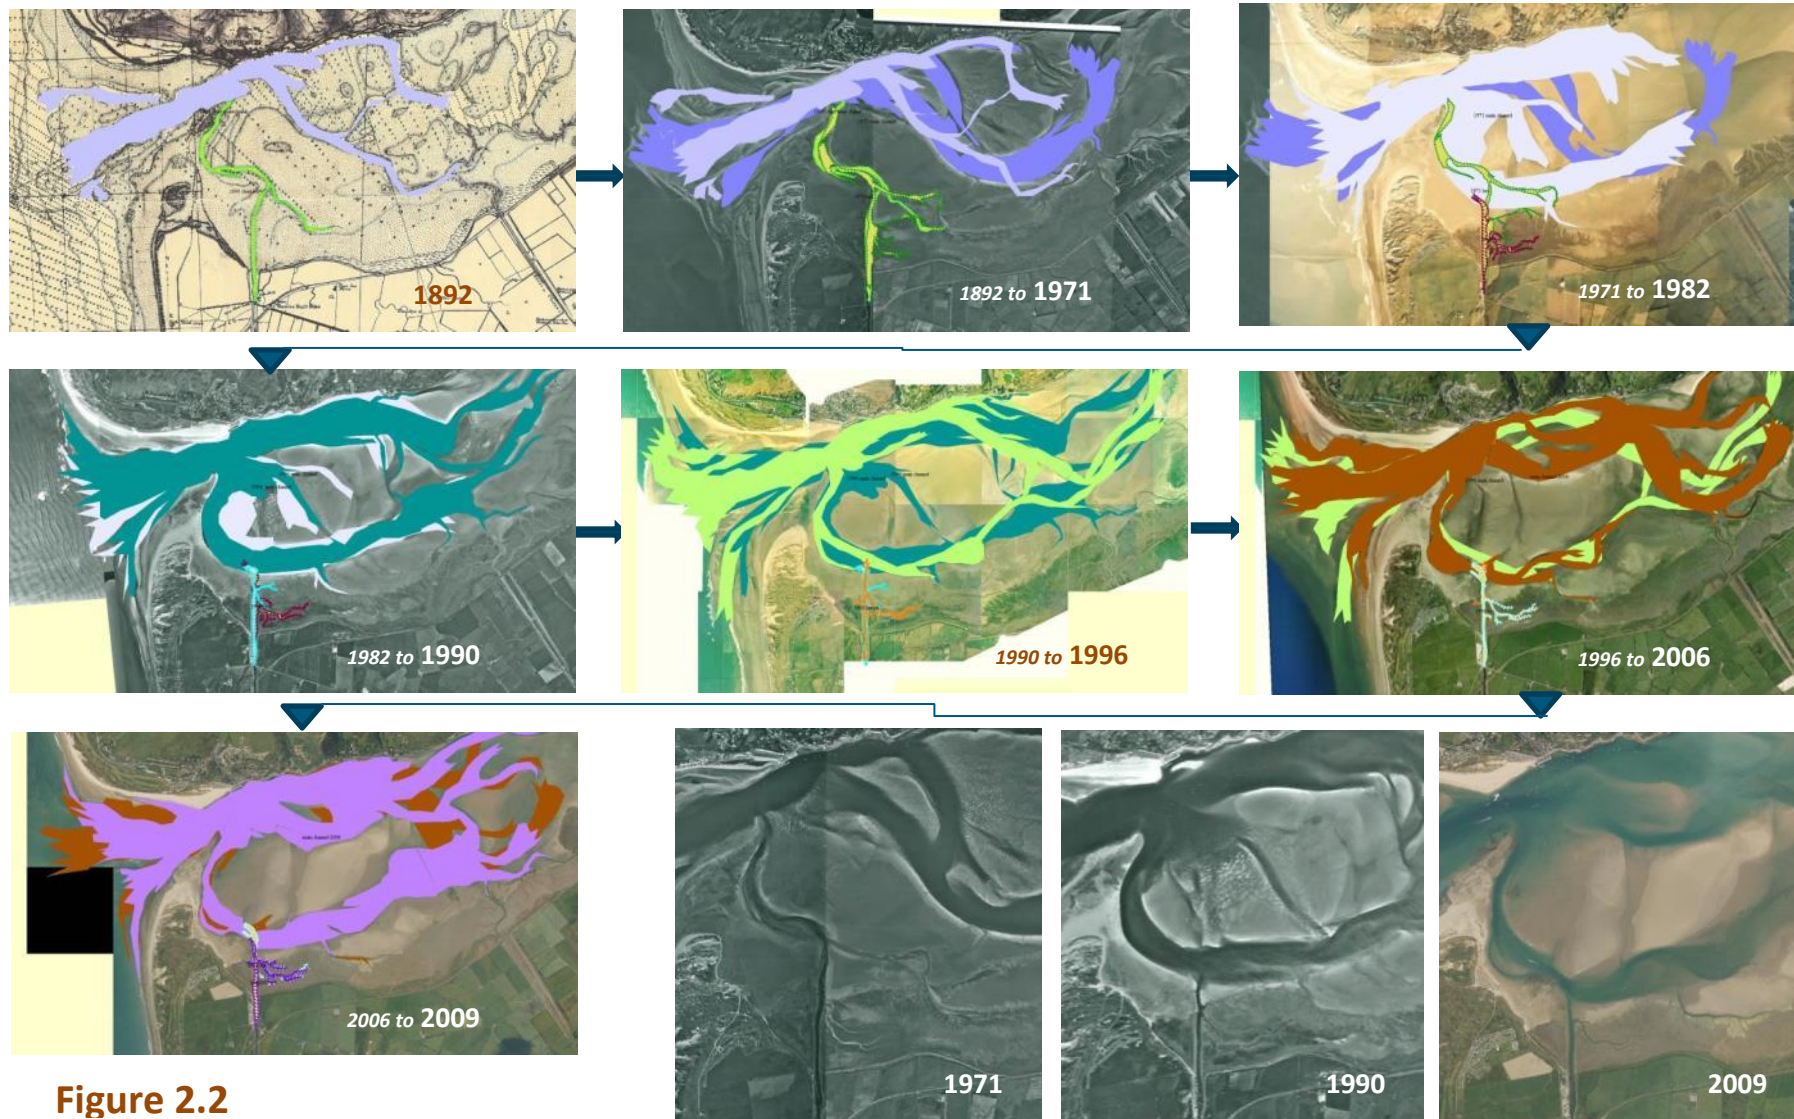
Figure 2.2

The BMT report suggested that further within the estuary, the arrangement of channels can be significantly influenced by fluvial flows within the Dyfi, influencing the way in which the channels within the estuary develop particularly on the ebb. This balance of flood and ebb flows, and the different strengths of tidal flow and fluvial flow creates a highly dynamic area within the inner estuary varying the position of banks and channels in this interactive zone. This change is clearly shown in the comparisons presented in Figure 2.2.

Notwithstanding the recognition that channels and banks can change over a tide, there does appear to have been a relatively fundamental change in the balance of the overall shape of the estuary over possibly the last 40 years. In the plot (Figure 2.2) comparing the 1892 to 1971, it may be seen that by 1971 the inner southern channel appears to take on more significance. Figure 2.3, overlaying part of an air

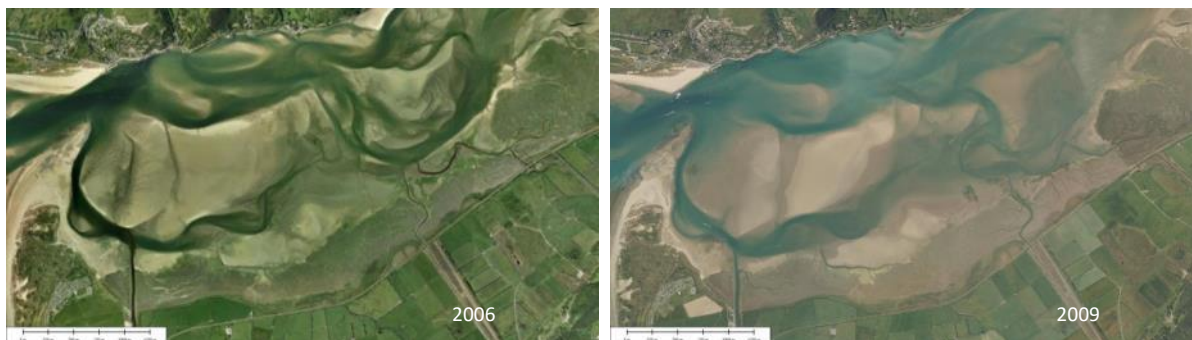
Figure 2.4. Air photographs 2006 and 2009.

This local system around the Leri has continued to develop. Initially (between 1982 and 1990) the southern channel appears to work almost independently of the northern channel within the estuary, forming a strong sweep cutting across the back of Ynyslas. Over more recent times this channel appears to have weakened. In 2006 the inner northern channel appears to have cut through, capturing at least part

of the flow of the upper section of the southern inner channel. Even though the general width of the section of the southern inner channel is possibly wider in the 2009 image, there is a strong indication that the form of this channel from 2006 through to 2009 has become less dominant (figure 2.4).

There is an indication that, as this seaward section of the southern inner channel has become less dominant in terms of the overall flows within the estuary, this has allowed movement in the central bank, squeezing and locally strengthening the local flows around the Leri.

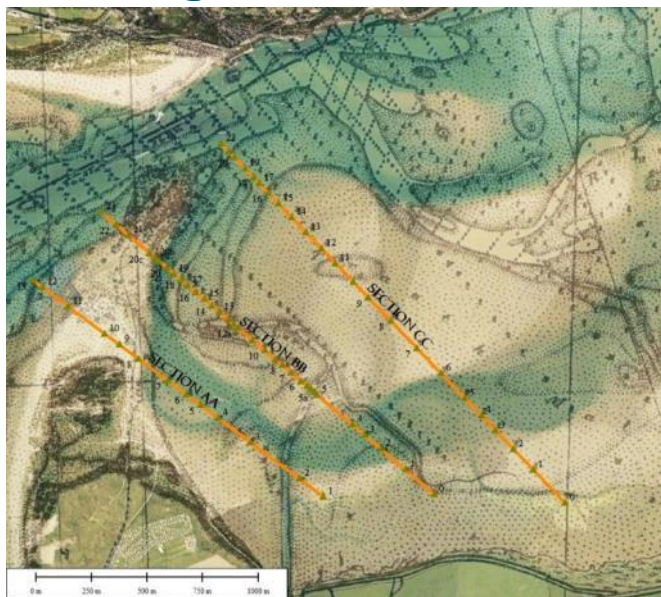
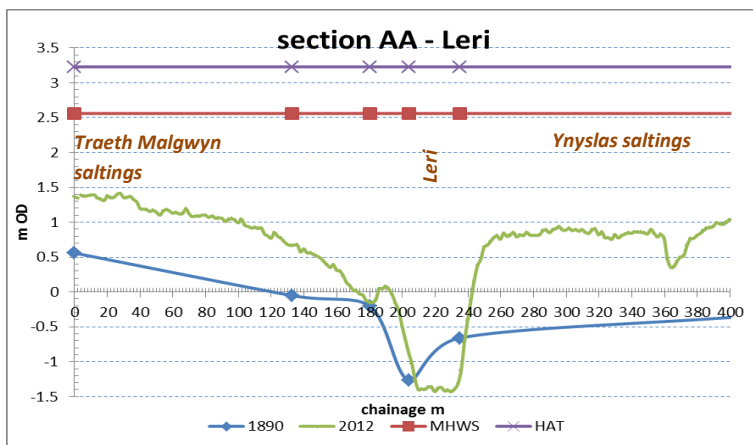
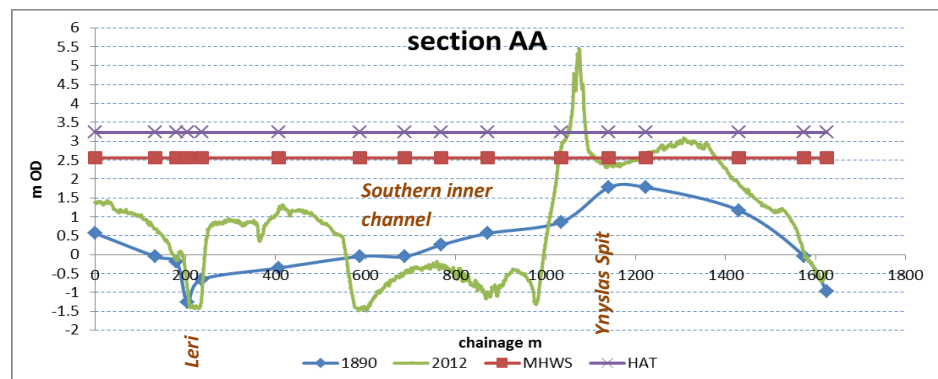
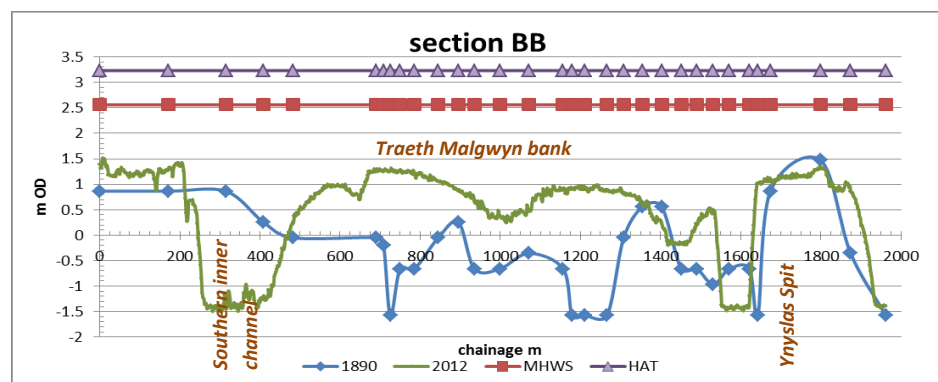
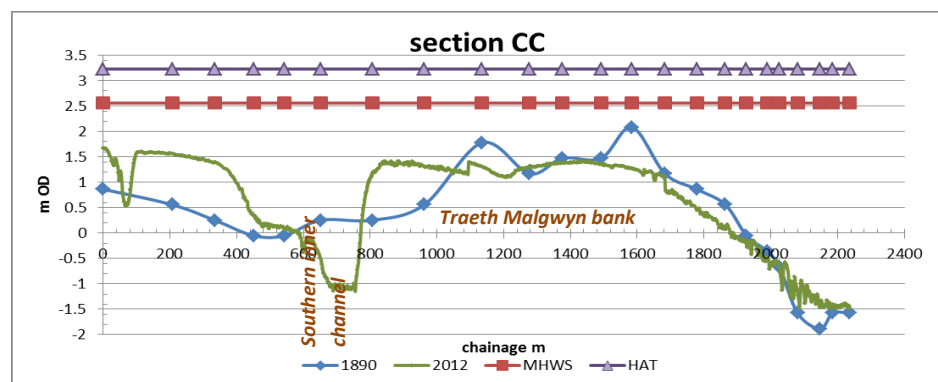
Figure 2.5

An analysis has been undertaken comparing historic change in bed levels, comparing soundings recorded on the 1892 chart (actually surveyed in 1890) with LIDAR data. Three profiles have been considered as shown in Figure 2.5.

The influence of the southern inner channel is quite evident on the present day survey, cutting below the level shown in 1890. Further back along the profile, the growth of the Ynyslas saltings is shown, with present day levels some 1m higher in the area of the wrecks than the historical levels, which might have characterised the area around the time that the wrecks were beached.

With the growth of the Ynyslas saltings and the growth (again in the order of 1m) of the saltings along Traeth Malgwyn (to east of the Leri), it can be seen that the Leri channel cuts deeper relative to the surrounding bed levels. A more detailed cross section, based on section AA across the Leri, is shown on the left of Figure 2.5. While recognising the inherent difficulty of rectifying the old chart soundings to present day, there is still a clear indication that the eastern bank of the Leri channel has moved westward, potentially by some 10m to 20m. The actual depth of the channel may also have deepened but the LIDAR only captures data on land above water levels. The difference in levels between the western bank is consistent with the position or level of the wrecks, assuming that they were beached at a level of the old bed.

Section BB shows the growth of the Traeth Malgwyn saltings at the landward end of the profile. The old chart soundings start at the start of the profile but it is reasonable to assume that, further shoreward, the saltings have also increased in level. Indeed, comparison with spot levels further within the estuary, along the southern shoreline, strongly indicate that the saltings all the way along this frontage have increased in level by around 1m. This would suggest that the estuary, certainly on the southern side, has been infilling. Further within the estuary, this growth on the southern side may have influenced the upper course of the southern channel.

Section BB also shows a significant growth of the central bank across the centre of the estuary. The profile also shows how the southern inner channel has cut in behind Ynyslas. At the seaward end of the profile, where the profile cuts just to the south of Cerrig y penrhyn, the present day and past levels remain remarkably consistent.

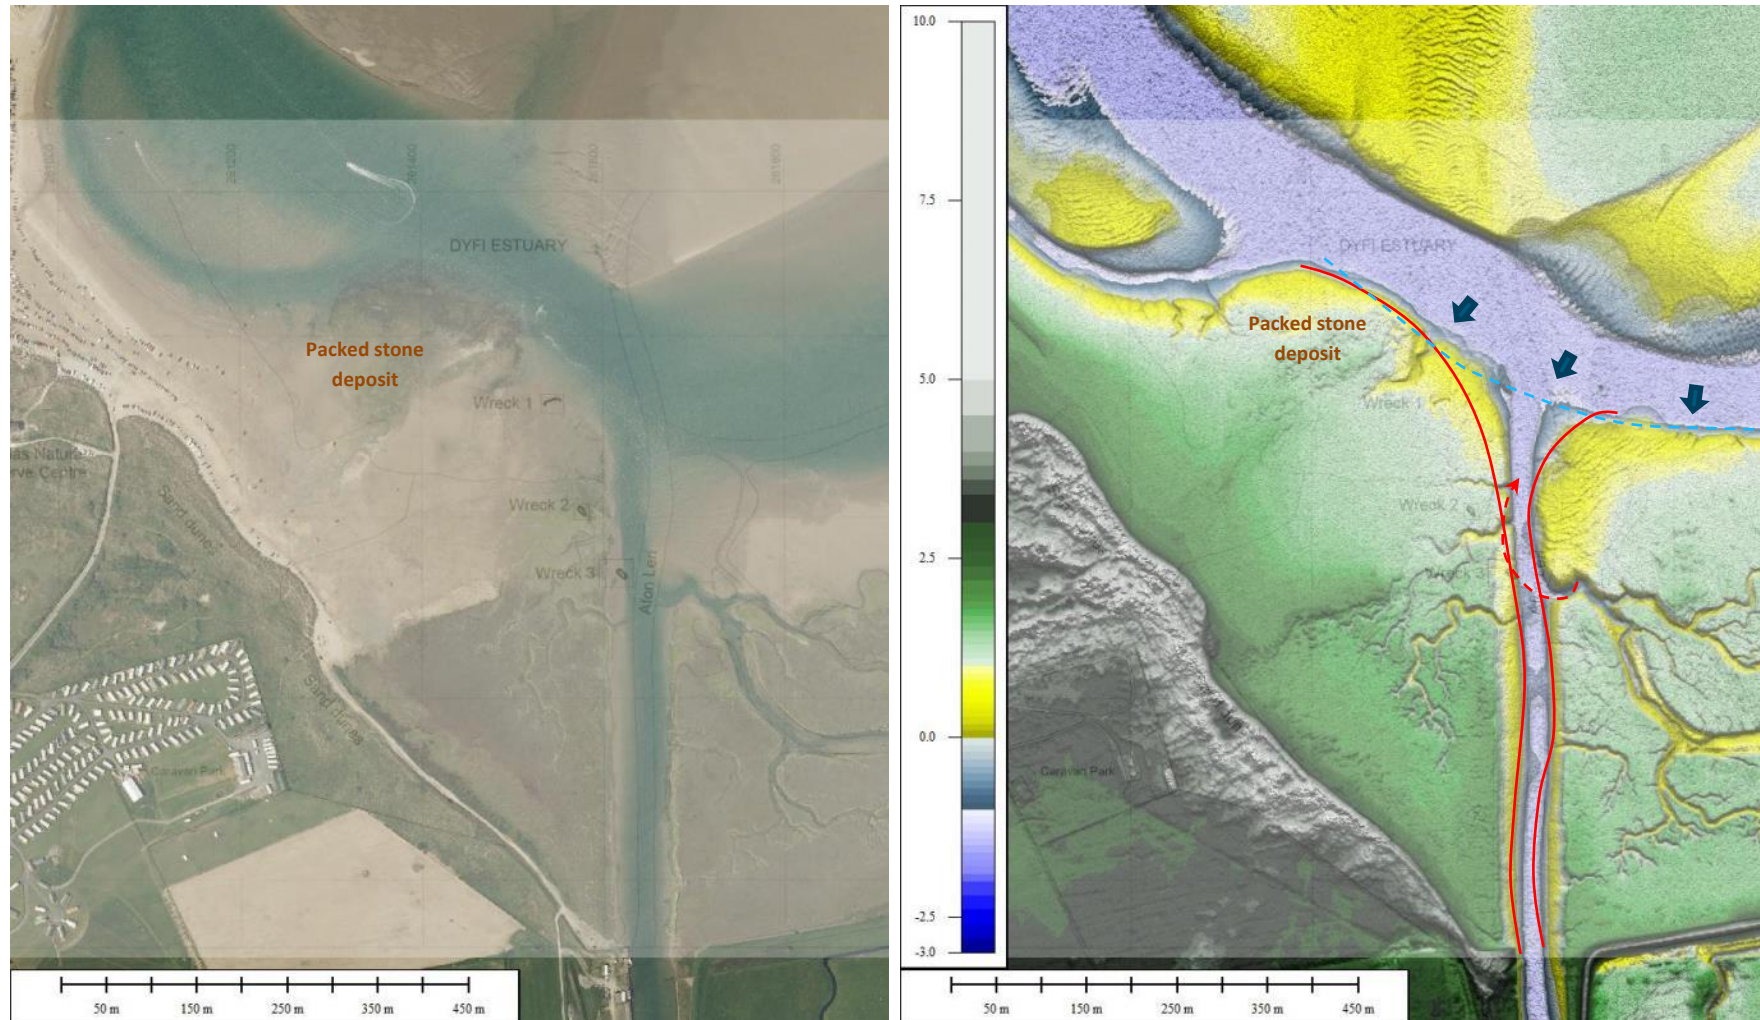
Figure 3.1 shows the local area of the wrecks. The image to the left shows the image of the 2009 air photograph, the image to the right shows the same area but taken as the LIDAR image understood to be from 2012. On the LIDAR image areas shown as blue are below typical mid tide level, with areas shown as yellow being areas between 0m OD and 1m OD. The green areas are progressively less exposed to normal tidal levels and typically less exposed to strong tidal flow.

- Wreck 3, however, is located at a critical inflection point of Leri Channel. Even relatively small changes within this local system have the potential to either increase or, in fact, reduce pressure on the wreck site. A further feature of the system is the deep creek on the eastern side of the Leri channel. Flow from this channel (as shown as a dotted red arrow on Figure 3.1) may also add to the erosion pressure at Wreck 3.

It does seem likely that Wreck 3 will be fully exposed and possibly lost over the next ten years, subject to more extreme conditions.

It seems probable that Wrecks 1 and 2 will be less affected. It would, however, be recommended that this is reassessed against further survey data as this becomes available.
