NEW MILL, NEW MOAT, CLARBESTON ROAD, PEMBROKESHIRE: ARCHAEOLOGICAL BUILDING RECORDING

Prepared by Dyfed Archaeological Trust
For: Mr and Mrs Masri

RHIF YR ADRODDIAD / REPORT NO. 2015/25
RHIF Y PROSIECT / EVENT RECORD NO.108523

Mai 2015
May 2015

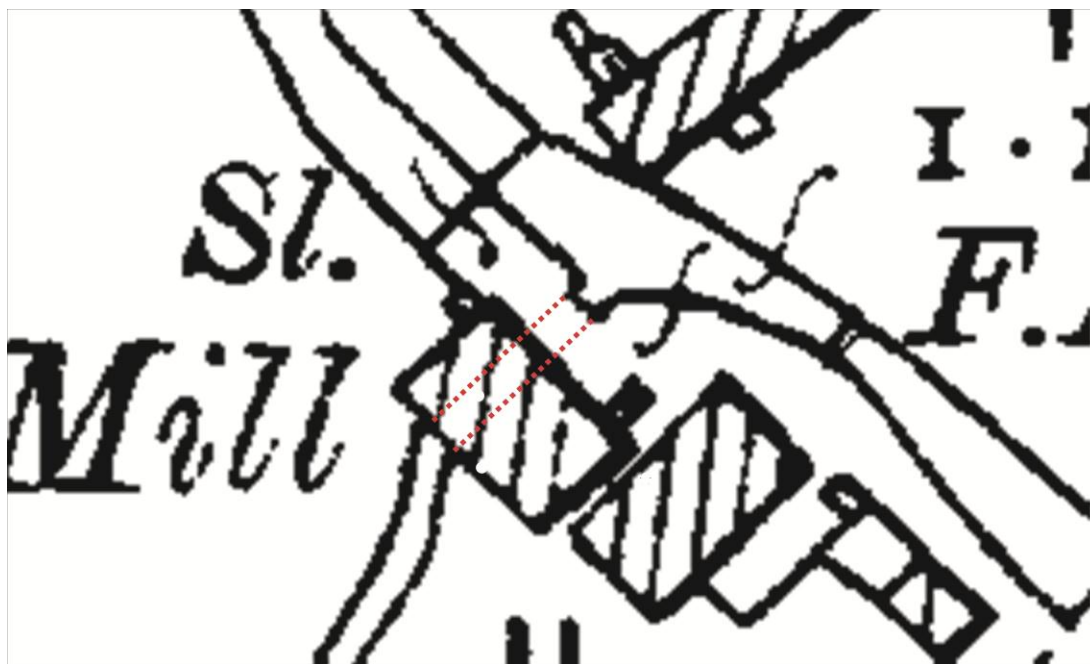
The most significant detail of the ordnance survey mapping is the fact that the water supply for the mill appears to be via a branch of the main leat, controlled by a sluice and entering the building half way along its northern side (see Figure 5). On the south side, the leat appears to exit from within the footprint of the building (see Figure 5). This appears to contradict the suggestion that there was a wheelpit on the western gable end of the building, and that the leat would therefore have run outside the building (see later discussion).

Figure 5: Detail from the 2nd edition 1:500 scale Ordnance Survey map of 1907, showing the leat entering and exiting within the footprint of the building

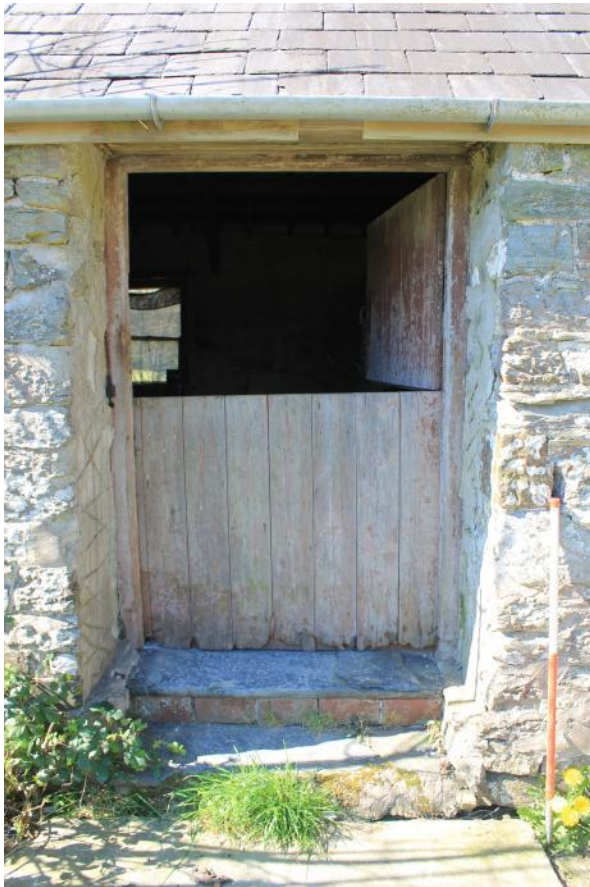
Photo 8: Detail of doorway, northeast facing elevation

The rear northeast facing elevation (Photo 6) is built into a bank. The openings are not symmetrically distributed. The first floor windows each side of the door, are directly under the eaves, with no lintels. The left window (Photo 9) retains a 12-pane sash. The right side window contains a modern metal clad shutter. The doorway (Photo 8) is not centrally located. It has slate threshold steps, and a boarded stable-type door.

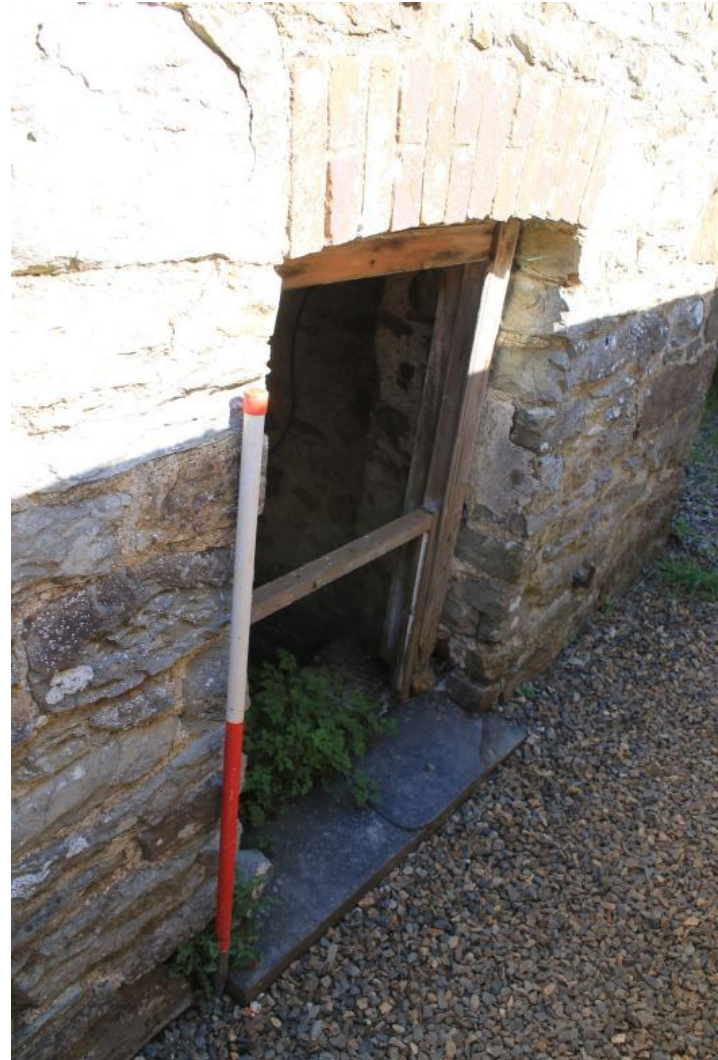
Photo 12: Window detail, Southeast facing elevation

The east facing gable end wall (Photo 11, Plan 4), opposite the rear of the old farmhouse has two symmetrically distributed windows at ground level with cambered red brick heads (Photo 12). The windows are at different heights, reflecting the rising ground level to the northeast. No other features are visible.

The northwest facing elevation (Photo 21, Plan 4) of the southeast gable end wall contains two symmetrically positioned window openings (Photos 12 and 22) with slightly splayed reveals. The sill height of the right hand window is lower than the left hand window, reflecting the sloping ground level outside.

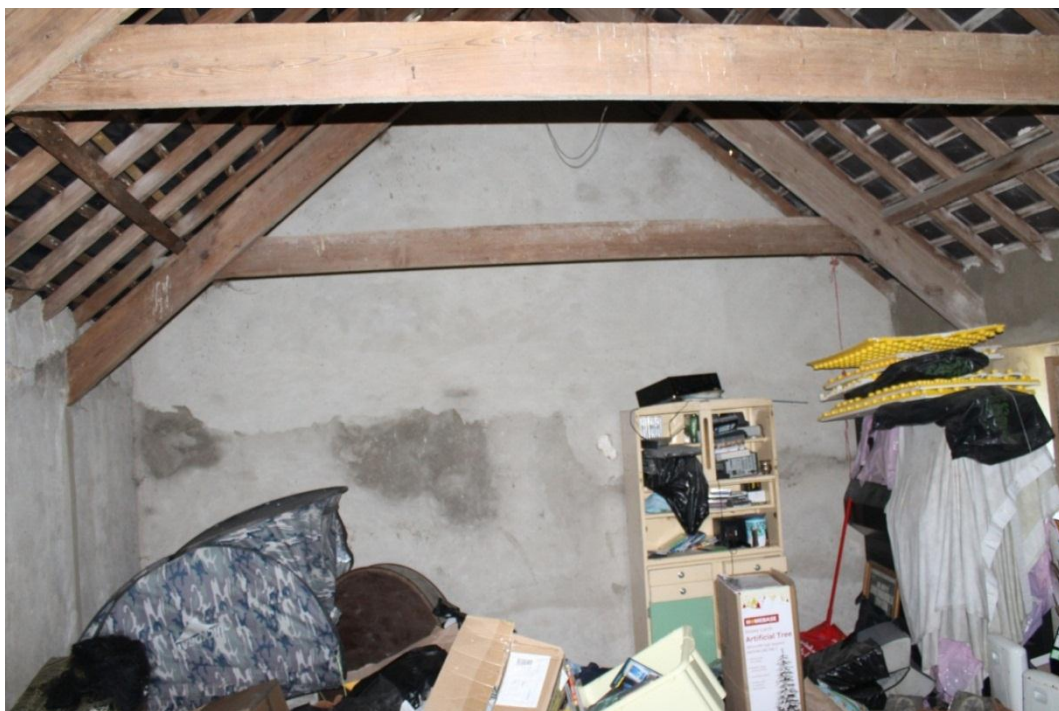
No machinery, fixtures or fitting survive within the building. The first floor appears to have been a single room. The gable end walls have been re-pointed and partially re-plastered, so no former openings are apparent (Photos 23 and 24). The side walls and openings have also been re-plastered, with no visible evidence of any former openings.

Photo 23: Upper interior floor, southeast facing wall (re-plastered)

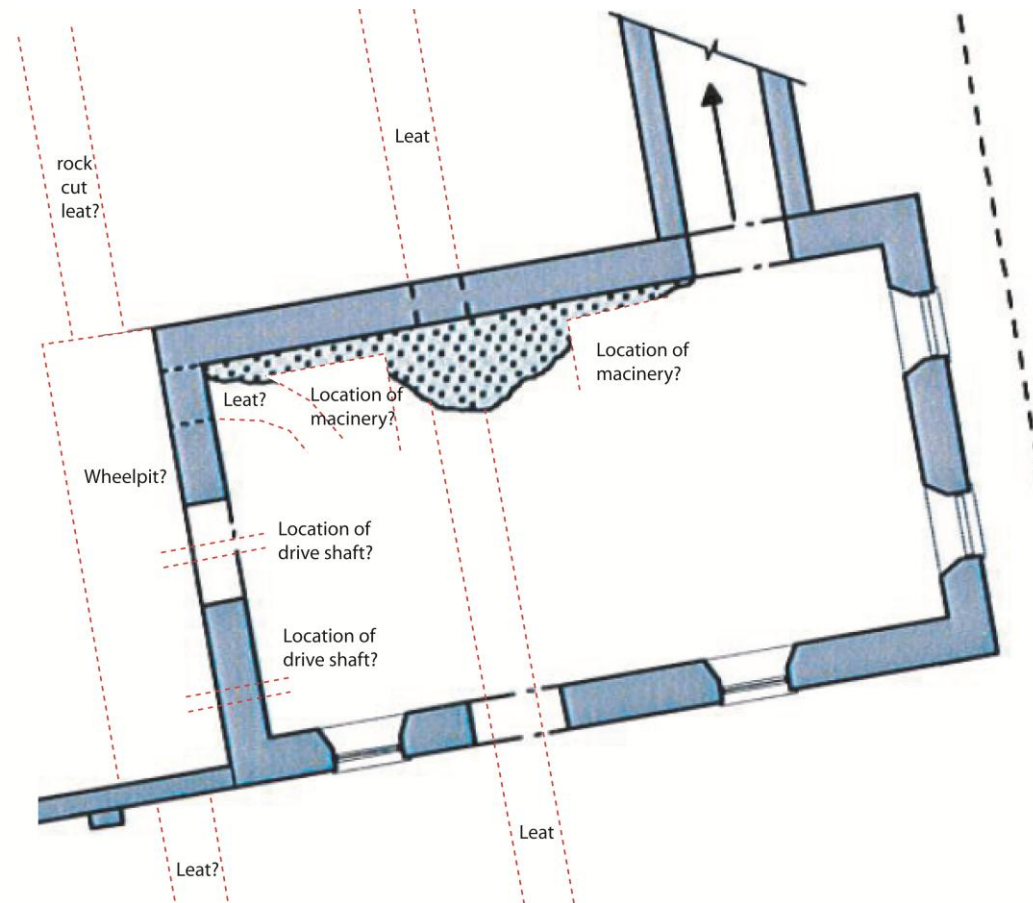
Plan 6: Ground floor plan showing known and hypothesised features
