nn Visited 19.II.1993.

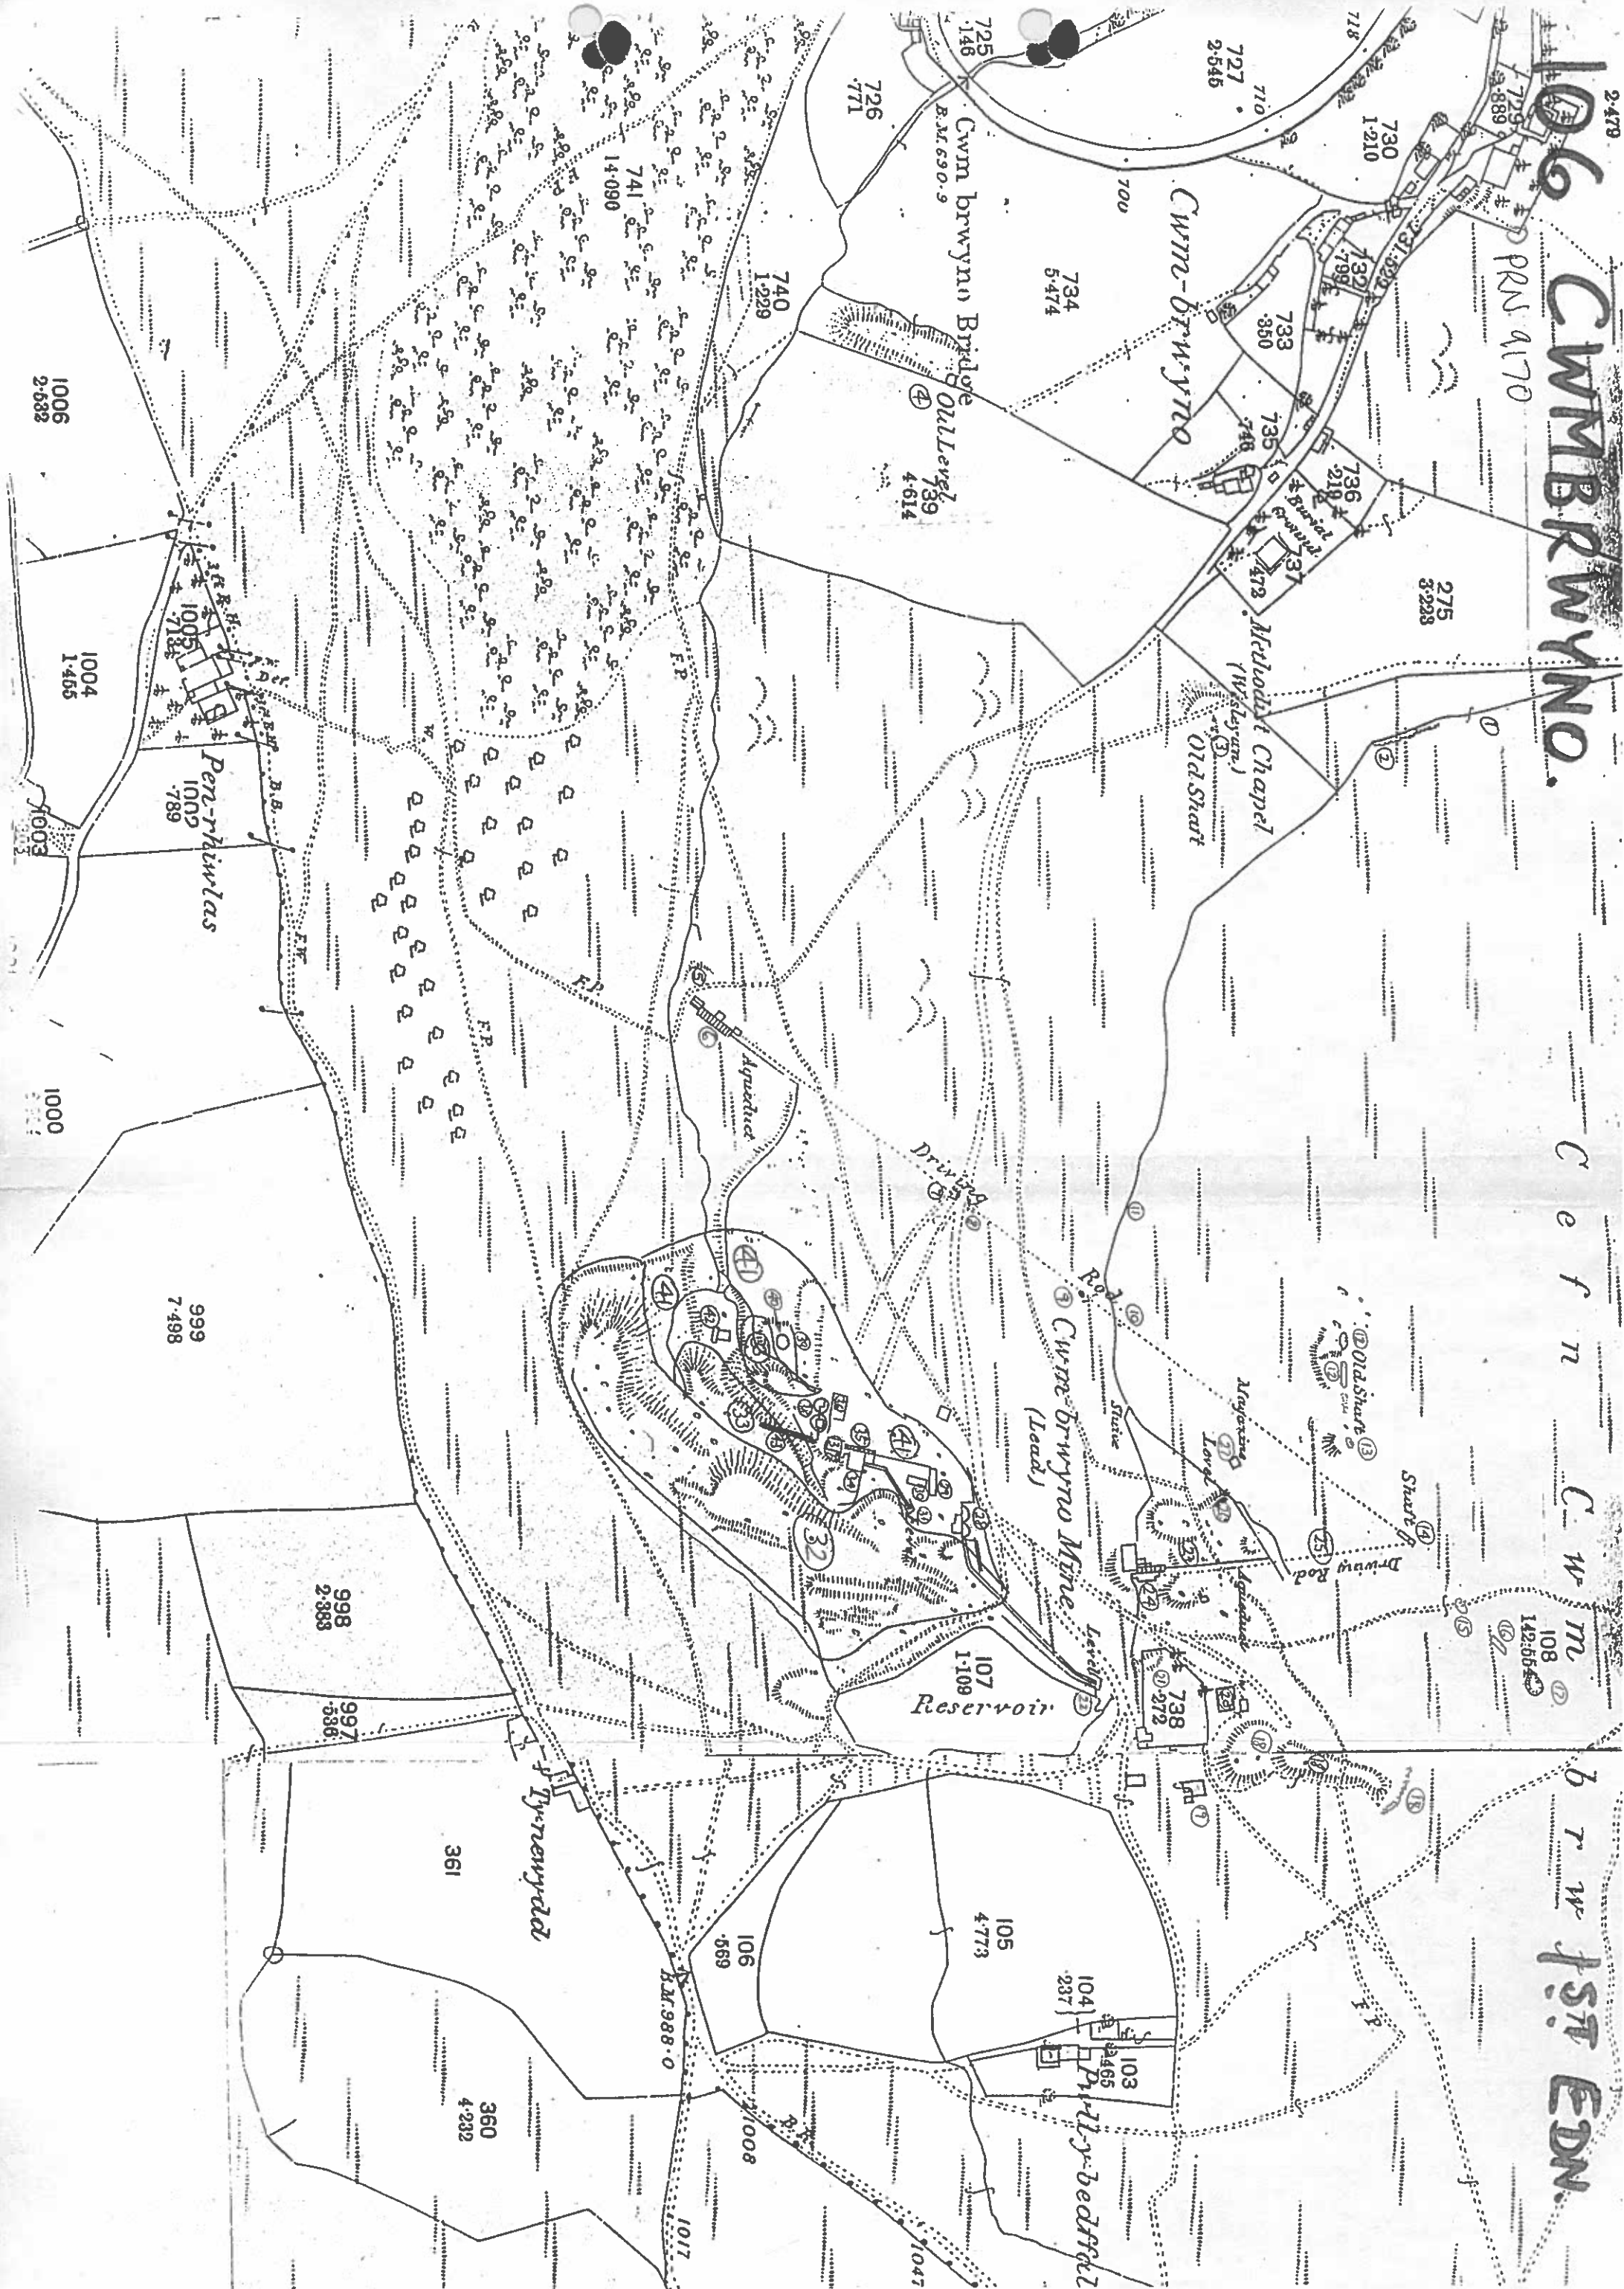
Winding Wheel Pit: sketch plan.

- 6034 ㉓ Fairly grassy development rock tips.
- 6035 ㉔ Winding Wheel Pit. Good condition though south end wall demolished. See sketch on page 2.
- 6036 ㉕ No trace of rods/winding rope route.
