PEMBROKESHIRE COAST NATIONAL PARK TRADITIONAL BOUNDARIES SURVEY

For: Pembrokeshire Coast National Park

March 2020

Trysor Project No. 2020/709
DAT HER Event Record PRN 114831

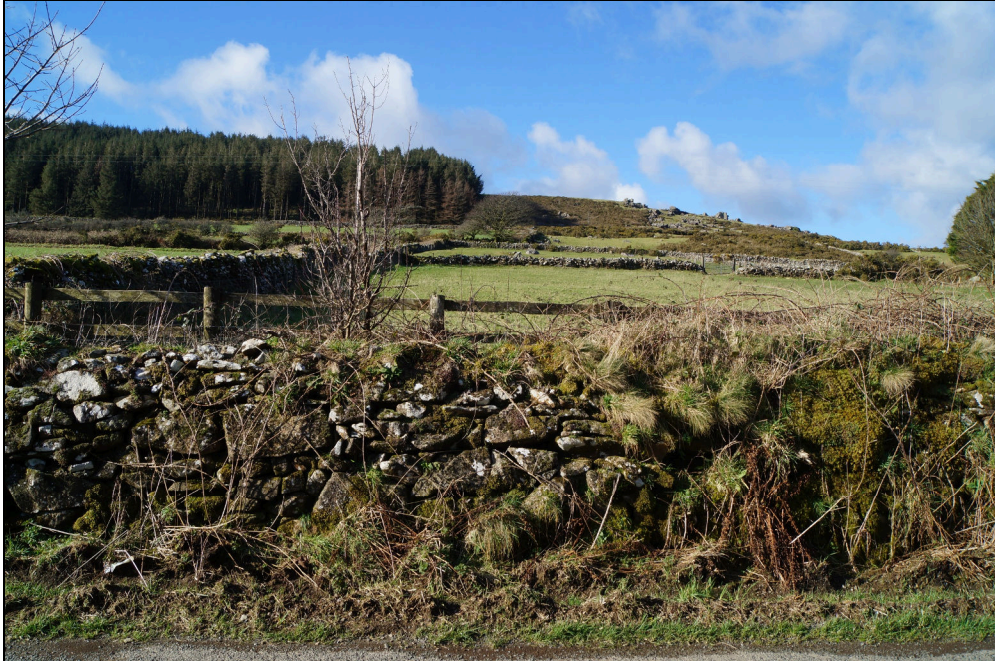
Plate 1. TBS2020_001: A Dry Stone Wall, HER PRN 114832, at the roadside with further Dry Stone Wall boundaries extending up the slope at Llethr. The use of stone reflects the ample supply of outcropping stone here on the south-facing Preseli slopes.

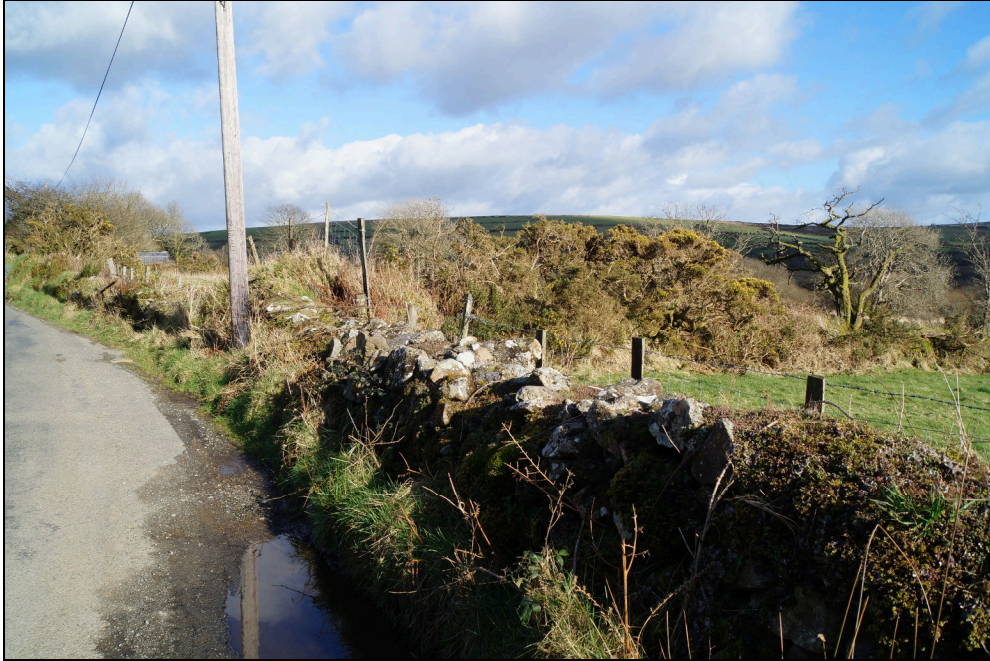
Plate 3. TBS2020_003: A section of Dry Stone Wall, HER PRN 114834, at the roadside.

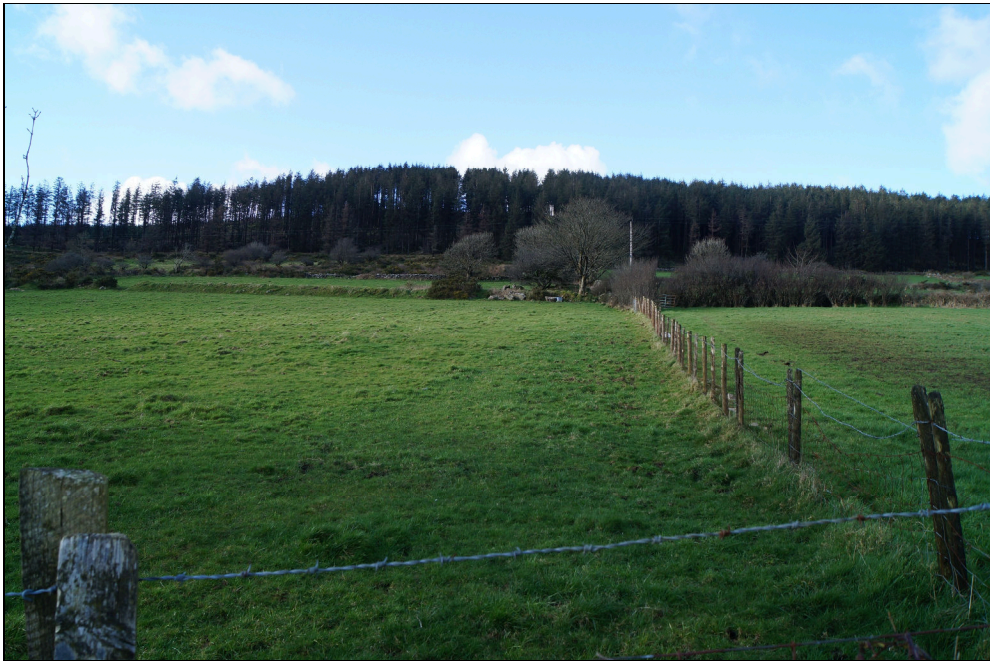
Plate 4. TBS2020_004: A simple fence to the right, HER PRN 114835, with an earth bank running off to the left beyond, HER PRN 114836. Whether this bank ever had a hedge is not known but some gorse and a tree are present at its right-hand end. It could not be ascertained from remote visual inspection if the bank has a stone component. The boundary which continues that line to the right of the fence, HER PRN 114837, is a rubble bank with a blackthorn hedge planted in front of it.

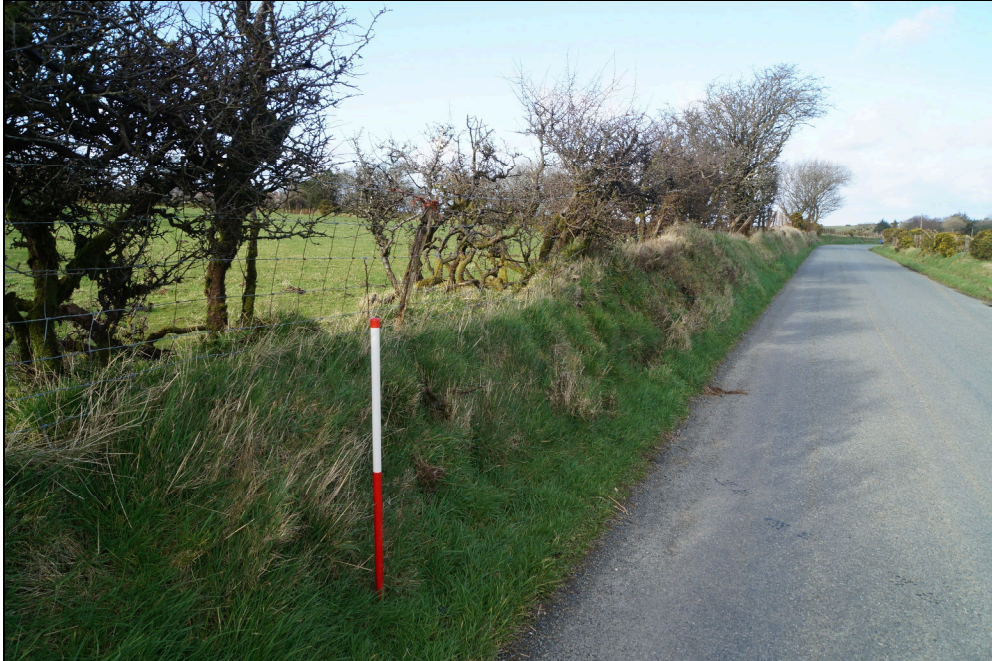
Plate 5. TBS2020_005: A Hedgebank, HER PRN 114838, along the roadside. The blackthorn hedge is not maintained and a post and wire fence now secures the field.

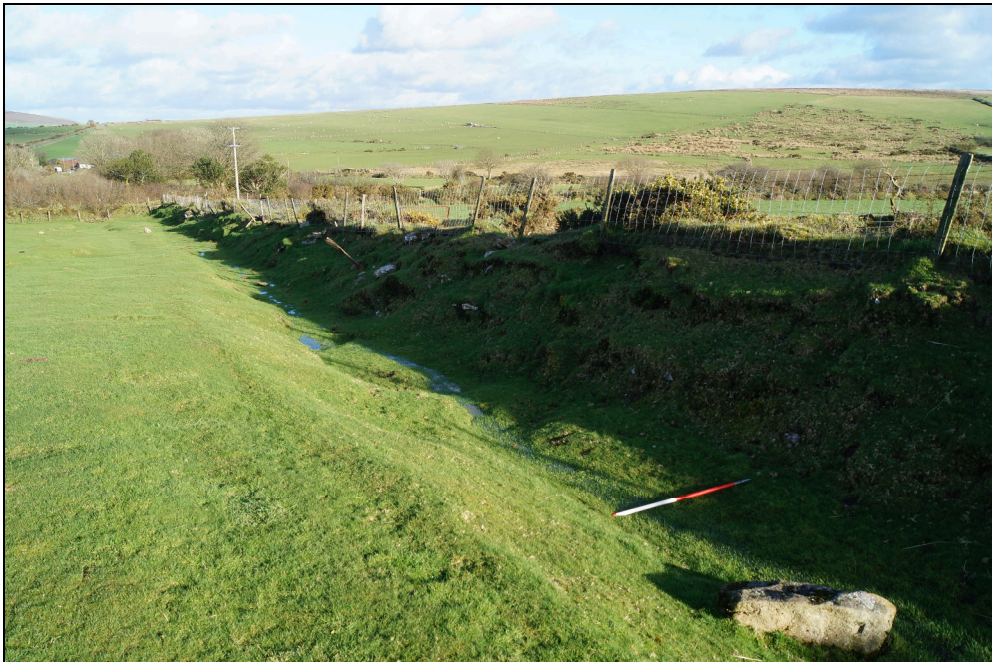
Plate 6. TBS2020_006: A large Earth Bank with an external ditch, HER PRN 114839, defines the common boundary at the northeastern end of the Llethr area. Here it is clear where the material to build the bank was obtained, i.e. from the excavation of the ditch. The bank has stone within it but no structure to the stone was visible.

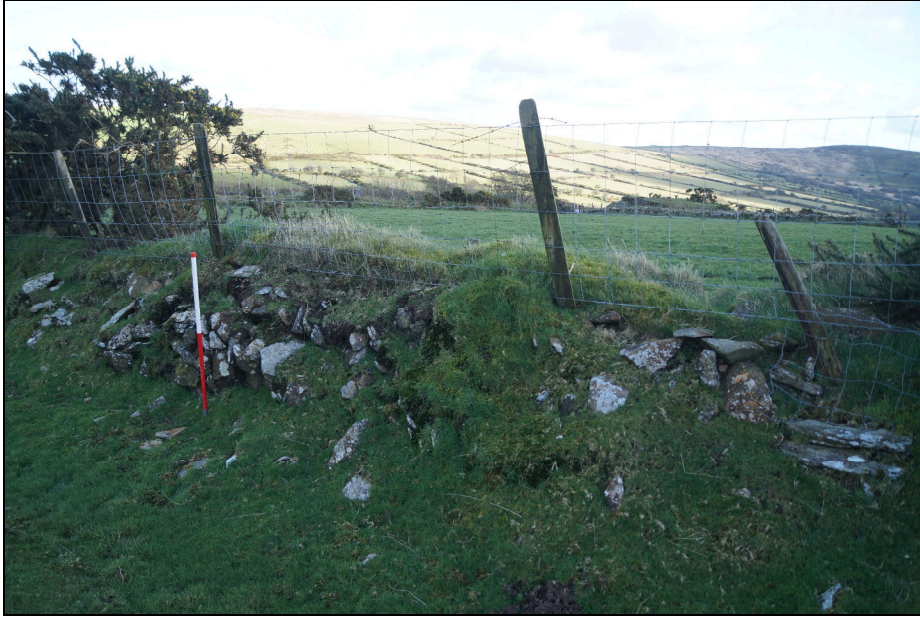
Plate 7. TBS2020_007: The same boundary line as in the previous image, but a separate node to node section further upslope to the west, HER PRN 114840. This section is a Cloddiau Variant. Field boundary banks can often change character more than once in a short distance and this may reflect the materials available close at hand when the bank was being constructed, although in this case it maybe because HER PRN 114839 was of a later construction as it is not shown on the 1810 OSD map, whereas HER PRN 114840 is. This boundary is just outside the Llethr LANDMAP HL Aspect Area but should be considered part of it.

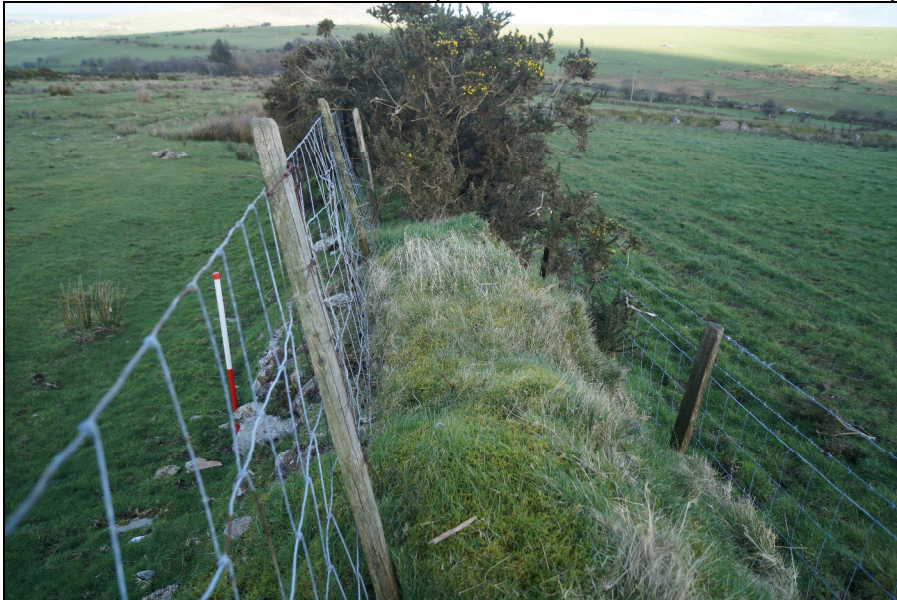
Plate 8. TBS2020_008: The top of the section of boundary, HER PRN 114840, shown in the previous image. Like all Cloddiau Variants there is stone to either side with an earth core, topped with turf and usually a hedge. The hedge is absent here and it is not known if the gorse is a relic of a gorse hedge planted along the boundary when it was constructed.

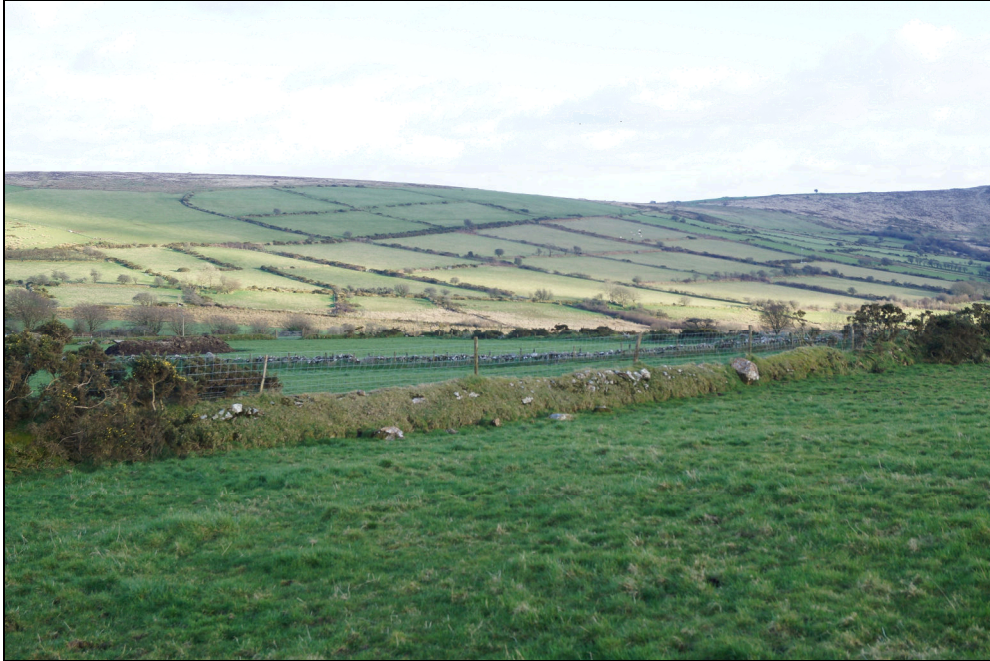
Plate 9. TBS2020_009: An Earth Bank, HER PRN 114841, within the field system at Llethr. Apart from some possible relict gorse, there is no hedge. The mixture of earth and stone, and the odd boulder incorporated into the bank, presumably reflects the material available when the bank was constructed.

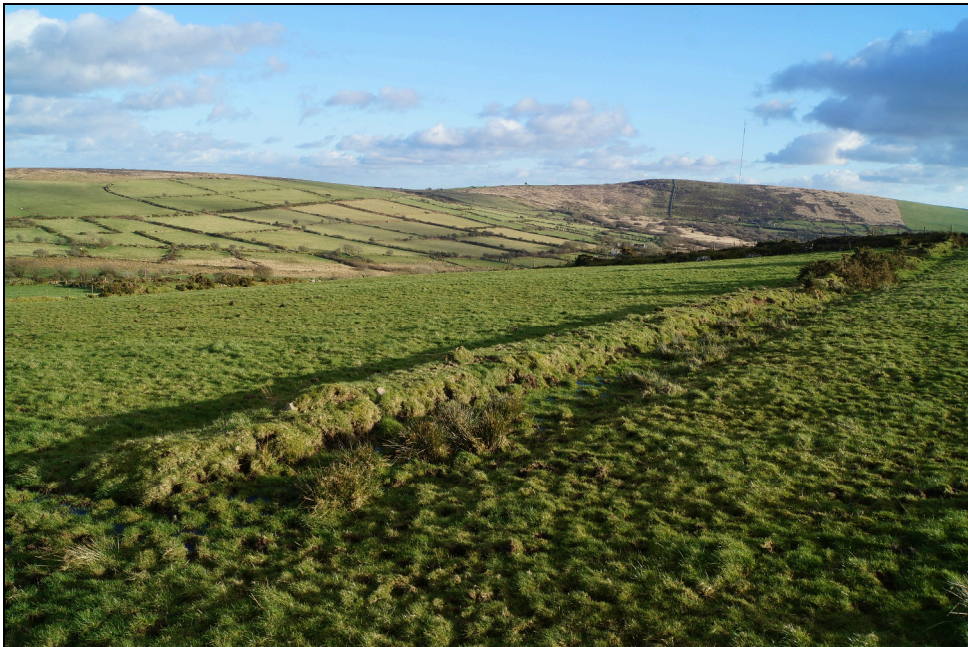
Plate 10. TBS2020_010: A simple Earth Bank, HER PRN 114842, within the field system at Llethr. The regularity of the ditch and bank suggest a machine may have been used to enhance the boundary. The presence of gorse may be as the result of recent invasion or a survival from original planting. The ditch seems to be from where turf, earth and stone were removed to create the bank.

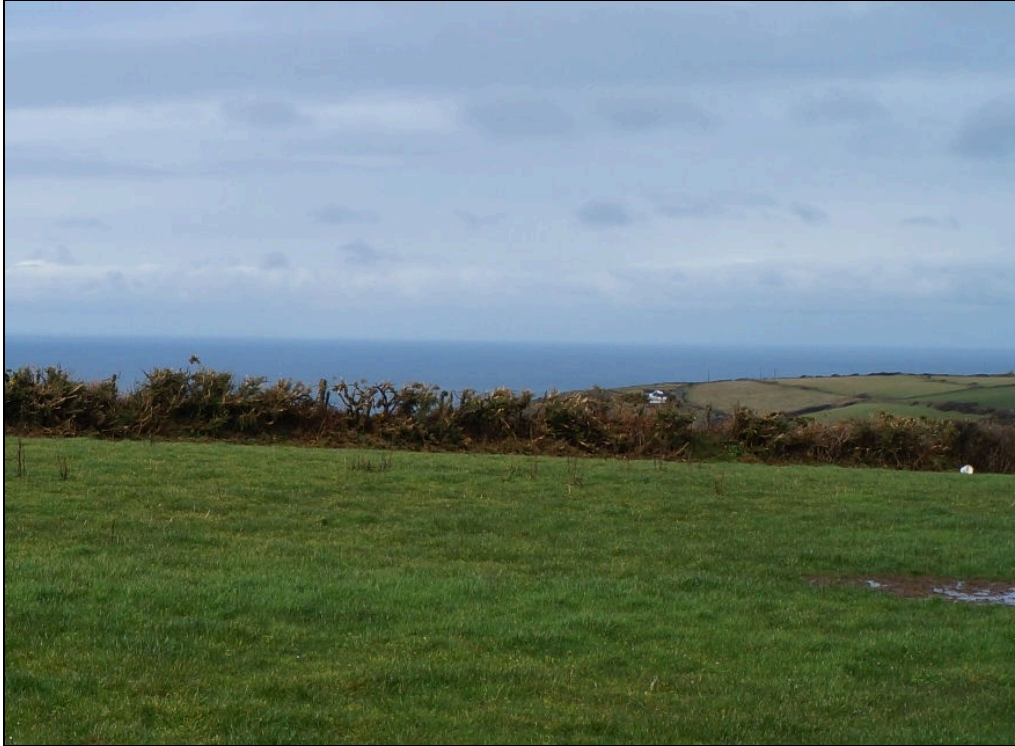
Plate 11. TBS2020_011: A typical Hedgebank, HER PRN 114843, in the Moylegrove area. A low earth bank topped with gorse, reinforced with a post and wire fence.

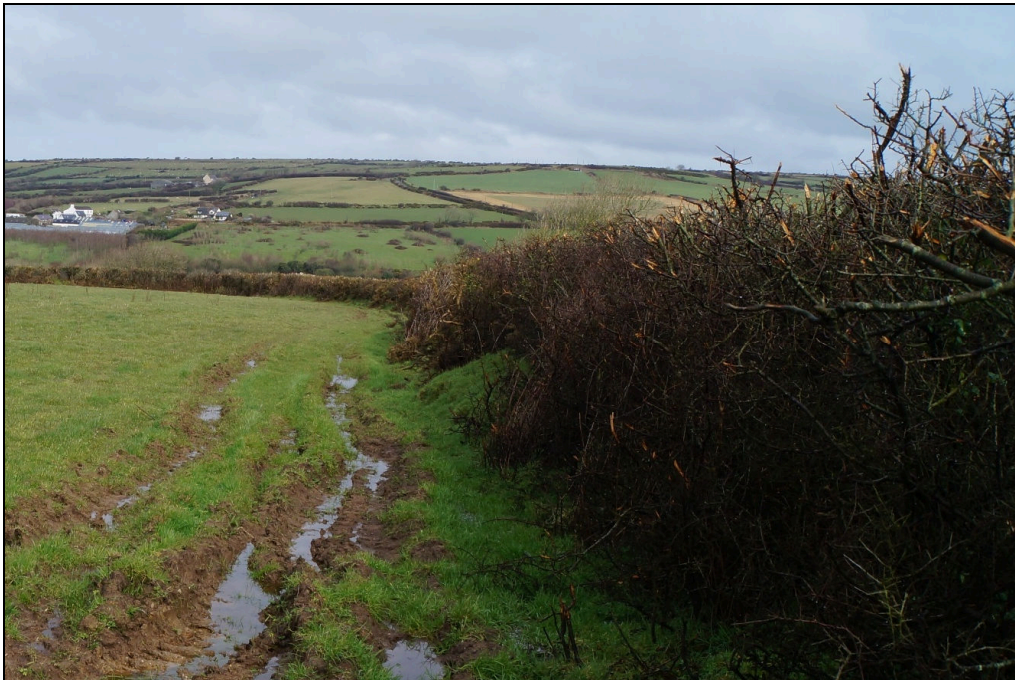
Plate 12. TBS2020_012: A Hedgebank, HER PRN 114844, consisting of a low earth bank, with a thick blackthorn hedge along its entire length forming an impenetrable barrier.

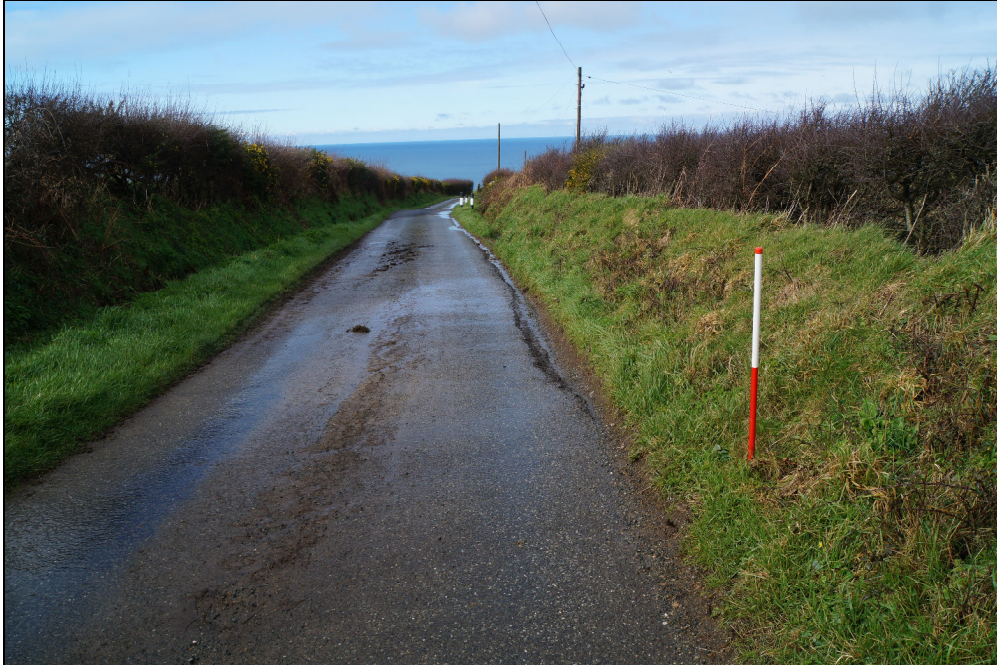
Plate 13. TBS2020_013: Hedgebanks either side of the roadway. The banks are approximately 1 metre high. That to the left, HER PRN 114845, has a ditch alongside it. The hedge on the bank to the right, HER PRN 114846, has been deliberately planted on the inside of the bank, rather than along the top of the bank.

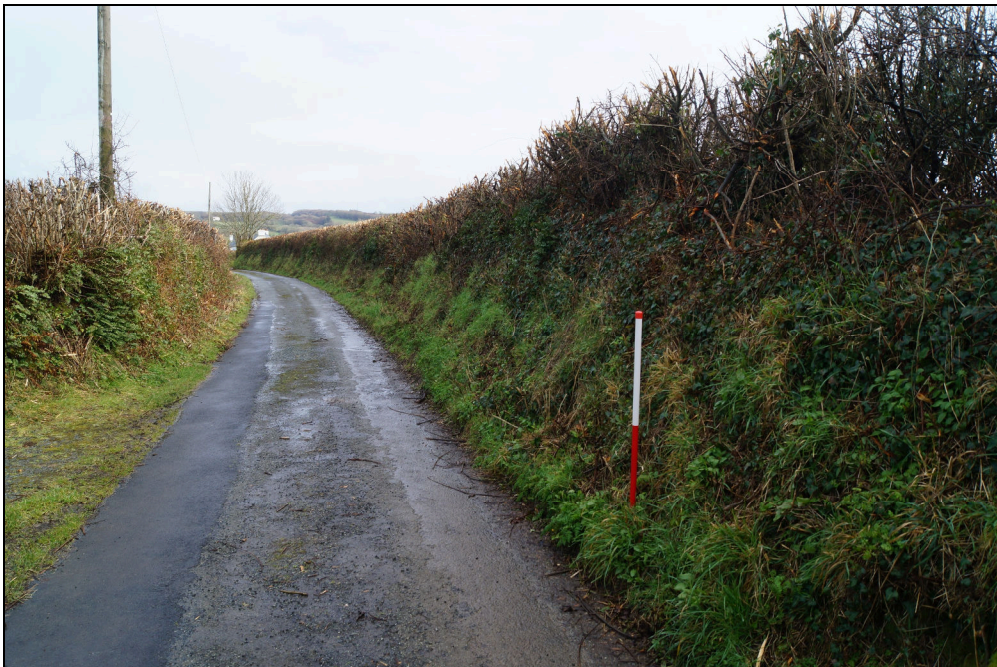
Plate 14. TBS2020_014: Another roadside Hedgebank, HER PRN 114847, this time over 1 metre high.

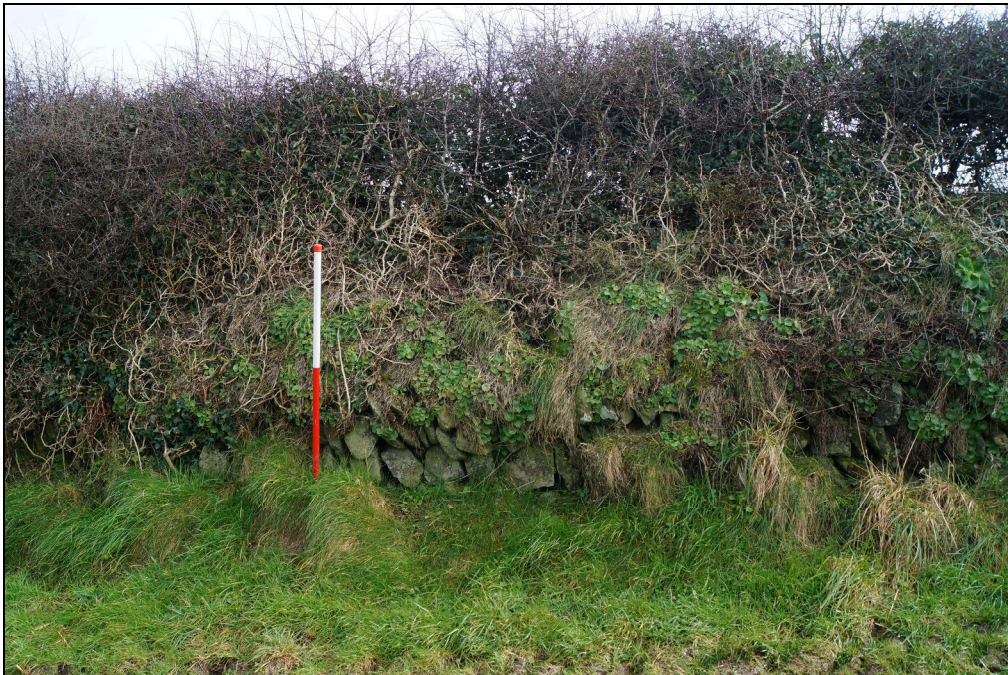
Plate 16. TBS2020_016: A Cloddiau Variant, HER NPRN 114848, where the stonework is still visible through the vegetation.

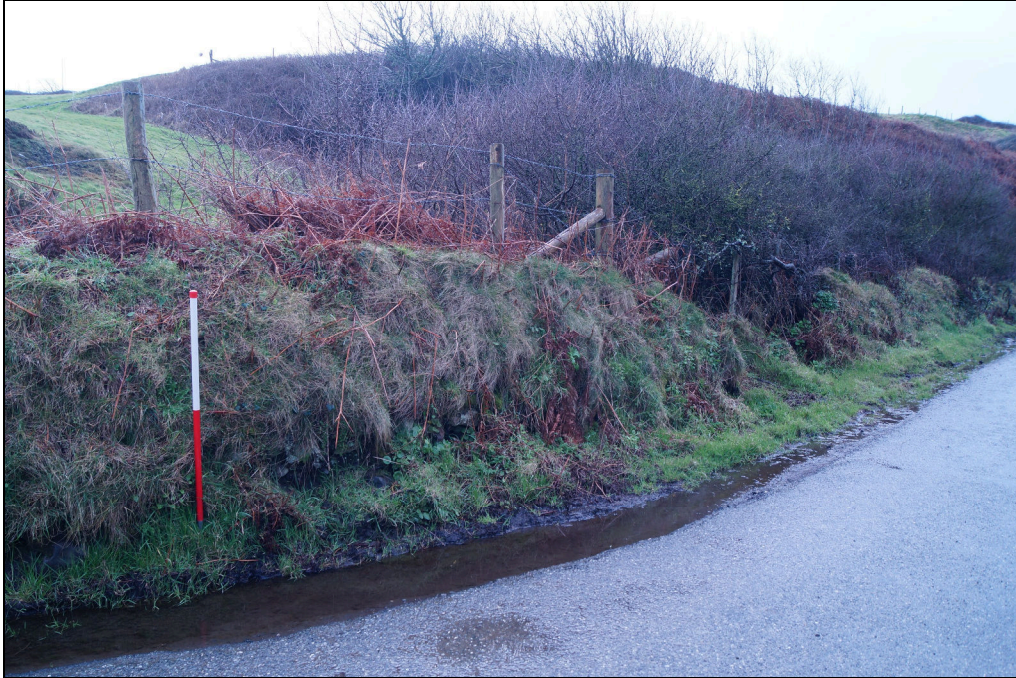
Plate 17. TBS2020_017: A roadside bank, HER PRN 114849, at Ceibwr. Stonework exposed at the base of the bank puts this example in the Cloddiau Variation category. There is no hedge on the bank and a post and wire fence makes the boundary secure.

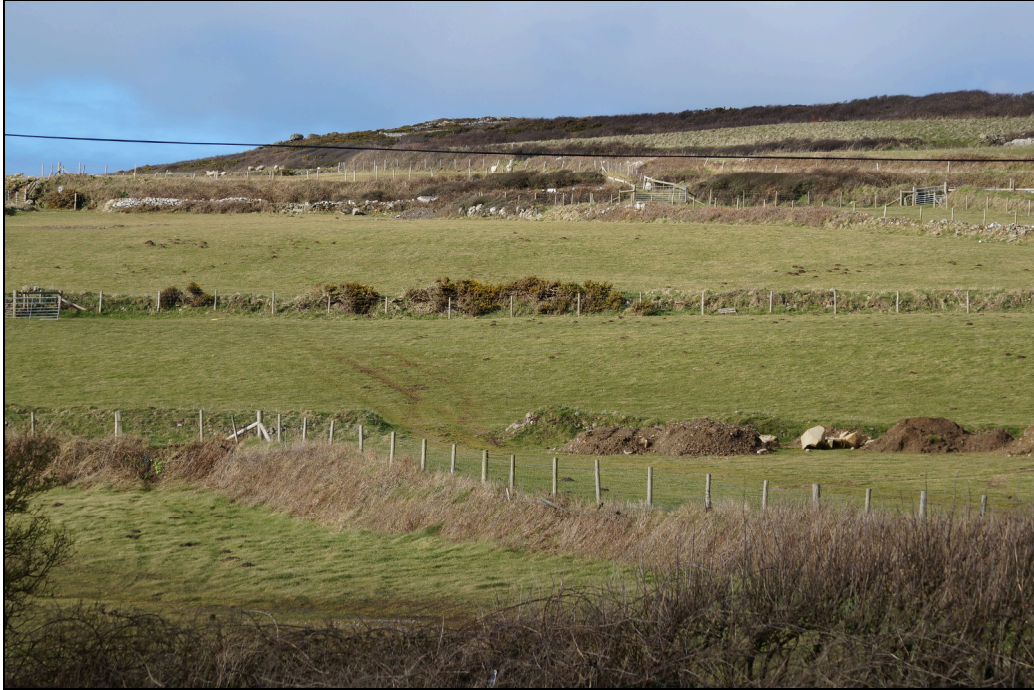
Plate 18. TBS2020_018: A view of the fieldscape at Ty Gwyn, showing a succession of Rubble Banks, Lynchets and Dry Stone Walls up the slope.

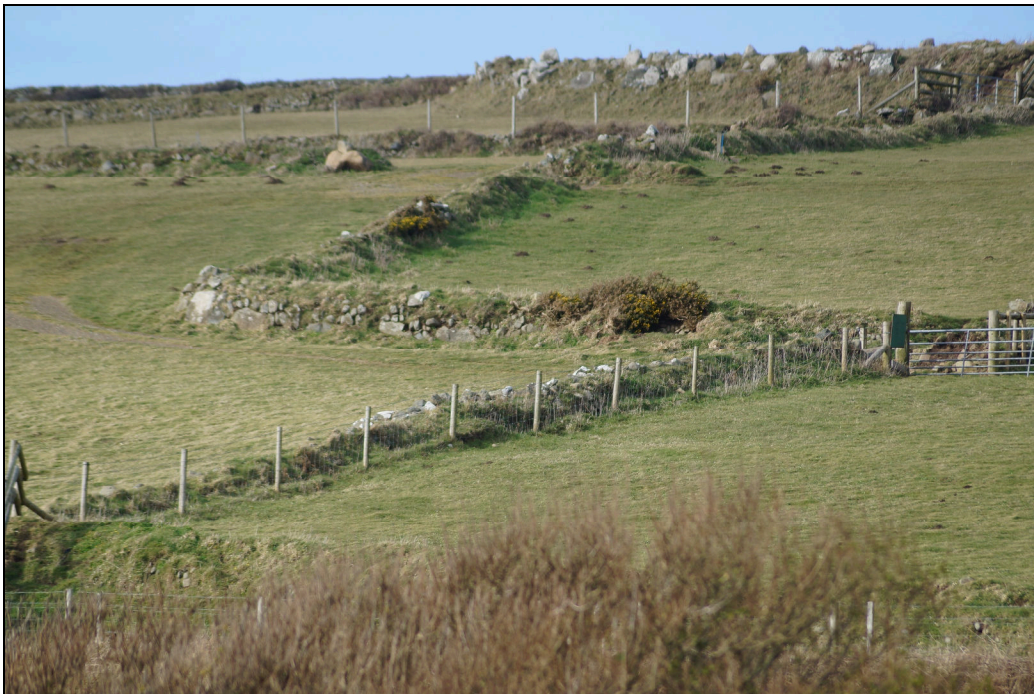
Plate 19. TBS2020_019: The boundary, HER PRN 114850, across the centre of the image appears to be a Cloddiau Variant, with stone-facing and an earthwork core. Other boundaries here seem to be Earth Banks with stone placed against one side only. The fenced boundaries visible are shown on the 1841 tithe map, the others are not.

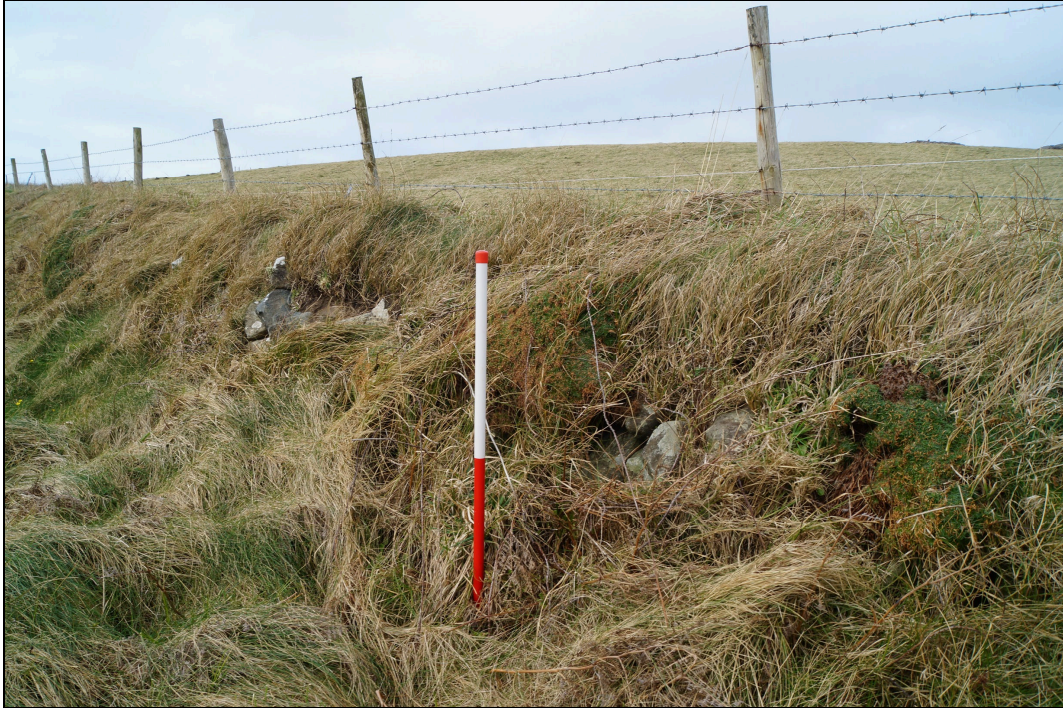
Plate 20. TBS2020_020: A Cloddiau Variant bank, HER PRN 114851, alongside the Coast Path.

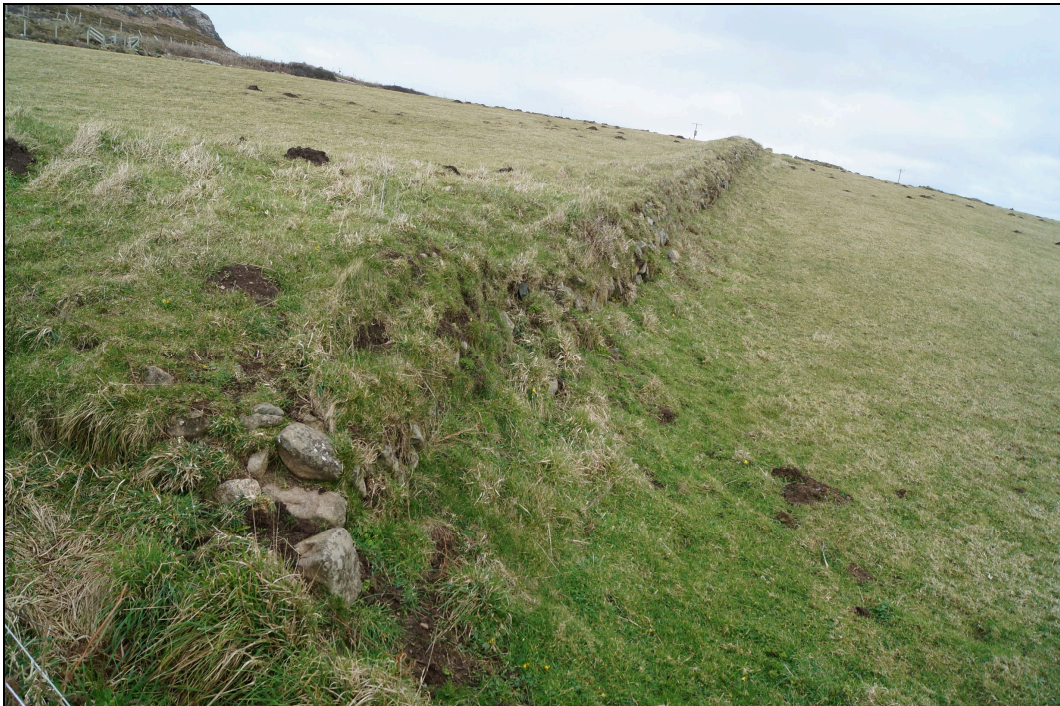
Plate 21. TBS2020_021: A Revetted Lynchet, HER PRN 114852, with a slight earth bank above the stone-faced lynchet. The Lynchet may be of prehistoric origin but the stone-revetting and bank are likely to be more recent features.

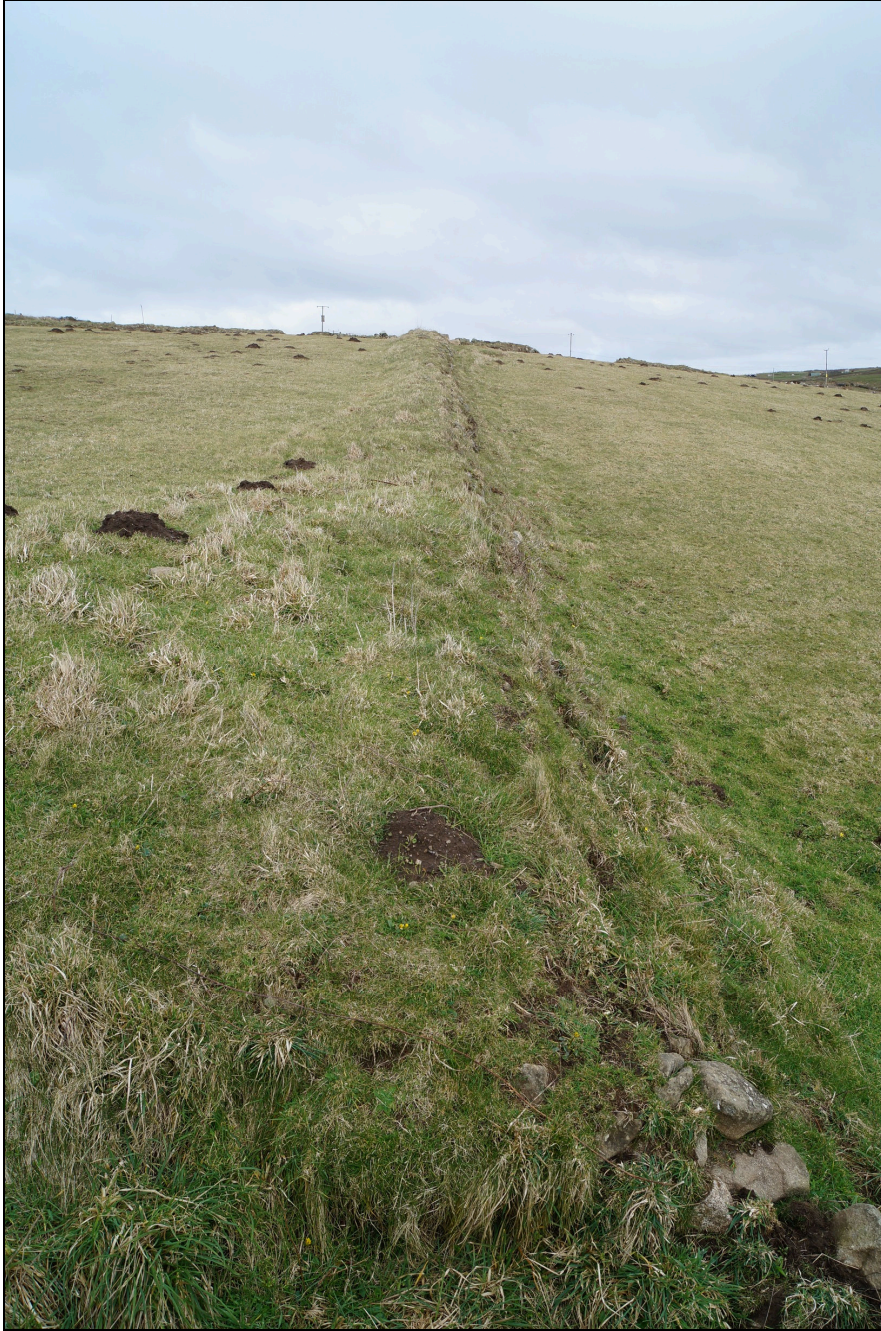
Plate 22. TBS2020_022: Another view of the Revetted Lynchet, HER PRN 114852, showing the earth bank more clearly.

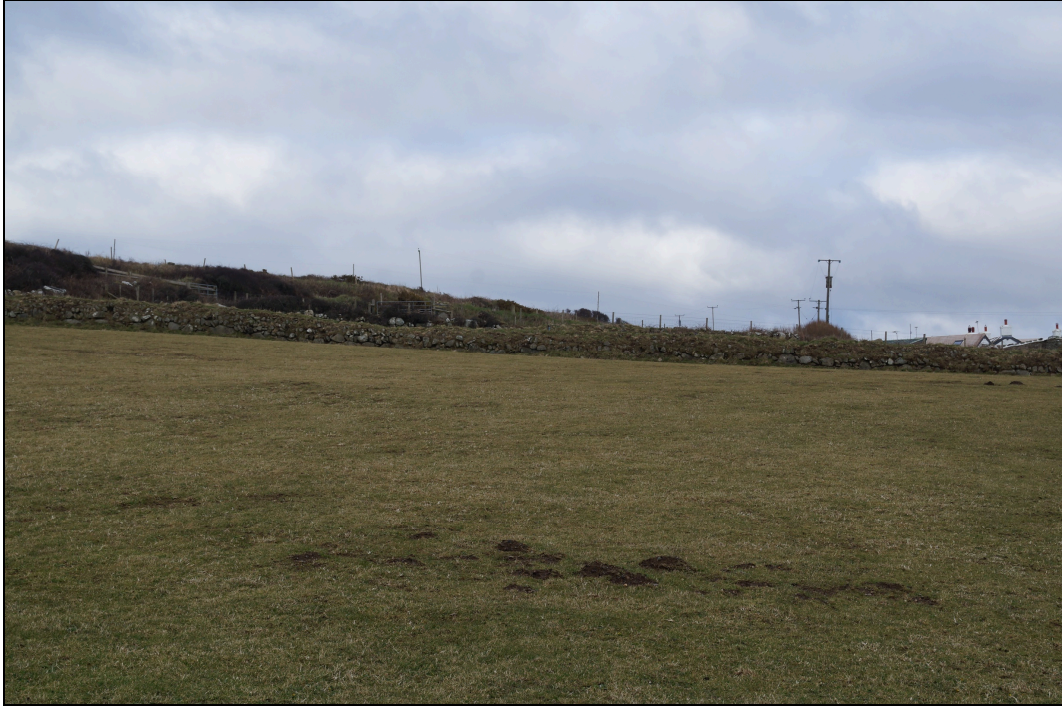
Plate 23. TBS2020_023: This boundary, HER PRN 114853, appears to have boulders at its base, stone-faced sides and an earth top and probable earth core. It is perhaps best described as a Cloddiau Variant.

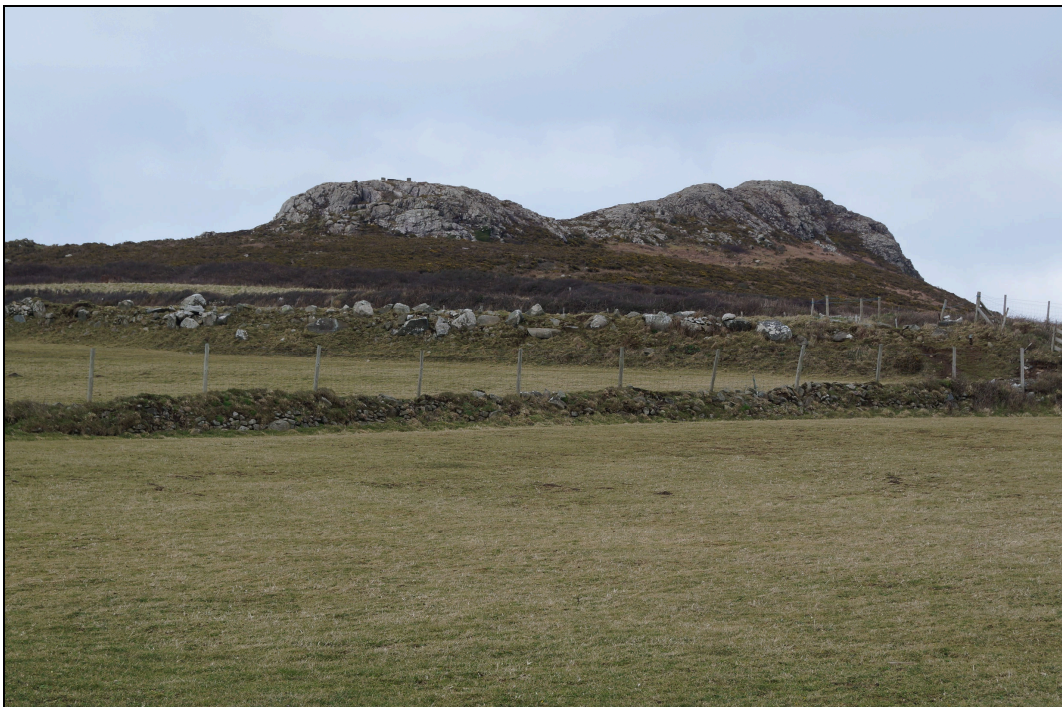
Plate 24. TBS2020_024: The boundary, HER PRN 114854, in the foreground is a Stone Rubble Bank, strengthened as a boundary by a post and wire fence.

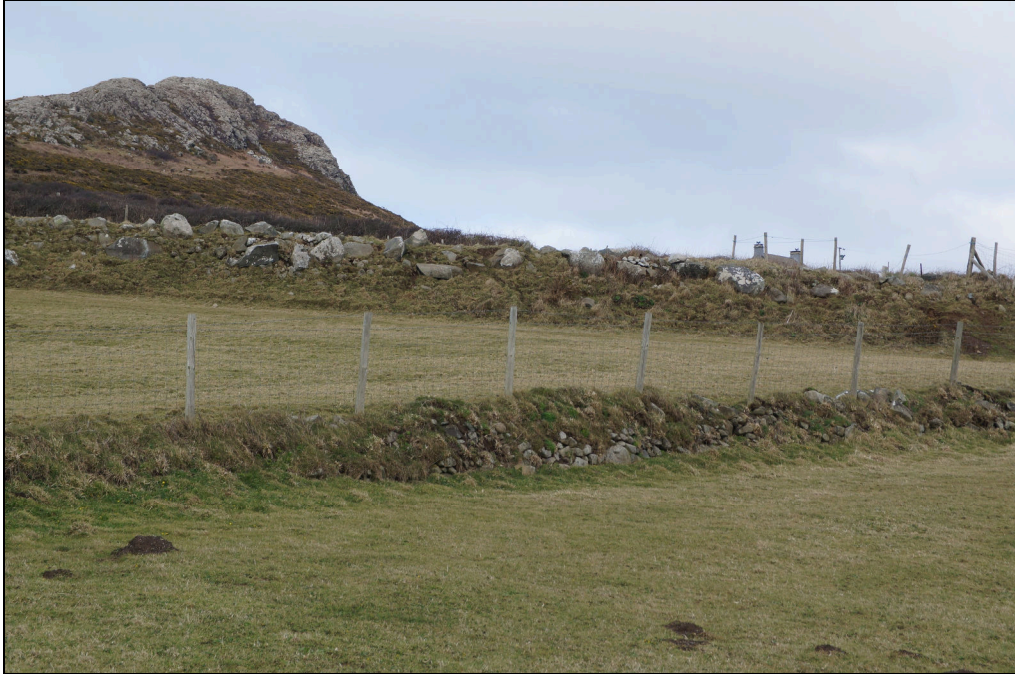
Plate 25. TBS2020_025: Another view of the same Stone Rubble Bank, HER PRN 114855. The chimneys of Ty Gwyn Farmhouse are visible in the background.

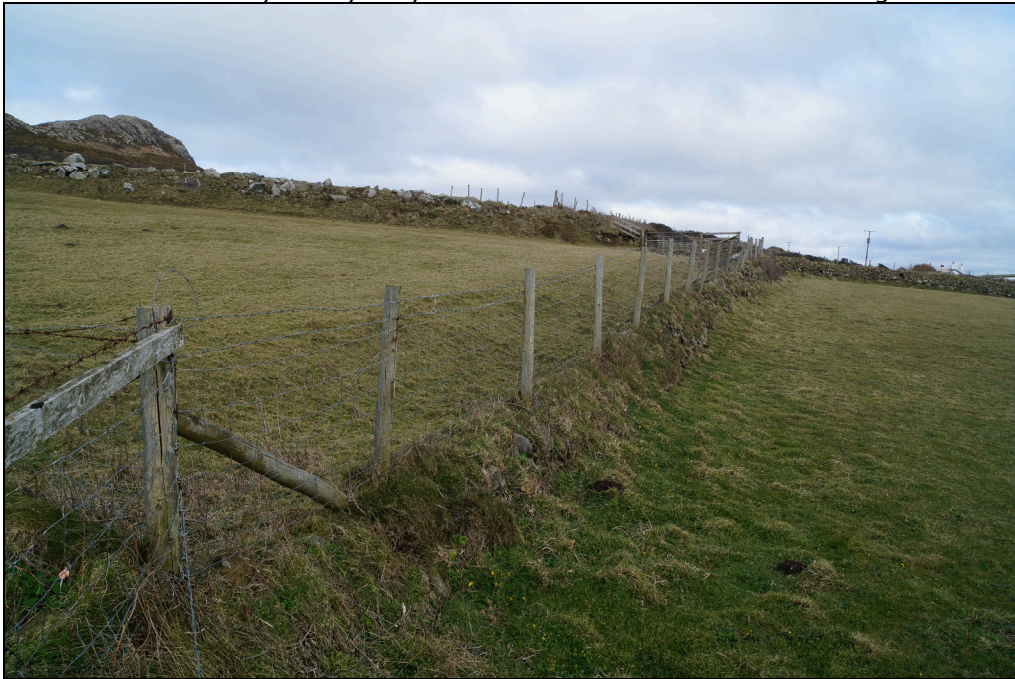
Plate 26. TBS2020_026: The same Stone Rubble Bank, HER PRN 114854, actually forms one side of a now disused trackway to Ty Gwyn, the other side being formed by a possibly Prehistoric Lynchet. This Lynchet has survived undisturbed with no bank or revetting added to it, as it has been incorporated into the Post-Medieval trackway. As it is an archaeological feature and not a traditional boundary it has not been given a HER PRN as part of this project.

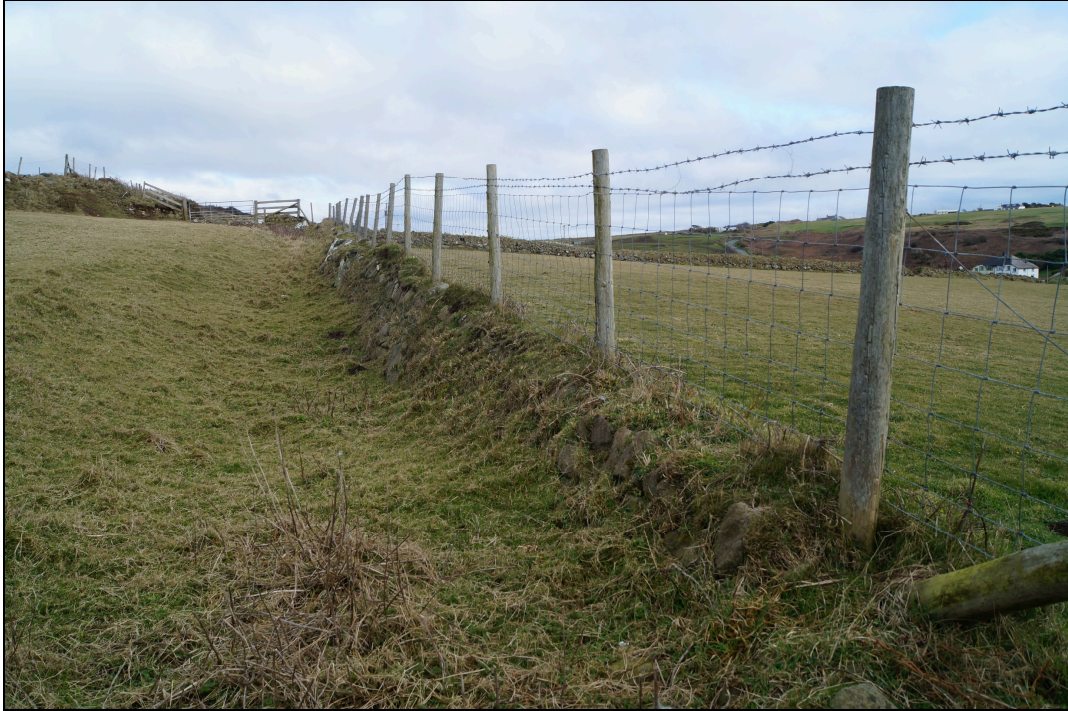
Plate 27. TBS2020_027: A view of the Post-Medieval trackway to Ty Gwyn from the Coast Path, with stone rubble bank, HER PRN 114854, to the right of the photograph, the lynchet to the left.

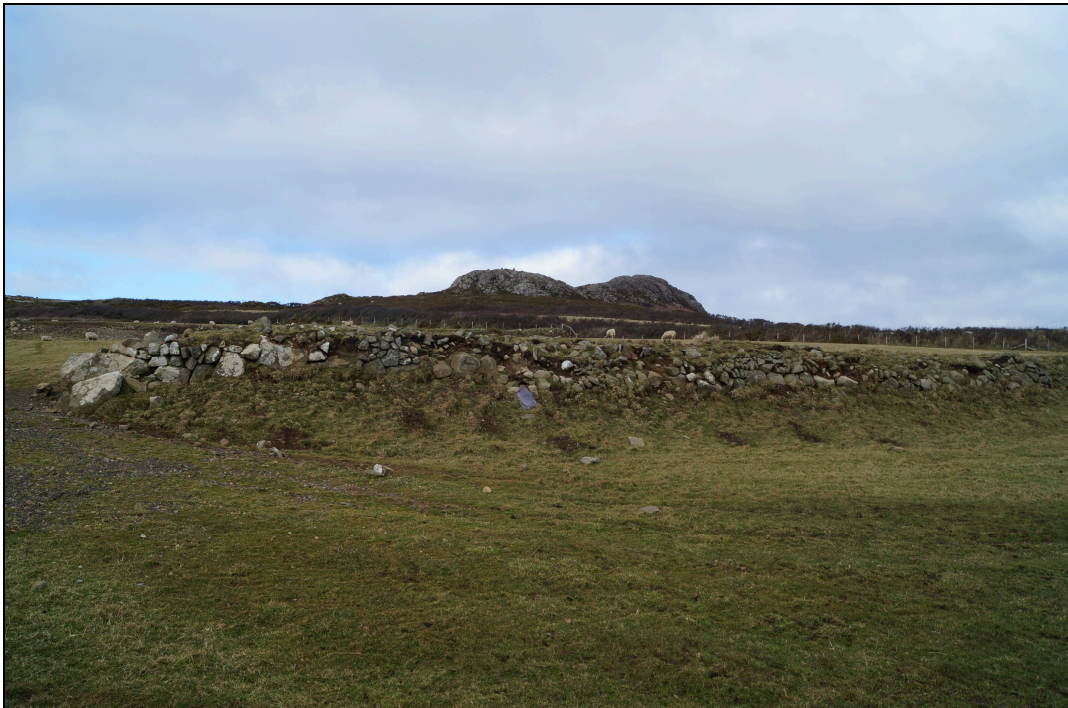
Plate 28. TBS2020_028: Stone revetting appears to have been added to a landform here to create an effective Revetted Boundary, HER PRN 114855.

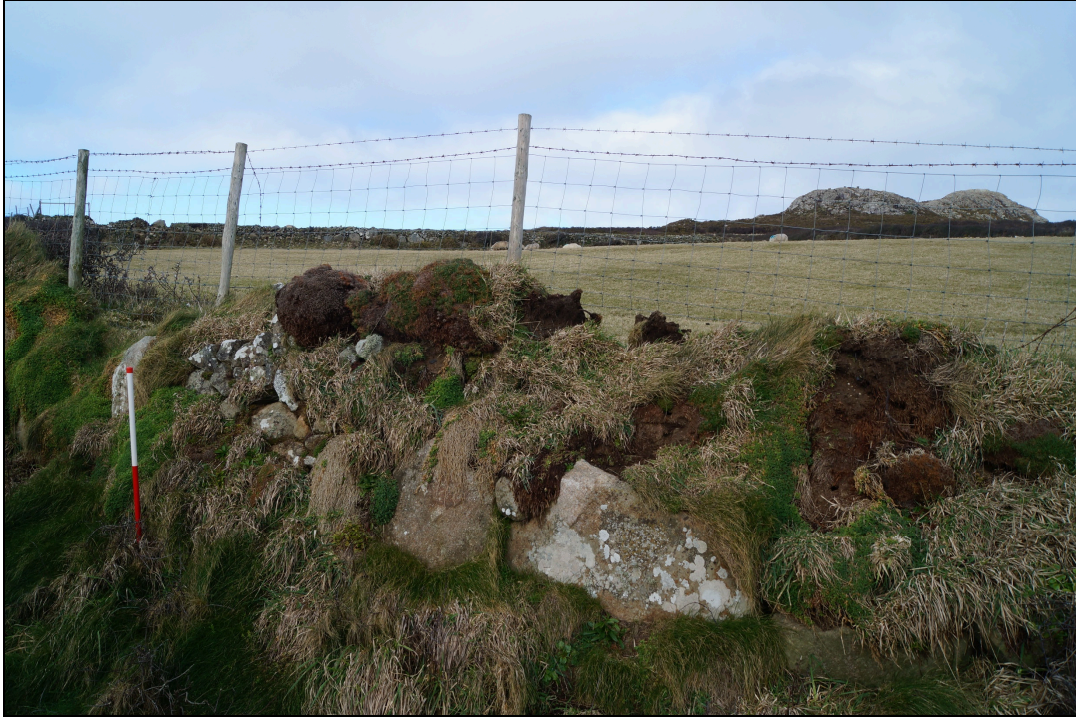
Plate 29. TBS2020_029: This section of boundary borders the Coast Path at SM7325027492, and displays elements of a Boulder Bank and a Cloddiau Variant, HER PRN 114856, demonstrating that a single boundary can change character within a short distance.

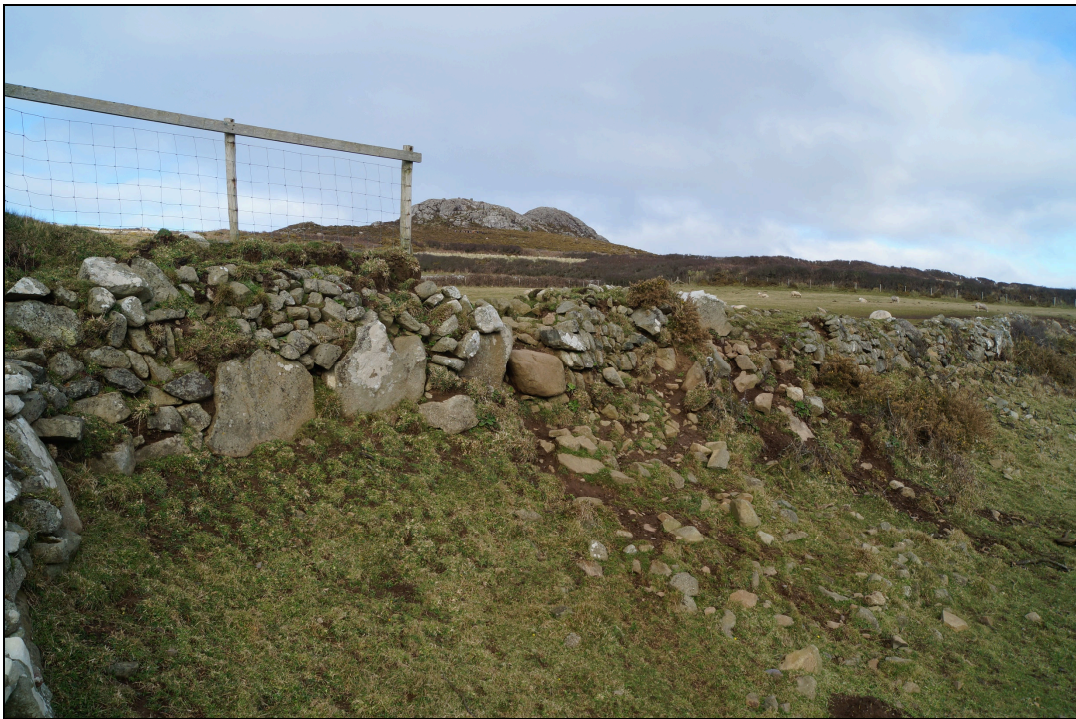
Plate 30. TBS2020_030: Another example of a Revetted Lynchet, HER PRN 114857, with the stone extending up to form a Stone Rubble Bank along the top of the lynchet.

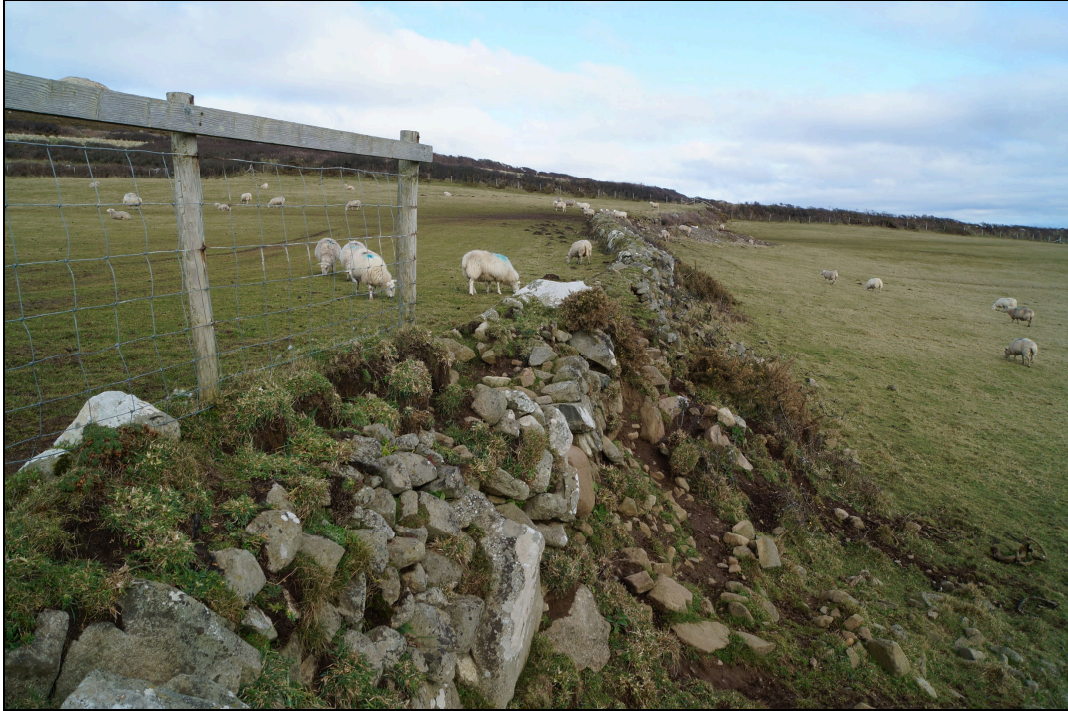
Plate 31. TBS2020_031: A photograph of the same Revetted Lynchet, HER PRN 114857, showing the Stone Rubble Bank clearly.
