PEMBROKESHIRE COAST NATIONAL PARK TRADITIONAL BOUNDARIES SURVEY

For: Pembrokeshire Coast National Park

March 2020

Trysor Project No. 2020/709
DAT HER Event Record PRN 114831

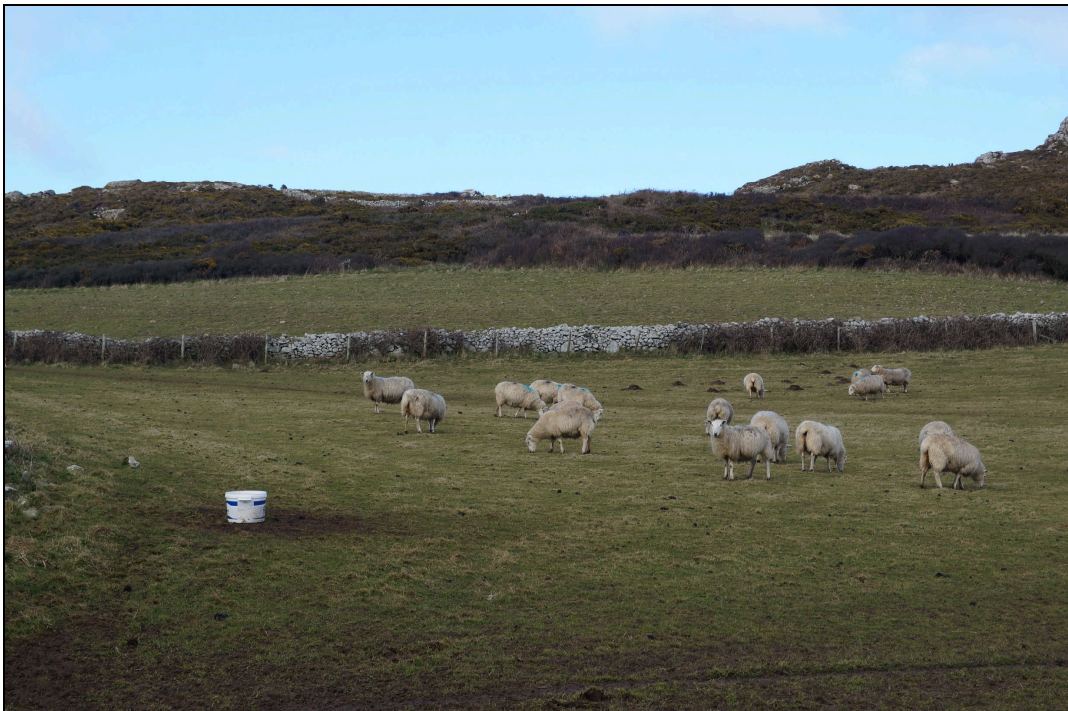
Plate 32. TBS2020_032: A Dry Stone Wall below Carn Llidi, HER PRN 114858. This boundary is not shown on the parish tithe map, 1st edition Ordnance Survey map or early 20th century Ordnance Survey maps.

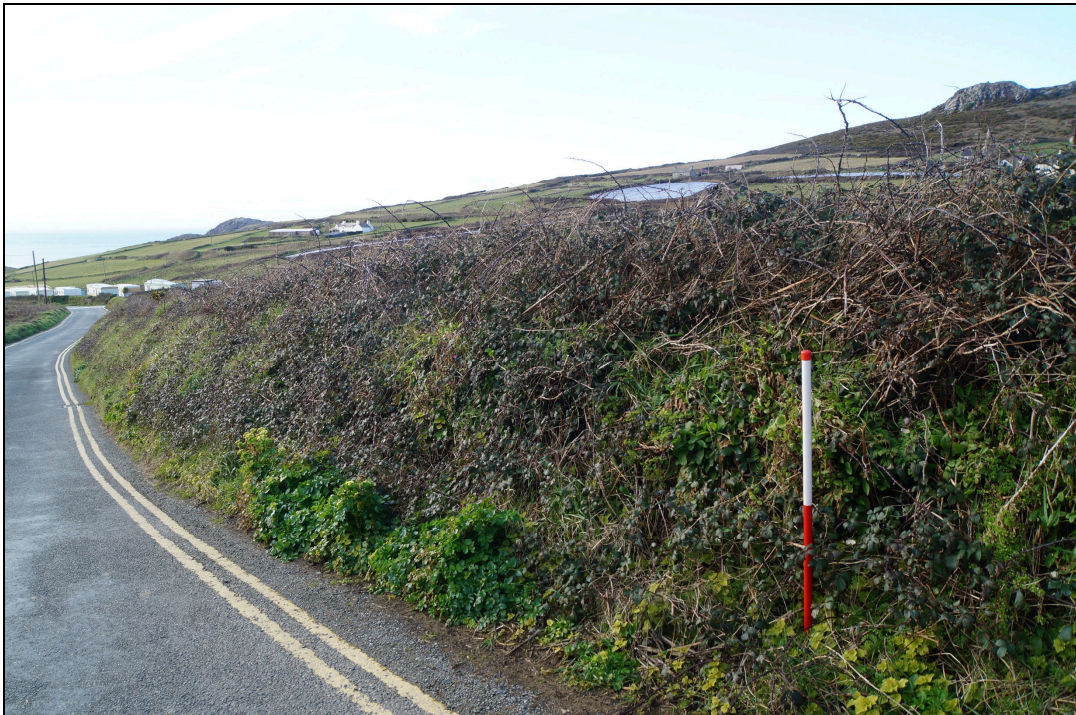
Plate 34. TBS2020_034: This large boundary bank, HER PRN 114 860, alongside the road to Whitesands Bay is an Earth Bank with little stone included in its makeup.

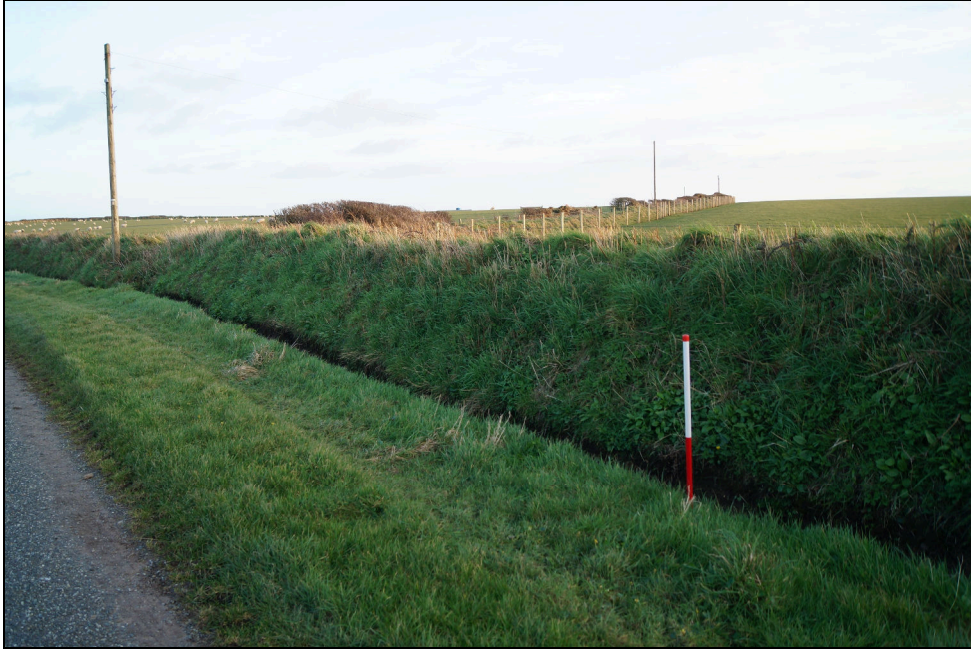
Plate 35. TBS2020_035: A good example of an Earth Bank, HER PRN 114861, with a drainage ditch along its base.

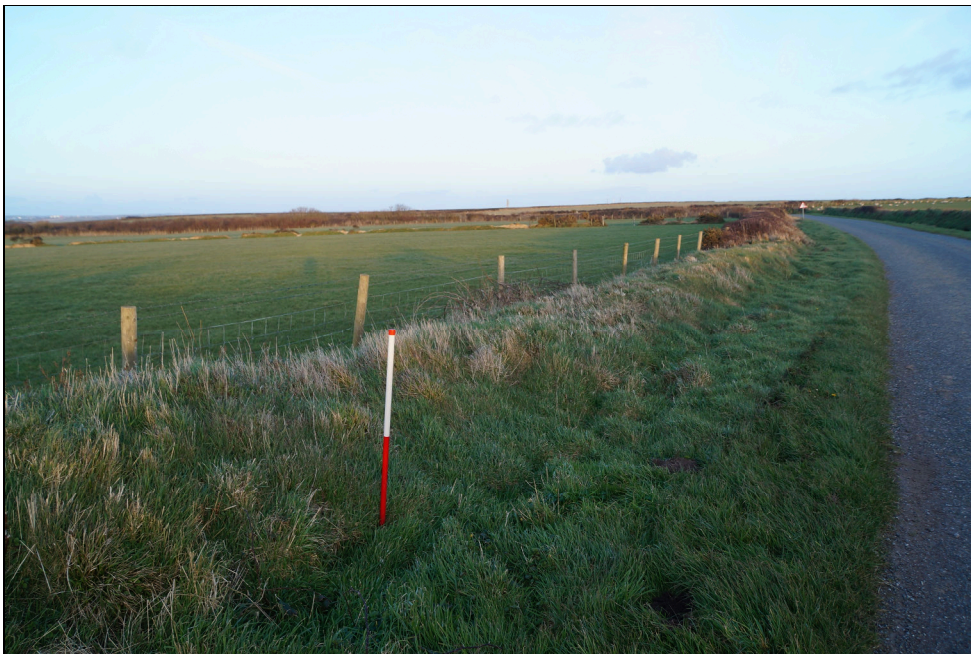
Plate 36. TBS2020_036: An Earth Bank, HER PRN 114862, with a post and wire fence forming the modern boundary. The bank turns into a Hedgebank further along the road.

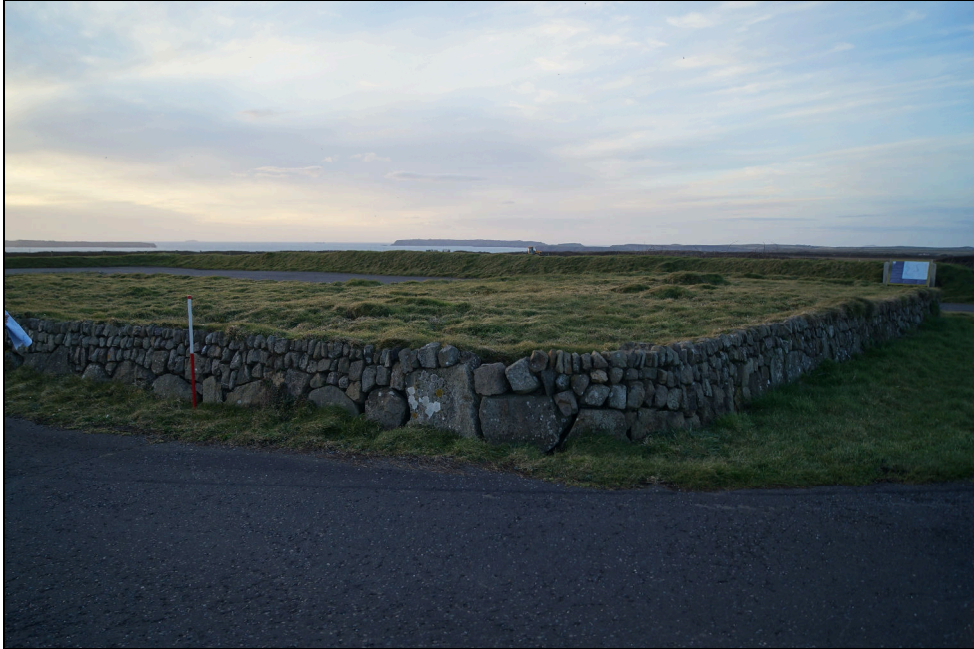
Plate 37. TBS2020_037: A modern Revetted Boundary at the Kete car park at SM8032404297.

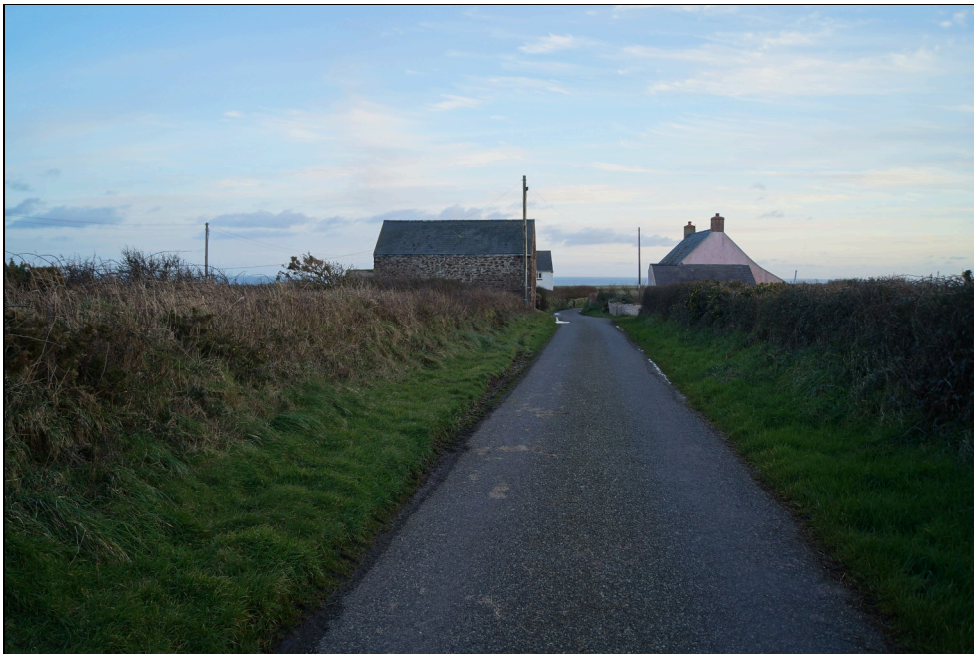
Plate 38. TBS2020_038: The road at Kete passes between two Hedgebanks; HER PRN 114863, to the left (east) and HER PRN 114864, to the right (west).

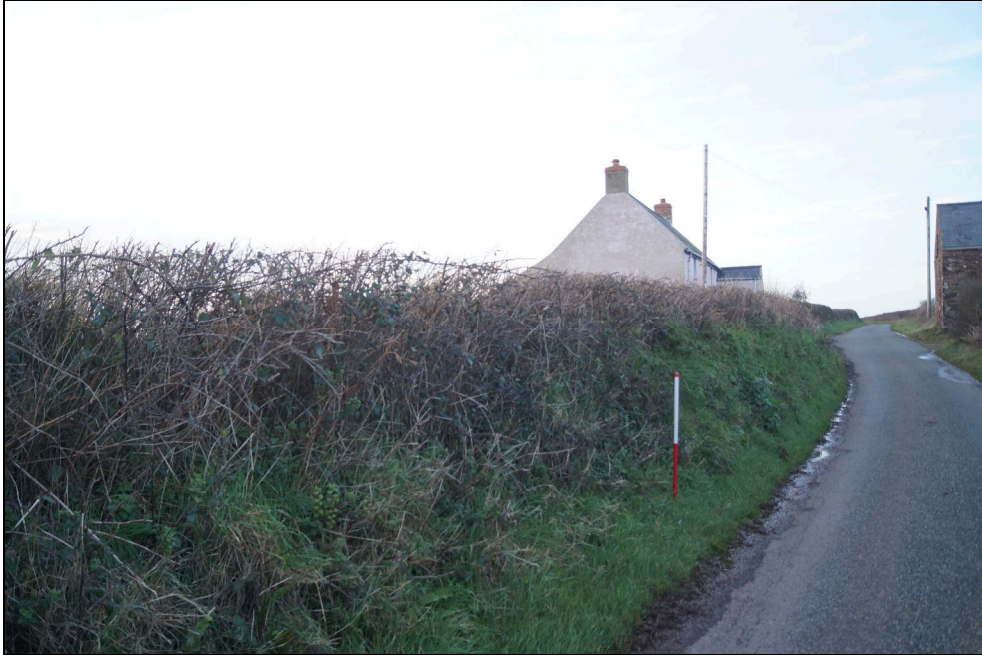
Plate 39. TBS2020_ 039: This section of boundary bank, HER PRN 114865, south of Kete appeared to have some stone-facing hidden by vegetation and is a section of Cloddiau Variant.

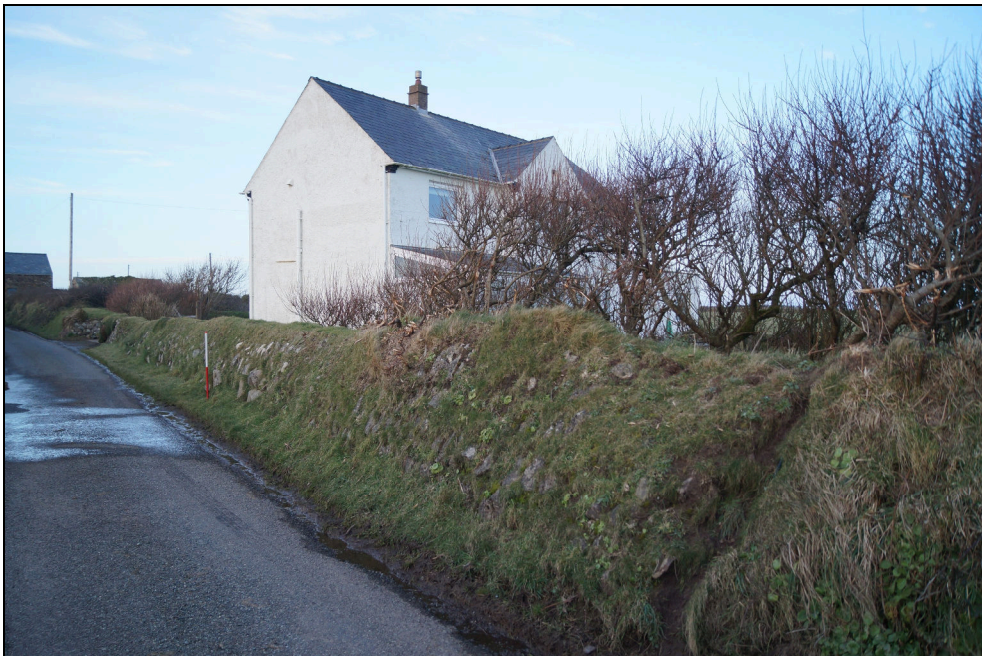
Plate 40. TBS2020_ 040: A Cloddiau Variant, HER PRN 114866, apparently a stone-faced, earth bank, used in a garden boundary at Kete.

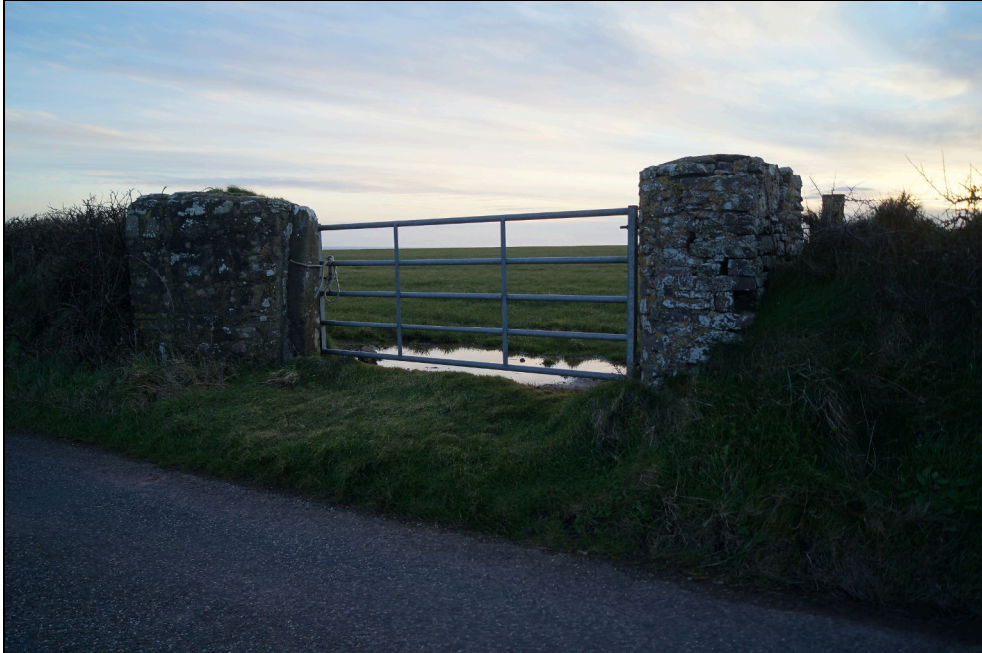
Plate 41. TBS2020_041: Mortared Stone pillars at a field gate at SM8041403807. Not an uncommon sight in this area.

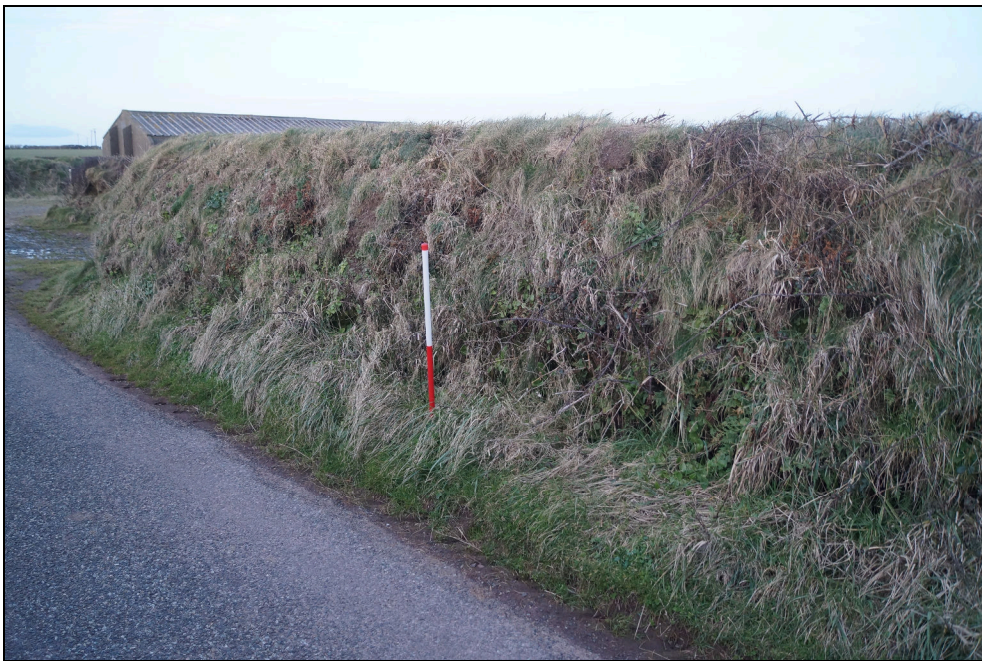
Plate 42. TBS2020_042: Another section of boundary bank, HER PRN 114867, south of Kete which appeared to have some stone-facing and is a section of Cloddiau Variant.

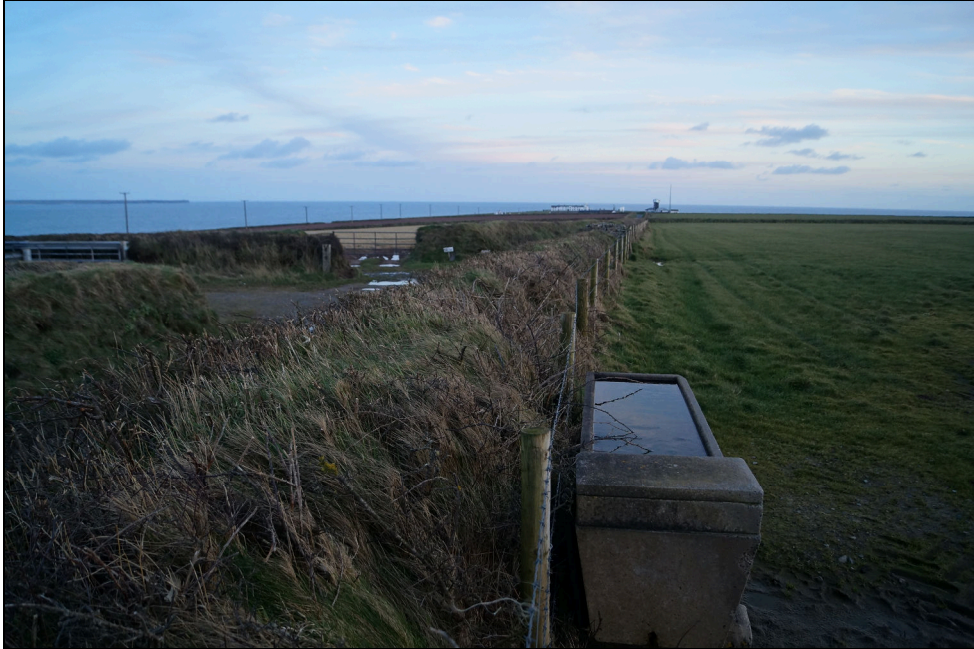
Plate 43. TBS2020_043: The Earth Banks of the area can be between 2 and 3 metres wide at base and form considerable boundary features. Their hedges, where present are often cut short and it is the post and wire fencing which are now relied upon for stock-proofing. This example is HER PRN 114868.

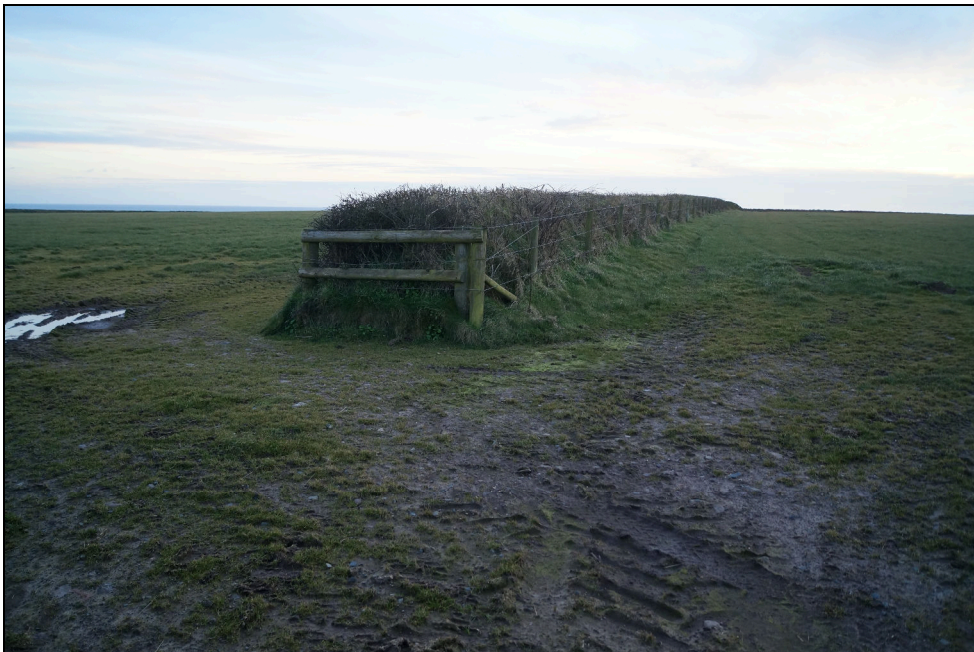
Plate 44. TBS2020_044: An example of a double-fenced Hedgebank, HER PRN 114869.

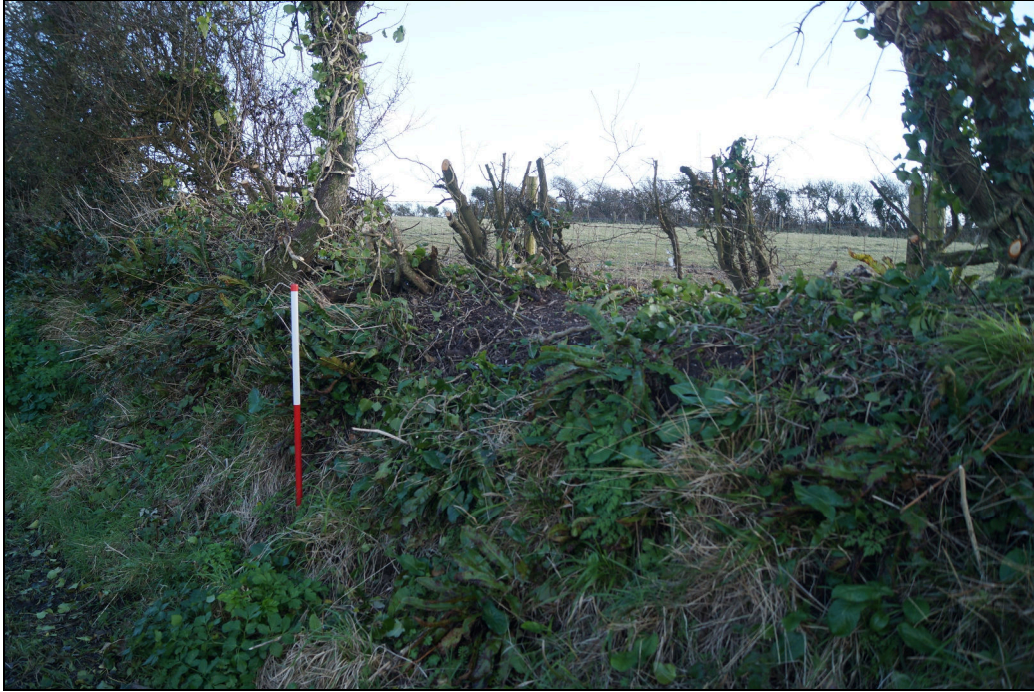
Plate 45. TBS2020_045: A Hedgebank near Jameston, HER PRN 114870. This single bank varied in character with some sections built of earth and others being stone-faced in the Cloddiau style. Individual boundary banks could clearly change character depending on the materials available to construct them.

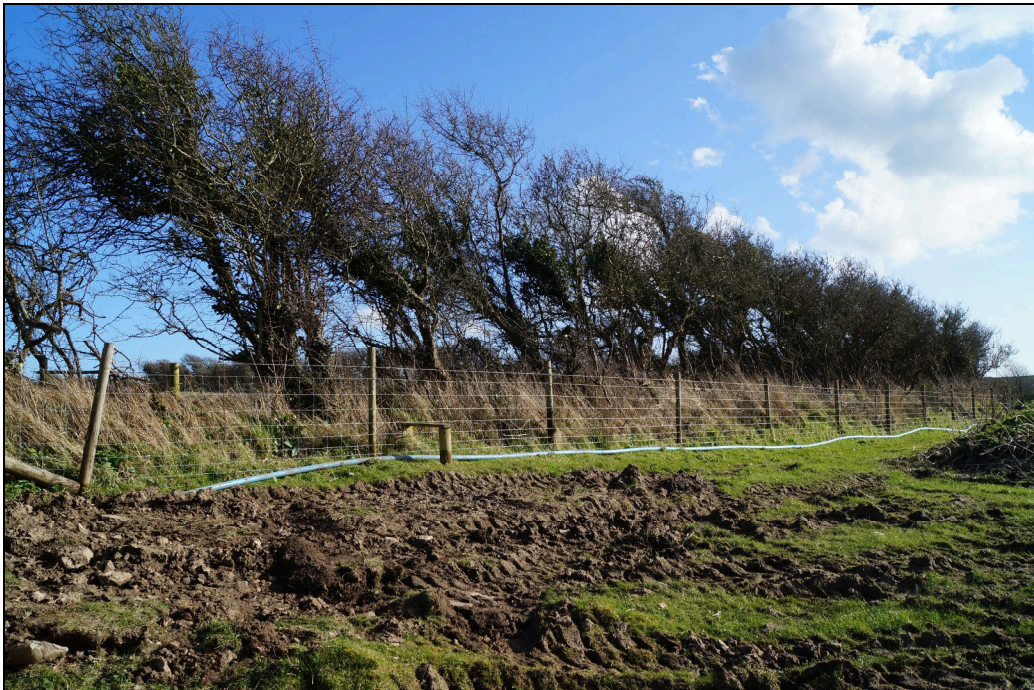
Plate 46. TBS2020_046: A typical Hedgebank, HER PRN 114871, double fenced to keep grazing animals away from the boundary and hedge.

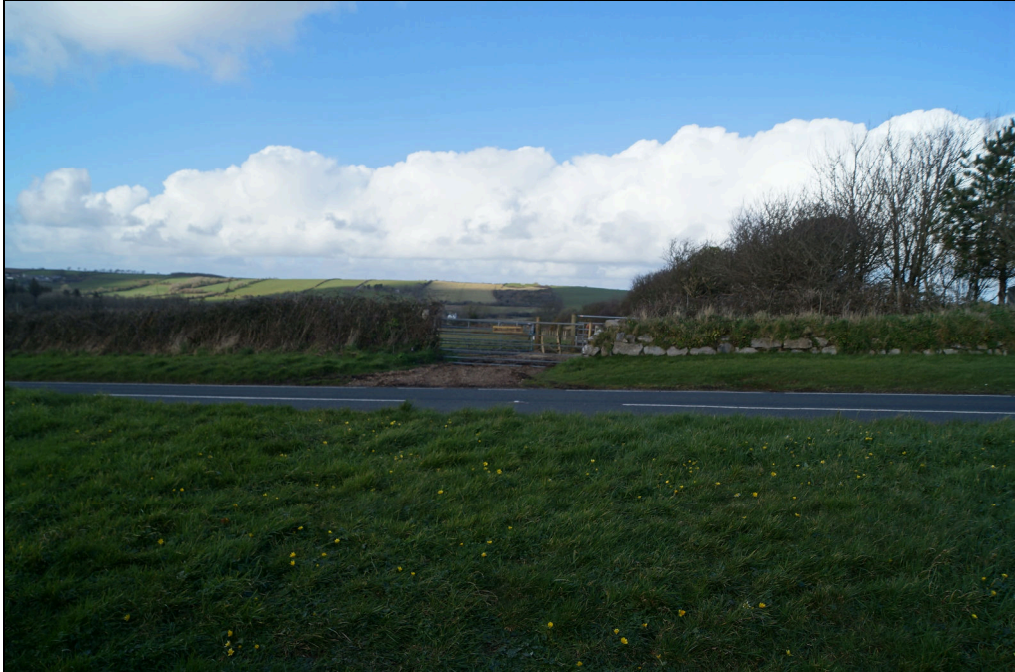
Plate 47. TBS2020_047: These are both modern boundaries created when this section of the A4139 was upgraded. To the left of the gateway is a hedgebank, to the right of the gateway the bank has a significant stone component at its base, and no hedge. The use of stone may be due to the proximity of a house and garden just off camera to the right, which is a trend also seen in older boundaries.

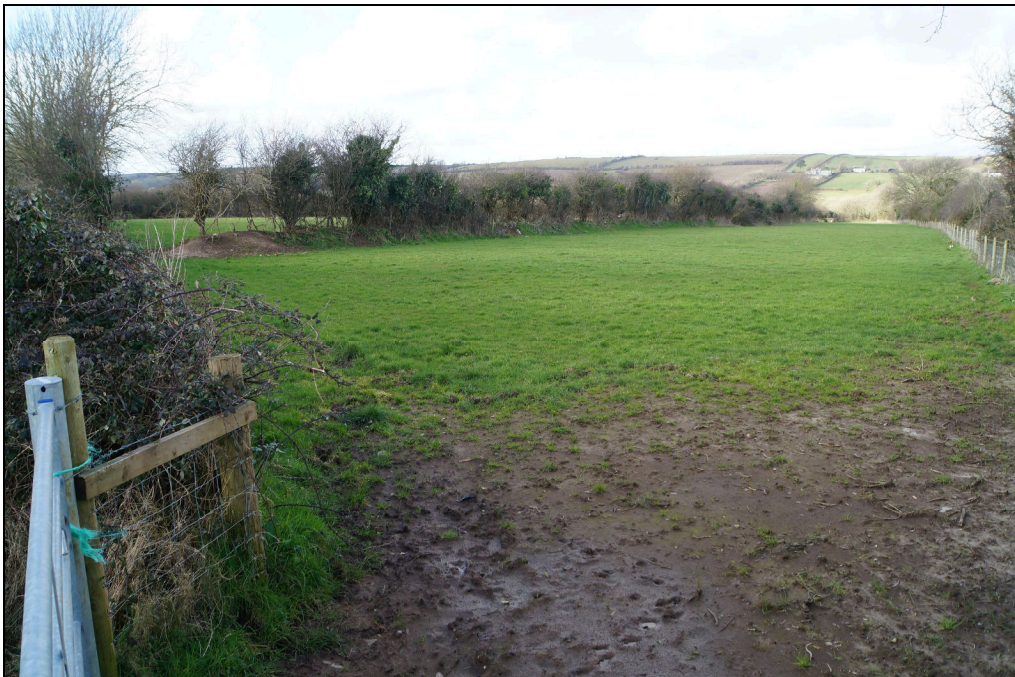
Plate 48. TBS2020_048: A view into one of the narrow strip fields between Jameston and Manorbier Newton. The boundary banks are low earth-built Hedgebanks and the one in the centre of the photograph is recorded as HER PRN 114872.

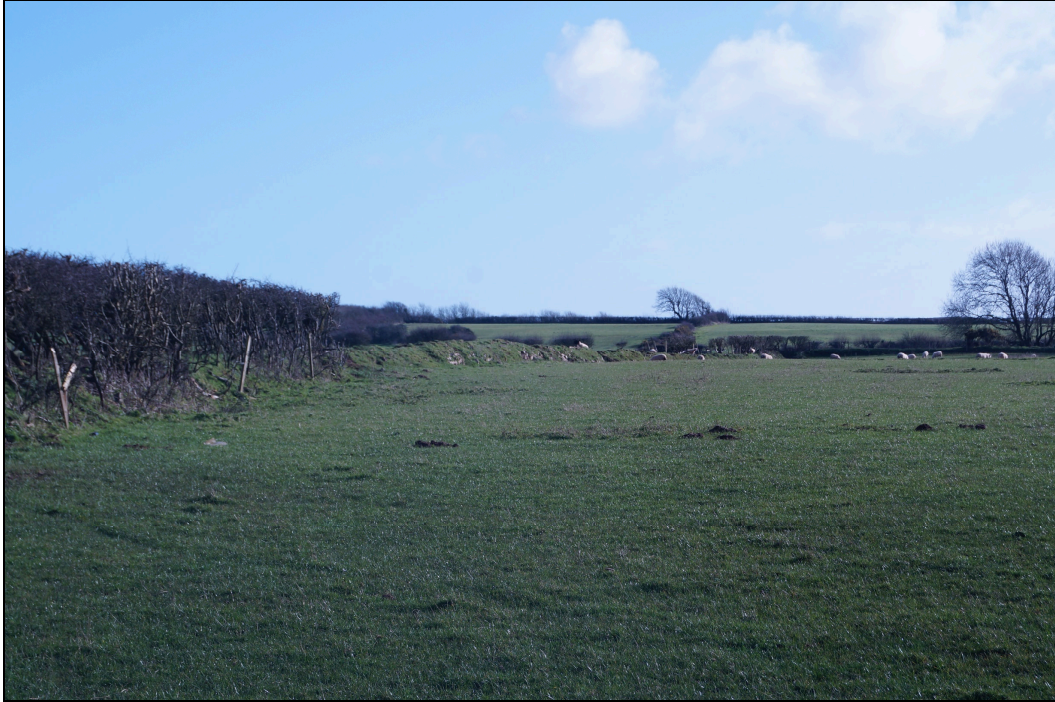
Plate 51. TBS2020_051: The Hedgebank, HER PRN 114873, shown in the previous image continues southwards but loses its hedge and has a stone component.

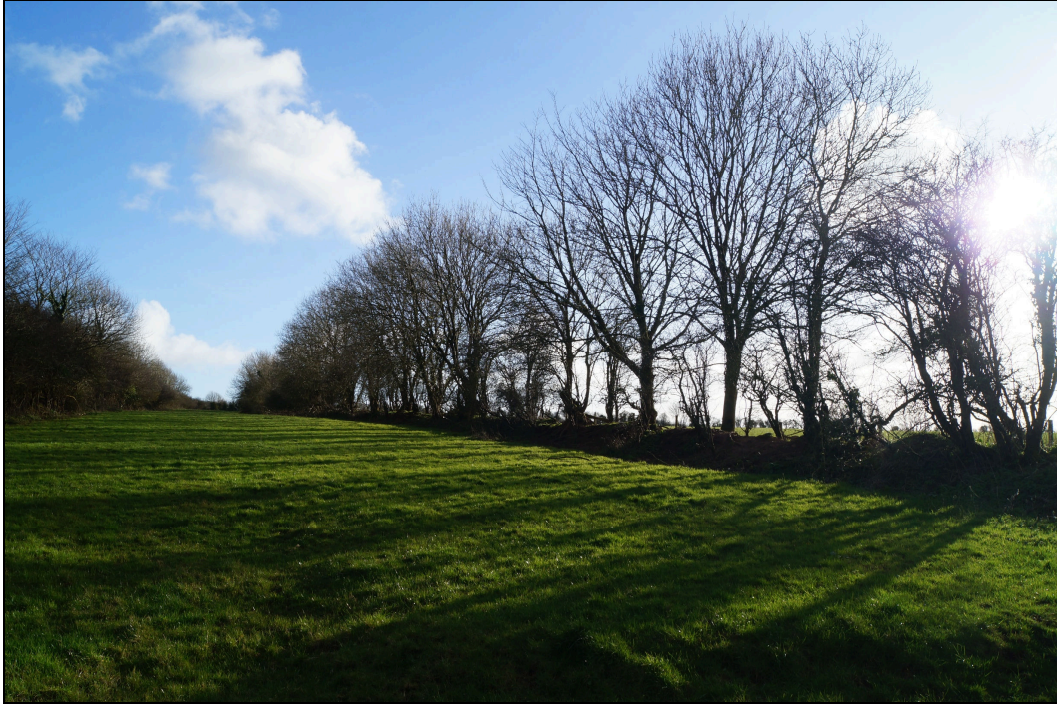
Plate 53. TBS2020_053: A good example of a strip field defined by a Hedgebank, HER PRN 114875, on which there is now a row of mature trees.

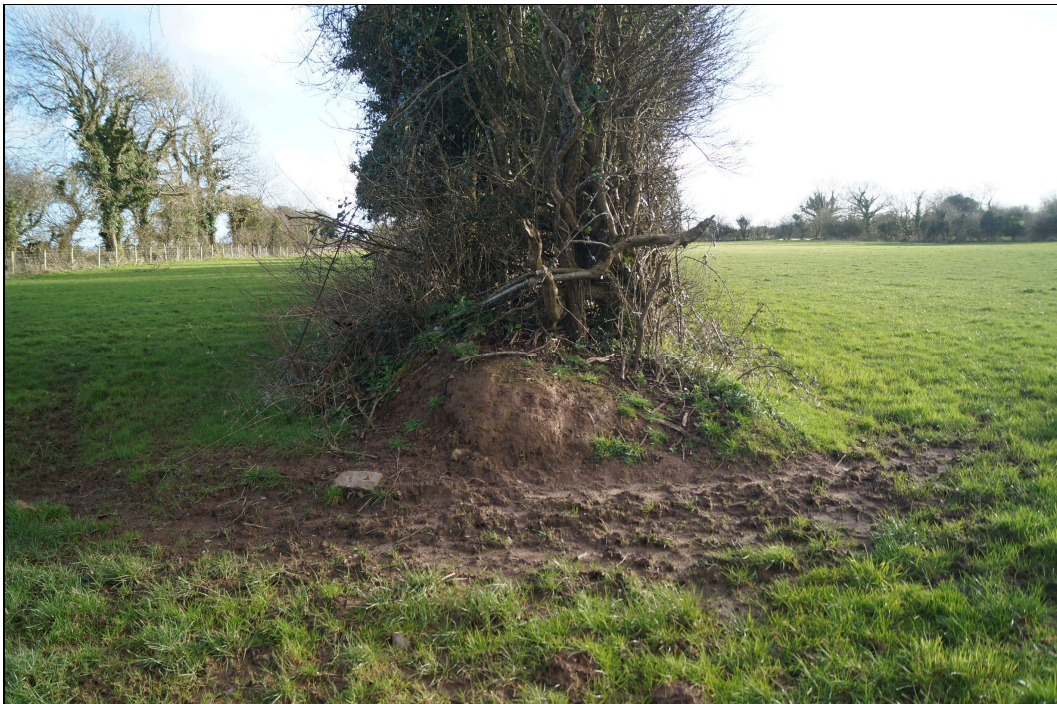
Plate 54. TBS2020_054: The northern end of the Hedgebank, HER PRN 114875, shown in the previous photo shows that it is of earth composition. It is now a low, broad bank, grassed on its sides.

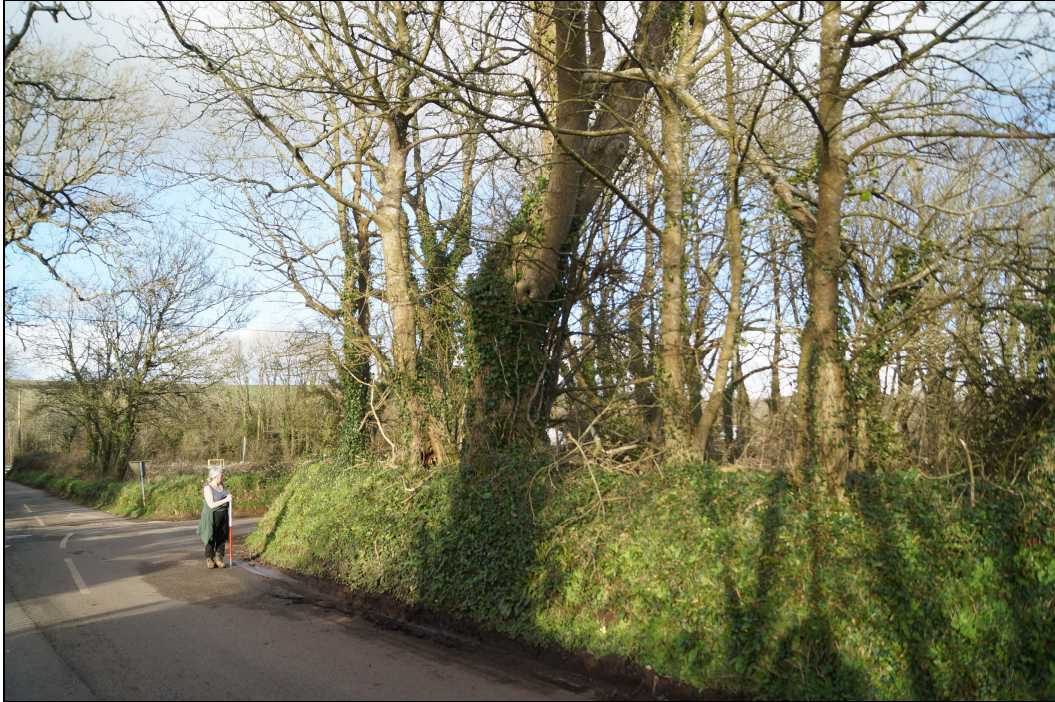
Plate 55. TBS2020_055: A substantial Hedgebank, HER PRN 114876, near Jameston which now has mature trees growing along it.

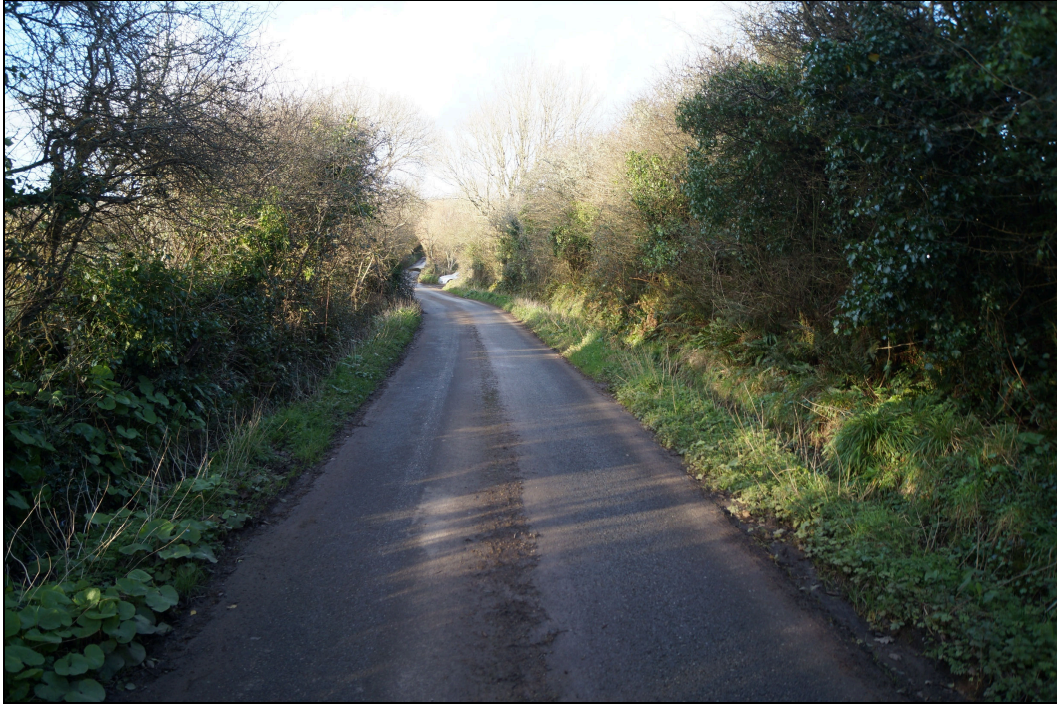
Plate 57. TBS2020_057: Ditches run parallel to the road with a Hedgebank either side, just north of Jameston at SS0561299261. The ditches are probably secondary additions to manage water run-off from the road. These boundaries not recorded.

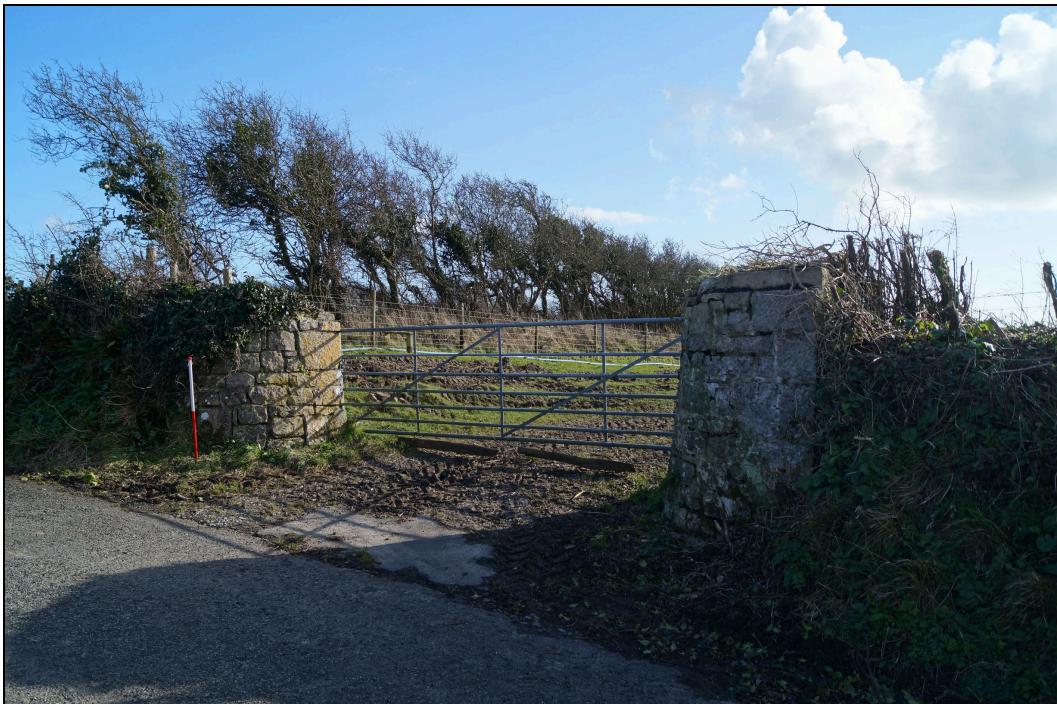
Plate 58. TBS2020_058: Mortared stone pillars at field gates such as these at SS0684398577, are not an uncommon sight in the Manorbier area. Local limestone has been used and presumably locally produced lime mortar.

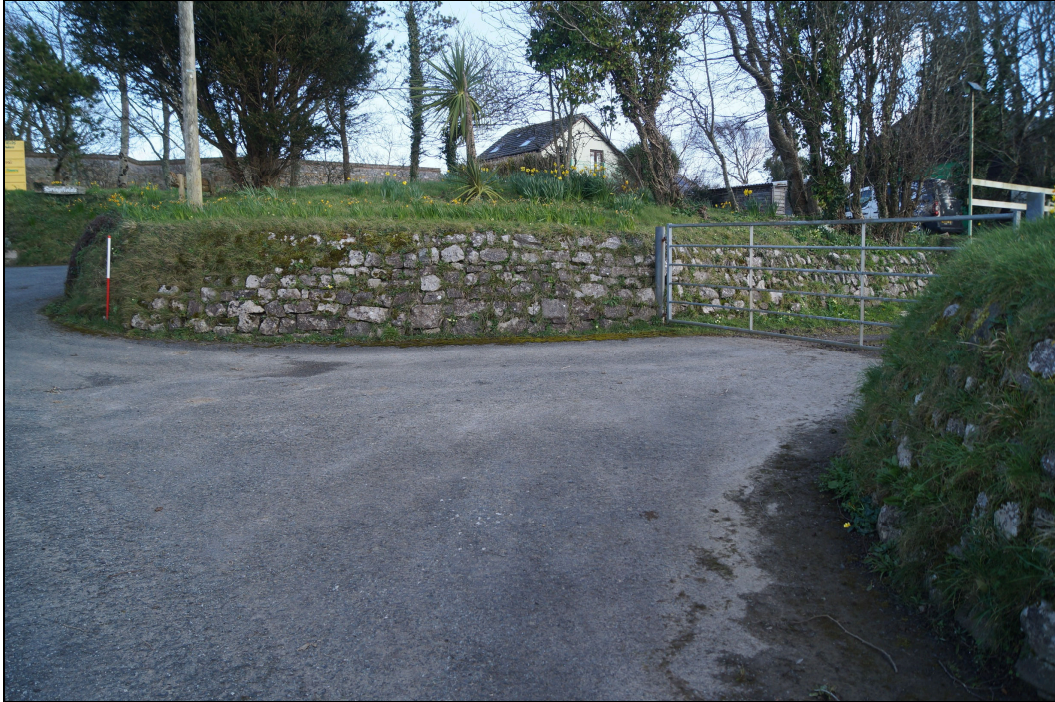
2.6.6 The boundaries close to farms and houses often become neater and are often built of stone or partially of stone. Those around dwellings around Manorbier Newton have mortared stone boundary walls alongside the road as well as round the property (see Plates 59 & 60). Near dwellings on St Ann's Head, the earthwork banks are replaced by Cloddiau and Dry Stone Walls (see Plate 41).

Plate 59. TBS2020_059: A Revetted Boundary close to a farm at SS0675098600. Stone is most commonly used in boundaries in close proximity to houses and gardens. Not recorded.

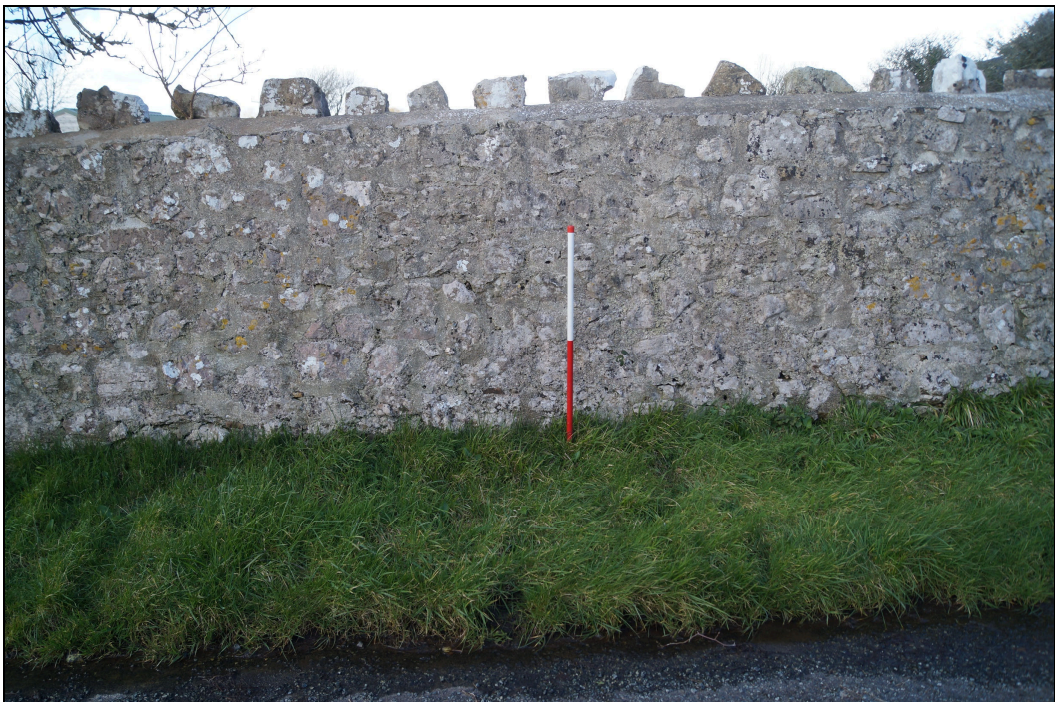
4.12 **Mortared Walls** are also almost entirely built of stone, but lime mortar is used to bond the stones. The mortar increases their stability and they can therefore sometimes be quite thin, single-skinned walls (see Plates 60, 61 & 62).

Plate 60. TBS2020_060: A mortared stone wall, HER PRN 114877, again forming the boundary of a garden

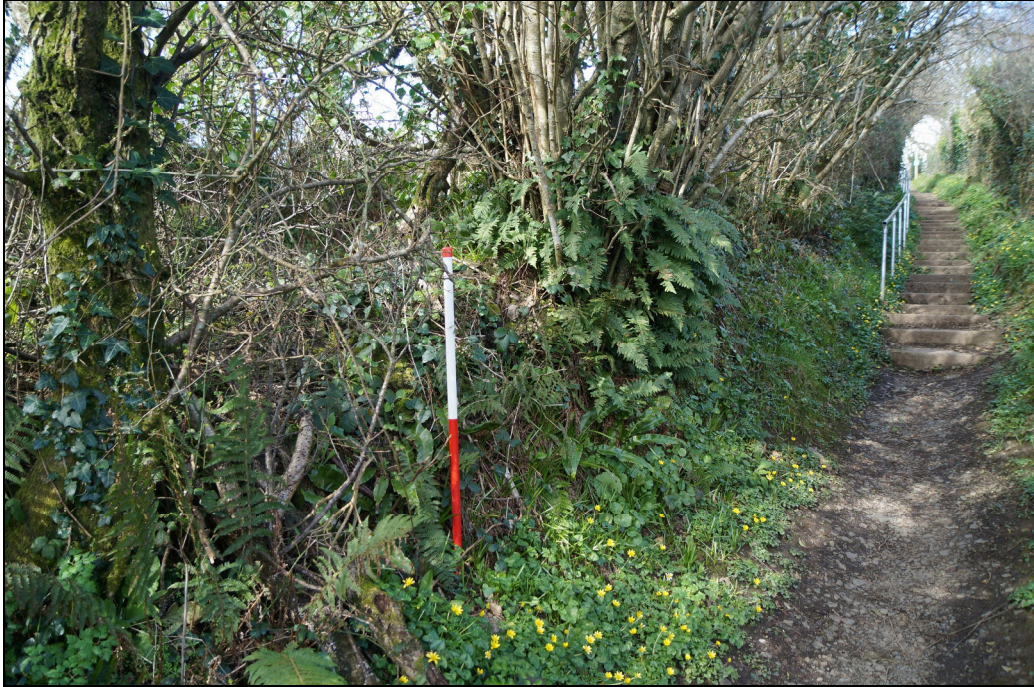
Plate 63. TBS2020_063: A typical Hedgebank, HER PRN 114880, in the Greenways aspect area. The bank is clothed in varied vegetation, even in early March, and the hedge is mature and unmanaged, with some relatively mature trees. The footpath here is part of the Pembrokeshire Coast Path. On the opposite side of the bank is a rock-cut lane.

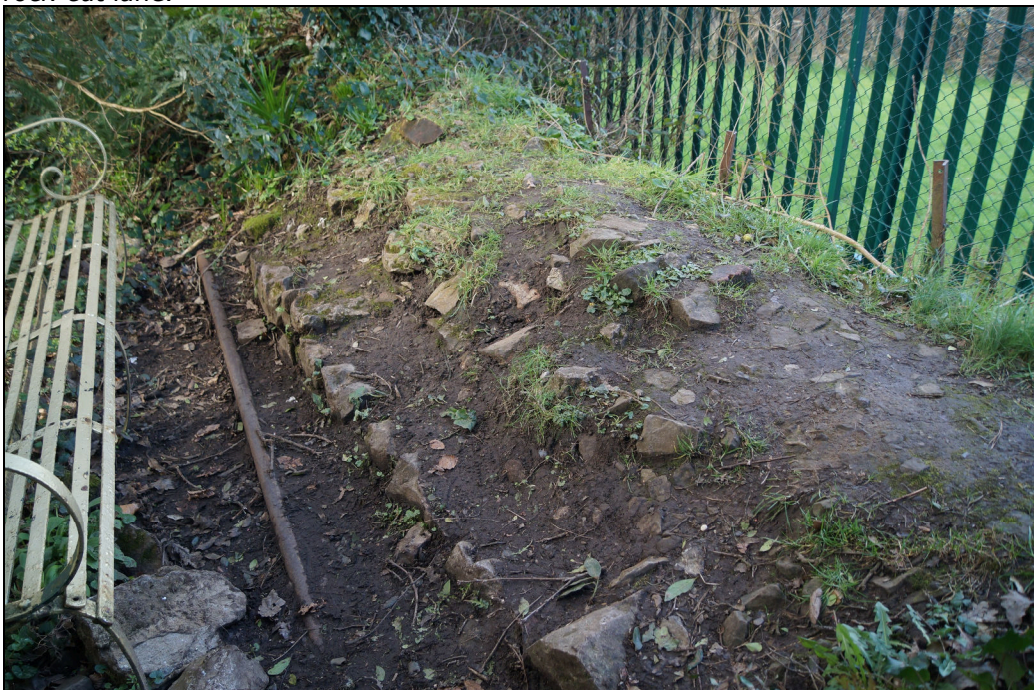
Plate 64. TBS2020_064: An eroded boundary bank, HER PRN 114881, at Allen's View garden. It appears that this hedgebank has a stone component and may fit into the category described by Walter Davies in 1815 as a "naked sod bank" i.e. with alternate layers of stone and earth.

Survival Condition: Damaged
Description: Main boundary: Hedgebank, eroded in central section to reveal stone and earth core
Secondary boundary: Metal fencing
Length Node to Node: 47 metres
Side to Side: Pasture field to the northeast, Allen's View garden to the southwest.
Nodes: At western end, boundaries at right angles, at the eastern end, boundary joins at right angles
Historic Mapping: Boundary line is shown on the 1841 parish tithe map and maybe shown on the 1809 OSD Tenby sheet.
Vegetation: Surveyed March 2020: Mature Trees, ivy, other plants, a little grass, bare central section

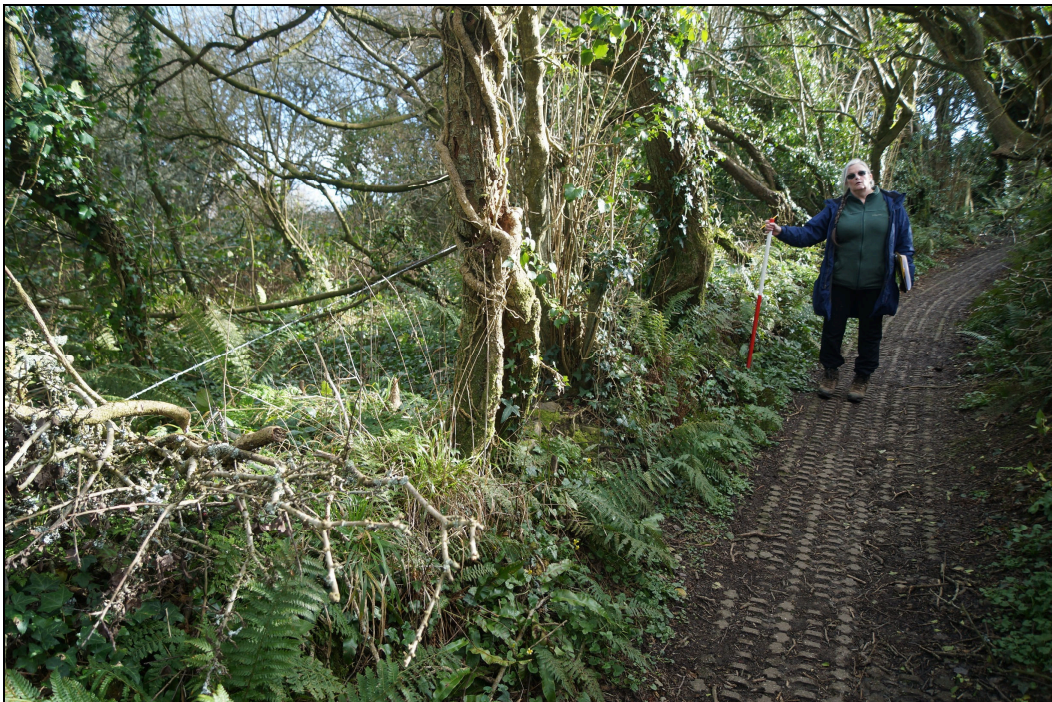
4.7 **Lynchets** are another type of Earthwork Boundary but they should be considered as relict features (see Plates 26, 27 & 68). Where they still act as field boundaries they must be accompanied by hedgebanks, walls or fencing to make them stock proof. Their preservation as historic landscape features is important as some may be of medieval or even prehistoric origin. Any fencing or hedging undertaken along a lynchet should avoid damaging the original earthwork. They should be managed as archaeological features, recorded and potentially investigated archaeologically in future. Lynchet is not a LANDMAP term and not a dominant traditional boundary.

Plate 68. TBS2020_068: Some Hedgebanks are quite low features and relatively mature trees have been allowed to grow along their course. This one, HER PRN 114883, is probably mid 19th century in date as this section of Waterwynch Lane was reconfigured in the mid 19th century between the time of the tithe survey and the 1st edition Ordnance Survey map.

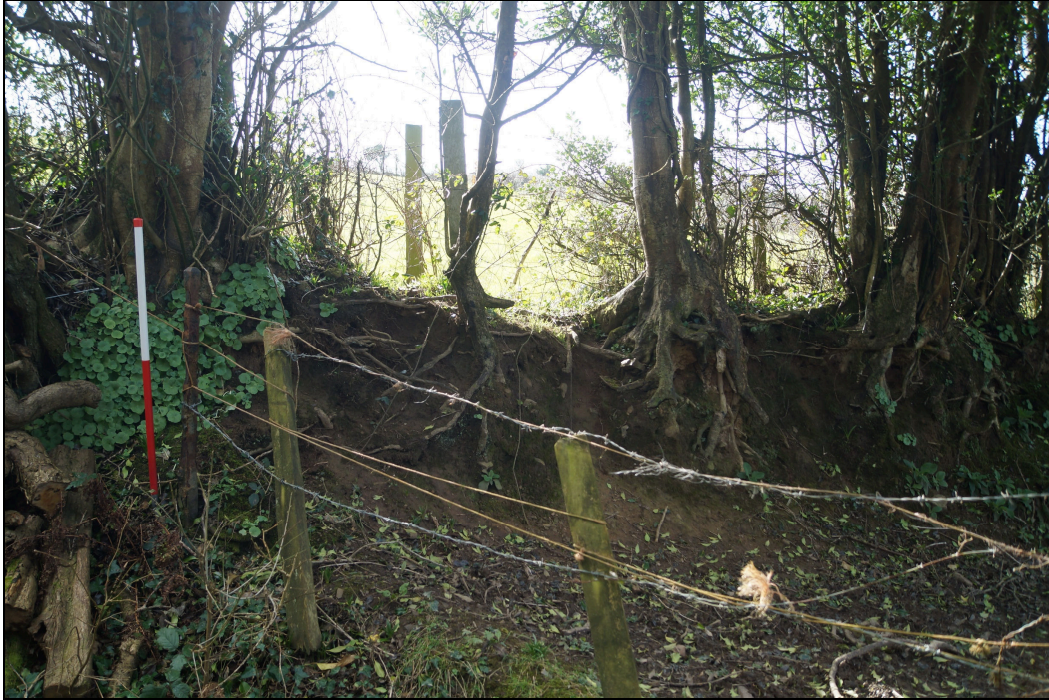
Plate 69. TBS2020:069: An example of a lynchet, HER PRN 114884, marking a step down from one field to the next. A post and wire fence in the upper field act as a barrier as the hedge has long fallen out of use.

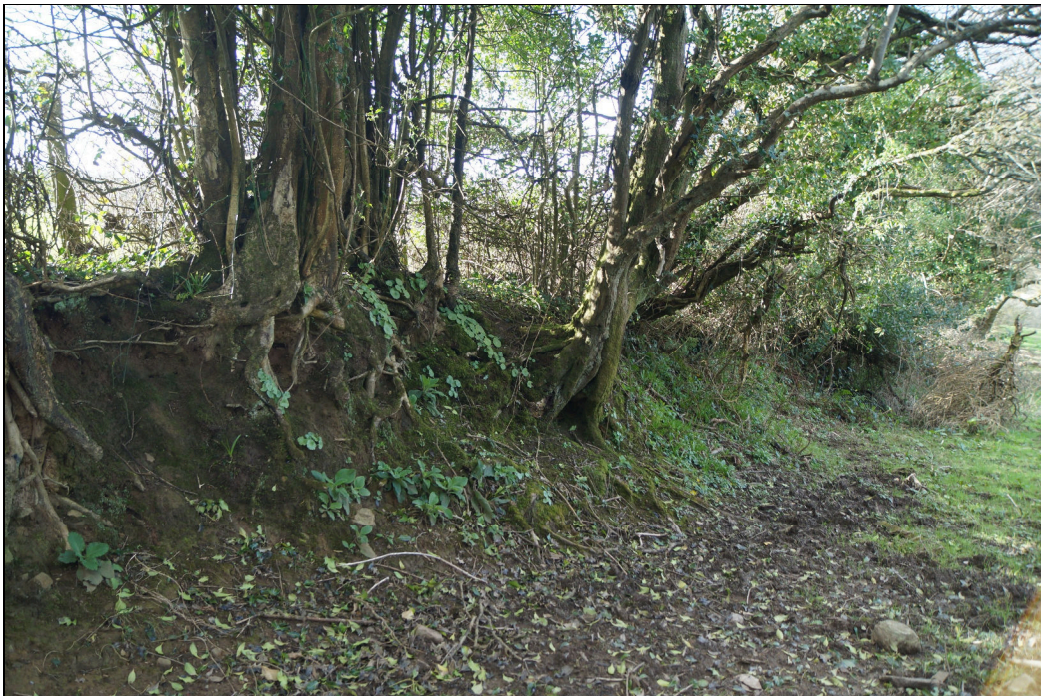
Plate 70. TBS2020_ 070: The same lynchet, HER PRN 114884, showing how a hedge must originally have been planted along its upper edge, which has been allowed to grow unimpeded.

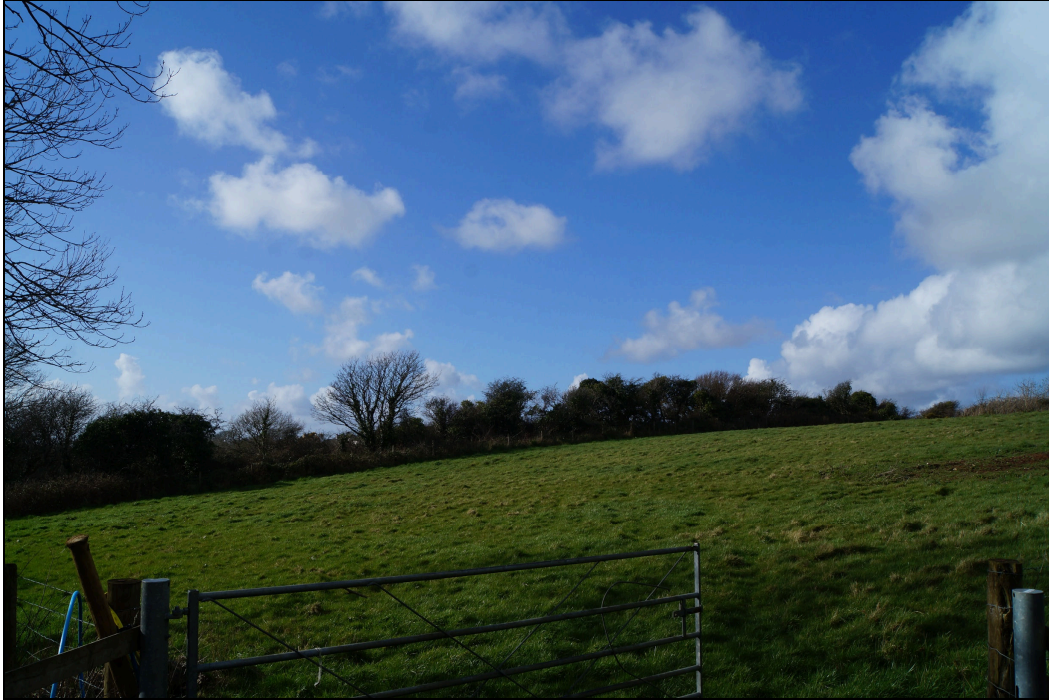
Plate 71. TBS2020_071: A view into Meadow Park, which is defined by Hedgebanks, consisting of mature hedgerows and some trees along relatively low earth banks. This is the common type of boundary bank in the area.
