PEMBROKESHIRE COAST NATIONAL PARK TRADITIONAL BOUNDARIES SURVEY

For: Pembrokeshire Coast National Park

March 2020

Trysor Project No. 2020/709
DAT HER Event Record PRN 114831

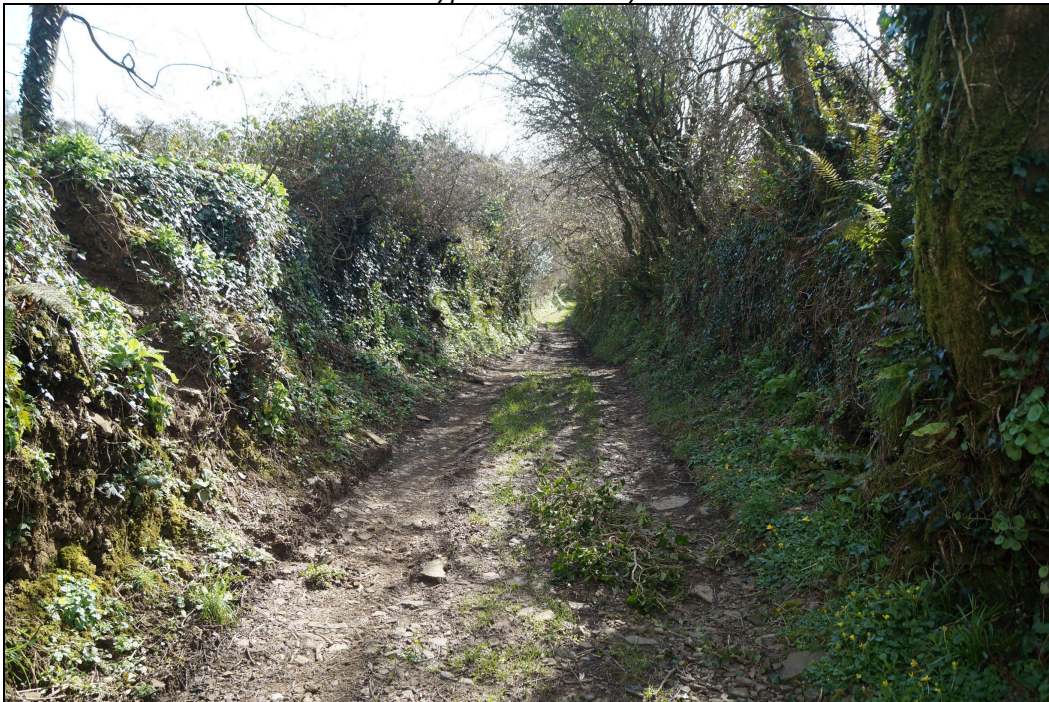
Plate 72. TBS2020_072: A view along a trackway which appears to be defined by high stony banks. Closer inspection shows that it is a hollow way, probably deliberately cut to some degree and the fields either side are at a level close to the top of the "banks" either side. The hedgebank to the left is HER PRN 114880, see also TBS2020_063.

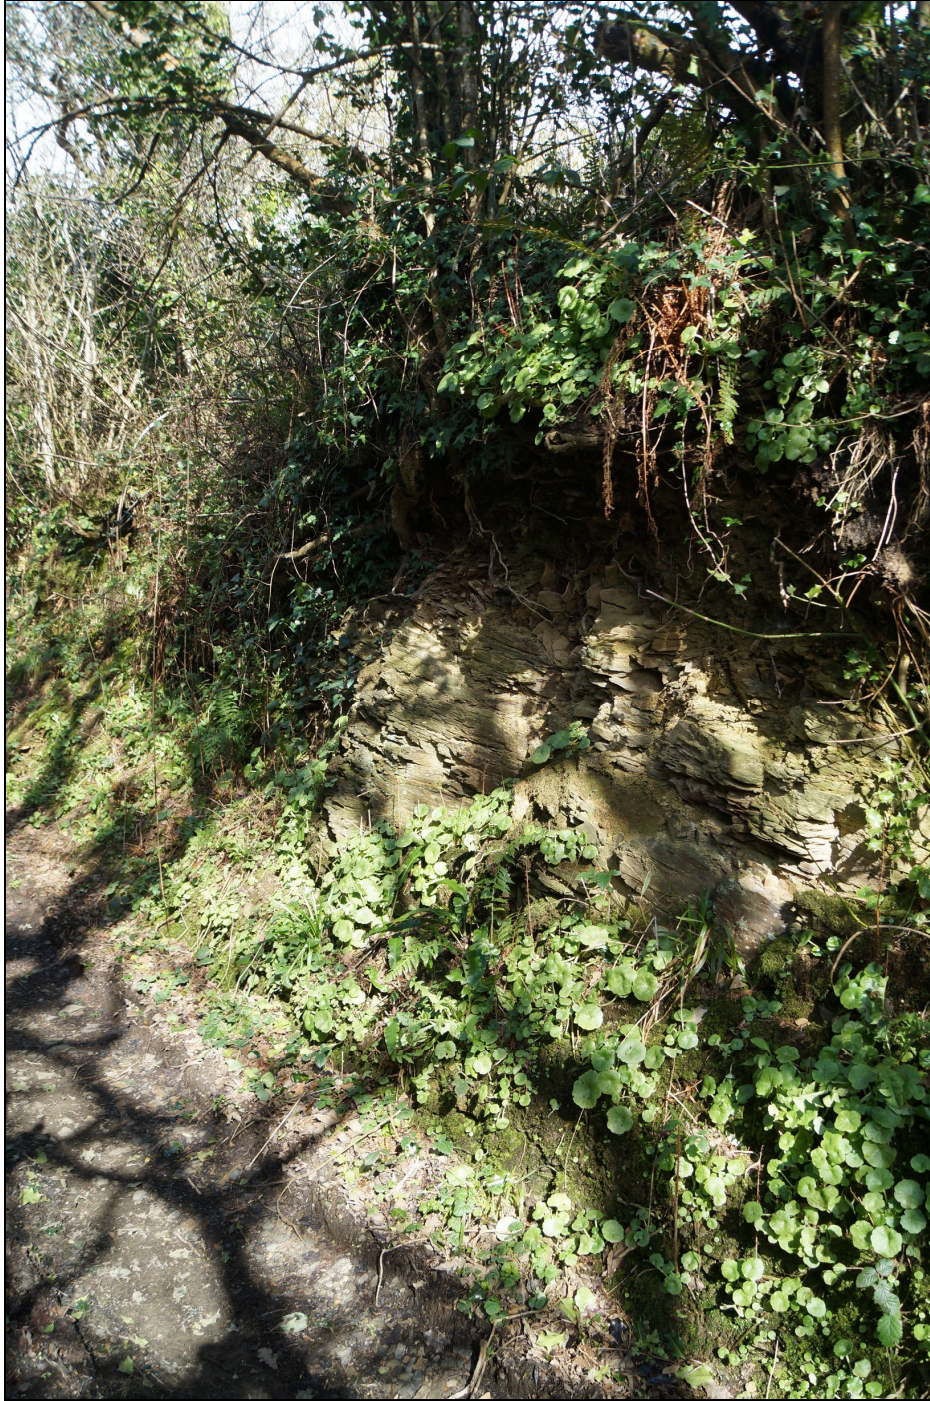
Plate 73. TBS2020_073: A view of the soft mudstone bedrock exposed at the side of the trackway shown in the previous photograph, giving an indication of the depth to which the trackway has been sunk into the ground surface. Hedgebank HER PRN 114880 is on top of the rock-cut section.
