CPAT Report No. 1794

Esgair Feithgen, Mydffai, Carmarthenshire

Building Survey

Project Name: Esgair Feithgen, Myddfai, Carmarthenshire

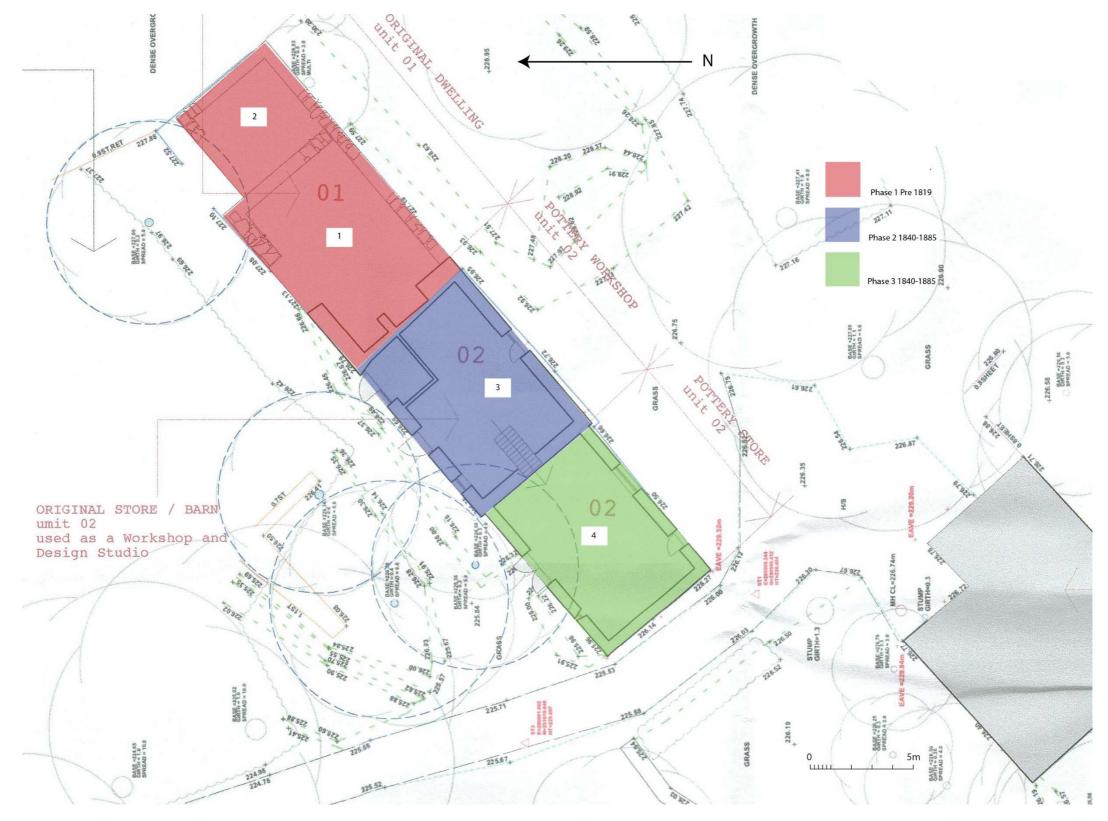
Fig. 18 Plan showing the house (1) byre (2) cowshed (3) and threshing barn with grain store overhead (4)

3.3. The house (Fig. 18, 1) measured approximately 10m by 7m and was built into the hillside on the south-east side (Figure 6). The stonework comprised random uncoursed lime mortared grey sandstone of variable size. Much of the mortar had washed out of the joints due to exposure to the elements. There were no quoins discernible on the corners of the building. A straight cut in the stonework indicated where the external doorway on the north-facing elevation was located (Figure 7). No window apertures were identified. An infilled doorway with a single stone header (Figure 11) between the house and the byre was located in the eastern gable end. No other internal details such as the flooring material or any internal subdivision were discernible at the time of the survey, and if the interior walls had been plastered or timber lined, no evidence survived. The chimney was located on the inside of the western gable end (Figure 8) and contained a large fire place measuring approximately 2m by 1m and height of 1.8m containing a bread oven on the south side (Figure 9). A chamfered oak beam formed a mantlepiece for the fireplace. There was originally a staircase to the upper floor located to the north side of the chimney stack but this had completely gone.

3.4. The house was in poor condition with none of the roof structure remaining and much of the stonework missing especially on the eastern gable end and the north-facing elevation (Figure 7). The chimney stack was still upstanding, although it had been braced with scaffolding due to a collapse of the masonry on the north-east side of the stack.

3.5. The building to the north of the house was most likely a byre (Fig. 18, 2). It was located to the east of the house. It measured approximately 6m by 5m and was built into the hillside on the south-east and north-east sides. The stonework comprised random uncoursed lime mortared grey sandstone of variable size, although the mortar was eroded and washed out. An access road recorded on early 19th century mapping was still extant as a rough farm track to the north of the byre. An external door would originally have been located on the north-facing elevation but its precise position was not discernible as the wall had collapsed. There had originally been an internal door between house and byre but this had subsequently been infilled.

3.6. It was not possible to identify any further internal or external details due to the extremely poor condition of the building. The interior of the building had become built up with soil and undergrowth so the flooring was not visible at the time of the survey. None of the roof structure had survived and the walls were in poor condition, with much of the upper structure completely missing.

3.7. The building to the west of the house was interpreted as a cowshed, mainly due to its rather low proportions and the use of limewash, although this was also used in other farm buildings such as dairies (Fig. 18 3). The stonework comprised random uncoursed lime mortared grey sandstone of variable size with stone quoins on the corners. The height of the west elevation had been raised when the adjacent threshing barn was constructed. The cowshed was constructed abutting the west elevation of the house and measured 8.5m by 7m. There were two doorways on the north-facing elevation, a larger one at the east end and a smaller probably later door in the centre. An unglazed wooden framed window was located at the west end of the north-facing elevation. The south-facing elevation contained a single doorway with a glazed light to the side of it, probably a later addition to the fabric. This doorway may have originally been rather wider as the stonework to the west of it had been remortared. The roof truss design was a simple A-frame retained with a collar. The purlins and ridge beam had been replaced with crude timber rounds. A modern electricity generator was mounted on the collar. The western gable contained a high level entrance into the upper level of the adjacent threshing barn with the door still intact (Figure 12). The lower section of the wooden access steps had gone however. The flooring within the cowshed had been removed leaving an earthen floor. There was no evidence of internal subdivision within the cowshed. The interior of the shed was limewashed, a common treatment in animal barns to aid cleaning and reduce the risk of microbial infection amongst the stock.

3.8. The building was in reasonable condition, but much of the floor and most of the internal fixings had been removed (Figures 12 and 13).

3.9. The threshing barn (Fig. 18 4) was built to the west of the cowshed abutting it, and measured 8m by 6.5m. The stonework comprised random uncoursed grey sandstone of variable size, with quoins on the corners and flush exterior bonding. It was marginally taller than the adjacent cowshed in order to allow for the height of the large doorway for grain wagons located in the north-facing elevation (Figures 13 - 15). At a later date this doorway had been made narrower with brick infill along its eastern side, and the upper section had been fitted with a large window. To the west of the doorway was a slit window. On the south elevation there was a smaller winnowing doorway, which had subsequently been partially infilled with stone in its lower section to form a window above, located opposite to the large cart doorway on the north side. A second small doorway, which a remnant lime mortar trace indicated originally had a porch, was located on the west end of the south elevation (Figure 14). The interior of the barn had subsequently been converted into a pottery workshop and the original floor had been replaced with concrete.
