Llanwenog Church - Llanwenog, Cerdigion.

Watching Brief

Trench for insertion of electric cable

26/07/04

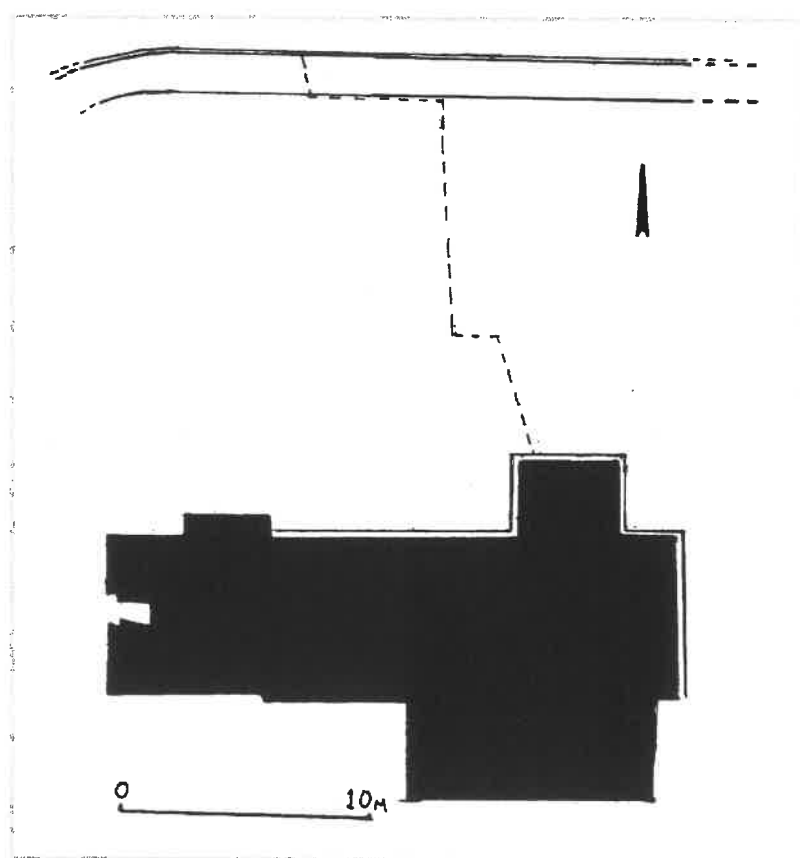
Fig.1. Plan of church (black) and the trench path (dotted line). The pathway and the churchyard wall are the features furthest north.

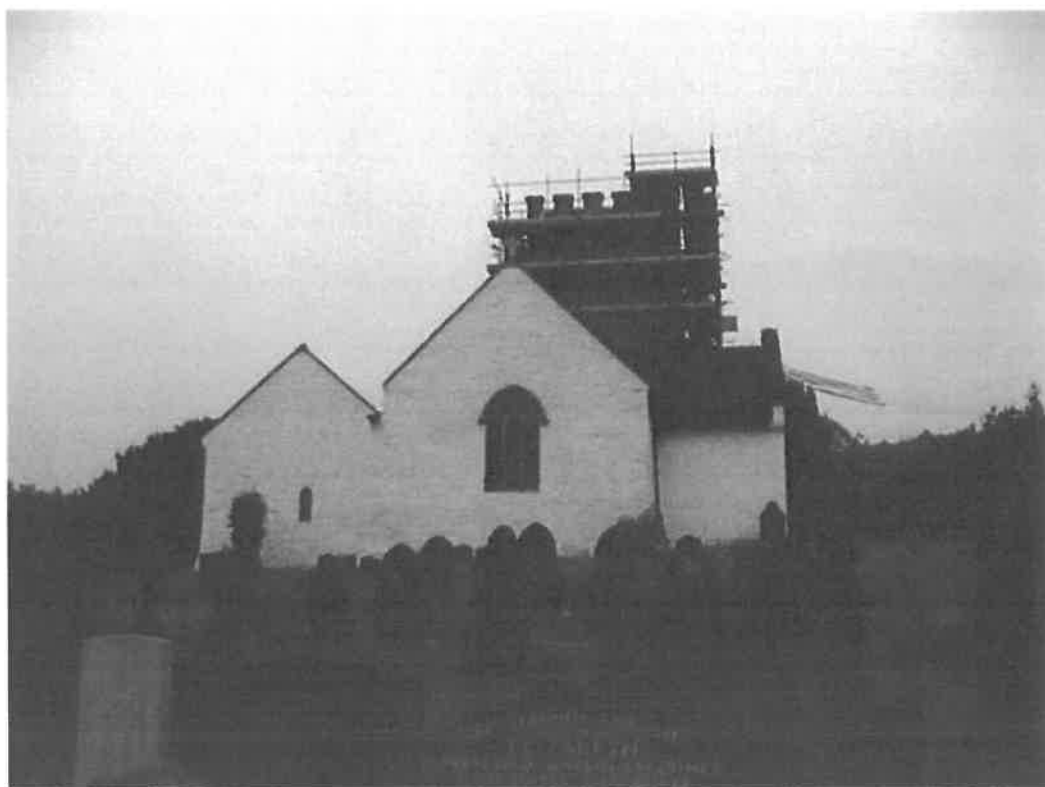
Photograph 1. View of church – looking west.
