HAROLDSTON HOUSE HAVERFORDWEST

A MANAGEMENT PLAN FOR THE CONSERVATION OF THE REMAINS FOR THE GILD OF FREEMEN OF HAVERFORDWEST

**MANAGEMENT PLAN FOR THE CONSERVATION OF THE MASONRY REMAINS OF
HAROLDSTONE HOUSE. HAVERFORDWEST, PEMBROKESHIRE.**

PART 1 – SURVEY WORK AND DRAFT CONSERVATION STRATEGY

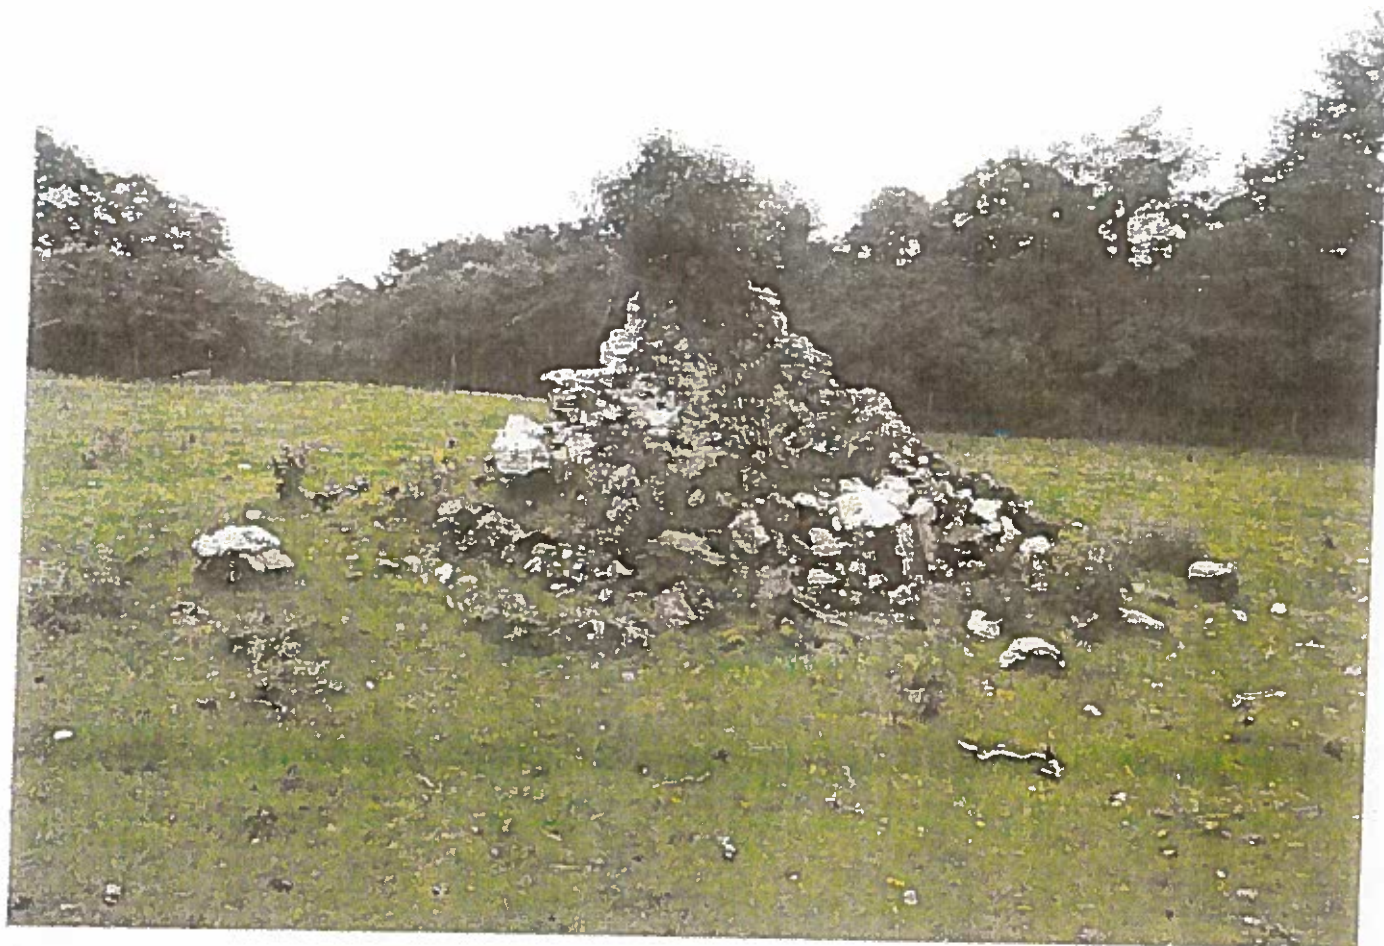
1

This is the only standing masonry of the south wall. The south face (photo 2) has good facework laid as random rubble in good quality lime mortar in the centre is stands about 2.4 metres high, 5.5 metres long and steps down to the east and west. The north side (photo 1) has lost most of its face except at the base and is exposed corework bedded in lime mortar. Ivy has rooted in the ground on both faces and grown up to the top on the centre. The roots are binding the north corework together.

The vegetation on the top should be killed to discourage sheep from grazing. The ivy roots should be left in situ. Both north and south faces need pointing and the east and west edges should be rebbed and protected with shelter mortar.

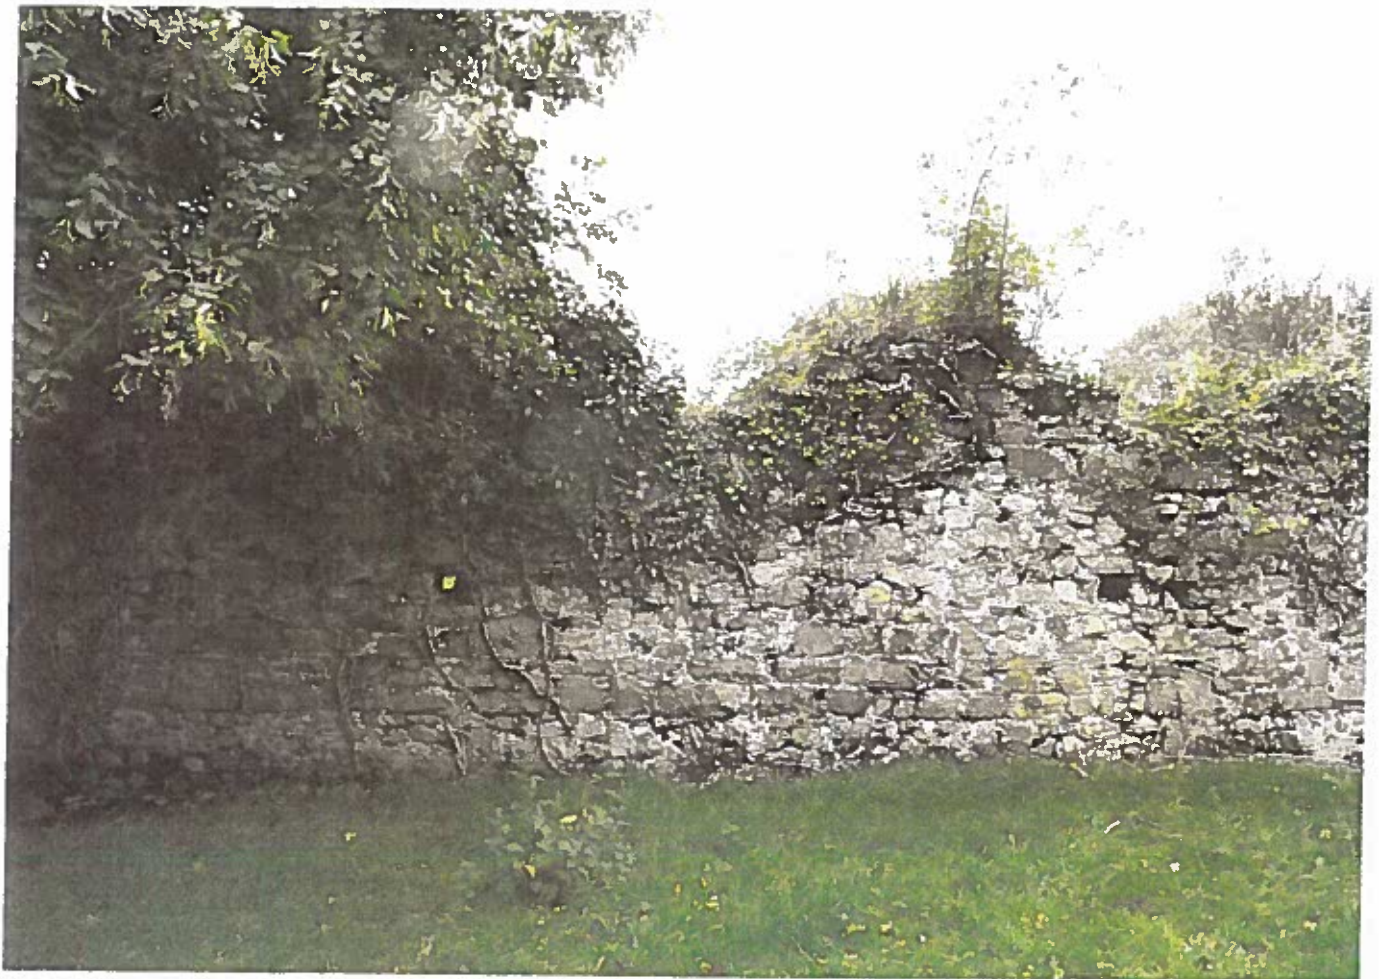
11

- 4.3.2 The west face (photos 3,4,5 & 6) has numerous open joints and some loss of face in isolated locations. Stone is loose around the blocked doorway where ivy is rooted in the wall. The alignment of the wall is good. The walltop is obscured by ivy.
- 4.3.3 The east face (photos 10,11, & 12) has been disrupted by the tree at the south end. There are open joints and holes at low level but the alignment of this is not as good due to ivy roots opening up the joints of the upper masonry and disrupting the wall top.

Ivy and saplings in the wall should be killed. Along the top of the east face masonry should be recorded numbered and dismantled to remove large roots. Open joints should be pointed, loose masonry rebbed and wallcap rebuilt to its original profile following removal of dead vegetation.

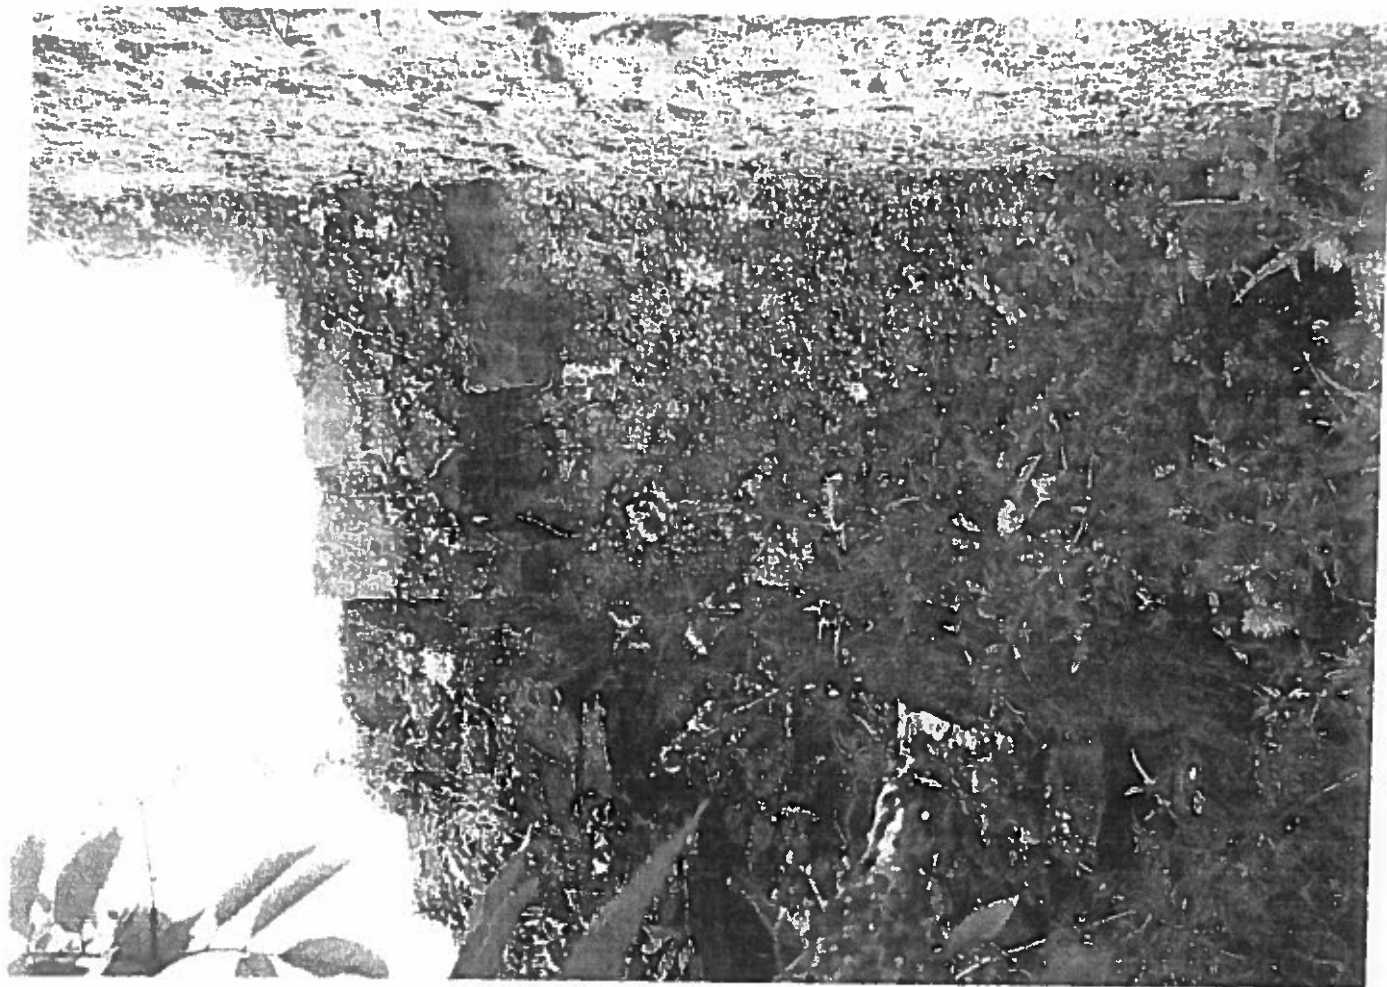
8

The alignment of the south west corner is good but there are open joints and ivy growing up at ground floor level. The rendered area at first floor level is in good condition, however, the masonry above is open jointed and the north west corner has loose and unsupported stones. Ivy conceals the upper masonry.

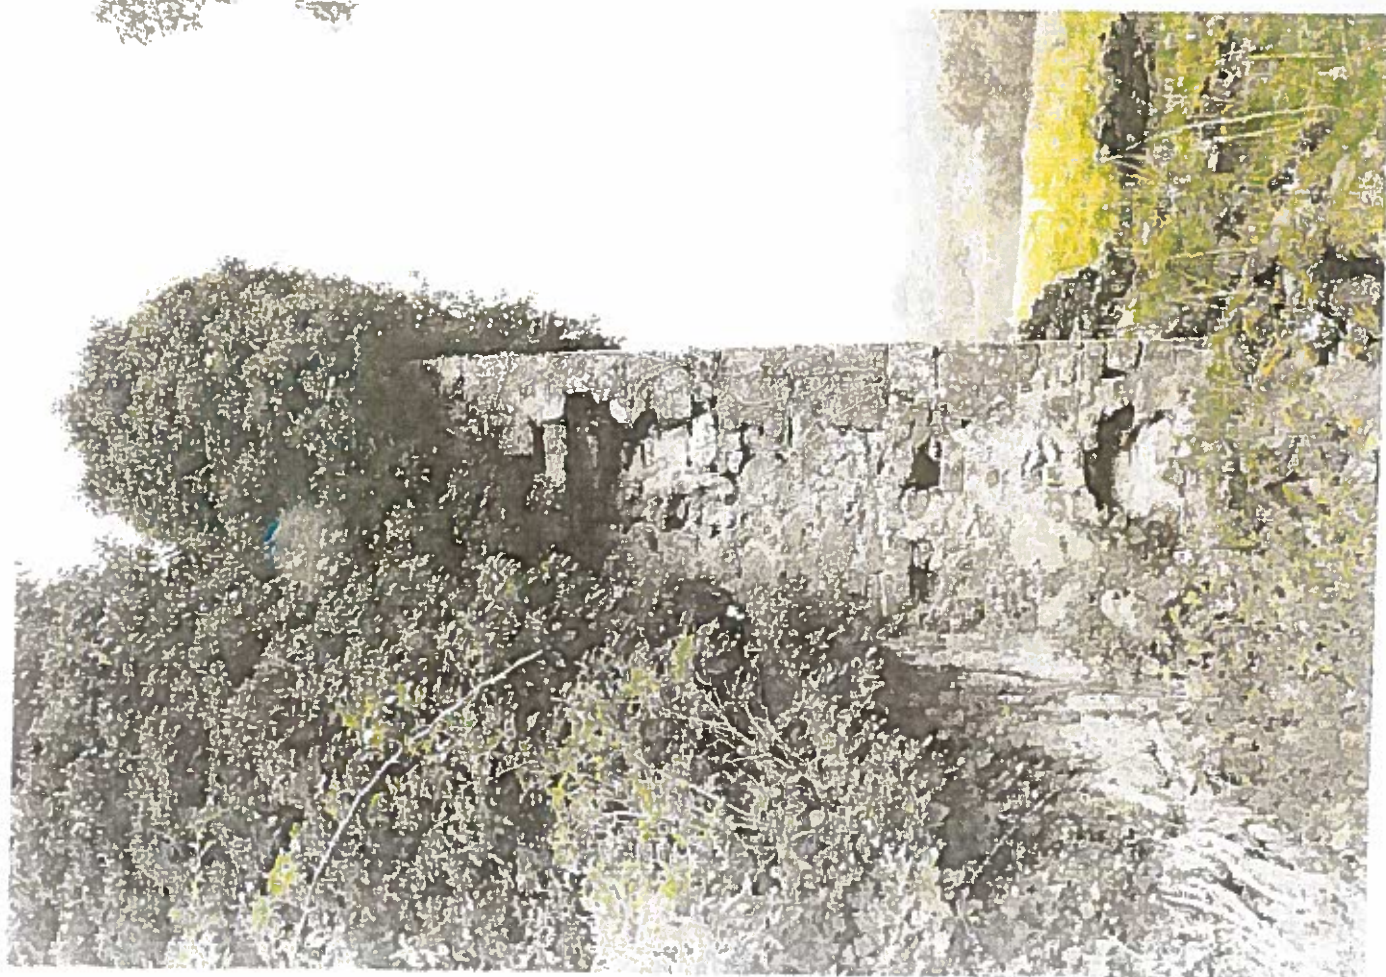
13

The ground floor masonry that can be seen is in relatively good condition with a small number of open joints. Above first floor level there has been a collapse of masonry leaving a gap at the junction of the stair tower and garderobe tower. Above this ivy obscures the rest of the wall with its windows and corbelling.

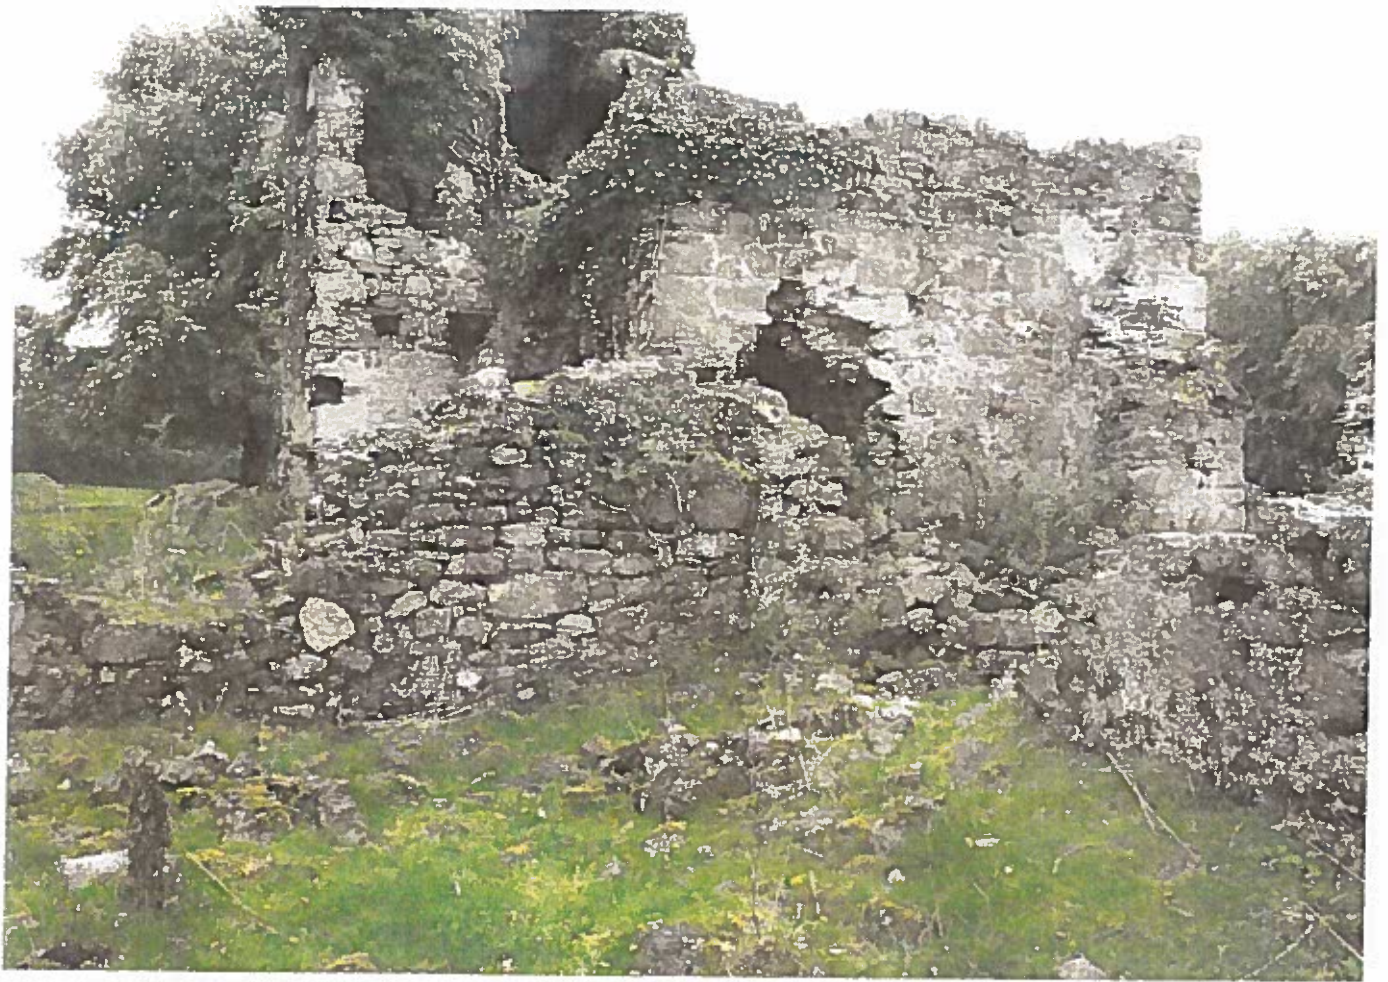
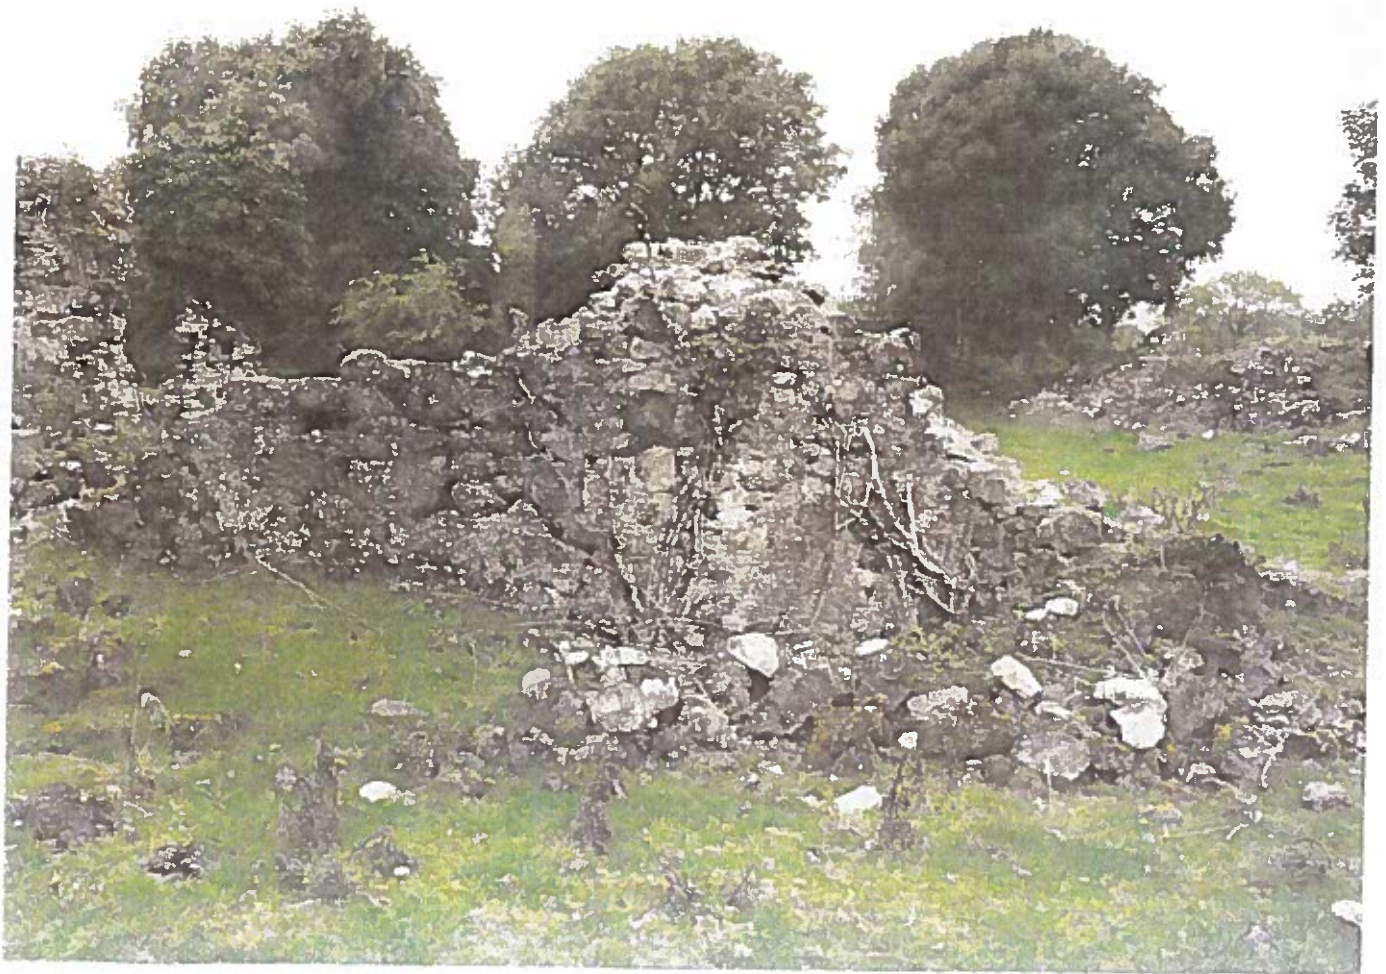
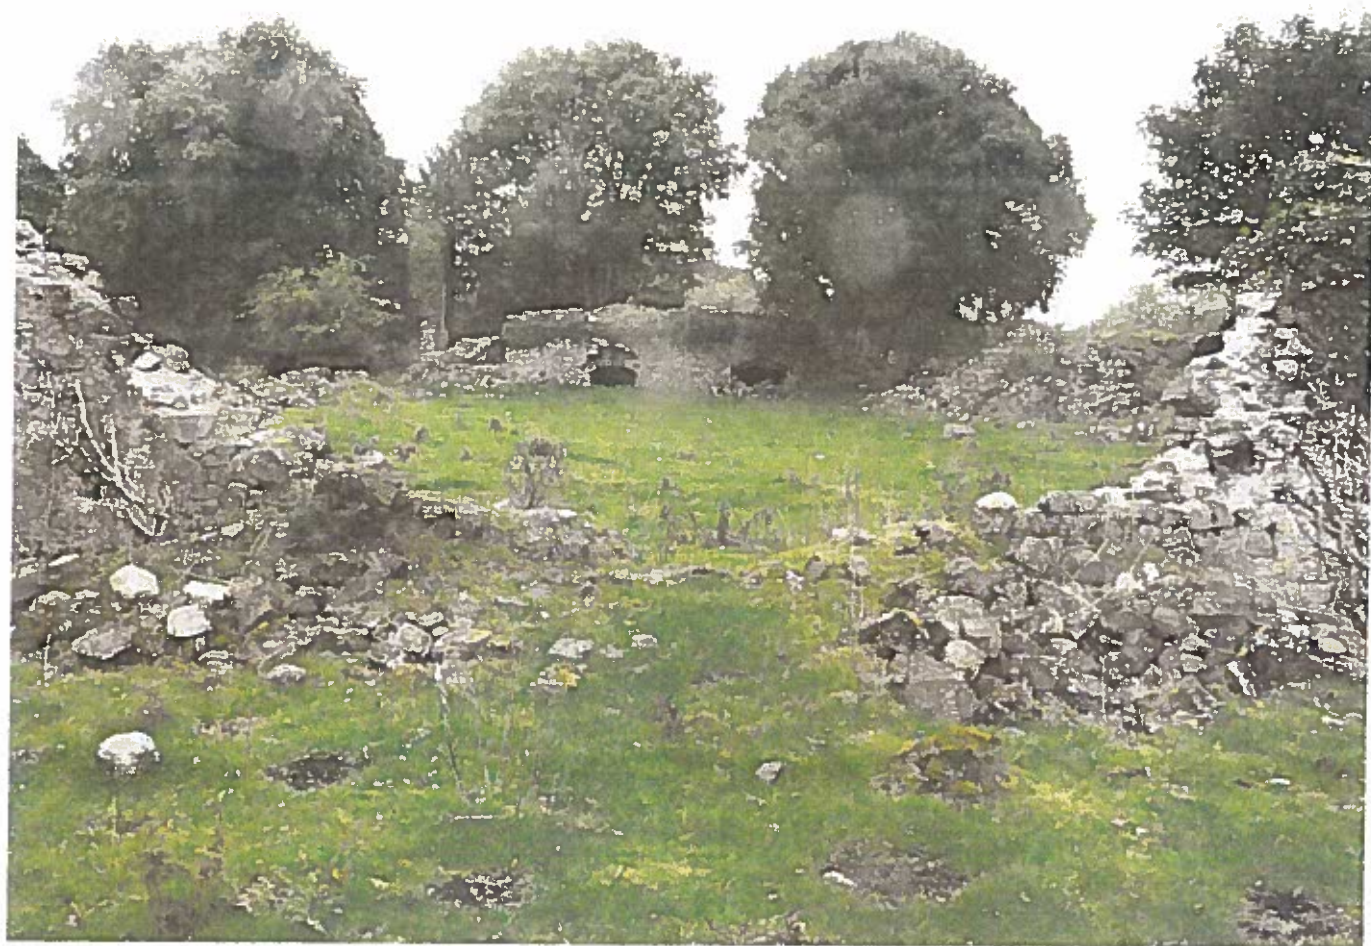
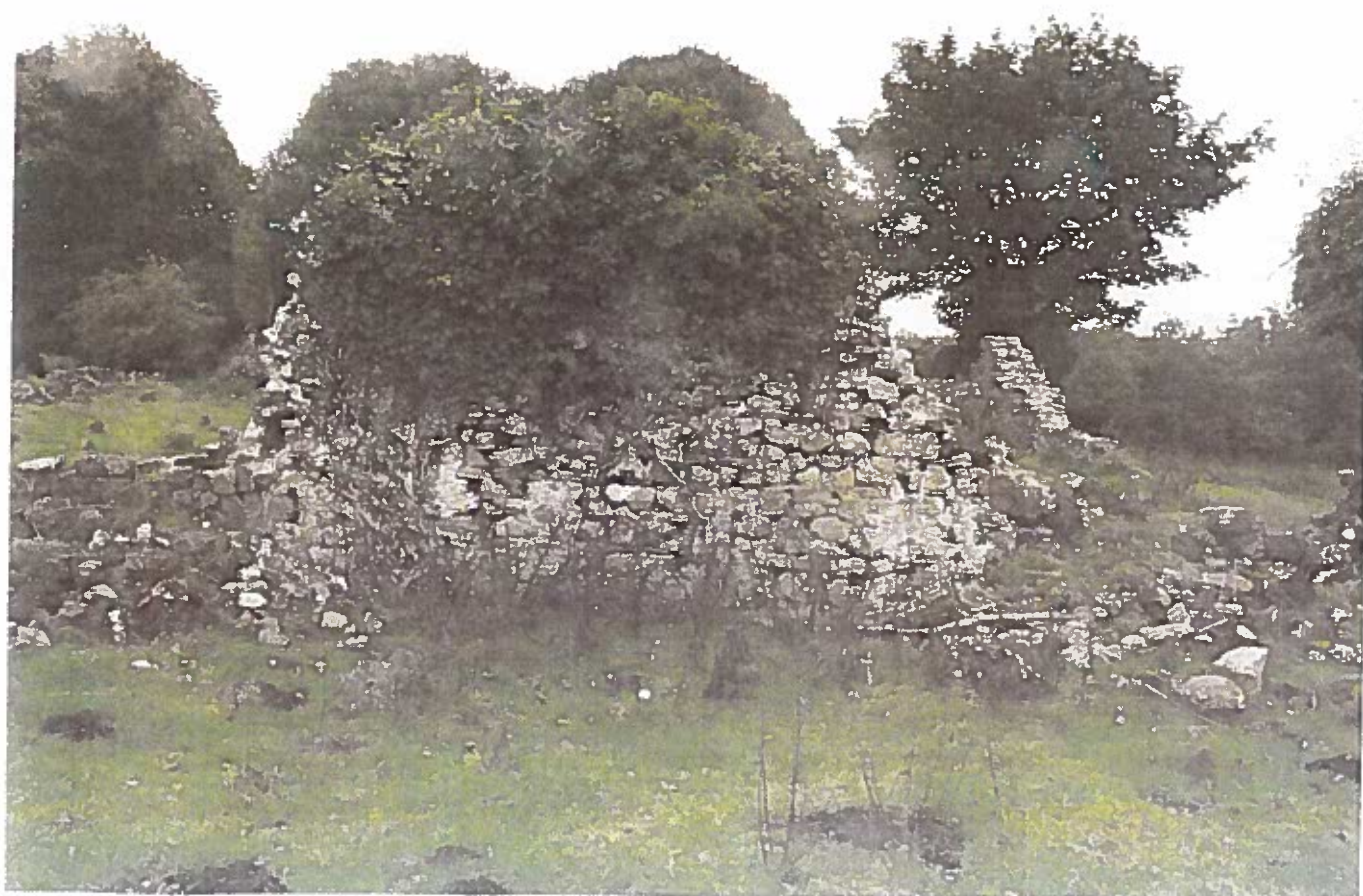
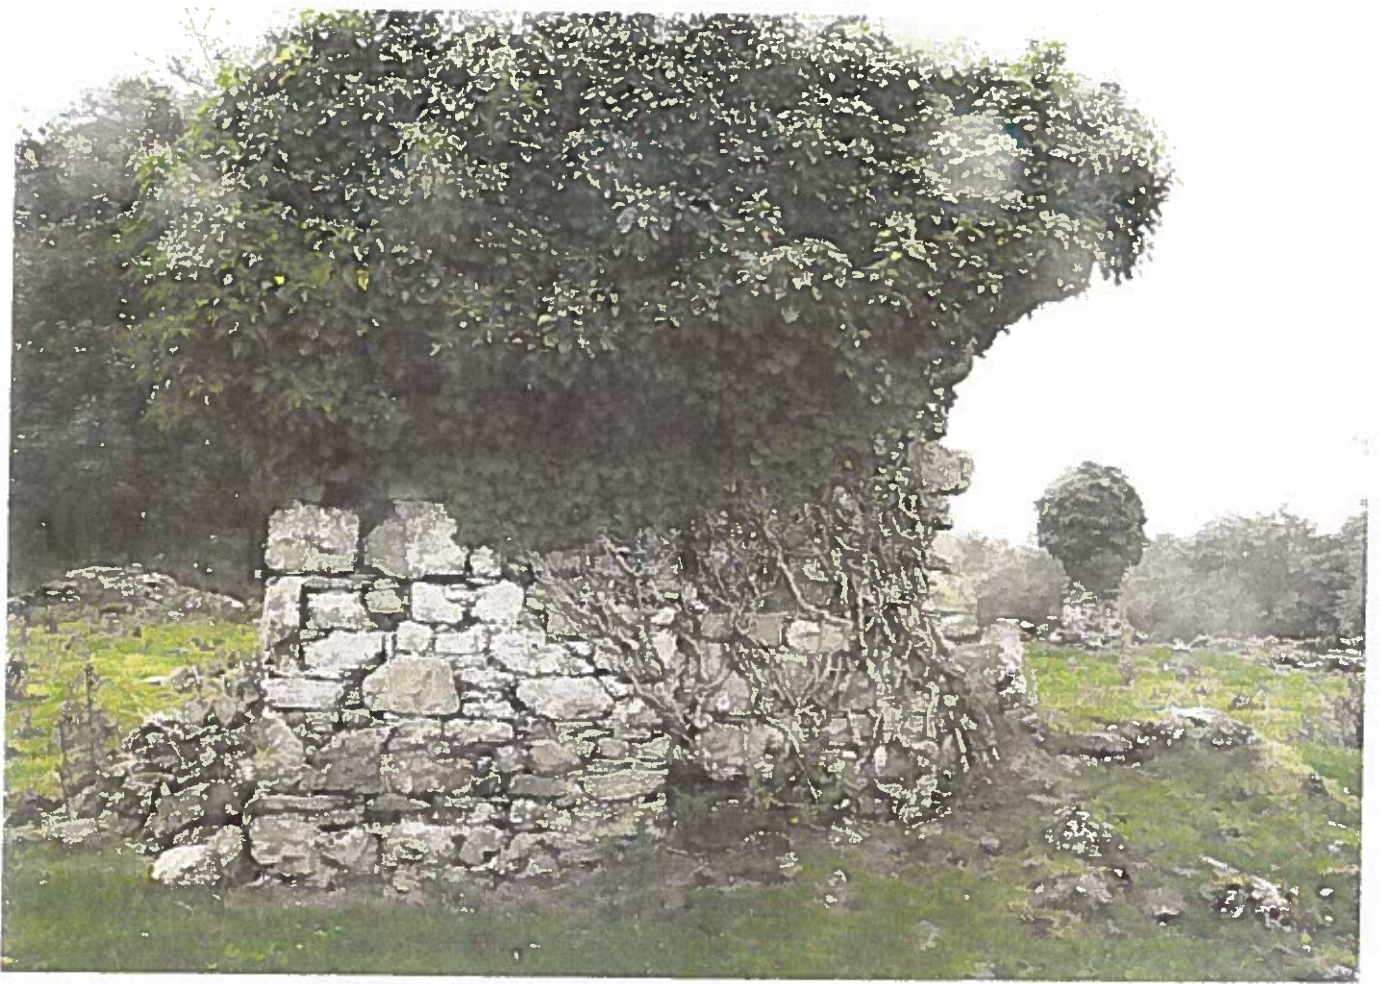
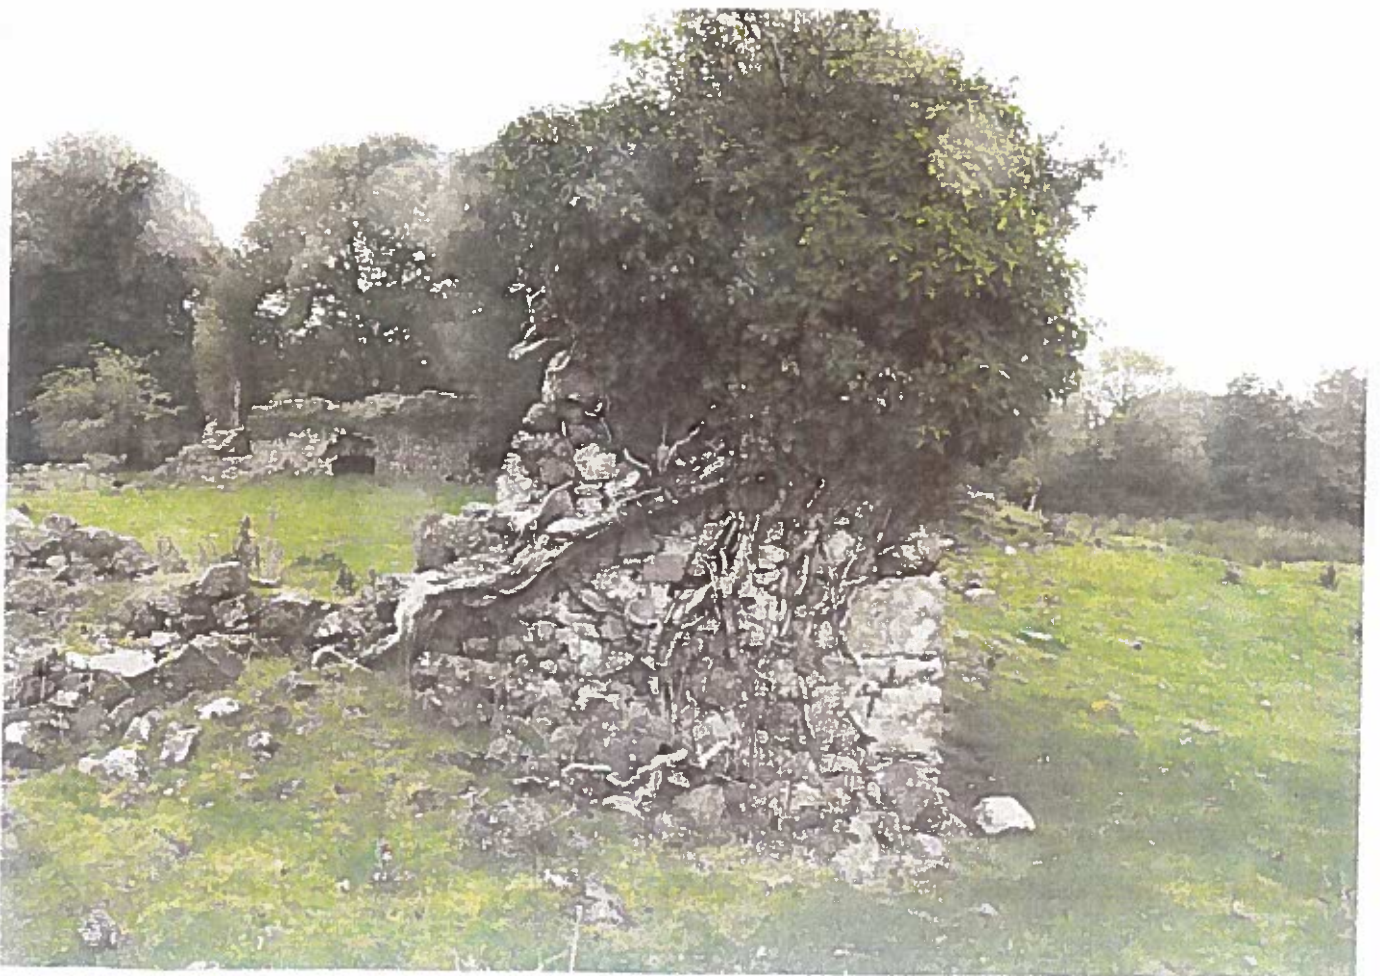
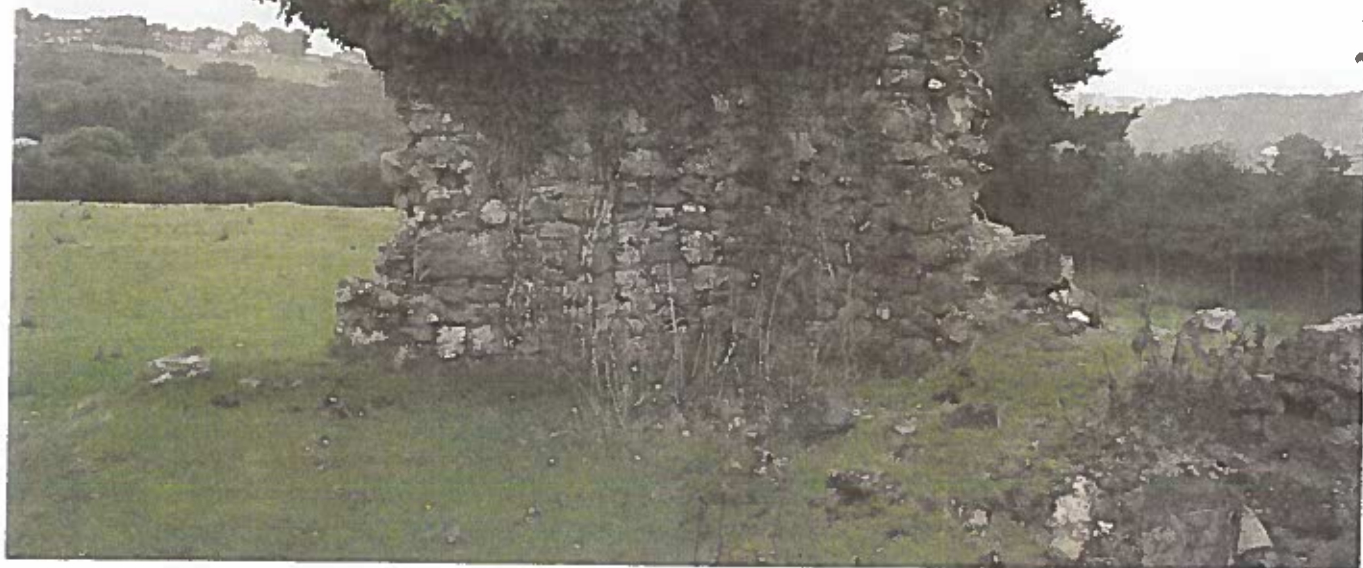
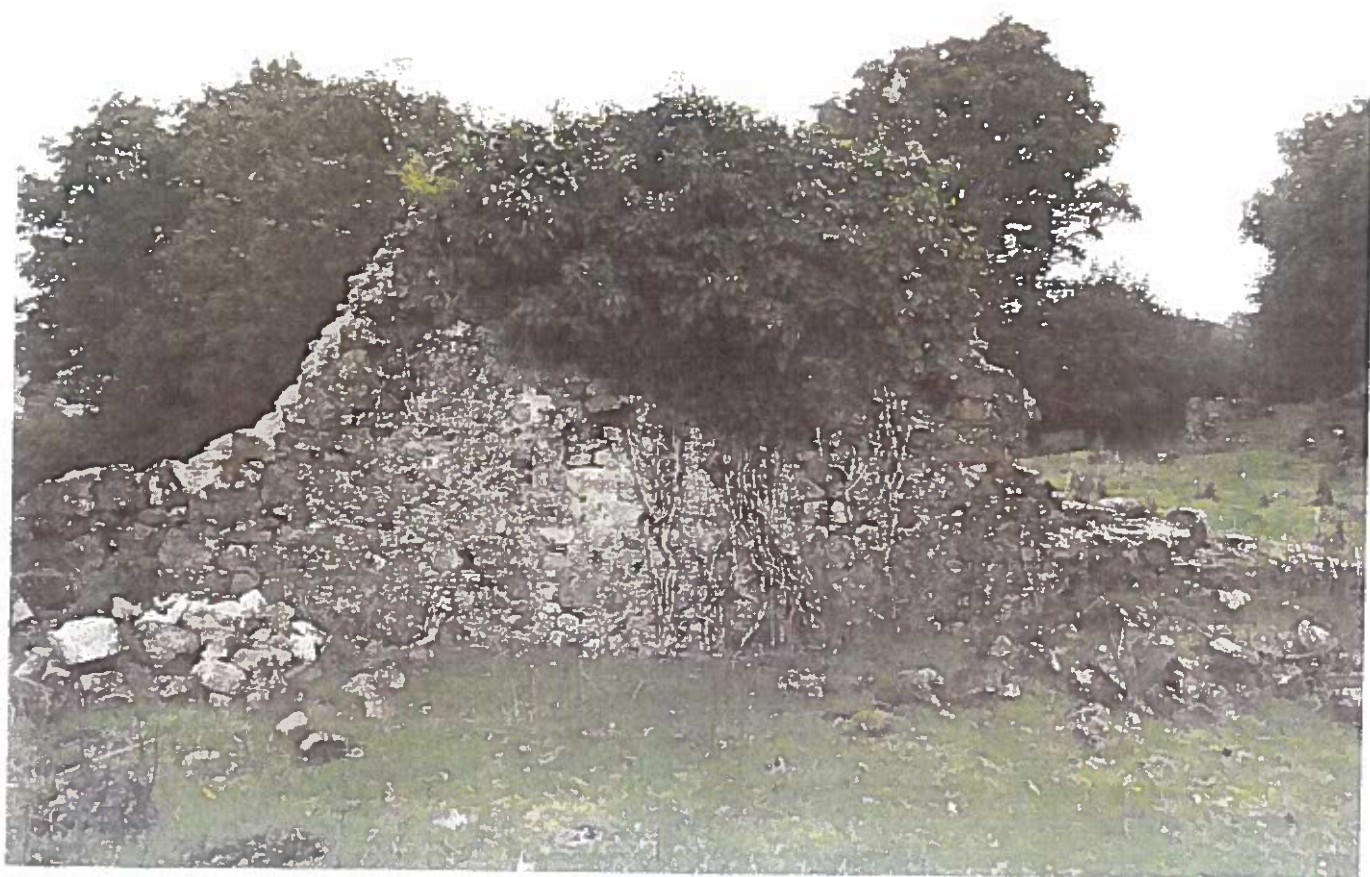
The south end has collapsed adjacent to its junction with the north room of the Steward Tower but immediately to the north of this there is a good section of masonry with lime render and putlog holes. The east face has ivy growth and a number of open joints. The west face is in better condition. The top and edges have numerous loose stones and evidence of recent losses. After a short gap there is a central section of standing masonry (photos 25,26 & 30). This has ivy growth up both sides. But a substantial are of rubble masonry with lime render and putlog holes remains. There is a recent collapse at the north end of the east face and numerous open joints and losses of facework. The west side is in better condition but edges are loose and show signs of recent damage. There is a further gap before the north eat corner (photos 27,28 & 29). This has a large ivy root growing up its east face and small roots on the north face where there is a blocked opening. The alignment of the wall is good but the ivy growth is heavy and at the top supplemented by brambles. All faces have open joints and some loss of facework. Edge stones are loose and there is high level overhanging masonry on the west edge of the north return.

Kill and remove vegetation on top of walls to discourage sheep grazing. Point open joints and holes. Support masonry above facework collapses with corework. Rebed loose edges and build up corework to support overhanging stones in shelter mortar. Rebed top stones in shelter mortar to shed water. Following consolidation provisionally allow for cintec anchor to cantilevered masonry on west edge of the north return.

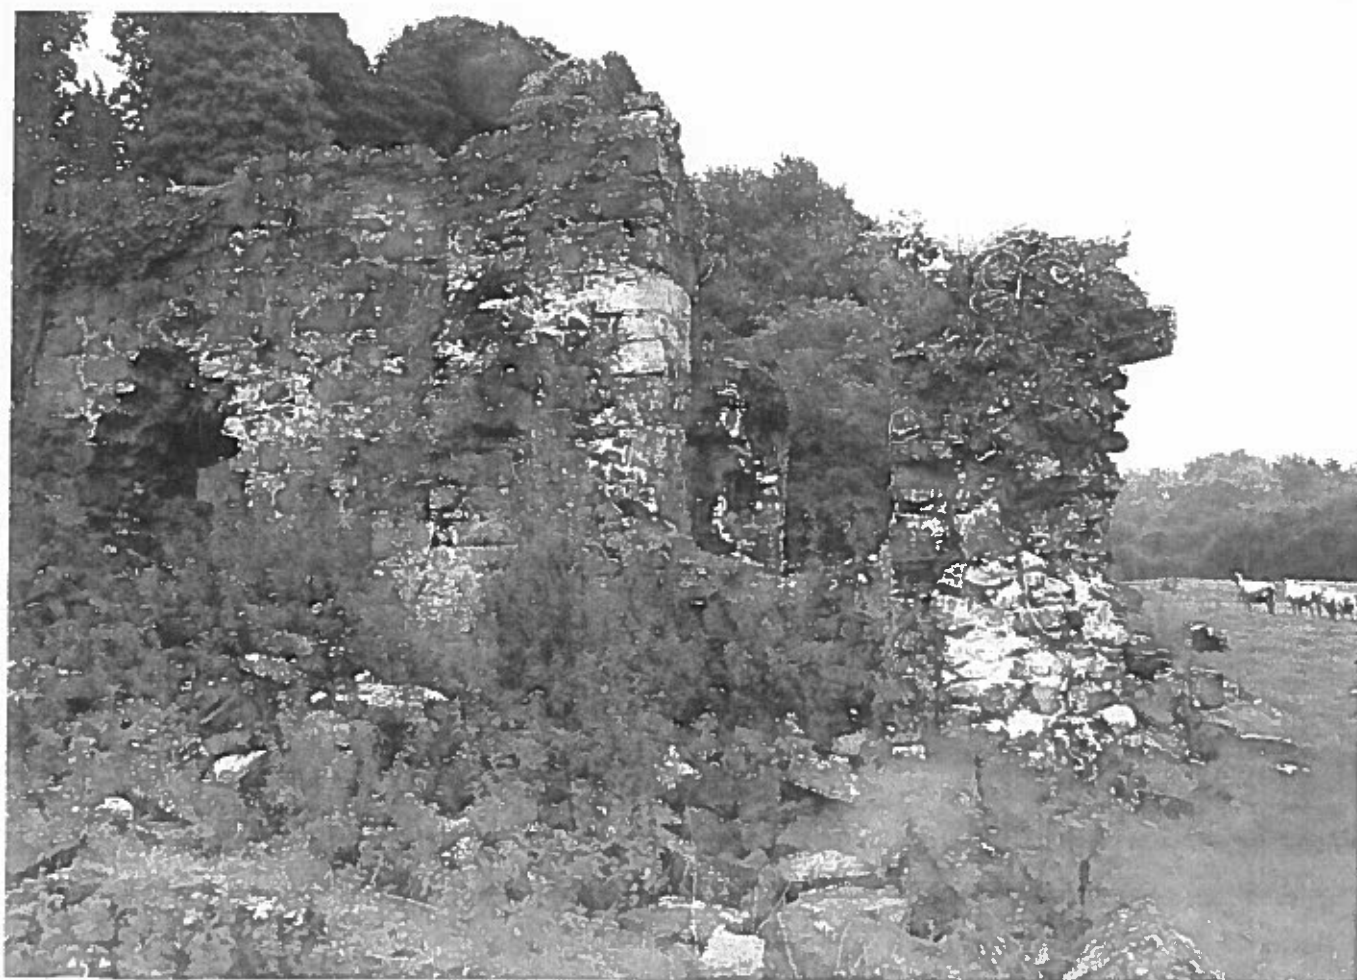
32

At the east end the east gate pier (photos 32,33 & 34) has a slight lean to the north. The east face is largely held together by ivy. The south face retains its lime render but the north face is corework with cantilevered masonry at high level on the west edge. The bottom south west corner is in need of rebedding. The west gatepost (photos 51 & 52) is, again, held together with ivy. Facework survives on the south side but the north face is corework. The drawbar slot survives in this pier. There are high level corbelled stones on both east and west edges. These masonry piers are worth saving as evidence of an original door to this courtyard. The remainder of the wall is narrower than the piers and survives as a line of tumbled masonry with the base still standing.

Kill the ivy on the piers but don't remove stems. Point open joints and holes in both piers. Remove rubble against south side of east pier and rebuild south west corner masonry. Introduce corework to support cantilevered stones on edges of both piers and point edges in shelter mortar. Rebed top stones in capping mortar on completion of consolidation. Insert stitching anchors to support cantilevered stones. Consolidate top of standing masonry of remainder of the wall in capping mortar.

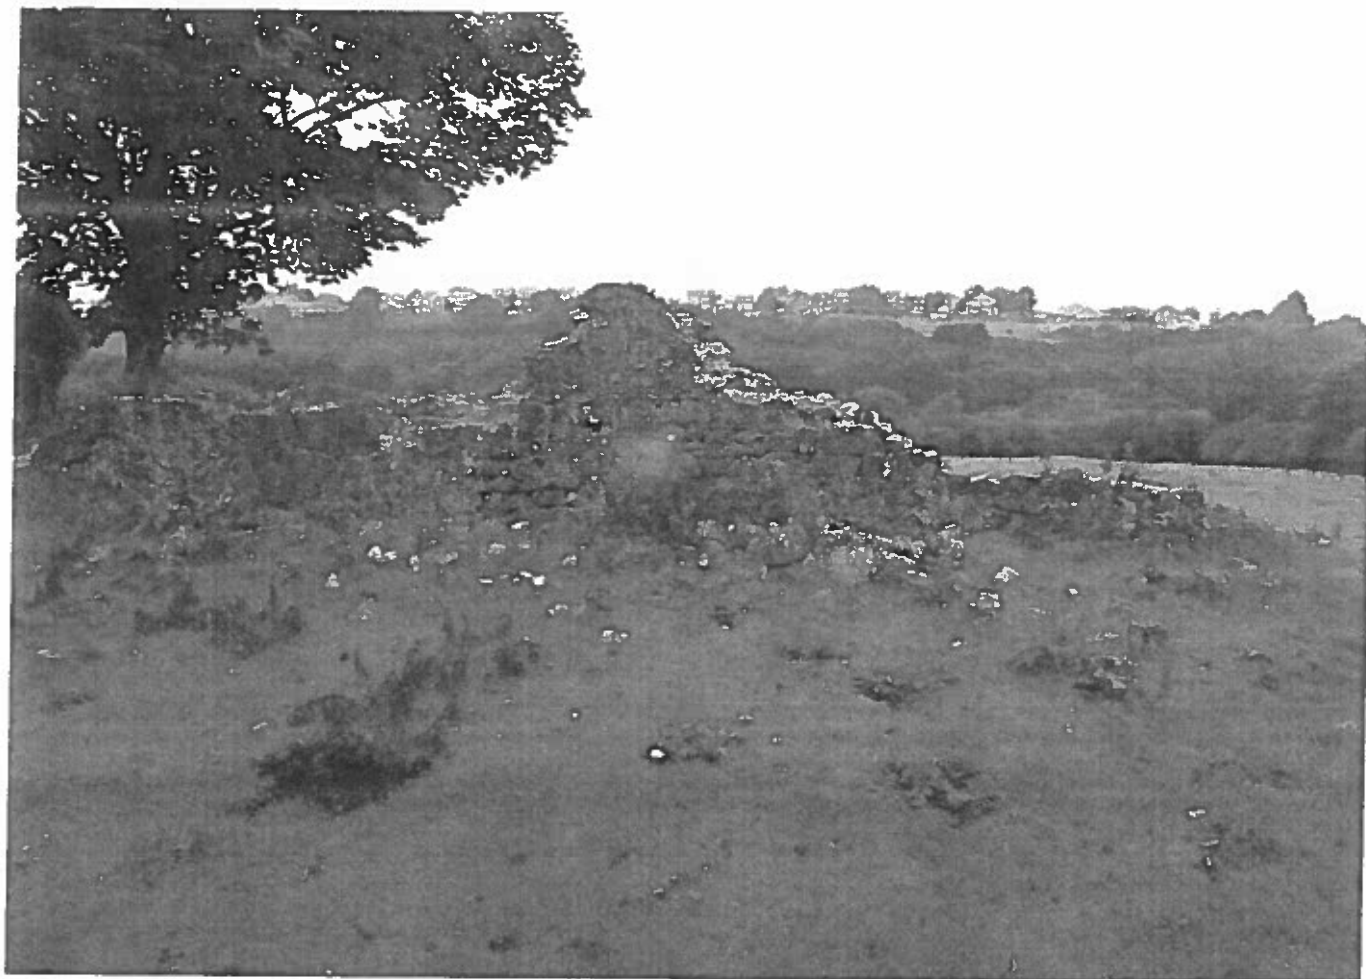
53

The north face is in good condition except for a hole at low level open joints and ivy growth on the south face and ivy on the top. There is recent dislodging of stones on the top of the wall.
