HAROLDSTON HOUSE HAVERFORDWEST

A MANAGEMENT PLAN FOR THE CONSERVATION OF THE REMAINS FOR THE GILD OF FREEMEN OF HAVERFORDWEST

**MANAGEMENT PLAN FOR THE CONSERVATION OF THE MASONRY REMAINS OF
HAROLDSTONE HOUSE. HAVERFORDWEST, PEMBROKESHIRE.**

PART 1 – SURVEY WORK AND DRAFT CONSERVATION STRATEGY

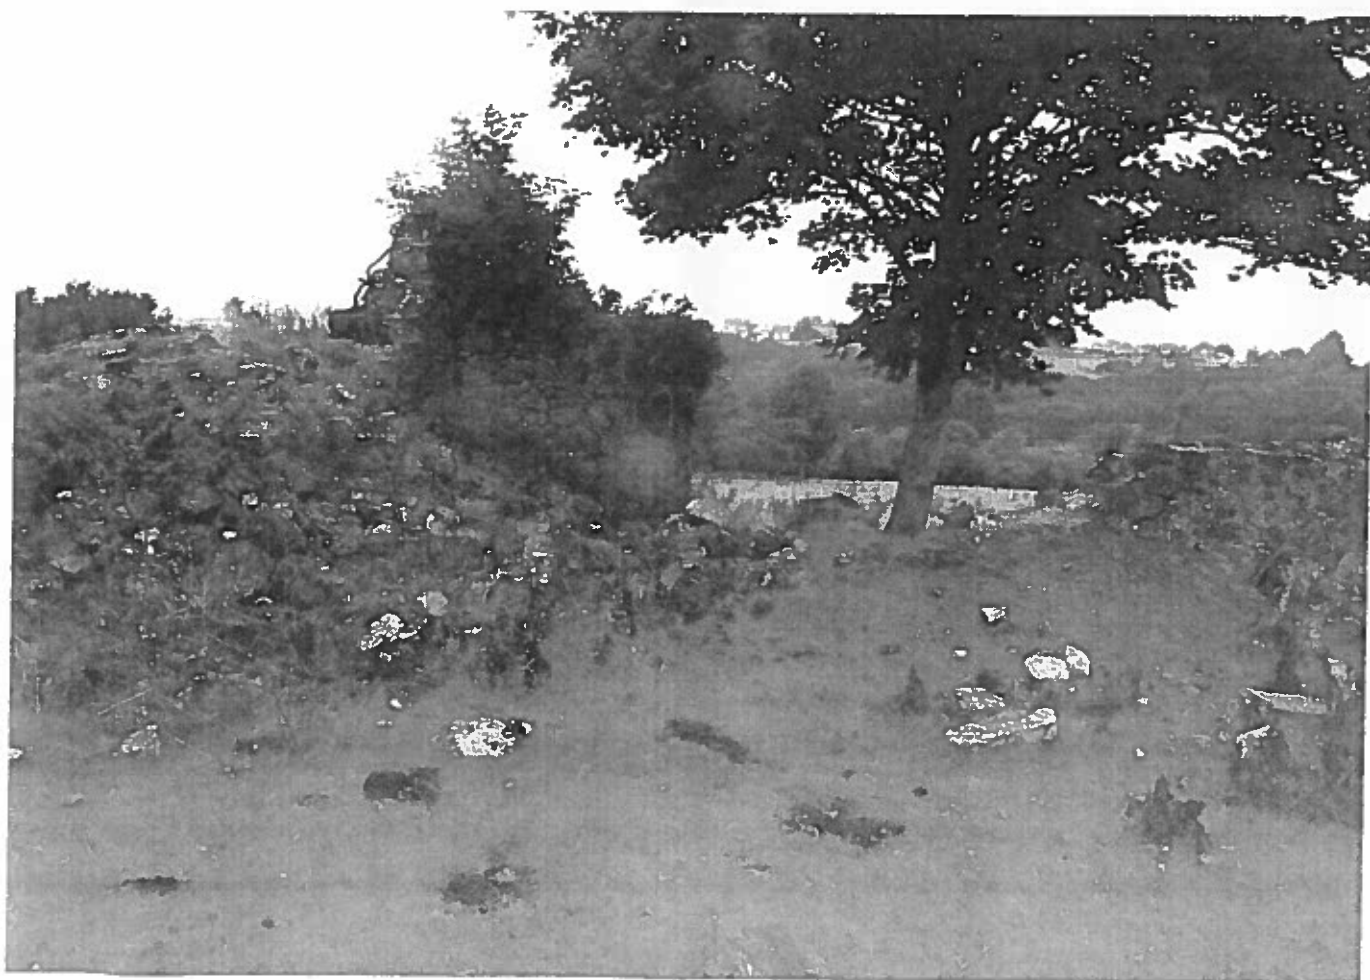
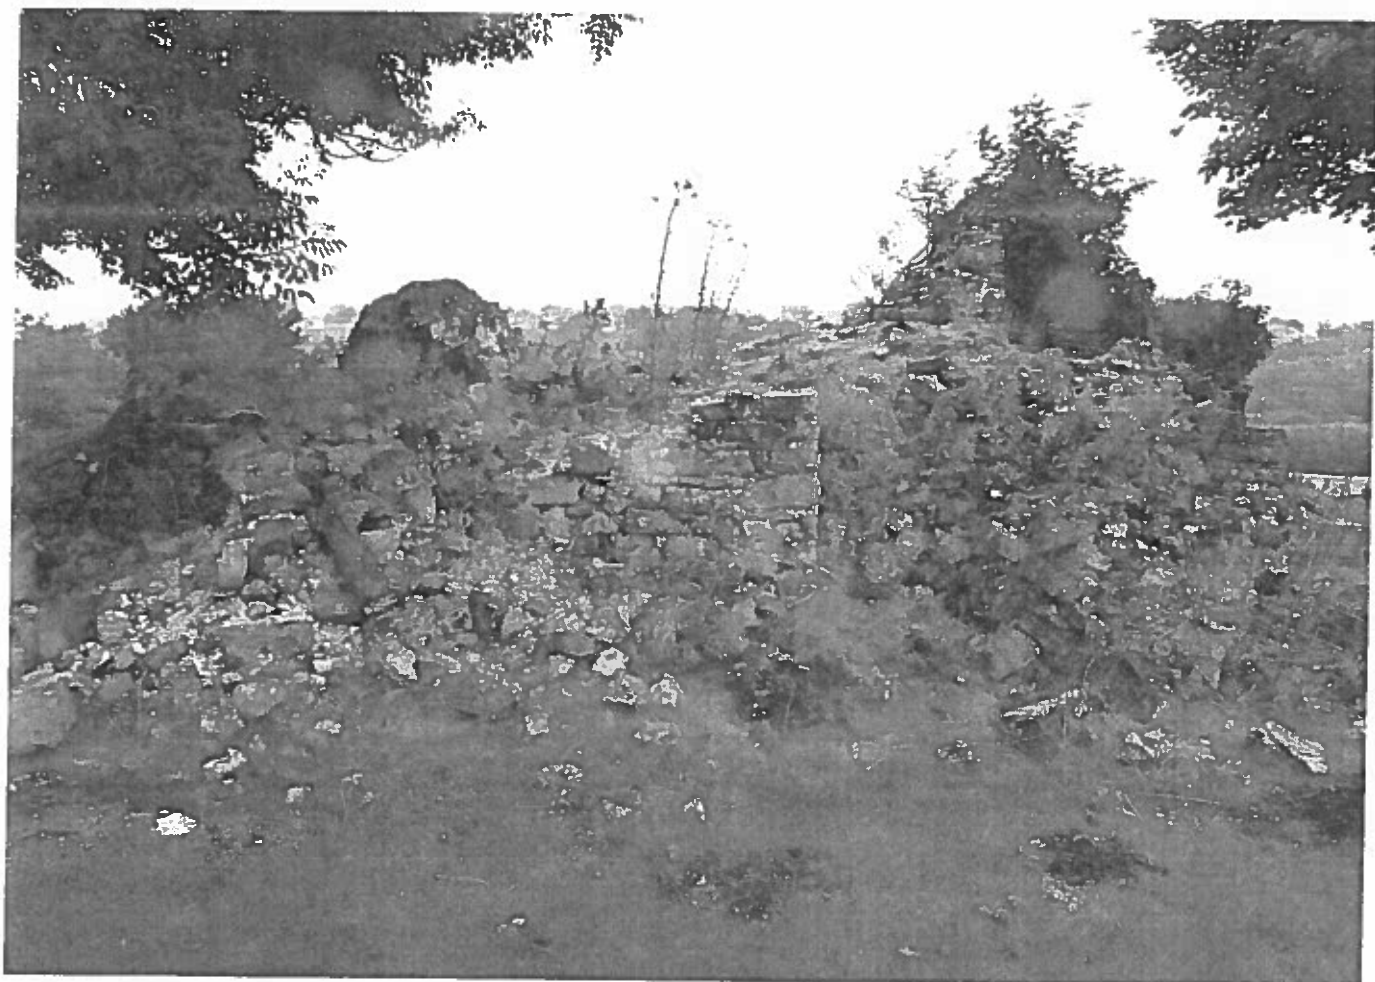
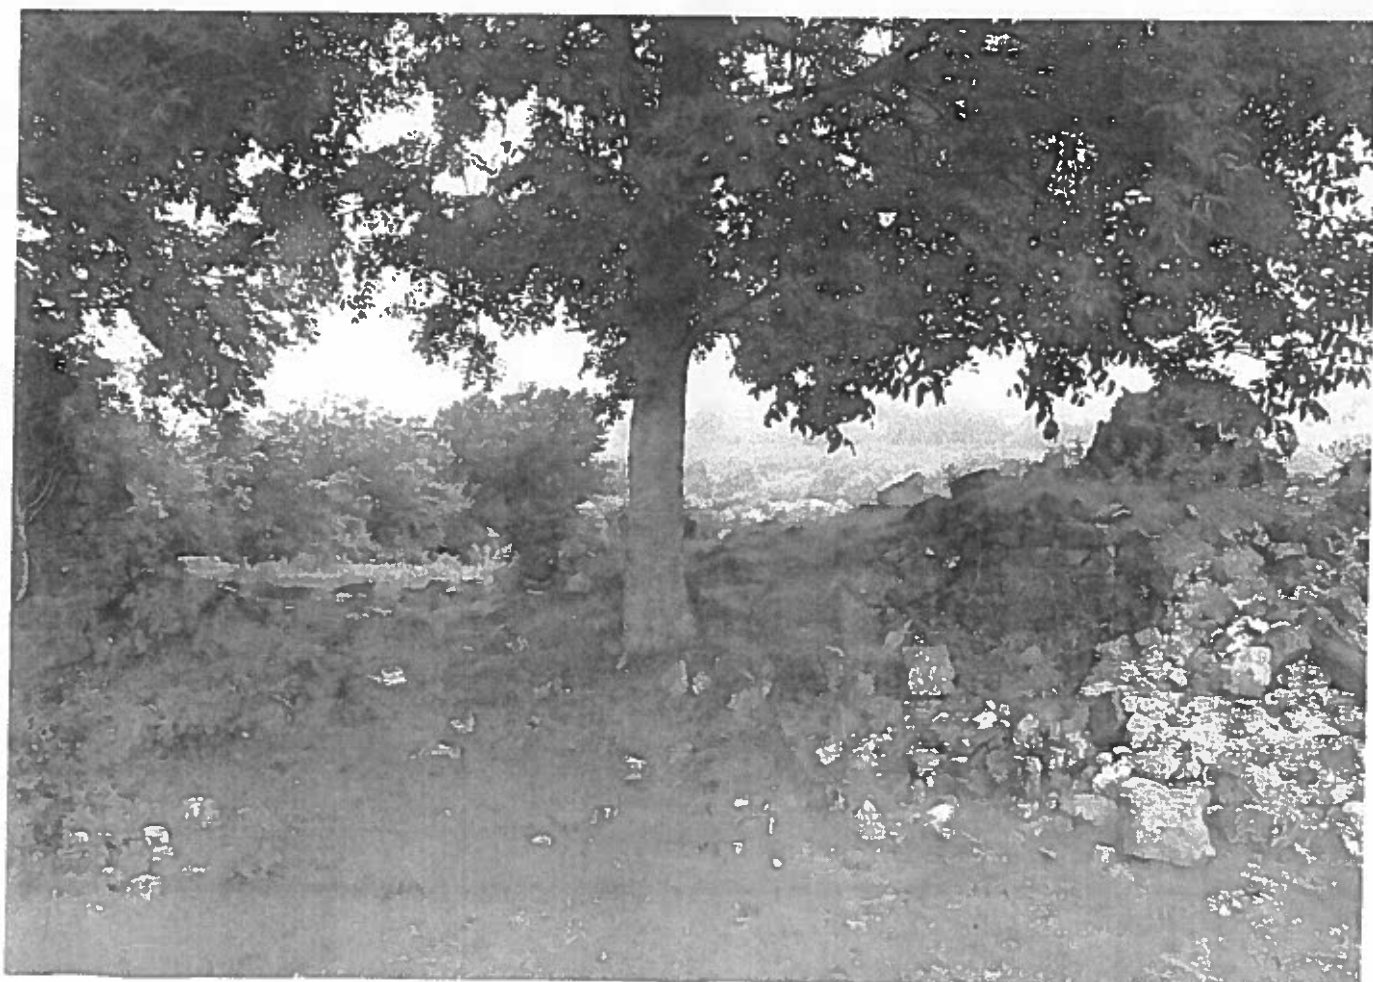
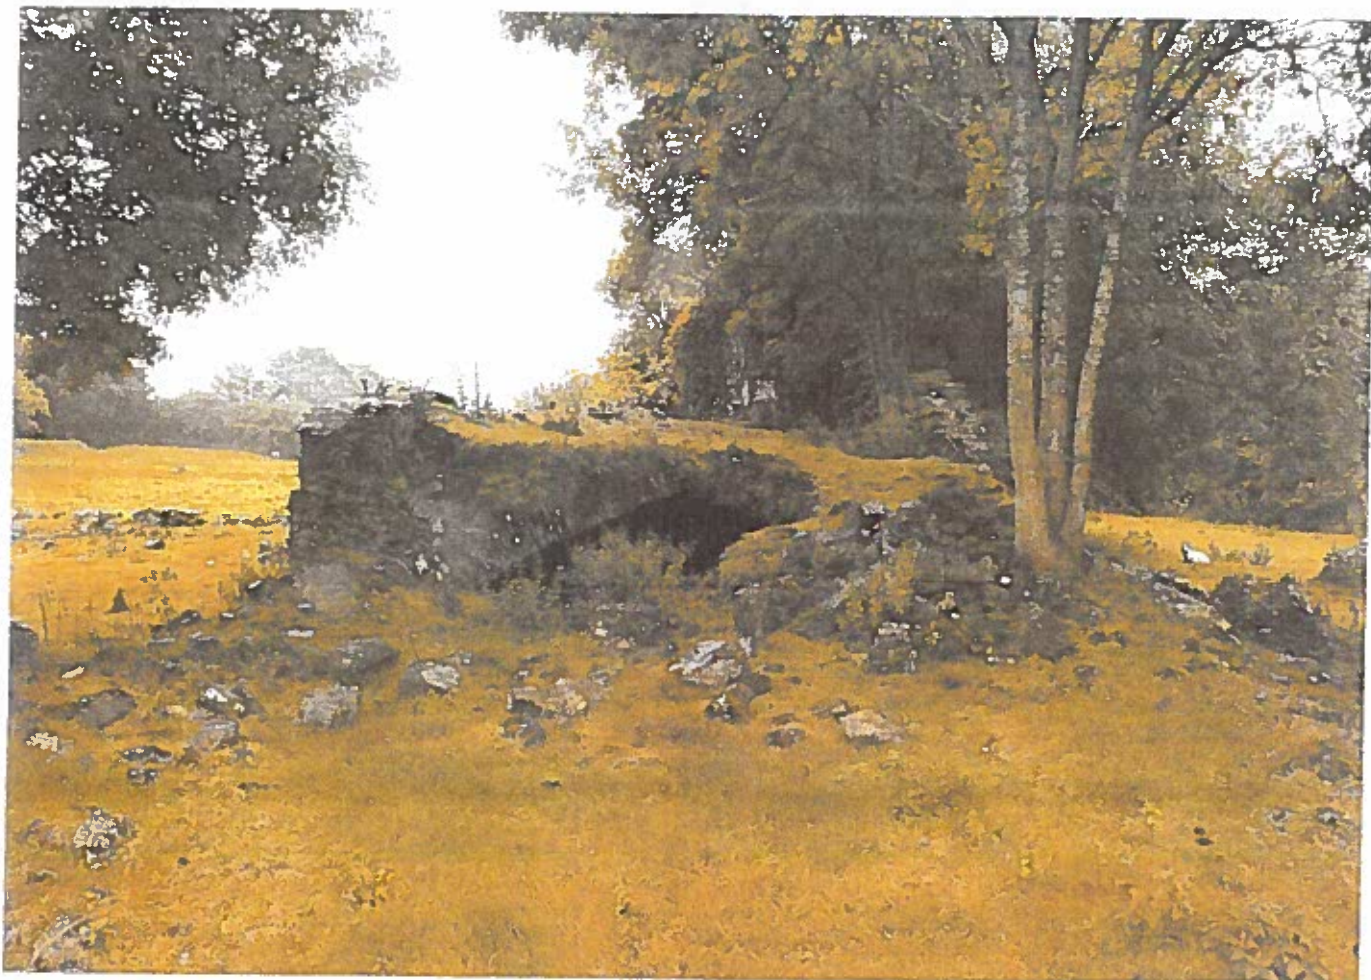
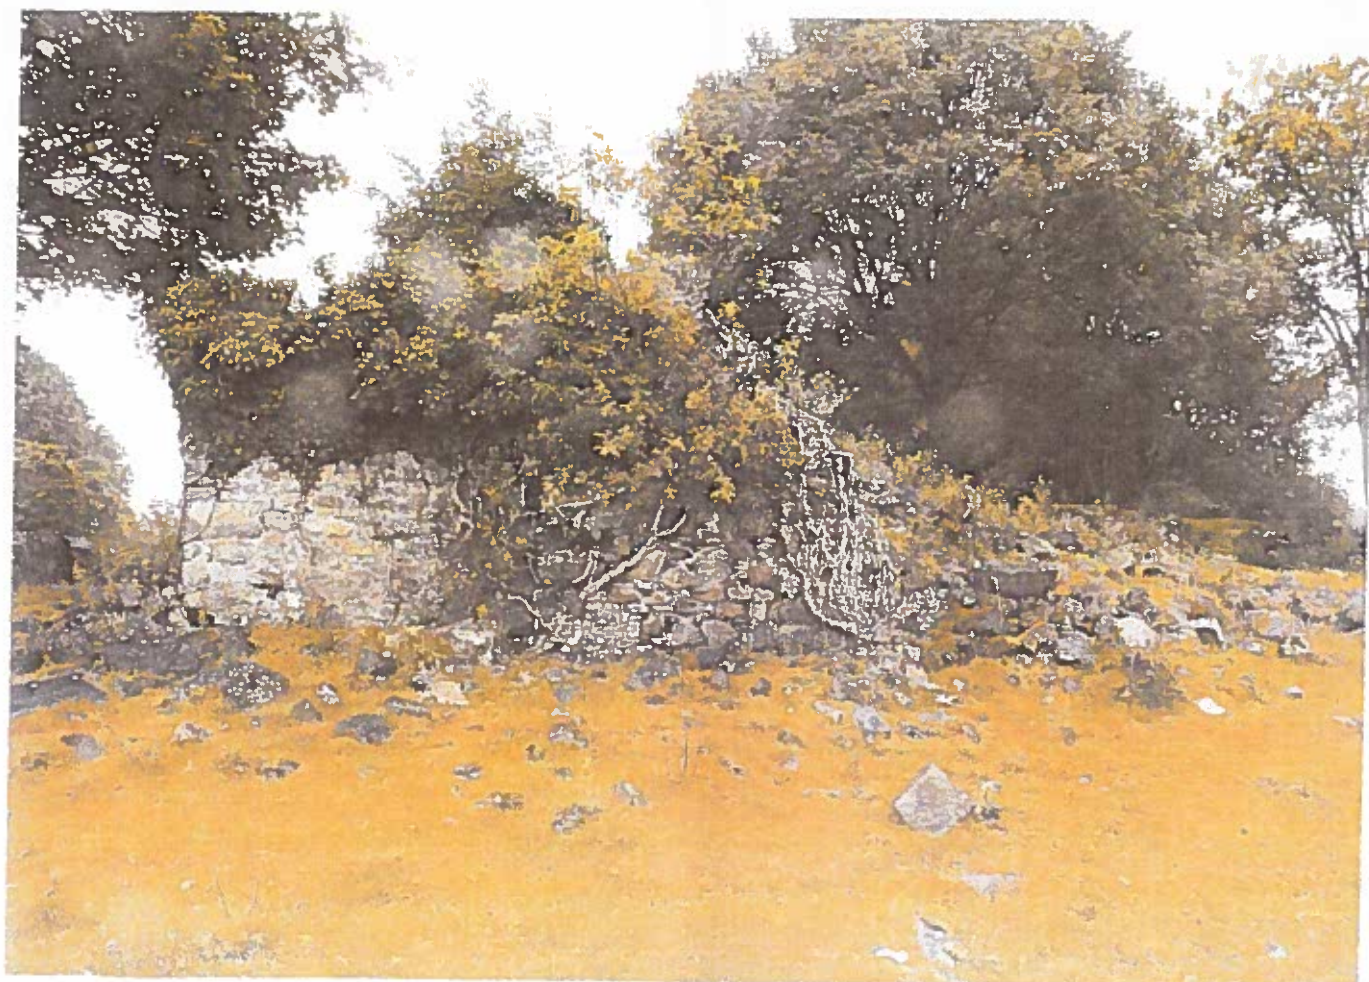
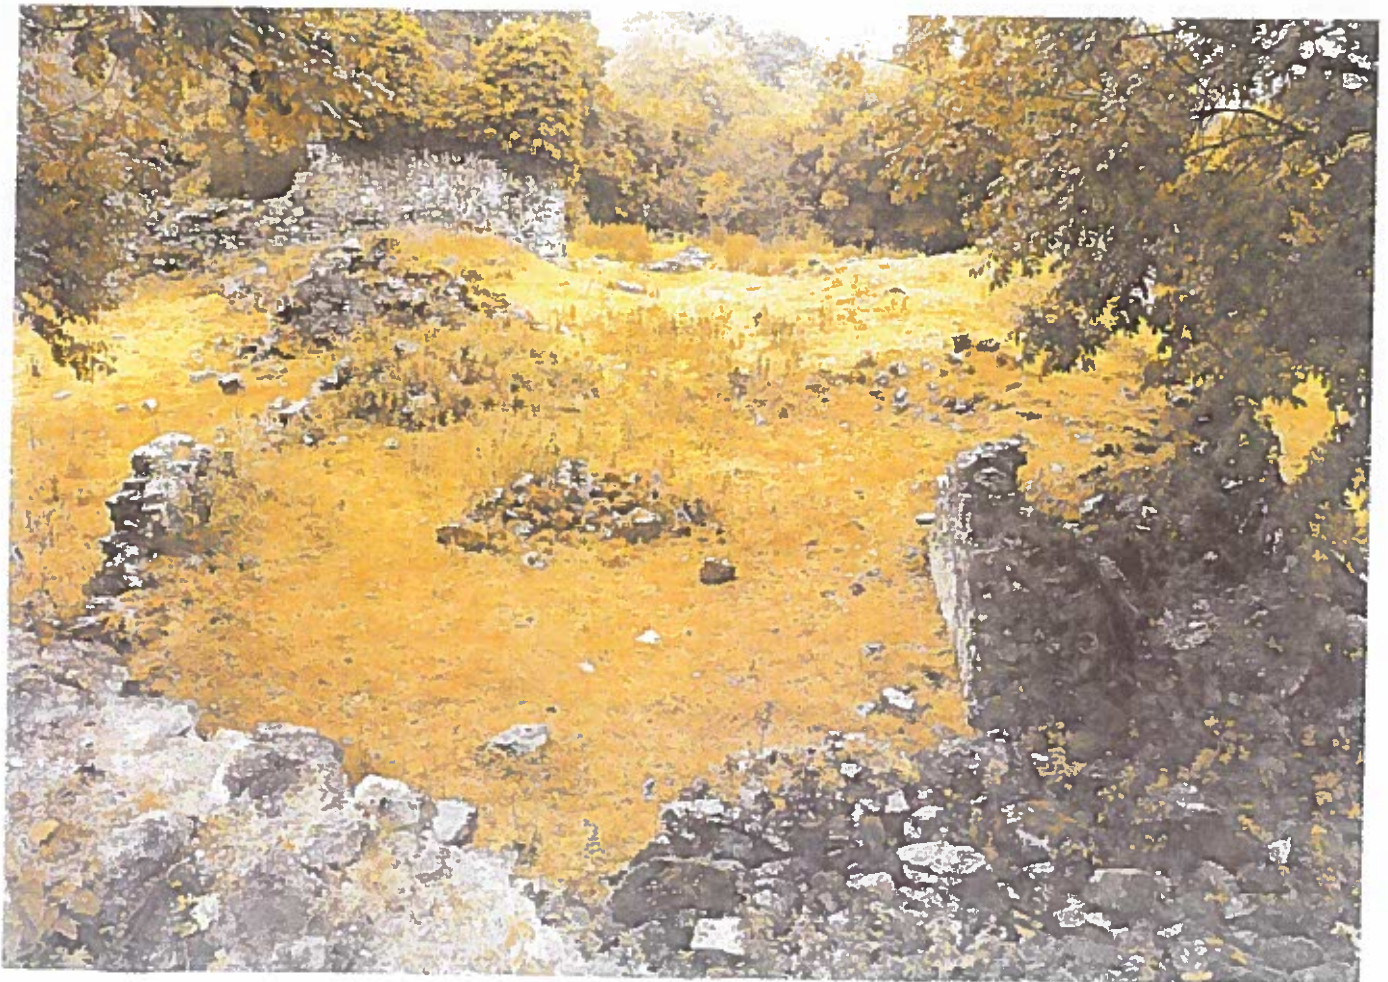
The walls of the east room are relatively stable. The east wall needs consolidation of the north east corner. The south wall is mainly buried in rubble. The north wall north face is in reasonable condition with ivy growing out of the top. The south face has numerous open joints and ivy growth.

The east wall of the west building has a hole at low level which needs filling and the remainder needs pointing. The north plinth wall is disrupted by ivy and in need of repair, the top of the chimney remains is difficult to see due to heavy vegetation. The surviving south wall is in reasonable condition.

The south and east walls need minor pointing and consolidation of wall tops to stabilise them pending further archaeology and investigation. It is worth spending more effort on the north wall as the remains of the upper chimney are worth protecting. The ivy and vegetation should be killed and removed. The remains of the upper north chimney face should be stabilised by building up mortared rubble against the south face to stop it collapsing following which facework should be pointed and holes filled.

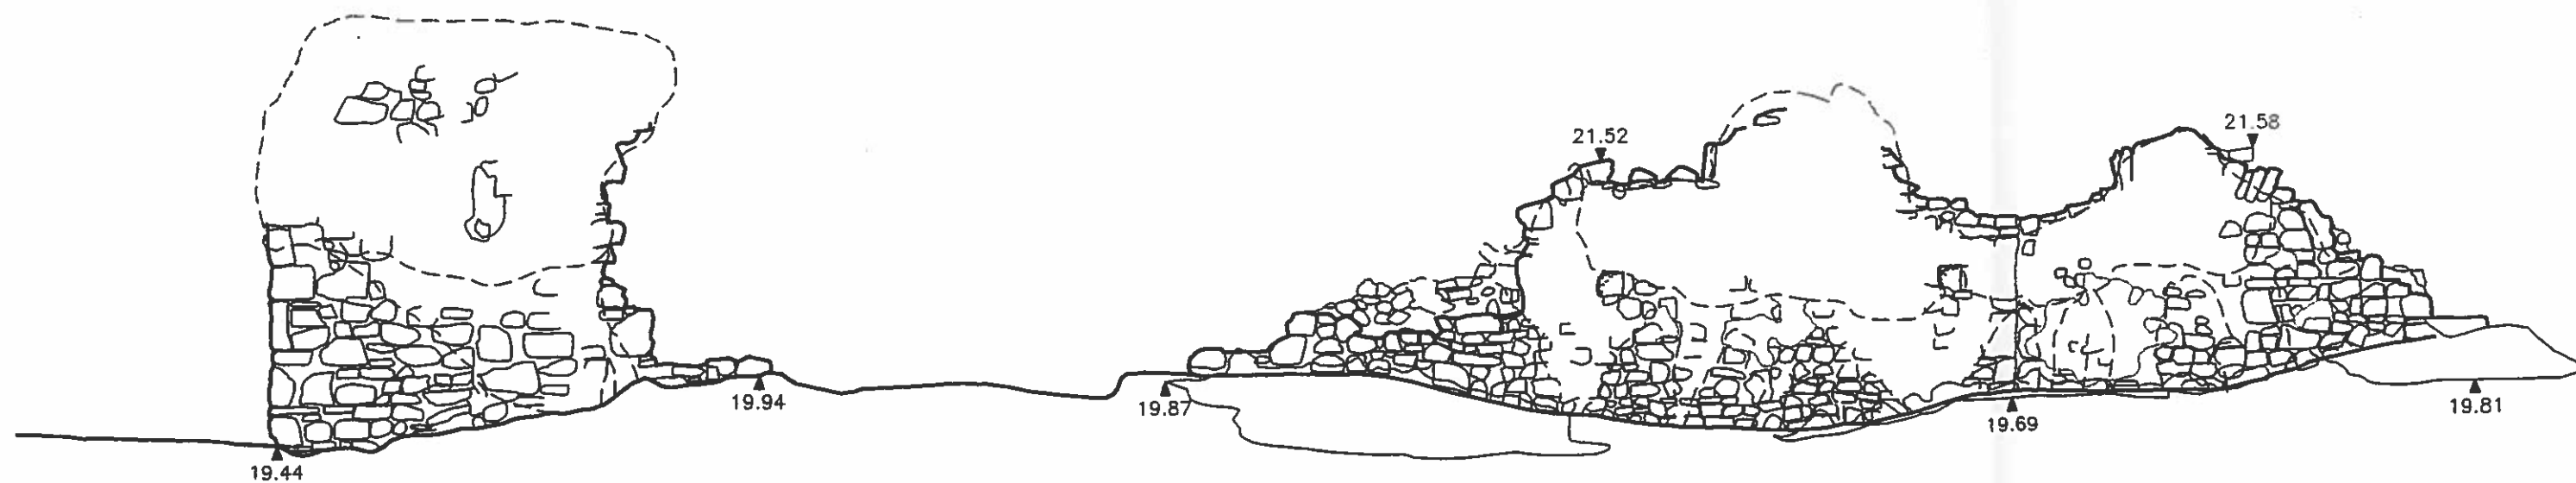
ELEVATION 29

The north face is in good condition except for a hole at low level open joints and ivy growth on the south face and ivy on the top. There is recent dislodging of stones on the top of the wall.

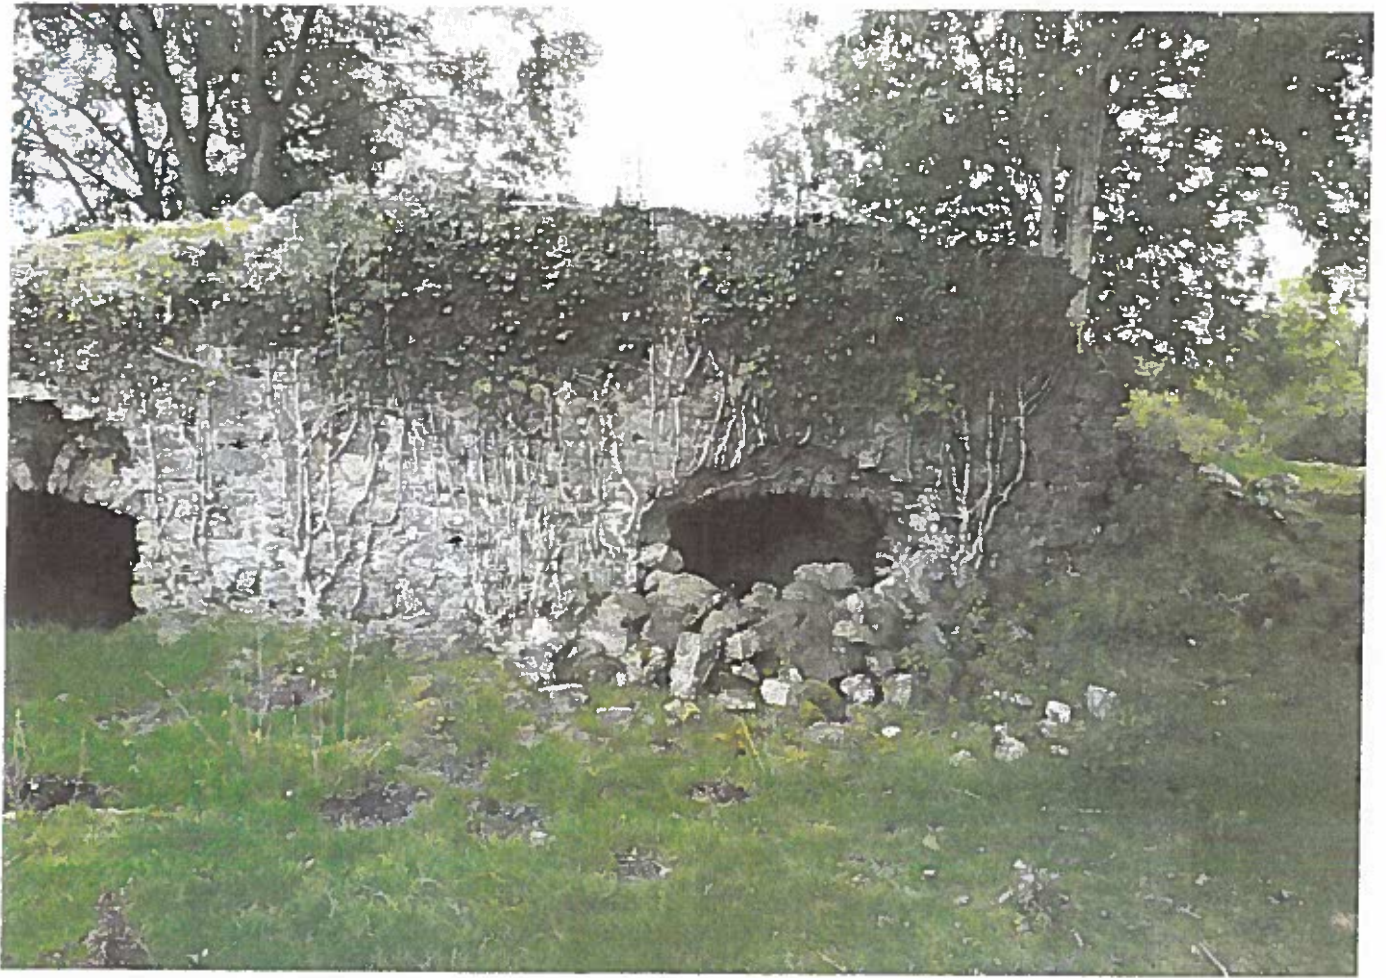
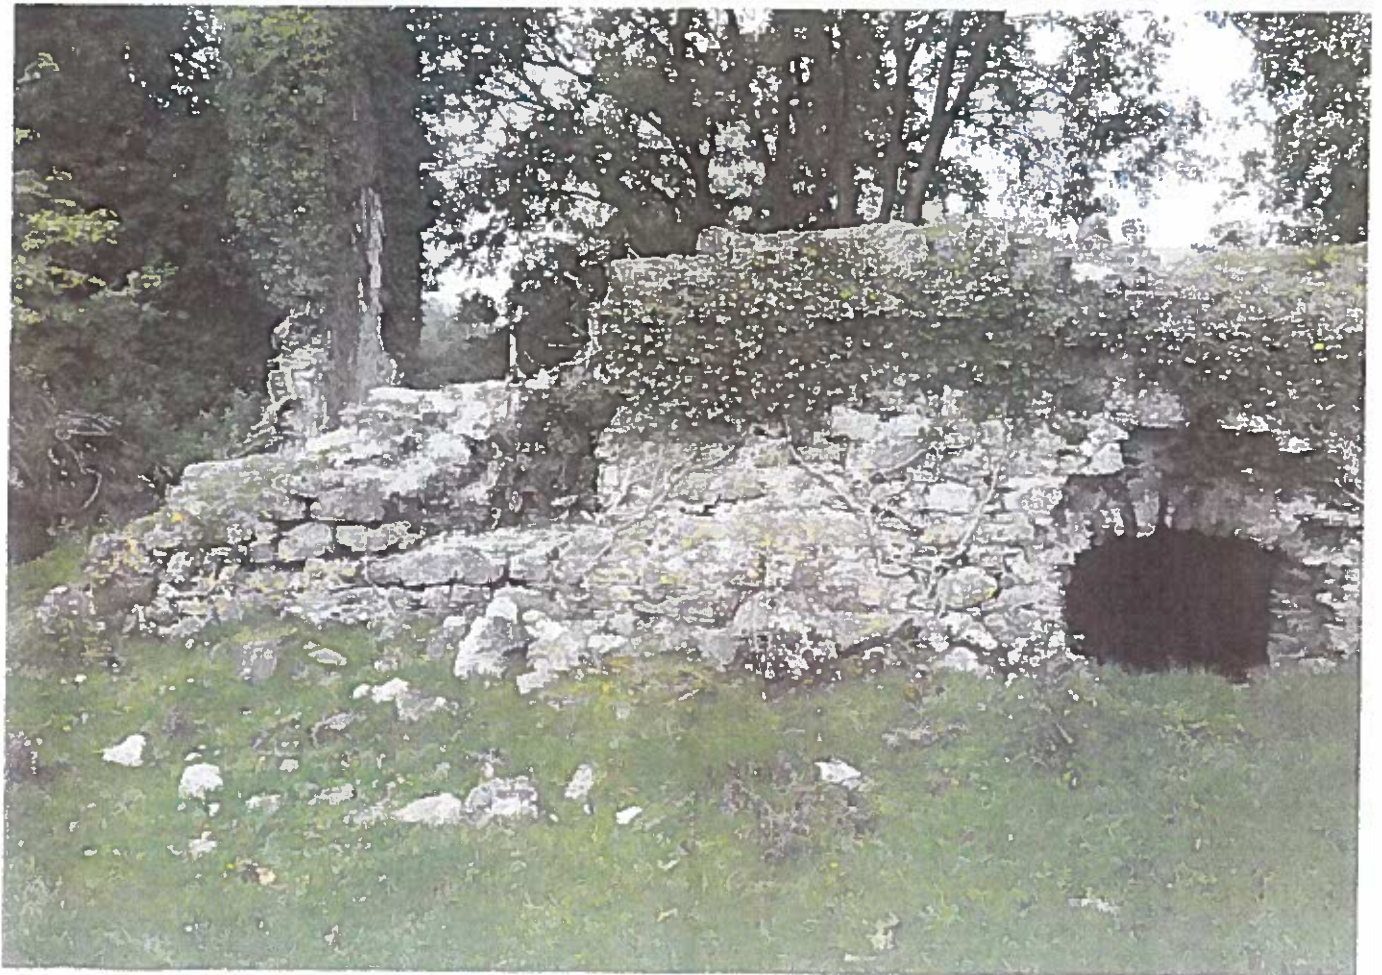
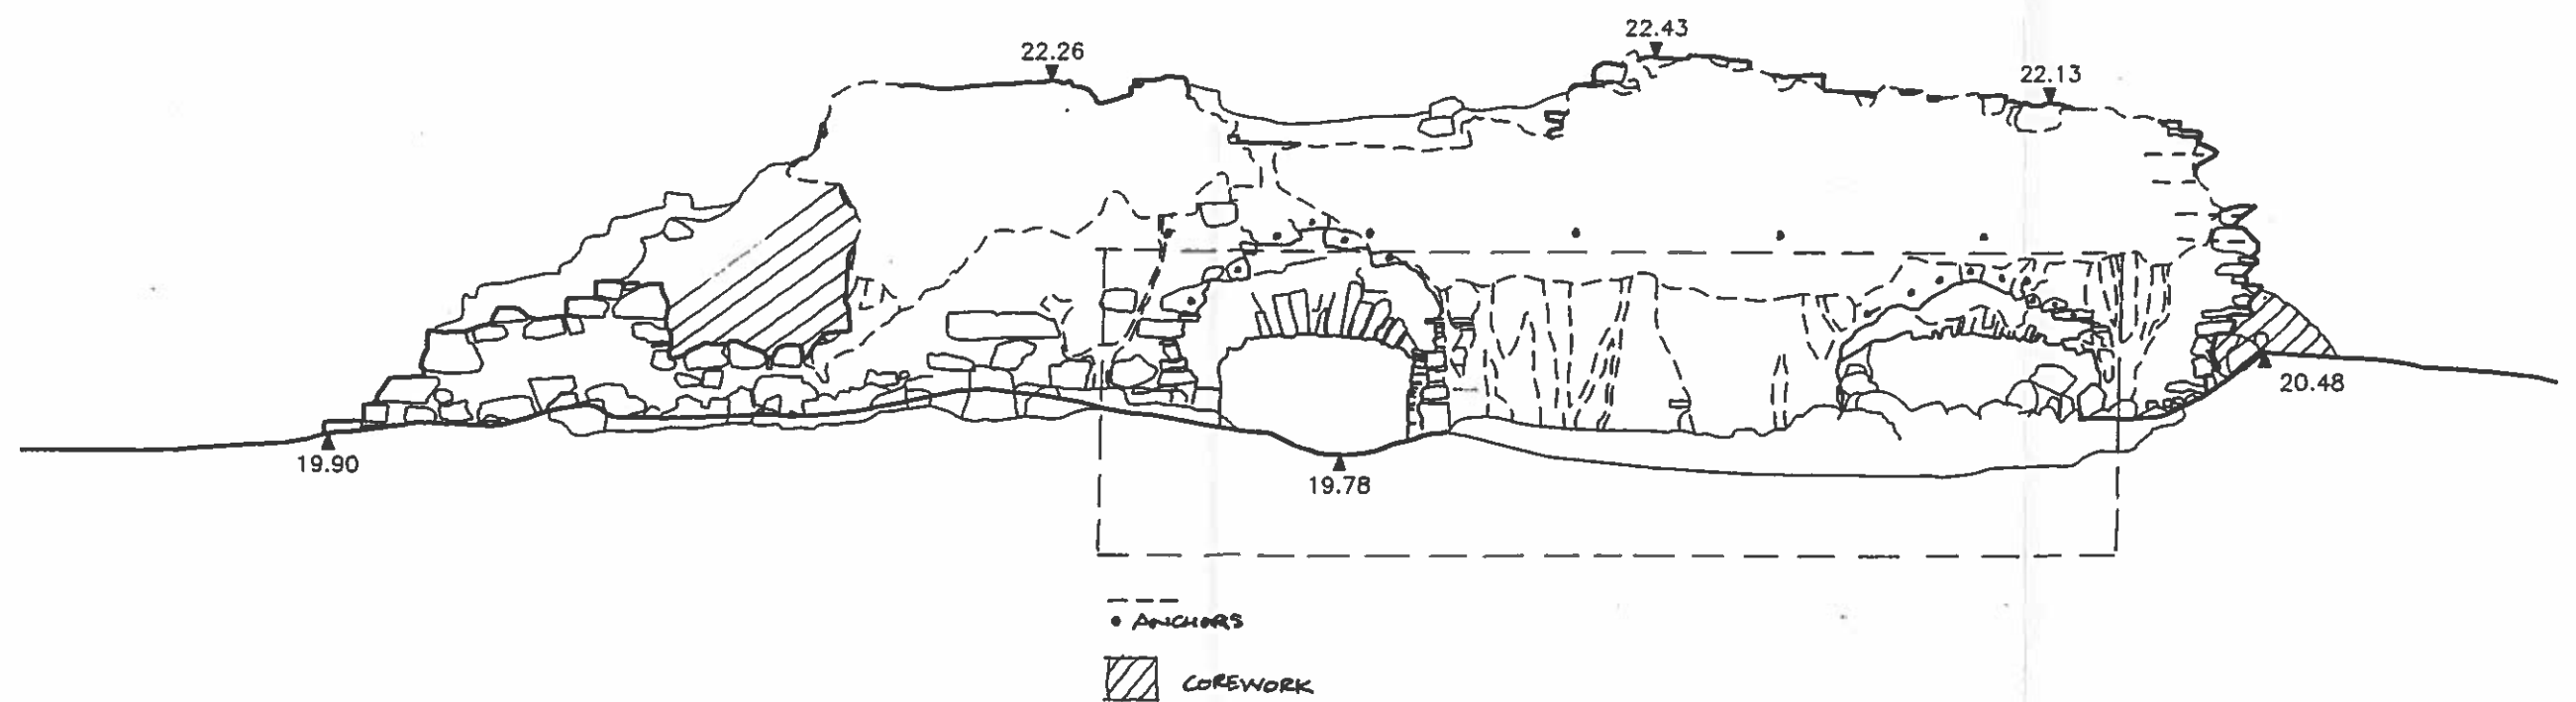
The north end of the wall has loose stones at the edge. The springing of the vault is apparent in the north rubble. The dressings of the two undercroft openings are missing and the outer facework has fallen away from the jambs and above the lintel. The outer blocking to the south room window is collapsing. Ivy growth is extensive and there are open joints in the base and south end of the wall.

Use cintec anchors to secure the corbelled face stones above the two undercroft openings to the inner face. Kill the ivy but do not remove the stems except at the south end and where required to build up corework. Rebuild and consolidate corework of undercroft opening jambs. Rebuild blocking of south room window in corework. Point and fill holes, rebed top stonework in capping mortar.

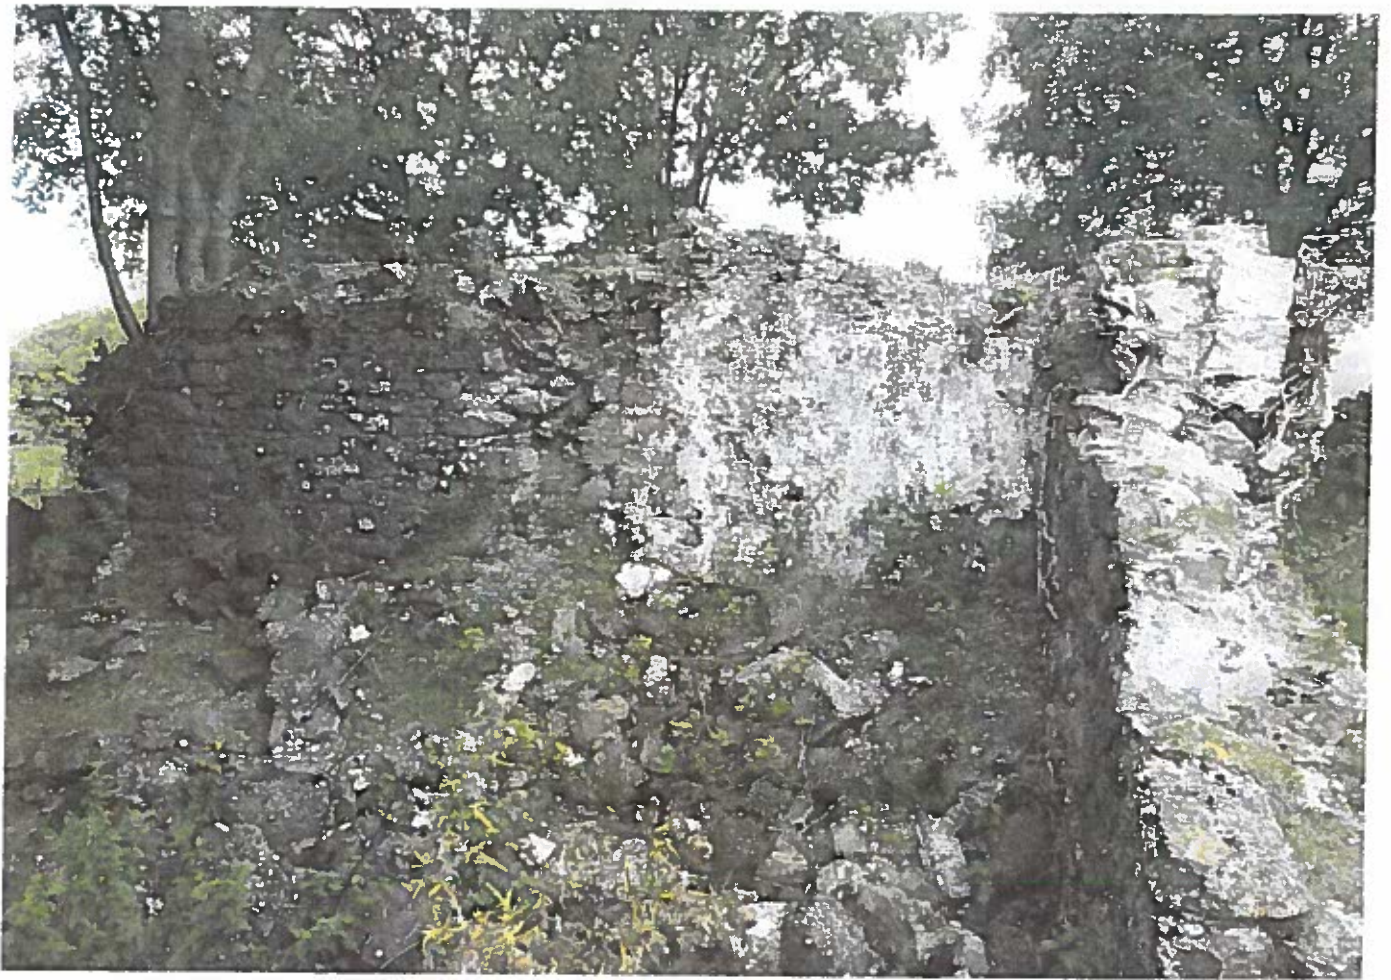
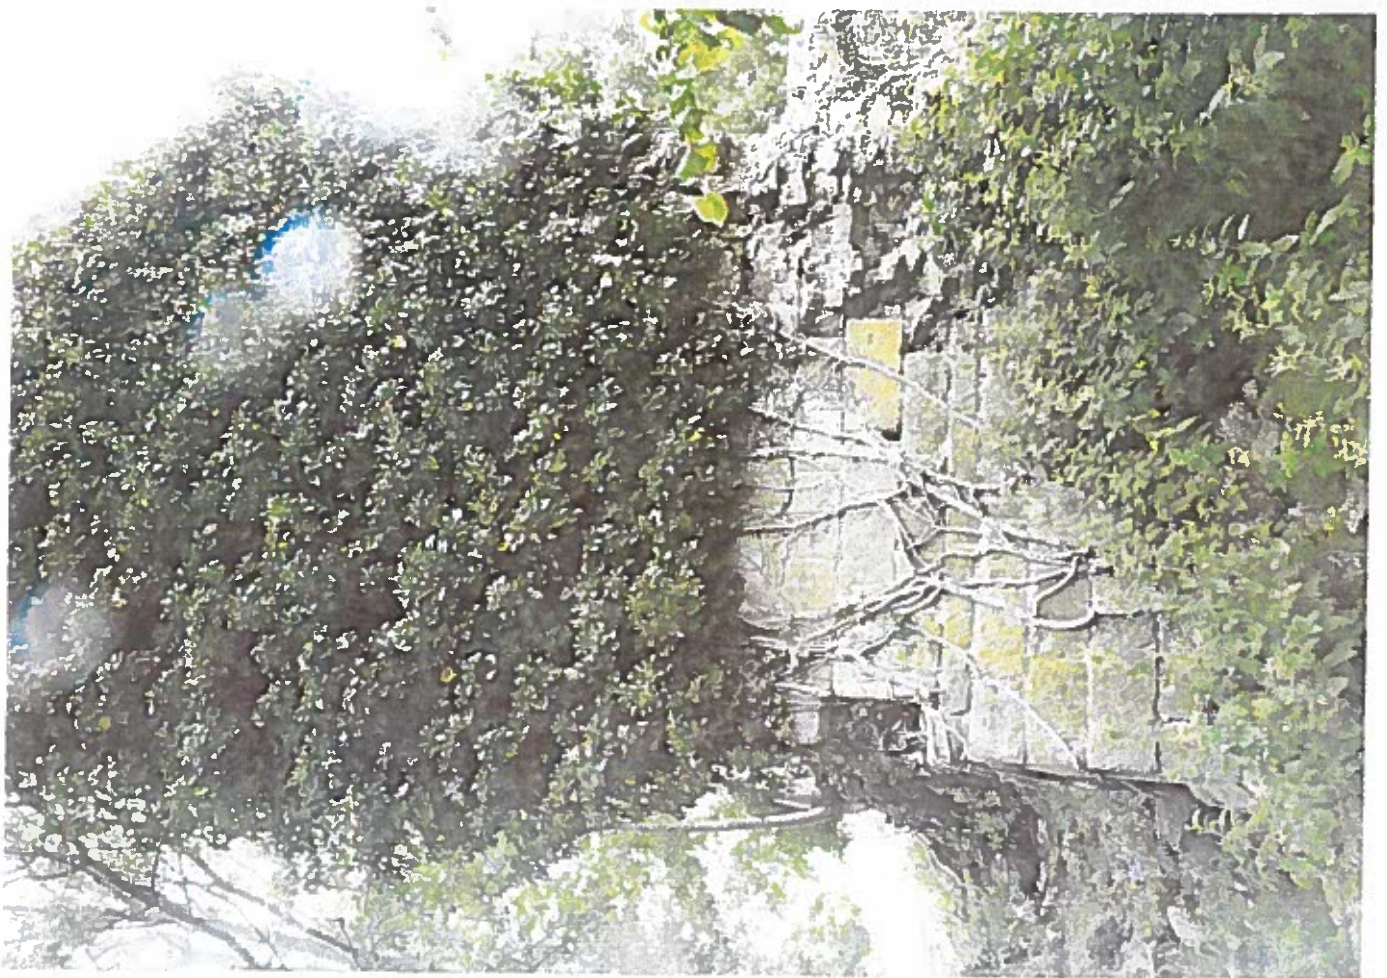
The south wall of the undercroft has been disrupted by tree roots in the top centre section. The root has been killed. The west section has open joints, a small collapse of the outer face and loose stones at the south west corner. The west bottom section of the south gable wall is in good condition but corner stones are missing at high level. However, the alignment of the wall appears good. The upper face is obscured by ivy. The exposed corework of the east section and edge is loose and there are unsupported projecting stones.

In south wall of undercroft, dismantle masonry to remove dead tree root and rebuild. Point open joints and holes in west section and rebuild small collapse in corework. Kill and remove vegetation and consolidate south west corner rebedding stones in shelter mortar. Kill and remove ivy from wall top, dismantle and rebed in capping mortar to original profile and cap in turf.

Remove the tree at the south east corner of the south gable, clear away vegetation and erect scaffolding. Carefully trim back the leaves of the ivy to establish whether it is rooted in the masonry. If not, carefully remove the ivy. Point open joints and fill holes. Consolidate the south west corner in corework to support overhanging faces stones. Consolidate surviving corework of east section and build up east edge in corework to support overhanging stones. Dismantle and rebuild wall top in capping mortar to match its original profile and shed water. Stitching anchors may be required. If ivy is rooted in the wall the conservation technique will need to be reviewed.

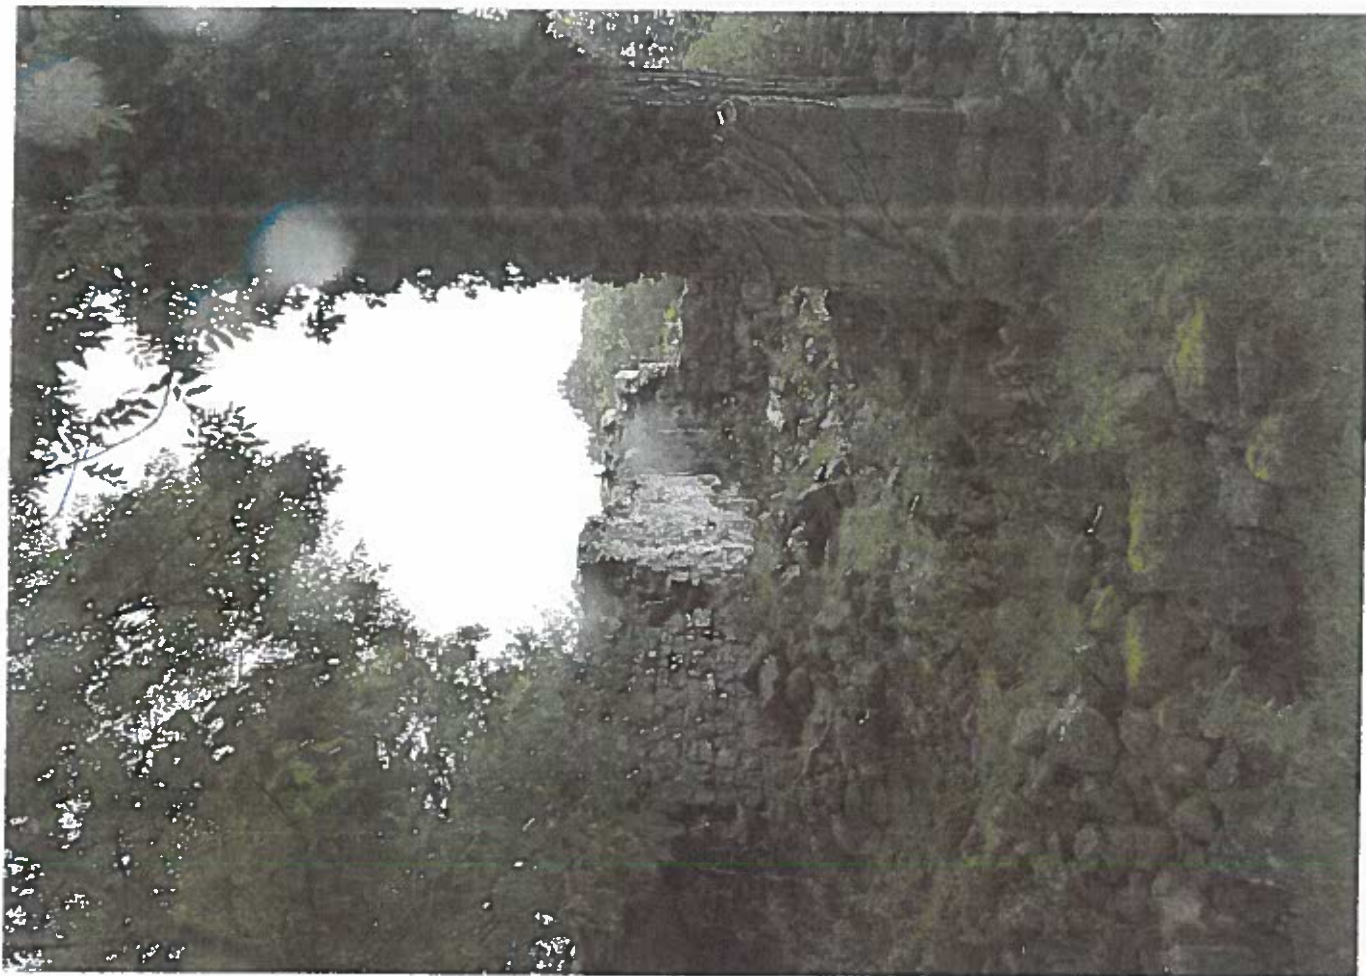
61

The base of the south west corner masonry is in good condition but corner stones above are missing and the top is obscured by ivy. The masonry of the south west corner of the undercroft is loose and insecure and disrupted by two ash trees. The rest of the wall has open joints, sections of missing facework and extensive ivy cover. Around the undercroft opening facework has collapsed and cantilevered stones are secured by ivy roots.

See 4.22.3 for work to the S.W. corner of the south room. Cut down the two ash trees at the SW corner of the undercroft and kill the roots. Remove previously killed stumps against the west wall. Kill ivy on the west wall but do not remove stems except where required to rebuild corework. Point and consolidate SW corner masonry and blocking masonry and insert anchors to tie it to the backing masonry. Consolidate the south edge of the high central masonry in corework bedded in shelter mortar to support overhanging stones and shed water. Insert stitching anchors to the unsupported face stone above undercroft opening and rebuild jambs in corework to support projecting stones. In remainder of wall point open joints and fill holes. Remove ivy from top of wall, record, number stones and dismantle. Rebuild to original profile in capping mortar and cap in turf.

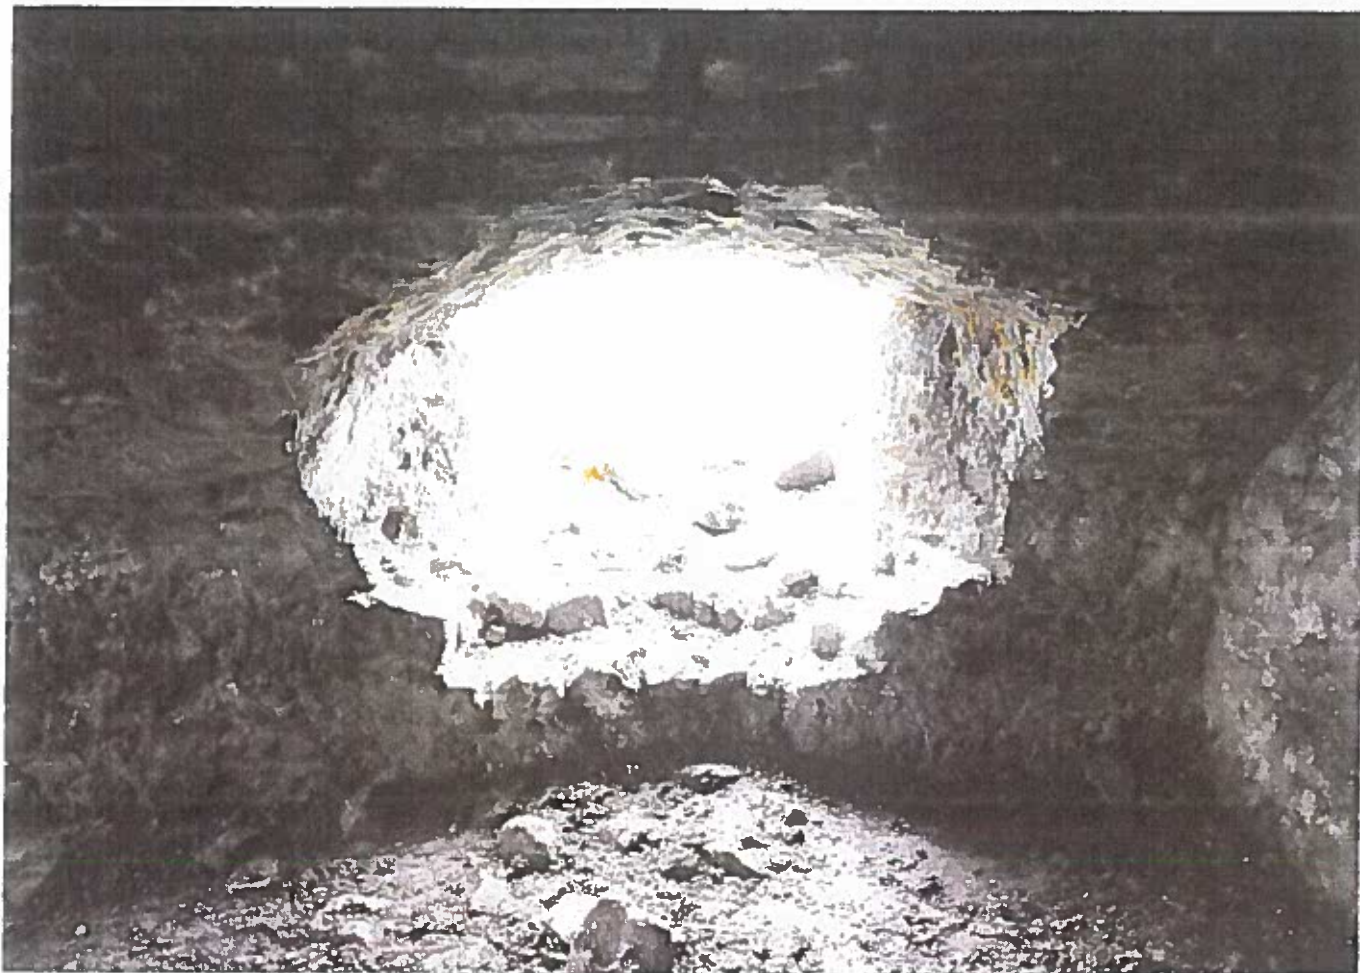
67

The south end of the west wall is open jointed and has a number of collapses on both its east and west faces, together with heavy ivy growth at high level where it is leaning to the east. The south return wall of the west protection is in poor condition with open jointed and unsupported corework on east and west edges, and heavy ivy growth at the top. It is leaning to the north. The rest of the south and west walls of this projection have lost much of their facework and are covered in vegetation. The north wall of this protection and adjoining north section of west wall is lost in rubble.

The west face of the north west corner is in good condition below first floor level, but there has been loss of facework at the corner, and stones are open jointed and unsupported above the losses. The upper face is concealed behind ivy. The base of the north face is open jointed with numerous holes above which ivy conceals the wall. The internal corner has numerous holes and the south and east edge corework is tied together by ivy stems. The ivy clads and conceals all the upper masonry.

The south return wall of the west projection needs the same treatment as the adjoining west wall and on completion should be tied to the west wall using cintec anchors @ 700 mm vertical centres. The other surviving remains of the west projection need the same treatment as described in Clause 4.26.3. The north west corner should be scaffolded and ivy leaves cut back to establish if it is rooted in masonry. If not, it should be killed and vegetation peeled back and discarded. Reinstall missing face stones on NW corner, point walls and fill holes. On internal face, fill holes in corework. Dismantle and rebuild wall top as described previously.

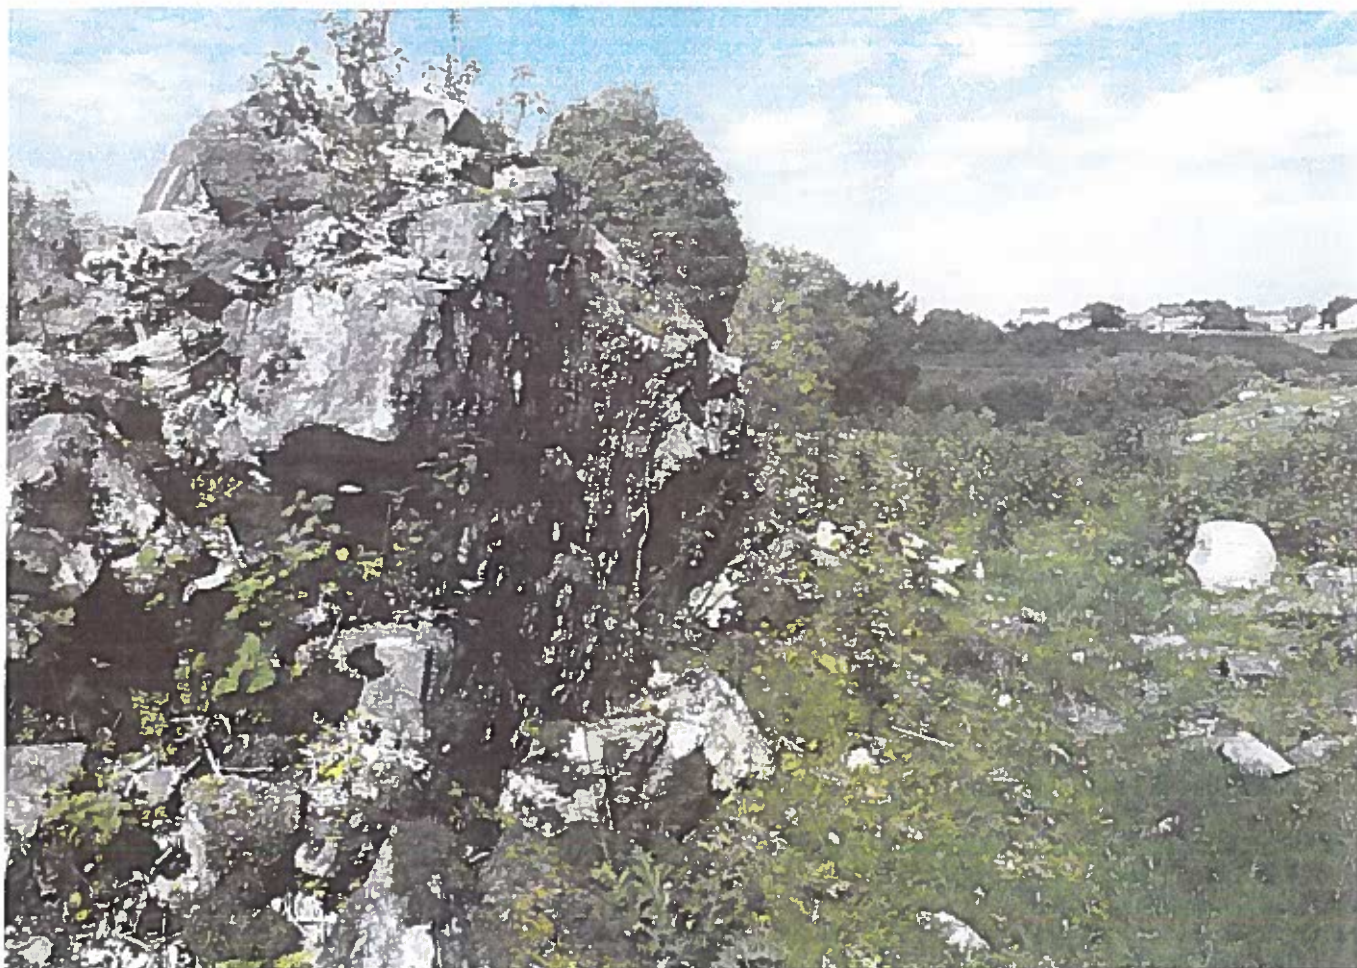
93

The east abutment of the south west wing and south wall of the Central Range survives in a fragment of masonry (photo 93) This continued to the south and north and had a partition running to the west. The remainder of the east wall and the south wall to this wing are missing except for the south west corner where square ashlar base stones survive (photo 94). The west wall stands to a height varying from just above first floor level to above second floor level. An offset for the first floor is evident on the east face of this wall. The remains of a wall running to the west extend from the south west corner, this extended about 10 metres before turning to the north and appears to indicate an enclosure rather than a building.

losses of facework and heavy ivy growth to upper masonry. The high masonry is leaning to the east. The west enclosure wall has recent damage from grazing sheep together with loose masonry and loss of facework.

The top of the west wall should be recorded, stones numbered, ivy roots removed and rebuilt in capping mortar to its original profile.

The west enclosure wall should be pointed, holes filled, ivy killed and wall tops consolidated as for the west wall.
