HAROLDSTON HOUSE HAVERFORDWEST

A MANAGEMENT PLAN FOR THE CONSERVATION OF THE REMAINS FOR THE GILD OF FREEMEN OF HAVERFORDWEST

**MANAGEMENT PLAN FOR THE CONSERVATION OF THE MASONRY REMAINS OF
HAROLDSTONE HOUSE. HAVERFORDWEST, PEMBROKESHIRE.**

PART 1 – SURVEY WORK AND DRAFT CONSERVATION STRATEGY

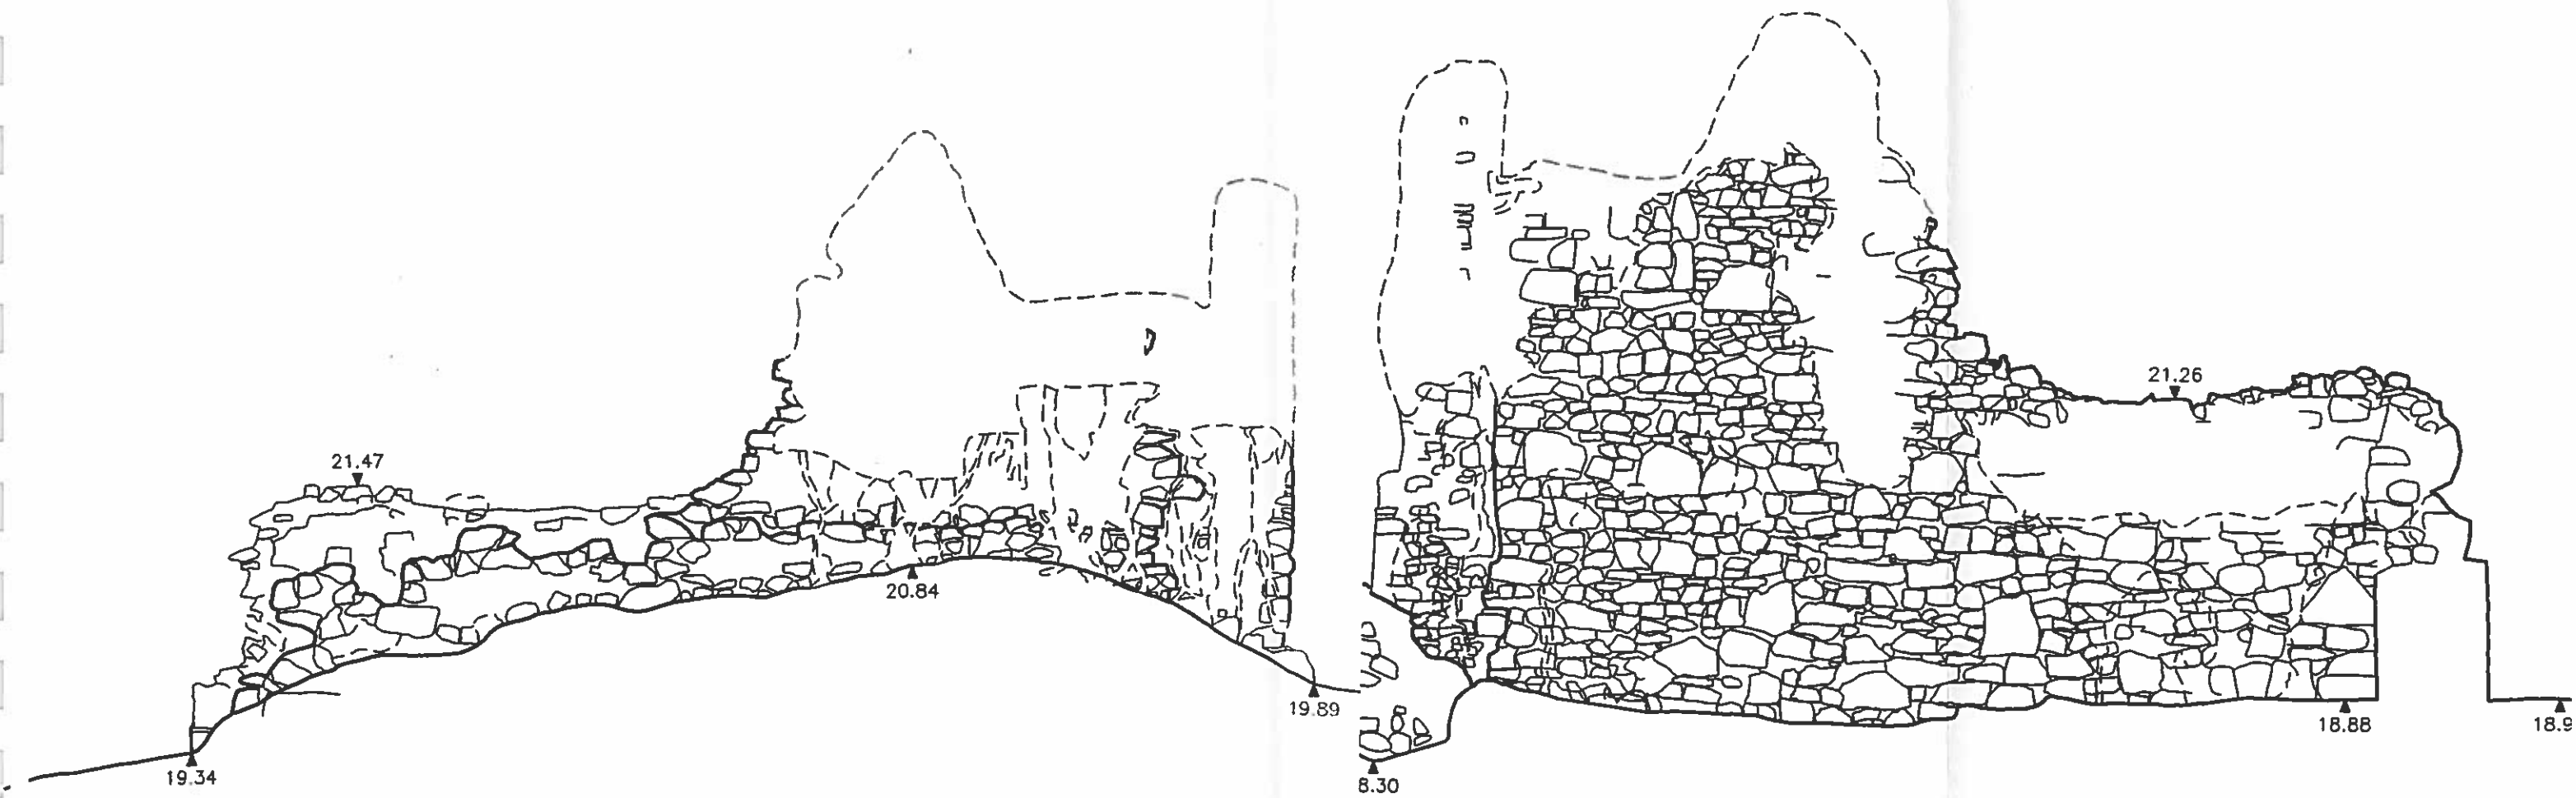
ELEVATION 23

The south end of the west wall is open jointed and has a number of collapses on both its east and west faces, together with heavy ivy growth at high level where it is leaning to the east. The south return wall of the west protection is in poor condition with open jointed and unsupported corework on east and west edges, and heavy ivy growth at the top. It is leaning to the north. The rest of the south and west walls of this projection have lost much of their facework and are covered in vegetation. The north wall of this protection and adjoining north section of west wall is lost in rubble.

The west face of the north west corner is in good condition below first floor level, but there has been loss of facework at the corner, and stones are open jointed and unsupported above the losses. The upper face is concealed behind ivy. The base of the north face is open jointed with numerous holes above which ivy conceals the wall. The internal corner has numerous holes and the south and east edge corework is tied together by ivy stems. The ivy clads and conceals all the upper masonry.

The south return wall of the west projection needs the same treatment as the adjoining west wall and on completion should be tied to the west wall using cintec anchors @ 700 mm vertical centres. The other surviving remains of the west projection need the same treatment as described in Clause 4.26.3. The north west corner should be scaffolded and ivy leaves cut back to establish if it is rooted in masonry. If not, it should be killed and vegetation peeled back and discarded. Reinstall missing face stones on NW corner, point walls and fill holes. On internal face, fill holes in corework. Dismantle and rebuild wall top as described previously.

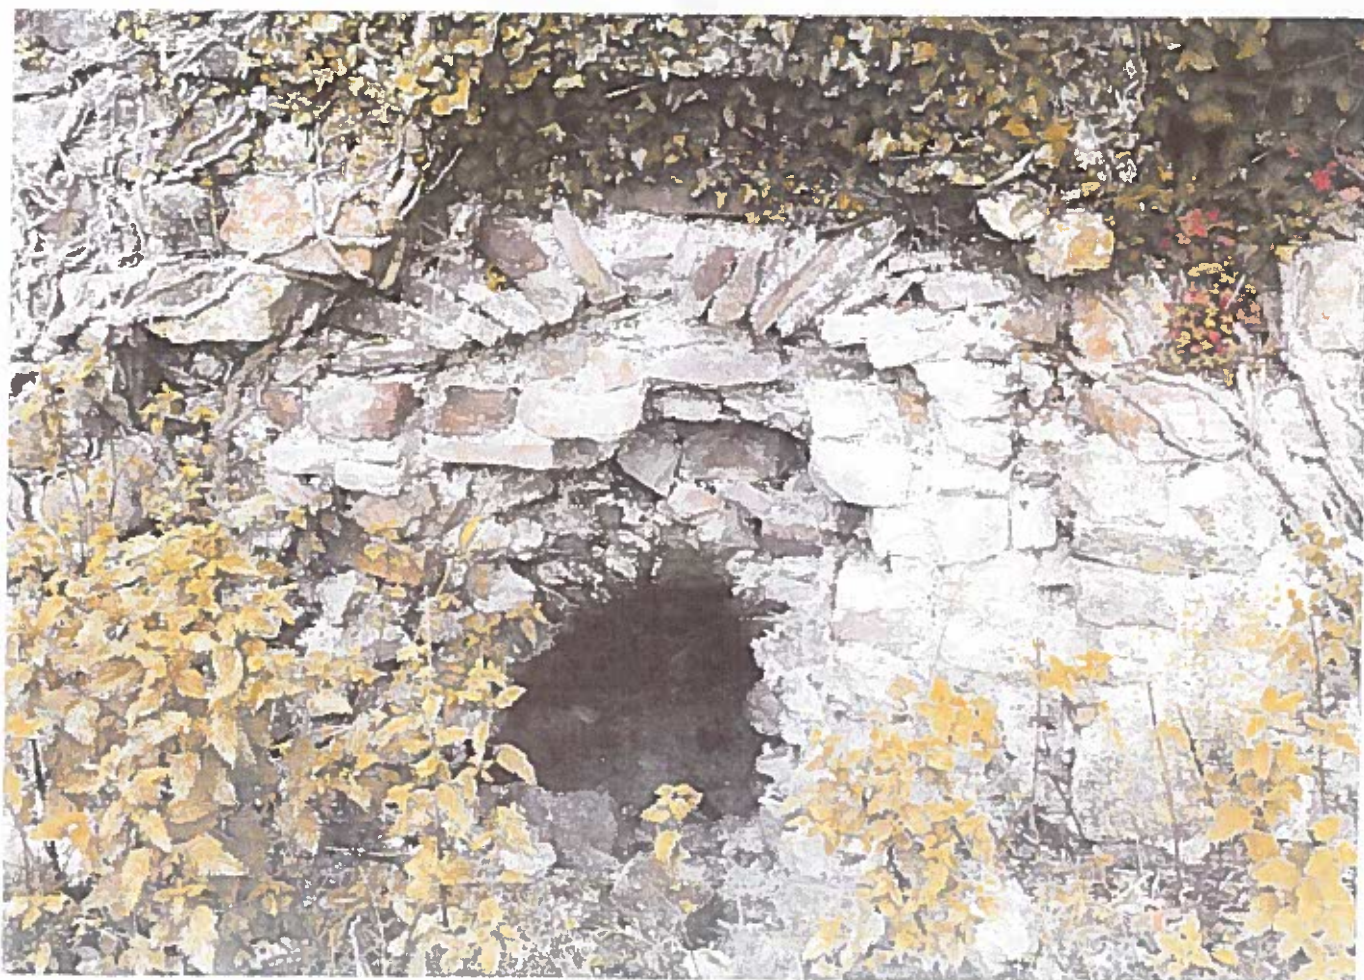
73

The base of the south west corner masonry is in good condition but corner stones above are missing and the top is obscured by ivy. The masonry of the south west corner of the undercroft is loose and insecure and disrupted by two ash trees. The rest of the wall has open joints, sections of missing facework and extensive ivy cover. Around the undercroft opening facework has collapsed and cantilevered stones are secured by ivy roots.

See 4.22.3 for work to the S.W. corner of the south room. Cut down the two ash trees at the SW corner of the undercroft and kill the roots. Remove previously killed stumps against the west wall. Kill ivy on the west wall but do not remove stems except where required to rebuild corework. Point and consolidate SW corner masonry and blocking masonry and insert anchors to tie it to the backing masonry. Consolidate the south edge of the high central masonry in corework bedded in shelter mortar to support overhanging stones and shed water. Insert stitching anchors to the unsupported face stone above undercroft opening and rebuild jambs in corework to support projecting stones. In remainder of wall point open joints and fill holes. Remove ivy from top of wall, record, number stones and dismantle. Rebuild to original profile in capping mortar and cap in turf.

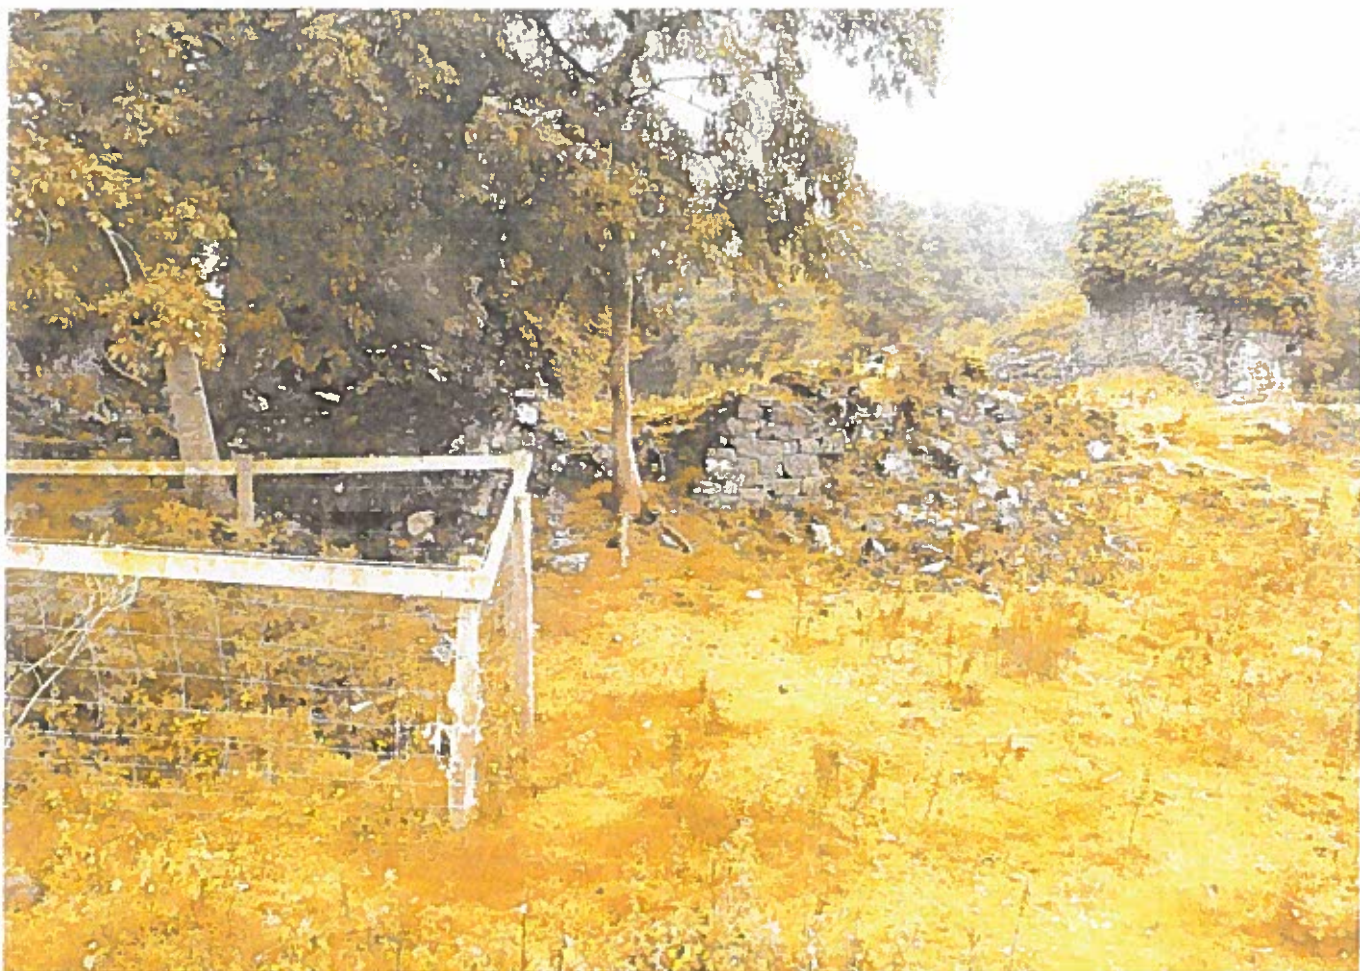
71

The north wall of the West Range is missing. Evidence of the north wall of the Central Range begins near its junction with the West Range. It comprises fragments of squared coursed facework (one with a culvert outlet) and section of tumbled masonry. The junction with the wall of the East Range is intact. There is a 1 metre wide doorway 2 metres west of the junction with the East Wing beyond which the wall thickens to nearly 3 metres. The internal face of the wall is an earlier hall wall. To the north of the culvert is a well and to the north of that an outlet through a retaining wall to the water gardens.

Point facework of west end of central section and consolidate top of tumbled masonry. Fell two ash trees and kill roots. Clear stone out of channel and point facework of wall at culvert, consolidate top of wall. Clear stone out of doorway and point exposed reveals. Point inner faces of wall to west of doorway. Further archaeological investigation of this area, the well and the outlet to the water gardens may reveal more masonry to be consolidated/pointed.

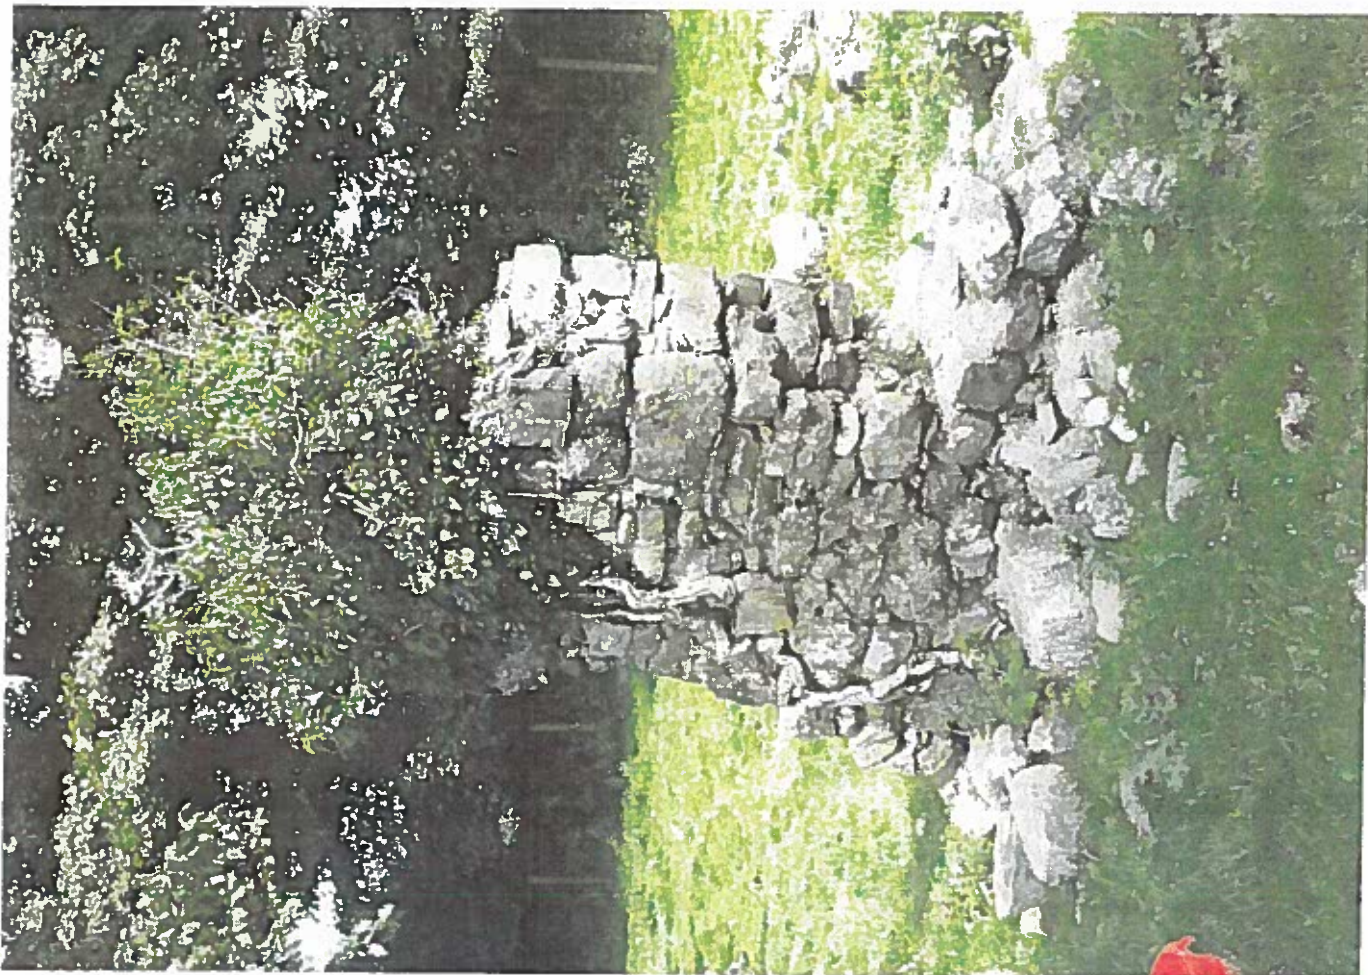
95

Most of these walls are turf covered rubble except the west wall where the standing masonry is important evidence of the original entrance. As with other fragments it has numerous loose stones and open joints and is covered in ivy. Facework survives on the east west and south edges.

Kill the ivy but retain stems that are holding together corework. Point holes and open joints and rebuild corework to support overhanging stones. Record, number stones and dismantle top of wall. Rebuild to original profile and bed both top and corework edges in capping mortar to shed water. The sheds should be removed to a less historically sensitive area.
