## Gilfach-y-berthog, Abergwilli, Carmarthenshire.

### Archaeological Watching Brief

HRSWales  
Report No: 131

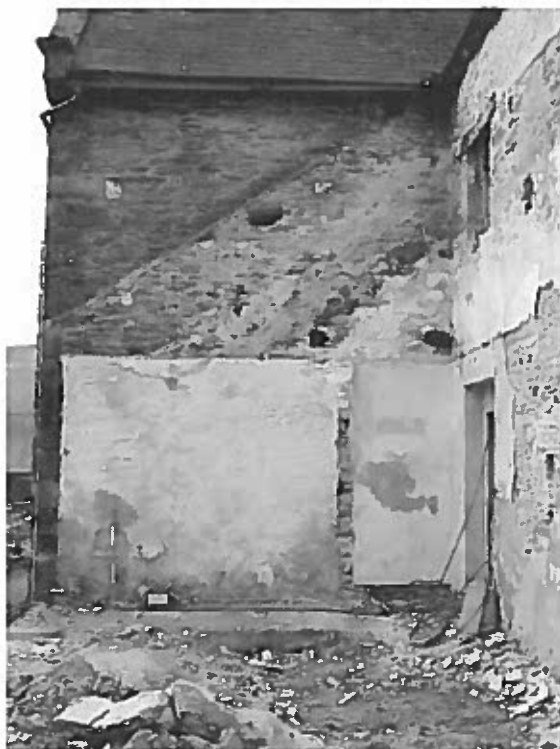
*Plate 82. Gylfach-y-berthog - Former 19th century kitchen extension demolished in preparation for new proposed kitchen extension. Note earlier extension outline. North facing elevation.*
