Talhardd Farm, Llandeilo Rural, Carmathernshire

Building Recording, Archaeological Observation and
Limited Evaluation

Report No. 2002 - 08 - 13

**Standing Building Recording, Archaeological Observation and Limited
Evaluation at Talhardd Farm, Llandeilo Rural, Carmarthenshire**

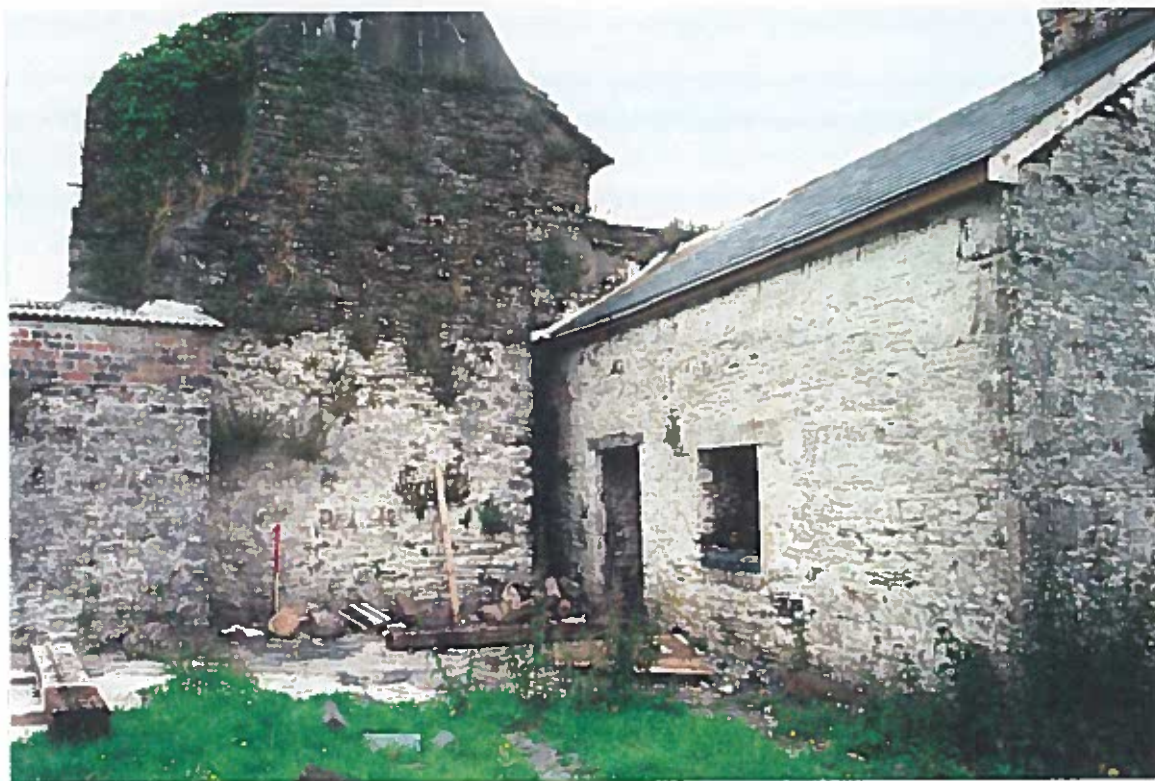
PLATE 6 DAIRY/WASH ROOM ABUTTING THE SOUTHERN GABLE END

modern plaster and a pinkish-red paint topcoat. The fireplace itself was constructed mainly of cut stone [slate/shale]. Externally, this feature, along with the chimney formed an external stack and was recessed from the main building (**Plate 6**). The RCHAM[W] report suggest that it is late Medieval in date.
