Crowback Tumulus Castlemartin Pembrokeshire

Archaeological Survey and Repair

Archaeological Investigation Report

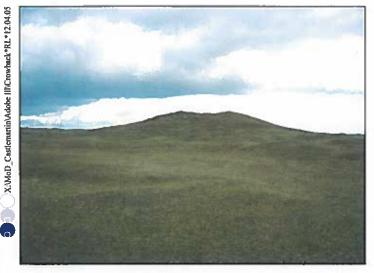
Crowback tumulus, view to the west

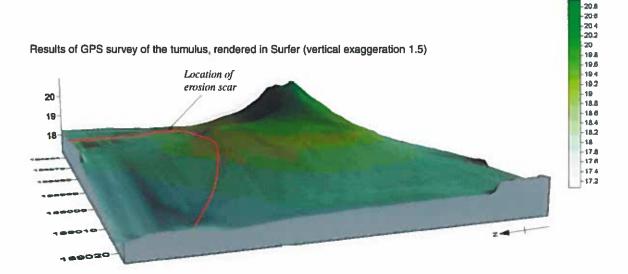
Figure 3: Crowback tumulus - general site views, showing the location of the erosion scar and the 3D survey of the site

- 1.1.2 The work was prompted by the observation of an erosion scar on the seaward (northwestern) side of the tumulus. An area of disturbance could be seen adjacent to the erosion scar, including old timbers dug into the ground, possibly the result of past military training activity. The brief called for a repair to the barrow, combined with work to record the exposed stratigraphy.

Crowback tumulus and full erosion scar, view to southwest
