TRE'R CEIRI
CONSERVATION PROJECT
1989 - 90
PART 1: TEXT

REPORT ON THE FIRST SEASON OF THE
TRE'R CEIRI CONSERVATION PROJECT
DECEMBER 1989 - MARCH 1990

S.D.BOYLE

GWYNEDD ARCHAEOLOGICAL TRUST LTD.

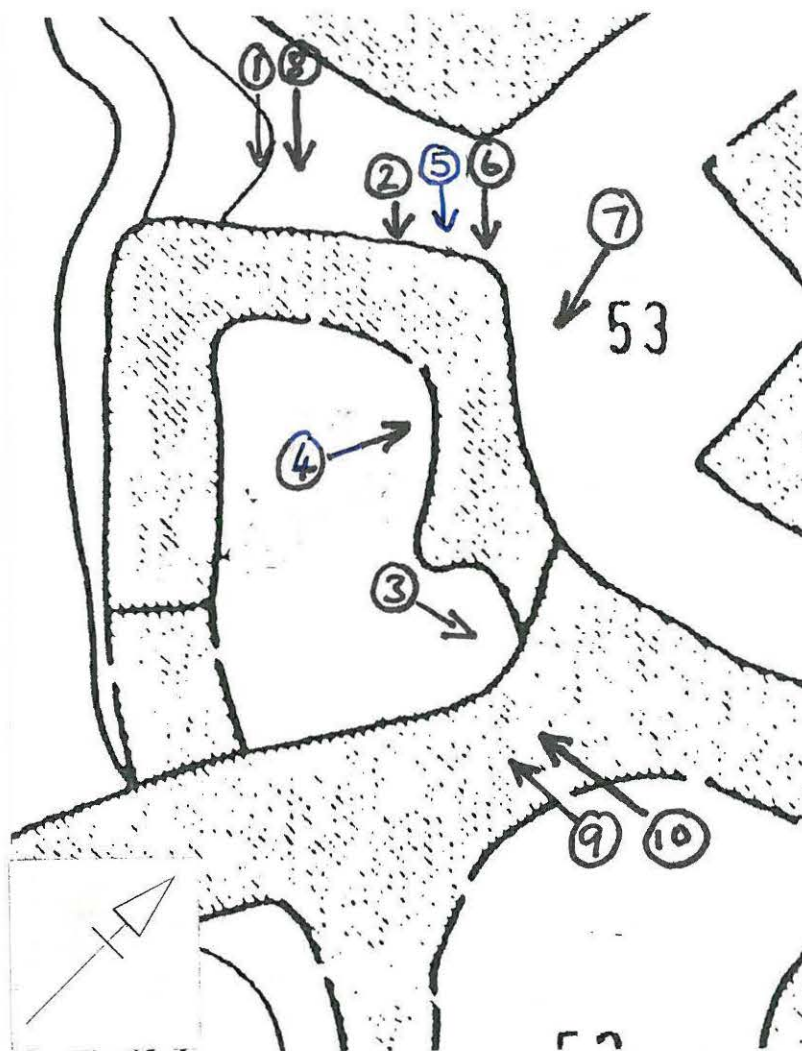
Fig. 6. Hut 86, showing direction of view of Plates 1 - 10.

A sub-rectangular hut on the SW edge of the group. Before conservation (Plate 1) much of the inner facing at the E corner remained standing, but the W end of the SE wall was much ruined and the N half of the NE wall had collapsed completely. The entrance in the NW wall was blocked, although both sides of the passage were visible (Plate 2). The position of the W corner was clear, although the stones were tumbled and spread. The S half of the SW wall was completely turfed over, but Griffiths' suggestion that there may have been an entrance here seems unlikely. In the E corner there was a hole 0.4m deep (Plate 3).

The tumble was removed from the inner face of the N end of the NE wall, revealing a core of large stones. Little remained of the wall face, but the surviving door jamb at the N end of the wall, and two large stones protruding from the core immediately S of this (Plate 4, above and to the left of the scale), indicated a wall thickness of c.1m, narrowing slightly towards the N end, much as planned by Hogg, and these stones were used as a guide

for refacing the 'missing' part of the wall (Plate 5).

The entrance (Fig. 7) was cleared of rubble, and both jambs were uncovered. The E jamb had tilted inwards, and was pushed back. At the inner and outer edges of the entrance flat slabs underlay the walls (the inner one is visible on Plate 5). Between these part of another slab was noted within the passage, 100mm lower down. This was not fully uncovered, but it may be that this hut has a foundation of some depth. Small stones were used to level up the entrance passage (Plate 5).

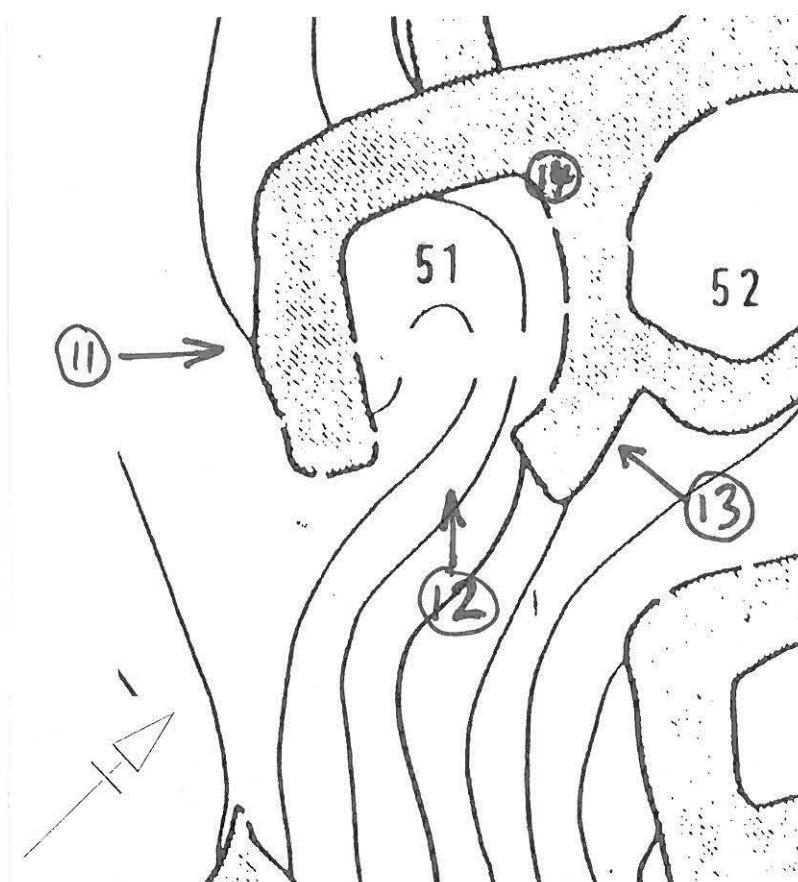
Fig. 8. Hut 51, showing direction of view of Plates 11 - 14.

A ruined hut immediately S of, and abutted by hut 86. The line of the outer face of the SW wall was clearly defined, two to three courses being visible above the heather (Plate 11), and part of the inner face of the NW side also survived. Otherwise walls were represented by no more than a low scatter of stones (Plates 12 and 13). The entrance was in the SE wall, at the S corner. The interior was pitted and uneven, although largely grassed over.

There are no records of any excavation of this hut, although the state of the interior, with holes up to 0.4m deep, would seem to indicate that there has been some illicit digging here. The walls certainly seem to have deteriorated during the last half century. Hughes planned this hut as a rectangular structure, with all inner faces surviving except at the S corner (Fig. 3), and Griffiths recorded both faces of the SW wall standing to a height of one foot (0.3m), although by then the NE wall was ruined. There seems to have been further deterioration during the next decade, as Hogg's plan of the hut shows only the outer face of

For the most part, these low rubble walls were stable, and little work was necessary. Apart from replacing the occasional fallen stone on the NW wall, the main cause of concern was at the N corner, where small core material from the wall between huts 52 and 86 was spilling out into hut 51. Removal of this rubble revealed more of the N end of the NW wall than appears on Hogg's plan, but also threw up a problem, in that two possible lines for the inner face of the NE wall became apparent. One of these was visible before work commenced, and can be seen in Plate 11 towards the top left of the frame, consisting of a short stretch of roughly built wall three to four courses high. The other possible wall face was uncovered during rubble clearance at the N corner. Plate 14 looks vertically down on the corner, with the NW wall running in from the top right. Immediately below the scale, at the base of the rubble, two large stones were uncovered, with roughly flat faces in line, suggesting a wall footing running off to the SE. No attempt was made to follow these footings, as this would have involved the disturbance of too much rubble.

wall it would have been extremely high. However, it was felt that the problem of the loose core material at the N corner had to be addressed, and therefore two courses were built up on the line of the 'broad' wall to prevent further spillage. The result is not wholly satisfactory from either an aesthetic or archaeological point of view, and in discussions on site Dr. Yates has expressed a preference for the narrower wall, mainly because the evidence for the other wall is so slight. Alterations will be made this summer, and at the same time the holes in the interior will be filled in.

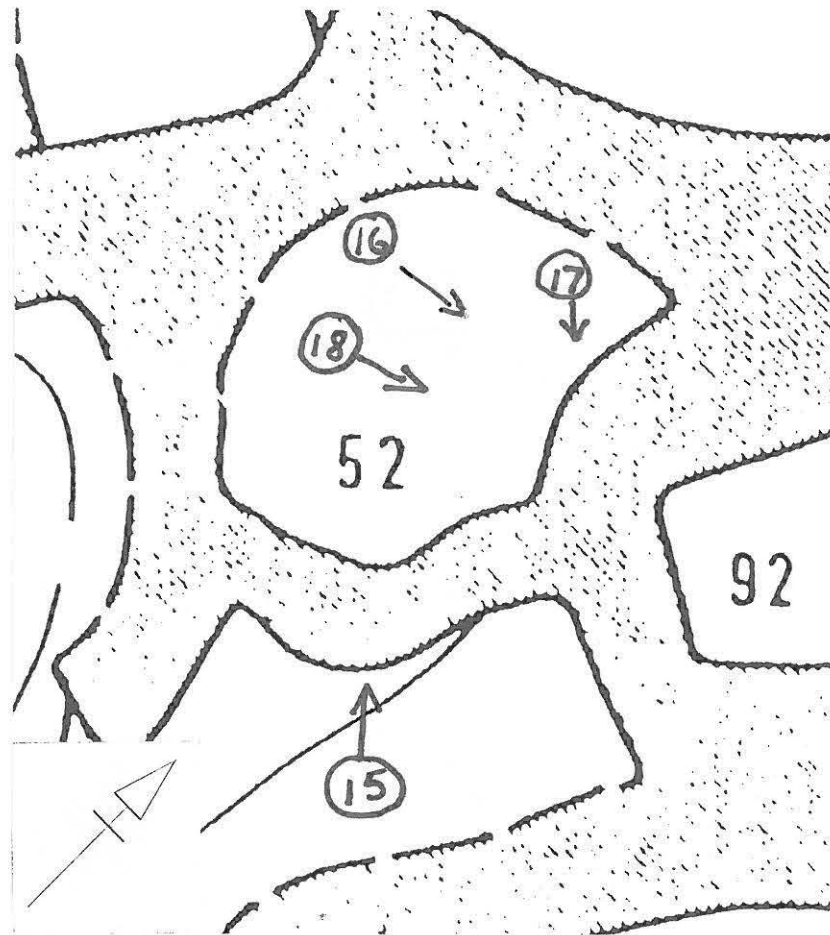
Fig. 9. Hut 52, showing direction of view of Plates 15 -18.

This 'hut' is little more than a grassed over hollow in the space between huts 51, 90 and 92, its shape largely defined by those huts. Only the footings of a SE wall indicate that this was ever a structure in any real sense. There is no record of it being excavated, although in 1956 Hogg apparently sought unsuccessfully to trace the outer face of roundhouse 53/89/90 where it forms the NW wall of this hut (Hogg 1956, 34). Hughes 'dots it in' as a rough circle, and from the descriptions of Griffiths ('perhaps...a circular hut') and Dallimore ('just recognisable as a hollow') its condition does not seem to have changed in the

The common wall with hut 51, to the SW, has been discussed above. Otherwise the walls of the hut, though ruinous, were in no danger of further collapse, except at the SE corner, where part of the outer facing of hut 92 had fallen outwards, exposing loose core material (Plates 15 and 16, on the right of the frame in both cases). Clearance of fallen rubble revealed a well defined basal course of large stones onto which fallen stones were replaced (Plates 17 and 18).

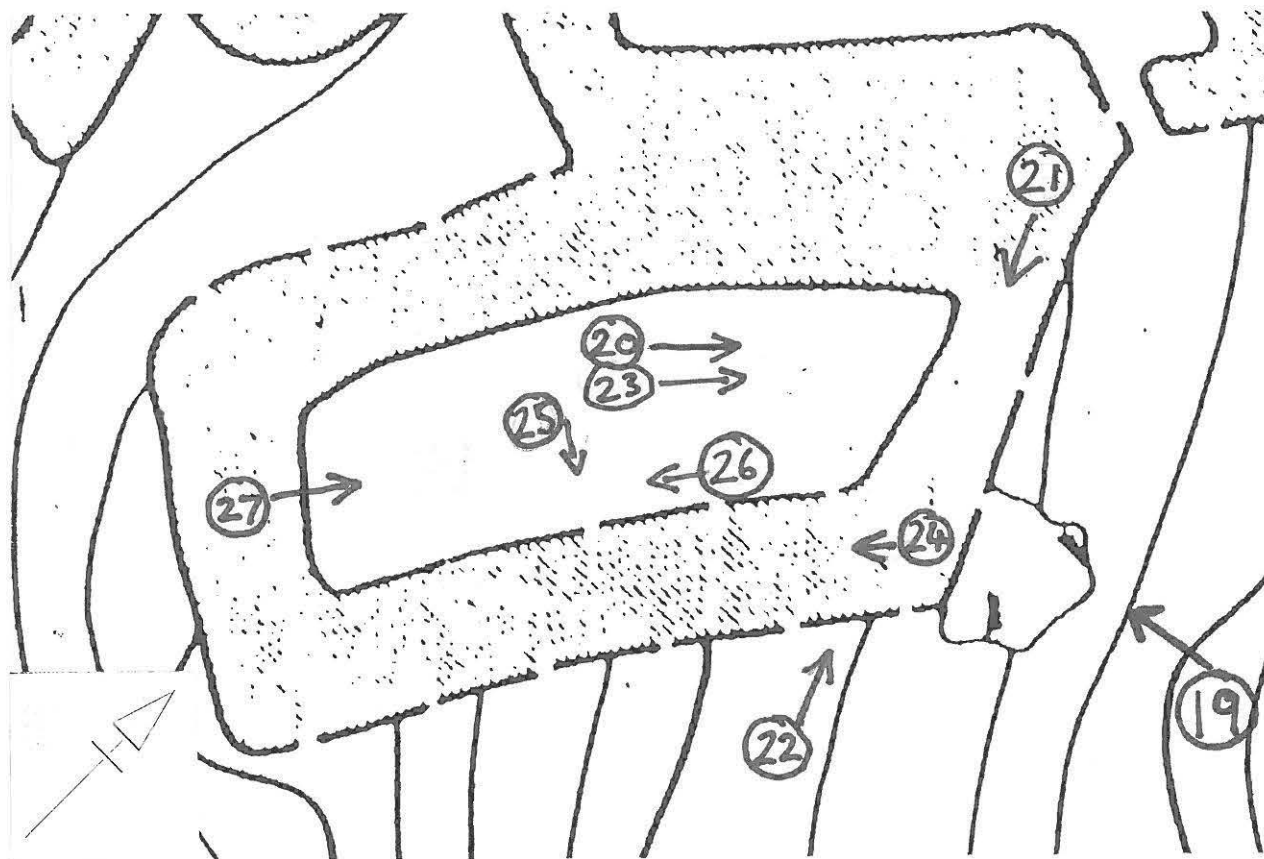
Fig. 10. Hut 72, showing direction of view of Plates 19 - 27.

A sub-rectangular hut on the SE edge of the group (Plate 19, left of picture). The NW wall survived to a height of c.1m, but only the footings of the SW and NE ends survived. The ground outside to the SE was up to 0.7m higher than the interior, so that the much tumbled remains of the SE wall appeared as little more than a revetment to the slope. The ground within was uneven, the level in the middle of the hut being 0.6m lower than at either end. There was no clearly defined entrance.

The other part of this hut needing attention was halfway along the SE side wall, where there was much loose tumbled stone (Plate 24, centre-right of frame), some of it recently collapsed, judging from the unweathered state of the exposed core material. Clearance of the fallen stones revealed a mass of small core material, too much to have come from the SE wall alone, as an unsuccessful attempt to use the fallen stones to continue the line of the wall confirmed. Before work began the masons had suggested that the tumble came not from the SE wall but from a partition jutting into the hut, but there was insufficient visible evidence to warrant building such a wall at the outset. When the heather was cleared away, however, evidence for a cross-wall 0.8m wide was found, consisting of two edge set slabs jutting out from the SE wall with a large boulder, lying at an angle, immediately beyond them (Plate 25). Although the side wall of the hut was much ruined, it appeared that the cross-wall was of one build with it, the edge set slabs running back into the core.

As there seemed to be little danger of the NW and SW walls collapsing, these were left undisturbed (but see below, under hut 92, for work on the core of the wall between the two huts). Most attention was needed at the NE end, where stones had been dislodged, exposing unweathered core material (Plates 20 and 21). The dislodged stones were replaced and the wall built up high enough (0.5m) to retain the core (Plates 22 and 23). As there was a shortage of stones here (fallen stones now buried in the heather were not dug out) a few slabs were brought from the scree to the NE of hut 74.

The boulder was twisted to provide a level foundation (Plate 26) and the loose stones in the hut were used to build it up to a height of c.0.5m (Plate 27). Dr. Yates and Mr Watkins have observed that, as finished, the gap between the end of the partition and the opposite (NW) wall of the hut is improbably wide, and have suggested that the partition should be 'stepped back' to indicate that it might have continued further across the hut. This will be done during the second season.

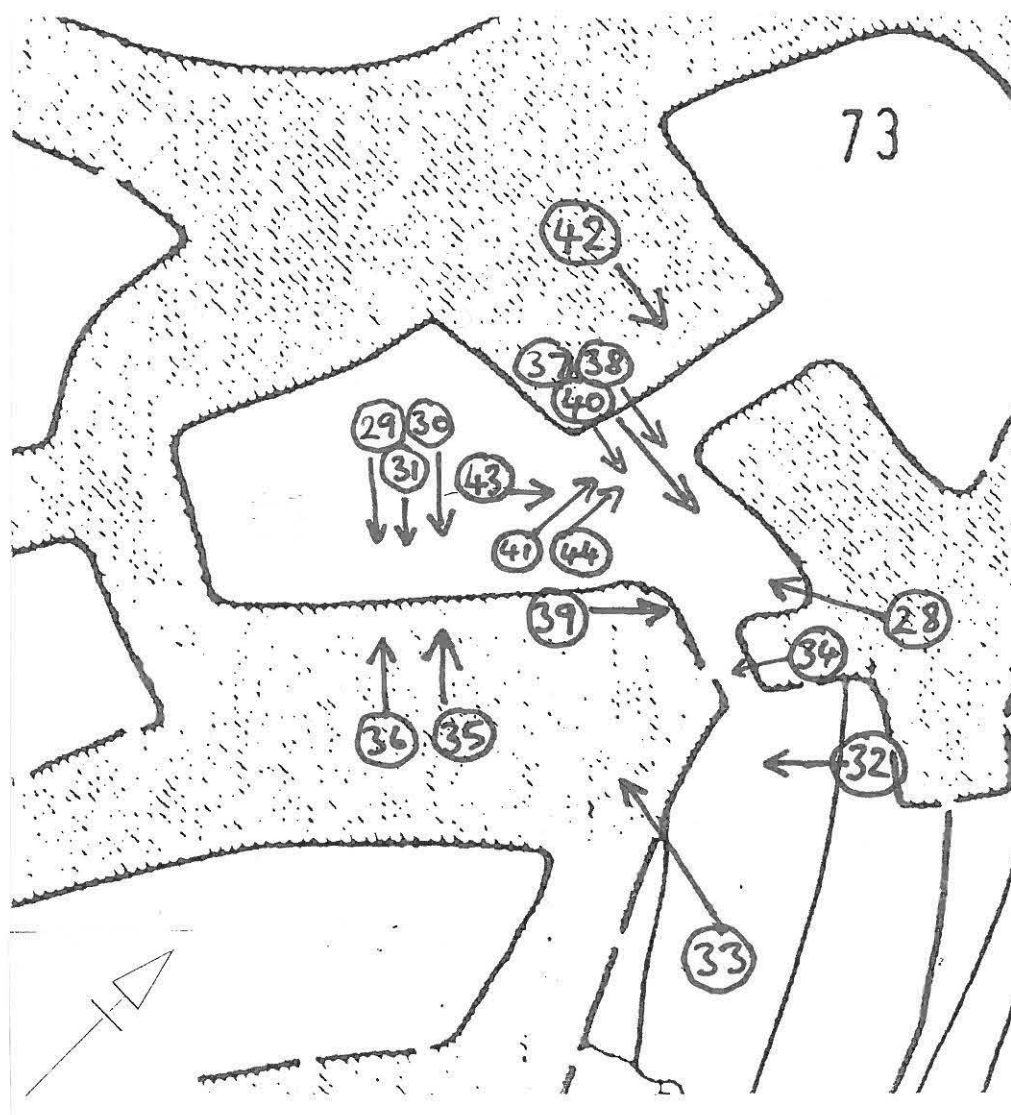
Fig. 11. Hut 92, showing direction of view of Plates 28 - 44.

A well defined hut to the NW of hut 72 (Plate 28). The inner faces of the hut walls stood to c.1.2m high, although part of the SE side had collapsed, and in many other places the facing was loose, buckled and in danger of collapse. The floor was pitted and uneven, with many large stones scattered about on it. There

were two possible entrances, one on the E which was partly blocked with loose stones and into which the S side of the passage had collapsed, and a possible second entrance on the N, leading through to hut 73, much obscured by rubble. The collapse of the outer face of the SW end has already been discussed under Hut 52 (above p.15).

The collapsed central stretch of the SE wall was addressed first. The rubble was cleared to ground level and the wall rebuilt using the same stones. It soon became apparent that the stretch of wall immediately to the SE was unstable (Plate 29) and it was decided to remove three to four courses of this in order to establish a good foundation for rebuilding (Plate 30). The whole of the wall was then built up to a height of c. 1.0m (Plate 31) and capped with large flat slabs to stabilise the top. At the same time the top of the outer face of the wall, against which the NW wall of hut 72 had been built, and which had been barely visible before work began, was exposed (compare Plate 32 with Plates 33 and 34).

The S end of the hut, and the NW side wall needed less attention. The upper courses on the NW had started to collapse, and much of the remaining masonry was loose (Plate 35). Stones were straightened here and the facing built up to the height of the core material behind (Plate 36). Otherwise the only work needed was the occasional pinning of voids to prevent further collapse.

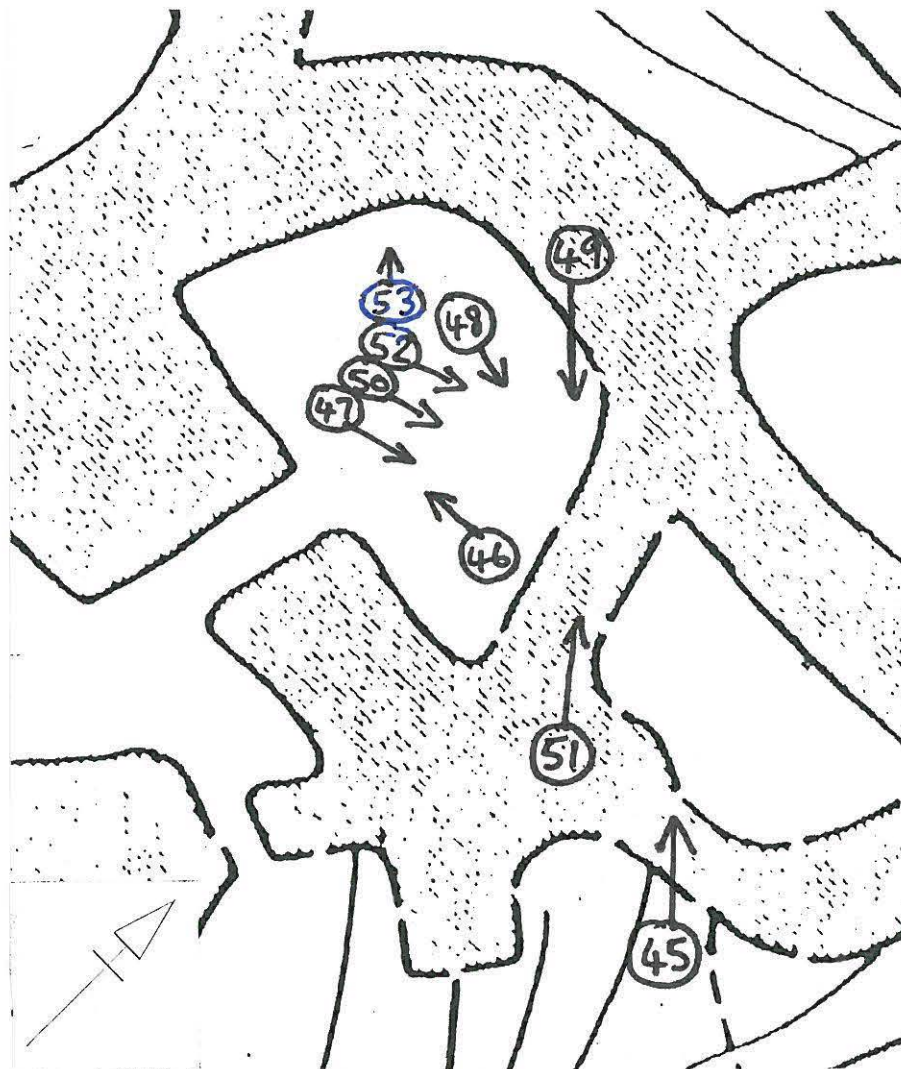
Fig. 13. Hut 73, showing direction of view of Plates 45 -53.

walls in very poor condition (Plate 45, left of centre). There were two possible entrances, one leading from hut 92, which has been discussed above, the other on the NW side of the hut, blocked with rubble (Plate 46, to the right of the scale). The E wall had collapsed totally.

The E wall appeared to have been a revetment built against the steeply rising ground outside the hut. The revetment had totally collapsed, leaving a pile of loose tumble across which a pathway had been worn (Plate 47). As one of the aims of the project was to block off pathways across hut walls, the rebuilding of this wall was called for. The tumble was peeled away but nothing remained of the wall except at its very base, where four large stones were all that remained (Plates 48 and 49). One of these

In general, the other walls of the hut required little attention. Large stones which had been 'squeezed out' were pushed back into position, and occasional fallen stones were added to the wall tops. Immediately W of the main entrance rather more work was needed: the wall here had collapsed (Plate 46, to the right of the scale) and rebuilding the face was necessary (Plate 53). Finally, the rubble was removed from the NW entrance passage, the sides of which were found in place, and only occasional packing stones were needed to stabilise them (Plate 53).

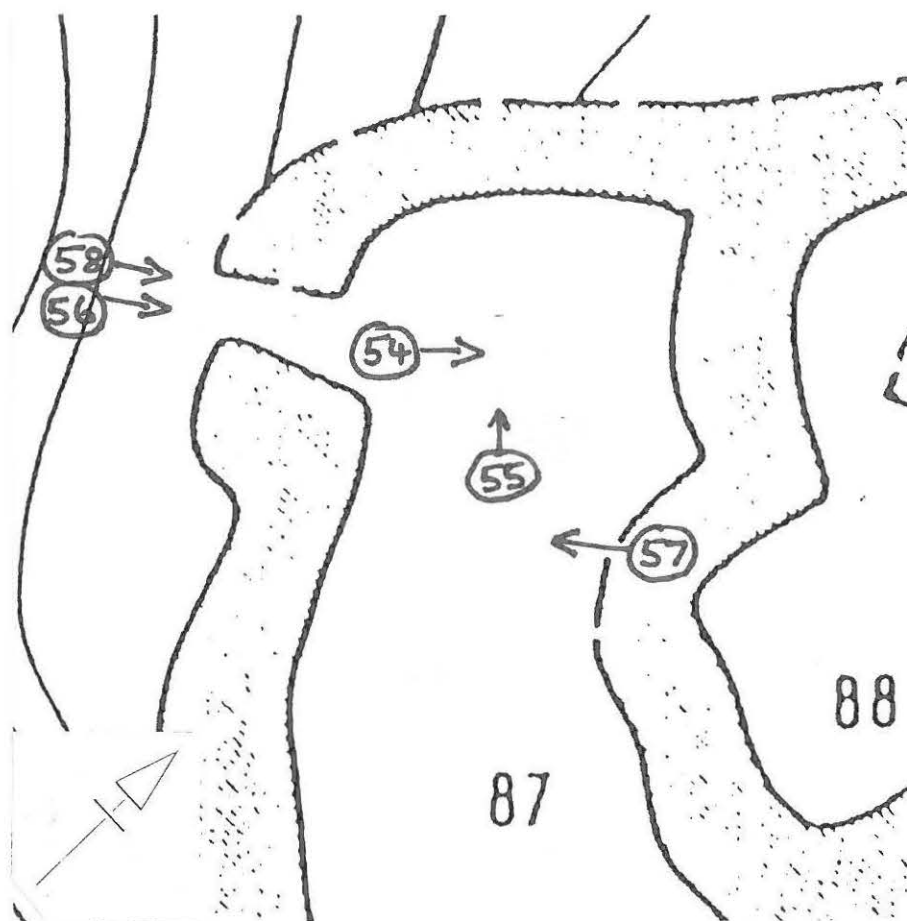
Fig. 14. Hut 36, showing direction of view of Plates 54 - 58.

A small sub-rectangular hut at the W edge of the group. The walls were best preserved on the NE, standing almost 1.0m high (Plate 54). Otherwise they were almost totally ruined, particularly on the NW (Plate 55). Both sides of a blocked entrance were visible in the SW wall (Plate 56).

In 1946 Griffiths described a 'clearly defined' entrance on the SE, leading into hut 87, but this was not shown by Hogg, who planned the SE side of the hut as being entirely open to hut 87 (Fig. 3). There are now only faint traces of this SE wall, almost buried beneath the turf (Plate 57), but inspection of the SW wall of these two huts revealed the outer face of hut 87 turning towards the NW and continuing through the thickness of the wall, demonstrating that 36 had been built against it. The exposed end of this outer face to hut 87 is visible in Plate 57, above the right hand end of the scale.

As the collapsed walls of the hut were not likely to deteriorate further, and as there was doubt about their precise line, it was decided to leave them as they were. The standing portion of the NE wall may need some attention, but this has not yet been tackled. The only work done in this hut was the re-opening of the SW entrance, which involved no more than the removal of rubble, some of which was placed on top of the wall on the E side of the passage (Plate 58).

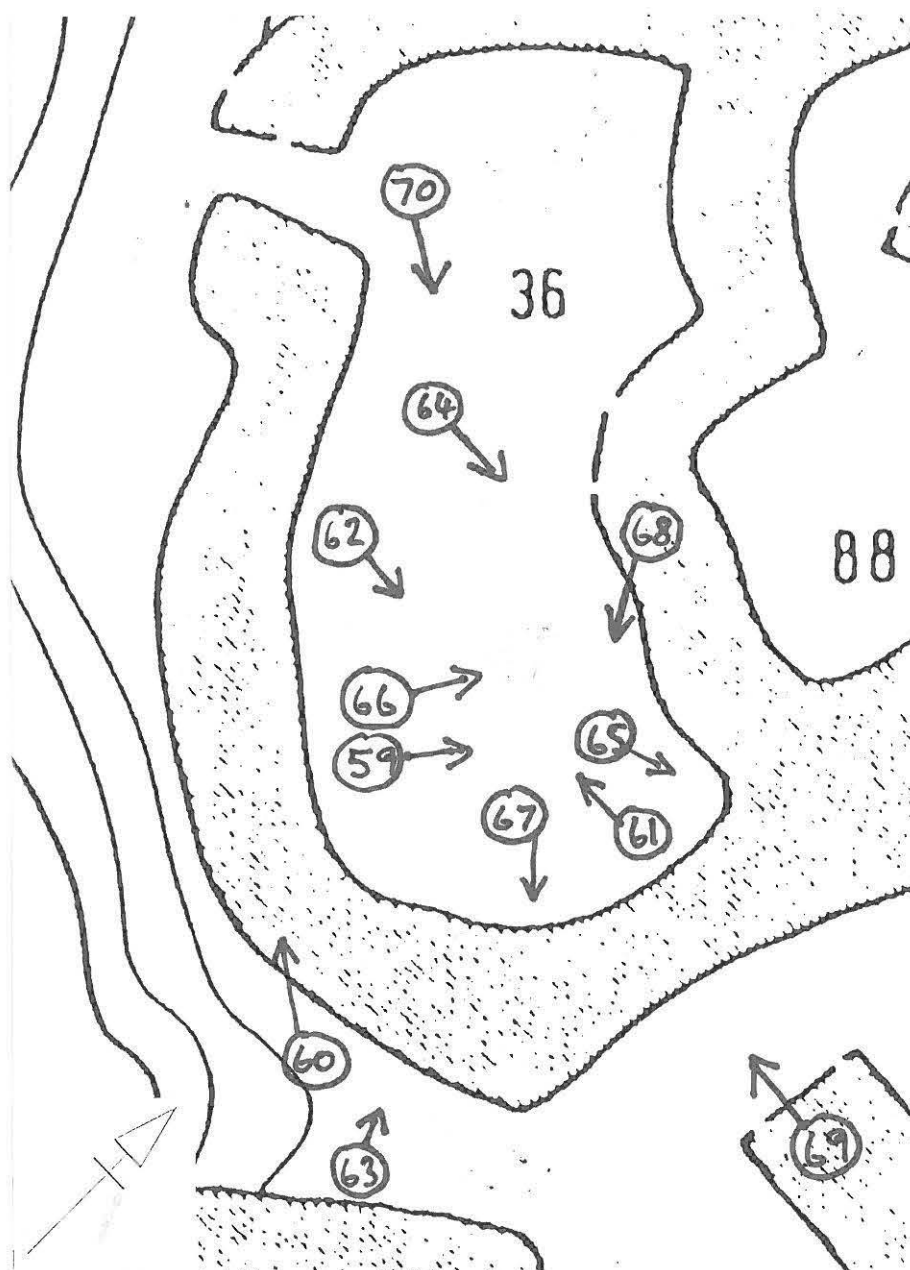
Fig. 15. Hut 87, showing direction of view of Plates 59 -70.

An approximately rectangular hut on the W edge of the group. The facing of the NE wall had collapsed (Plate 59), as had part of the facing on the E side. On the S and SW sides, the footings of the wall remained in place, partly grassed over (Plate 60), though reaching a maximum height of c.0.7m above modern ground level at the W corner (Plate 61). The NW wall has been discussed above with hut 36. The interior was littered with rubble and pitted with holes (Plates 61 and 62).

The collapse was stripped away from the NE wall. Only part of the basal course of the wall remained *in situ* (Plate 64), but this was enough to establish a convincing line for rebuilding. The first attempt at rebuilding this wall was criticised by Dr. Yates

and Mr. Watkins as being unstable, and under their guidance the stone masons made a second attempt at rebuilding. On this occasion more of the core was removed than during the first attempt, revealing part of the outer face of roundhouse 53/89/90 (Plate 65), and thus confirming Hogg's observation (see Fig. 4) that hut 87 had been built against the roundhouse. The second attempt at refacing the wall (Plate 66) proved more stable, and its general style has been approved. The method used to secure the top of this wall is discussed below (page 29).

The facing of the E wall of the hut had also partly collapsed. Removal of the loose tumble at the SE corner showed that the outer face of the roundhouse wall continued into the core (Plate

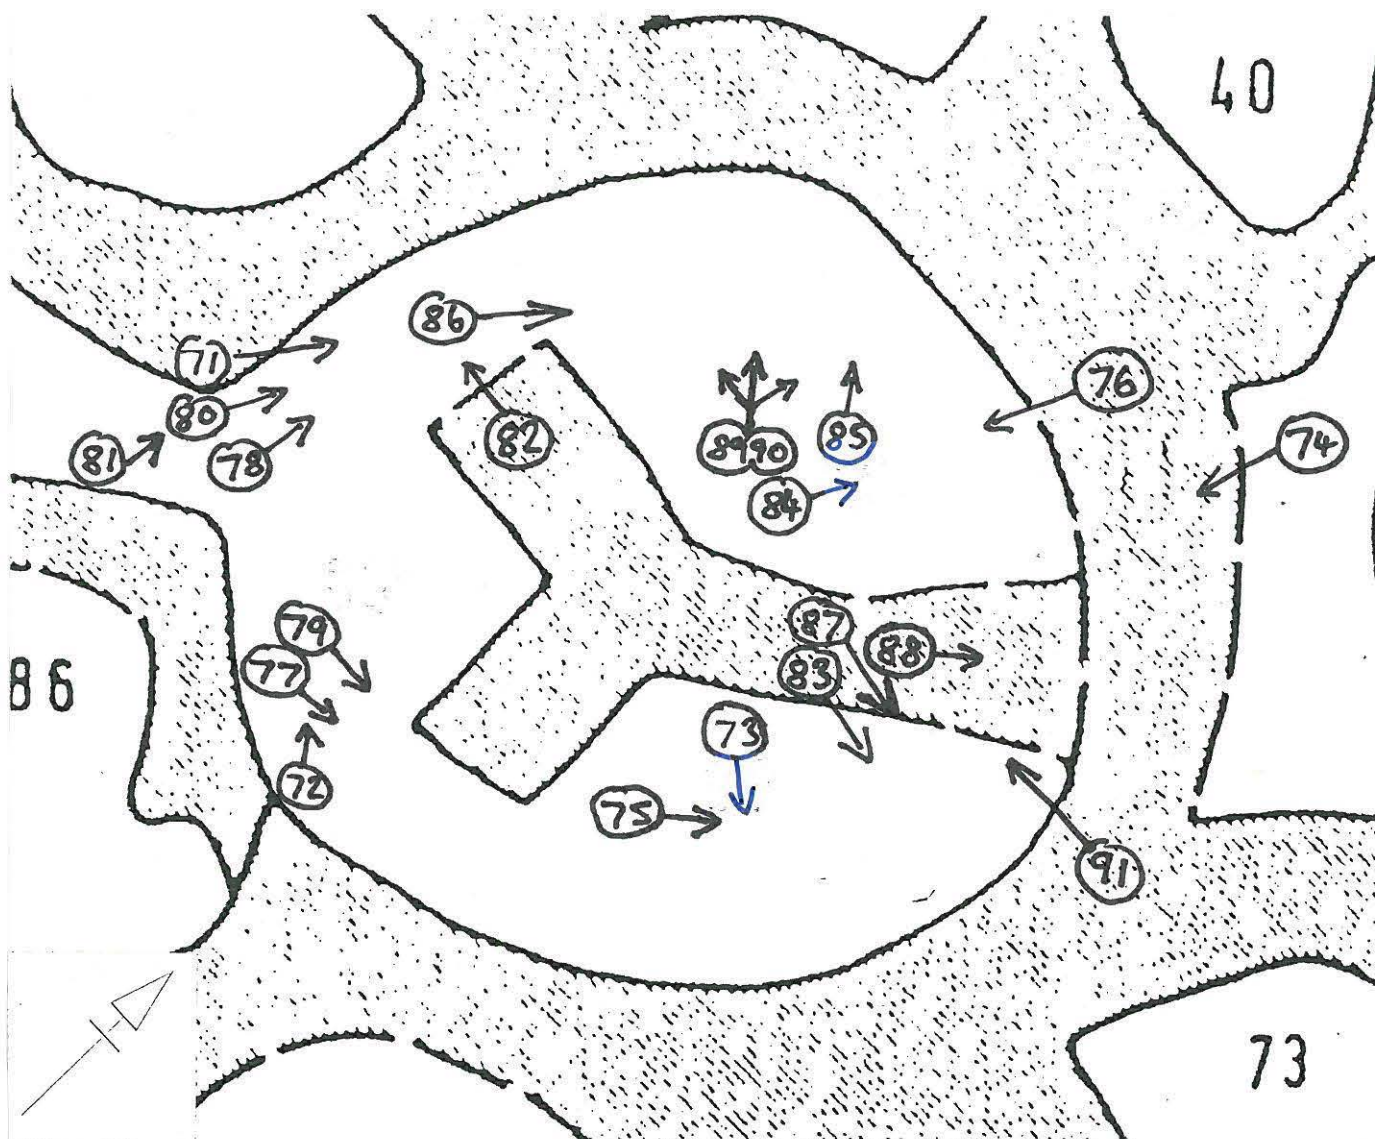
Fig. 16. Roundhouse 53/89/90, showing direction of view of Plates 71 - 91.

These three 'huts' are subdivisions of one large roundhouse, and can be discussed together. The roundhouse measured approximately 7.5m in internal diameter, divided into three by a Y-shaped partition. Before conservation the best preserved stretch of wall was around the NW arc, which stood to about 1.0m high (Plate 71). On the W and SW sides the wall was much spread, and partly obscured by tumbled stones (Plate 72, left of picture), while on the SE side the wall, although in poor condition with much of the facing displaced, remained to a height of 1.0m (Plate 73). On the E, at the rear of the roundhouse, the wall had totally collapsed (Plates 74 and 75). The partition was of poorer quality than the outer wall, its construction employing fewer large blocks of stone. It stood just over 1.0m high, but it was much spread, appearing at first sight as little more than an amorphous pile of loose rubble (Plate 76).

None of these fieldworkers seem to have recognised the true nature of these huts: it was not until Hogg's excavations that it was demonstrated that together they formed part of a single roundhouse (Hogg 1960, 32-34). Indeed it appears that in 1903 the rear (E) wall of hut 89 was rebuilt too far to the W, thus

rubble revealed that only the basal course of the W wall survived (Plate 81, to the right of and parallel to the scale) but this was enough to provide a foundation for rebuilding. It is worth noting that at the S edge of the jamb, the foundations did not continue precisely the curve towards the SE, as planned by Hogg (Fig. 4), but flattened out slightly, running due south. Rather than attempt a correction of what may have been an error in laying out the hut, rebuilding followed the line suggested by the foundations. The resulting kink can be seen in Plate 69, immediately to the left of the rebuilt jamb.

Little remained of the jamb itself. In Plate 82 rebuilding has already started: the two stones in front of the scale have been placed to provide a secure foundation. Immediately in front of these can be seen the tops of two edge set slabs which provided a convincing front edge, and suggested a width for the jamb of c. 1.0m, which agrees closely with Hogg's plan. The edge set slabs were set so firmly into the ground that they are unlikely to have been inserted in 1956, and it seems safe to assume that they are original.

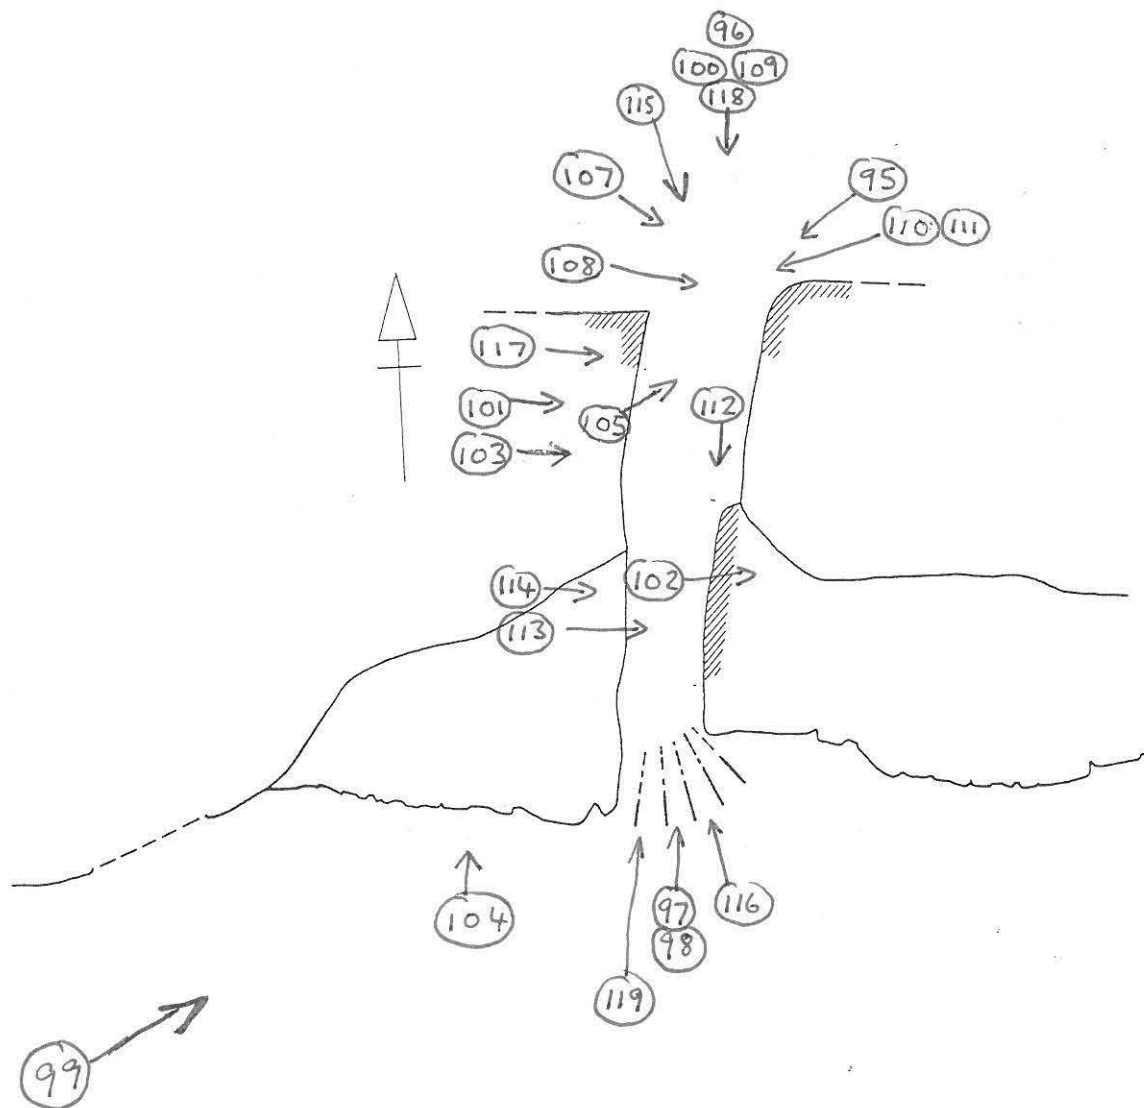
Fig. 18. North Postern, showing direction of view of Plates 95 - 118.

In 1946 Griffiths measured the height of the front of the passage at 4ft. 6in. (1.37m) but by 1989 the height of the opening above the rubble was no more than 0.8m. One cannot know from which point Griffiths took his measurement, but comparison of a photograph taken during the 1956 excavations (Plate 95) with one taken in 1989 (Plate 96) showed that there had been further collapse in recent decades. The condition of the inner end of the passage had changed little since 1956 (compare Plates 97 and 98).

Against the inner face, to either side of the entrance, was an additional tier or step. Slight excavations in the late-nineteenth century by Prichard (1887, 257) established that this had been built against the face of the main rampart, and the excavator suggested that it might have been added as a buttress. Griffiths, however, thought that it might have been built to provide access to the wall top, and this interpretation was followed by the Royal Commission, who identified it as one of a number of 'sloping ramps' leading to the wall walk (R.C.A.H.M. 1960, 102). Before conservation this feature was much obscured by tumble, but there was no visible evidence that it sloped up to join the wall walk at any point (Plate 99).
