YMDDIRIEDOLAETH ARCHAEOLEGOL GWYNEDD GWYNEDD ARCHAEOLOGICAL TRUST

REPORT ON THE FOURTH SEASON OF THE TRE'R CEIRI CONSERVATION PROJECT JUNE TO NOVEMBER 1992

PART 1: TEXT

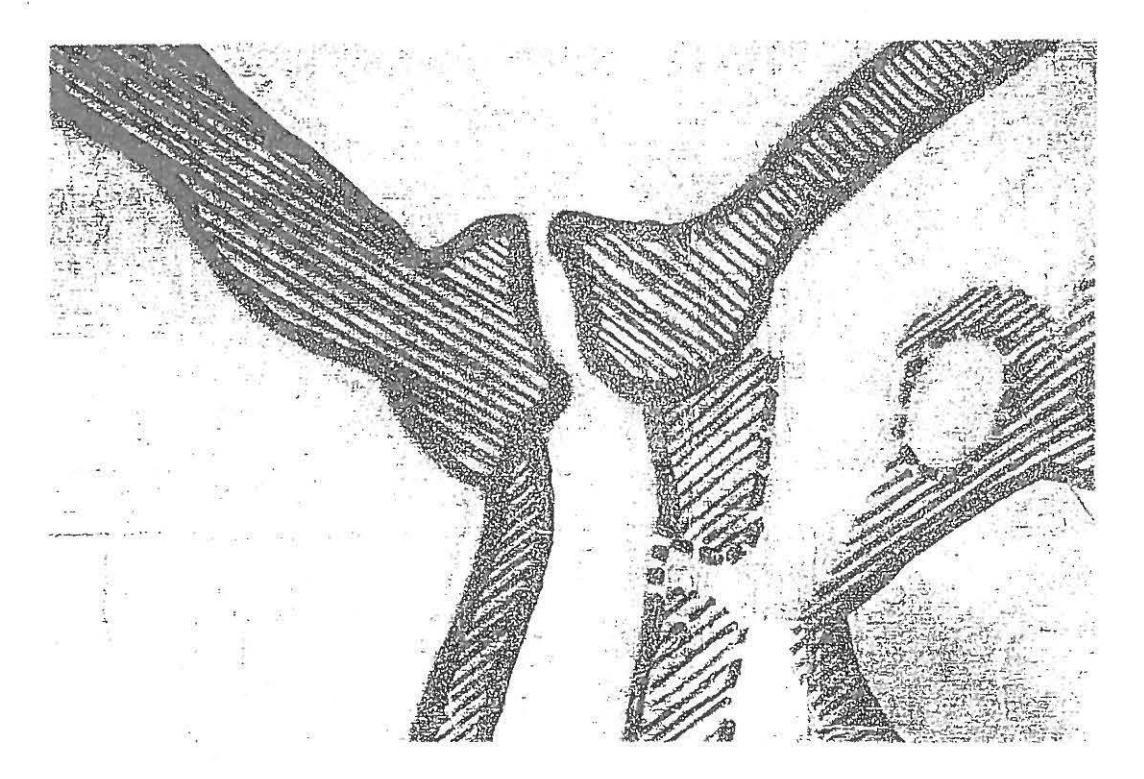
Fig. 10. South-west entrance (Hughes 1906)

The northern corner of the passage had partially collapsed (A7). 1m of facing at the inner end of the passage was standing up to 0.3m above the collapse and a large amount of stone had fallen into the passageway (Plate 95). It was therefore decided to clear the passage floor and collapse EE1 at the same time as A7. 2.8m of facing on the south-eastern side of the passage, including the inner corner, had been lost (EE1, Plates 92-94). It was generally assumed that the passage widens to about 2m at its inner end, indeed a small stretch of unweathered facing similar to upper A5 was standing here (Plate 93). This was obviously a recent rebuild, the stones were small and it was standing on tumbled core. Hughes, however, in 1906 cleared the passage 'sufficiently to ascertain its plan' and uncovered 'some stones low down, which in all probability, indicate the outline of the wall; though on the other hand, they may form portions of a rough paved way'. These stones suggested that the entrance narrowed to 2 ft (Fig.10).
