# TRE'R CEIRI IRON AGE HILLFORT MANAGEMENT PLAN

Ymddiriedolaeth Archaeolegol Gwynedd Gwynedd Archaeological Trust Ffordd y Garth, Bangor, Gwynedd

by D. Hopewell with appendix by G. Smith

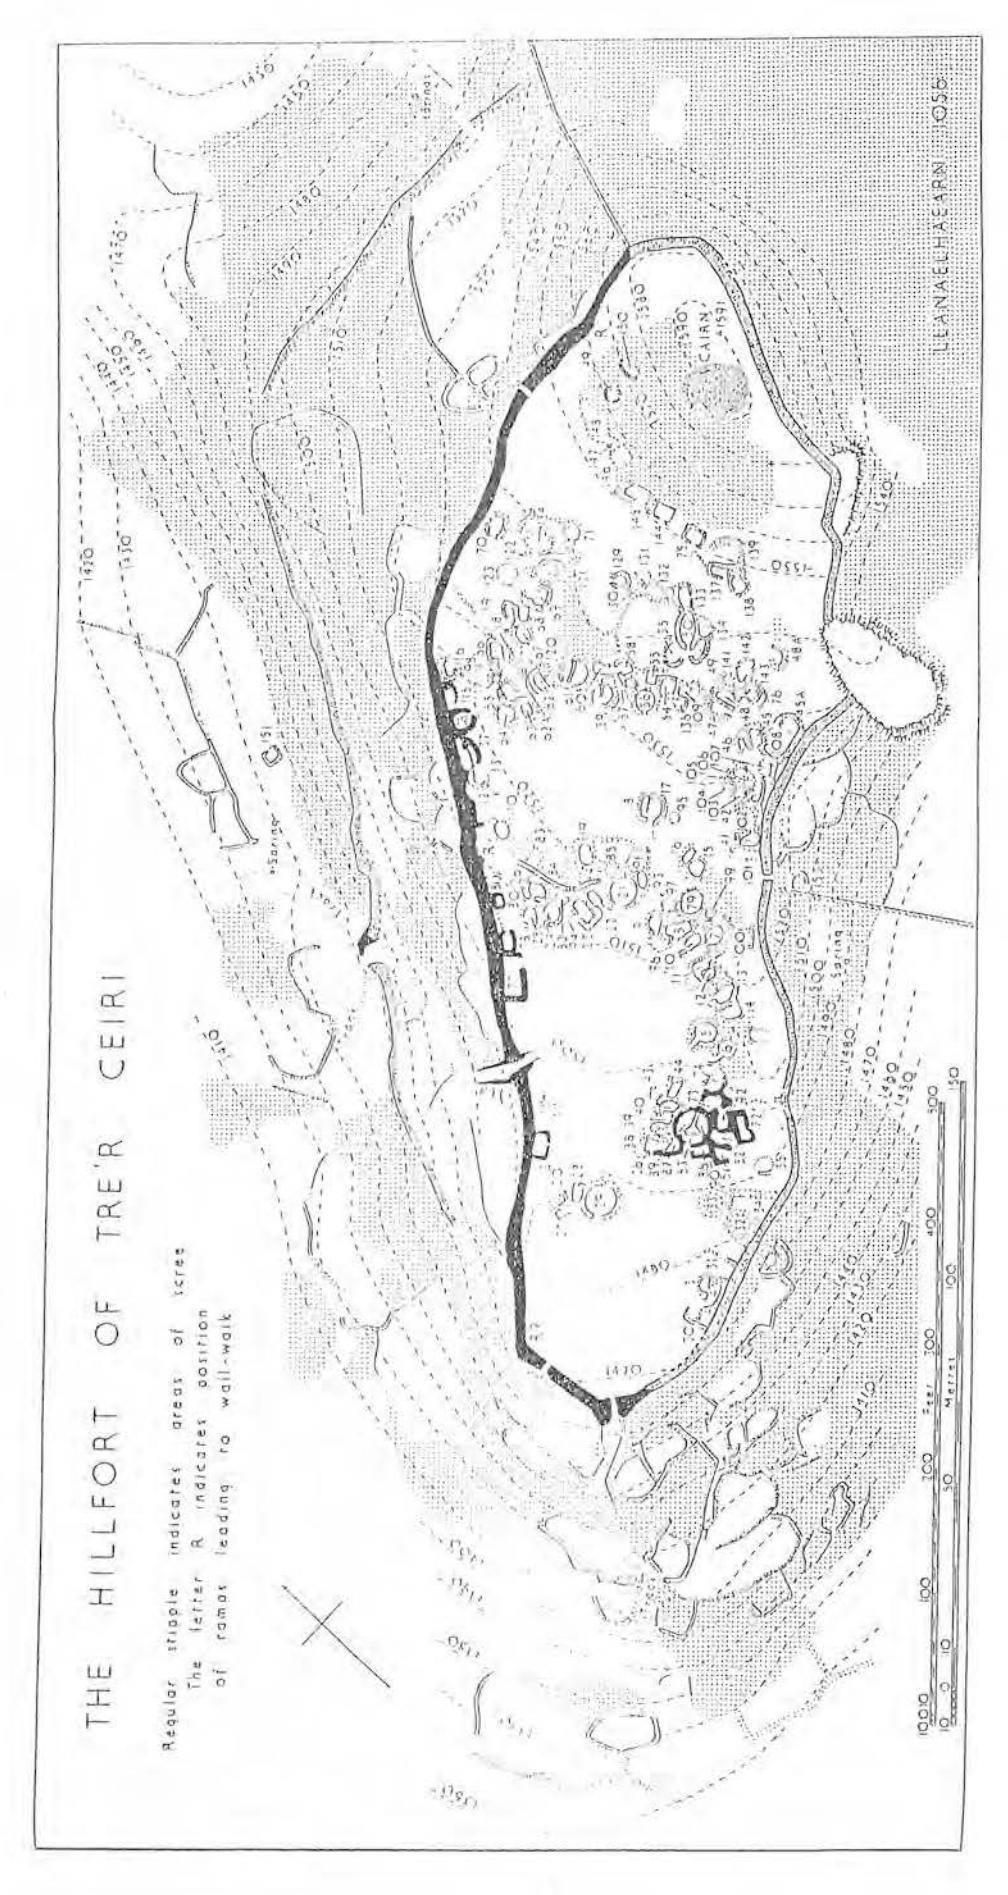
Fig. 2 Areas conserved, 1989 to 1993.

The 1993 season marked the end of the initial five-year project. Works have mainly been concentrated on the inner rampart and the huts abutting it (fig. 2). In addition to this, 11 huts in the interior of the fort have been conserved and the entrance through the outer rampart has been stabilised (fig. 2).

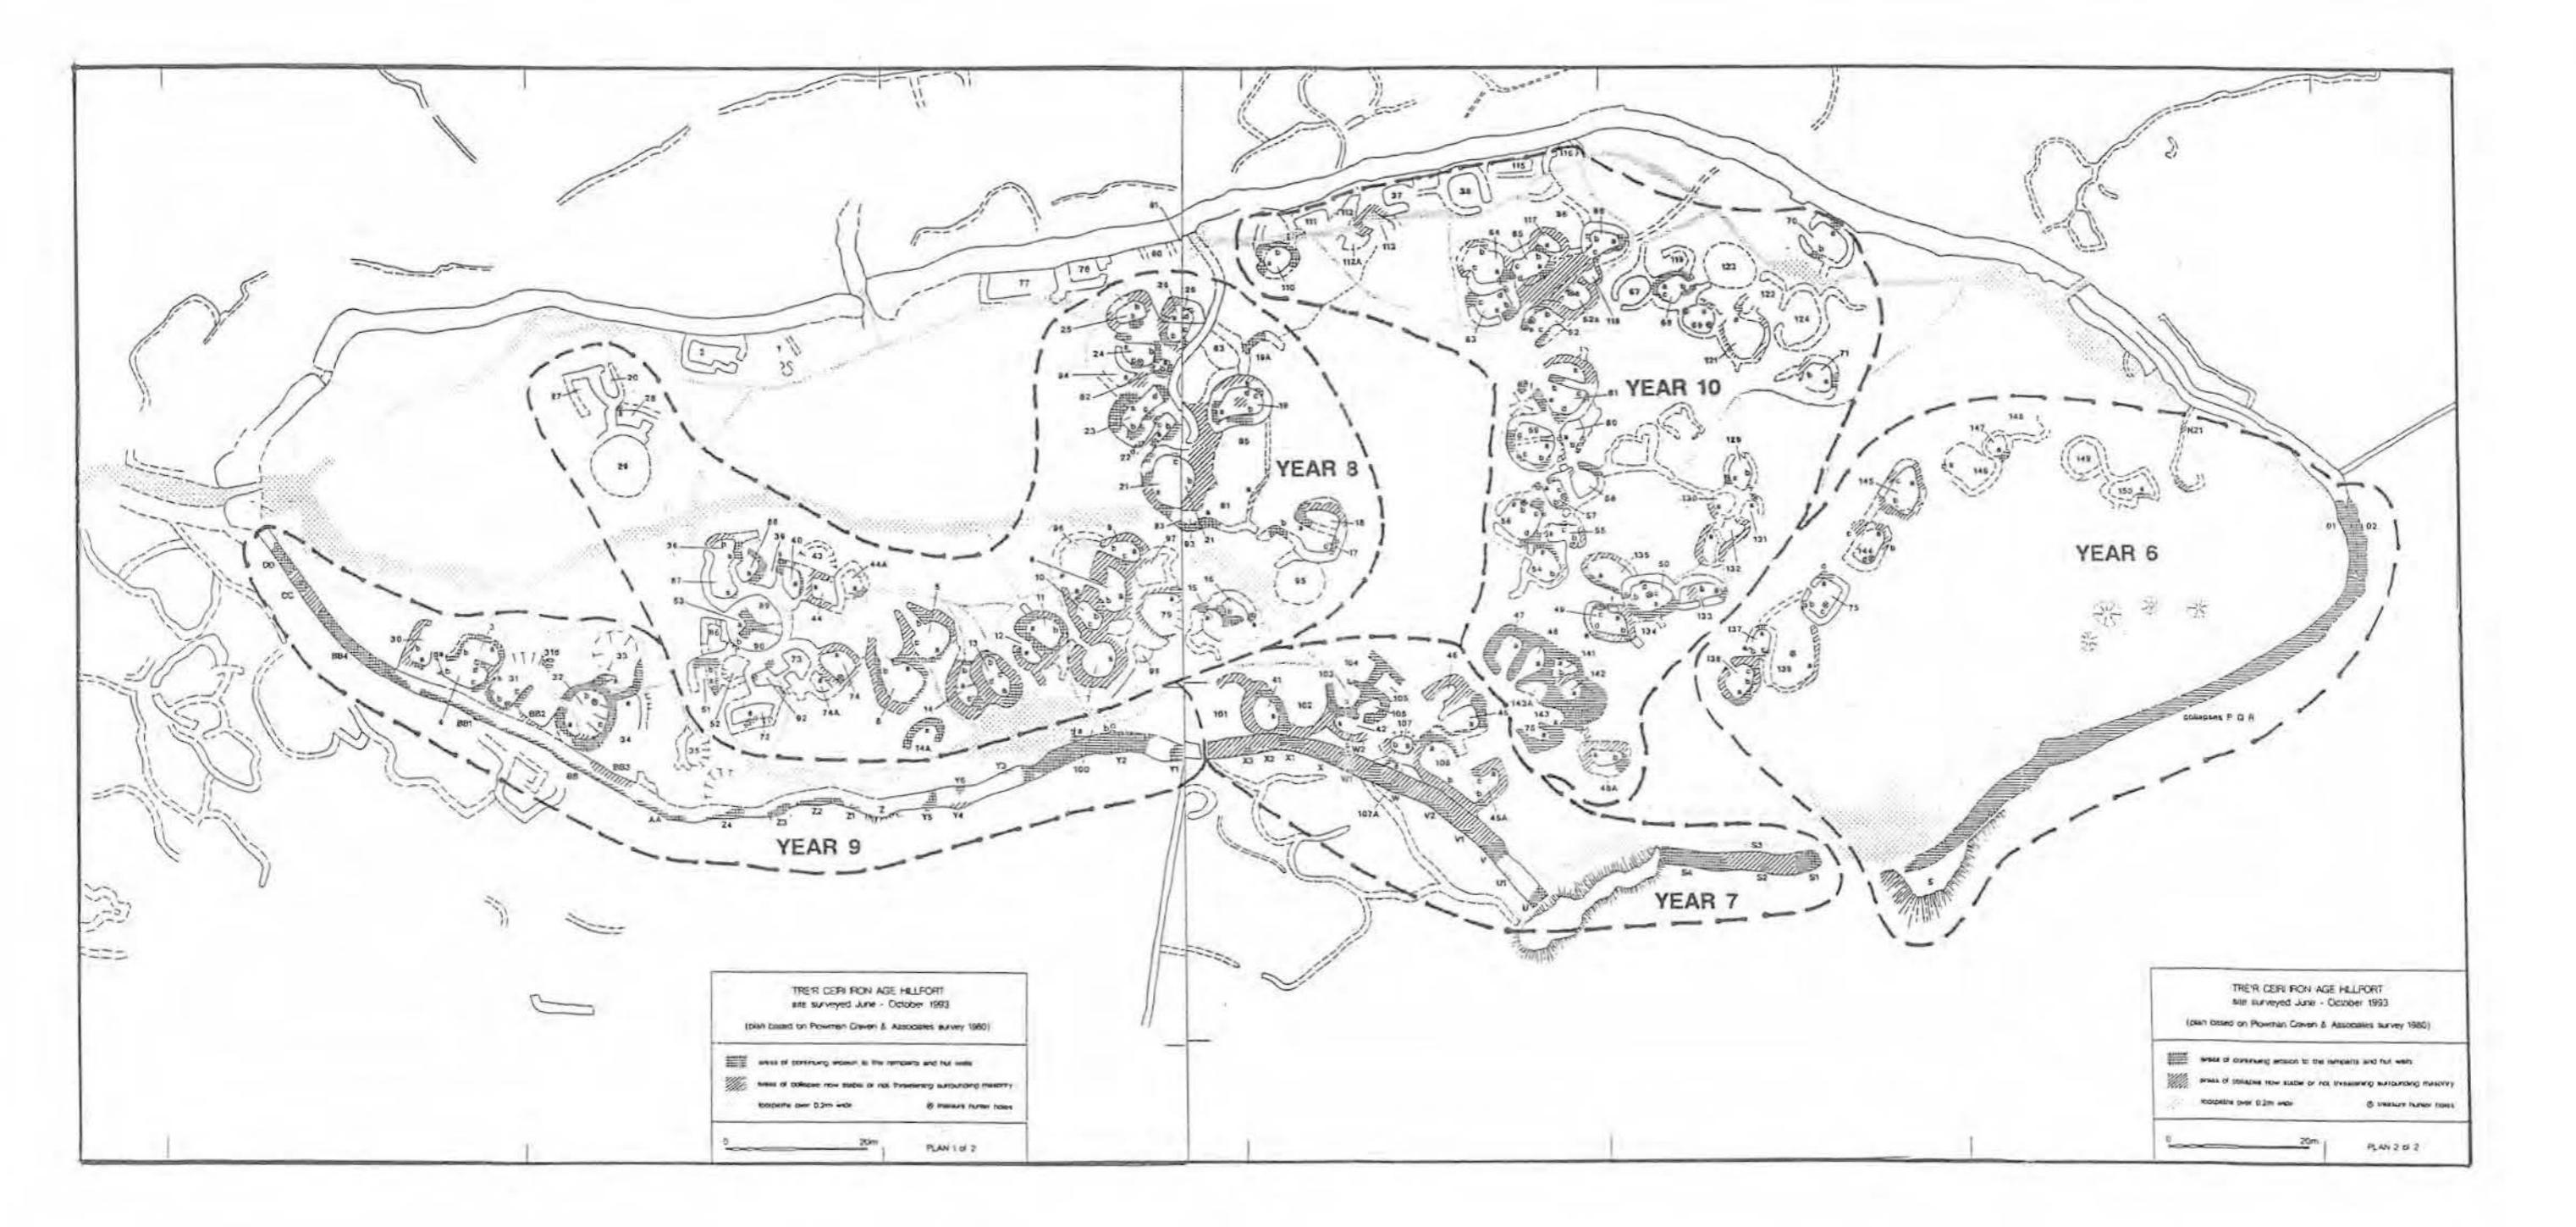
The areas designated for conservation in years 6 to 10 are shown on fig. 6.

Fig. 6 Tre'r Ceiri, areas designated for conservation in years 6 to 10.
