Report on the Third Season of the Tre'r Ceiri Conservation Project May to October 1991

Part 1: Text

S. D. Boyle

Ymddiriedolaeth Archaeolegol Gwynedd Gwynedd Archaeological Trust

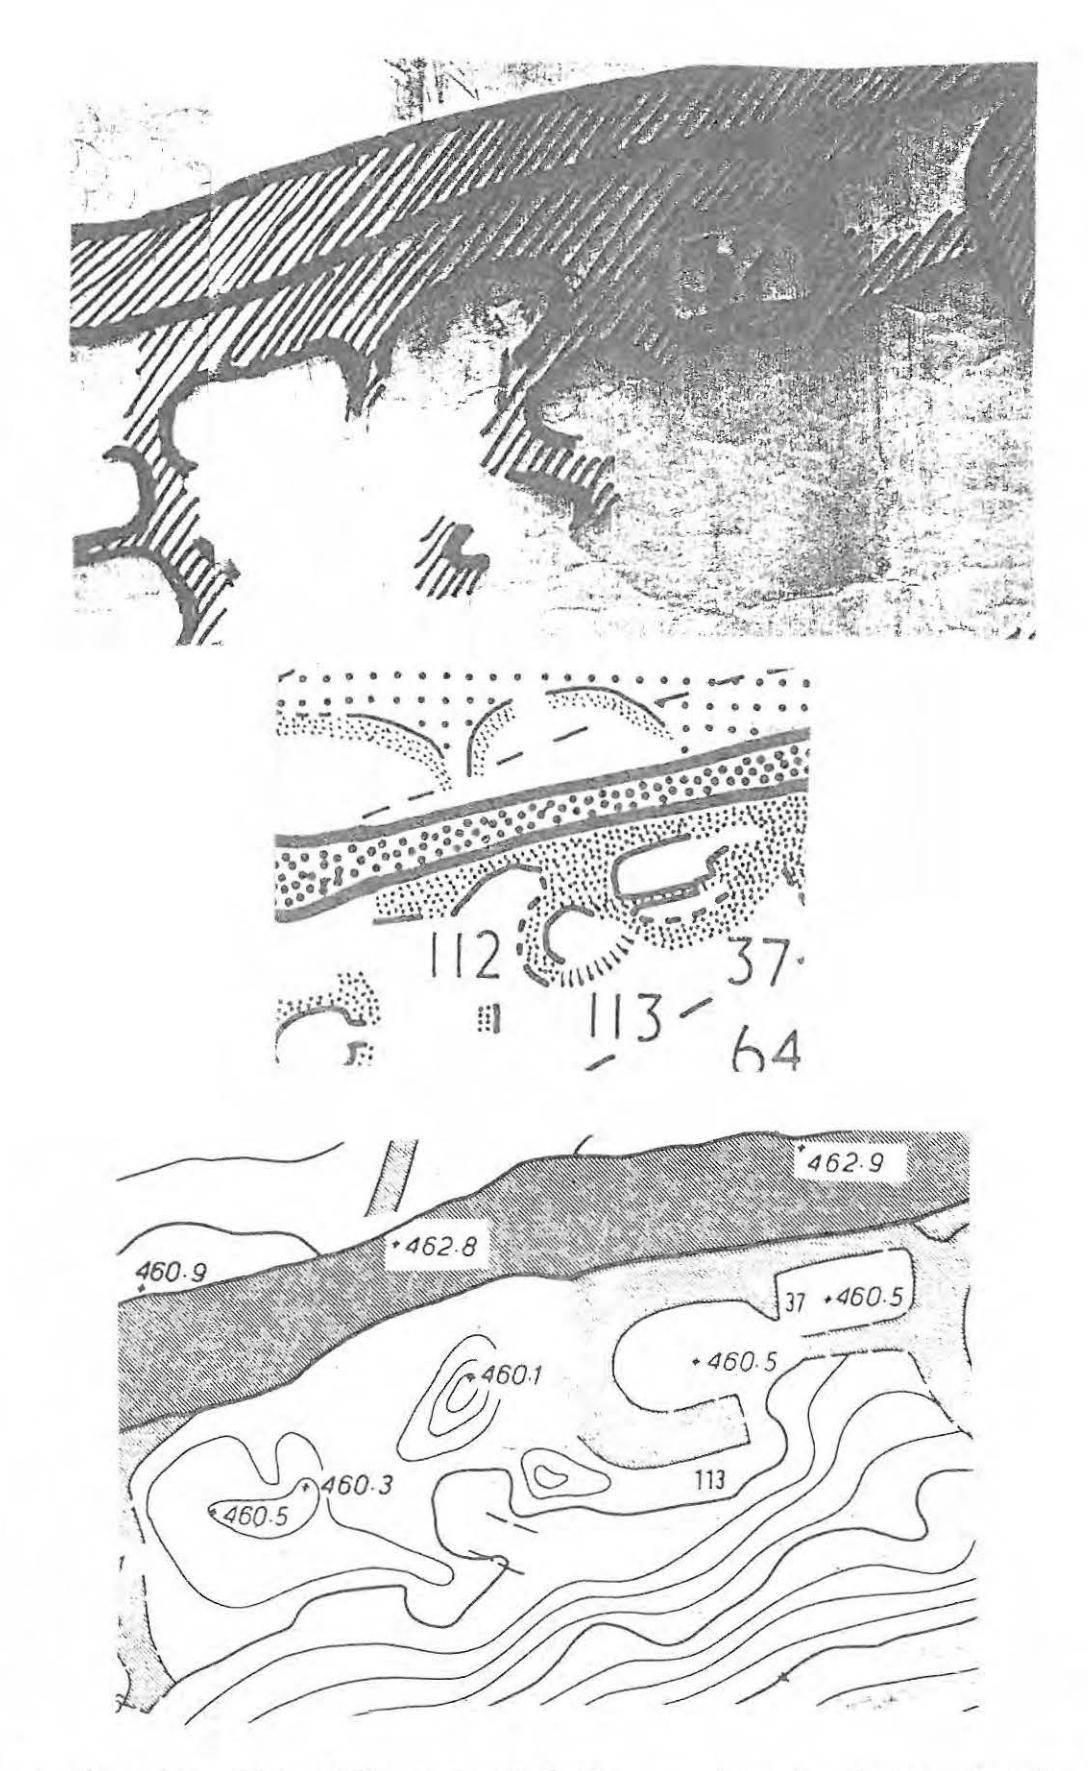
Fig 4. Huts 111, 112, 112A, 113, 37 & 114, as shown by Hughes, RCAHMW and Plowman Craven.

This group of huts is depicted quite differently on each of the three surveys of the fort (see Fig 4). The visible remains are complicated, with walls in some places reduced to spreads of rubble, in others turfed over. A footpath now runs through these huts, and before the 1991 season the collapsed rubble in front of Collapse I, at the west corner of Hut 111, was used as an access over the fort wall. It was impossible to reconcile the various drawings of these huts, so a completely new plan was made before conservation work began. A simplified version of this is shown on Fig 5. Areas of stone are shown cross-hatched, and the footpaths are stippled. Otherwise the area was overgrown with heather and bilberry.

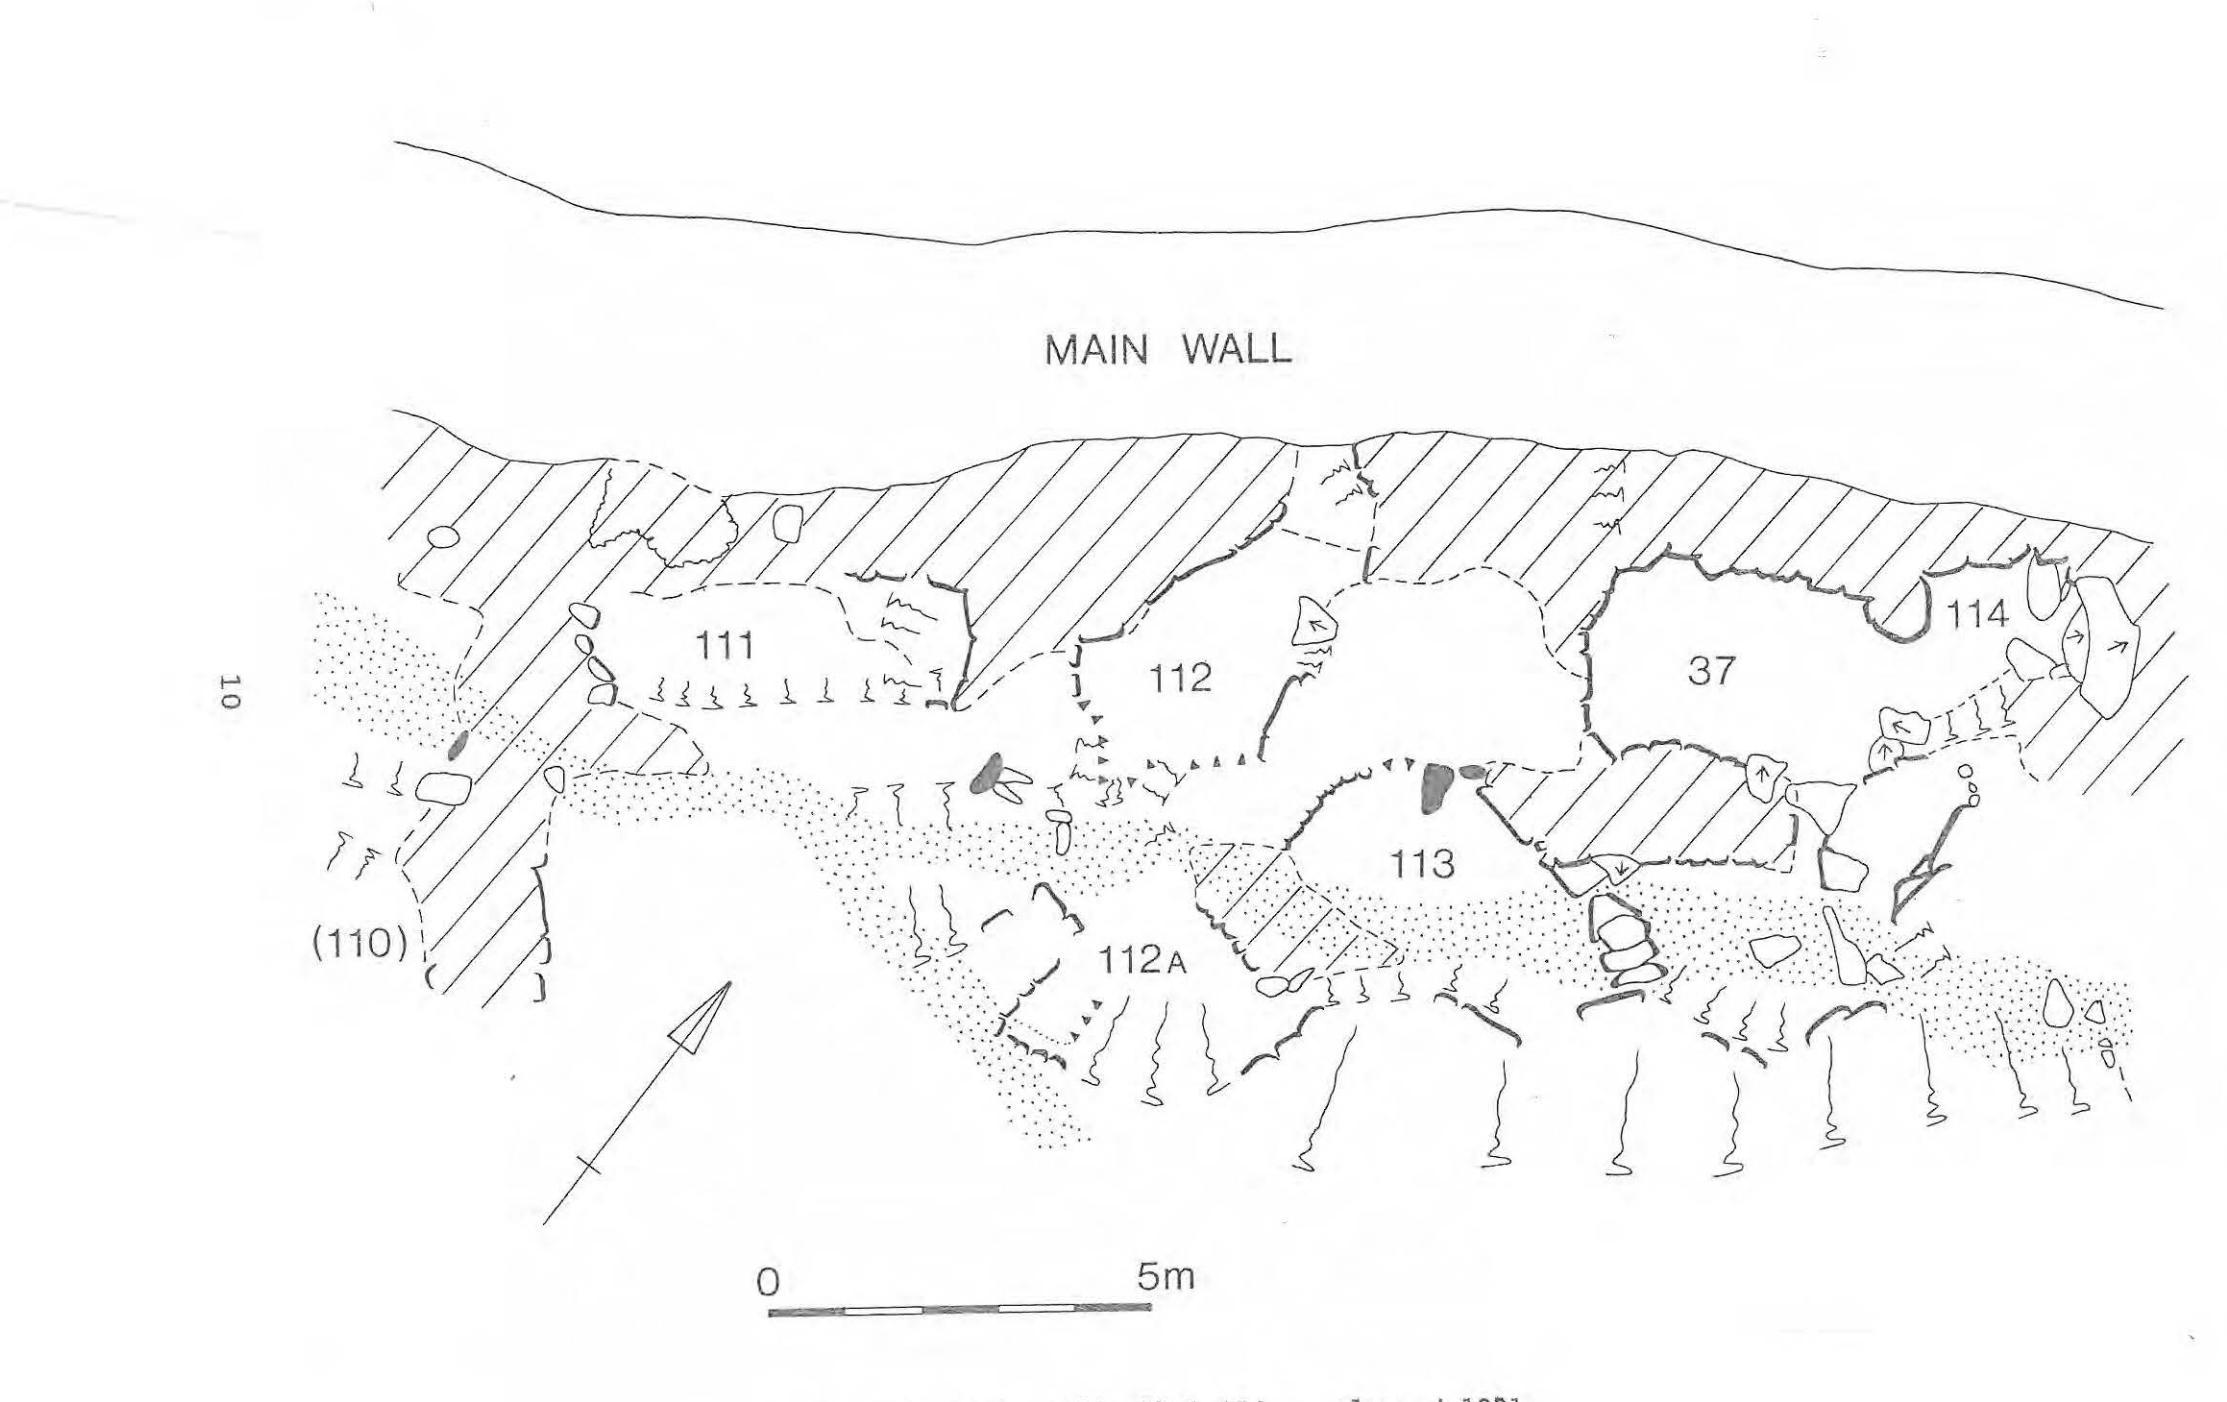
Fig 5. Huts 111, 112, 112A, 37 & 114, replanned 1991.

Before conservation the hut was fairly clear (Fig 5). The inner face of the north-east wall stood 0.7m high, and for about 2 metres from the north corner the north-west wall also stood up to 0.7m, although this had partially collapsed. The rest of this wall was defined by a sharp edge to a spread of small stones in front of the base of the fort wall, although no facing stones could be identified. Four large earthfast stones provided a convincing south-west end to the hut, while the south-east wall, although totally overgrown, stood 0.5m above the hut floor and 0.1m high above ground level outside the hut. A large edge set stone appeared to indicate the outer face at the east corner (see Plate 13 for a general view).

The north end of the hut is not clearly defined. What appears to be the base of a wall face, now much spread and reduced to ground level runs between the north ends of the east and west walls (Fig 5), but behind this is a 'dip' in the rubble against the fort wall, one side of this dip having a much ruined built face. It may be that the hut had a recess at this end, although it is equally likely that the north wall suggested on Fig 5 is no more than a spread of tumbled stones. The north end was the only part of the hut where the walls were not stable, but as there was not enough visible evidence to determine the true shape of the structure, it was thought best to record the remains and leave them untouched.
