REPORT ON THE FIFTH SEASON OF THE TRE'R CEIRI CONSERVATION PROJECT APRIL TO SEPTEMBER 1993

prepared for Cyngor Dosbarth Dwyfor by D. Hopewell illustrations by H.F. Riley April 1994

Gwynedd Archaeological Report No. 98

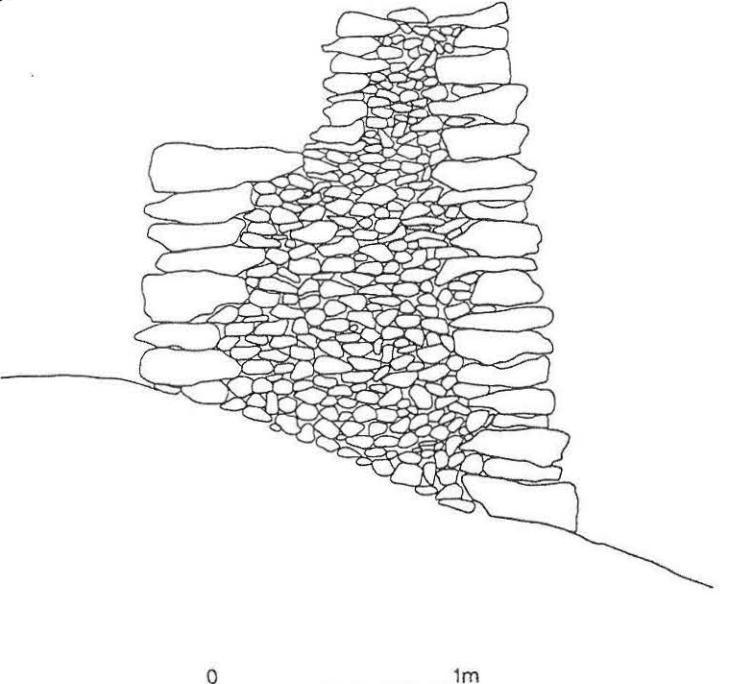
Fig. 18. Sketch section through the ramparts at the north of Tre'r Ceiri.

This 32m length of wall was well preserved, with the parapet surviving for much of its length. The walkway associated with the parapet is constructed from large slabs which stabilise the top of the wall (Fig. 18). The major cause of collapse in this area is the displacement of the slabs from the walkway, allowing the core to be eroded and thus undermining the parapet. The stabilisation of the walkway was thus seen to be a priority.

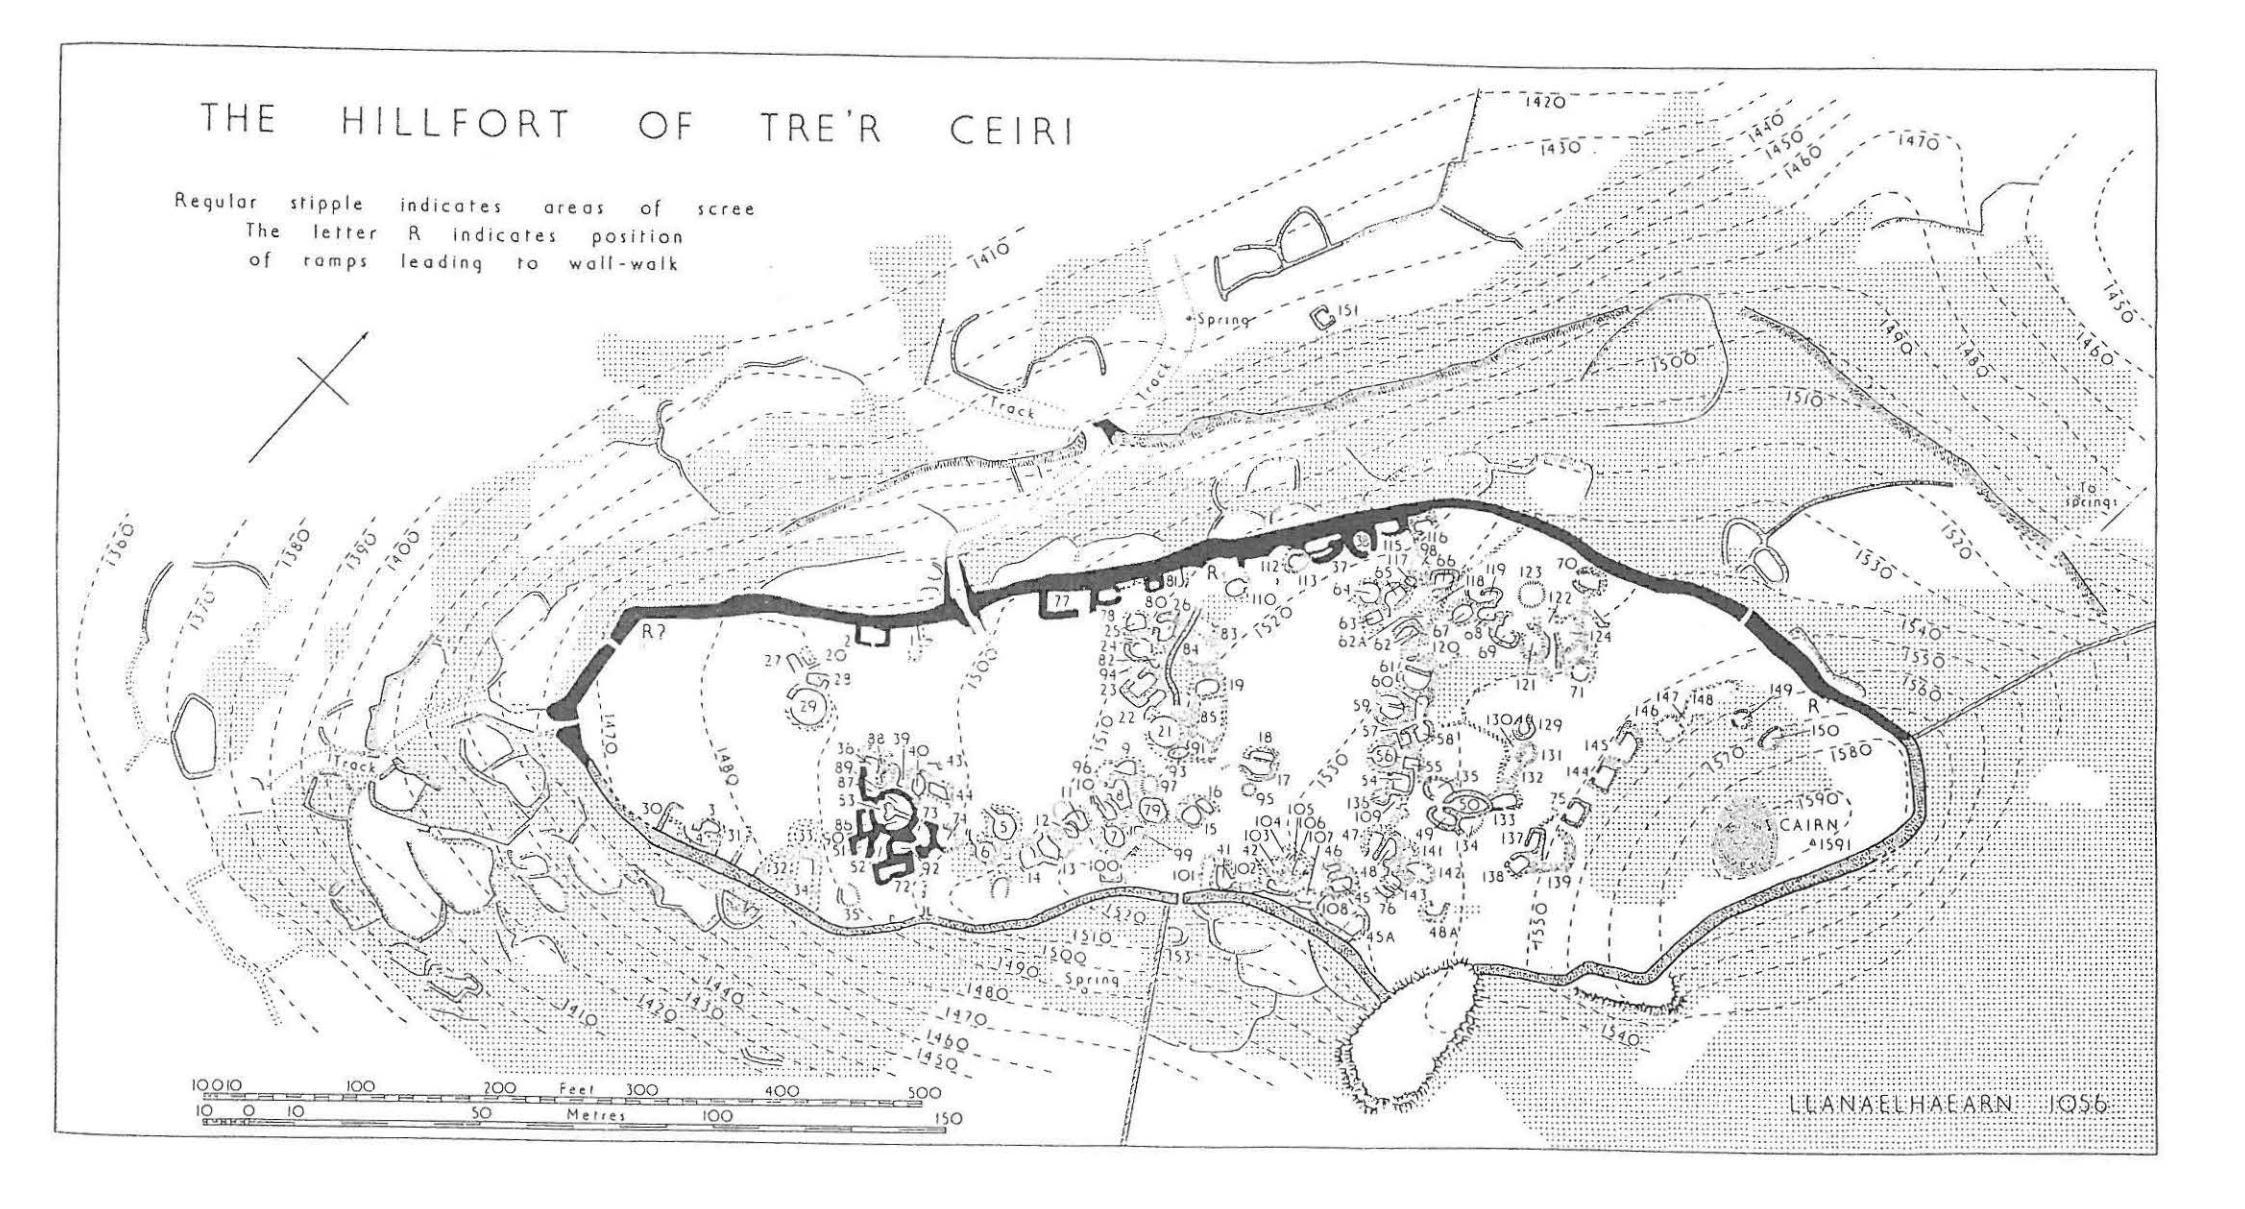
Fig. 20 General Plan, showing areas conserved in the first five seasons.

The 1993 season marked the end of the initial five-year project. Fig. 20 shows the areas conserved so far.

Half (330m of the 660m) of the inner rampart has been conserved on the north-west side of Tre'r Ceiri, encompassing the south-west, west, north-west and north entrances. A total of 145 collapses have been stabilised, representing close to 50% of the conserved wall length. Many of the collapses amounted to little more than small dips in the facing but there were a number of serious collapses necessitating rebuilding from ground level. The clearance and conservation of the north-west, south-west and north entrances have provided easy access to the fort which, when combined with the rebuilding of the major collapses in the rampart, has provided an incentive for visitors to use the entrances instead of climbing over the ramparts.
