## North West Wales Dendrochronology Project: Trefadog, Llanfaethlu

Project No. G2113

Report No. 1021

**Trefadog, Llanfaethlu, Anglesey. NGR SH 29288613**

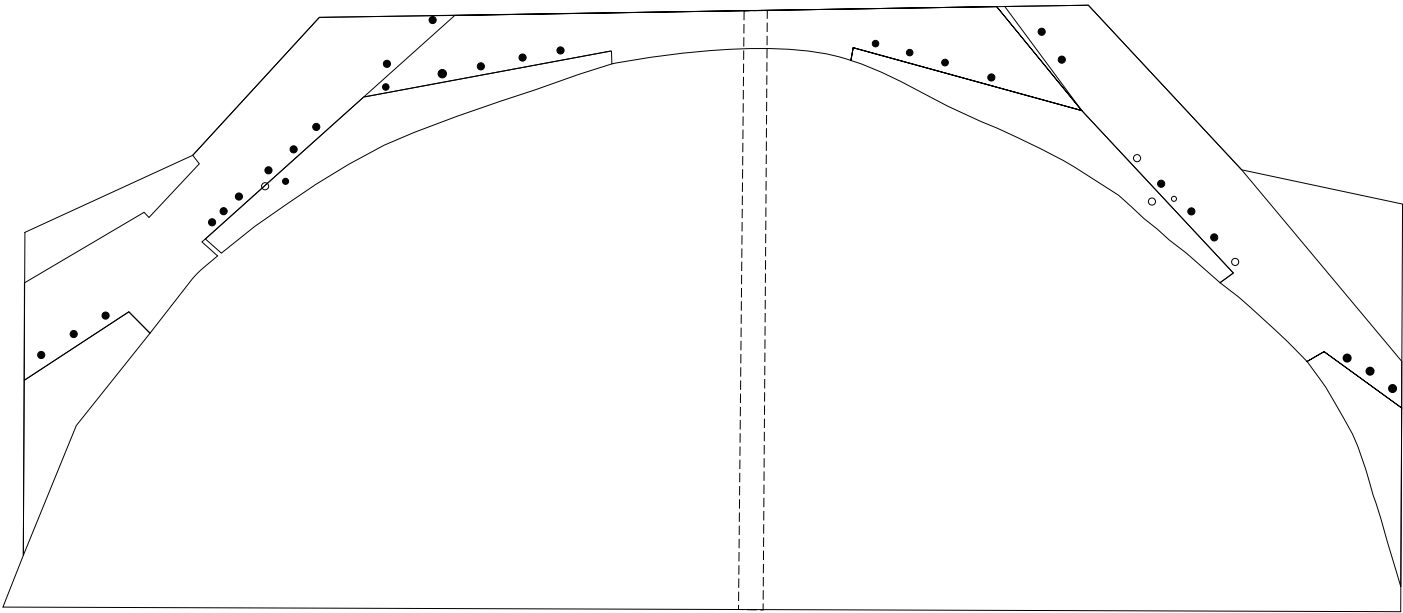
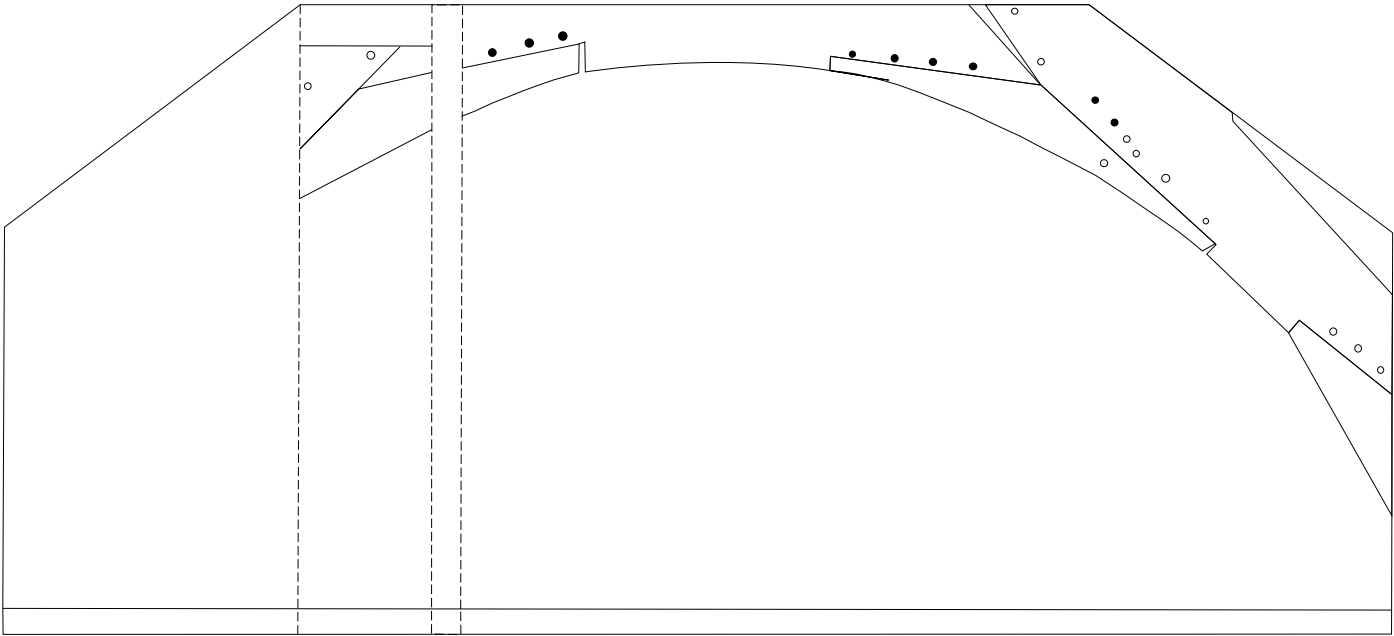
Figure 4: Trefadog, southern cruck

The cruck which divides the hall consists of two principals which disappear into the wall on either side. These have a jointed vertical post which curves onto the principal to form the bend of the cruck. The two are fastened by a wide mortise and tenon joint held with three pegs. It is not possible to see how far the vertical post goes into the wall. None of the vertical posts appear to go below the level of the present first floor, and it is not known if they ever went below that level. An arch-braced collar beam is partly visible below first-floor ceiling level – the remainder hidden by the ceiling. The braces are joined to the collar and principals by mortise and tenon joints (see plates 1 to 6).

The northern face of the southern cruck which divides the hall

The southern face of the southern cruck which divides the hall

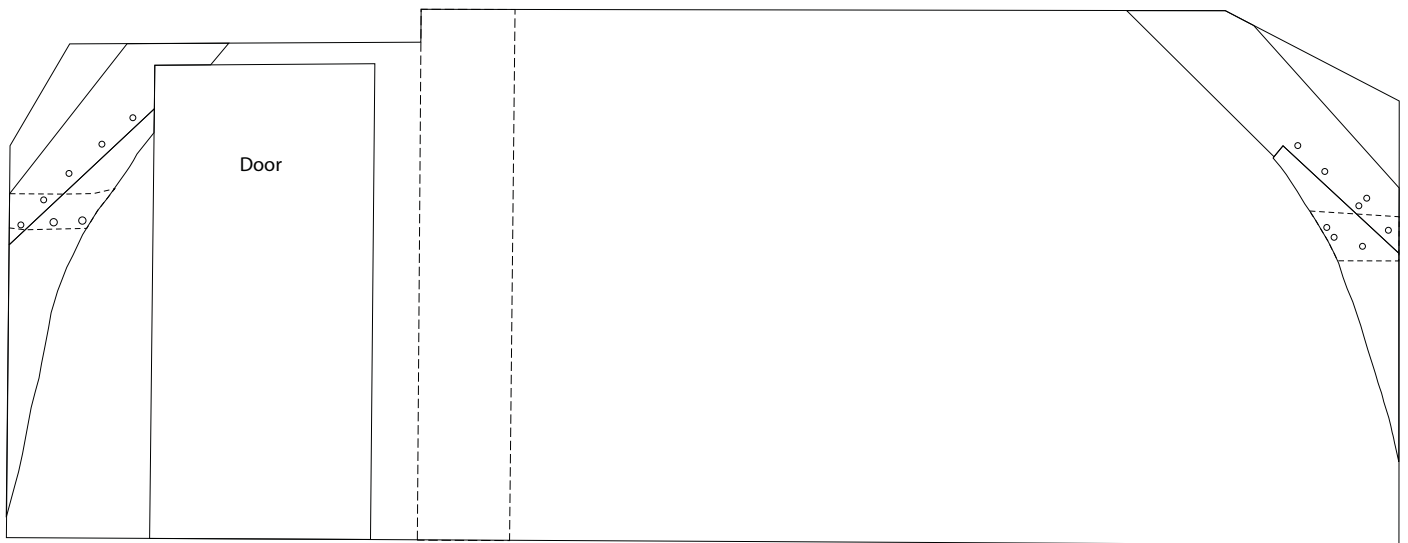
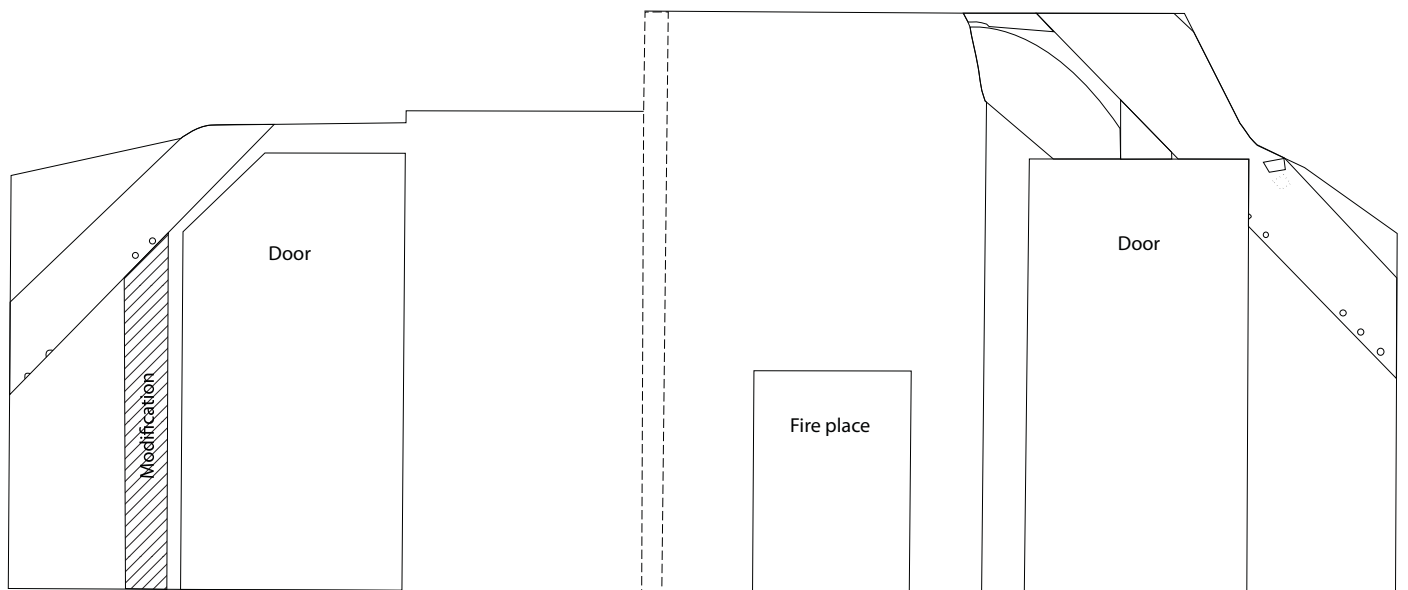
**Figure 5:** Trefadog, the crucks on the northern and the southern sides of the cross passage

The southern face of the cruck on the northern side of the cross passage

The southern face of the cruck on the southern side of the cross passage

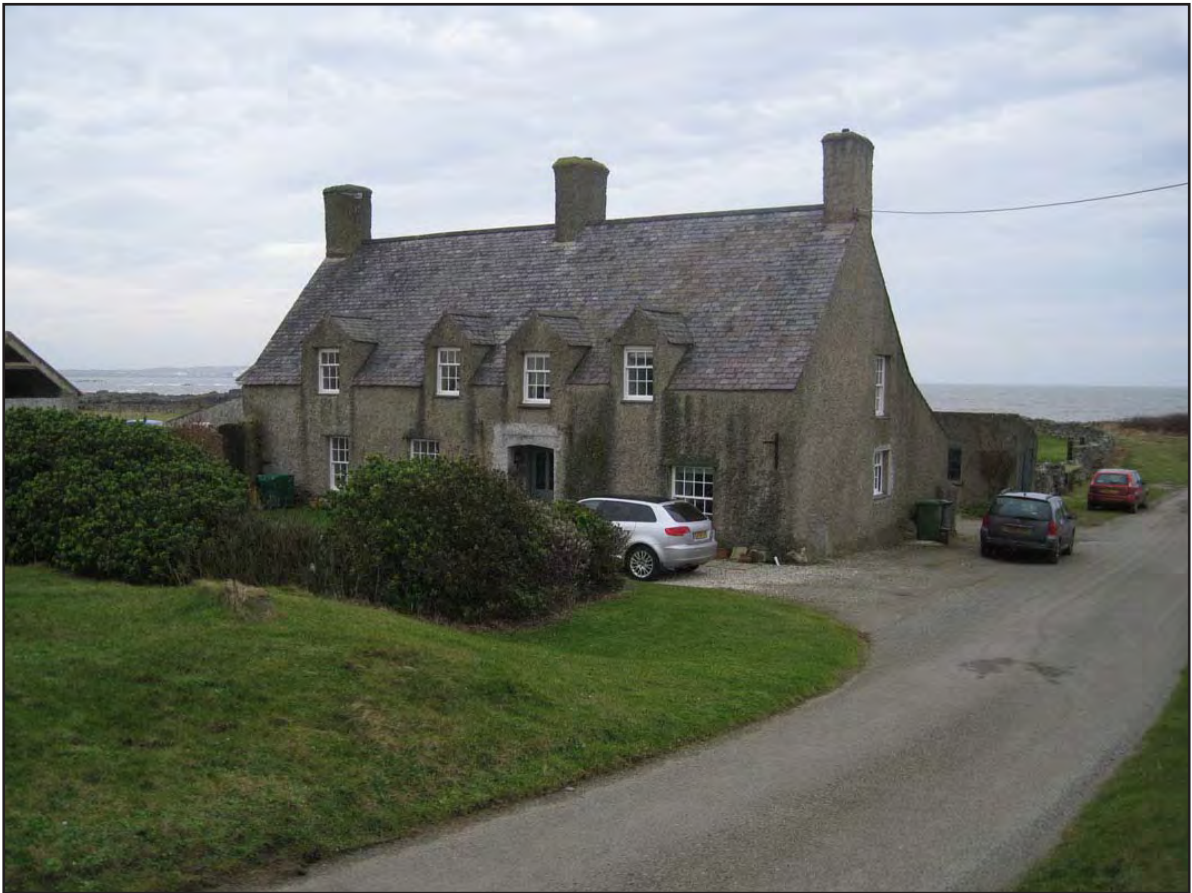
The house is aligned approximately north-south, parallel to the coast edge, and is in a slight hollow 50m from the sea. The house is of two storeys, of rendered stone. The slate roof is modern. There are three rectangular chimney stacks, two at the gables and one to the left (south) of centre. The main front faces east, with an off-centre door to the north, two replaced sash windows to the south and one to the north. Four gabled dormers, all fitted with replaced sash windows, light the first floor. The north side of the house has a catslide addition occupying the north half, of probable 19<sup>th</sup> century date, though with modern horizontal casement windows in the west wall. The south side of the house is lit by a sash window on the ground floor and two gabled dormers on the first floor. A rear door lies in the corner created by the catslide extension (see plate 2).

**Plate 01:** The eastern elevation of Trefadog; view from the northeast.
