MAENAN STREAM WALL, CONWY VALLEY

Archaeological Mitigation

Project No. G2396

Report No. 1212

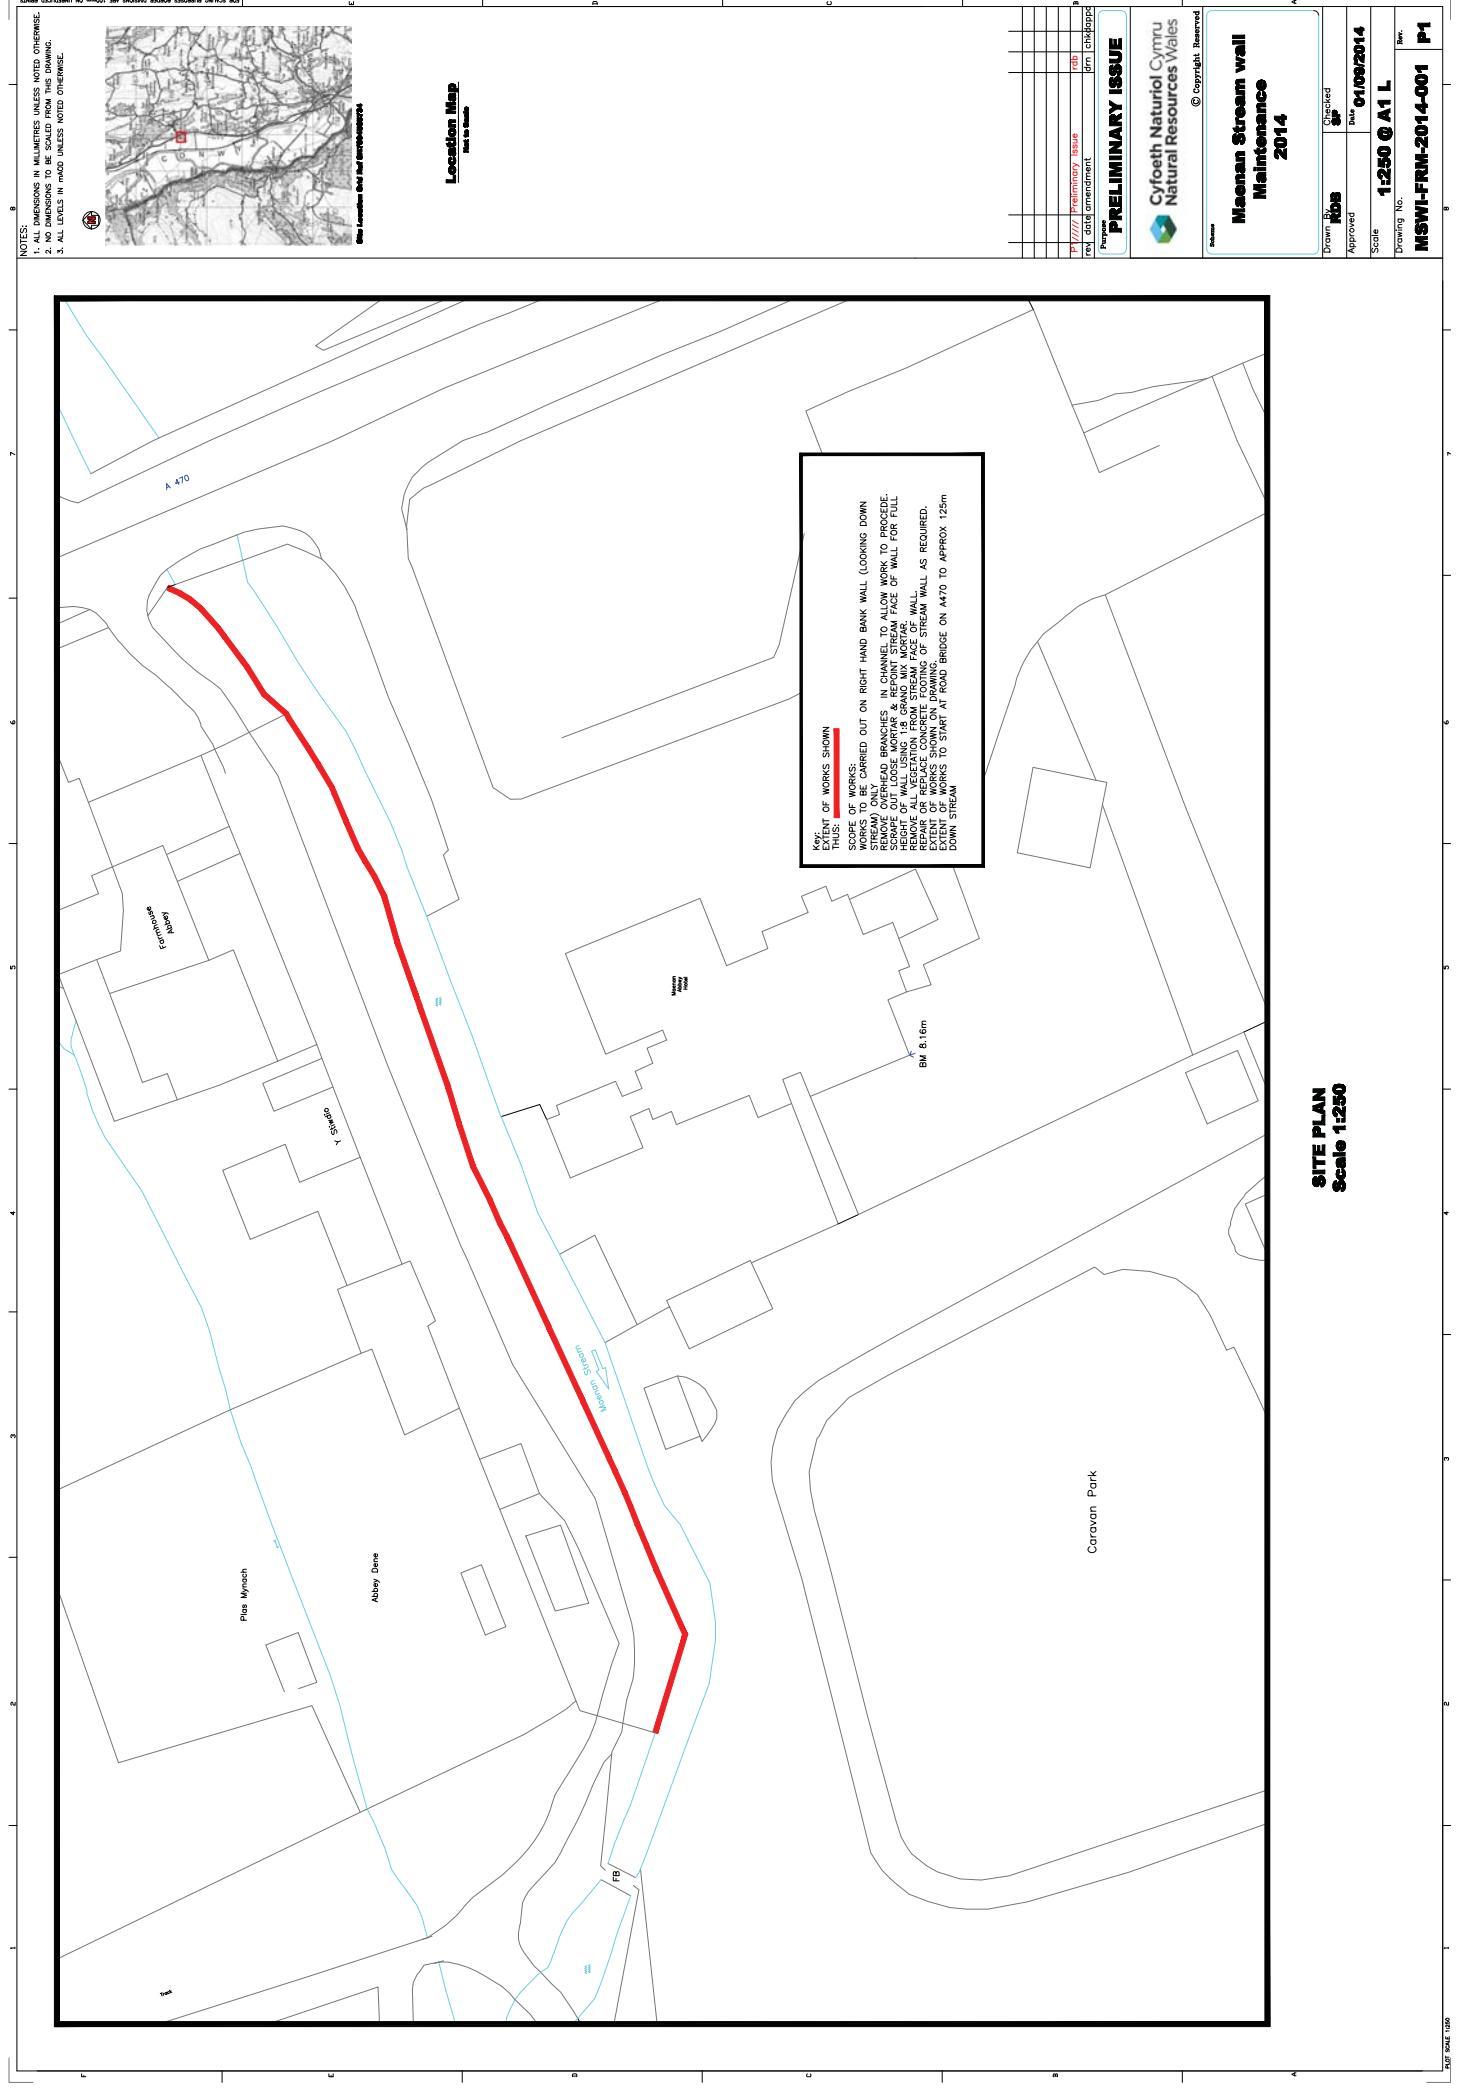
Figure 01: Site Location Plan – Reproduction of Natural Resources Wales Drawing MSWI-FRM-2014-001

- Removal of the overhead branches in the channel and the removal of vegetation from the southern face of the northern stream wall.
- Repointing the southern face of the northern stream wall using a 1:8 grano mix mortar and, where necessary, replacing missing stones within the face, along the section of wall (as indicated on the *Natural Resources Wales drawing* MSWI-FRM-2014-001 reproduced as Figure 01).
- Repairing and replacing the concrete footing of the stream wall.

The repair works (as detailed on *Natural Resources Wales drawing* MSWI-FRM-2014-001 - reproduced as Figure 01) focused on a 125m section of the northern stream wall, commencing at the A470 road bridge and following the water course downstream.

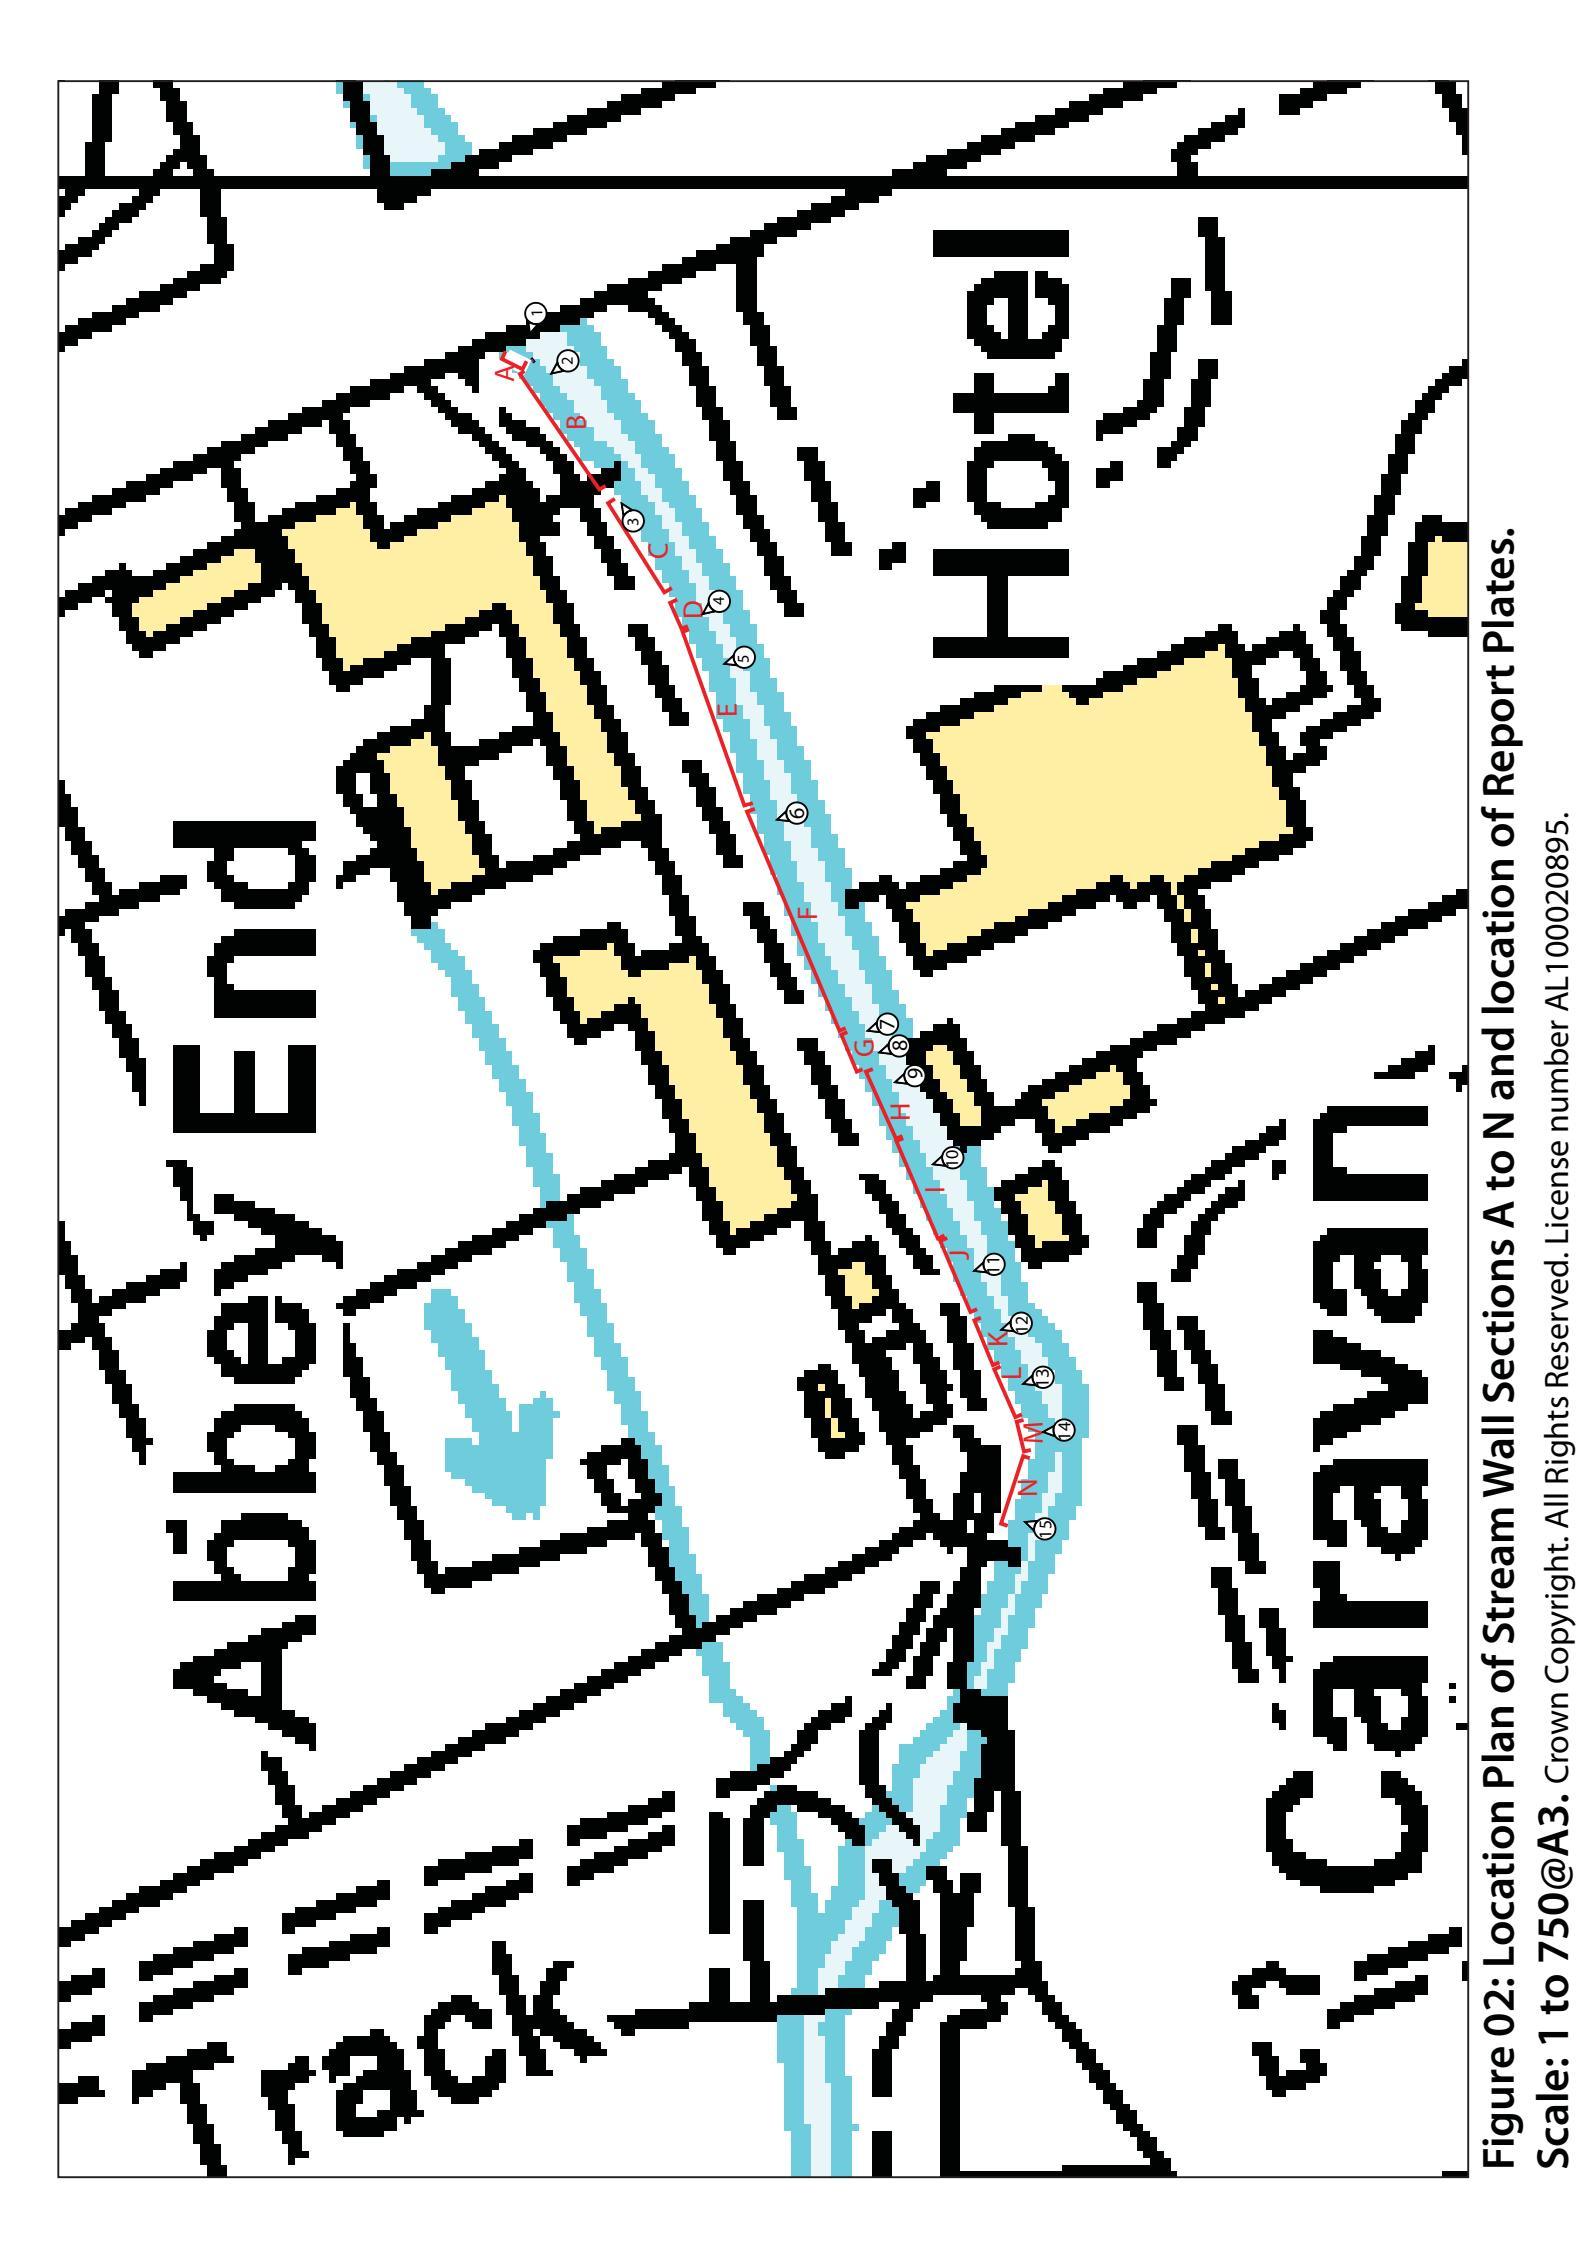
Figure 02: Location Plan of Stream Wall Sections A to N and location of Report Plates. Scale: 1 to 750@A3.

The stream was located to the immediate north of Maenan Abbey Hotel (PRN 34661) and the site of the Cistercian Abbey of Maenan (PRN 34662). The northern wall of the stream was incorporated within properties that back onto the stream, such as Abbey Deane and Plas Mynach (Figure 02).

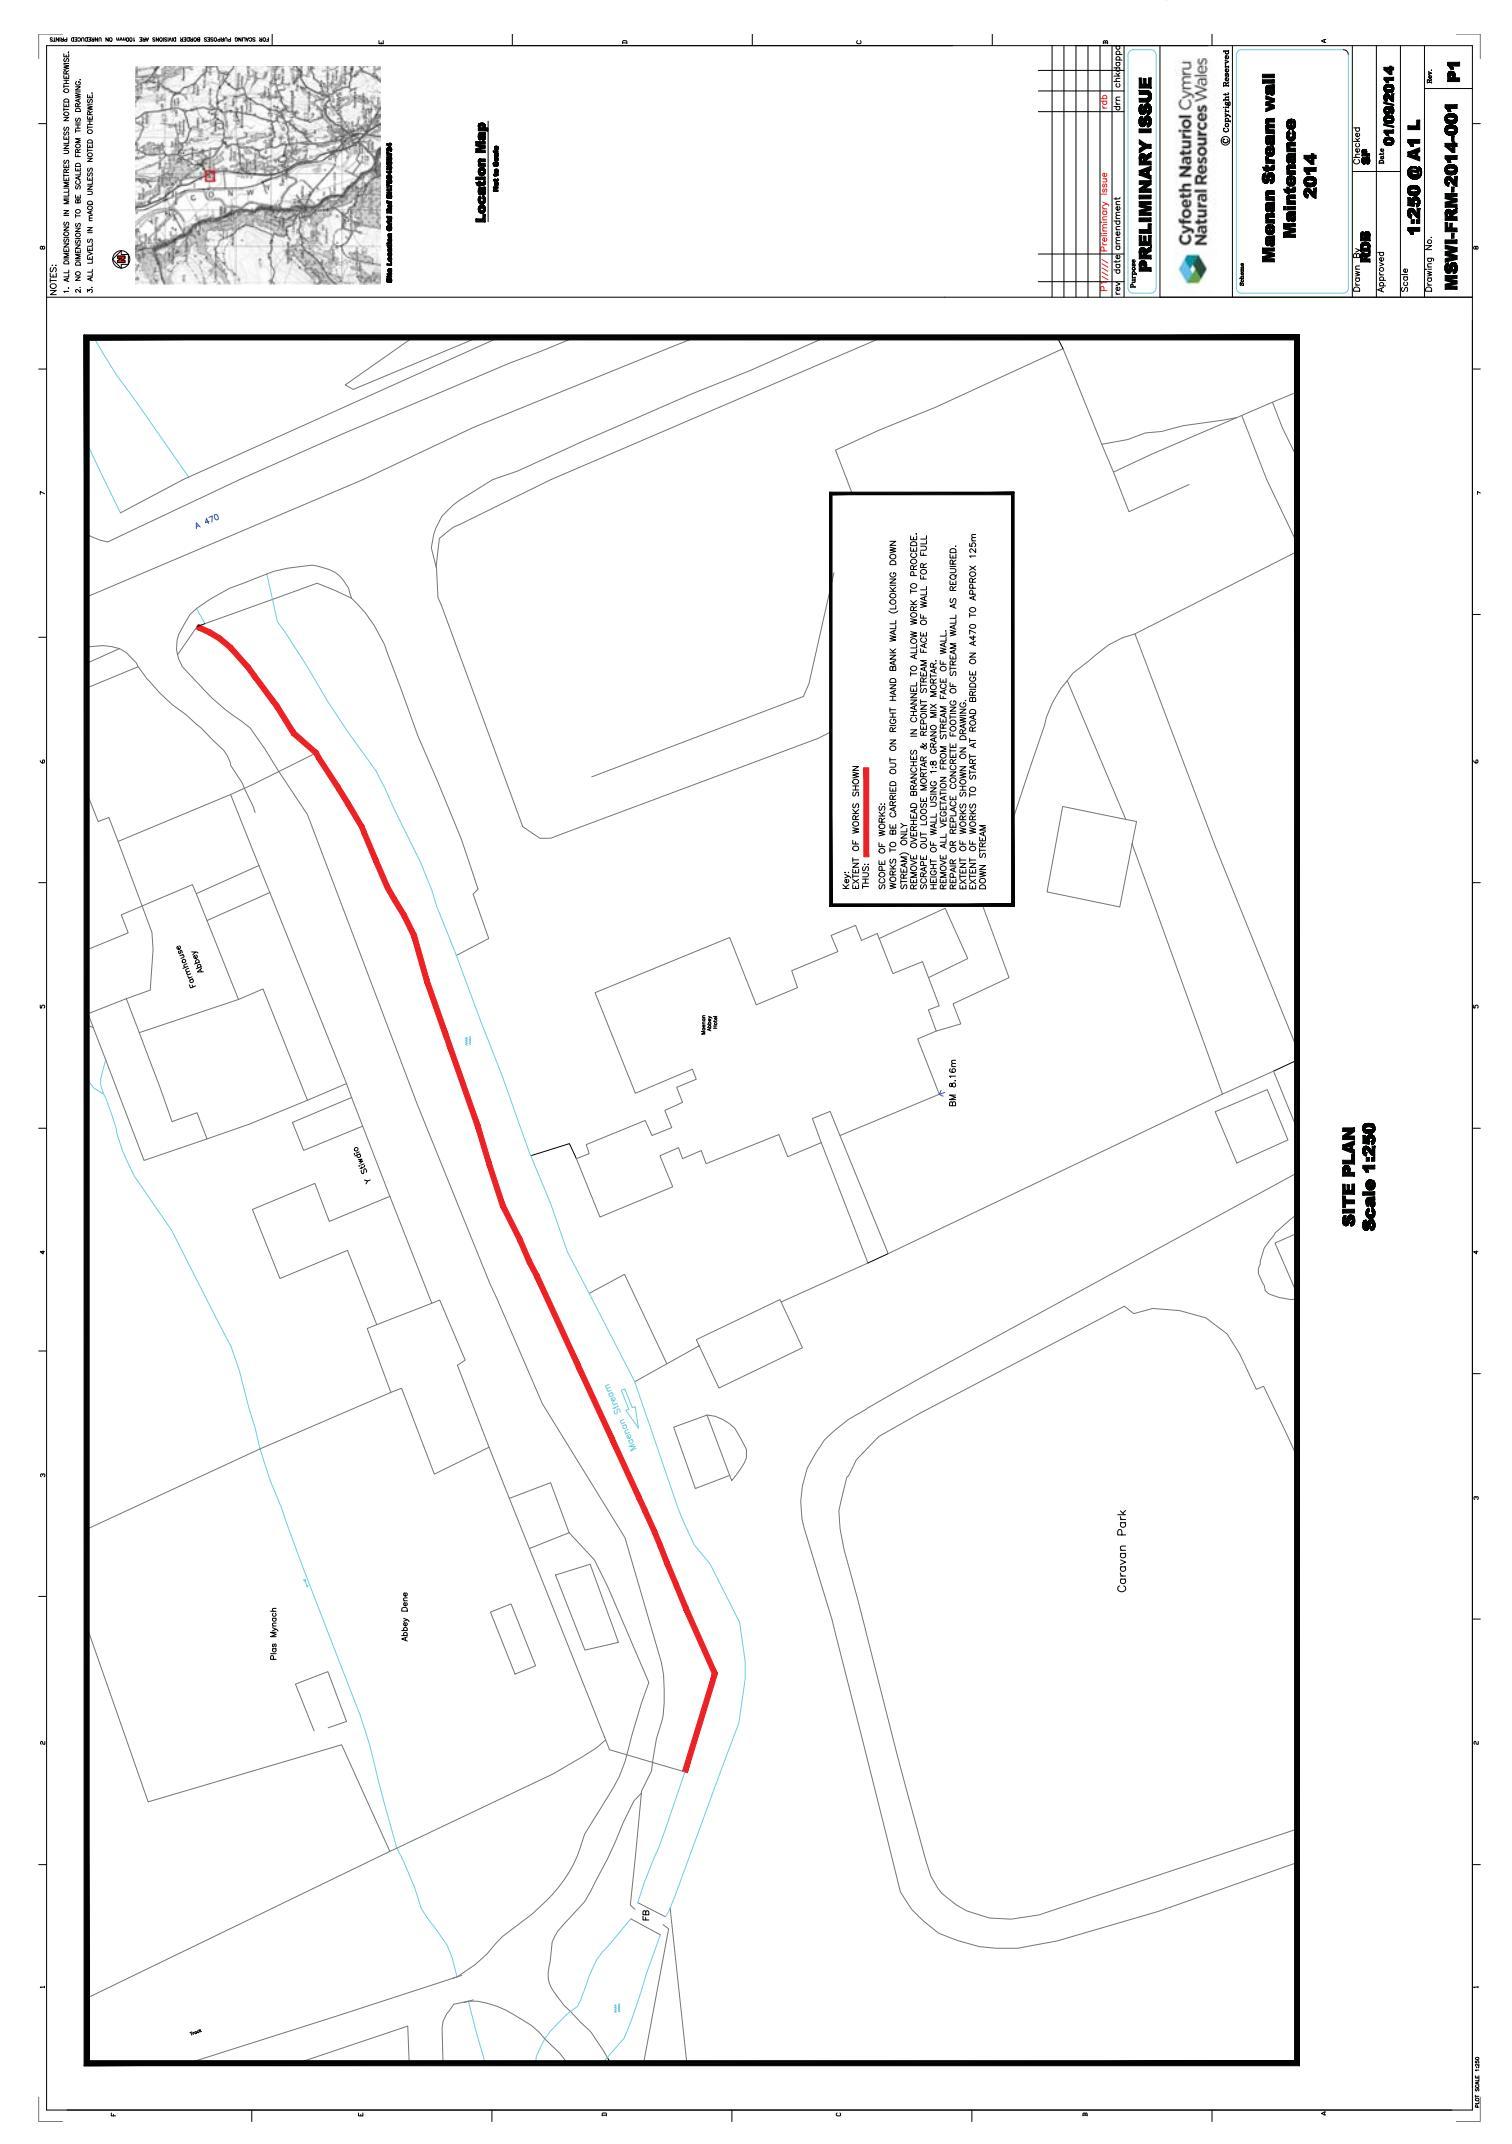
FIGURE 01

- Remove overhead branches in the channel and remove all of the vegetation from the stream face of the wall.
- Repoint the stream face of the wall for the full height of the wall using a 1:8 grano mix mortar and, where necessary, replace missing stones within the face of the wall along the section of wall indicated on *Natural Resources Wales drawing* MSWI-FRM-2014-001 (reproduced as Figure 01).
- Repair and replace the concrete footing of the stream wall as required.

Site Location Plan – Reproduction of Natural Resources Wales Drawing MSWI-FRM-2014-001
