# TERFOR PIER, TREFOR, GWYNEDD

Level 2/3 Building Record

Prosiect Rhif / Project No. G2474

Adroddiad Rhif / Report No.1328

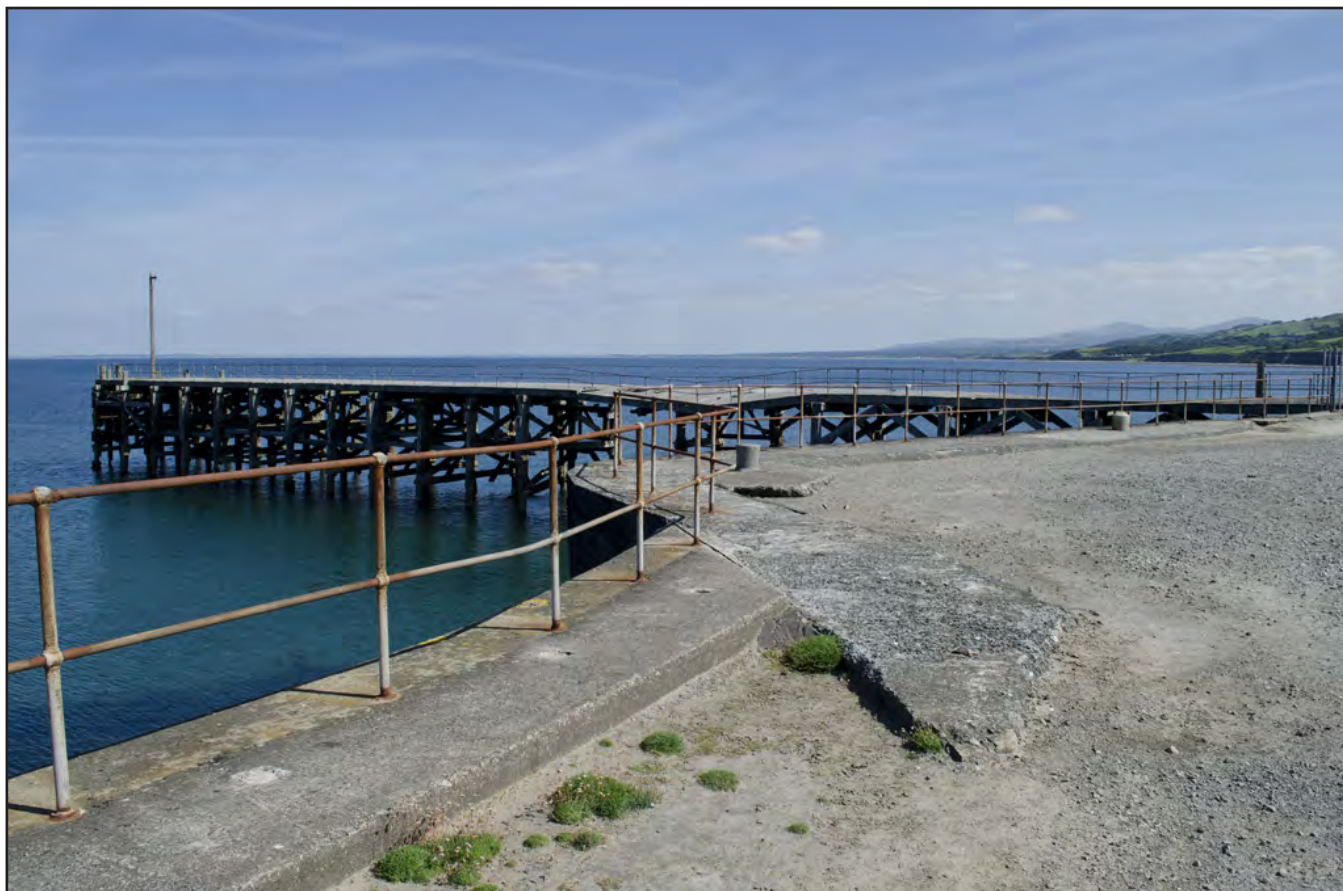
Plate 04: View of Trefor pier from the beach showing damaged northwestern side of the timber pier (archive image: G2475\_Trefor\_Pier\_016)

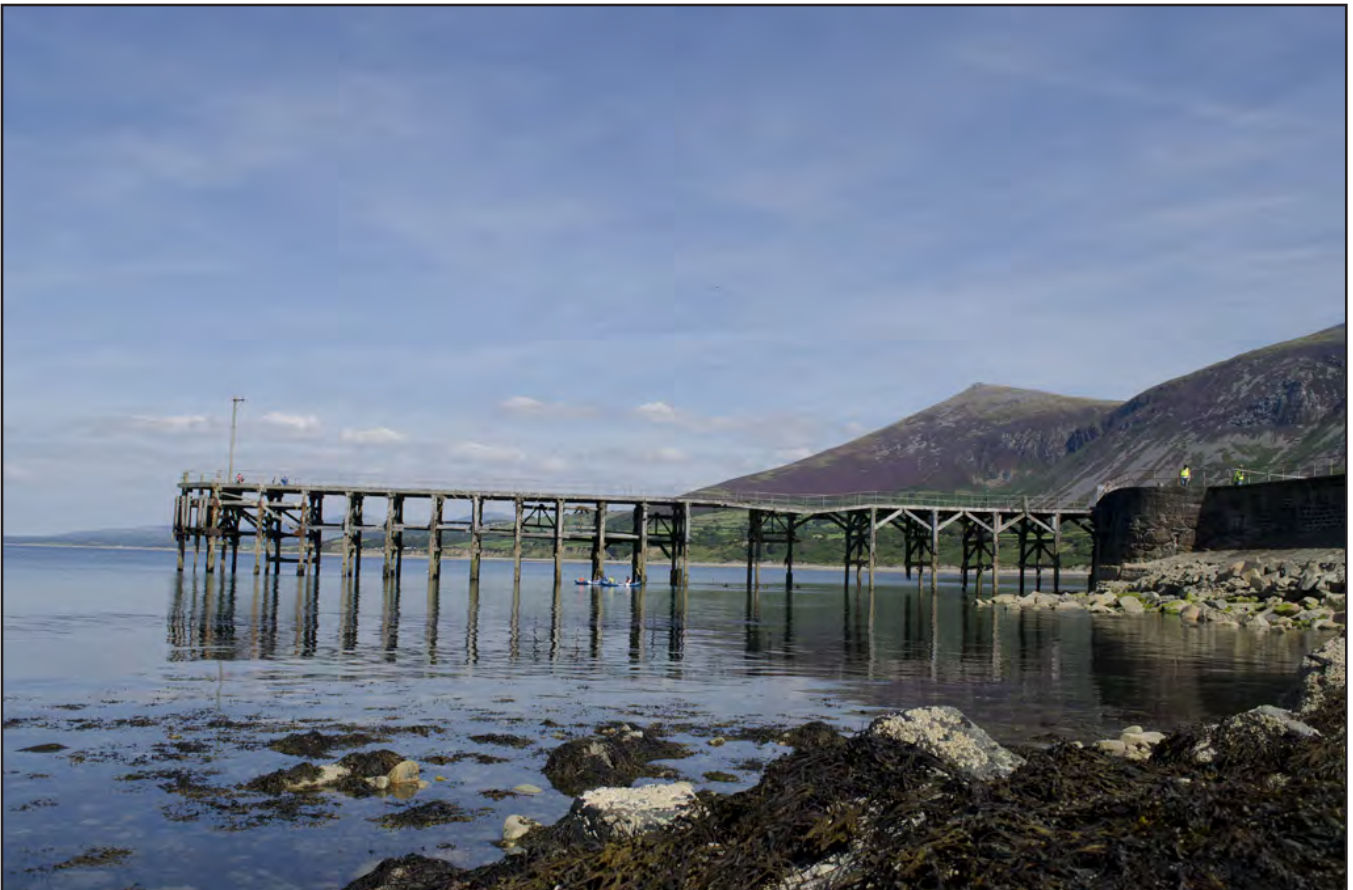
Plate 09: Detail of timber pier showing collapsed section (archive image: G2475\_Trefor\_Pier\_006)

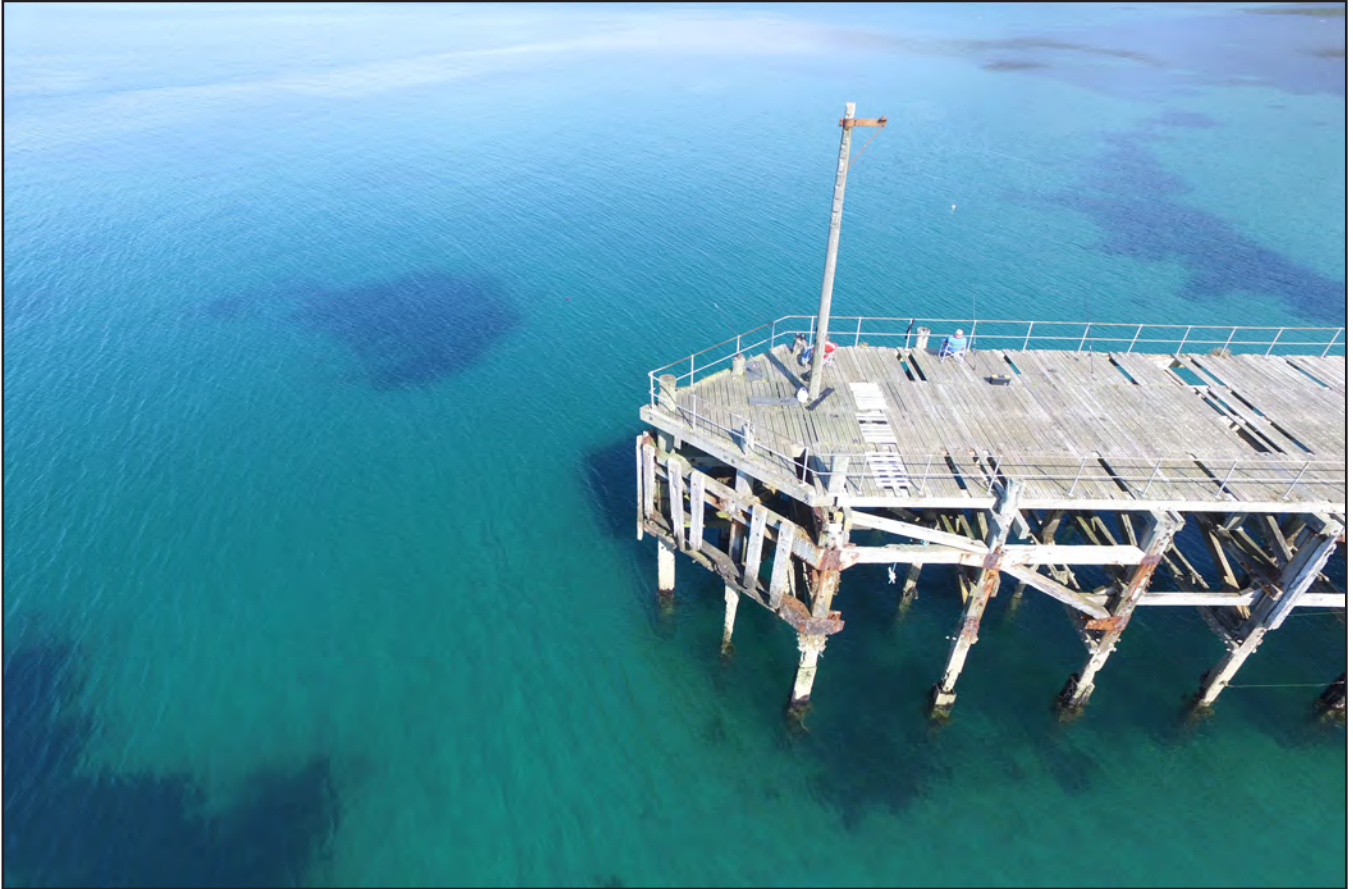
Plate 10: View from the west of the northeastern side of the timber pier (archive image: G2475\_Trefor\_Pier\_021)

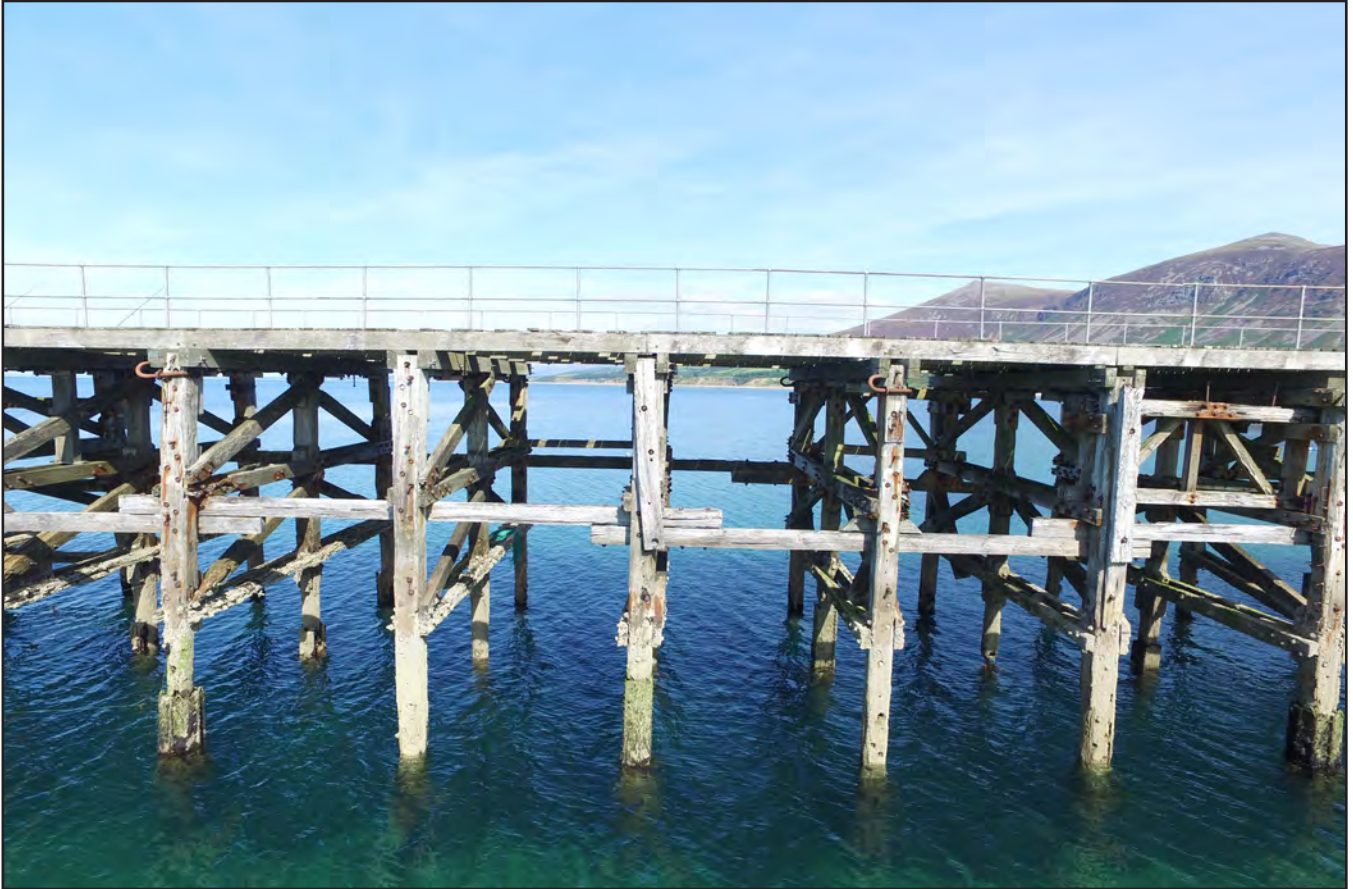
Plate 12: Aerial view of Trefor Pier from the east-southeast showing the condition of timber decking over collapsed trusses (Trusses 12 to 18) (UAV image: DJI\_0108)

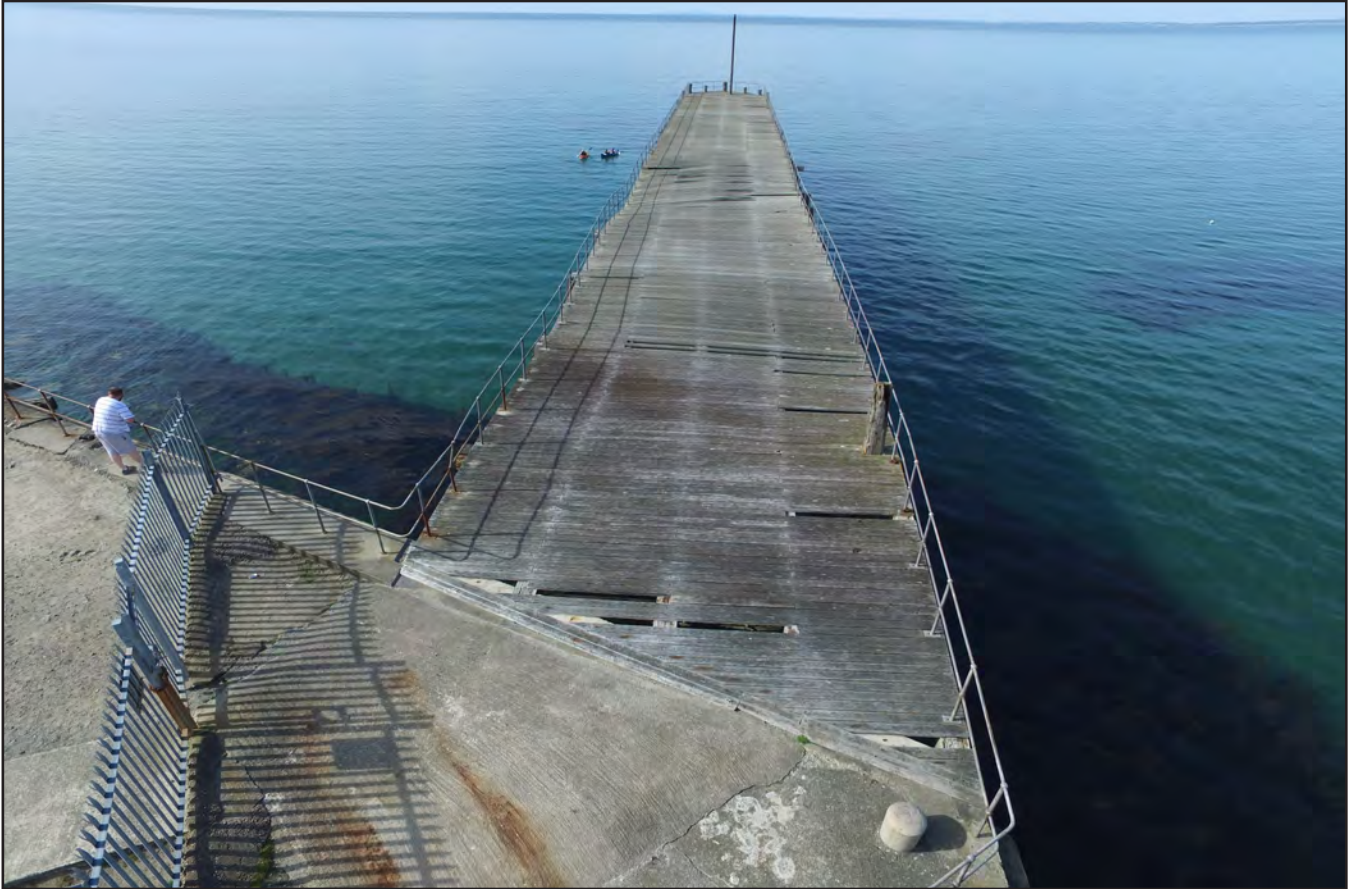
Plate 14: View of Trefor pier from the northwest showing the terminus and the trusses on the west-southwest side of the pier  
(UAV image: UAV image: DJI\_0153)

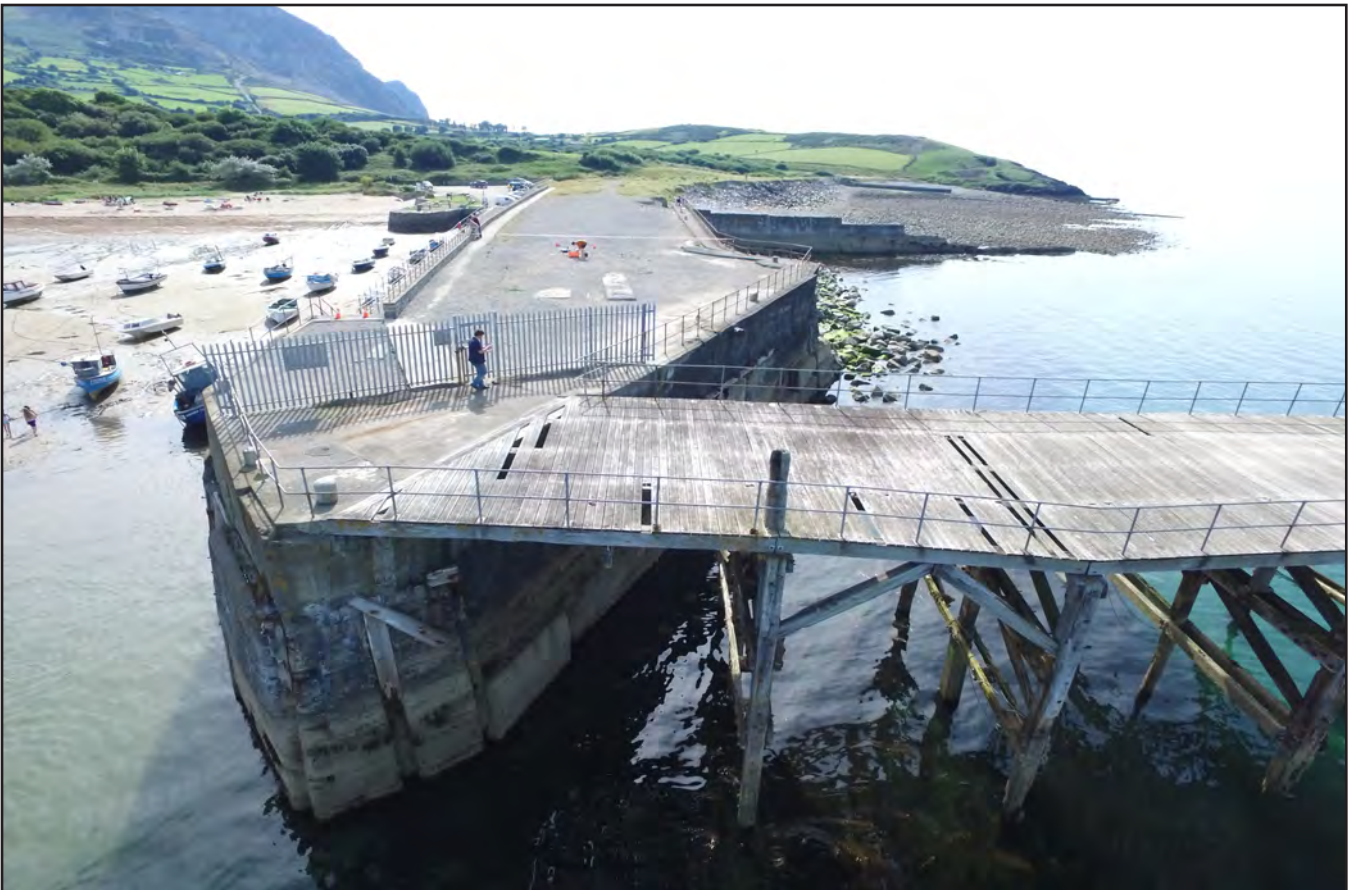
Plate 17: View of Trefor pier from the east southeast showing the damaged section of the pier from trusses 13 to 15 (UAV image: DJI\_0143)

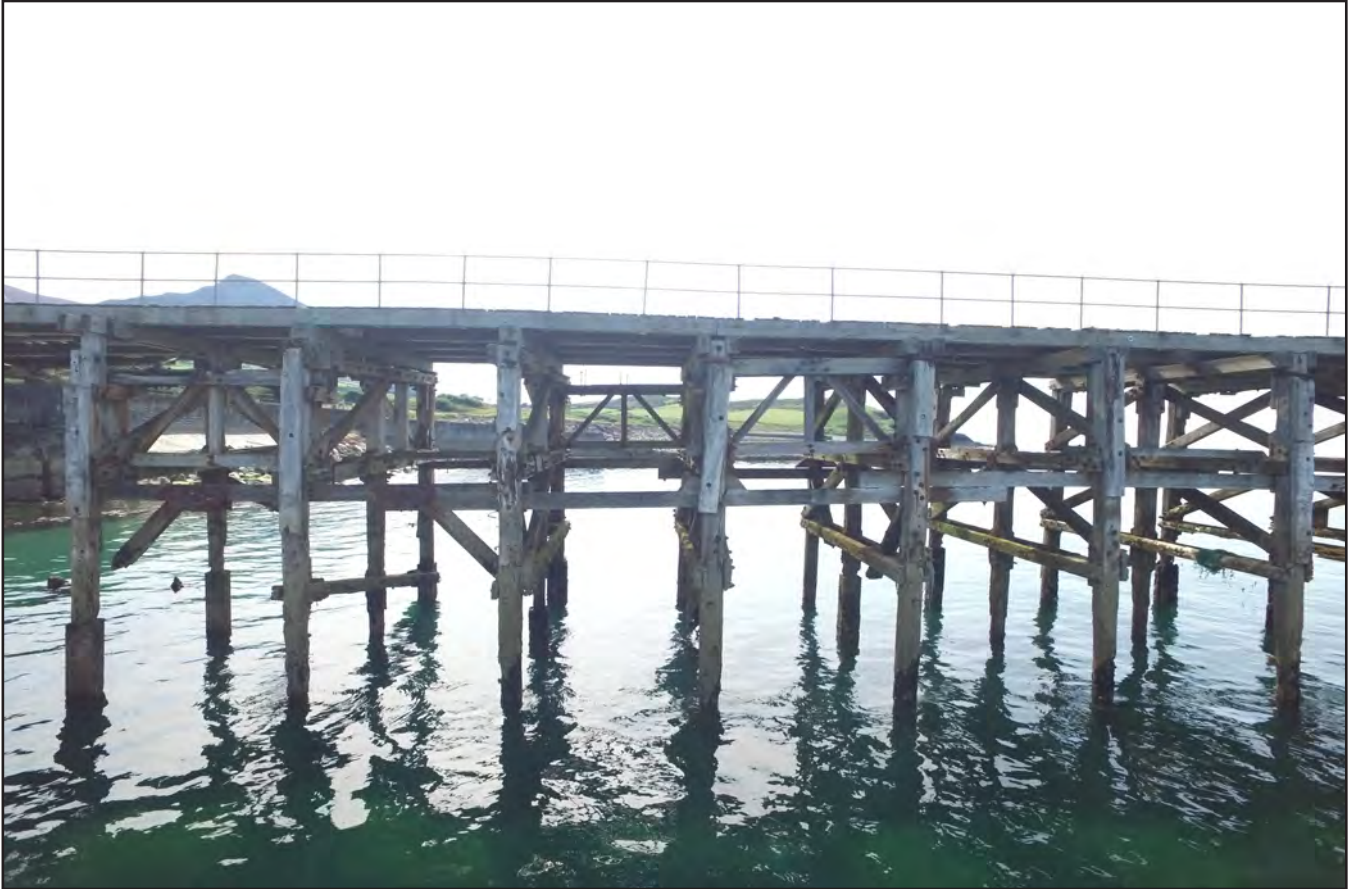
Plate 20: Construction detail for the end of the pier (Trusses 1 to 7) (UAV image: DJI\_0713)

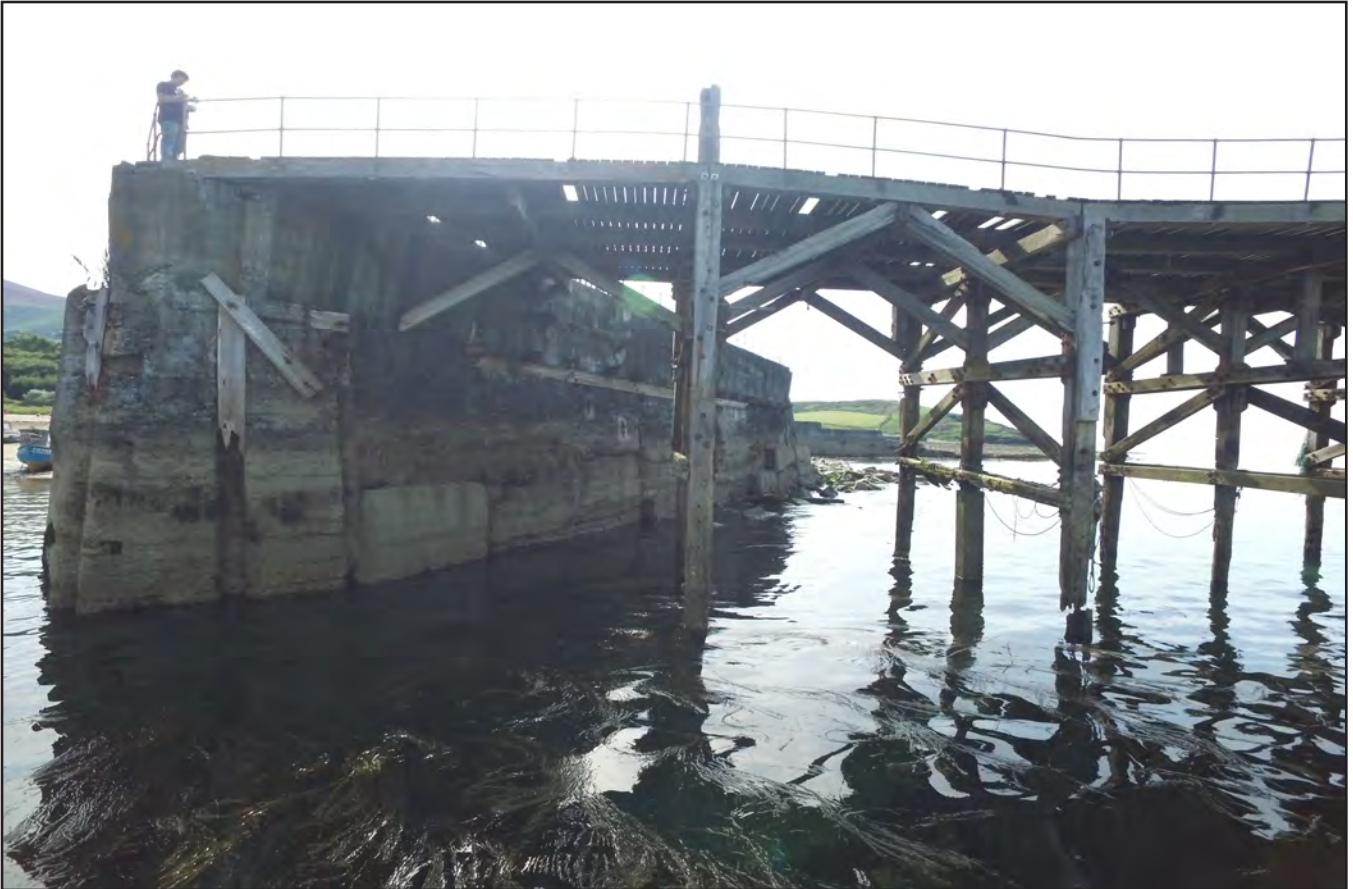
Plate 21: Detail of truss construction (Trusses 6 to 12) (UAV image: DJI\_0709)

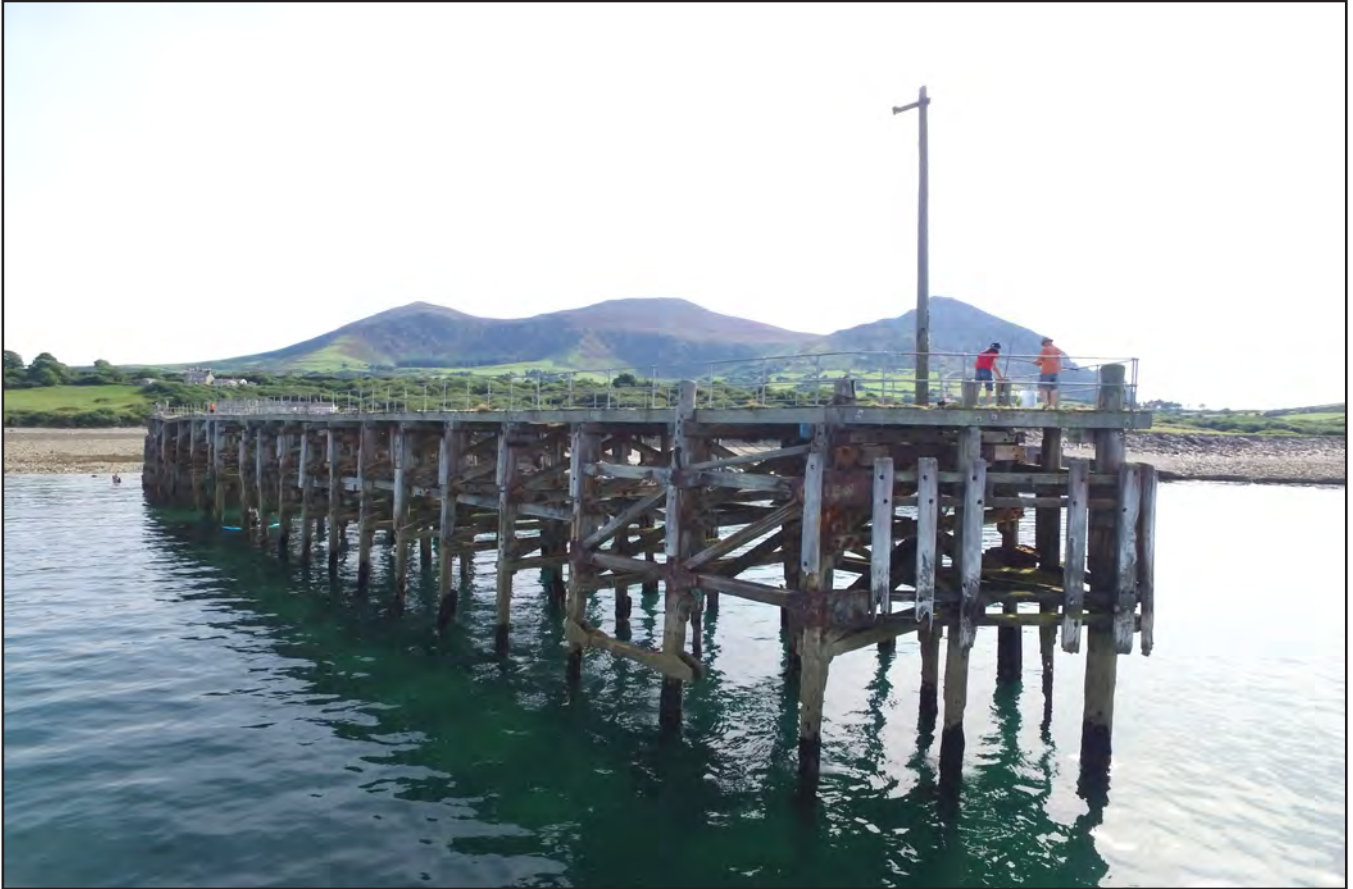
Plate 22: Detail of truss construction and stone pier (Trusses 18 and 19) (UAV image: DJI\_0698)
