MAENAN ABBEY, LLANRWST

Briff Gwylio Archeolegol/
Archaeological Watching Brief

Prosiect Rhif / Project No. G2616

Adroddiad Rhif / Report No. 1506

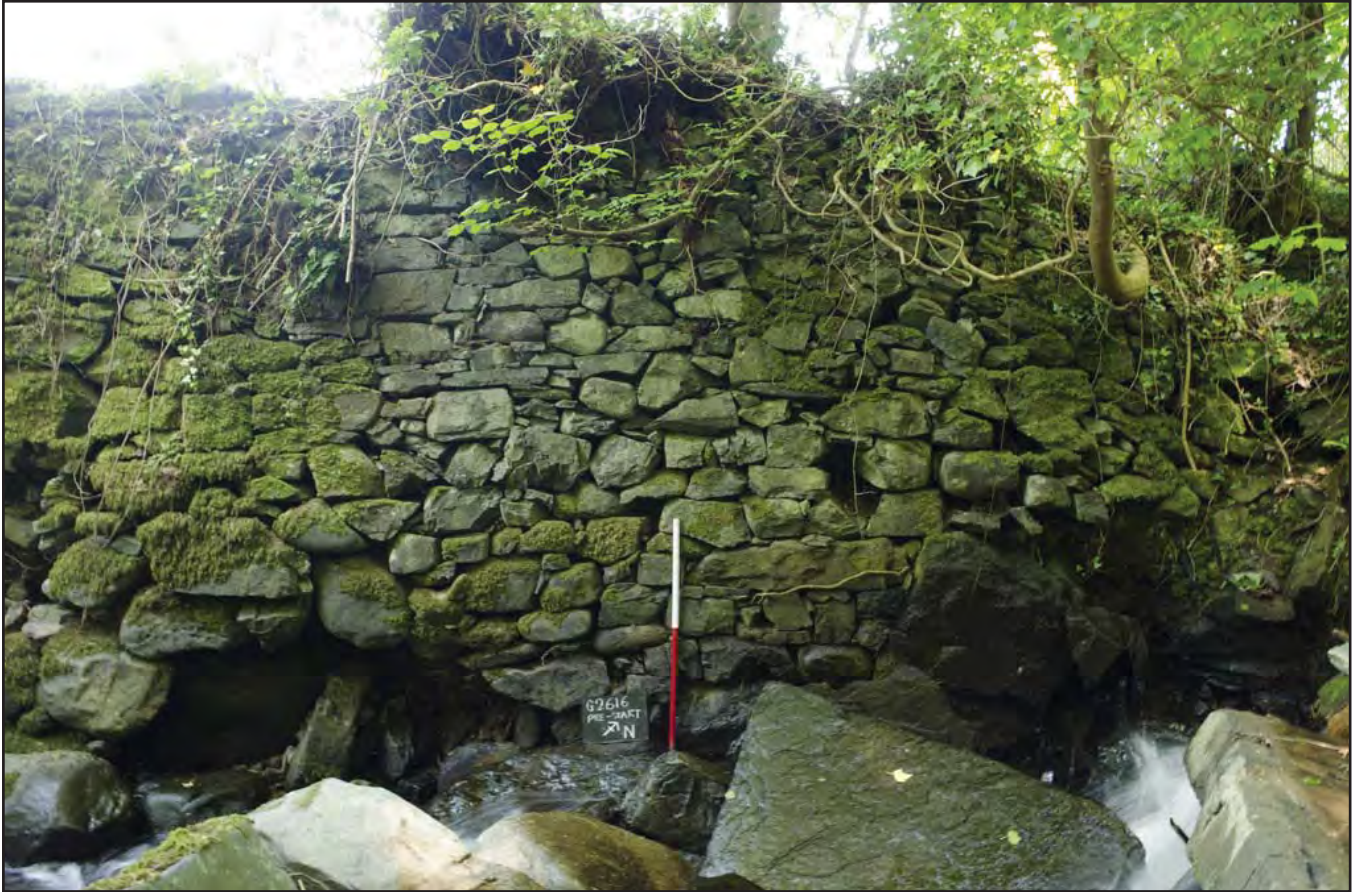
Plate 5: Entire width at the wall opposite the weir; scale 1 x 1m; view from SE (archive reference: G2616_018).

Plate 5: Entire width at the wall opposite the weir; scale: 1 x 1m; view from: SE
(archive reference: G2616_018).

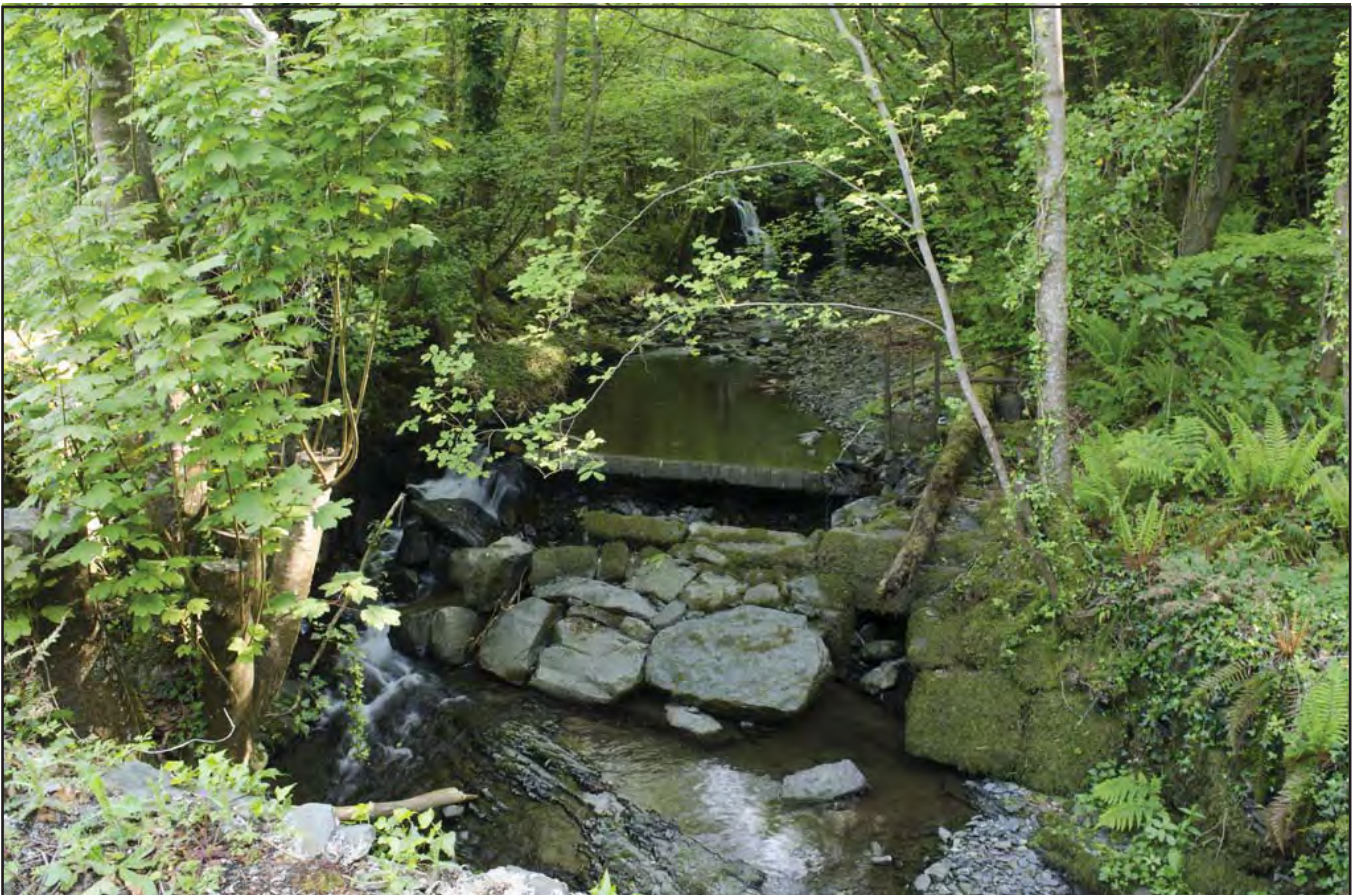
Plate 6: View of wier and river from the bridge; scale not used; view from SW (archive reference: G2616_005).

Plate 6: View of weir and river from the bridge; scale: not used; view from: SW
(archive reference: G2616_005).

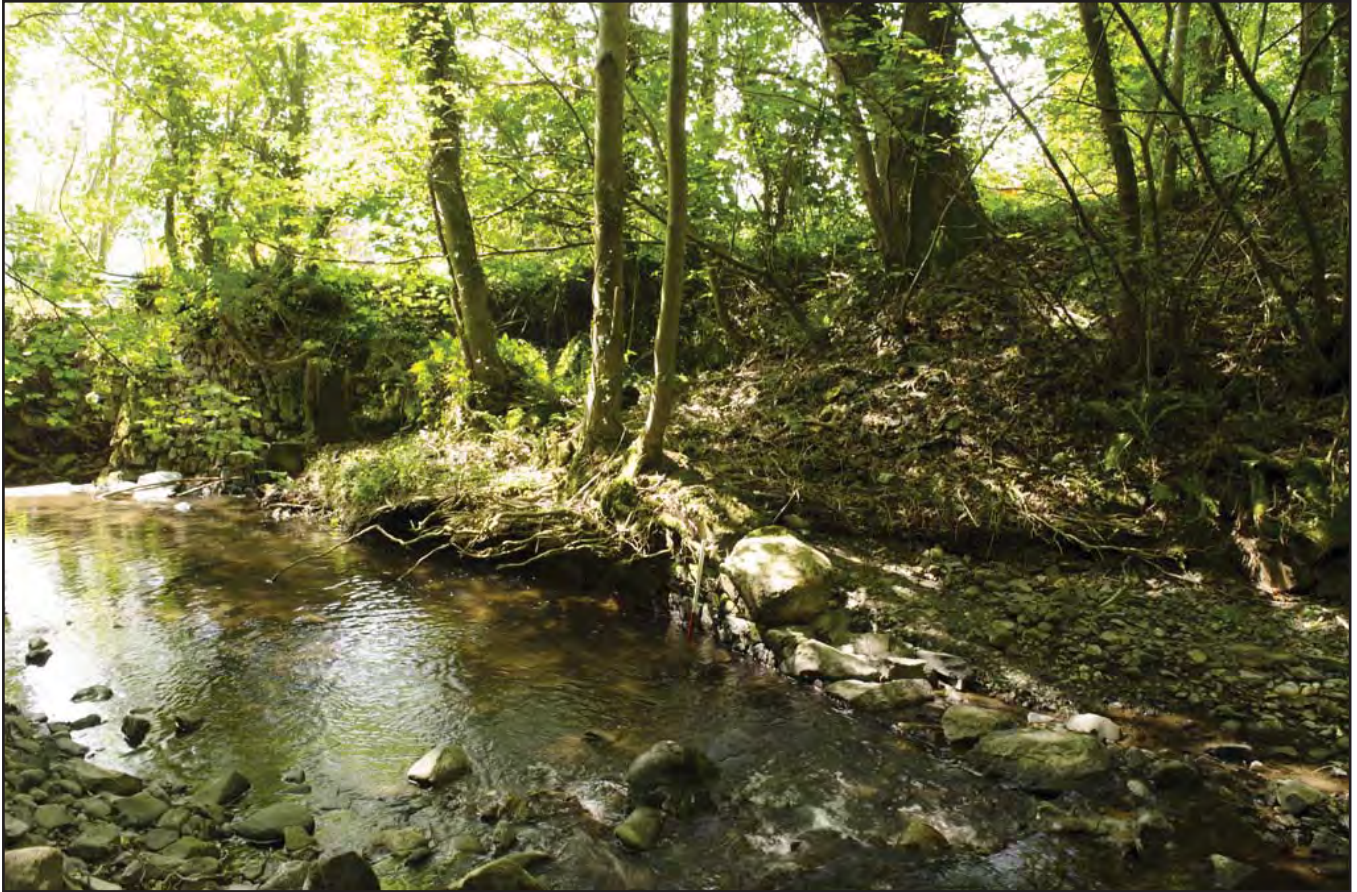
Plate 7: East limits of retaining wall, beneath trees; scale 1 x 1m; view from SE (archive reference: G2616_033).

Plate 7: East limits of retaining wall, beneath trees; scale: 1 x 1m; view from: SE
(archive reference: G2616_033).

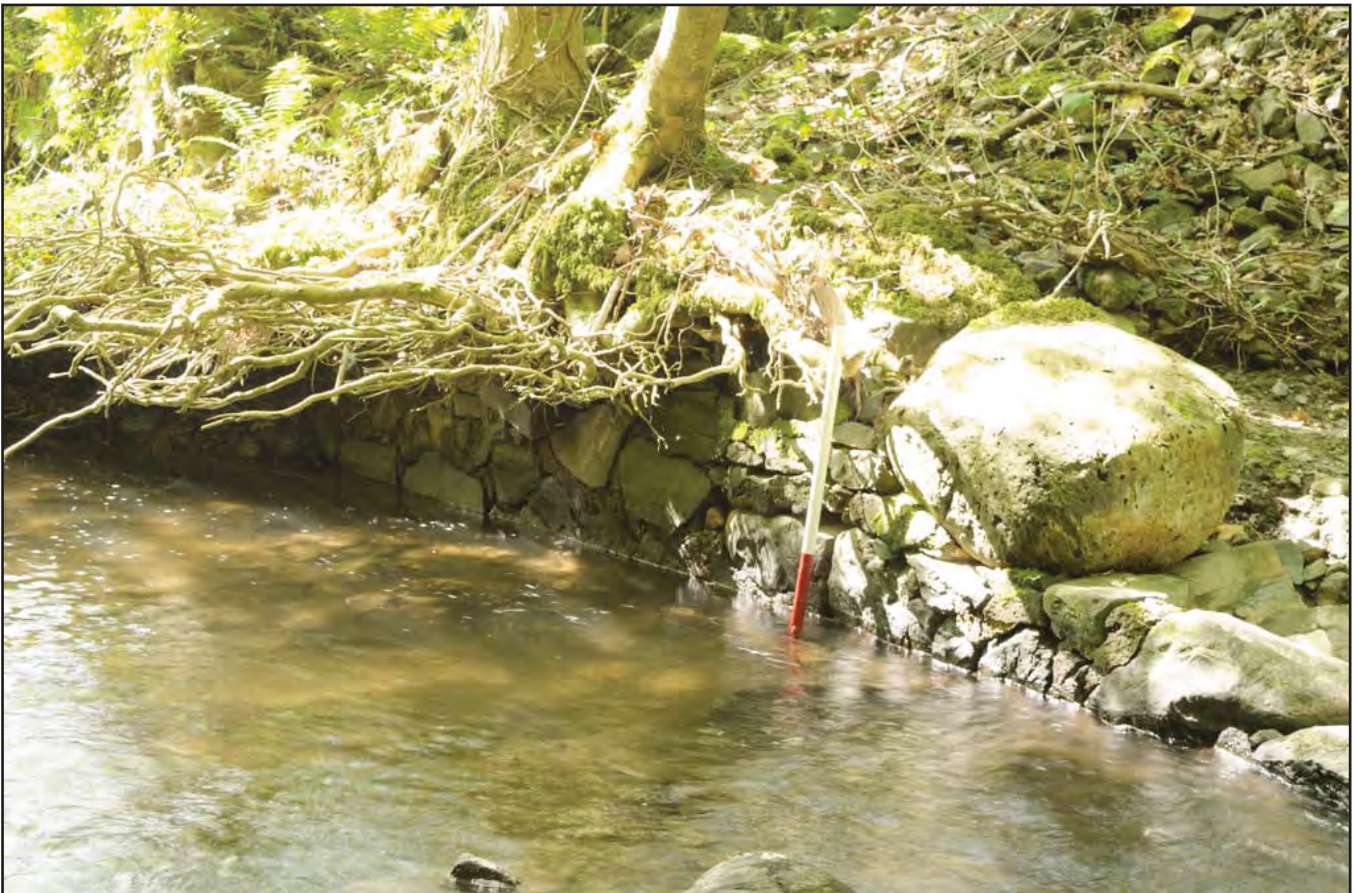
Plate 8: Close-up of east limits of retaining wall; scale 1 x 1m; view from SE (archive reference: G2616_034).

Plate 8: Close-up of east limits of retaining wall; scale: 1 x 1m; view from: SE
(archive reference: G2616_034).

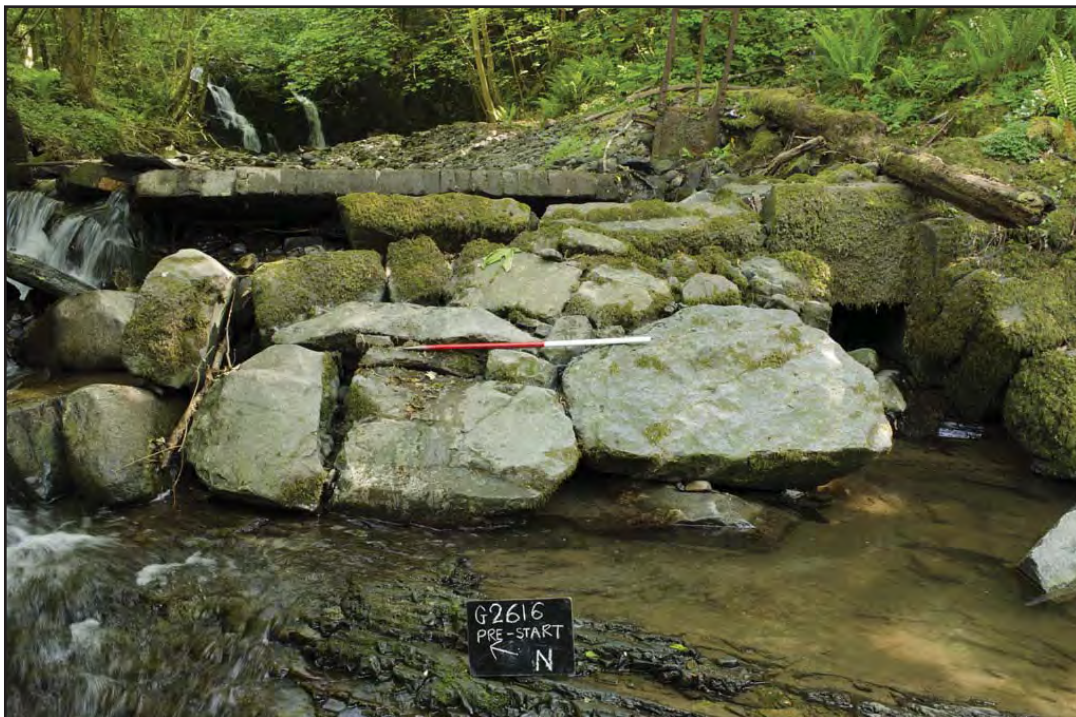
Plate 9: Stone (w facing) at weir; scale 1 x 1m; view from W (archive reference: G2616_023).

Plate 9: Stone (w facing) at weir; scale: 1 x 1m; view from: W (archive reference: G2616_023).

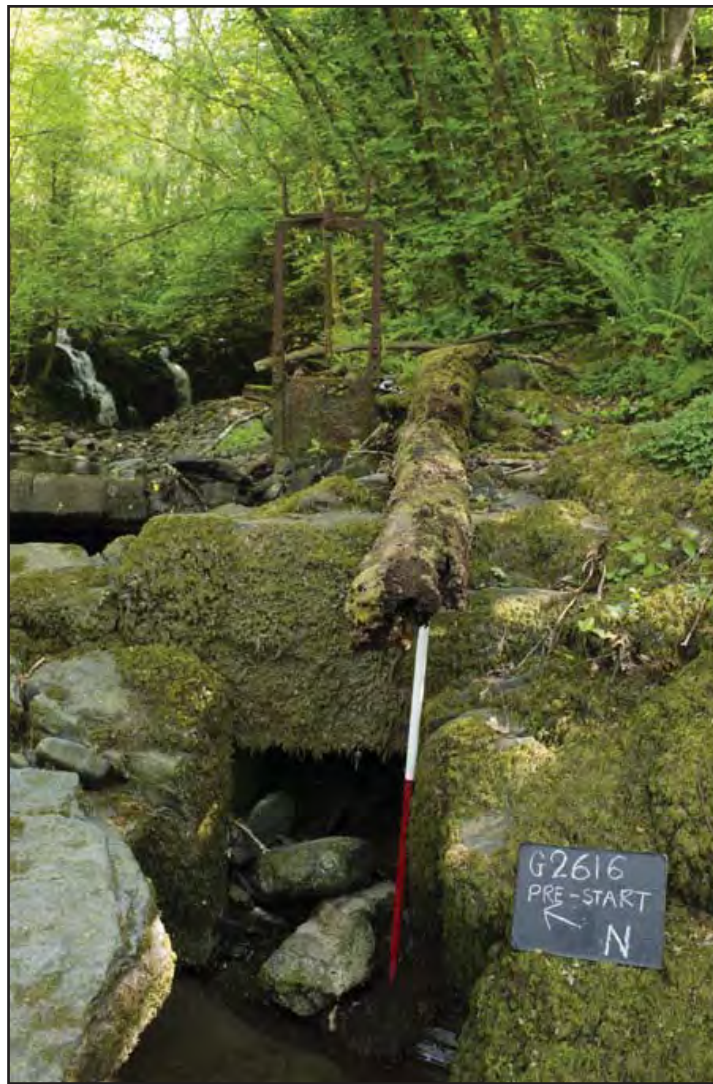
Plate 11: Stone channel/culvert with metal sluice gate in the background; scale 1 x 1m; view from W (archive reference: G2616_026).

Plate 11: Stone channel/culvert with metal sluice gate in the background; scale: 1 x 1m; view from: W (archive reference: G2616_026).

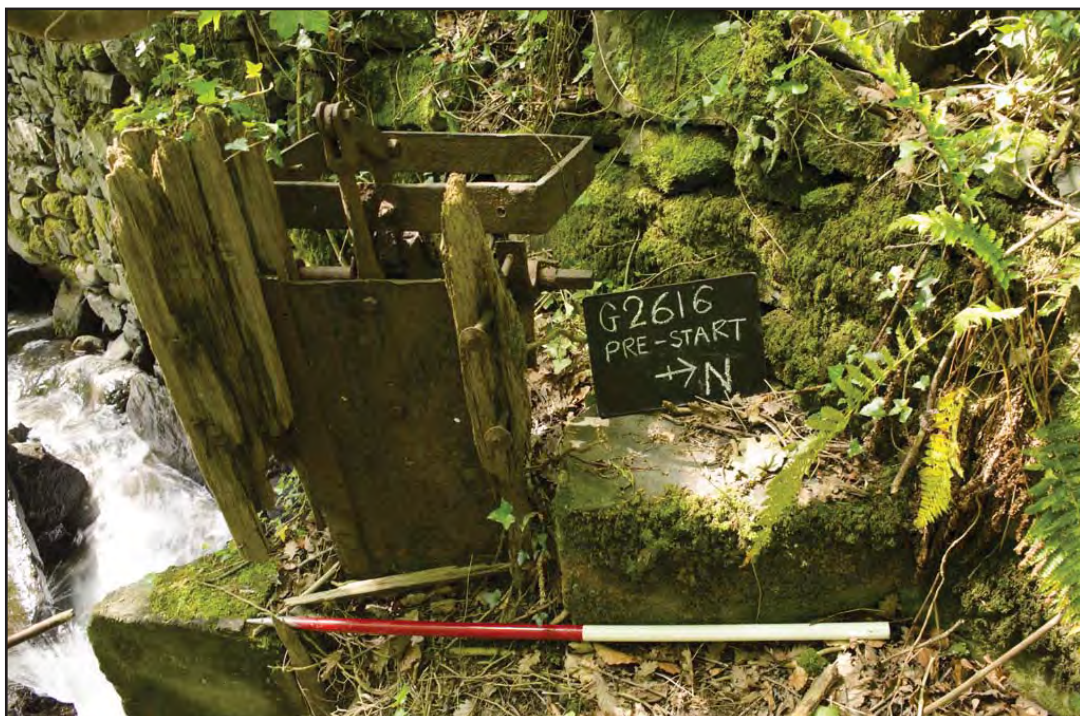
Plate 12: Close-up of north bank sluice gate; scale 1 x 1m; view from E (archive reference: G2616_030).

Plate 12: Close-up of north bank sluice gate; scale: 1 x 1m; view from: E (archive reference: G2616_030).

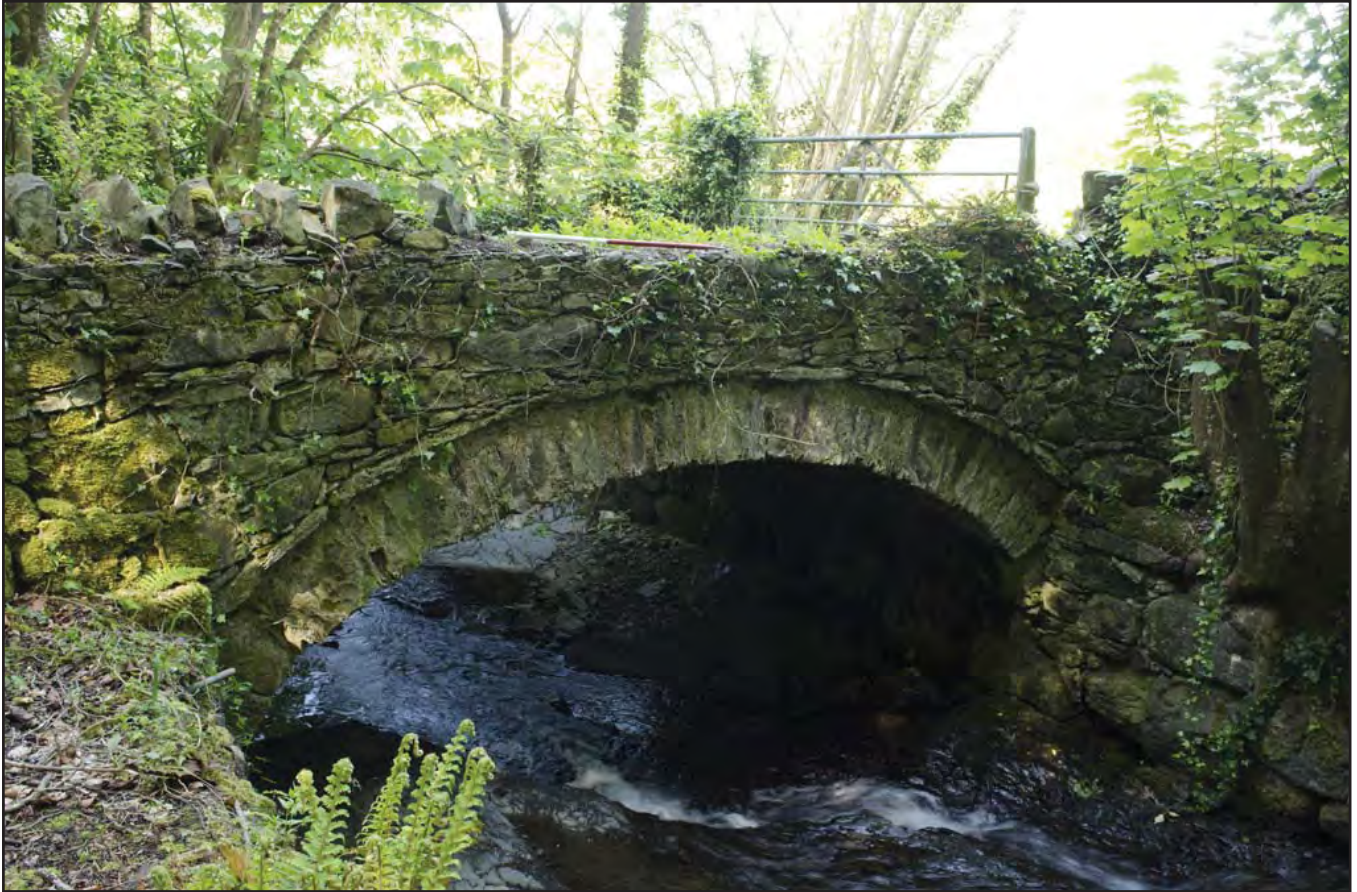
Plate 13: Span of the arch at the bridge (no board); scale 1 x 1m; view from ESE (archive reference: G2616_009).

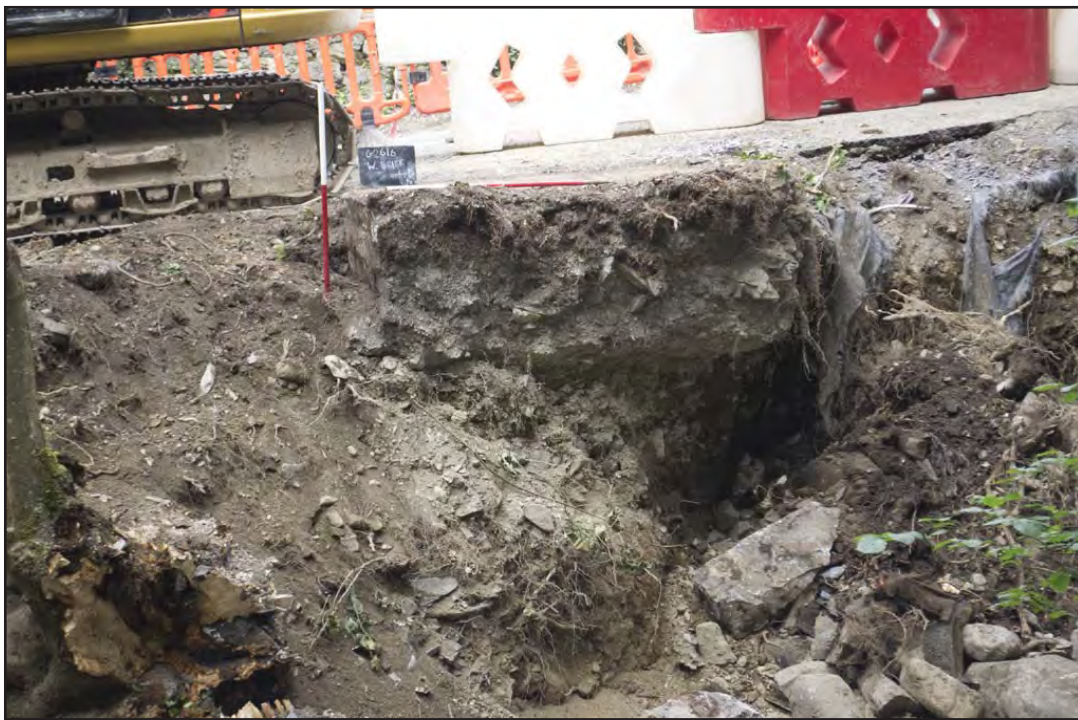
Plate 23: View of NW bank of the river showing BT box in bank profile to the NE of the bridge; scale 2 x 1 m; view from SE (archive reference: G2616_099).

Plate 23: View of NW bank of the river showing BT box in bank profile to the NE of the bridge; scale 2 x 1m; view from SE (archive reference: G2616_099).

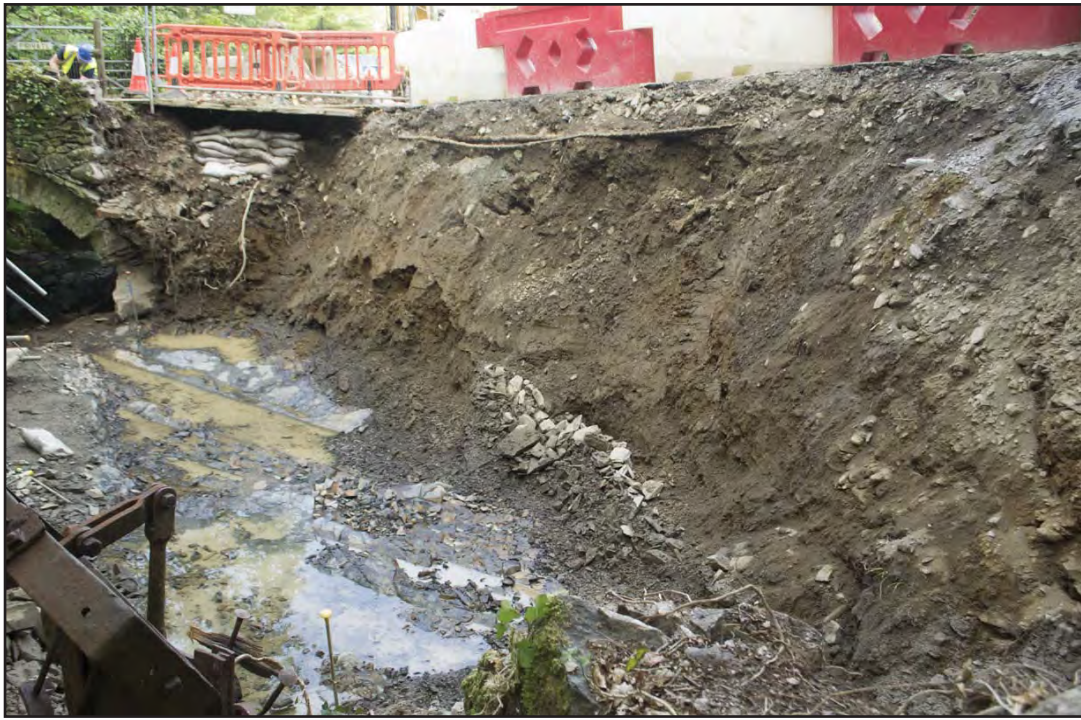
Plate 25: As above, but showing the bridge with sandbagging at the NW end of the bridge; scale not used; view from NE (archive reference: G2616_123).

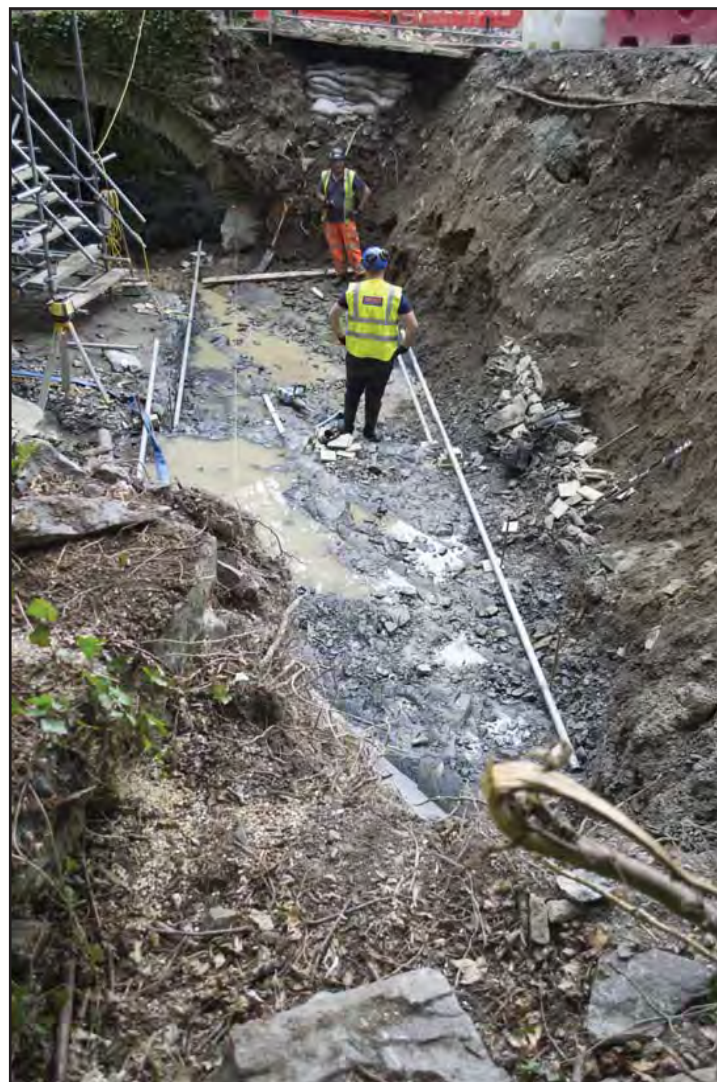
Plate 26: View of NW bank of the river at the conclusion of excavation works with foundation preparation being undertaken; scale not used; view from ESE (archive reference: G2616_133).

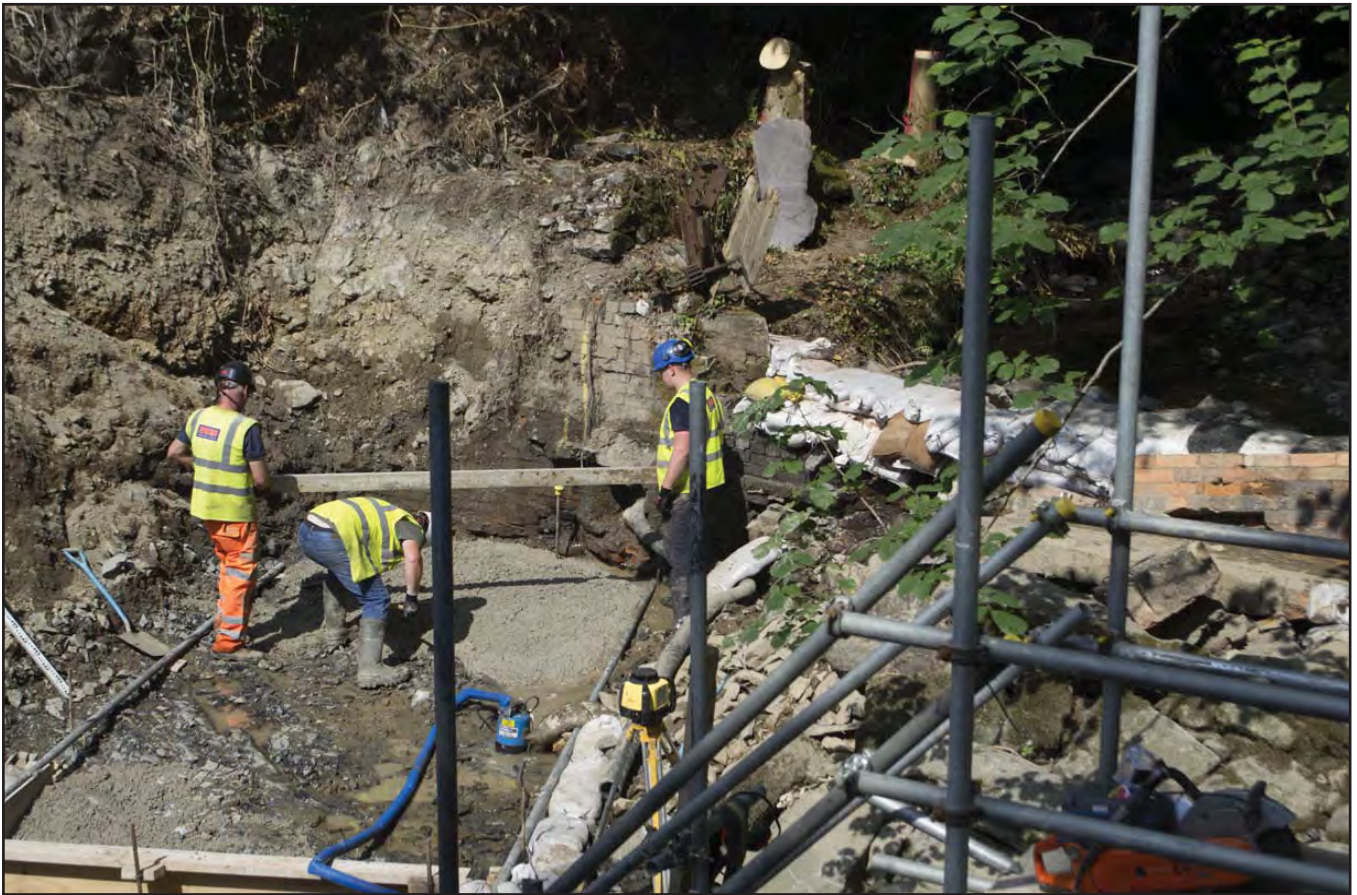
Plate 27: View of the concrete laying from the bridge, showing the weir; scale not used; view from S (archive reference: G2616_138).

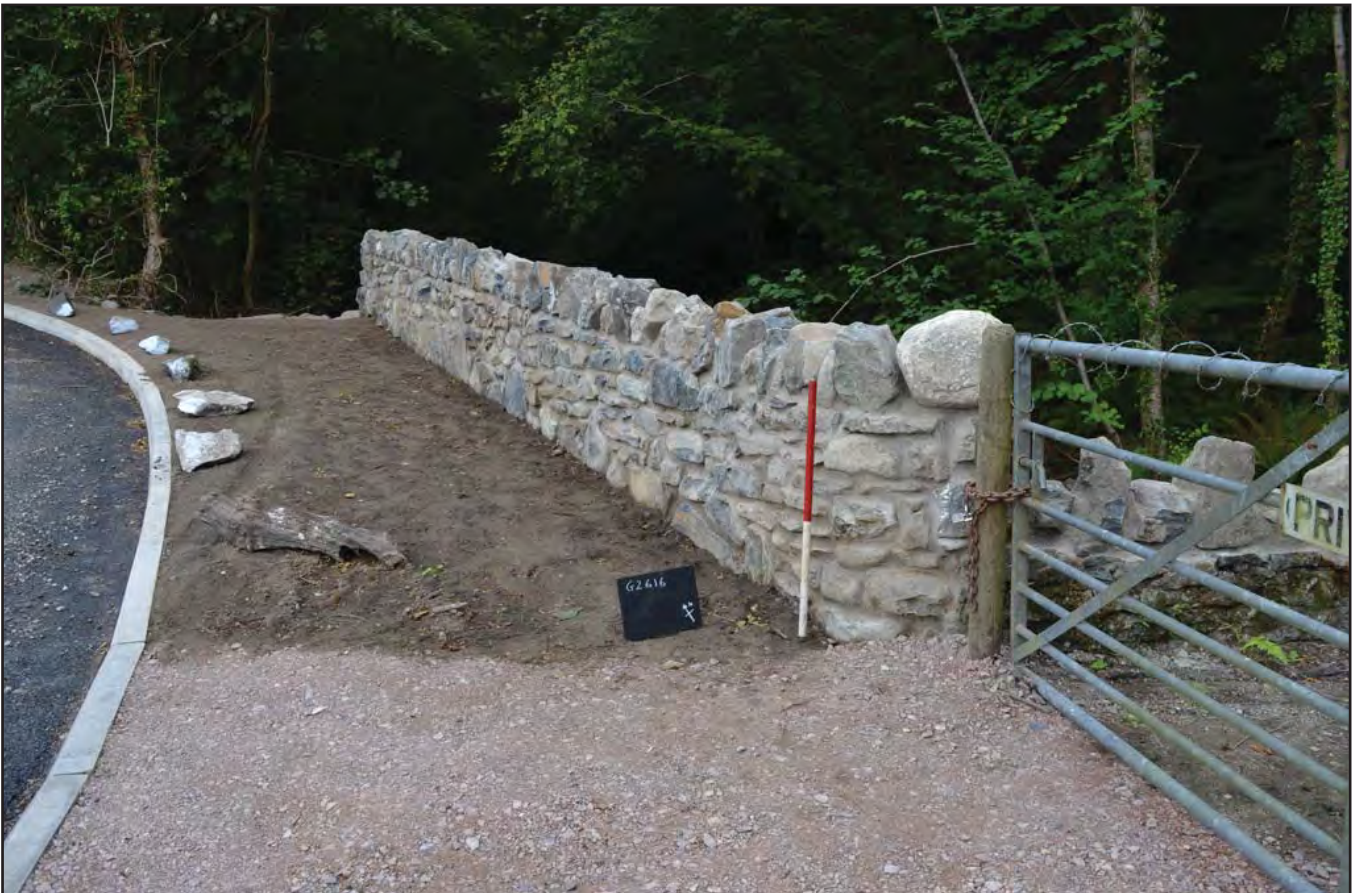
Plate 28: View of the retaining wall parapet from the side of the minor road; scale 1 x 1 m; view from SW (archive reference: G2616_144).

Plate 28: View of the retaining wall parapet from the side of the minor road; scale 1 x 1m; view from SW (archive reference: G2616_144).

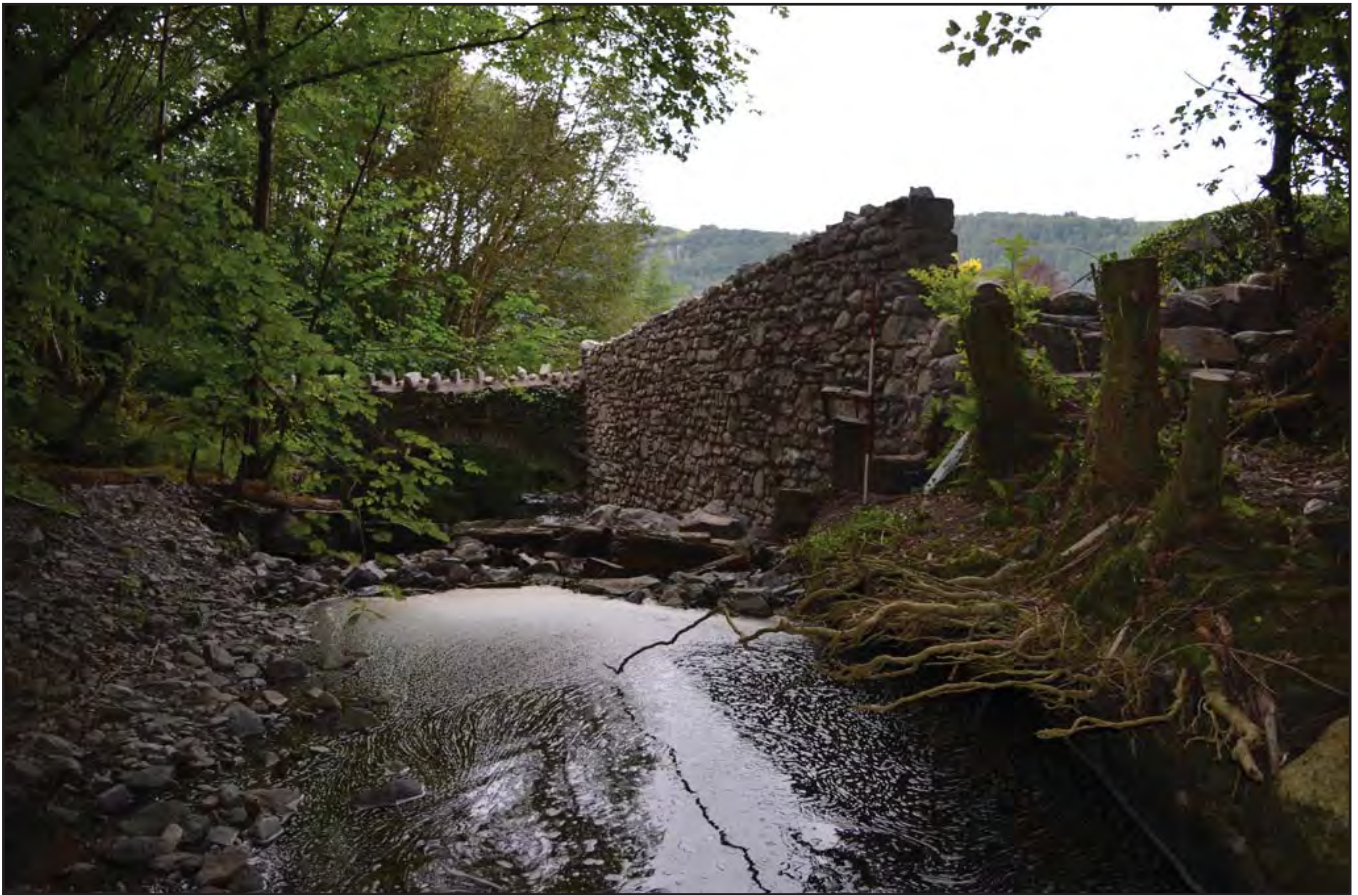
Plate 29: View of the retaining wall, 3m high, from the river to the NE of the bridge; scale 1 x 2m; view from NE (archive reference: G2616_145).

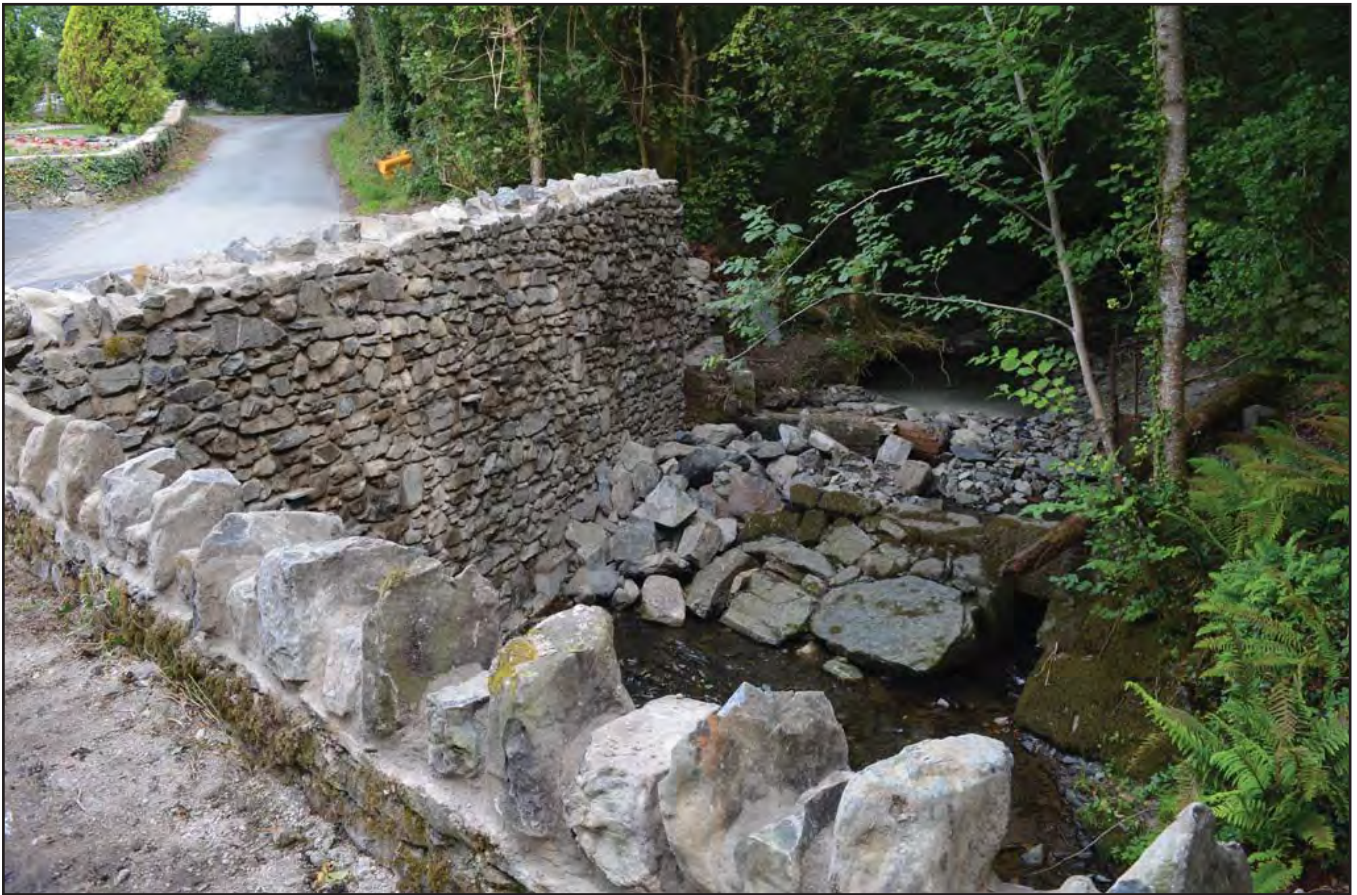
Plate 31: General view of revetment walling from the bridge showing bonding with the sluice; scale not used; view from SSW (archive reference: G2616_152).
