REPORT ON THE SEVENTH SEASON OF THE  
TRE'R CEIRI CONSERVATION PROJECT  
MAY TO SEPTEMBER 1995

REPORT NO. 185

prepared for Cyngor Dosbarth Dwyfor

December 14th 1995

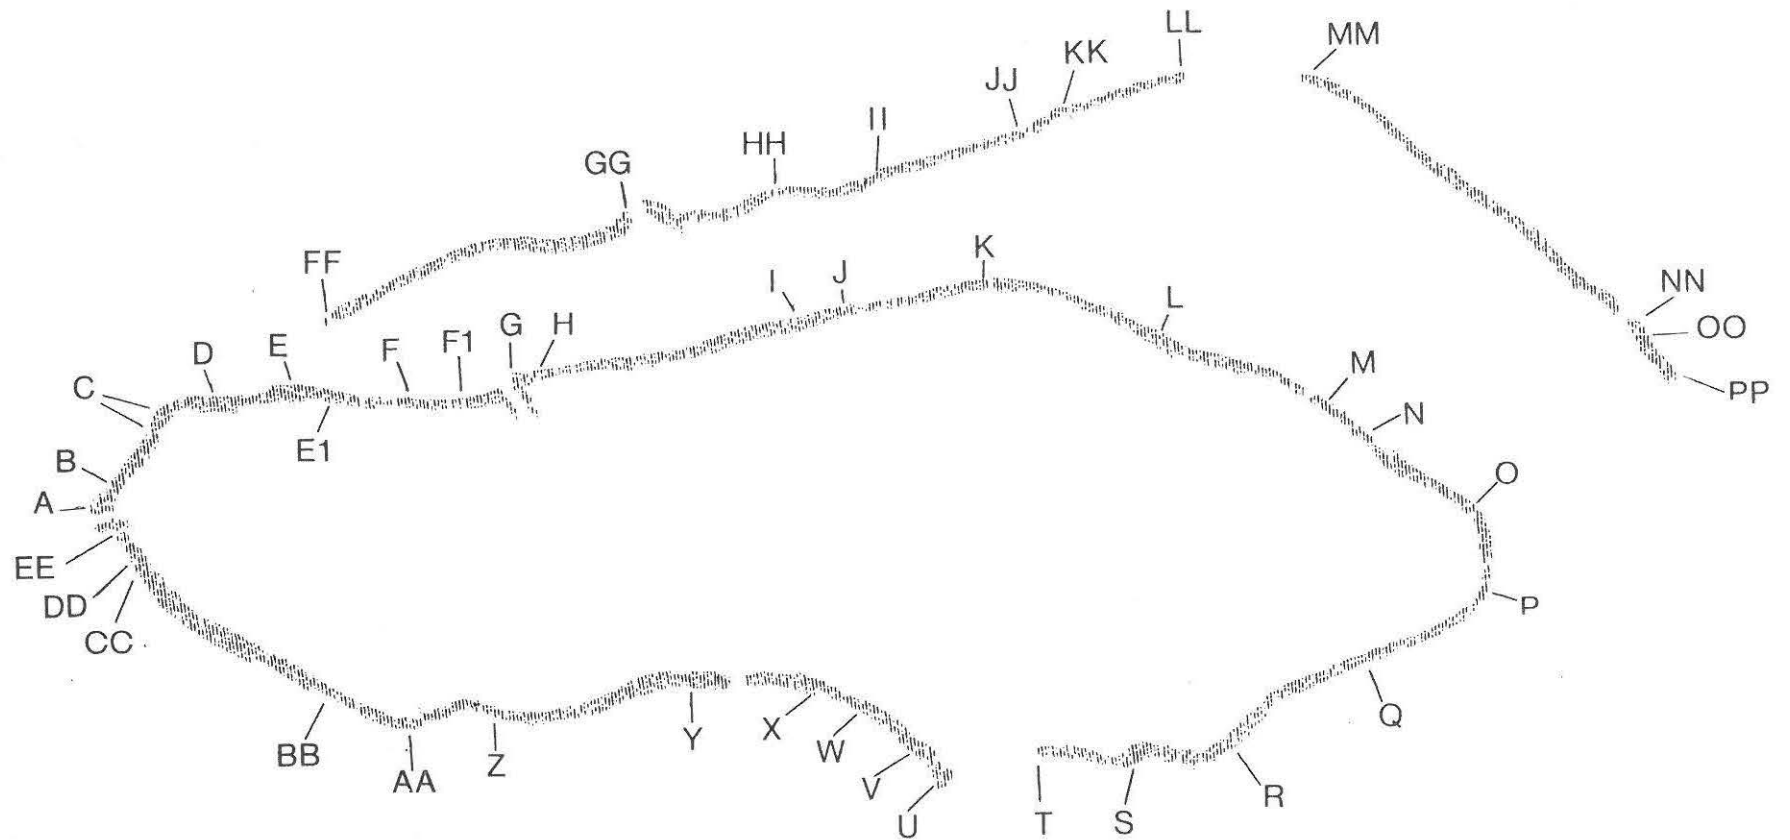
Fig. 2 The Ramparts: points of collapse (after Dallimore, 1978).

Details follow of all conservation works completed during the seventh season. Works conducted on the main rampart wall can be located by reference to the numbering scheme produced by K. Dallimore in 1978 (Fig. 2) and detailed location plan, Fig. 3. Works conducted on the huts can be located by reference to Fig.1 (R.C.A.H.M.W , 1960) and detailed location plans, Figs. 6, 9, and 10. As the works were predominantly recorded photographically, it is recommended that the relevant Plates in Part 2 be consulted alongside the text. At the end of the season the edges of the collapses and any disturbed masonry were marked with discreet 10mm diameter drill holes. In addition to this, polypropylene cord was placed at the lowest point of disturbance in the wall core and at any other relevant points in order to indicate the extent of clearance undertaken.

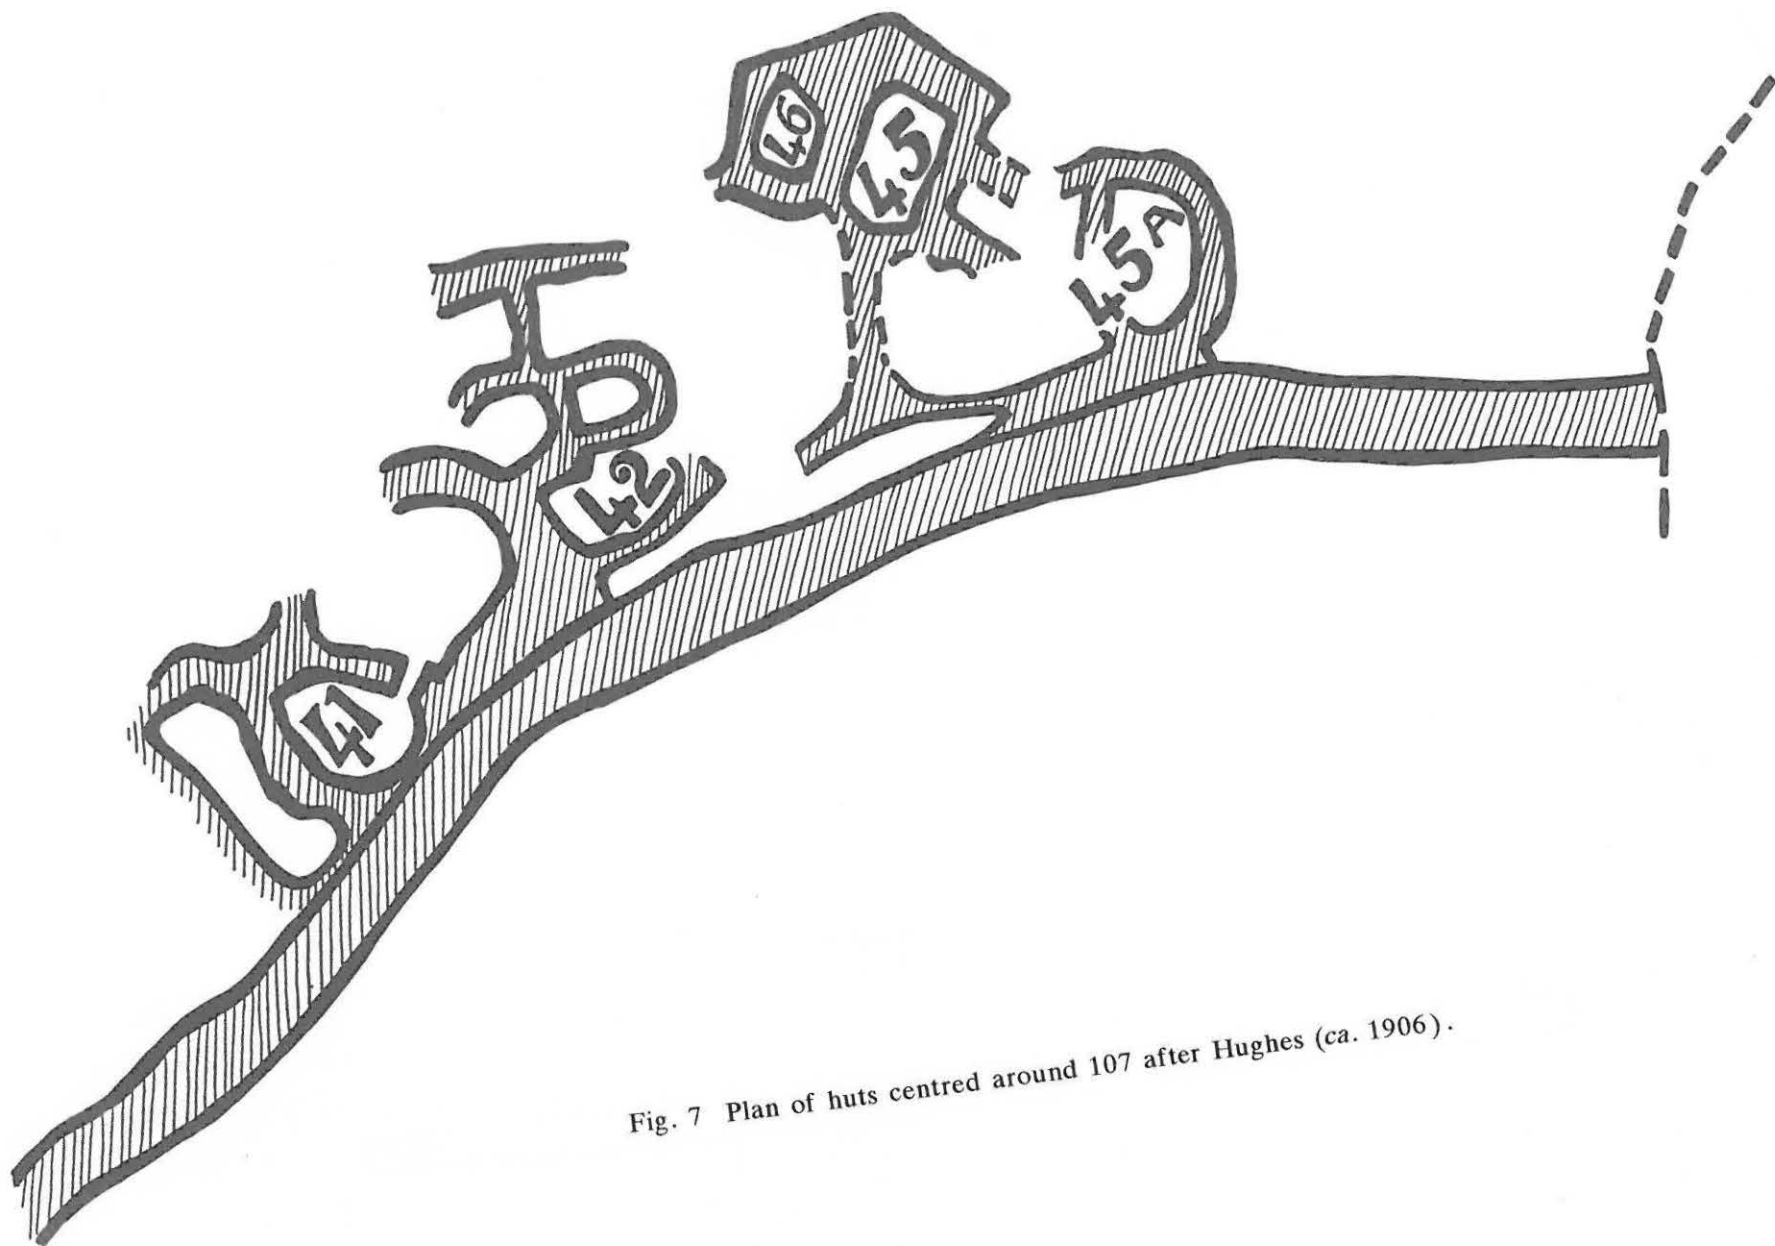
Fig. 7 Plan of huts centred around 107 after Hughes (ca. 1906).

There was a slight discontinuity just to the west of the centre of the collapse which presumably represents the stub of wall shown on Hughes plan (Fig. 7). It is no longer clear if this is part of a wall but it suggests that Bersu, Gresham and Hemp's (*ca.* 1939) of the hut as being L shaped may be incorrect.

His plan (Hughes, *ca.* 1906) shows a roughly oval hut with a break in the north-east wall which may correspond to the entrance (Fig. 7). The north-west wall is shown to be formed by the outer faces of huts 103 and 106.

When Hughes excavated the hut in 1906 (Hughes, 1907) he recovered fragments of a bronze beaded torque, the remains of an iron loop, part of the base of a red earthenware vessel, two rim sheds from a black pottery vessel, charcoal, pot boilers, burnt stones, a small pebble, burnt bone and the jawbone of a horse. His plan shows the hut to be roughly oval with an entrance on the north-east (Fig. 7).

It was necessary to build a new face on this side of the hut in order to revet the core and eroded stone, the construction of a stable 'built collapse' would have entailed the importation of excessive amounts of stone and the loss of line of the wall. It was decided to replace the marked masonry from the edge of the entrance on a stable base. Stones A to J were reset close to their original positions. A 0.7m high face was built across the rest of the face, following the line suggested by the alignment of the stones seen in the collapse (Plates 189 and 190). This also corresponds to the line of the wall on Hughes' plan (Fig. 7).

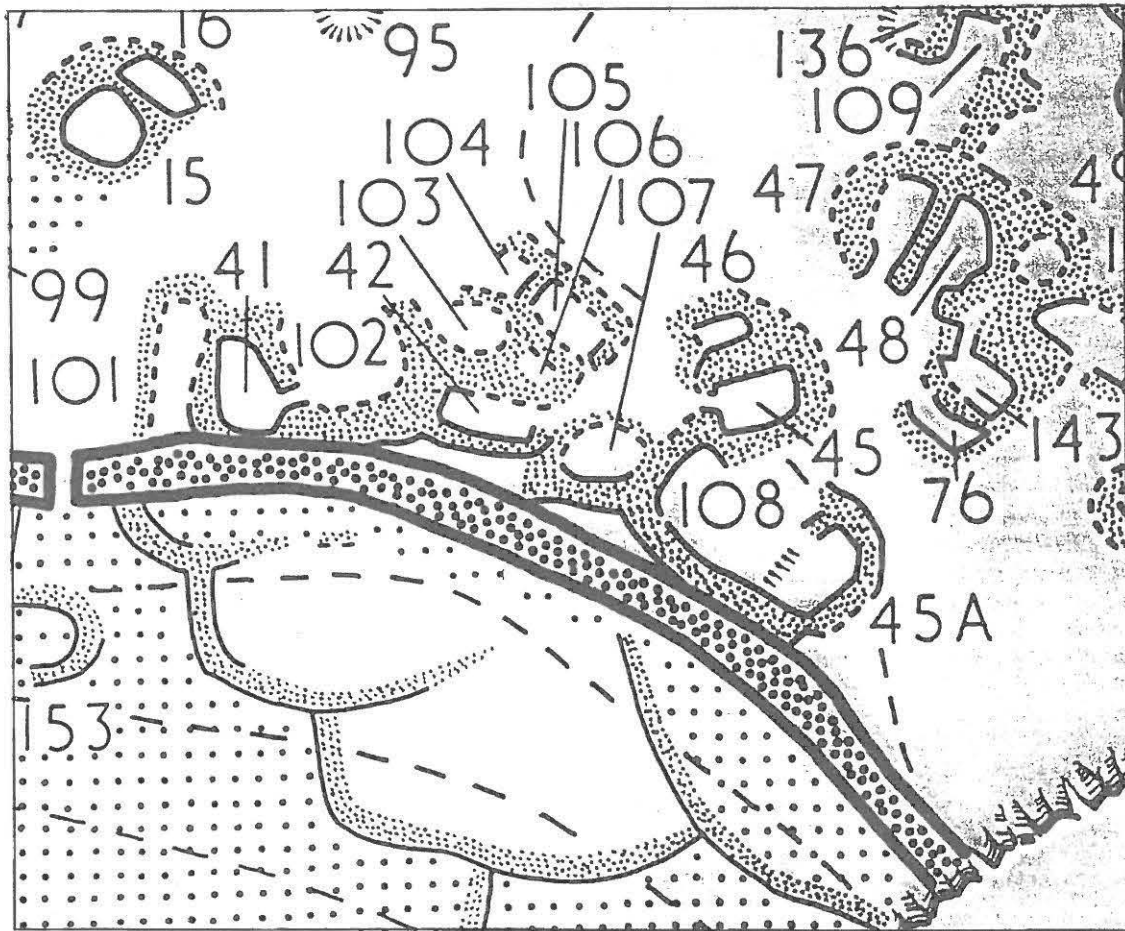
Fig. 8 Plan of huts centred around 107 (R.C.A.H.M.W. 1960)

A D shaped enclosure, centred around collapse V6, is depicted on modern plans of Tre'r Ceiri (e.g. Fig. 8). Collapse W marks the south-west end of the enclosure and it has been assumed that the south-eastern wall of hut 107 abuts the rampart.

Hughes (1907) depicted this hut as being roughly oval with facing at the south and north east. When Bersu, Gresham and Hemp cleared the hut in 1939 (*ca.* 1939), the inside of the wall could be traced for most of its circumference. The wall was described as being well preserved and standing to a height of over 0.6m, with a break in one of the longest sides. Griffiths (1946) recorded 0.6m high facing at the south and west of the hut. Dallimore (1978) described the hut as being 'fair but overgrown' with walls in places up to a height of 1.0m. The R.C.A.H.M.W. (1960) plan (Fig. 8) depicts the south-west and north-west corners as being square.

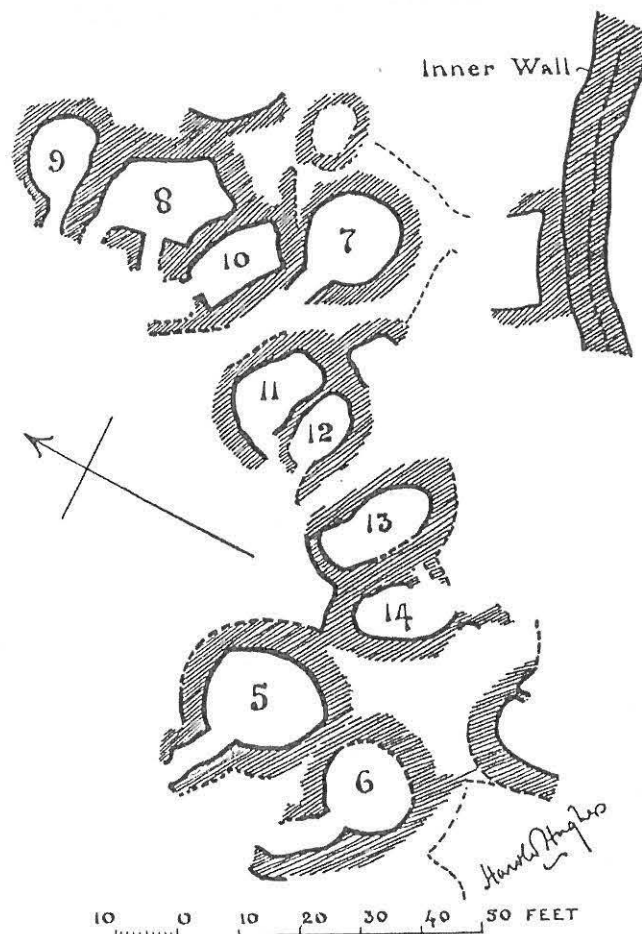
Fig. 10 Plan of huts 9 and 10 by Hughes (Baring-Gould and Burnard, 1904)

Hut 9 was excavated by Baring-Gould and Burnard in 1903 (Baring-Gould and Burnard, 1904) and planned at the same time by Hughes (Fig. 10). No finds were recovered but it was recorded that, 'regularly-built drain-like cavities acted as catch-pits under the paved floor. There was no drain to carry the accumulated water out of this hut.' A 0.9m wide, west facing, entrance was recorded along with hut walls of 1.8m in height.
