REPORT ON THE EIGHTH SEASON OF THE TRE'R CEIRI CONSERVATION PROJECT APRIL TO SEPTEMBER 1996

Prepared for Cyngor Dosbarth Dwyfor by D. Hopewell

GWYNEDD ARCHAEOLOGICAL TRUST REPORT NO. 246

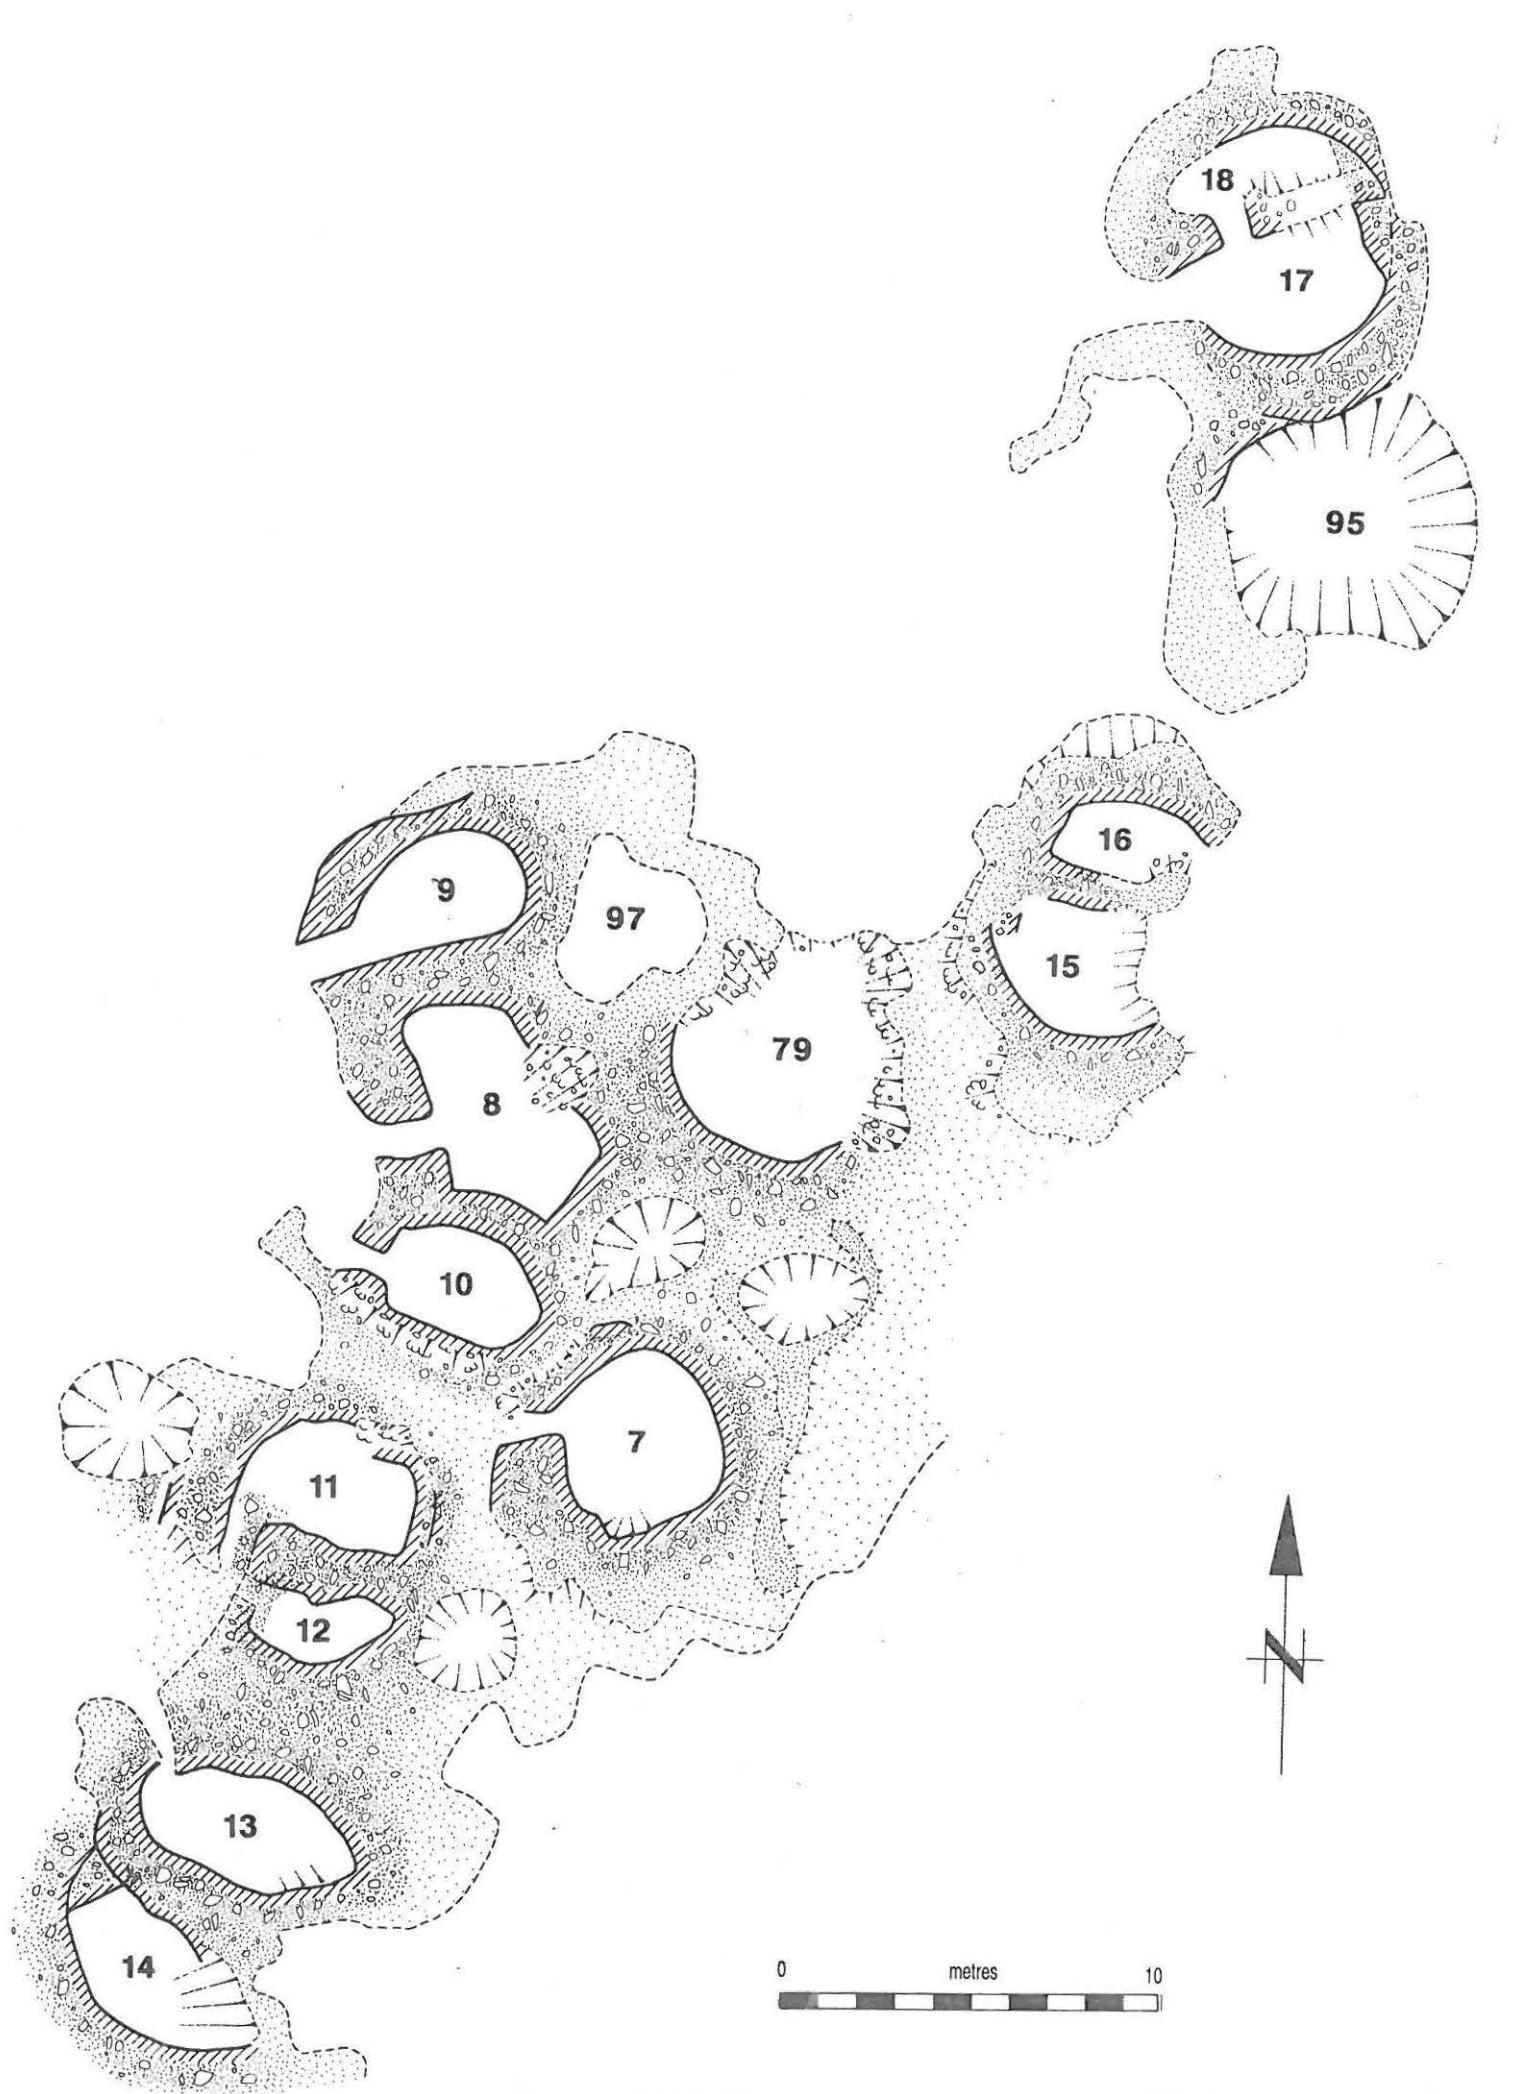
Fig. 10 - scale 1:200 - The central south-eastern group of huts after conservation.

The earlier surveys and plans agree on the overall dimensions and form of the huts but differ on the details of the entrance through the dividing wall. Hughes (*ca. 1906*) shows a break in the north-east end of the wall while the RCAHM plan has a break in the south-east end. Neither Griffiths (1946) or Dallimore (1978) mention the entrance. It was clearly visible 1.0m from the south-west end of the dividing wall when the hut was examined at the beginning of the present season. There was no obvious explanation for the discrepancies in the previous reports.

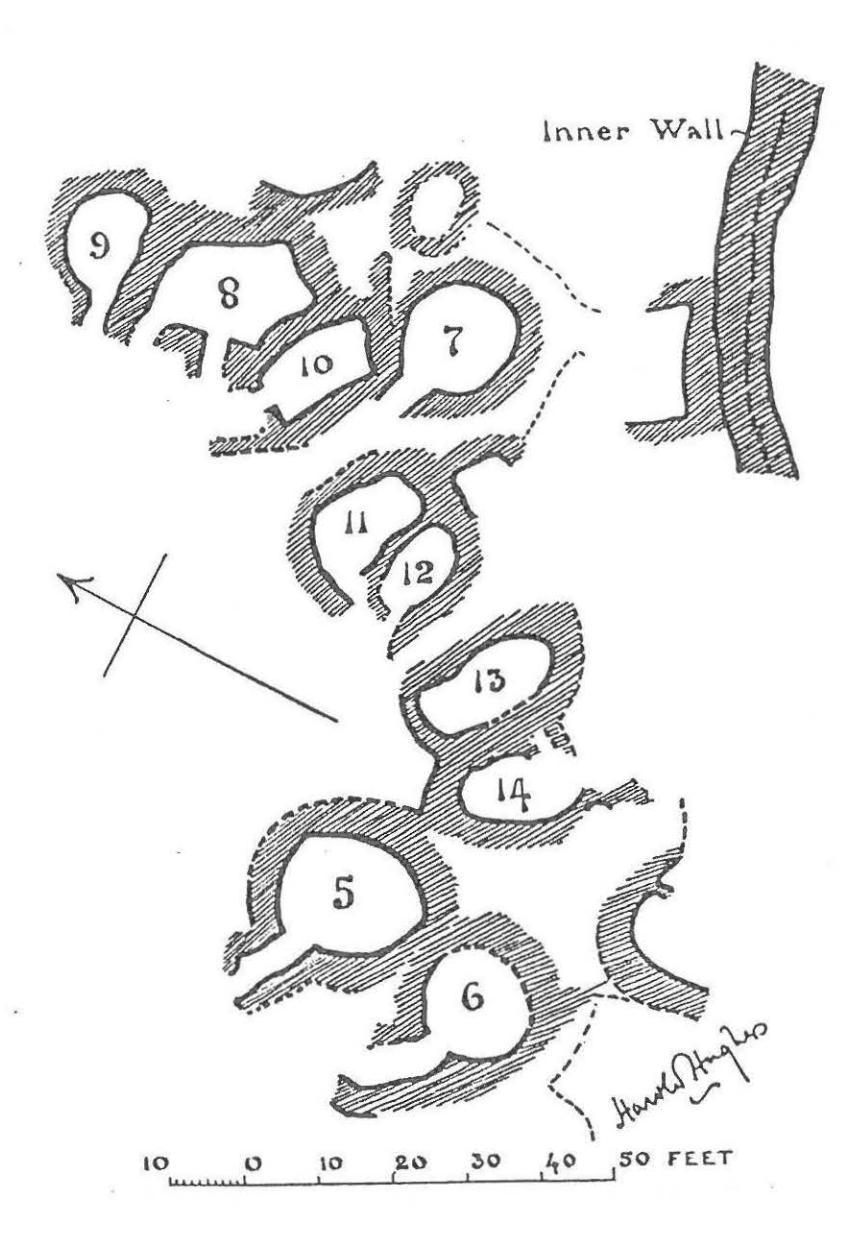
Fig. 12 Plan of huts 5 to 14 inclusive (Hughes in Baring-Gould and Burnard, 1904)

A detailed plan of some of the huts along the south-eastern side of Tre'r Ceiri, drawn by Harold Hughes, was published as part of Baring-Gould and Burnard's excavation report (Fig. 12). This showed a second entrance or break in the south-eastern wall of the hut. The edge of the break in the wall was drawn with a broken line indicating that facing could not be traced through it. A slight inturn and a change in the character of the facing is all that can presently be seen at this point (see below, collapse 8b).

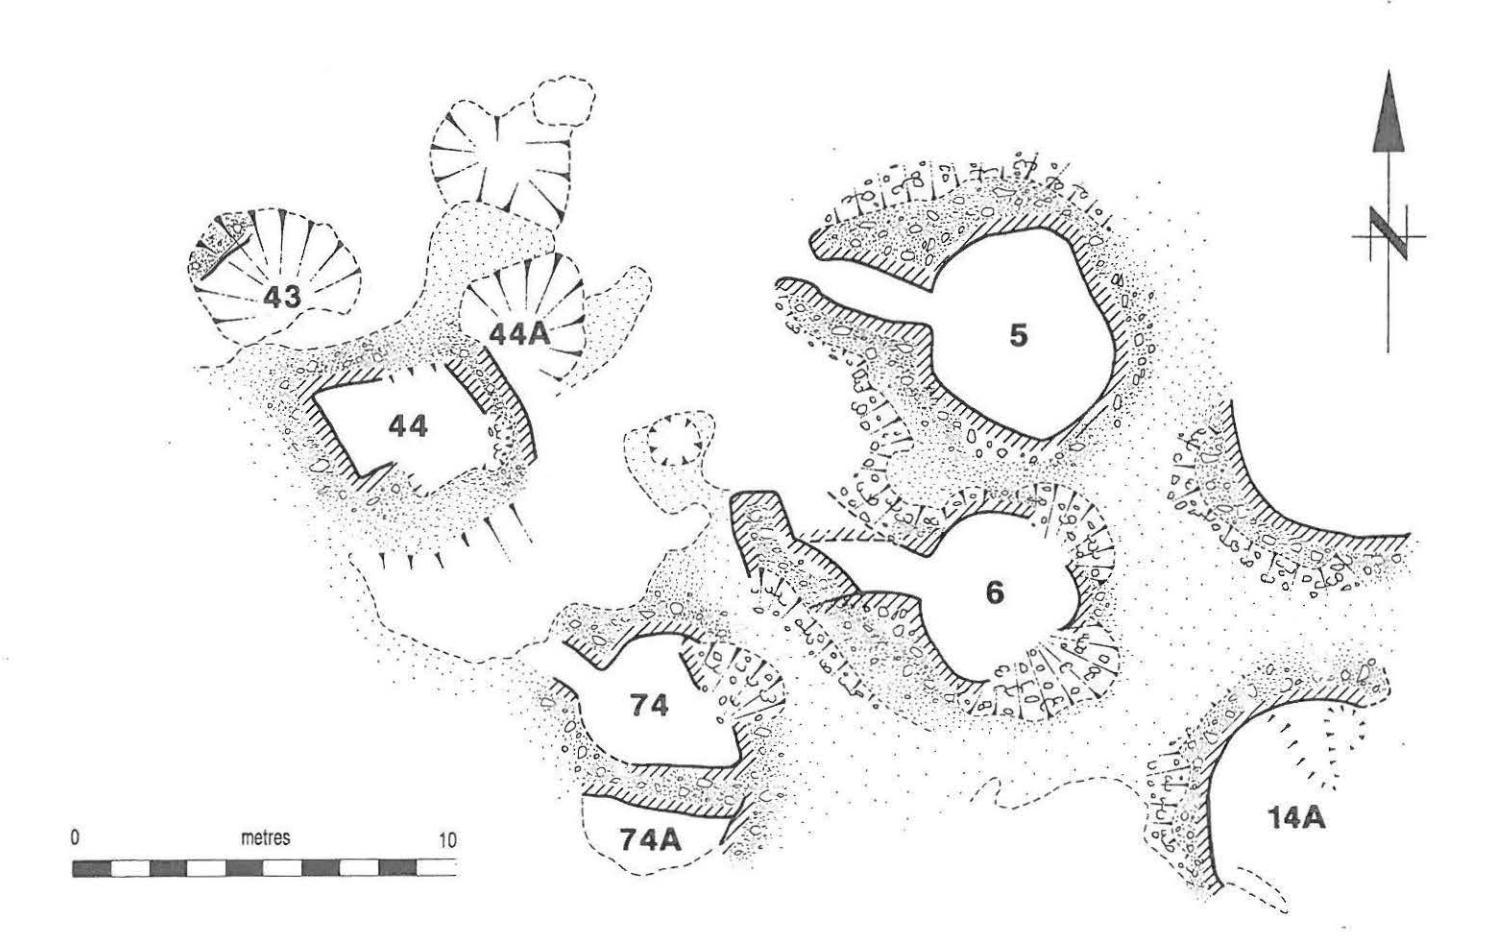
Fig. 16 - scale 1:200 - Huts 5,6,74 and 44 after conservation.

The hut was surveyed at the beginning of the present season and it could be seen that the deterioration recorded by Dallimore had continued. About 50% of the internal facing of the hut had collapsed making it difficult to trace the line of the wall. Most of the facing that remained was semi-collapsed and unstable. There was a large hole in the centre of the hut that was emphasised by the large amounts of stone spilling forwards from the collapse. The walls had obviously been undermined by treasure hunters and possibly to a certain extent by the early excavators resulting in large areas of collapse and the reduction of a 'fine hut' (Griffiths, 1946) to little more than a rubble filled hollow. There were two possible courses of action that could be taken during the conservation of this hut. In many cases a poorly preserved hut such as this would be stabilised with the minimum of disturbance as most of the masonry would have been either destroyed or buried. In this case however the stone slopes overlying the line of the wall were still eroding thus threatening any buried facing. Several short lengths of possible facing could be seen within the rubble suggesting that there was enough information to allow new walling to be built. The hut was also close to the main footpath through the fort and it was felt that a well defined hut in this position would be instructive to the casual visitor who would perhaps treat an easily understandable structure with more respect than a pile of rubble. It was therefore decided to attempt to consolidate the hut by clearing the fallen stone and adding new masonry. This was somewhat beyond the normal extent of the conservation project but as this was all recent damage and there were good plans of the original hut it was felt to be acceptable.
