Management of archaeological sites on Cochwillan Estate

GAT Project G1523

Report no. 285

October 1998

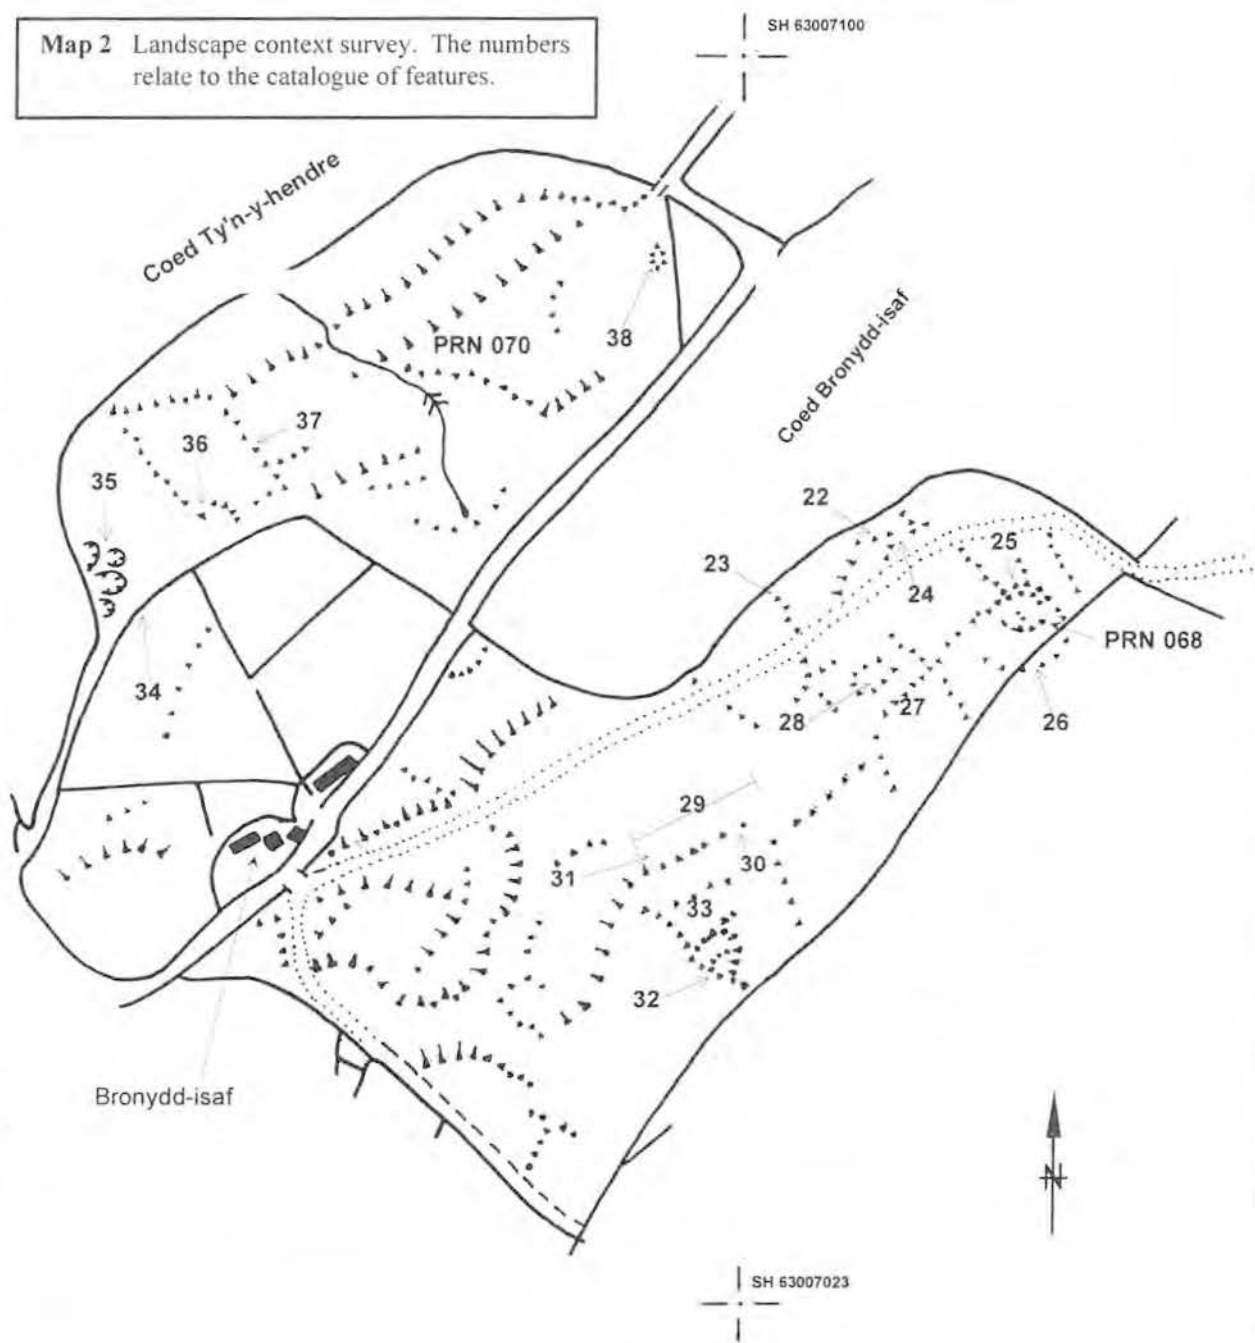
Map 2 Landscape context survey. The numbers relate to the catalogue of features.

- 22 Slightly terraced ancient trackway (turved).
- 23 Area of lynchets and banks which have been damaged by ploughing, probably as part of land improvement works in the 1950s (Mr. T.W. Davies, Bronydd-isaf, pers. comm.).
