YMDDIRIEDOLAETH ARCHAEOLEGOL GWYNEDD
GWYNEDD ARCHAEOLOGICAL TRUST

REPORT ON THE NINTH SEASON OF THE
TRE'R CEIRI CONSERVATION PROJECT
MAY TO OCTOBER 1997

D. HOPEWELL

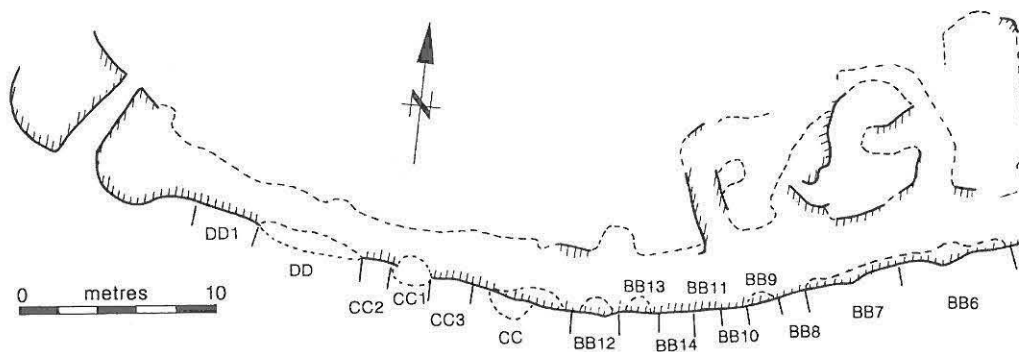
Fig. 3 Plan of ramparts DD to BB, showing location of collapses conserved during the ninth season.

The facing to the west of DD1 had been conserved during the fifth season. DD1 was 3.0m wide and consisted of facing standing to a height of 0.5m (Plate 1). This was stable apart from some stones on the wall top which had been displaced and were overhanging the rest of the facing. These were pushed back into line (Plate 2).

Collapse CC2 was on the point of collapse, so CC1 was conserved first in order to provide support for the weak masonry (see below). A 1.3m length of facing to the east of DD had survived to a height of 0.6m. This was however extremely unstable due to the displacement of the basal course (see Plate 8) and the large proportion of short headers that had been used in its construction. The stones had been numbered A to W before the clearance of DD (Plate 12) and stone had also been added to CC1. An attempt was made to pin the masonry as it was now supported by the rebuilt collapses DD and CC1. It soon became apparent that the facing was inherently unstable and that there was no solid masonry for the pinning to lock against. The facing was therefore dismantled in order to rebuild it in a stable fashion. A number of stones were replaced in the facing as the original stones were very short and could not be locked together. Stones A, B, H, L, I, K, M, S, R and U were replaced close to their original positions but the high proportion of new stones rendered this little more than a cosmetic exercise. Plate 13 shows CC2 after conservation.

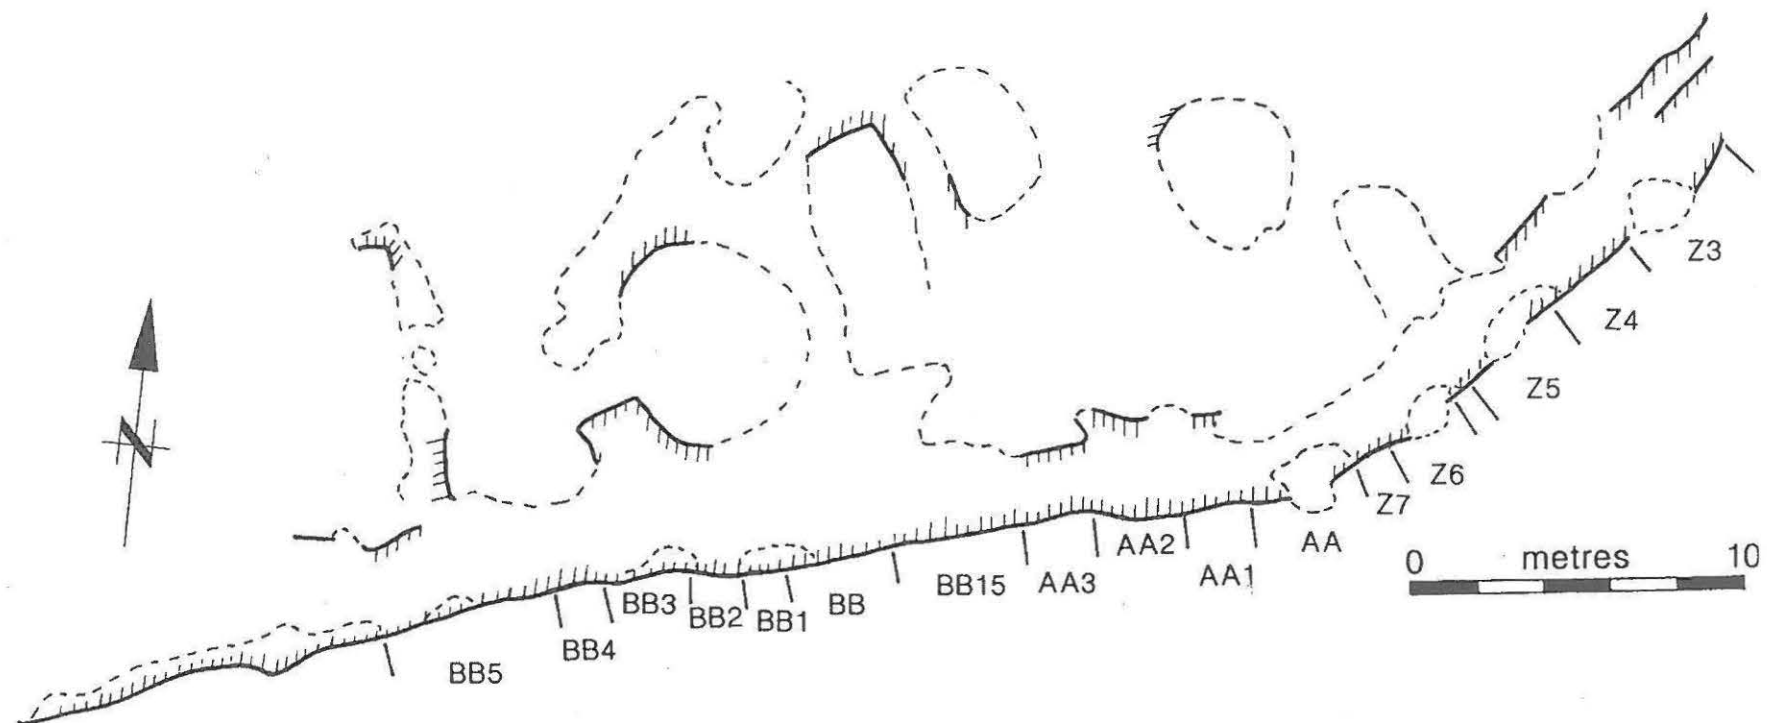
Fig. 4 Plan of ramparts BB to Z, showing location of collapses conserved during the ninth season.

The upper 0.3 m of the outer face was somewhat loose and jumbled here (Plates 62 and 64). This was stabilised by the addition of the stones indicated on Plates 63 and 65. The collapse was 3.3m wide.

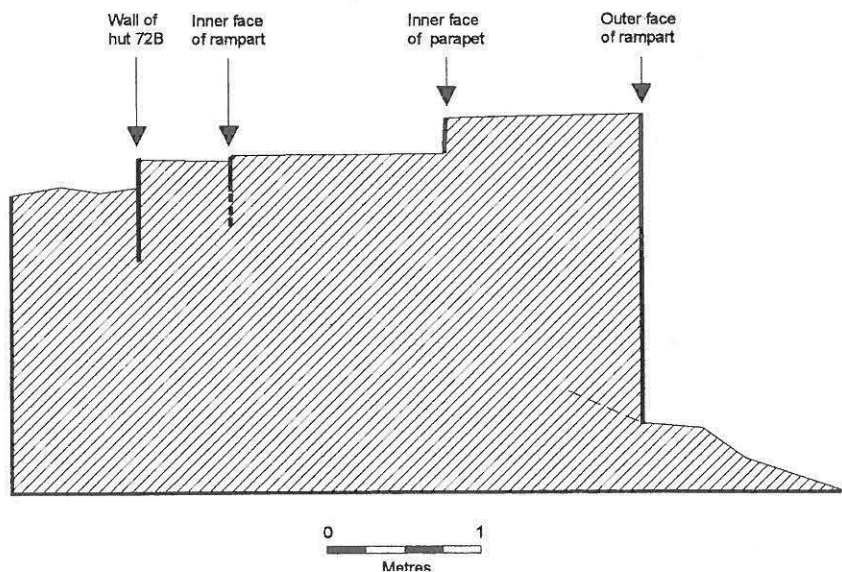
Fig. 8 Profile across Hut 72b and rampart.

The inner face to the south-west of the step at the end of Z9 was standing to a height of 0.8m. It fell to close to ground level 2.0m beyond this and could then only be traced as stones within the rubble and core where hut 72B was standing against the rampart. The parapet was however relatively well preserved standing to a height of 0.4m in places. It had been lost for 0.9m beyond the step (collapse Z9, Plate 204) but became well defined across the subsequent 6.8m (collapse Z10, Plates 204 to 206). The conservation of the outer face had considerably strengthened this feature. The area in front of the step was infilled with irregular rubble but no attempt was made to add new facing to the parapet across Y10 as its line could not be traced. The inner face of the rampart across Y9 and Y10 required no conservation. A profile across the wall of hut 72b, the rampart and the parapet was drawn (Fig. 8) in order to demonstrate the relationship between the various features.

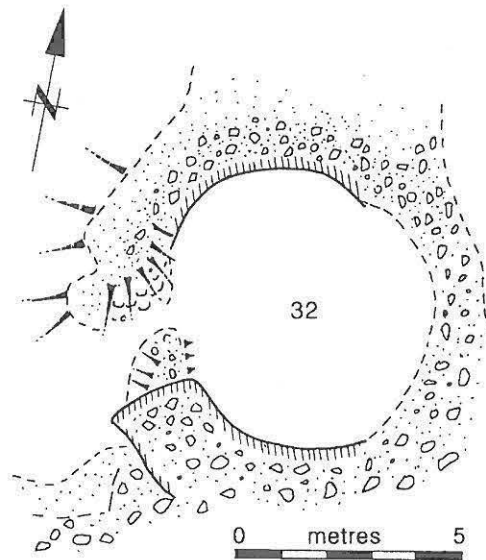
Fig. 15 Hut 32, after conservation

Before conservation the hut was visible as a circular structure with an internal diameter of about 6.0m. The south side of an entrance, blocked by large slabs, was visible in the western side of the hut. Facing was surviving across much of the western half of the hut. The eastern side had been reduced to an eroding rubble slope. The surviving internal facing was assigned two collapse numbers.

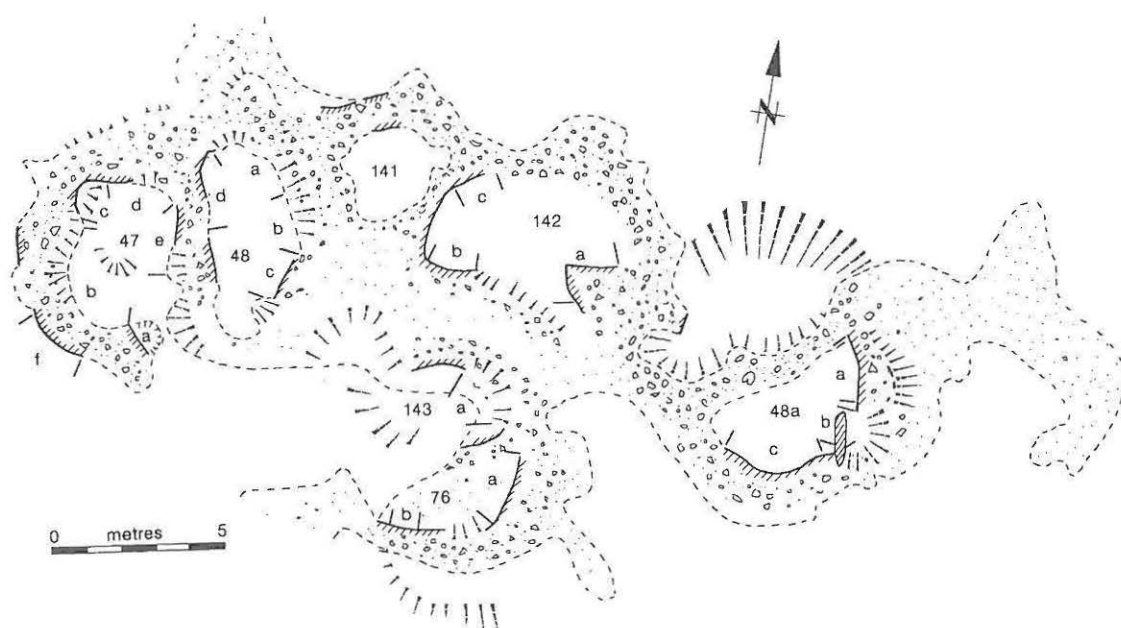
Fig. 23 Huts 47, 48, 48A, 48B, 76 and 141 to 143, before conservation.

The rest of the southern wall was sound apart from instabilities in the upper 0.2m (Plates 285 and 286). It was standing to a height of 1.0m at the east, grading down to ground level over the next 4m. Some of the discrepancy in height was however due to differences in the level of the interior of the hut. The loose stones were reset and a few heavy slabs were added to the wall top (Plates 287 and 288).
