**MALLTRAETH TIDAL DOORS IMPROVEMENT SCHEME  
ARCHAEOLOGICAL RESEARCH, RECORDING AND MONITORING PROGRAMME**

**GAT Project Number G1578  
GAT Report Number 367**

**June 2000**

**MALLTRAETH TIDAL DOORS IMPROVEMENT SCHEME  
ARCHAEOLOGICAL RECORDING AND ARCHIVAL RESEARCH PROGRAMME**

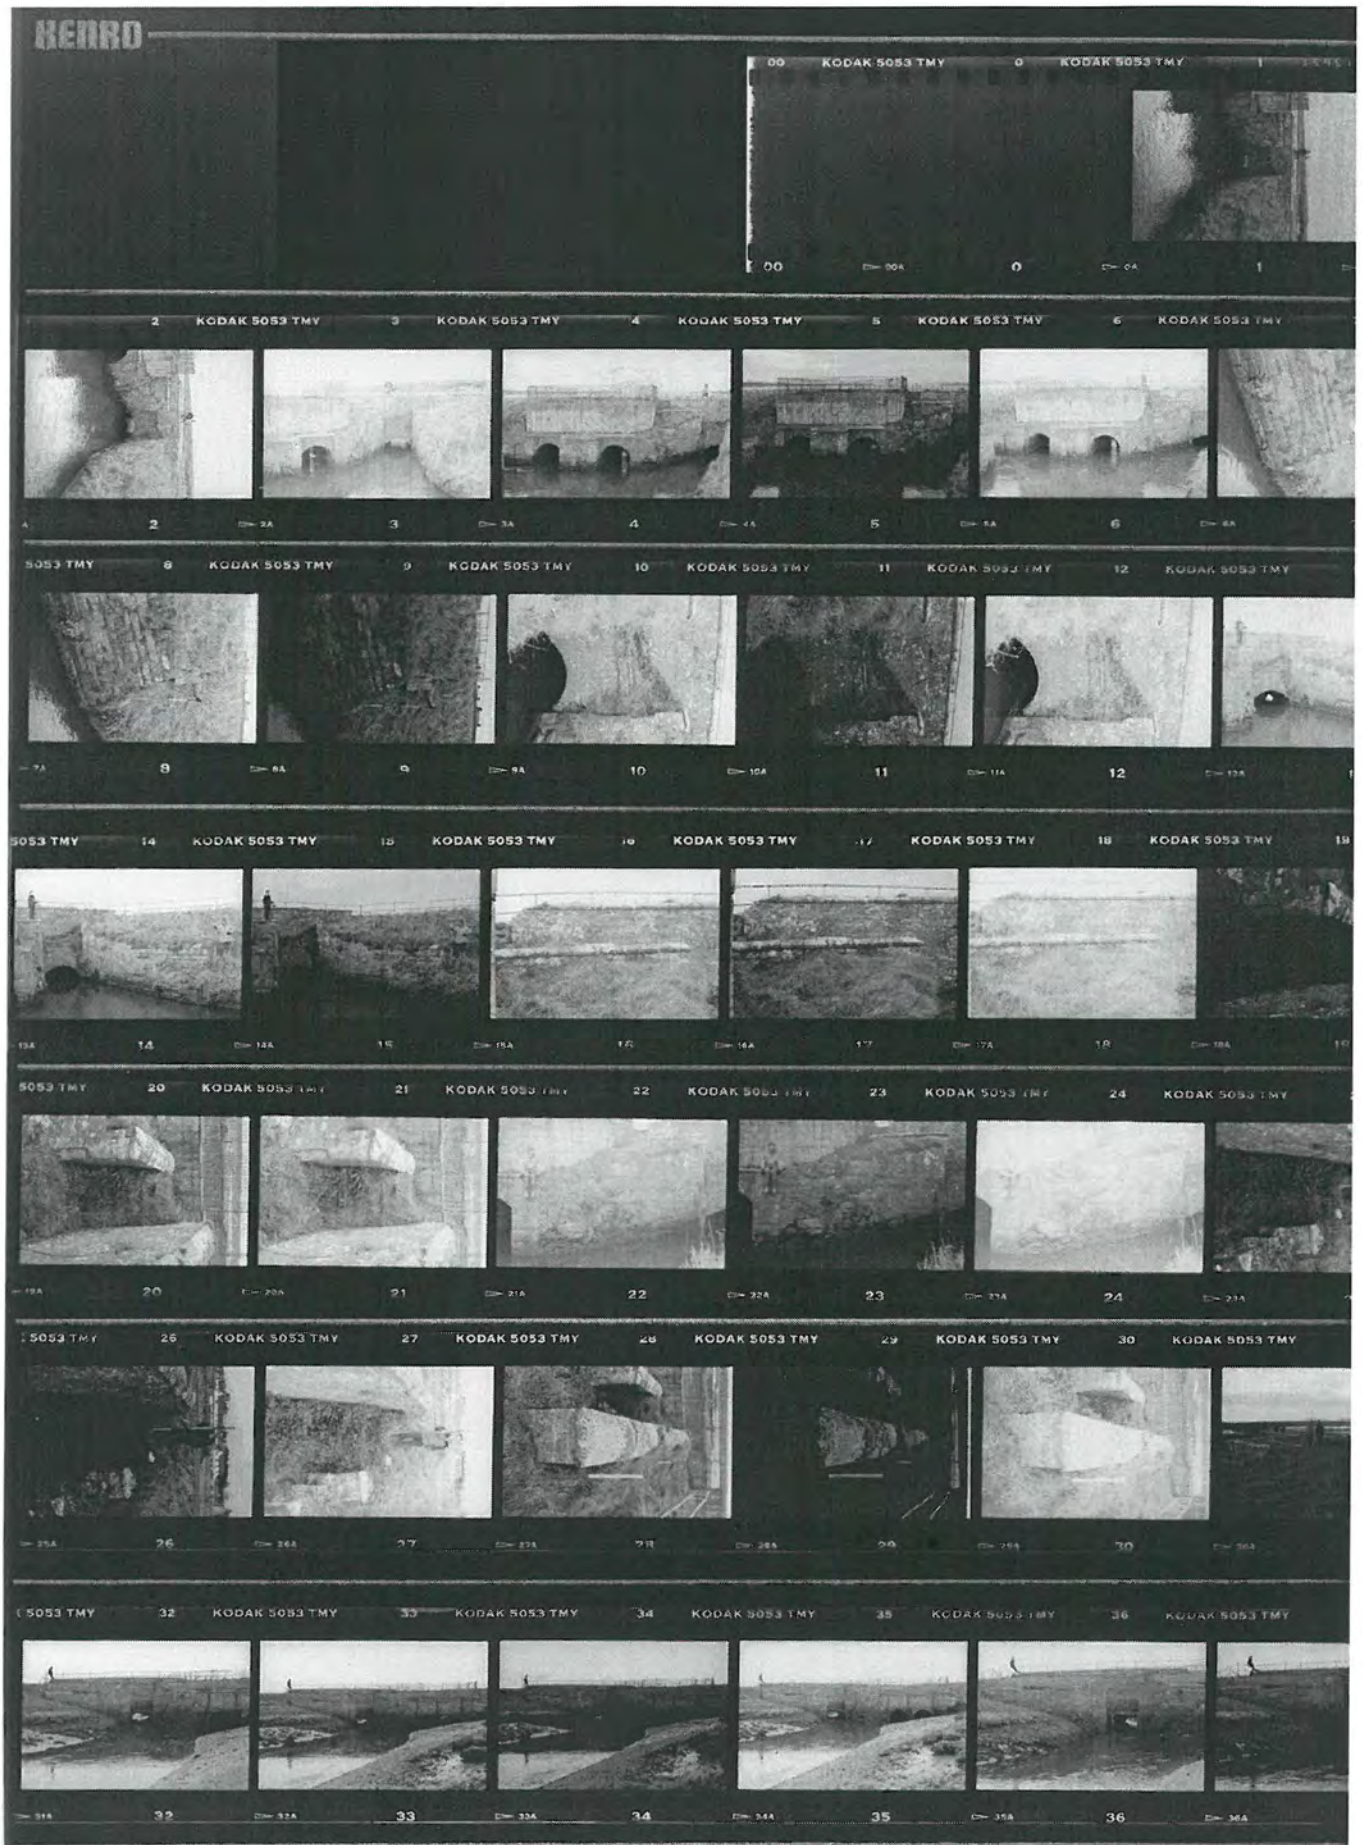
G1578 MALLTRAETH TIDAL DOORS IMPROVEMENT SCHEME  
FILM ONE (B&W PRINT) - NEGATIVES CONTACT SHEET

29	Dressed slabs capping wall to N side of track across north culvert, facing E.
30	Dressed slabs capping wall to N side of track across north culvert, facing E.
31	Track across north culvert, facing SE.
32	North culvert, general shot facing N.
33	South drain, north and south culvert, facing N.
34	South drain, north and south culvert, facing N.
35	South drain, north and south culvert, facing N.
36	North culvert, general shot facing N.
37	North culvert, general shot facing N.
<b>FILM ENDS</b>

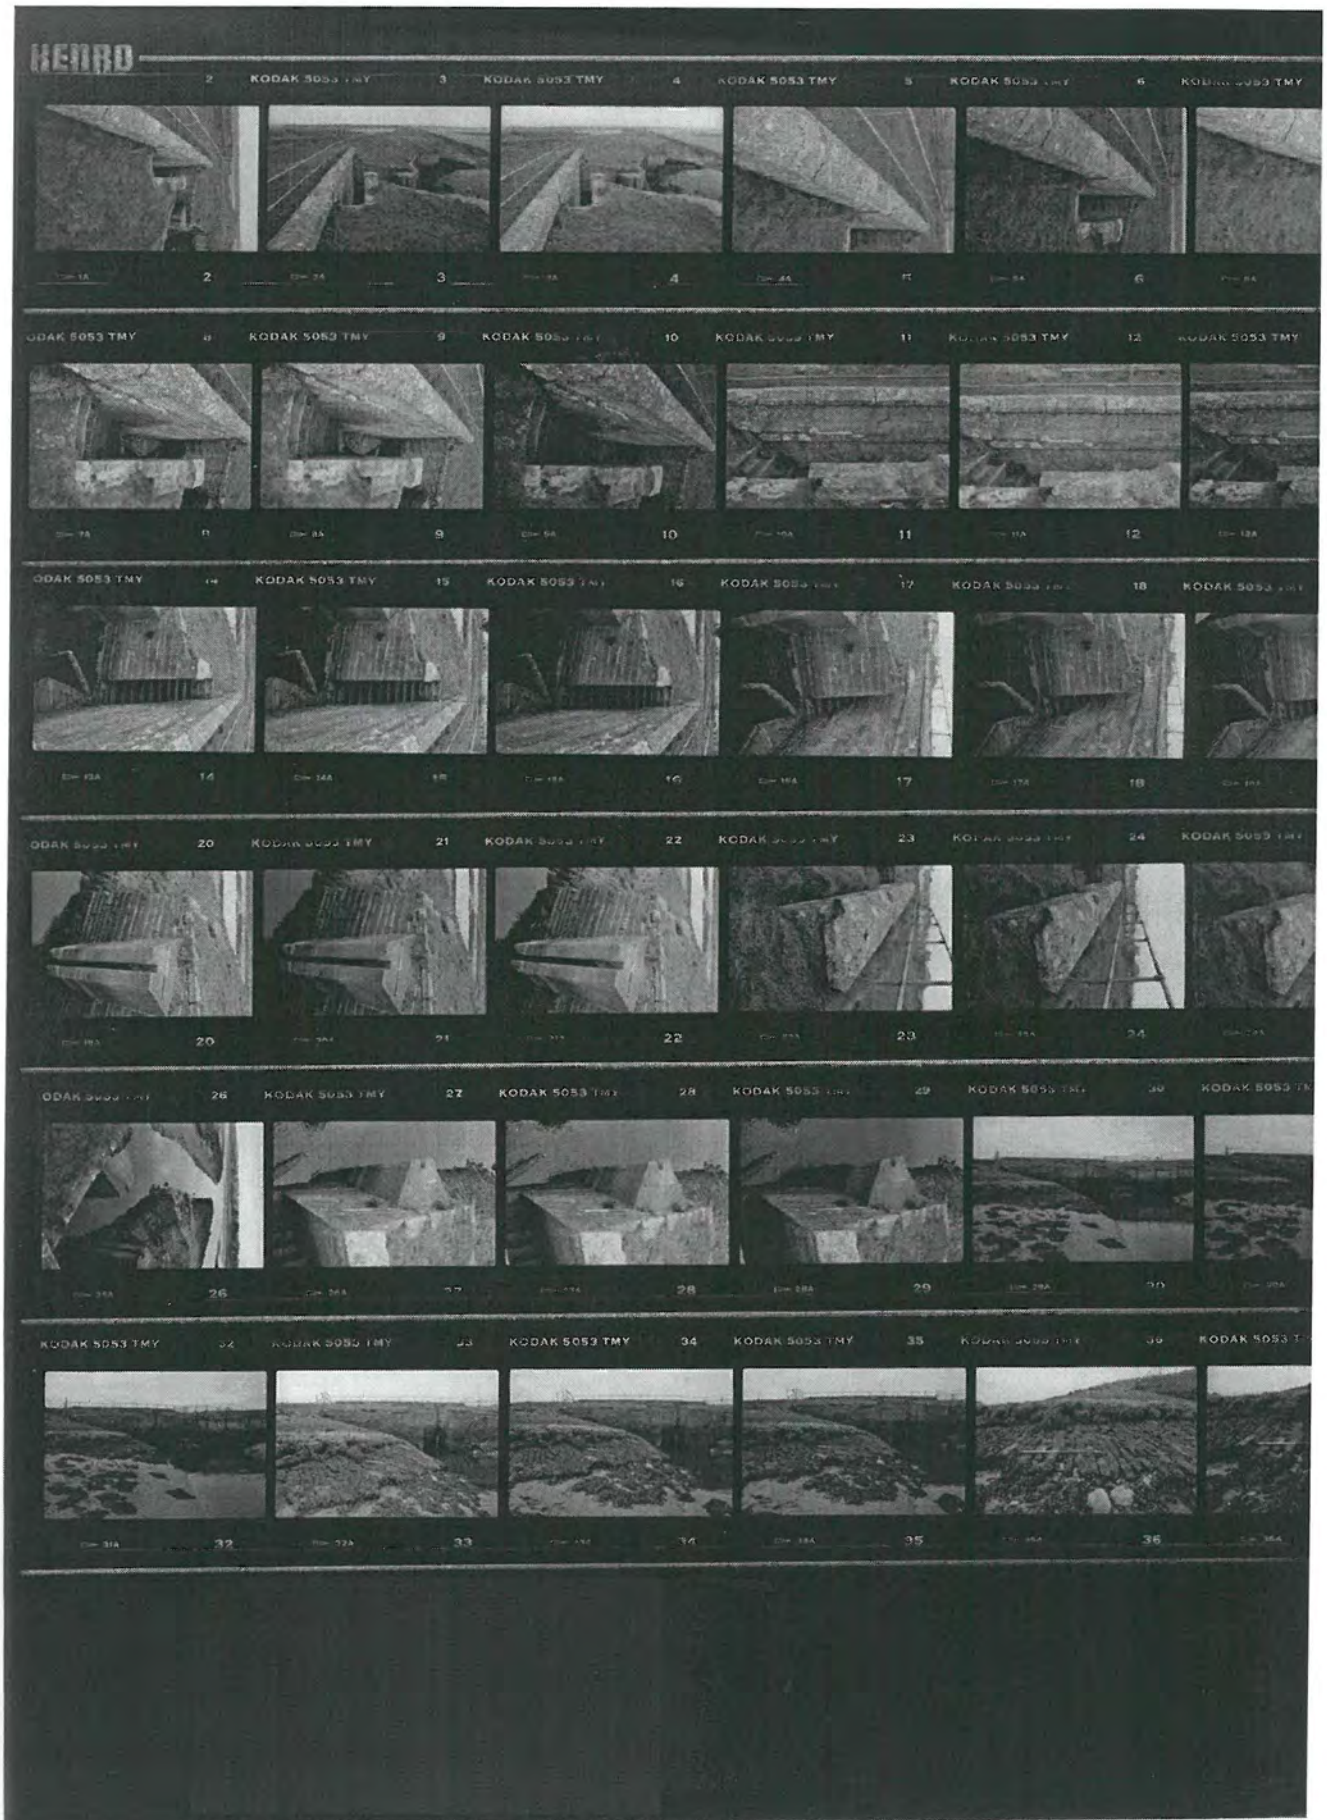
**G1578 MALLTRAETH TIDAL DOORS IMPROVEMENT SCHEME  
FILM TWO (B&W PRINT) - NEGATIVES CONTACT SHEET**

36	Detail of stone pitching SW of north culvert, facing NW.
37	Detail of stone pitching SW of north culvert, facing NW.
<b>FILM ENDS</b>

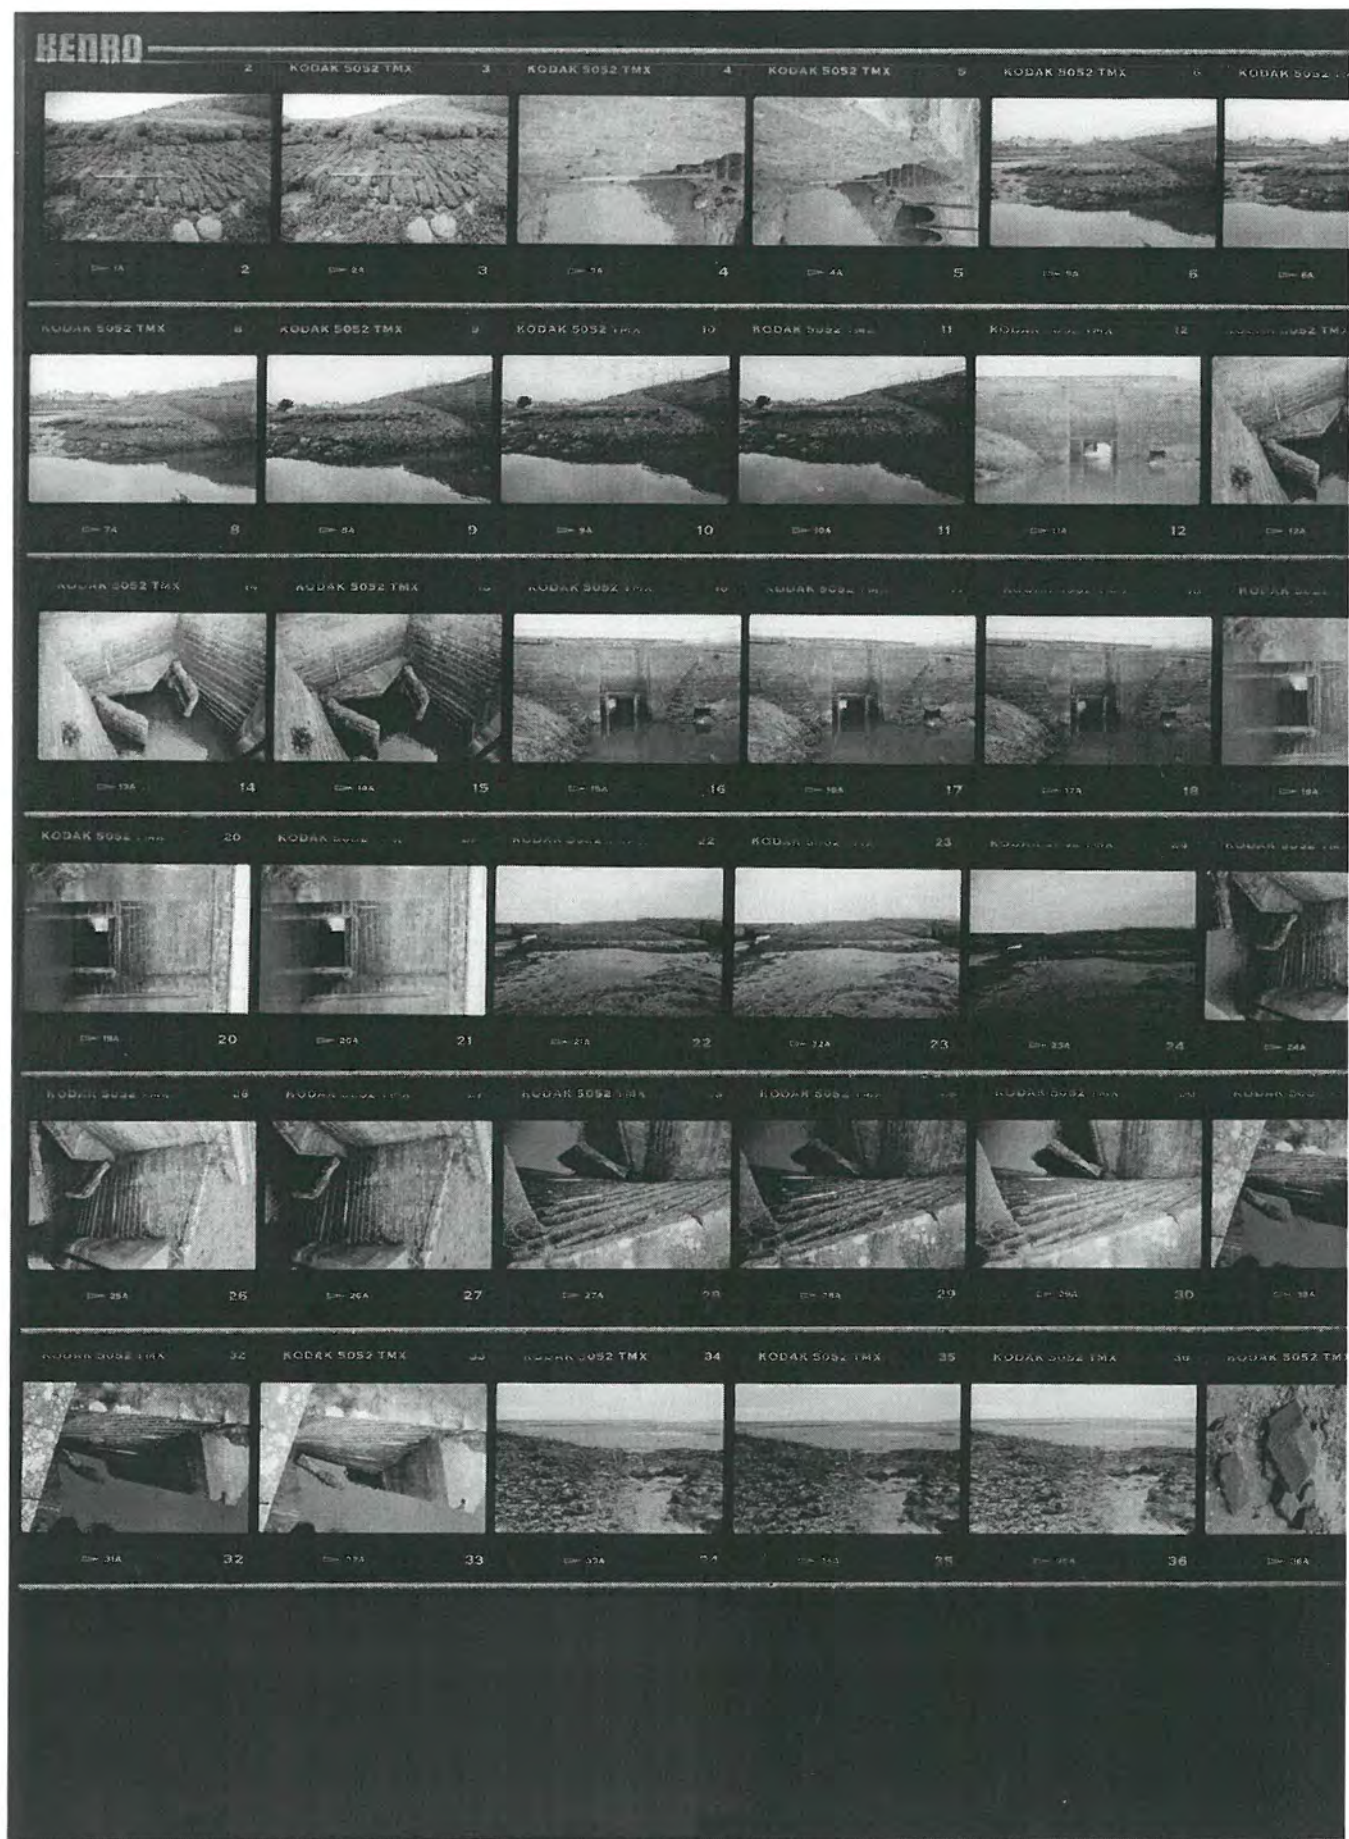
**G1578 MALLTRAETH TIDAL DOORS IMPROVEMENT SCHEME**  
**FILM THREE (B&W PRINT) - NEGATIVES CONTACT SHEET**

29A	Detail of stepped revetment, E wing wall, S side of north culvert. Facing N.
30A	Detail of stepped revetment, E wing wall, S side of north culvert. Facing S.
31A	Detail of stepped revetment, E wing wall, S side of north culvert. Facing S.
32A	Detail of stepped revetment, E wing wall, S side of north culvert. Facing S.
33A	Disturbed area of stone pitching to SE of south drain arrangement. Facing SE.
34A	Disturbed area of stone pitching to SE of south drain arrangement. Facing SE.
35A	Disturbed area of stone pitching to SE of south drain arrangement. Facing SE.
36A	Displaced, dressed, capping slab from walling on north culvert. Lying amongst area of disturbed stone pitching SE of south drain.
<b>FILM ENDS</b>

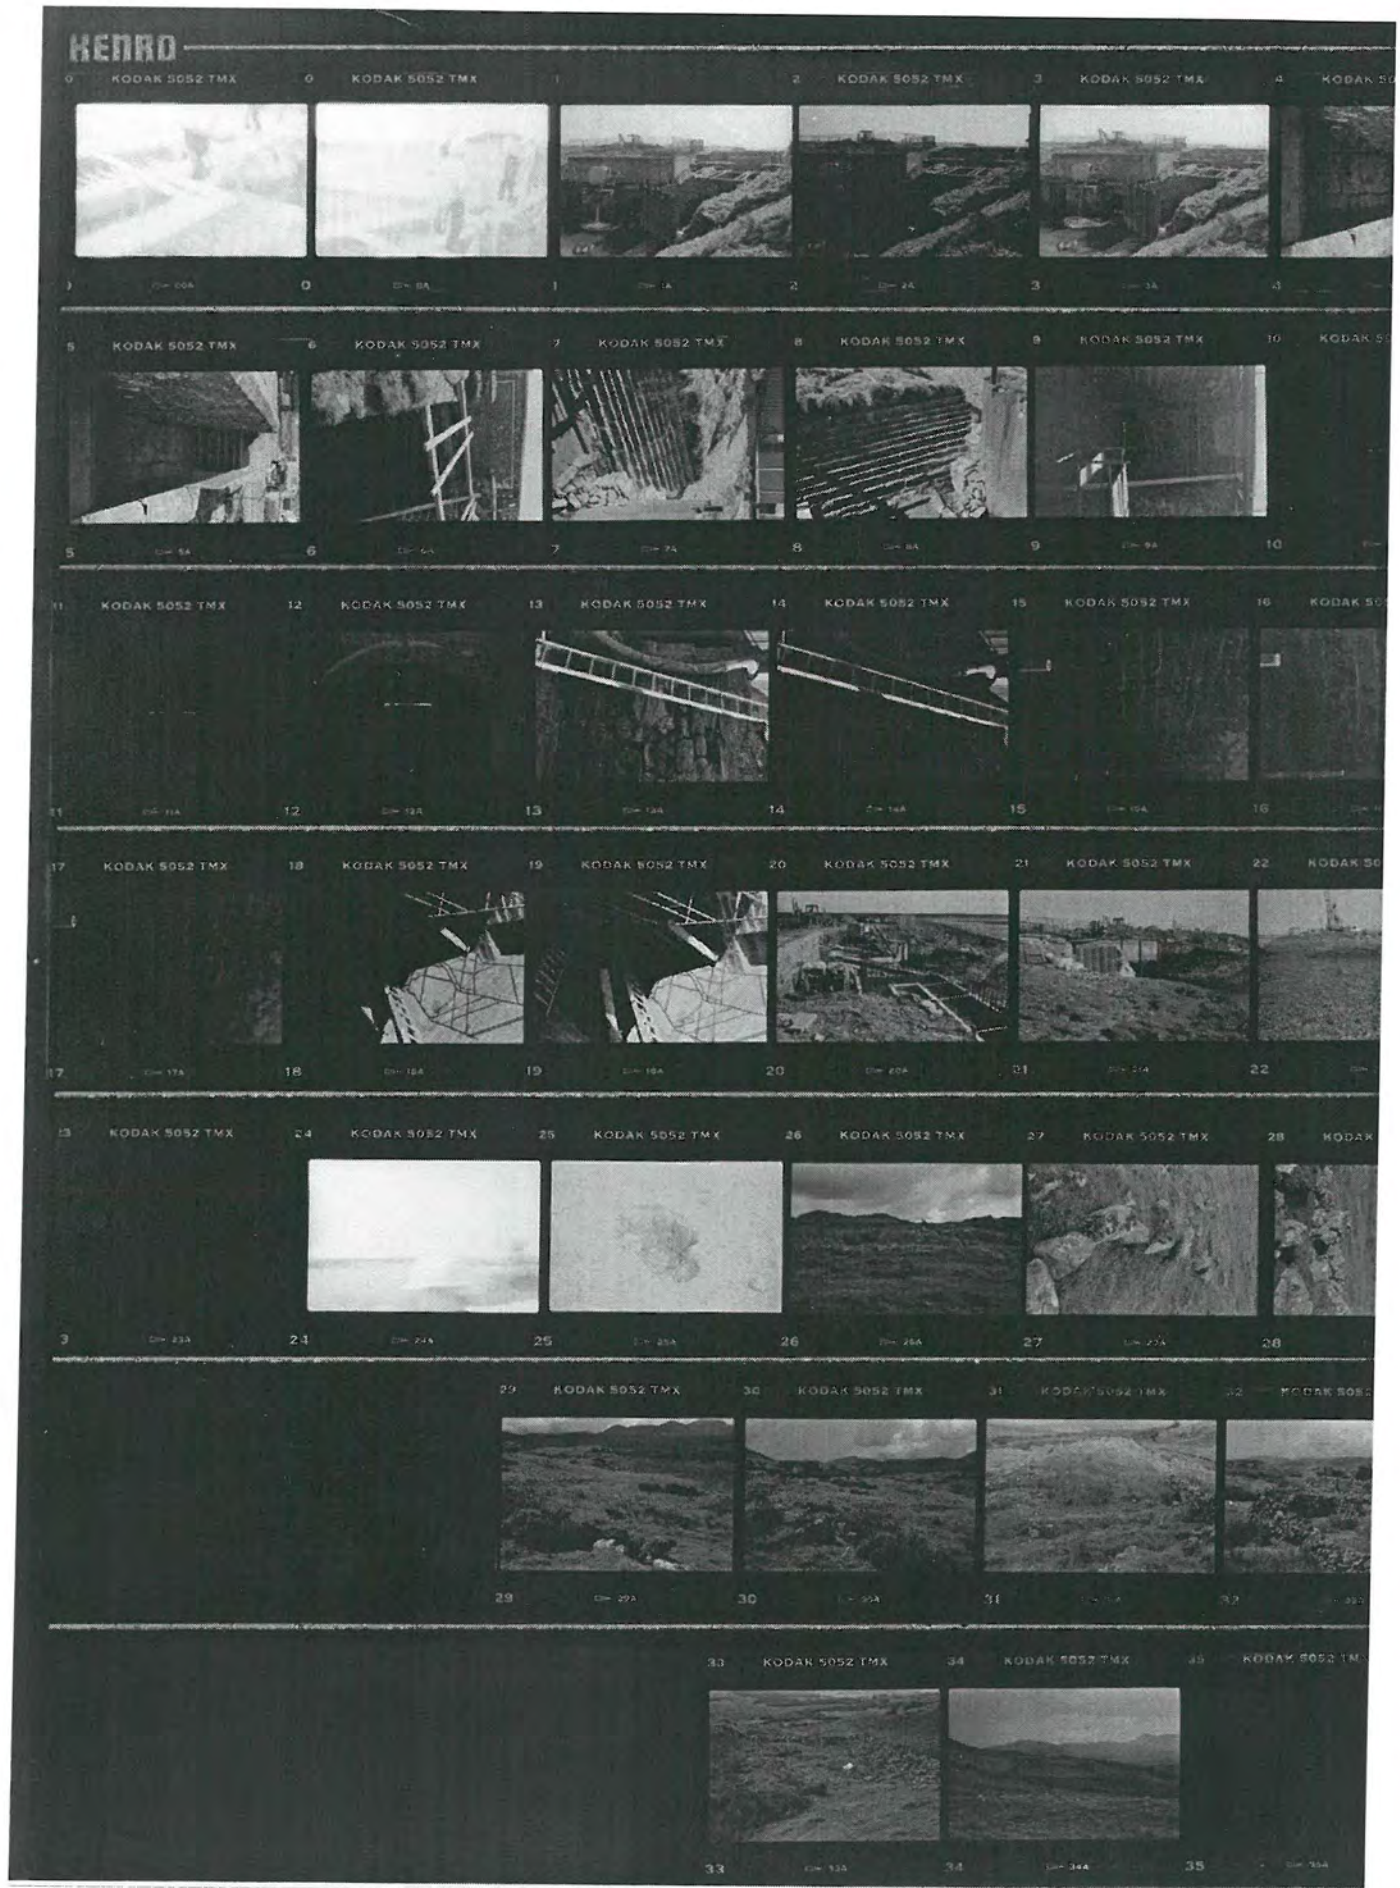
G1578 MALLTRAETH TIDAL DOORS IMPROVEMENT SCHEME  
FILM FOUR (B&W PRINT) - NEGATIVES CONTACT SHEET

15A	Stepped walling, E wing wall, N side of north culvert after evacuation of water, and following removal of old concrete stop log mounting. Facing SE.
16A	Stepped walling, E wing wall, N side of north culvert after evacuation of water, and following removal of old concrete stop log mounting. Facing SE.
17A	Stepped walling, E wing wall, N side of north culvert after evacuation of water, and following removal of old concrete stop log mounting. Facing SE.
18A	Wooden tidal door, S side of north culvert, following evacuation of water.
19A	Wooden tidal door, S side of north culvert, following evacuation of water.
20A	General view of S side of south drain, work in progress. Facing E.
21A	General view of S side of south drain, work in progress. Facing NE.
22A	General view of S side of south drain, work in progress. Facing N.
<b>FILM ENDS</b>
