YMDDIRIEDOLAETH ARCHAEOLEGOL GWYNEDD GWYNEDD ARCHAEOLOGICAL TRUST

REPORT ON THE TENTH SEASON OF THE TRE'R CEIRI CONSERVATION PROJECT JUNE TO NOVEMBER 1998

D. HOPEWELL

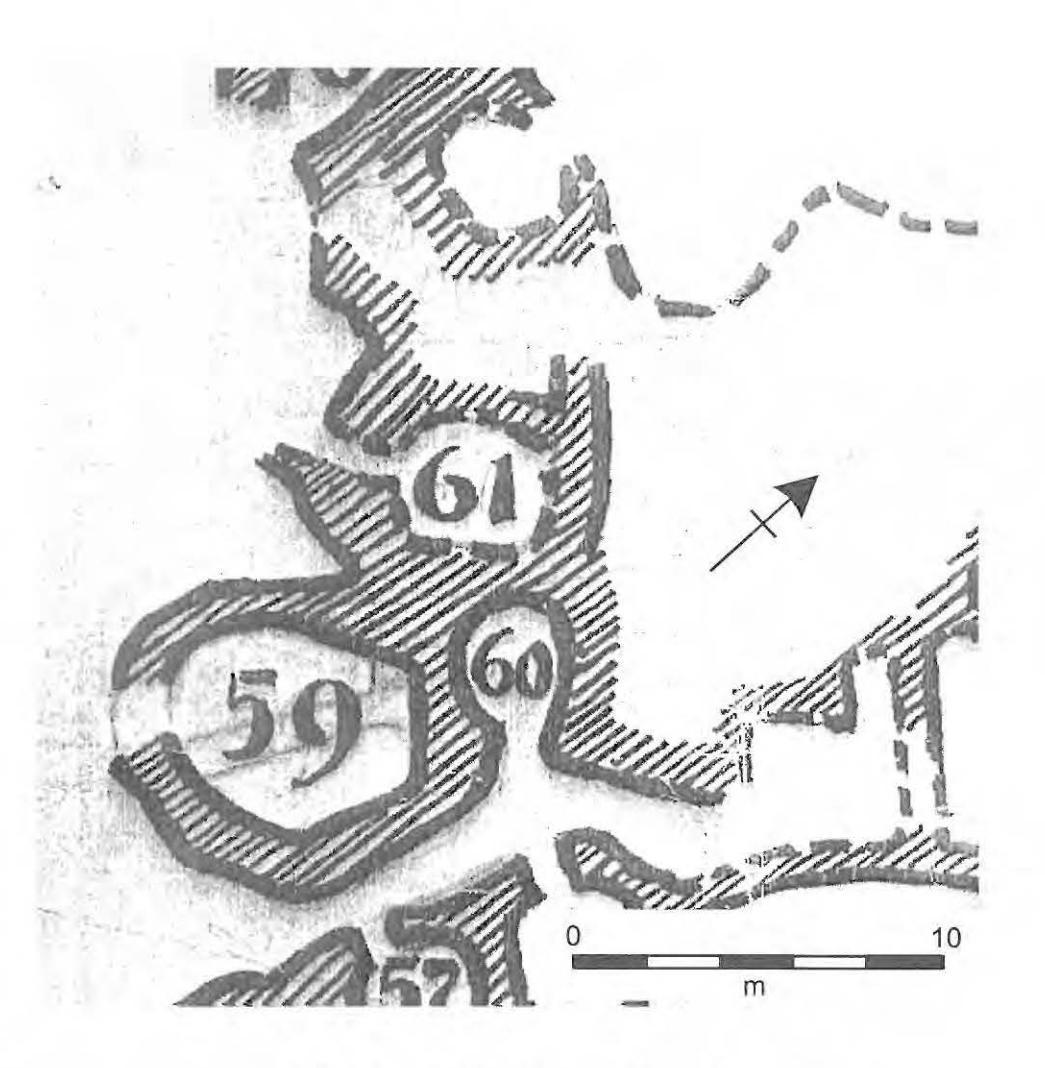
Fig. 9, Huts 59 to 61 (Hughes ca. 1906)

The fallen masonry was cleared revealing the off-line and forward-sloping basal stone (beneath the lower scale, Plate 108). Behind this was a 1.0m length of reasonably well-defined facing running obliquely into the wall (Fig. 11). The upper 0.5m of this facing was quite clear but the base of the wall was jumbled and unconvincing. No further facing could be seen running into the wall beyond this point. The facing could be the remains of an earlier phase of building in this hut; the angular northern end of the hut suggests that modifications may have been made at some time in antiquity. The lack of a convincing basal course however must cast some doubt on this hypothesis. The lower part of the wall could have been lost due to the wall being undermined but it is also possible that the short length of surviving facing was originally a temporary revetment designed to retain the scree while the hut wall was being built (This type of detail has been observed in several other huts, see collapse 59b below). The fact that the facing is continuous with the main hut wall does suggest that the first hypothesis is correct as all other temporary revetments so far observed have been set back into the wall and separate from

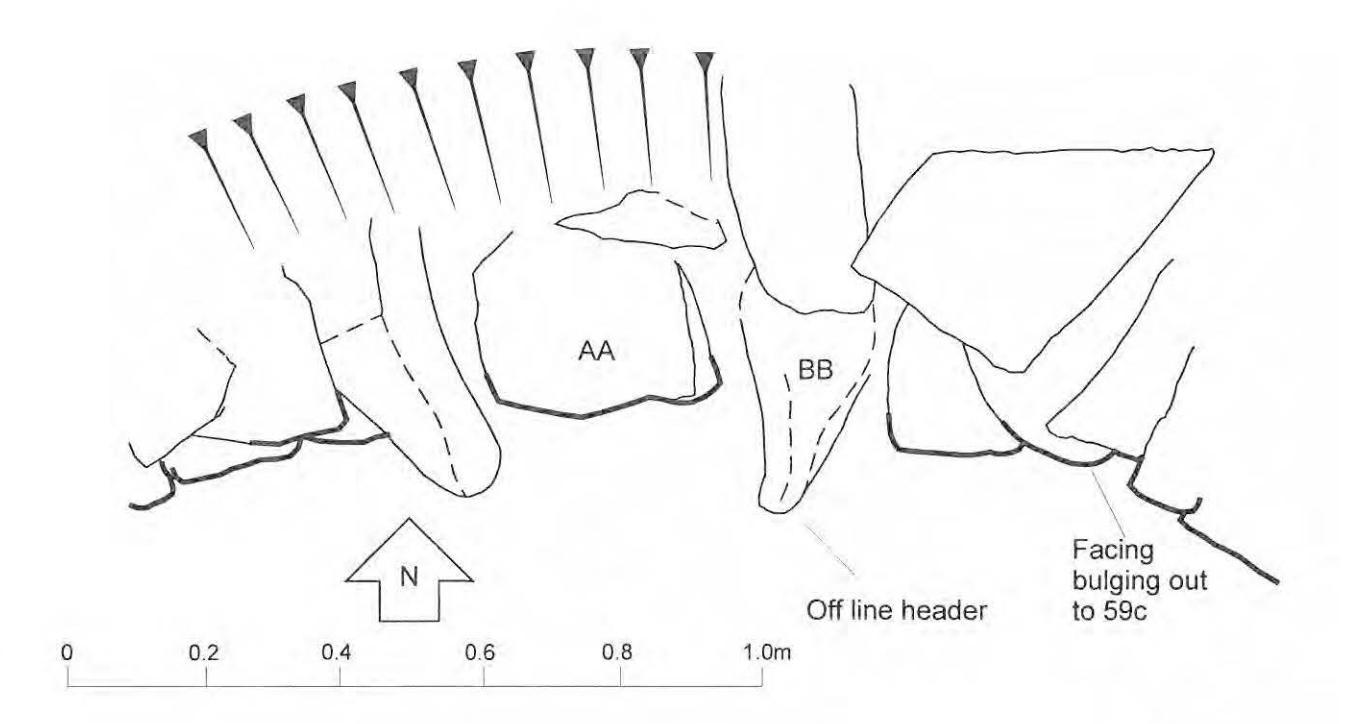
Fig. 13, Collapse 59b after clearance

There had been a serious slump in the base of the wall at this point. Jumbled masonry was still standing to a height of 1.0m but the lower courses had slipped forwards by close to 0.5m. The masonry had retained some structure but at the centre the stones were all tilted forwards and were too far off line to be reset. All stones that appeared to be close to their original positions were marked (1 to 7 and 12 to 24 at the left of Plate 129 and A to W at the right) and the collapsed masonry was cleared. The base of the wall appeared to have been undermined as most of the rubble that had been cleared was tipped forwards at an acute angle. The core was however remarkably stable and contained what appeared to a number of long pinning stones suggesting that this was a continuation of the revetting observed in 59b. The marked stones W, V and U in the centre of the collapse were too far out of position to be replaced and were used elsewhere. All of the marked stones apart from number 7 on the right of Plate 129 were taken from the wall and retained because the base of the wall had been lost and the stones were standing on unstable rubble. The marked masonry on the right of the collapse was stable and was not disturbed. Plate 130 shows the collapse after clearance (the stone marked with an X is not original), as expected no basal course had survived.

The surviving masonry at either side of 59c gave a good indication of the line of the wall so a new basal course was laid across the collapse. Most of the marked stones from the right of the collapse were replaced close to their original positions after the new basal course had been constructed. The stones had to be set back into the wall by a few cm to compensate for the bulge at the edge of the collapse so a few minor adjustments had to be made. Stones 12, 14, 15 and 26 were all short packing stones and could not be reset. Stone 2 was reset upside down. Stone 7 could not be incorporated in the rebuilt masonry because there was not enough space for it after the masonry was set back in line with the rest of the wall. The new and rebuilt masonry is indicated on Plate 131.

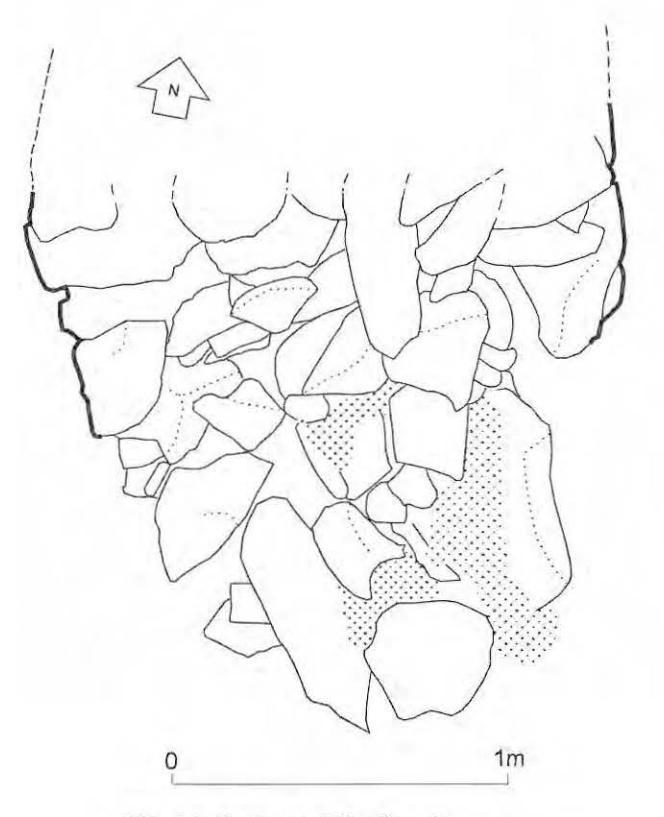
Fig. 19, Collapse 62b after clearance

The facing at the southern end of the eastern wall was partially collapsed and very fragile (Plates 176 and 177). This 2.9m length of masonry was standing to a rough face but the wall appeared to have failed close to the base at the centre of the collapse. Much of the standing masonry had fallen sideways from the wall to the south and was sloping forwards at an acute angle. Fallen stone obscured the southern end of the wall.

All of the collapsed masonry was cleared from the line of the wall revealing an intact basal course (Plate 178). New masonry was constructed above this up to the height of the ground level on the outside of the hut (Plate 179).

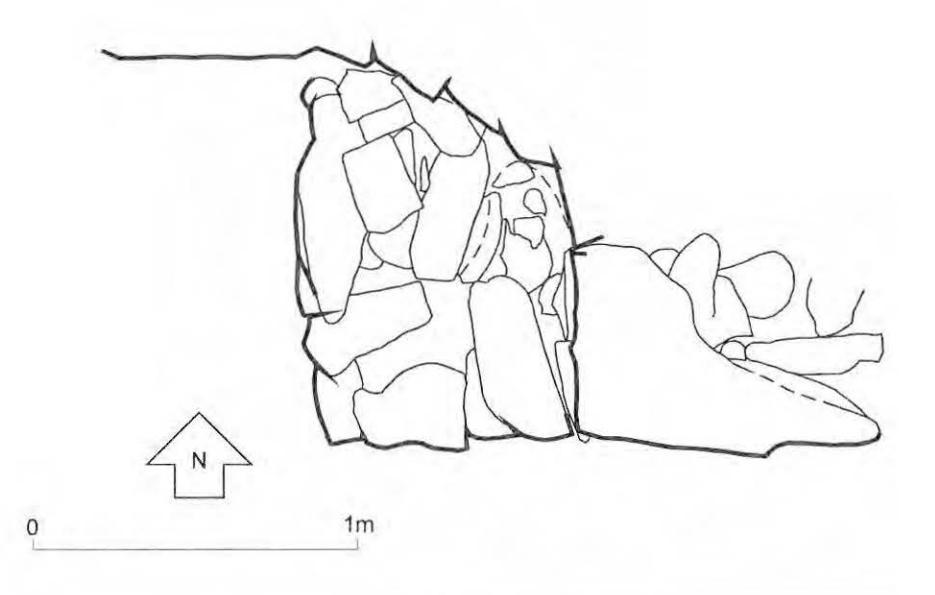
Fig. 22, Collapse 65a after clearance

The rubble was cleared from the collapse revealing two lines of facing standing behind the current wall line (Plate 235 and Fig. 22). One was a continuation of the northern wall that could be seen to curve through 90° to form the eastern wall of the hut. A large slab then defined the corner of an entrance through the eastern wall. All of this facing was well preserved and was standing to a height of 0.5m. A further length of low facing could be seen to link the inner end of the entrance passage through the outer wall to the end of the surviving inner wall. The southern side of the entrance could not be traced and no standing masonry had survived across the southern side of the collapse (Plate 236).

New masonry was added to the top of the surviving entrance passage and to the top of the inner face in order to retain the core and to support the previously buried face. Plate 237 shows an oblique view of the northern side of the collapse and the entrance passage after conservation. The southern side is shown on Plate 238.

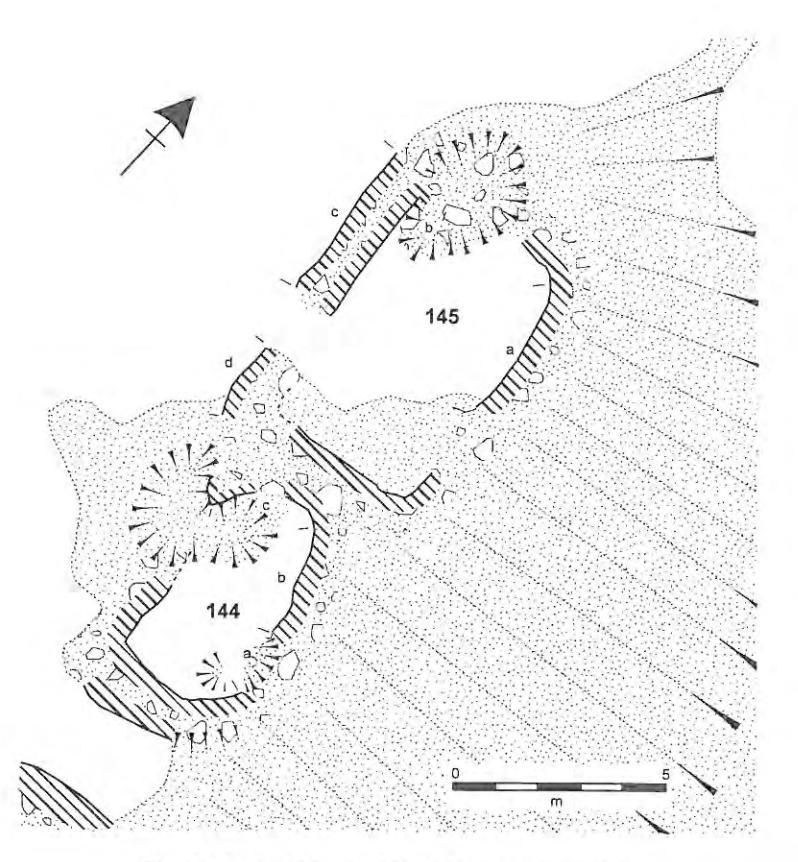
Fig. 37 Huts 144 and 145 before conservation

HUT 144 (Fig. 37)

This hut remains unexcavated but was planned by Hughes in 1906. His plan (Fig. 38) shows a rectangular hut with an entrance in the western wall.

This 1.0m wide collapse had been caused by the movement of the two massive uprights that had formed the base of the wall. These stones had slipped forwards and had become immovably embedded at an angle in the hut floor. The facing above had collapsed (Plate 399). The rubble was cleared from the line of the wall and was used to build new facing behind the uprights which could not be moved without digging a large hole in the hut floor (Plate 400).

The northern wall had been severely damaged by a deep treasure hunter hack in the floor of the hut (Plate 403). A short length of facing had survived at the western end but this had ridden forwards on a large slab and was clearly not even close to its original position. It was also very unstable. Nothing could be done to stabilise this facing so no further action was taken beyond the infilling of the treasure hunter hack.

The central part of the wall had been reduced to a rubble slope. Several stones were reset here in order to prevent further erosion. The north-eastern corner of the hut was reasonably stable although loss of core from behind the facing was beginning to cause instability. Several large blocks of stone were dragged down from the scree and piled behind the face in order to retain the core. One stone was reset on the end of the surviving facing (Plate 404). The stones placed behind the facing can best be seen on Plate 402.

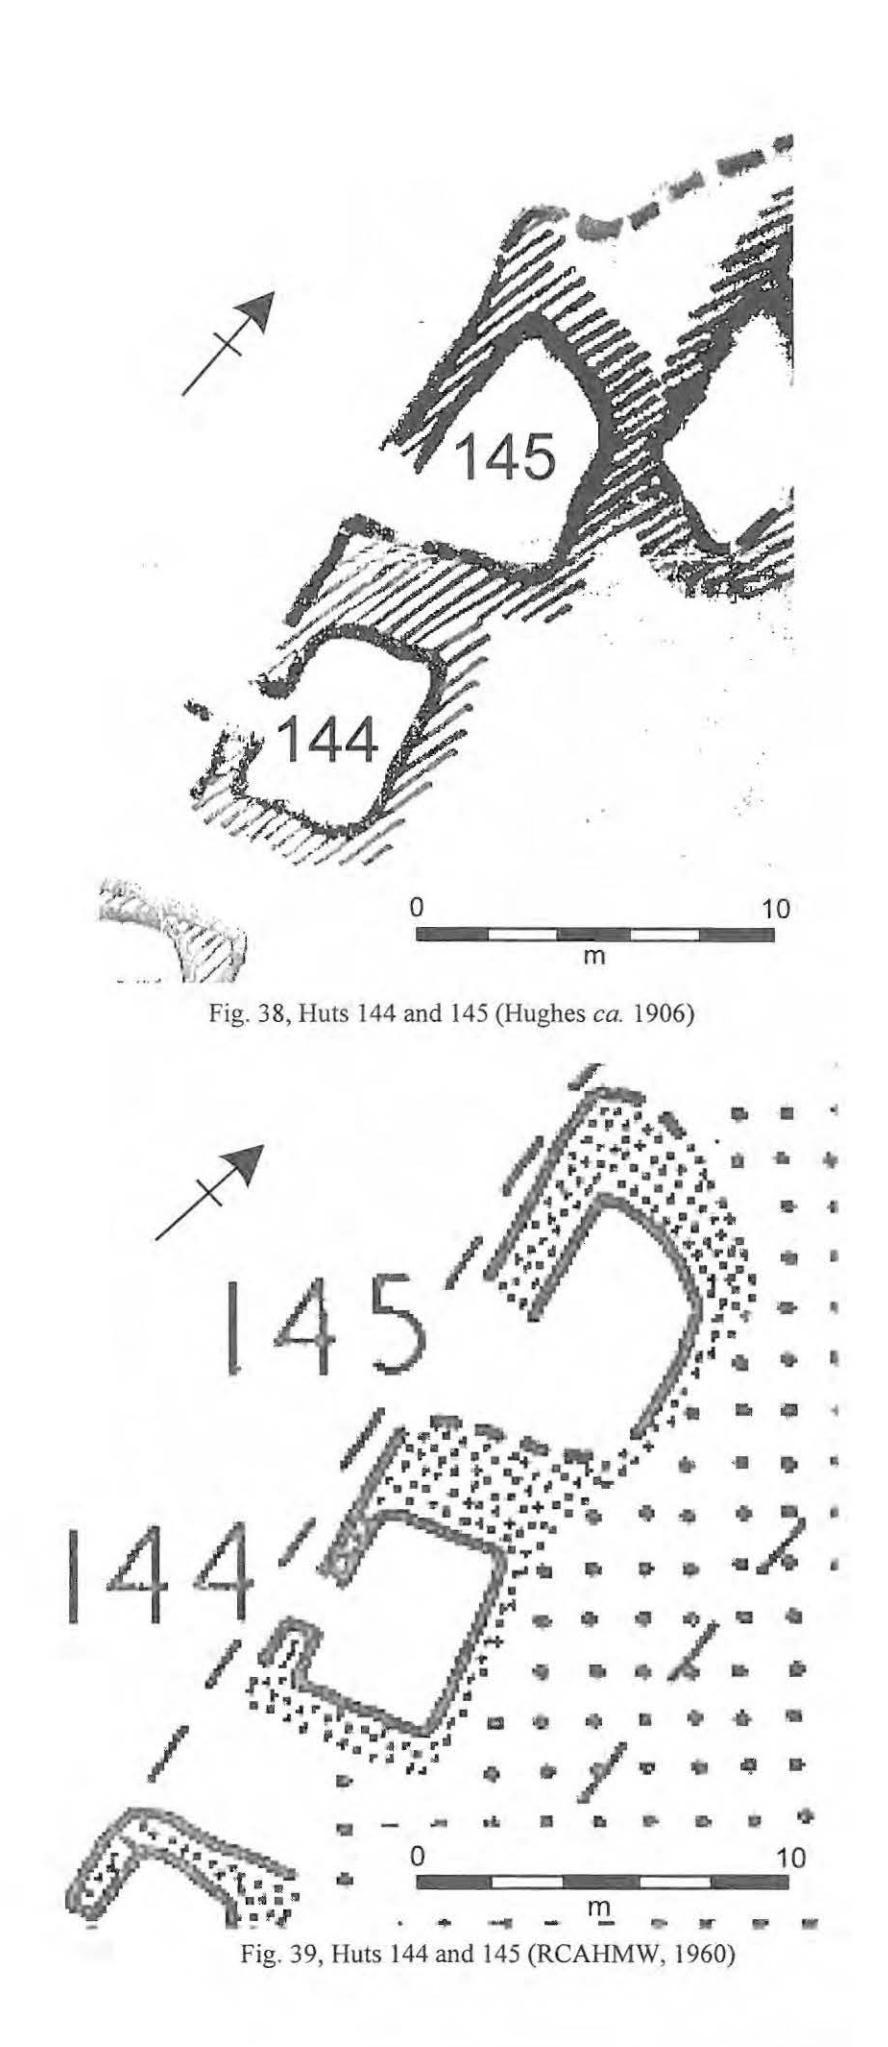
HUT 145 (Fig. 37)

Hughes planned hut 145 in 1906 and depicted a large sub-rectangular structure with a break in the western wall (Fig. 38).

There was a collapse close to the southern end of the eastern wall, the wall falling steeply from a height of 0.8m to ground level. The wall top to the north of this was loose and littered with displaced stones (Plates 405 and 406).

A semi-collapsed length of outer face had survived to the south of the entrance (Plate 415). The slab on the top of the wall was slightly reset and was supported by the addition of small packing stones. The end of the wall was stabilised by the addition of a number of irregularly laid heavy stones. The new masonry is indicated on Plate 416.

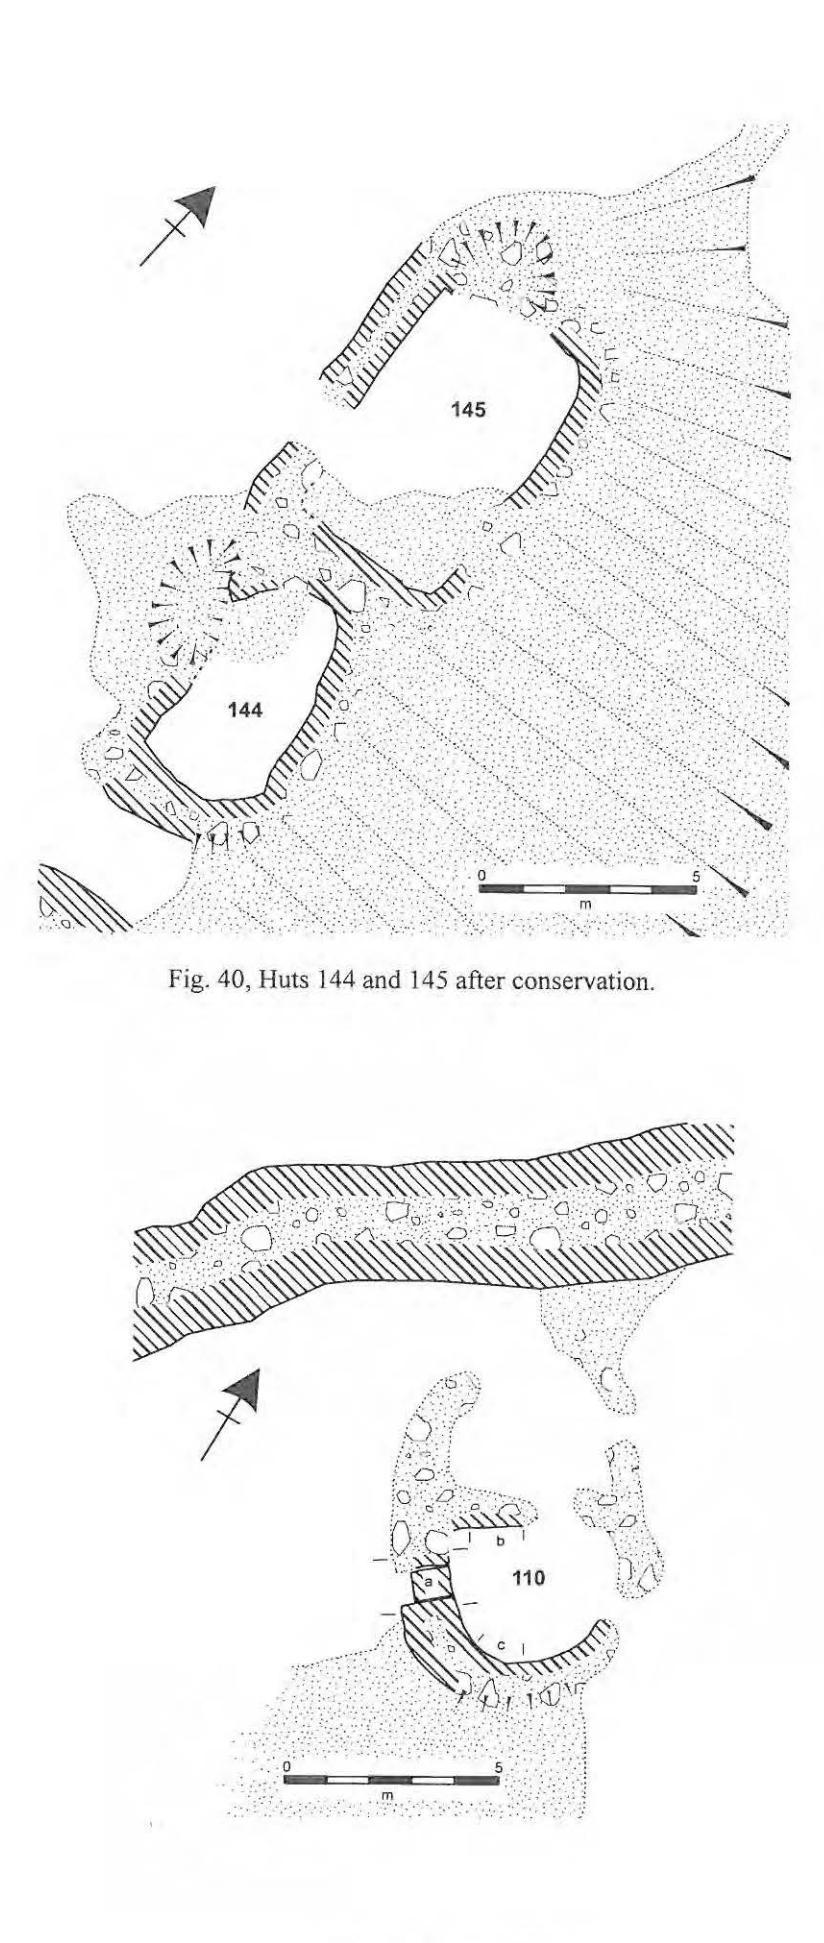
Fig. 41, Hut 110

HUT 110 (Fig. 41)

This poorly preserved hut stands on the line of the main footpath on the north-western side of Tre'r Ceiri and remains unexcavated. Hughes (1906) depicted the hut as being circular with an entrance on the north-west (Fig 42). Another small hut on the north-eastern side of 110 is also shown on his plan.

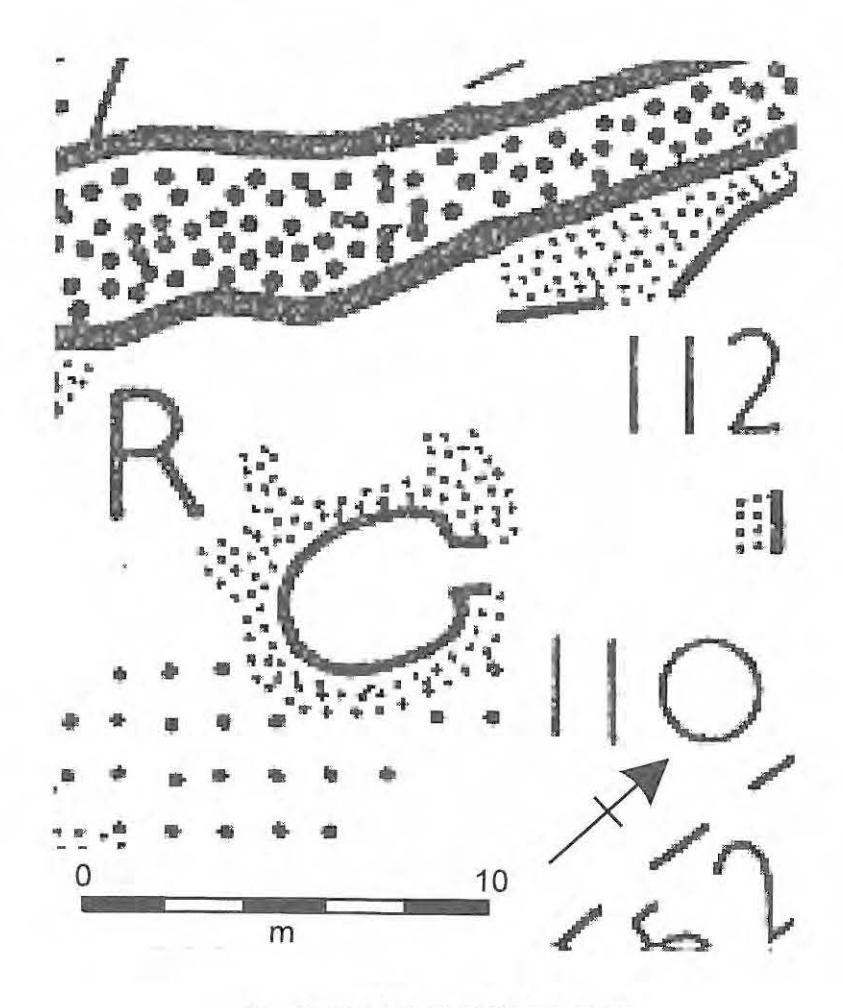
Fig. 43, Hut 110 (RCAHMW, 1960)

The RCAHMW (1960) plan confusingly shows an entrance in the south-eastern wall of the hut (Fig. 43).
