A470 (T) DOLWYDDELAN TO PONT-YR-AFANC  
IMPROVEMENT : SITE 74

ARCHAEOLOGICAL RECORD

Report No. 384

October 2000

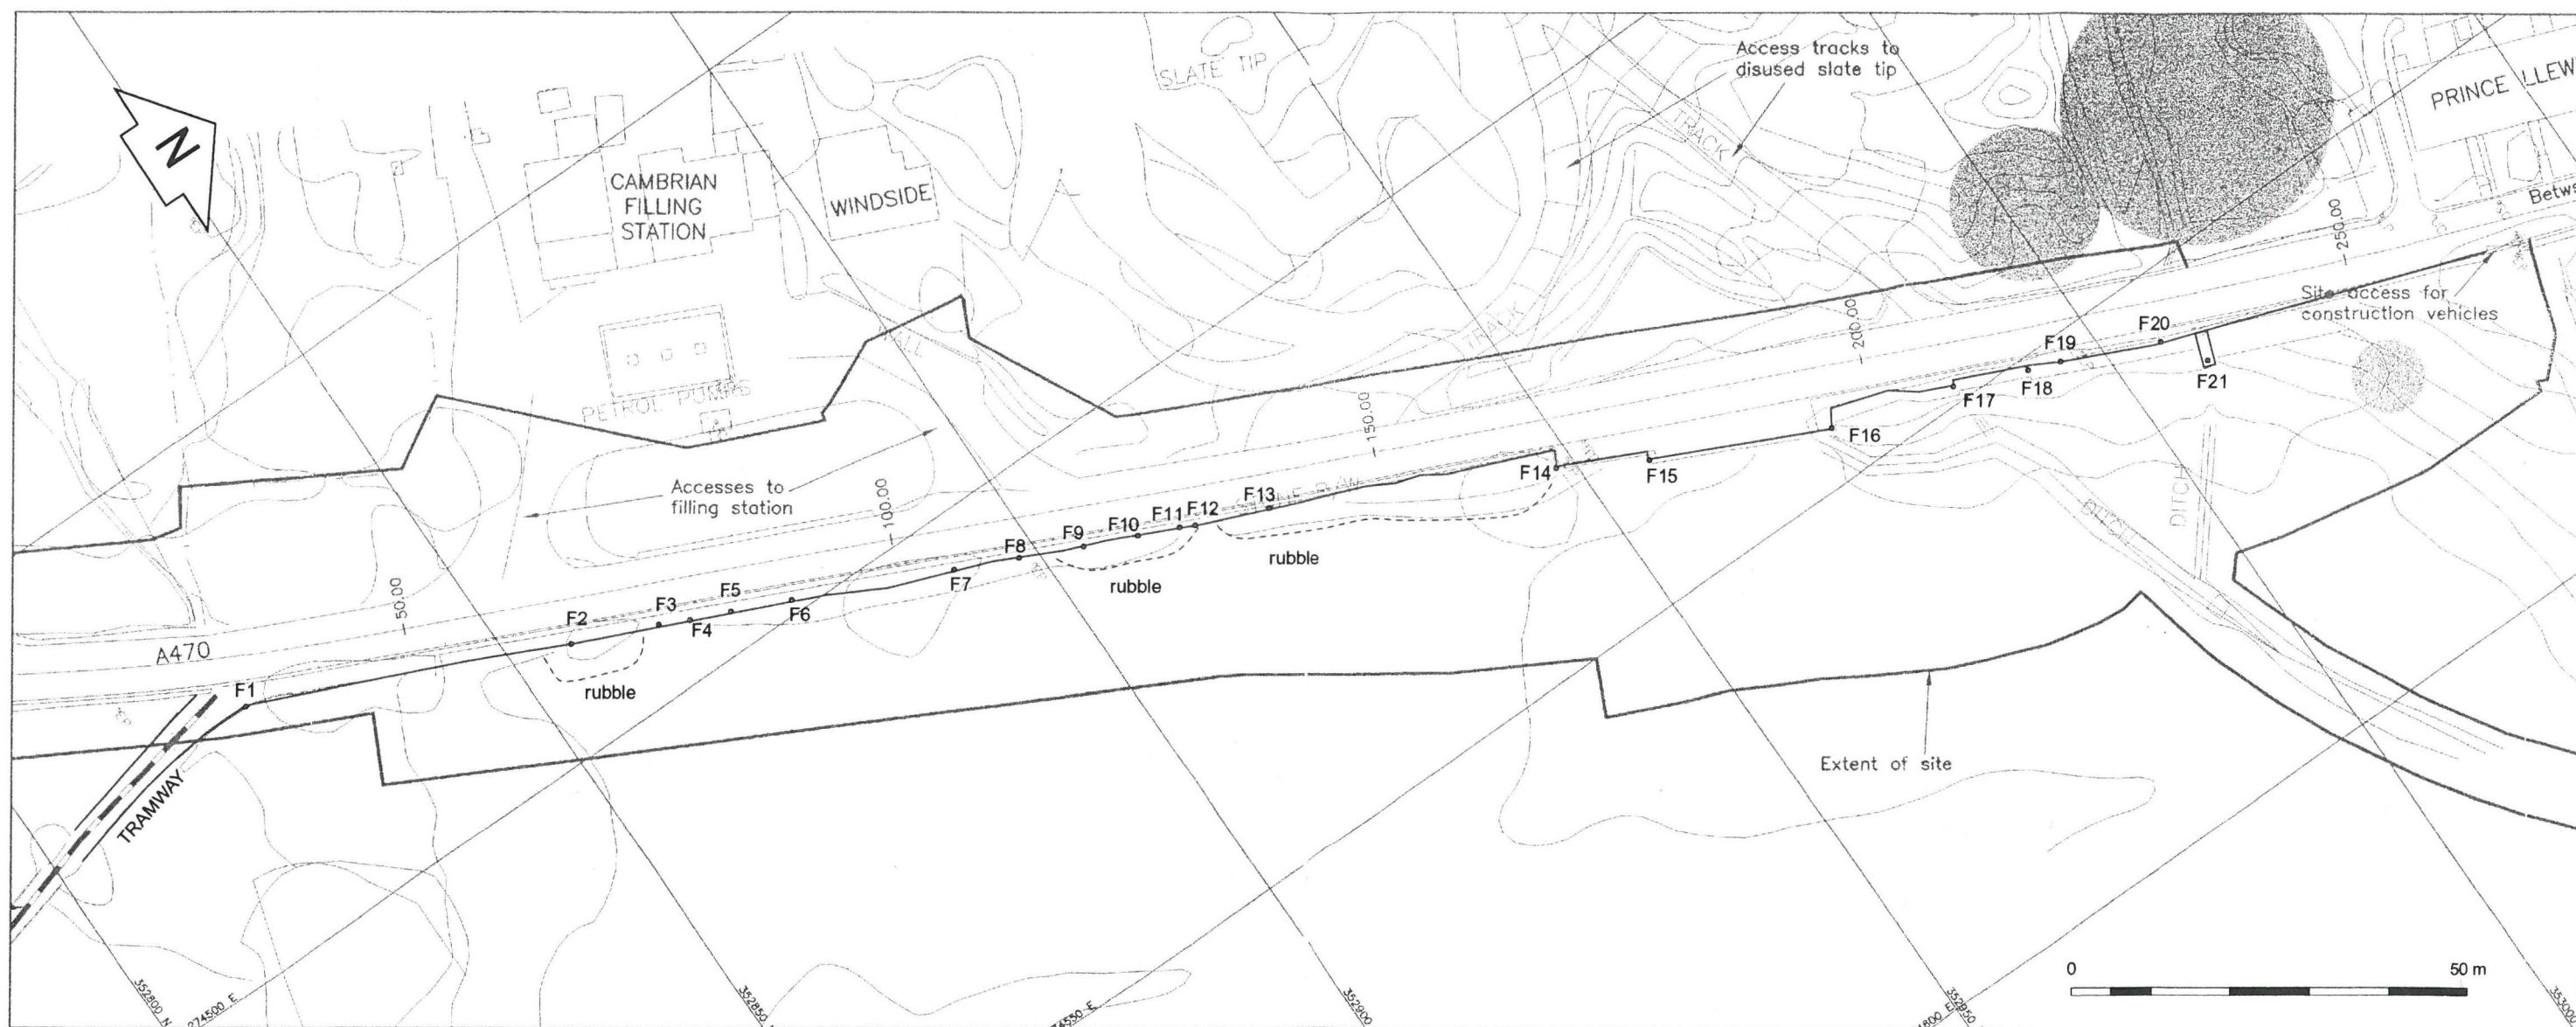
<b>Ymddiriedolaeth Archaeolegol Gwynedd</b> <b>Gwynedd Archaeological Trust</b> <small>01248 352535 01248 370025 email: gat@heneb.co.uk</small> <small>Craig Beuno : Ffordd y Garth : Bangor : LL57 2RT</small>			
<b>Title: Location of features (F) along line of revetment wall.</b>			
<b>Client:</b> National Assembly for Wales / Halcrow / Wyn Thomas Gordon Lewis		<b>Scales:</b> 1: 7500	<b>Date:</b> 04/10/00 <b>Drawn:</b> LAD
<b>Drawing number</b> C:\G1583_A470_A3.ai		1 of 1
