The Iron Waterwheel at Gilfach Ddu

Archaeological Monitoring and Recording at the Welsh Slate Museum, Llanberis

Report number 430

Prepared for Posford Haskoning Ltd
By Andrew Dutton

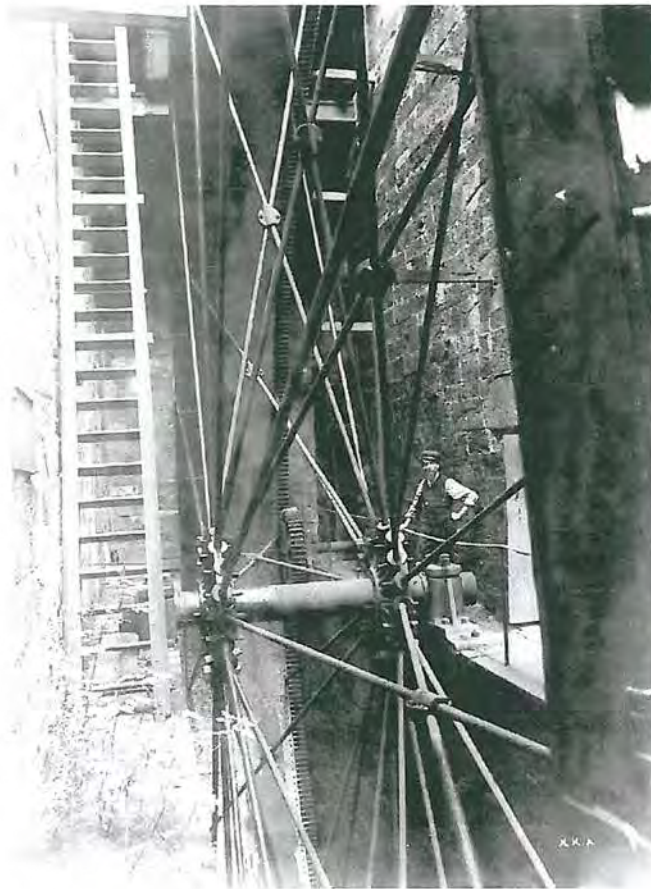
Plate 1 : The Waterwheel at the end of the nineteenth century. Note the spacing of the sole plates, the extant access ladder and the rudimentary safety rail.

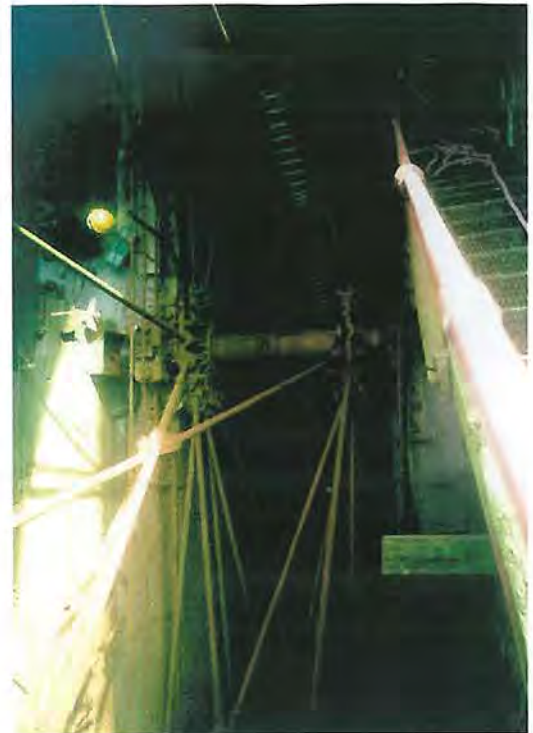
Plate 2 : A view of the wheel taken during the initial survey in 1998. The safety cage has been removed but the latterday safety rail is still in place and the lower section of the ladder has been removed..

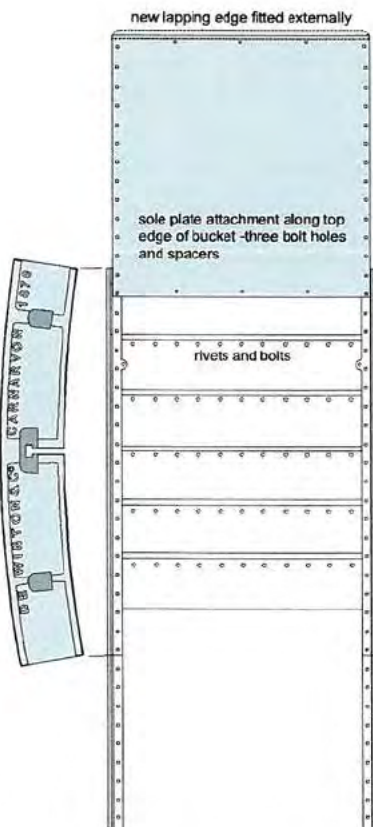
Fig 3 : Diagrammatic plan showing location of rivetted buckets within the shroud. Non-original sole plates vary in size and are located within a recess along the internal edge of the shroud. These later replacement plates were bolted to both the shroud and particular buckets at intervals.

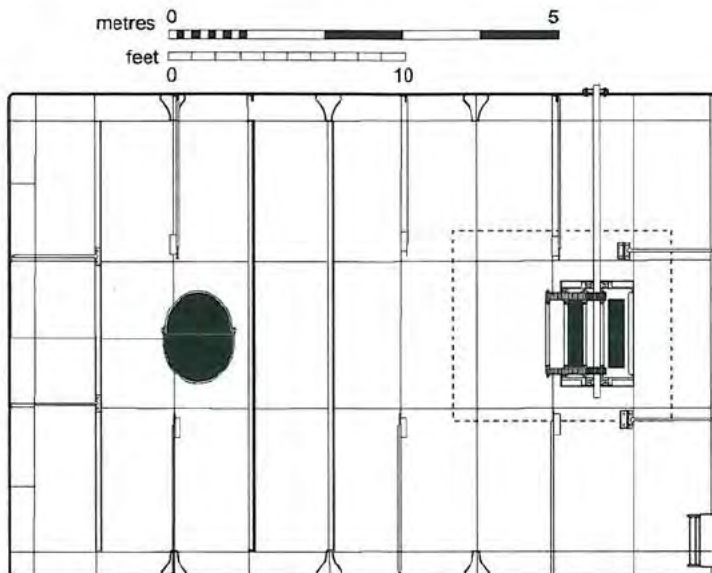
During the pre-restoration survey it was apparent that the remains of the original draw gate for the sluice was incomplete and the arrangement had been modified to accommodate the galvanized cistern. Subsequently the missing components have been identified in the quadrangle yard of the Slate Museum. The original location of these is shown in Fig.7.

Fig 7: Plan view of the header tank showing its original configuration and with the double sluice gate in the open position.

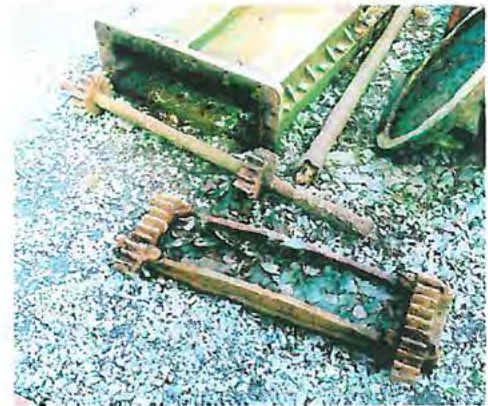
Plate 12 : In the foreground are the two additional remains of the rack and pinion draw-gate system found in the museum quadrant yard. These were removed in order to install the cistern and pipe in the 1980s.

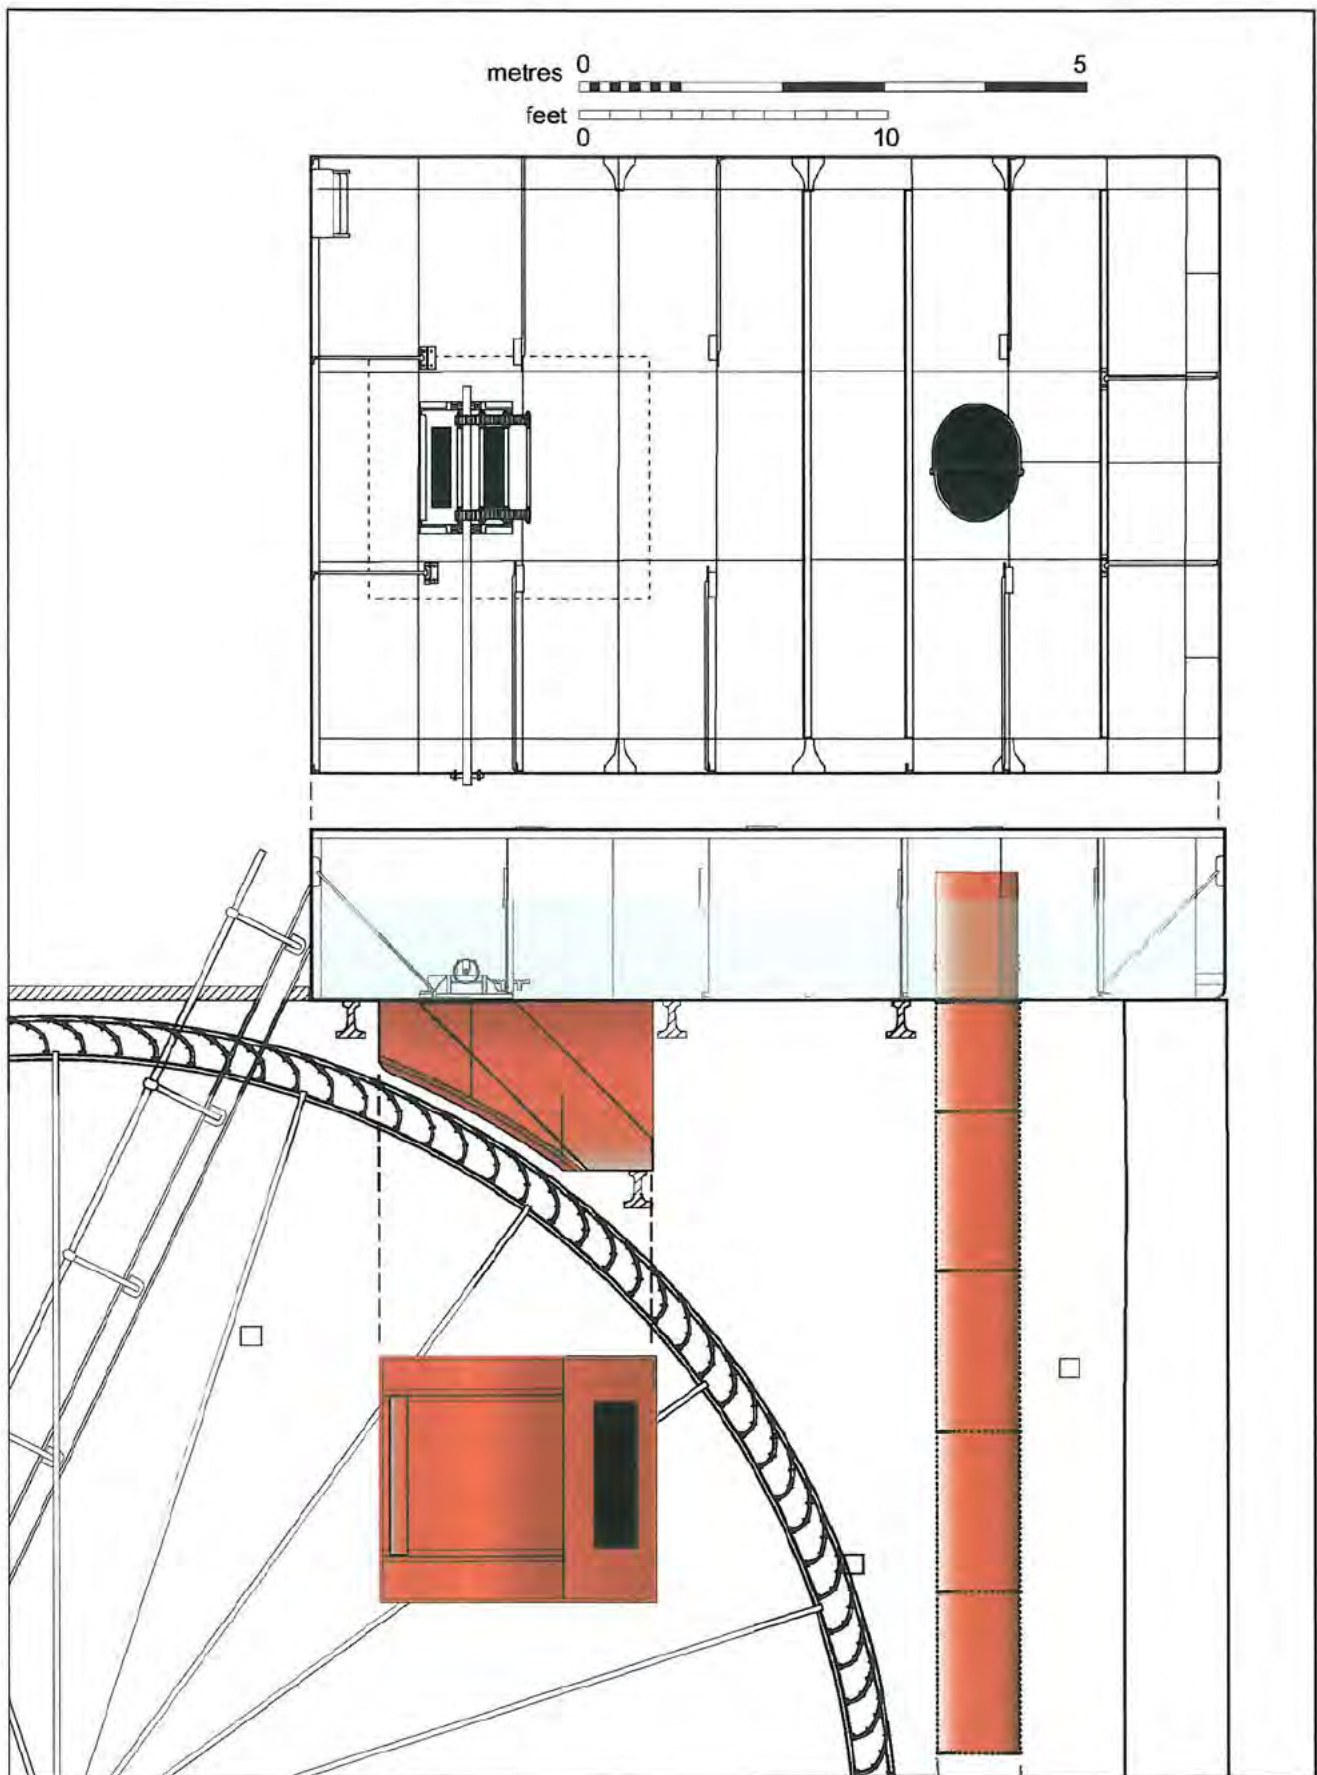
Fig 9 : Composite plan and elevation of the header tank, feeder and rising main viewed from the north. Note the potential maximum water level in relation to the overflow stack and the indicated angle of the water chute inside the feeder.

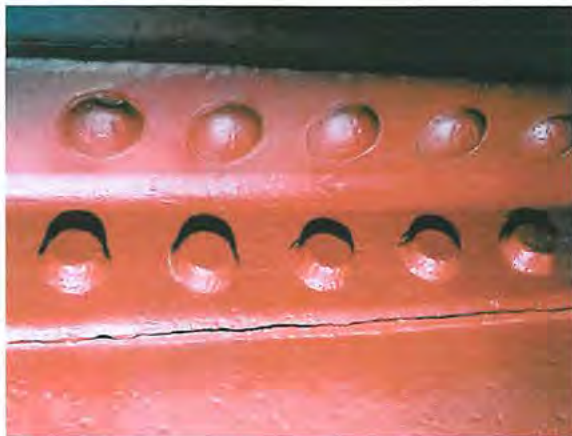
Plate 17 : Revealed on one of the angles connecting the feeder to the header tank - a milling stamp C.C 3

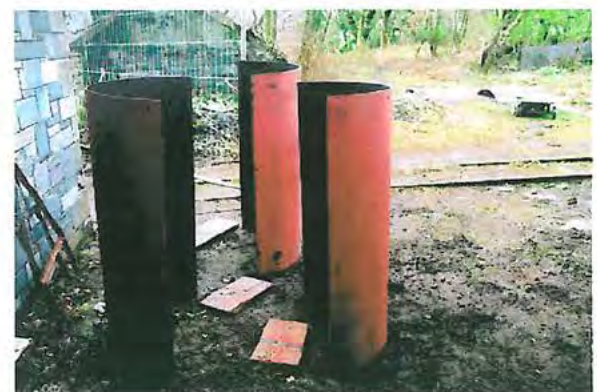
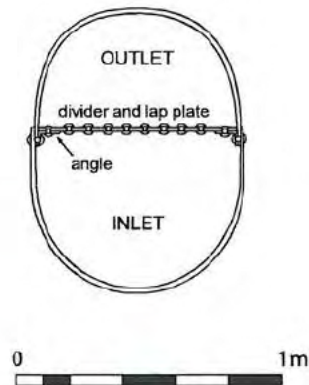
Plate 18 : New sections tailored from dimensions of removed sections used as templates.

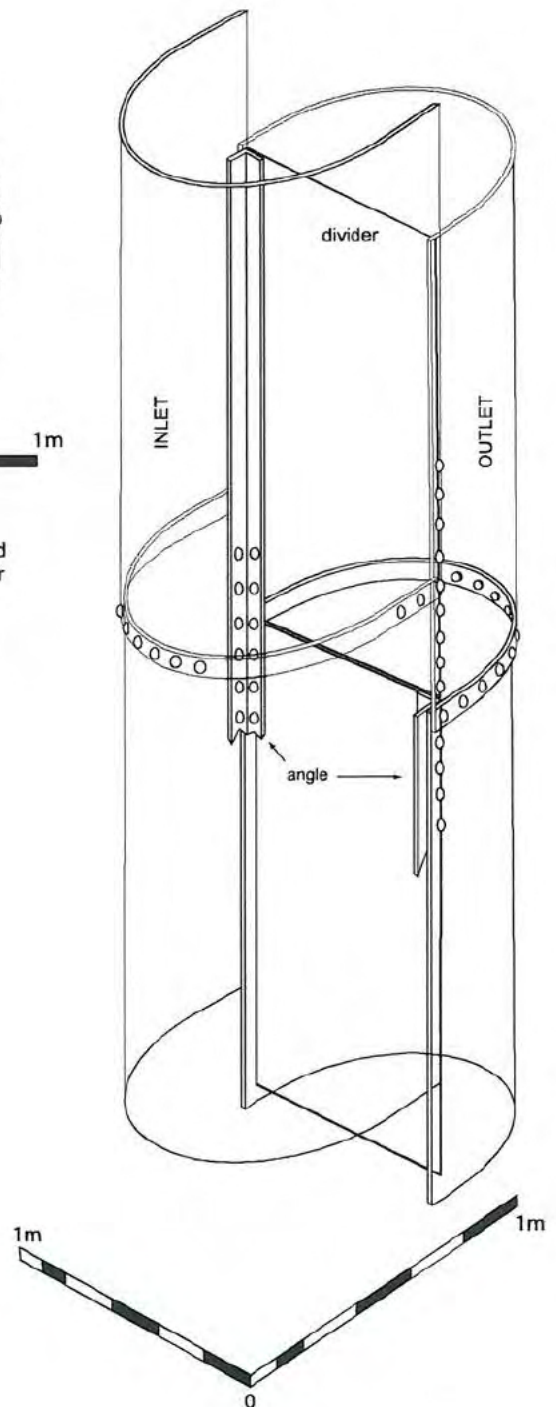
The construction and overall finish of the tank and riser are fine testament to the abilities of the De Winton workforce. The techniques employed were those used in shipbuilding and boiler making, these being the staple of De Winton's contracts. The tank and riser were constructed entirely from overlapping wrought iron plate, angle and rivets. The seams were to some extent self-caulking; being red leaded and close riveted, or in some instances hammered and beveled out. The manner of construction used on the split riser, from evidence during repair of the feature, can be seen in fig.12. *many of*

Fig 12 : cross-section and isometric view of the riser construction.
