A470 DOLWYDDELAN TO PONT-YR-AFANC IMPROVEMENT

ARCHAEOLOGICAL WATCHING BRIEF AND RECORDING

REPORT No 531

Revision 1a, 29/11/2004

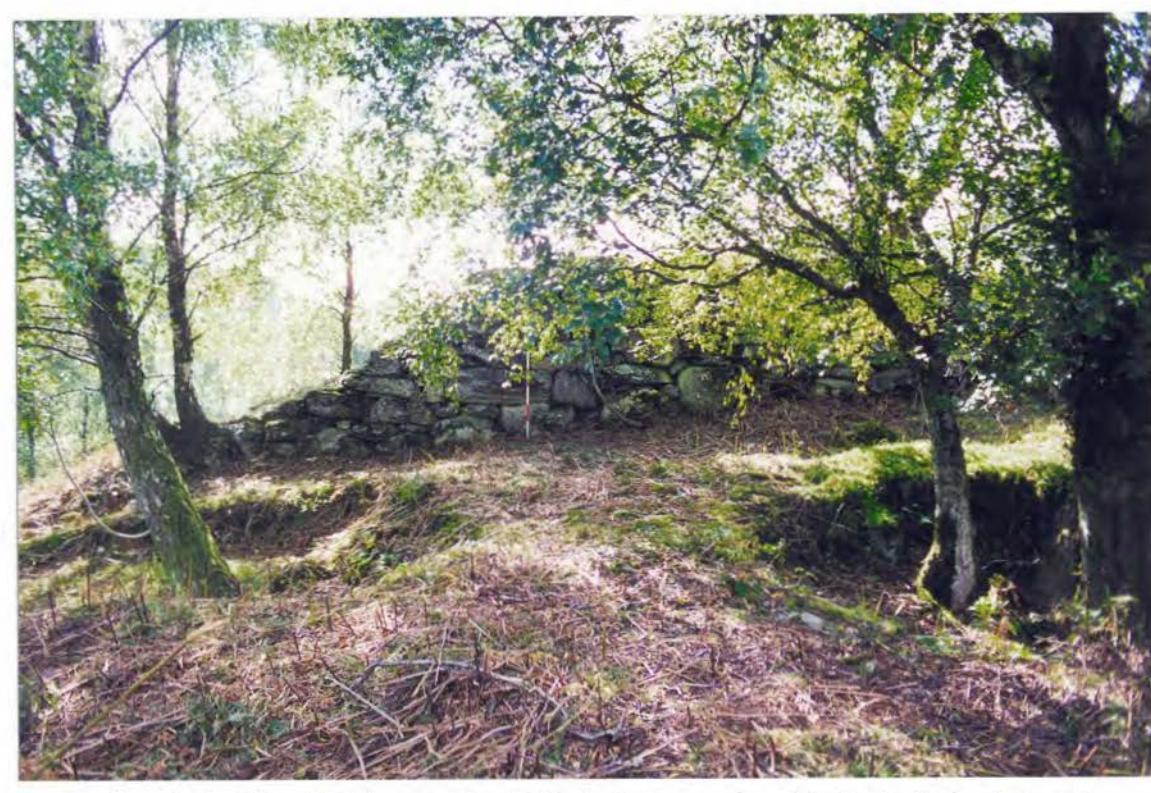
The raised barrow run led to site 89, a drystone ramp or small incline (Plate 6). This structure stood to a height of 2.0m at its northern end with dimensions of $9.3m \times 2.9m$. The northern half of the structure originally formed a level platform. This had been subsequently partially dismantled in order to build a rectangular shelter (Plate 7). The southern half of the structure formed a steep ramp running down towards the road at an angle of about 40°. The end of the ramp ran into a 13m long, grassed over, chute.

Plate 6 Site 89 in 1999, features 5 and 6 in the foreground and incline in the background

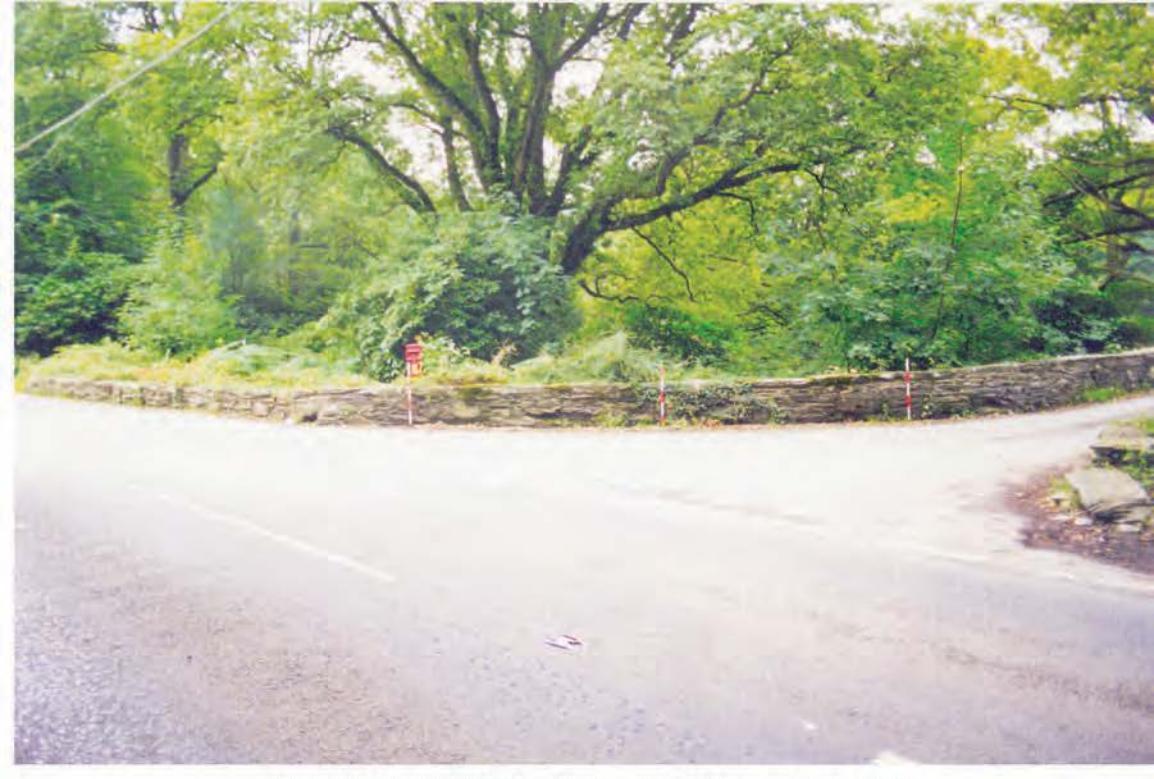
Plate 11 Site 99, Pont-ar-Lledr wing wall, inner face, 1999

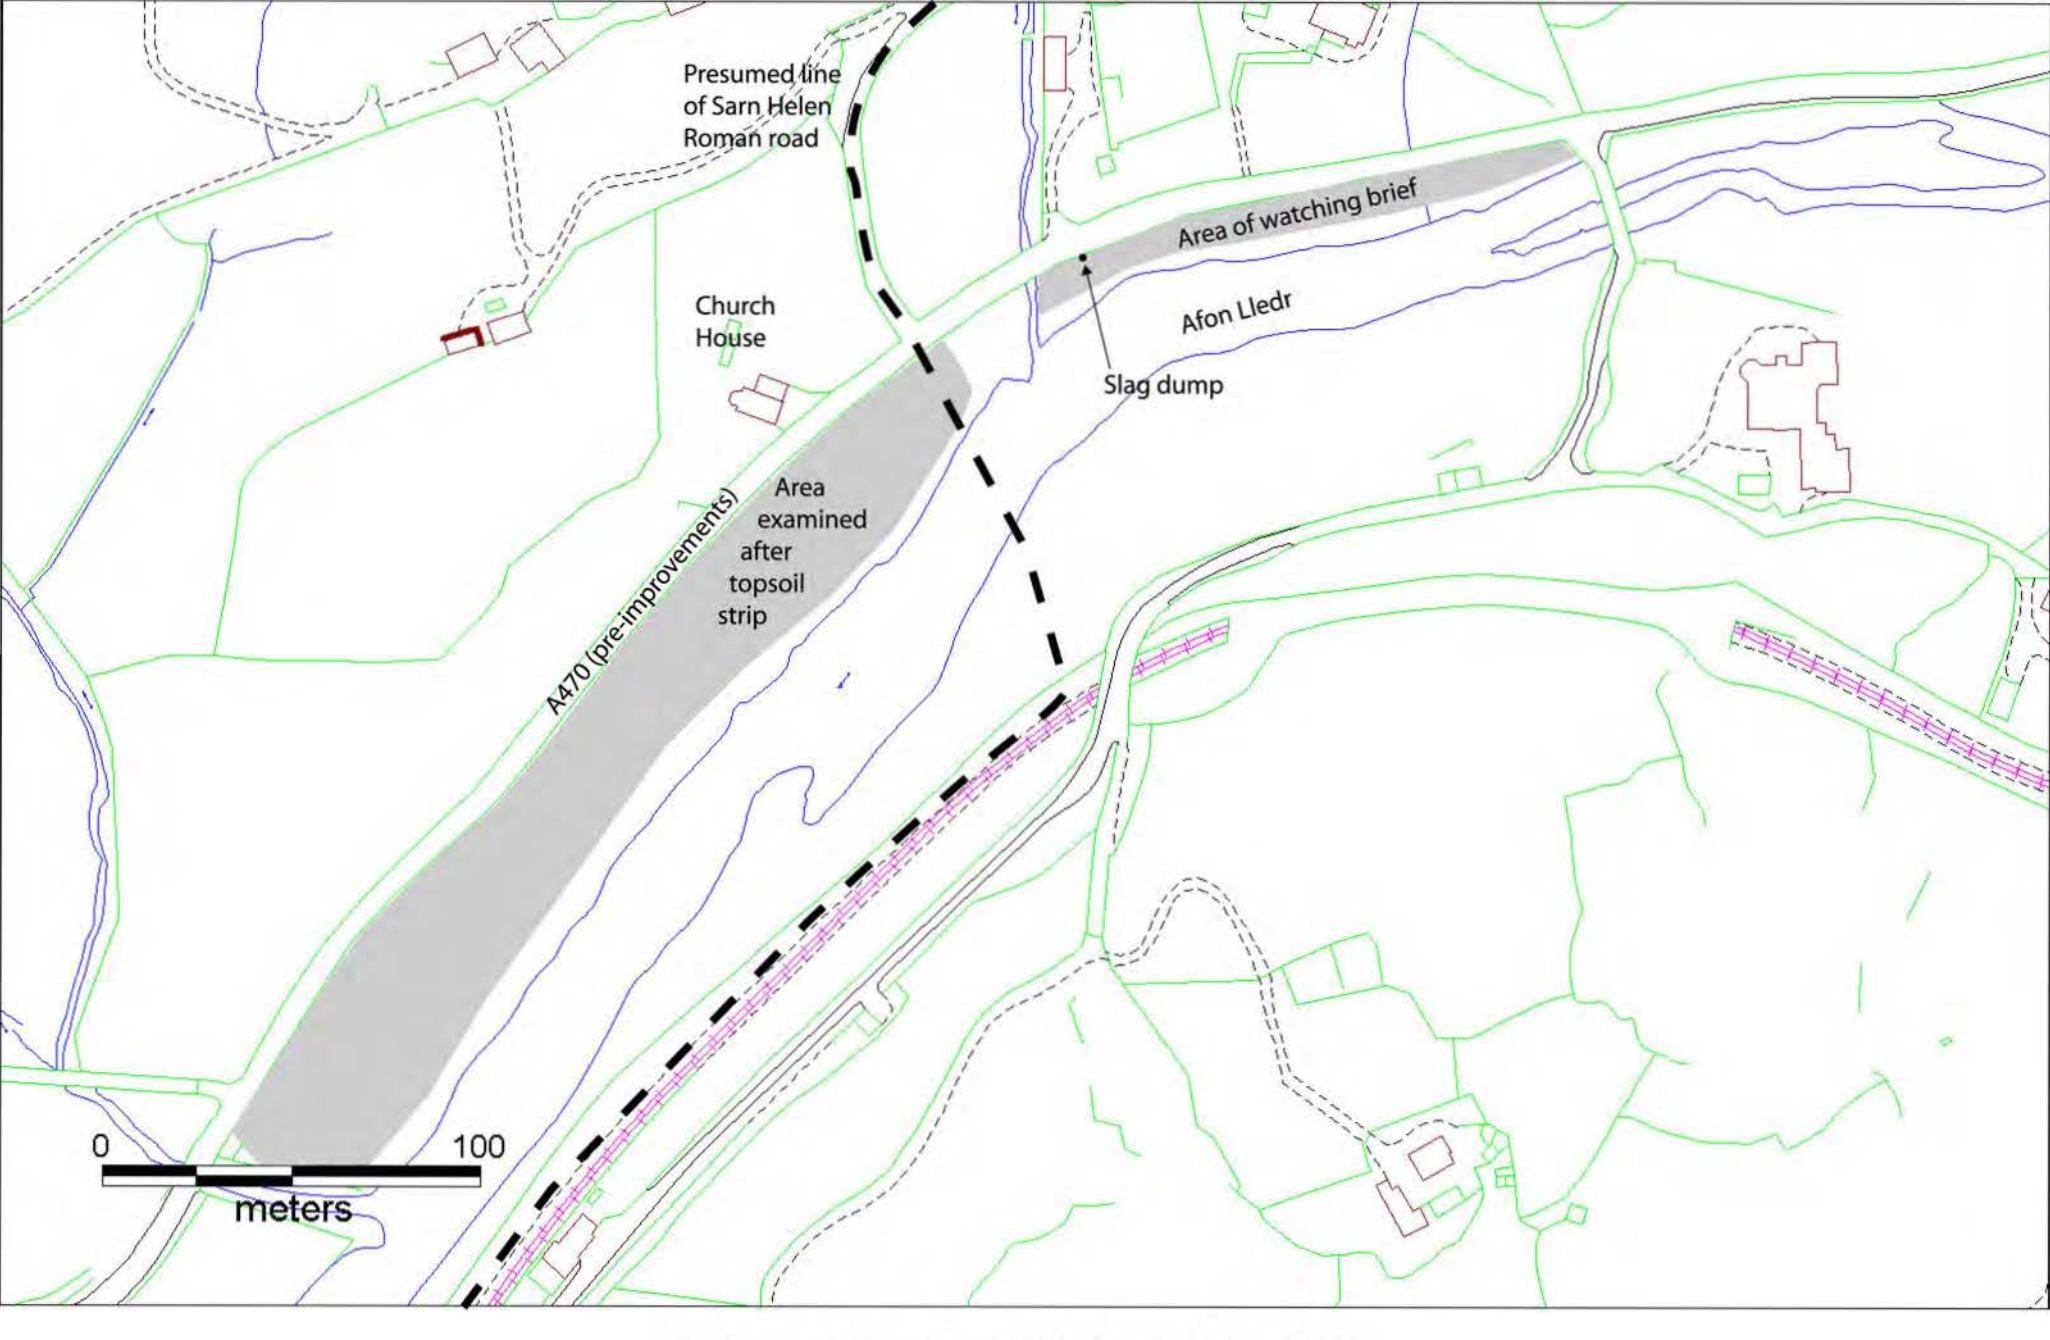
A watching brief was carried out during topsoil stripping to the south of the A470 near Pont-y-Pant (Fig. 7). The area comprised a 5-10m wide strip stretching 160m to the west of Pont-y-Pant and directly to the south of the road.

Fig. 7 Site 81, Sarn Helen Roman road, location of watching brief

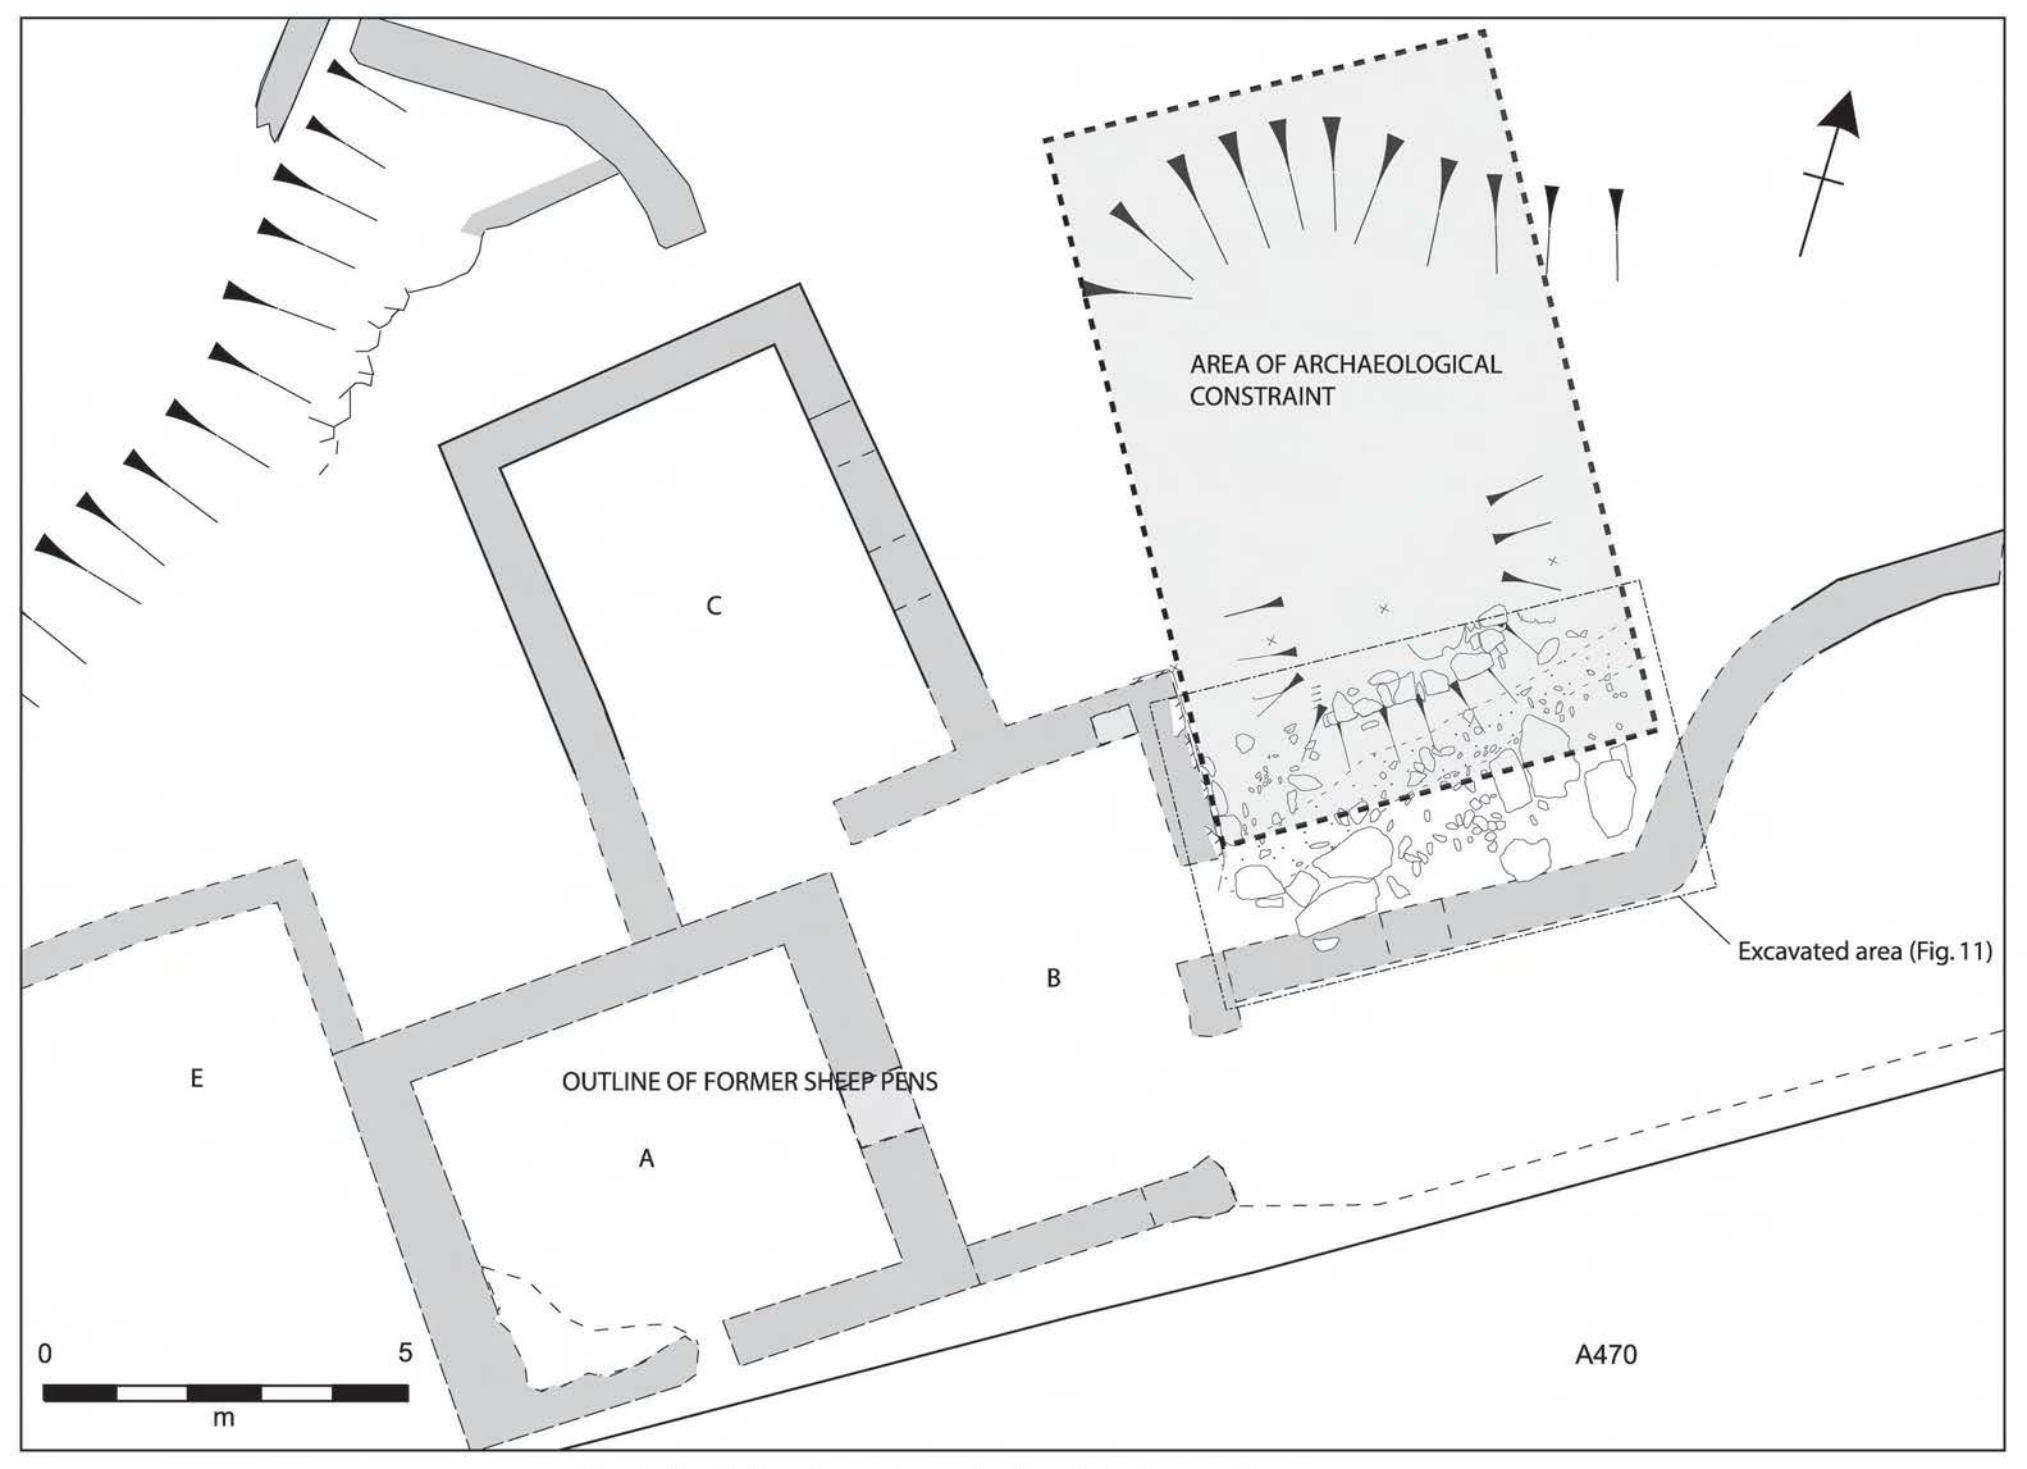
A revised area of archaeological constraint (Fig. 10) was recommended in view of the excavation results. This was defined as a rectangular area of 6.5m x 9.5m set back 5.5m from the edge of the present A470 and bounded to the south-west by the remains of the north-eastern side of the sheep pens where no ground disturbance could take place without archaeological consultation and supervision. It was recommended that the possible medieval long hut should be preserved *in situ*. It stands just to the north-west of the new carriageway and associated drainage works. The site stands to the outside of the fence-line alongside the new road and will thus be within National Trust land. The shallow excavation was backfilled with topsoil and was re-seeded thus stabilising the site.

Fig. 10 Site 86, location and area of archaeological constraint

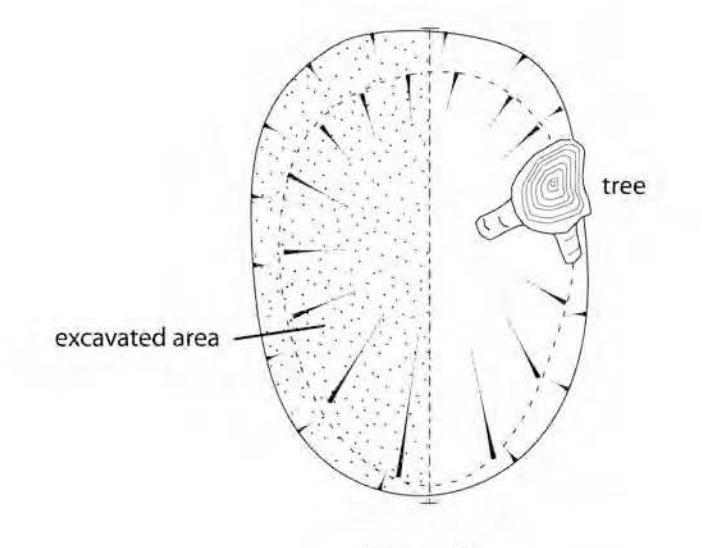
Feature 4 was visible as a 2.4m x 1.8m oval hollow, cut into a moderate slope to the west of the foot of the incline (Fig 14). It had a semi mature birch tree growing in its eastern side. The feature was a maximum of 0.7m deep. It was half sectioned and found to contain a humic fill, about 0.2m deep. The feature was cut into natural subsoil.

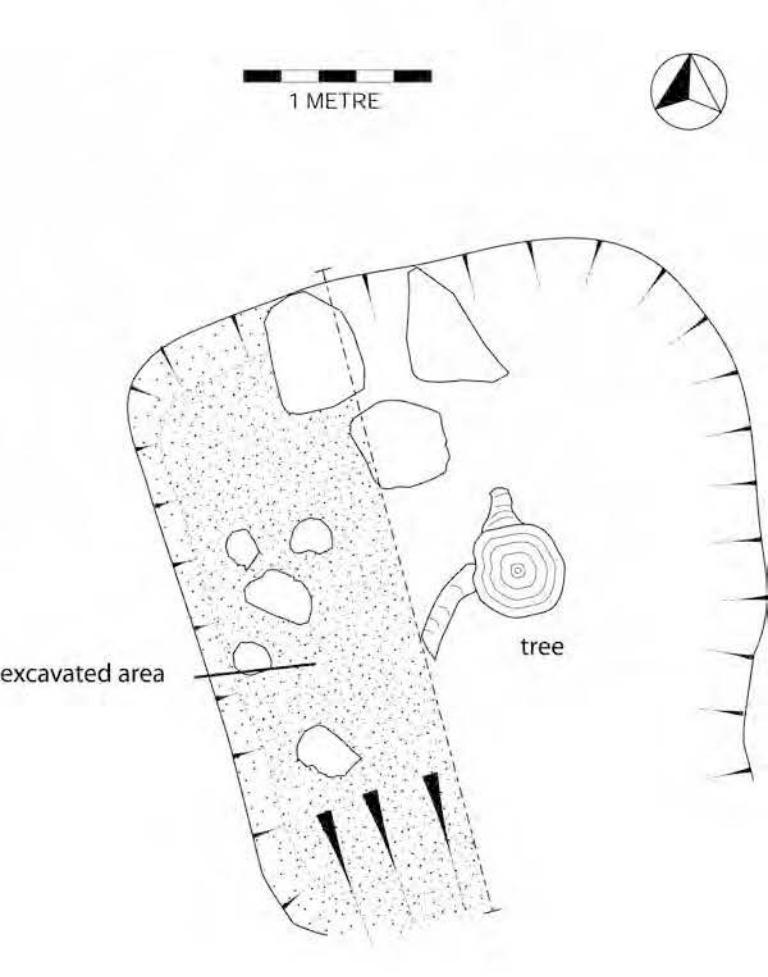
Feature 5 (Fig 14) was a roughly square (3.2m x 3.0m) platform or embayment cut into the slope to the east of the incline. It was sectioned and found to be filled with a 0.2m deep layer of humus and roots. The base was of hard-packed subsoil with occasional large stones embedded in it.
