**REGENT HOUSE,
17, CHURCH STREET, BEAUMARIS**

**ARCHAEOLOGICAL WATCHING BRIEF DURING NEW
CONSTRUCTION AND RENOVATIONS AT REAR OF PROPERTY**

GAT Project No. G1807

Report No. 585

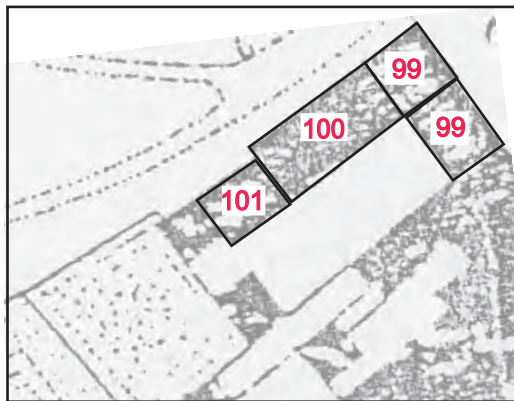
Regent House, Beaumaris Fig. 3a
No. 17 Church Street in 1829
(Baron Hill UWB BH 6496)
Re-oriented to OS north
and structural divisions emphasised

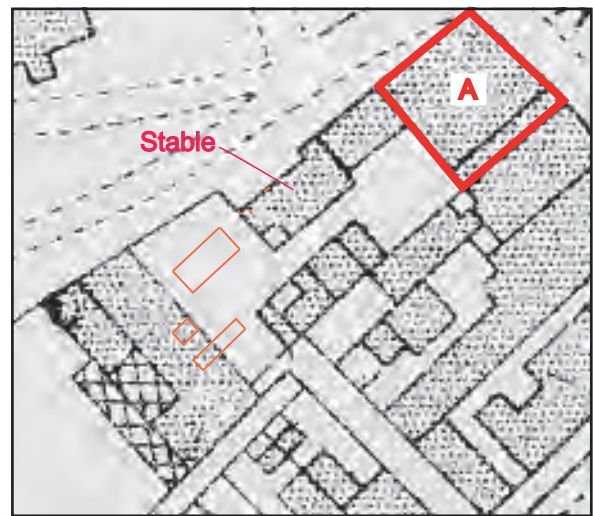
Inspect all exposed walls. The outline of the former smithy, which may have also previously been a boiler house for the adjoining glasshouses seen on the 1919 map (Fig. 3b) was visible in the exposed facing of the south yard wall (Fig. 6).

Regent House, Beaumaris Fig. 3b
No. 17 Church Street in 1919 and position
of trenches excavated Nov. 2003
Based on Ordnance Survey 1:2500 map, 1919

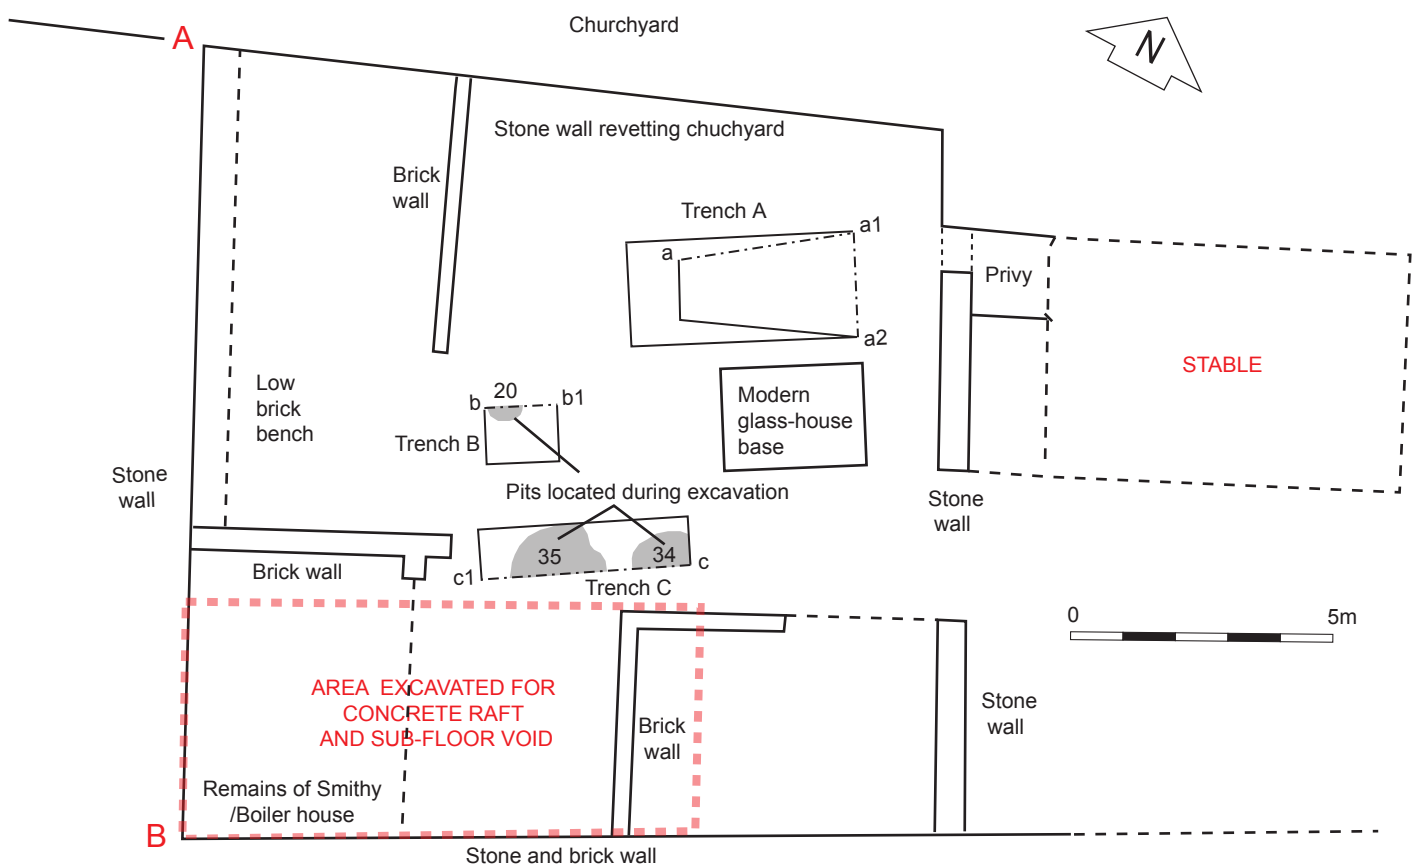
Regent House, Beaumaris Fig. 4 Location plan of excavated trenches in relation to
the area excavated for concrete raft and sub-floor void

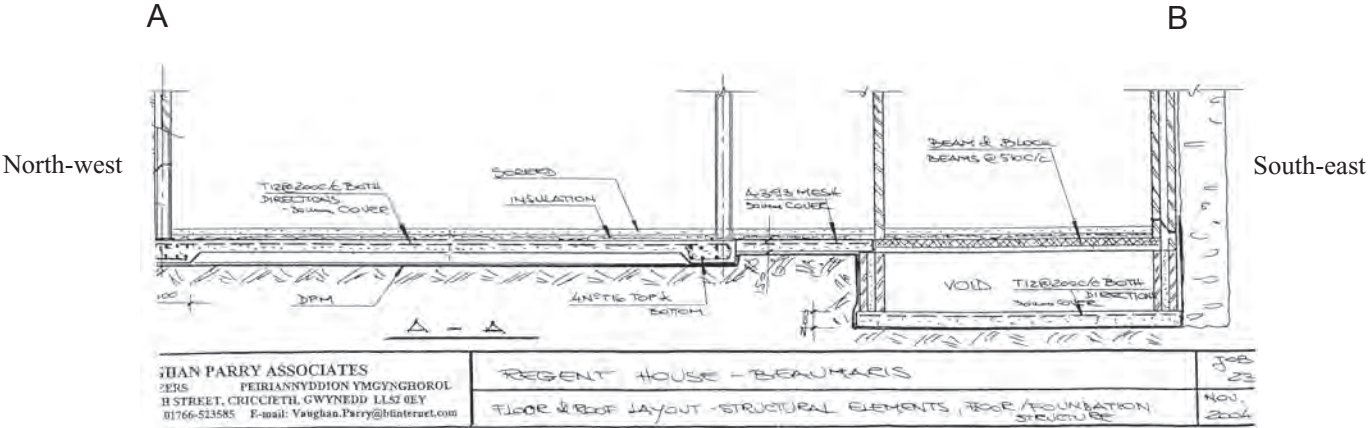
Informed on site that construction design had changed at request of the building inspector. The eastern, downslope wing of the building was now to be built on a concrete raft, not footings, at the level of the road outside the yard wall. There would then be a sub-floor void beneath the new building (Fig. 5). This entails excavating the yard surface in this area to a depth of about –1.5m instead of the 0.4m originally intended and this excavation was already in progress. This depth of material removal would affect mainly layers of post-medieval made ground as well as pits of 17th-18th century and more recent date, found during the evaluation. It might expose a significant area of buried subsoil surface, which could contain Medieval features. The excavated surface should therefore be cleaned to see if any features were present, which could then be recorded.

Regent House, Beaumaris Fig. 5 Architects' cross-section of proposed building showing raft foundation and sub-floor void cut into subsoil at south side of yard
