A470 BLAENAU FFESTINIOG
TO CANCOED IMPROVEMENT
ARCHAEOLOGICAL RECORDING REPORT
G1874

Report number : 621 part 1

Prepared for
White Young Green plc and Gwynedd Consultancy Environment Directorate
December 2005

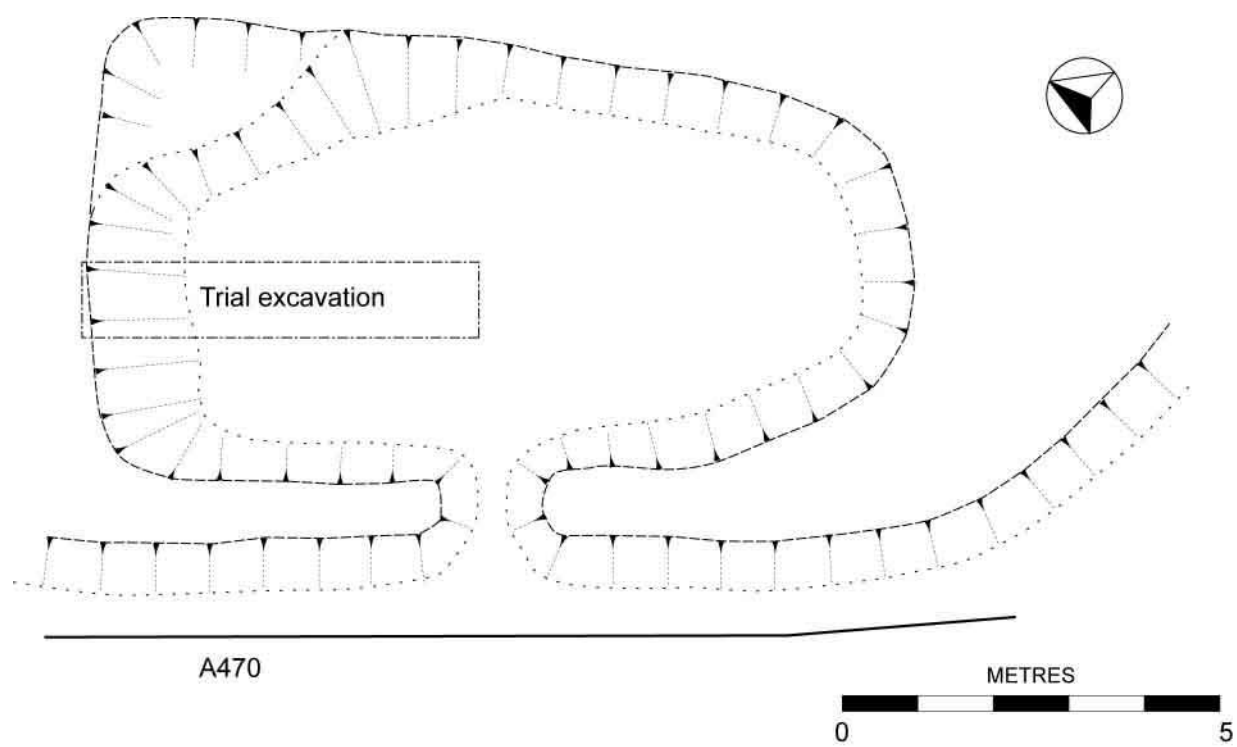
Fig. 9 Site 17 – Sub-rectangular scoop

A poorly defined 10m x 5m sub-rectangular hollow stands 2.4m to the north-east of the A470 (Fig. 9 and Plate 1). A low bank that forms one side of the hollow separates it from the road. There is a 0.4m wide break in the bank half way along the feature.

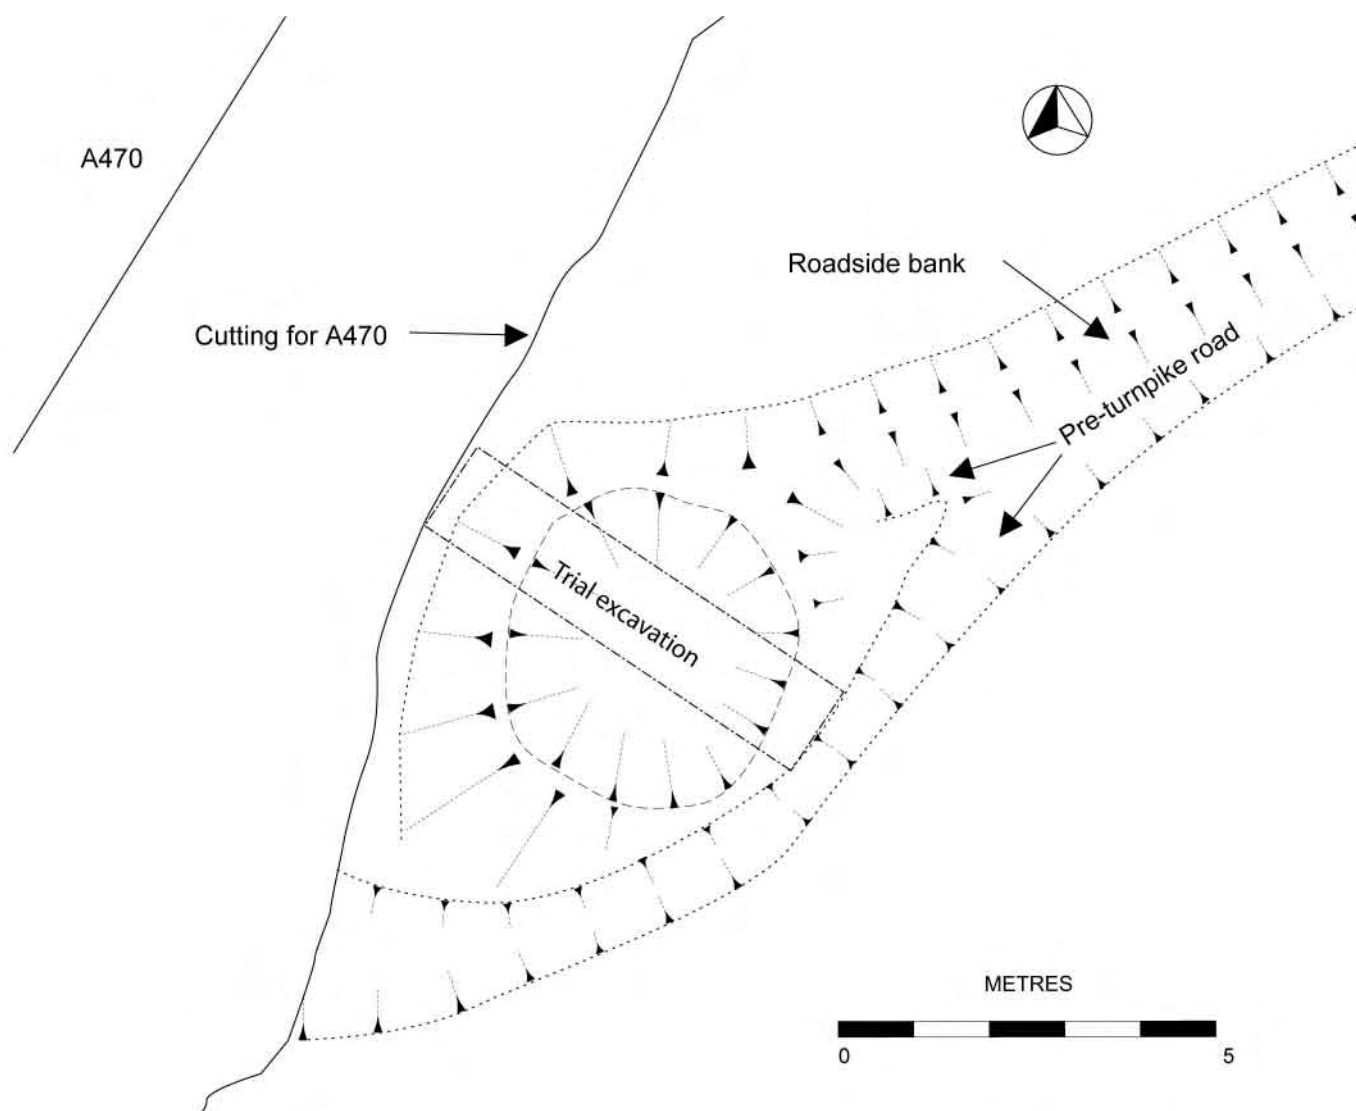
Fig. 11 Site 25 Small circular feature

A well-defined circular hollow (Fig. 11 and Plate 3) lies on the edge of a terrace above the A470. The hollow is 3.4m in diameter and terraced into the slope. A 1m wide stony bank defines the north-western side. The hollow appears to cut one or two courses of the pre-turnpike road and both are truncated by the cutting for the present A470.

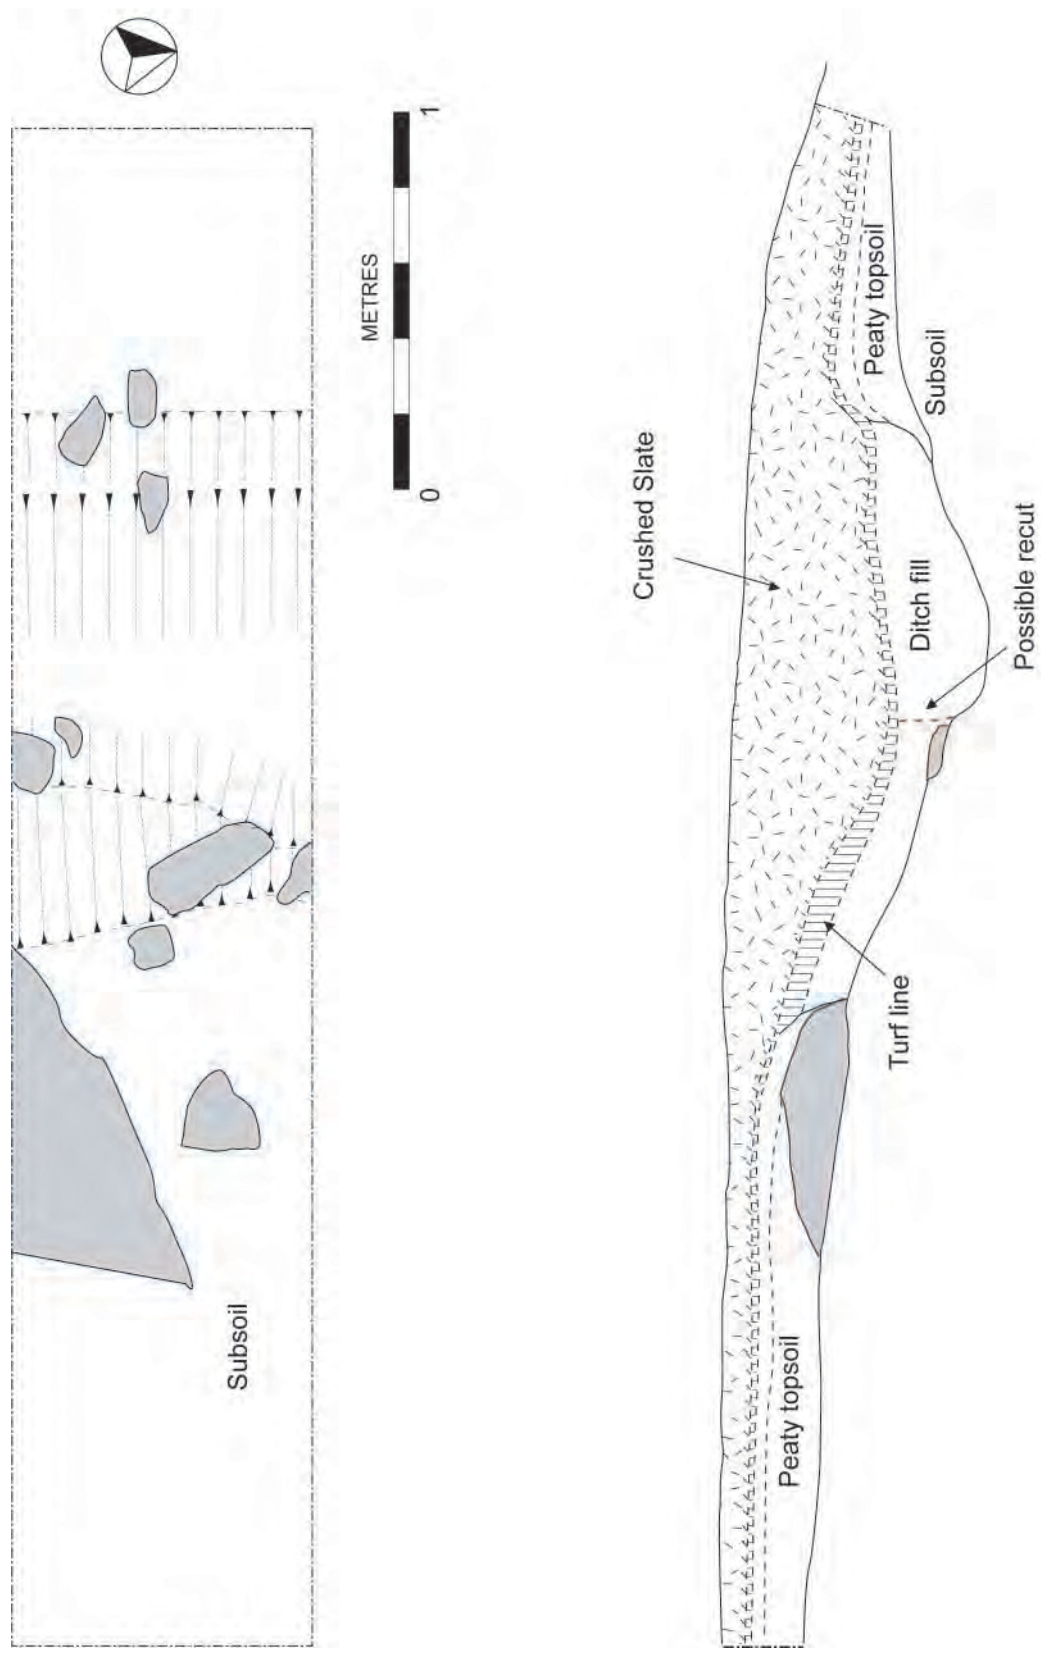
Fig 14 Site 33a Embanked curvilinear feature. Plan after excavation and north facing section

A 4m x 1m trench was excavated across the estimated position of the ditch and bank (Fig. 14 and Plate 7). Up to 0.4m of compacted slate waste was removed, revealing a partly decomposed turf line with a linear depression corresponding to the ditch. The ground level was 0.2m higher on the eastern side, confirming that the feature was slightly raised. The trench was excavated down to subsoil, revealing a

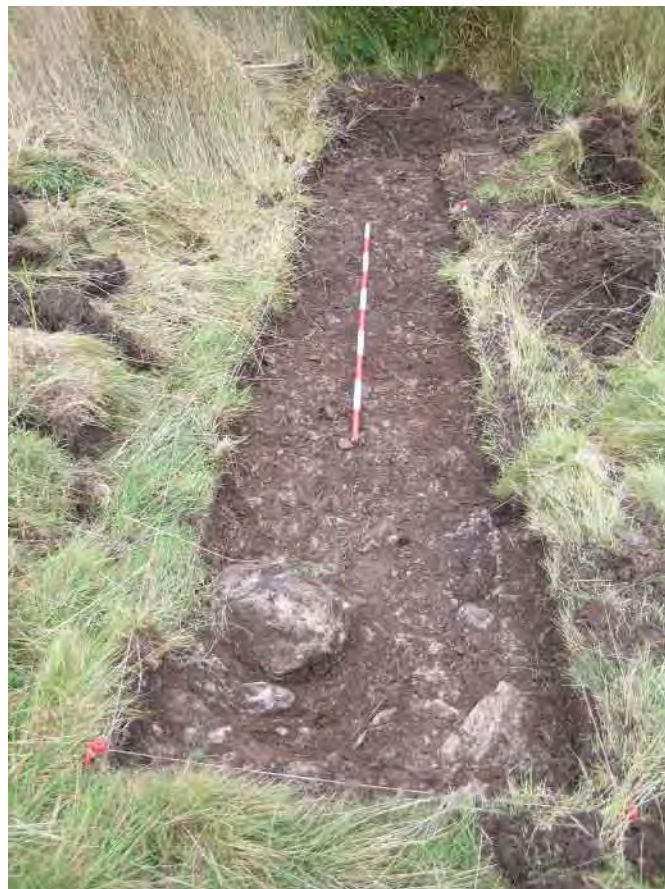
Plate 2 Site 17 Sub-rectangular scoop, excavation trench

A 5m x 1m trench was hand dug along the northern half of the feature (Fig. 10 and Plate 2). The turf and topsoil was 0.15m deep and contained frequent modern finds including broken glass, tin cans and plastic wrapping. One sherd of 19th century Buckley ware was also recovered from the same context. The finds were distributed throughout the context indicating modern disturbance. This was overlying typical subsoil of the area: mid-reddish-brown silt containing slate fragments. Shattered bedrock was visible on the north-western end of the trench along with one larger stone that had been partially dragged from the subsoil, leaving a hole. The subsoil level dropped gradually to the south-eastern end where bedrock was exposed.

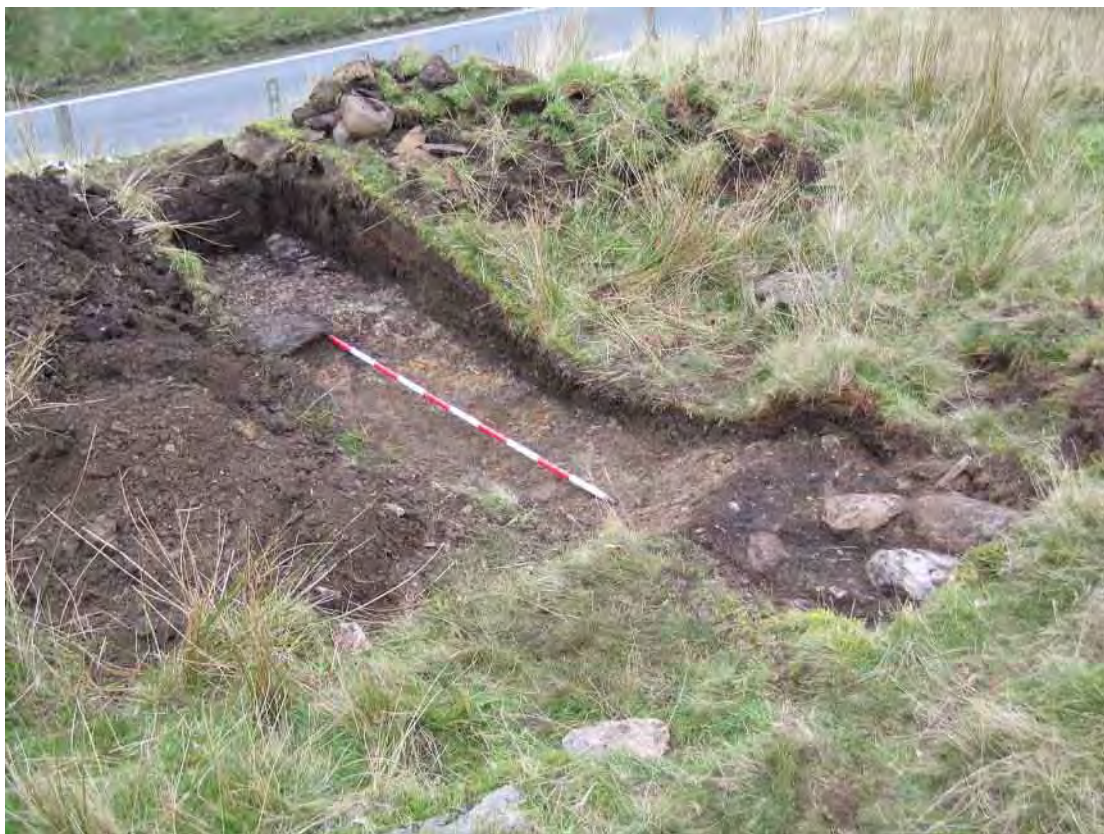
Plate 4 Site 25 Small circular feature, excavation trench

A 5.8m x 1m trench was excavated across the centre of the feature (Fig. 12 and Plate 4). The turf and peaty topsoil were removed revealing stones and peat at the north-western end of the trench and subsoil and bedrock at the south-east. A mixture of gravel, peat and stones filled the central part of the hollow. Upon further excavation it was found that the earliest feature was a turf and peat bank covered by a buried peaty topsoil. There was no dating evidence from this feature but it seems likely that it was a continuation of the low bank that runs along the lower side of the pre-turnpike road.

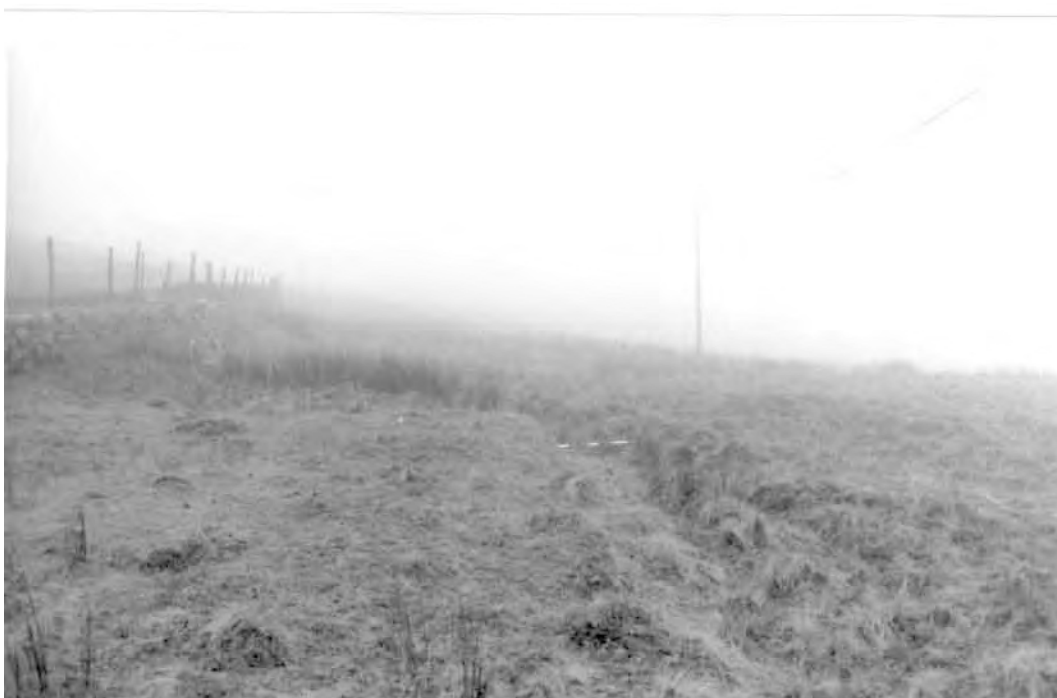
Plate 5 Site 33a Embanked curvilinear enclosure in 1992

The feature is no longer visible. A level working platform of compacted slate waste was built over it during repairs to the A470 revetment wall during the last 5 years (Fig. 13). Plates 5 and 6 show the site in 1992 and 2005.

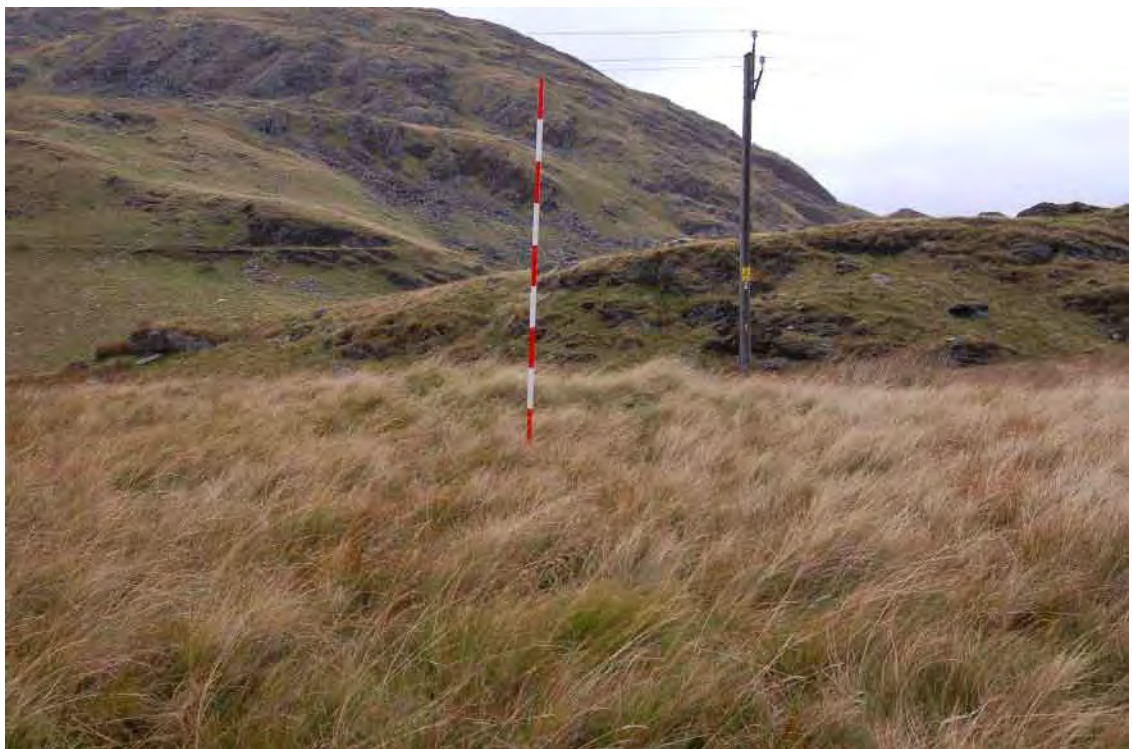
Plate 8 Site 33b Possible cairn

A possible small cairn was identified just to the west of site 33a during the assessment. It is 2.2m in diameter, 0.4m high, flat-topped and roughly circular in plan (Fig. 13 and Plate 8).
