CPAT Report No. 1728

St Grwst's Church and Gwydir Chapel, Llanrwst, Conwy

Archaeological Watching Brief

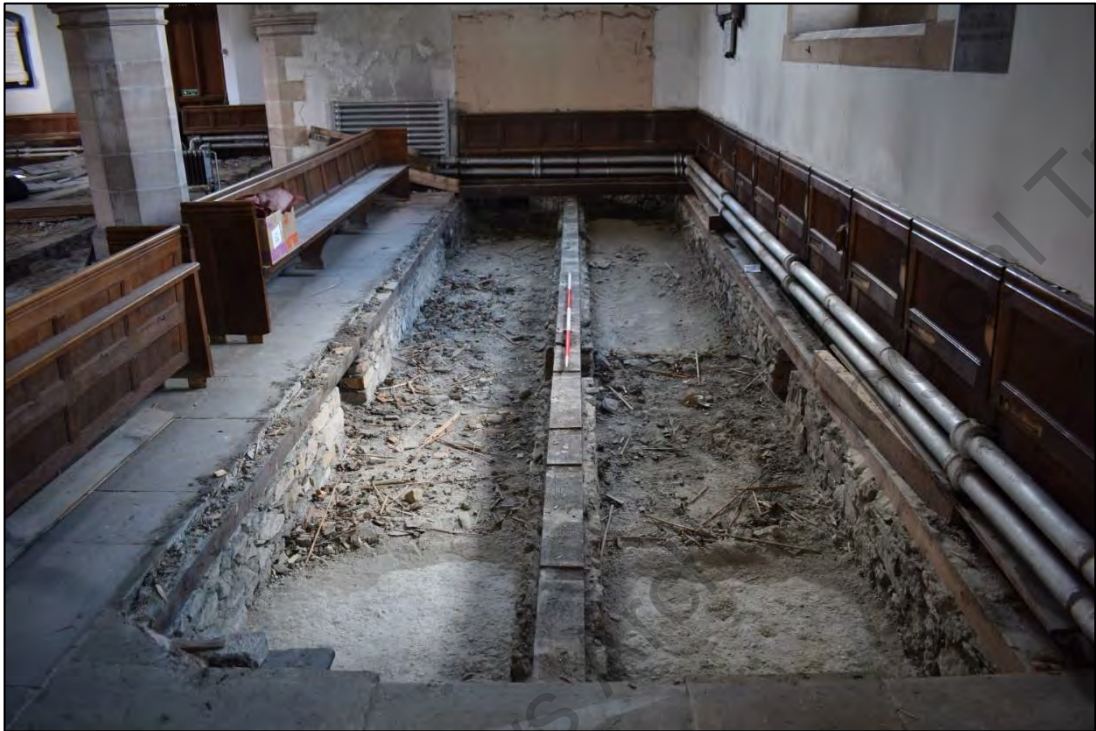
- 3.2. The main part of the work within the church which had the potential for significant archaeological impacts involved the lowering of the floor level and the subsequent construction of a new floor slab to support the new structures. This was carried out in the nave, north aisle and tower. The reduction of the floor level revealed sections of an earlier floor which was clearly in use in the 18th century, and perhaps also the beginning of the 19th century to judge from the ledgers that were revealed. Some of the ledgers were taken up as they were too close to the surface and were placed between the sleeper walls of the floor in the north aisle after the wooden and stone slab flooring there was removed and before the new floor had covered them. Apart from these walls, no archaeological features or structures were seen in the floor of the north aisle (Fig. 2). No evidence was revealed for grave cuts or

Fig. 2: The north aisle floor, showing the sleeper walls, from the east. CPAT 4679-0001

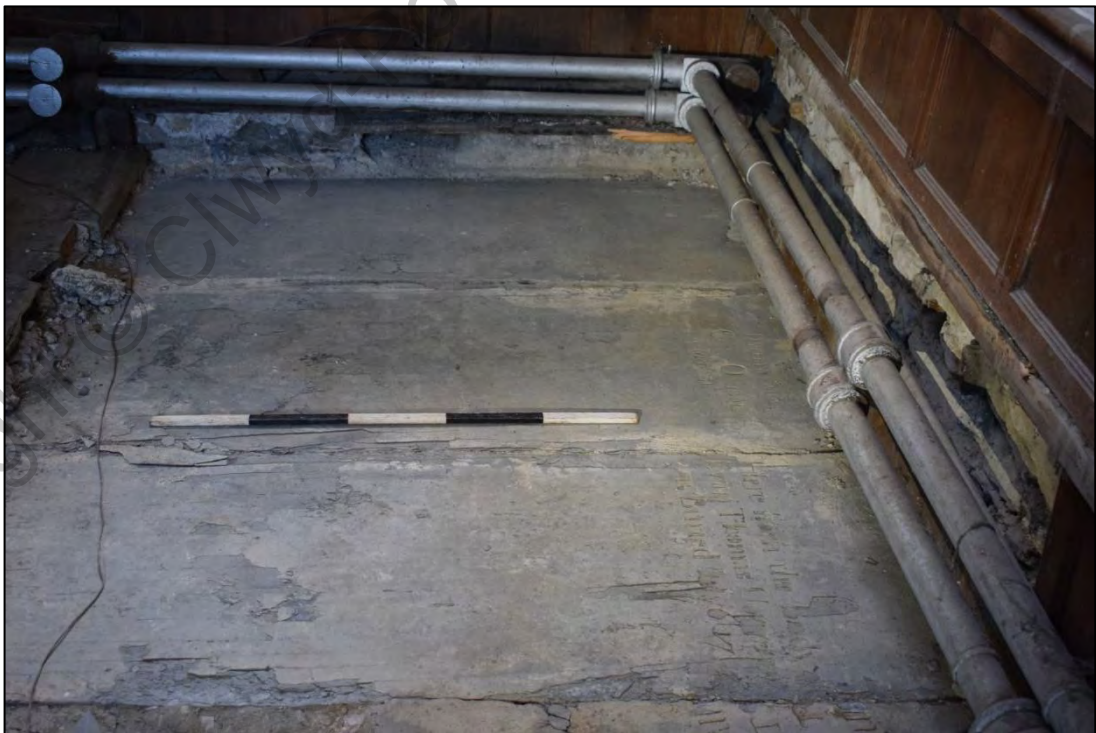
Fig. 3: The ledgers in the south-west corner of the nave, from the north. CPAT 4679-0012

- 3.3. At the west end of the nave, the removal of the modern flooring in the south-west corner of the church, where the font had been sited, revealed four ledgers and other slabs which had been used as flooring (Figs. 3 and 4). The ledgers were dated to between 1751 and 1801; all had to be taken up to give sufficient depth for the new floor to be installed. These were positioned so closely together that they may represent the reuse of ledgers as flooring.

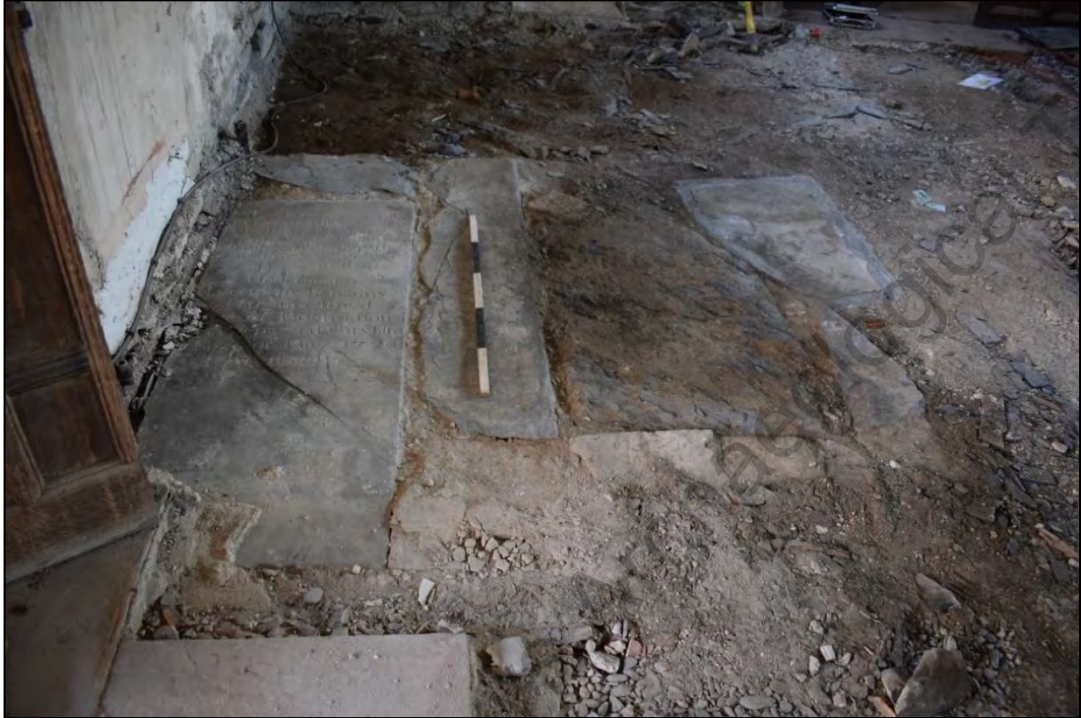
Fig. 4: The 1751 ledger (left) and floor slabs to the west of the main entrance to the church, as revealed by the taking up of the font, from the east. CPAT 4679-0102

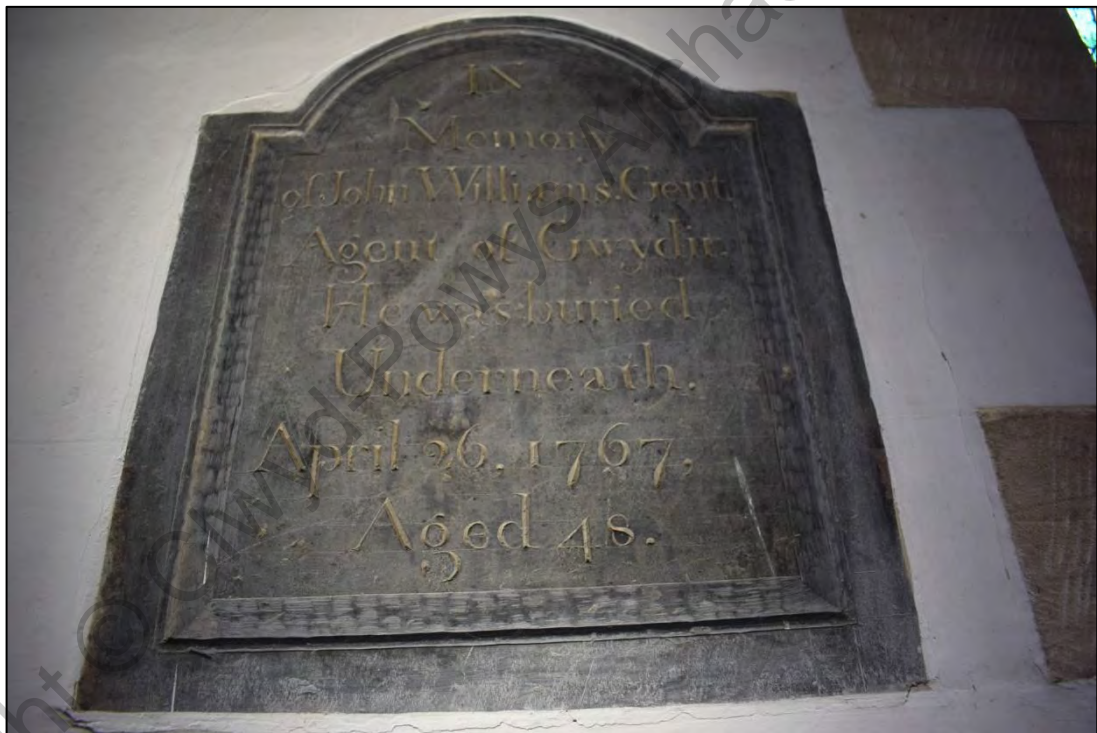
Fig. 6: The John Williams memorial plaque on the wall of the north aisle. CPAT 4679-0075

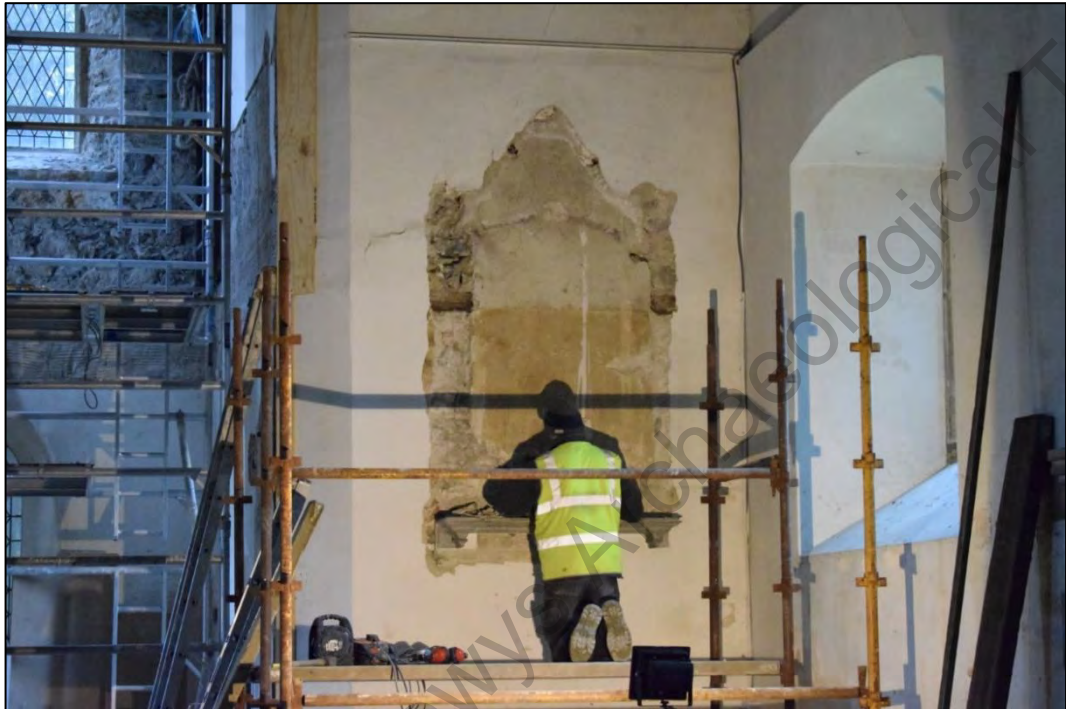
- 3.16. A number of wall monuments needed to be moved from their existing positions to allow for the reorganisation of the internal space of the church. Two, on the south side of the tower at the west end of the nave, were placed higher on the wall (Fig. 15). Another, on the north side of the tower (Fig. 14) was removed and attached to the north wall of the north aisle. As far as the writer is aware this work was accomplished without damage to the monuments.

Fig. 14: The wall monument on the west wall of the nave, to the north of the tower in the process of being taken down, and moved to the north wall of the north aisle. CPAT 4679-0115

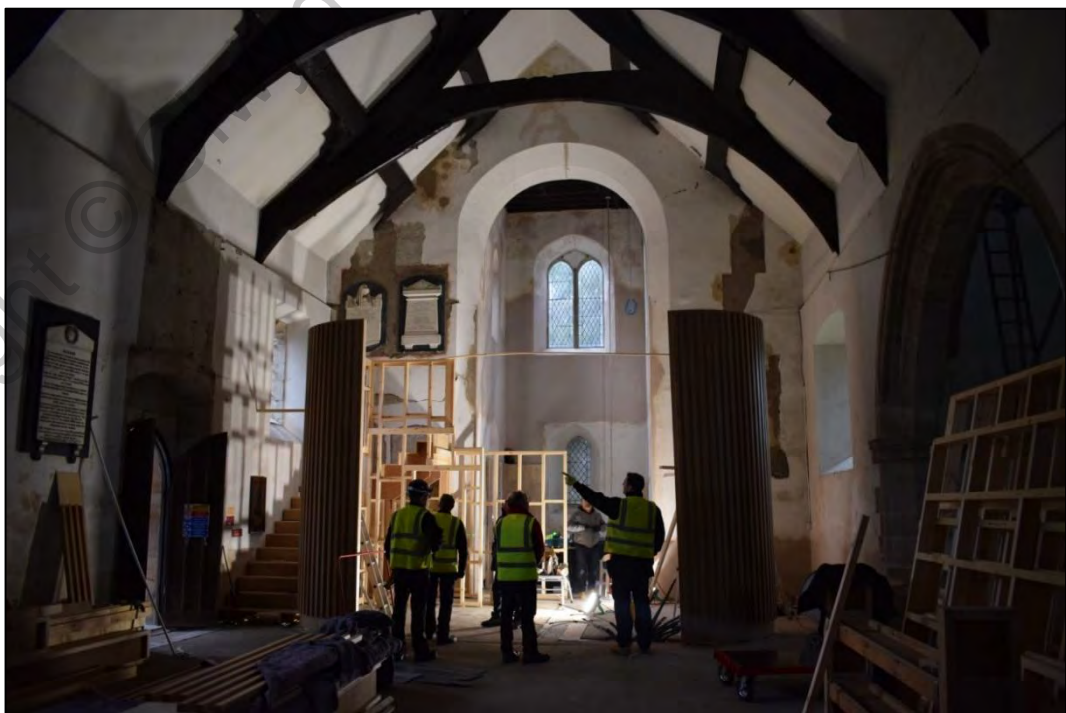
Fig. 15: The west end of the nave after the monuments were repositioned. CPAT 4679-0179

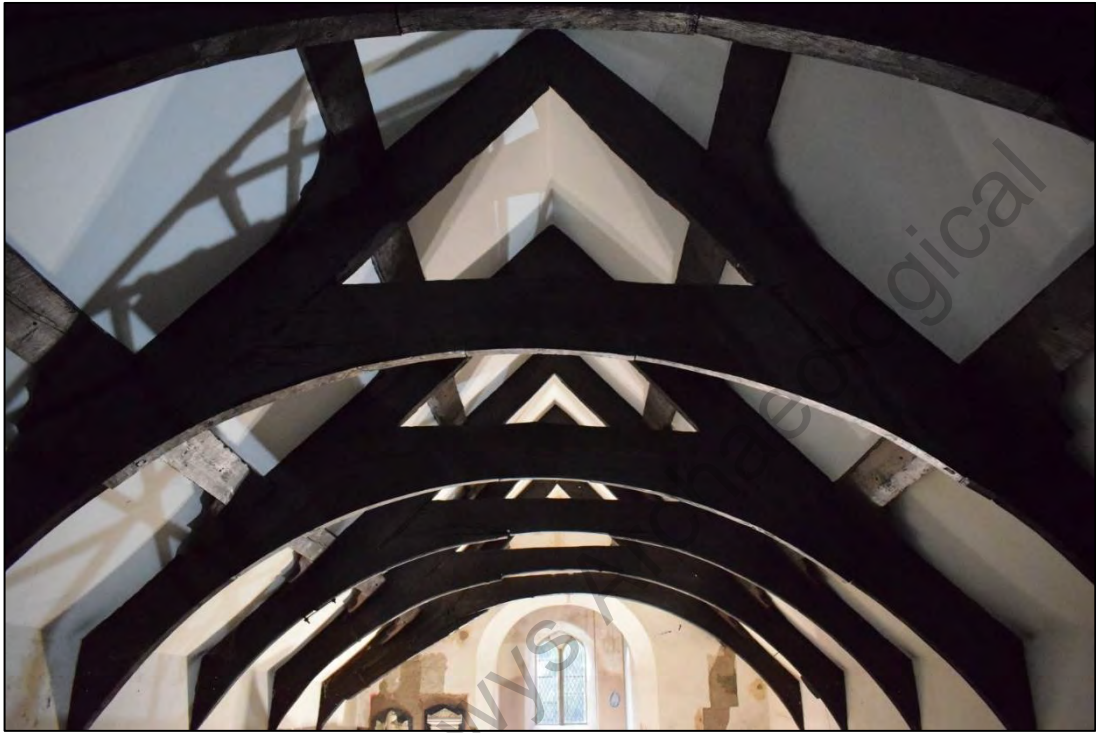
Fig. 16: The roof trusses in the nave taken from the top of the rood screen, from the east. CPAT 4679-0181

- 3.18. Access was possible to the walkway on the top of the rood screen via the spiral staircase on its north side, where pencil graffiti of 1928 was noted in passing. This allowed for scrutiny of the corresponding roof truss, but little of significance was observed. It was interesting that there was some evidence of probable repairs where timbers had been bolted together (Fig. 17), though when this had been done could not be determined, and the less formal nature of the carpentry than that in the north aisle was readily apparent. It was not possible to examine any of the other roof trusses.

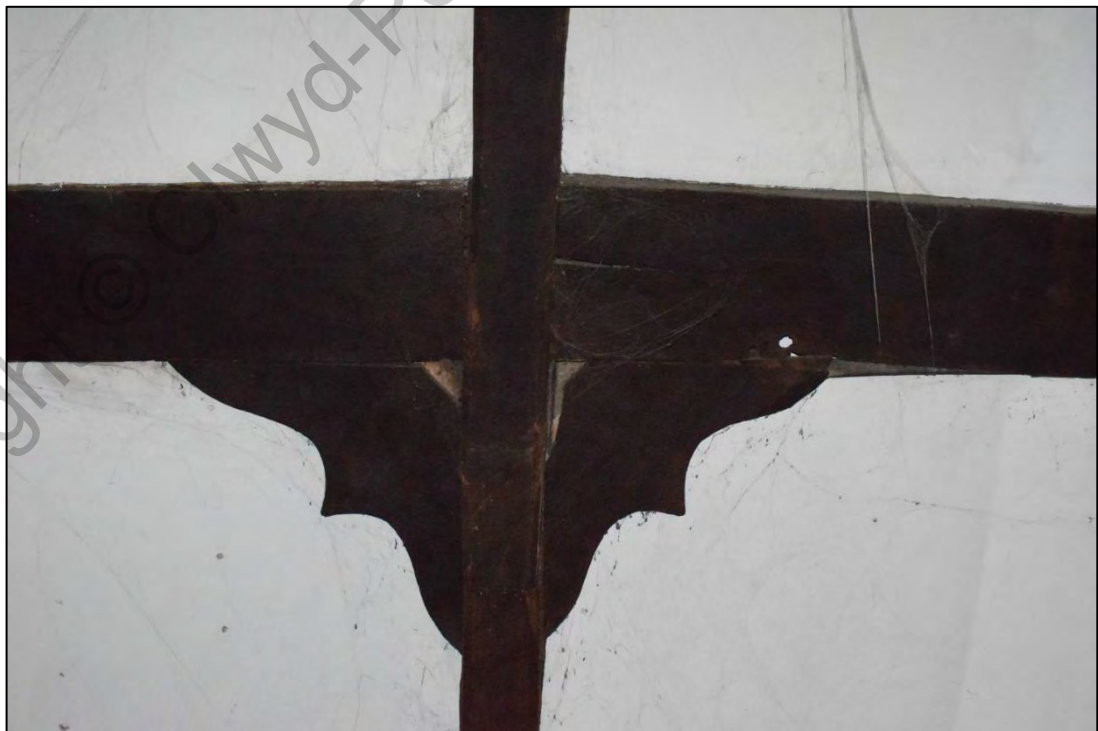
- 3.19. It is widely agreed by previous sources that the roof of the nave and chancel dates to the late 15th century and the visible features gave no reason to doubt this attribution. It was evident that the pattern of the original roof timbers and windbraces (Fig. 18) was copied to provide the roof structure of the 19th-century north aisle (Fig. 19).

Fig. 18: Windbraces on the roof truss crossing the rood screen, which most likely provided an overall appearance copied to shape those in the north aisle (see Fig. 19). CPAT 4679-0182

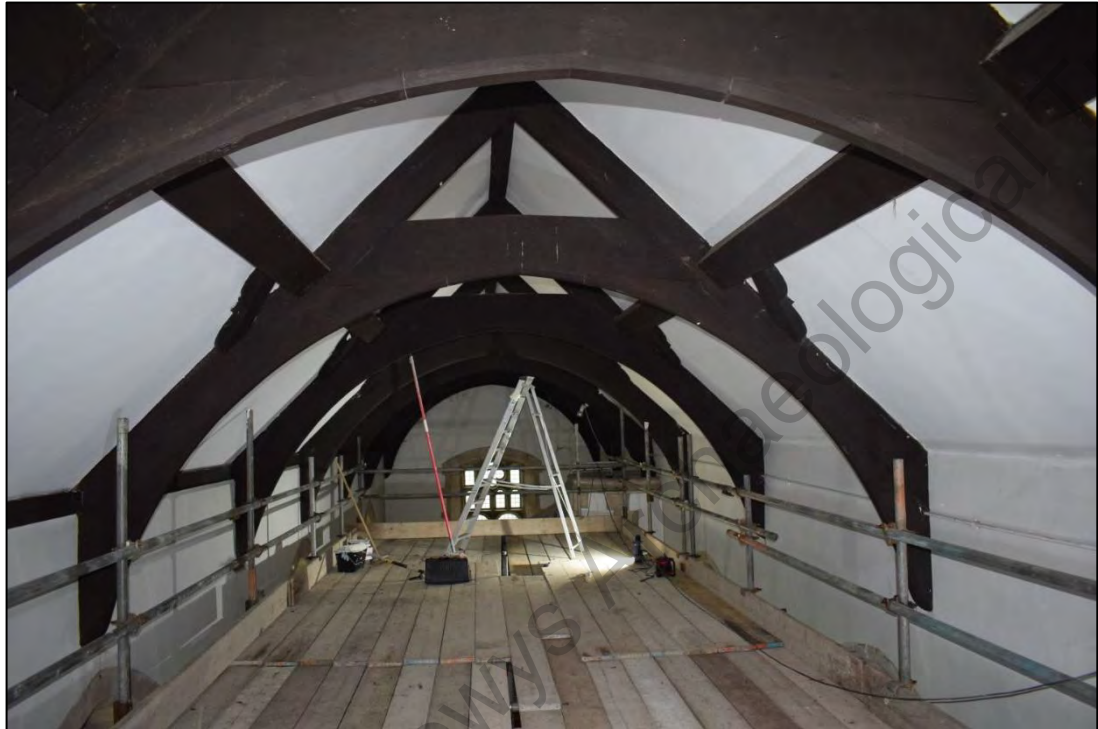
- 3.20. Scaffolding was erected in the north aisle to allow the ceiling to be painted, which allowed close scrutiny of the timbers; these all appeared to be machine sawn and very much made to a pattern. No reused timber was found and there were no carpenter's marks. The timbers were evidently all created at the same time for use here, something highlighted by the similarity between these windbraces and trusses and those in the original roof of the nave. The roof almost certainly dates to the end of the 19th century, when the aisle was constructed.

Fig. 19: The roof trusses of the north aisle. CPAT 4679-0173

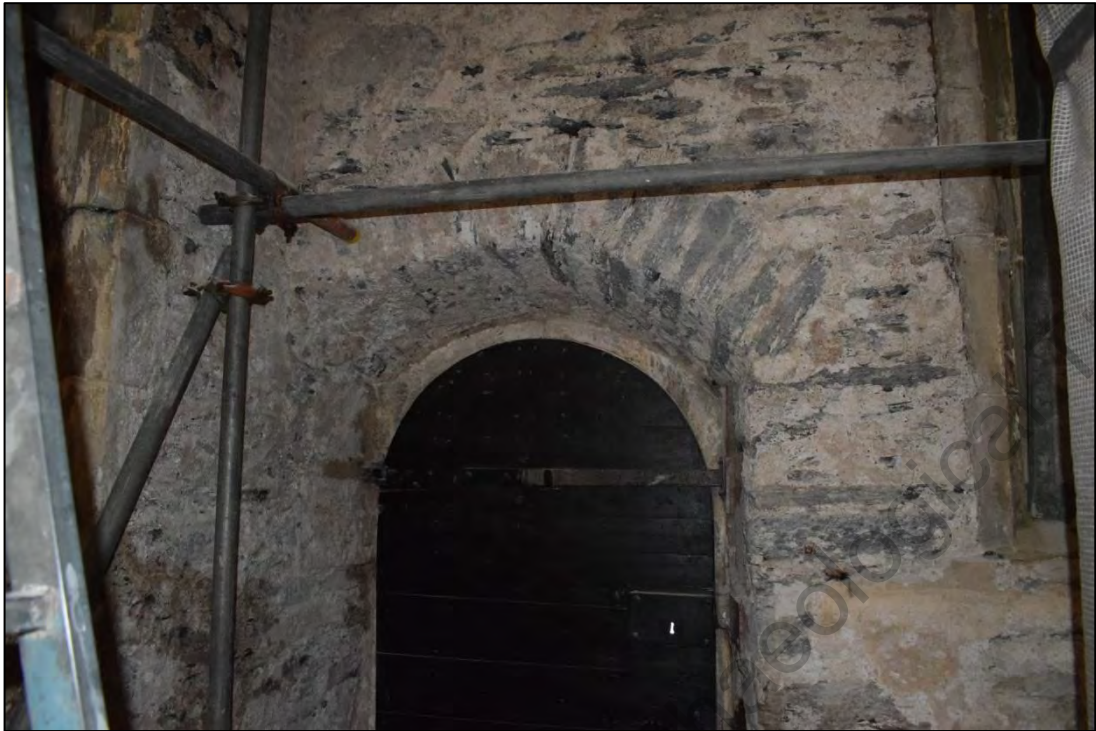
- 3.23. Little additional information was forthcoming from the repointing, the only evidence that had not been recognised related to the west (external) doorway of the chapel, where the stone arch (Fig. 22) forming the doorhead was exposed and a slot in the wall was identified which seems to have been used to permit a wooden bar to be inserted in the wall which could then be drawn across the internal side of the door to secure the entrance (Fig. 23).

Fig. 22: The stone arched doorhead at the external door at the south-west corner of the chapel. CPAT 4679-0169

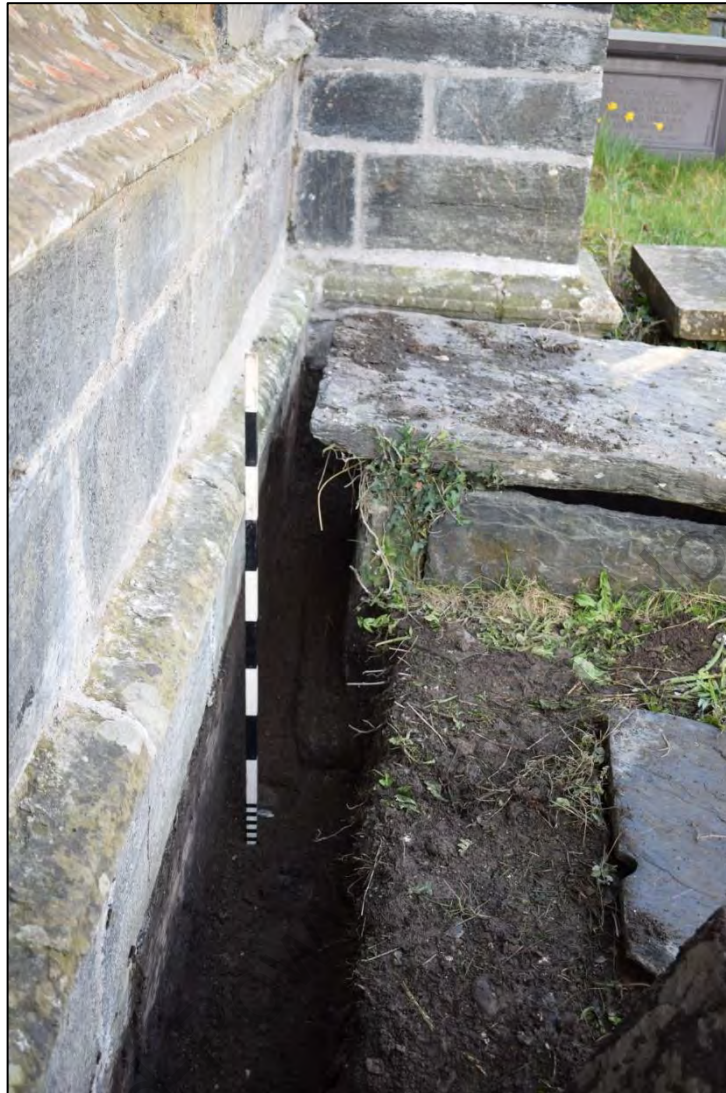
Fig. 26: The end of the chest tomb on the east side of the chapel, from the south. CPAT 4679-0194

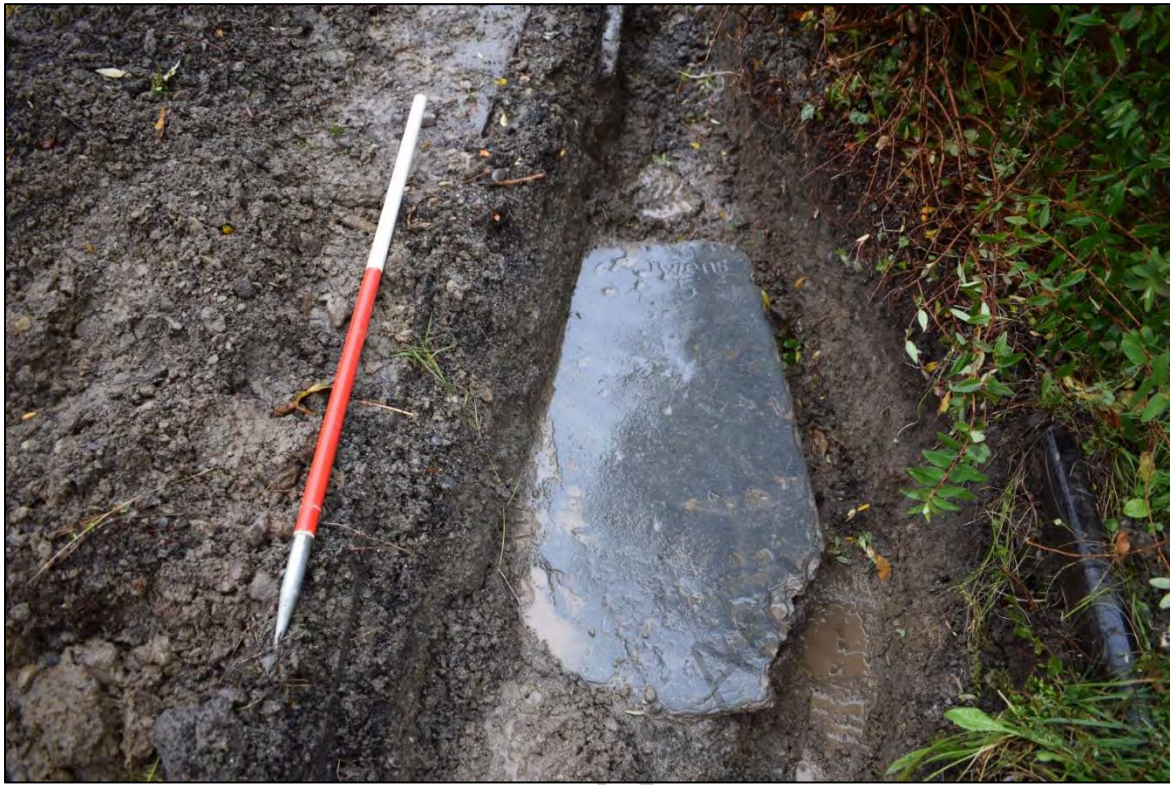
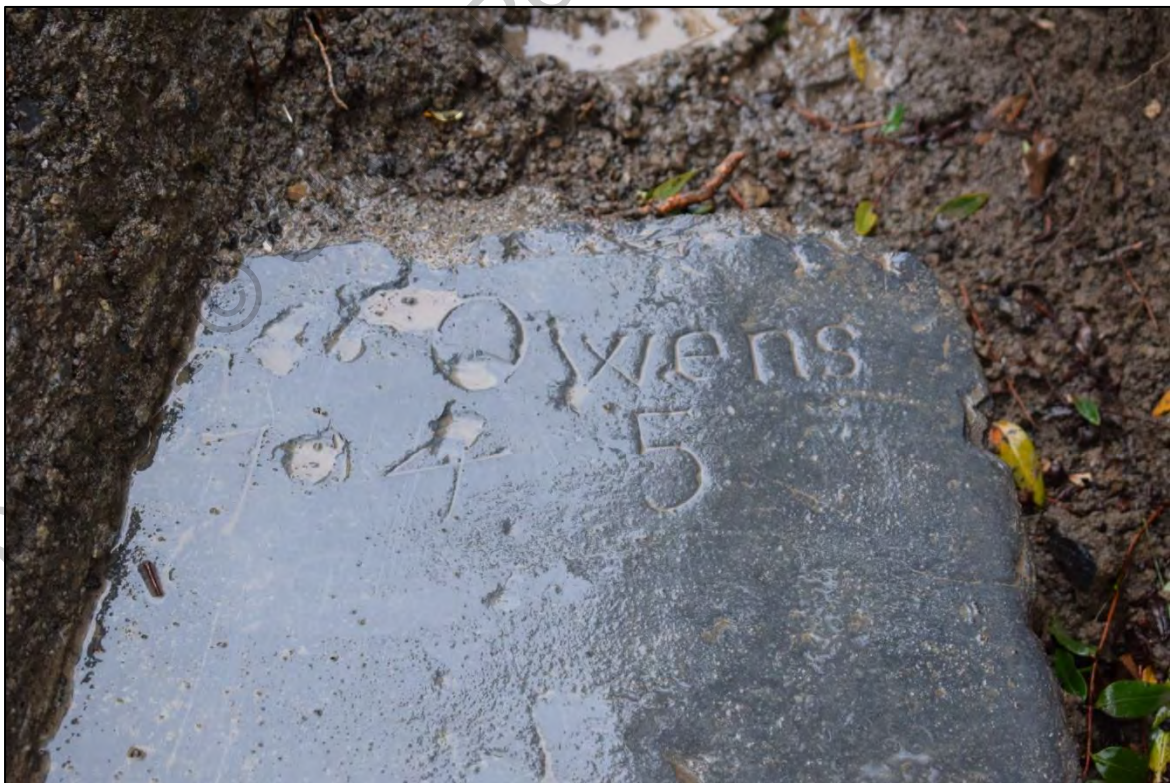
Ledger 7

- 3.24. A series of stone ledgers were identified during the works in the churchyard, the inscriptions and images of the ledgers are included in Appendix 2. The dated ledgers belonged to either the 18th or 19th century and can be compared with the monuments identified within the church to demonstrate that both church and churchyard would have had a crowded appearance. It is probable that there would have been so little space in the churchyard that access would have entailed walking over ledgers and there was evidence in some cases of the resultant wear, notably so with ledgers 7 and 11, found beneath the current path.

***n Owens

*745

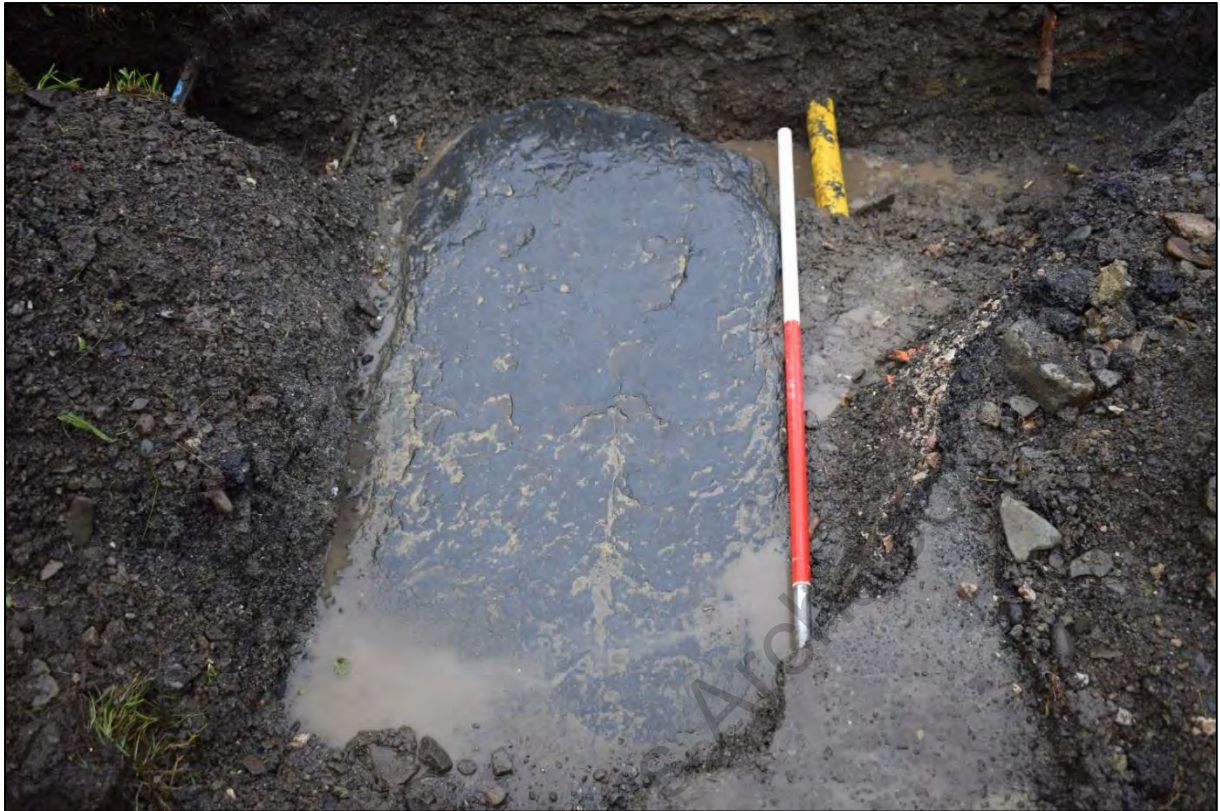
Ledger 11

No inscription, potentially of an earlier date than the 18th-century ledgers.
