**Results of Archaeological Works at**  
**10 & 11 Lower Gate Street,**  
**Conwy**

**Project Number CR135-2016**

<b>Planning Application Number:</b>	N/A
<b>National Grid Reference:</b>	SH 78186 77716
<b>Client:</b>	Ms Jan Tyley
<b>Report Author:</b>	Catherine Rees
<b>Report Number:</b>	CR135-2016
<b>Date:</b>	20/12/2016

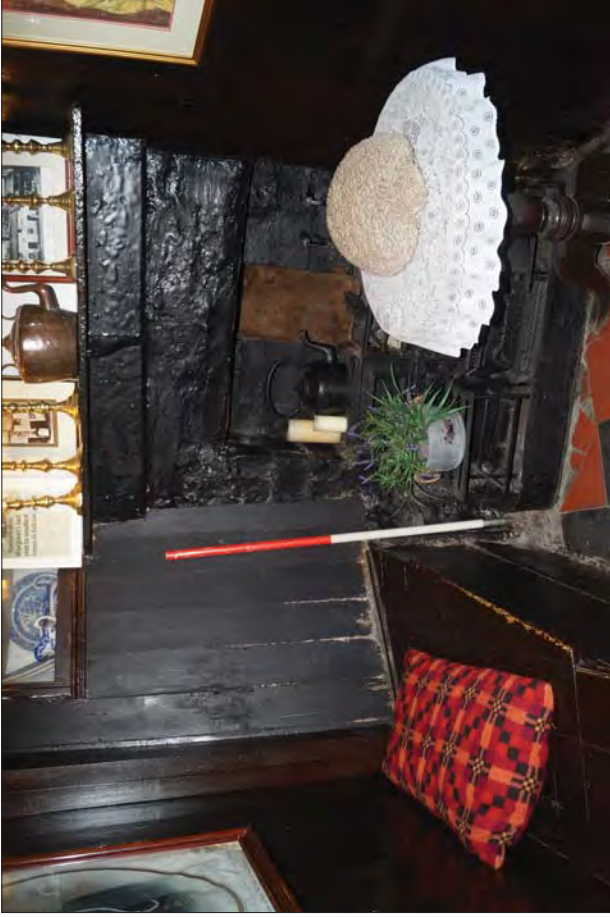
**Plate 11.** 10 Lower Gate Street Ground Floor Before Works

Plates 7 – 14 detail the property prior to the commencement of works and show the water damage to the first floor. Plates 15 – 22 detail the first floor following the stripping back of the plaster. No works were undertaken to the ground floor level.

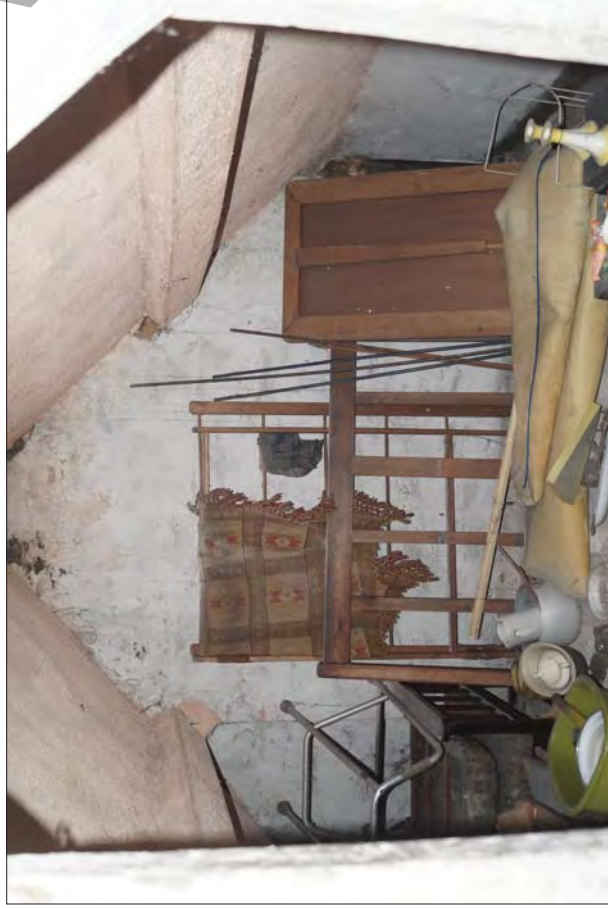
**Plate 25.** 11 Lower Gate Street, Attic Level Room Facing North-Western Gable

The attic was the only level at which works were taking place and a photographic record of the space was made both before (plates 23 – 26) and after (plates 27 – 35) the clearing of the attic and the removal of some areas of plaster.

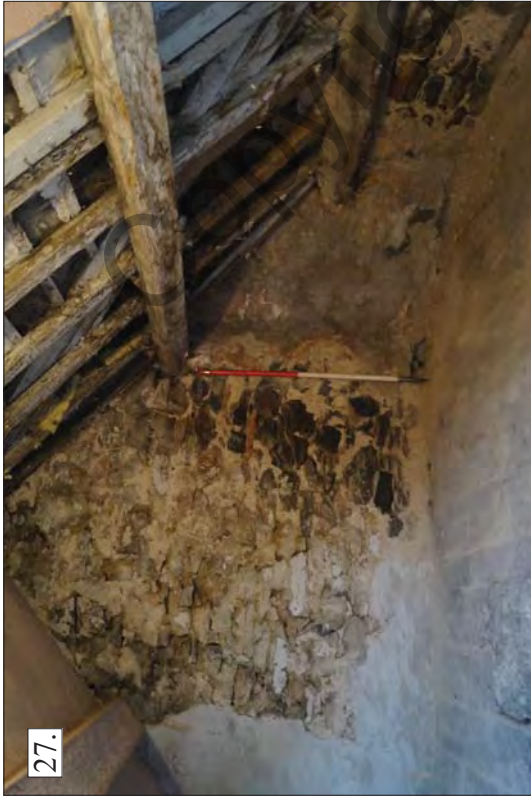
**Plate 27.** Gable (South-Eastern)  
Elevation Following Removal  
Of Plaster

There was a small area of the Town Wall tower identified in the south-eastern corner of the attic (plates 26 – 31). No architectural features were identified on this structure and the wall construction does not differ from that observed elsewhere around the wall circuit.

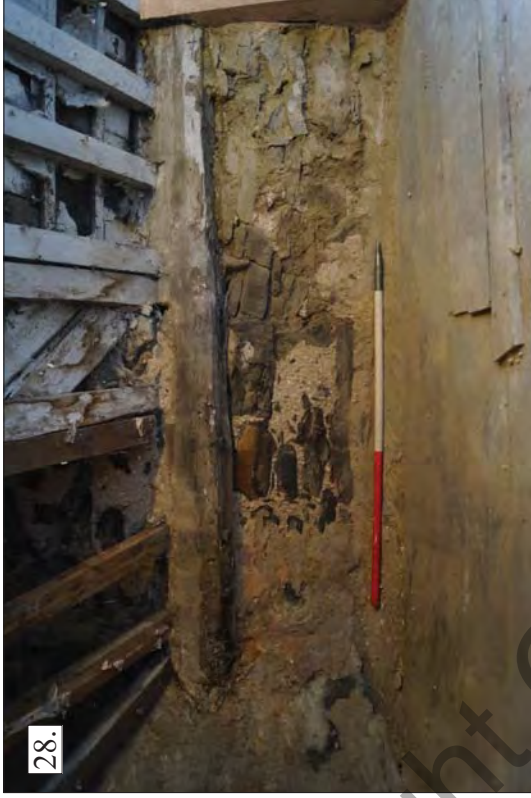
**Plate 28.** Rear (South- Western)  
Elevation Following the  
Removal of Plaster

There appears to have been some infilling in the rear elevation (see plate 28) and it is possible that there is a blocked fireplace here. There is a sky light in the rear elevation and although it may be an original opening the current window is not an original or particularly early feature.

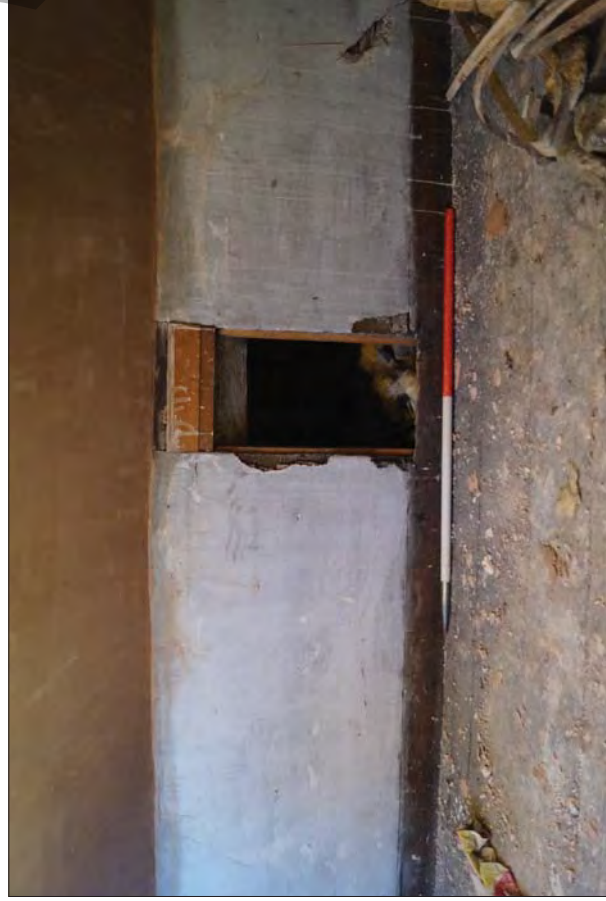
**Plate 34.** Attic Level Front (North-Eastern) Elevation

The attic is divided into two rooms by a wooden partition (plates 23-4). Lathe and plaster had been utilised to form low walls within the eaves of the roof structure on the front and rear elevations, other than the rear wall in the room against the Smallest House which was rendered stone. The space created under the eaves in the front elevation was likely to have been utilised for storage and could be accessed via an opening shown in plate 34. The lathe and plaster on the rear wall was almost flush against the stone.

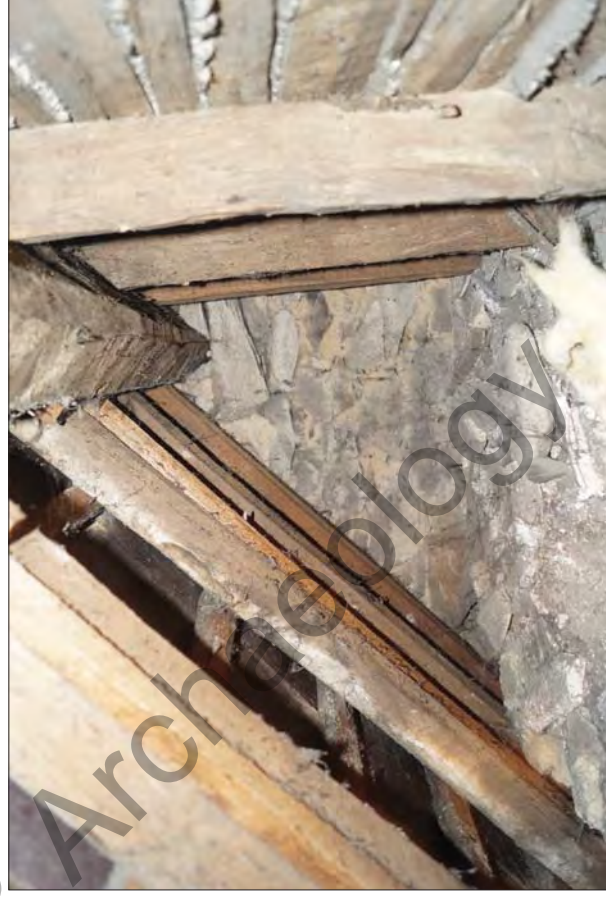
**Plate 35.** Attic Level Space Between Roof and  
Lath and Plaster Room Division

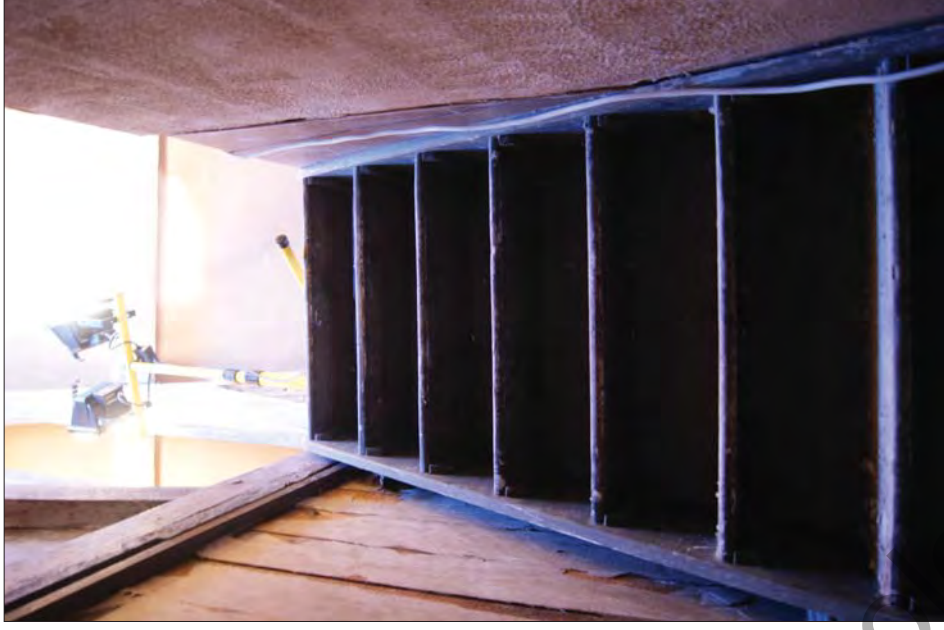
At first floor level the two rooms in the main building are connected by a narrow central corridor which also leads to the stairway to the attic. The two main rooms are in use as bedrooms and there is a bathroom in the rear extension. There is also surviving wooden panelling between the first floor and the attic (plate 38) although as is to be expected it is of much poorer quality than that used in the ground floor.

**Plate 38.** Continuation of Original Wooden  
Division Leading from First Floor to Attic
