Watching Brief Commissioned by The National Trust Wales

Hafod y Llan Hydro Scheme Watching Brief October 2013 EAS Client Report 2013/10

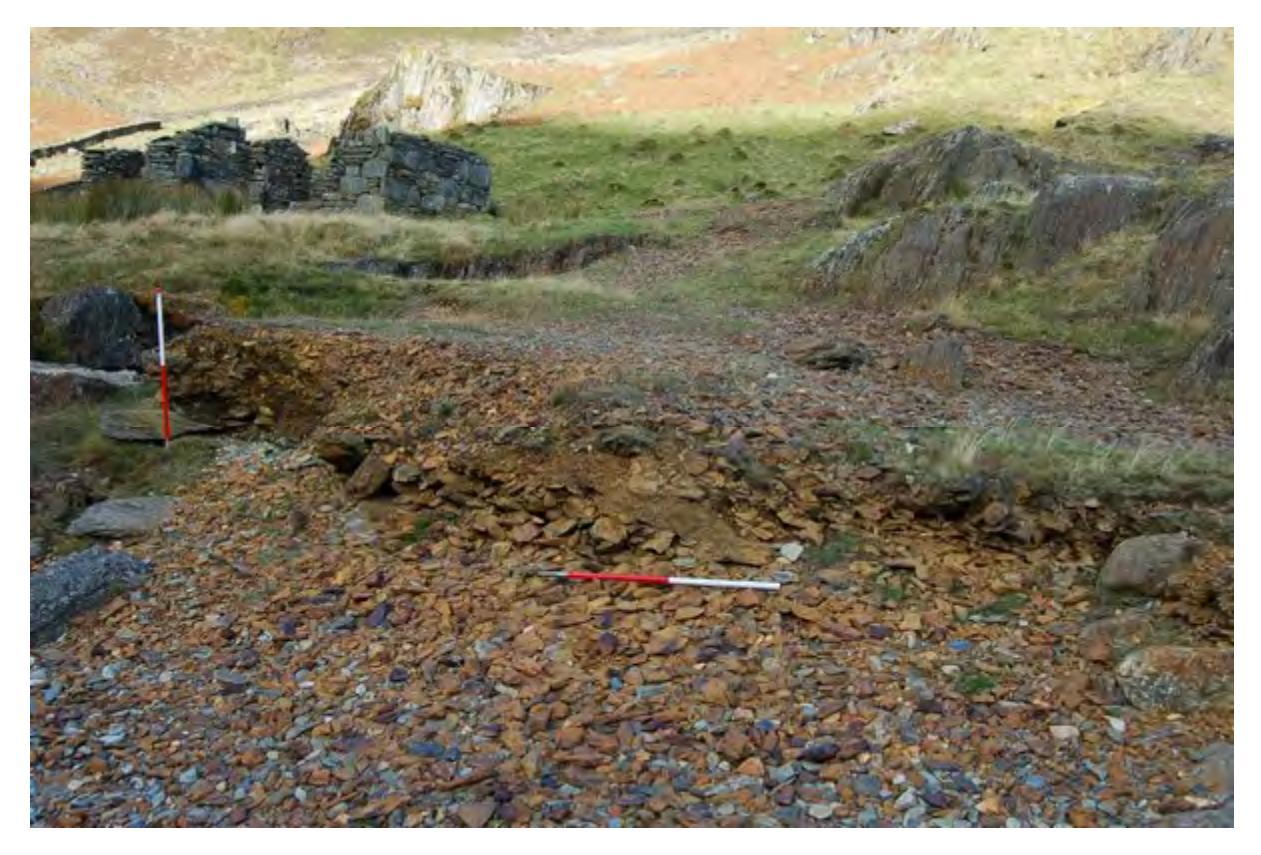
Plate 3: Copper waste alongside the Afon Cwm Llan (source K. Laws, taken October 2012)

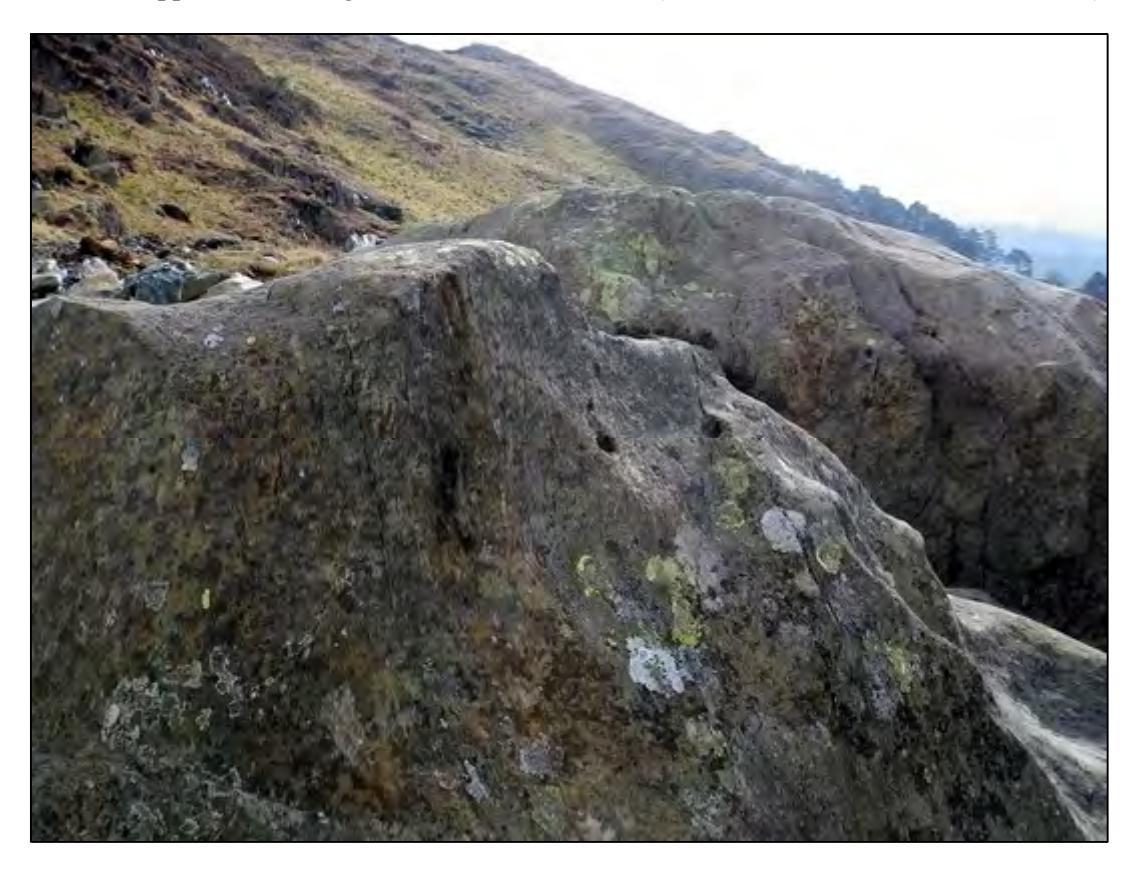
This north western end of the pipeline had the most potential for disturbing archaeological deposits. It was threaded through the remains of Hafod y Llan copper mill (NT PRN 44858), avoiding the major buildings, but running along the line of the tramway which fed the crusher. Before Engineering Archaeological Services Ltd were appointed K. Laws recorded the presence of dumps of crushed waste alongside the Afon Cwm Llan at the point where the dam was to be constructed (Plate 3). Adjacent to this point one of the rocks within the river bed of the Afon Cwm Llan has the remains of a series of iron fittings (Plate 4 - 6). It is not entirely clear as to the original function of these fittings. One interpretation is that they supported a bridge carrying a tramway from Braich-yr-oen Copper mine (Plate 7), however it is also possible that they were part of the support system for a leat providing the water supply to the Hafod y Llan copper mill.

Plate 4: Rock with iron fittings in the river bed of the Afon Cwm Llan

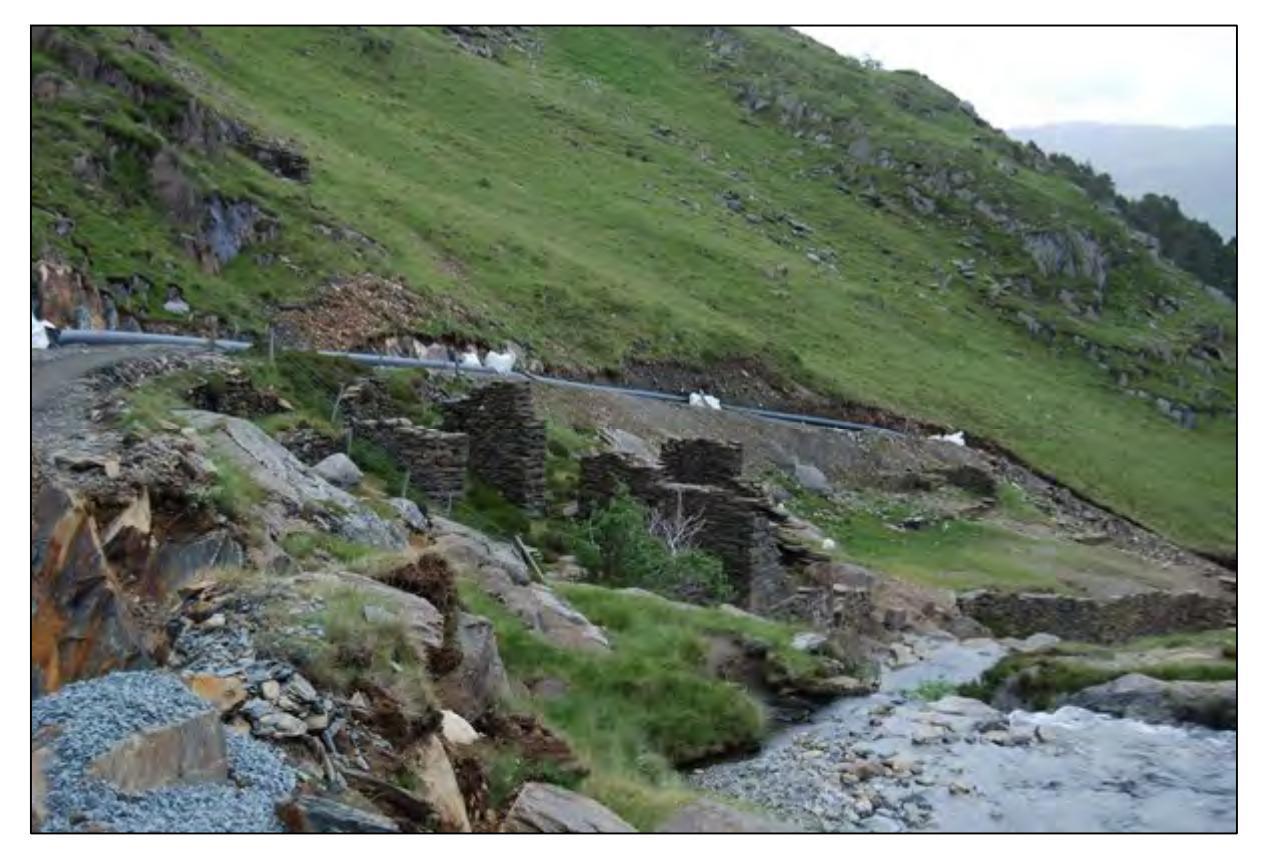
Plate 10: Hafod y Llan copper mill looking SE

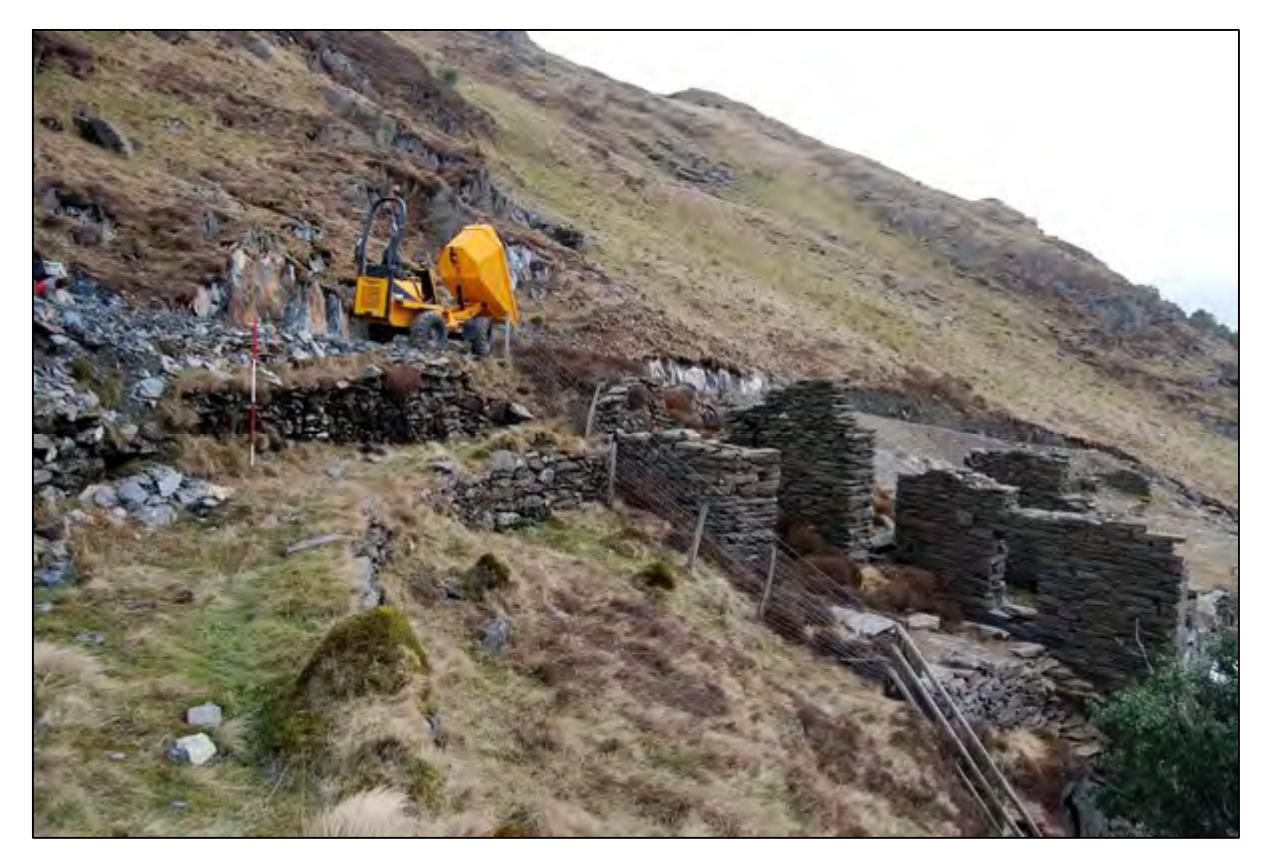
Whilst the Office building (NT PRN 44829) and an open shaft (NT PRN 44857) at SH 62130 52023 were protected during the course of the construction works, the space between the office and an adit (NT PRN 44857) at SH 62146 52023 was used as a temporary construction compound for storing materials and the turning vehicles causing disruption to this area. The main copper mill (NT PRN 44858, Plate 10) was also avoided with both the haul road and the pipeline skirting the eastern side of the buildings and associated platforms. However this required both of these to run along the line of the tramway (NT PRN 44856, Plate 11) which originally ran from the river crossing to the hoppers which fed the crusher within the copper mill. The tramway would appear to have been a two phase construction with a lower tramway being replace by a higher level route, presumably to allow ore to be tipped into the top of the ore bin. Both of these routes had dry stone revetting along their south western sides and were terraced into the hillside to the north and east. During construction, the surface of the upper tramway was buried with debris from pecking the rock so that the tramway could be widened to allow access by mechanical excavators to the dam site. The pipe trench was then dug through this debris (Plate 12). This trench was very shallow, such that the majority of the pipe was above the level of the trench. On reinstatement little attempt was made to follow the original contours of the tramway, however this resulted in the tramway being protected with the layer of spoil which also covered the pipe (Plate 13).

Plate 11: The tramway feeding the Hafod y Llan copper mill

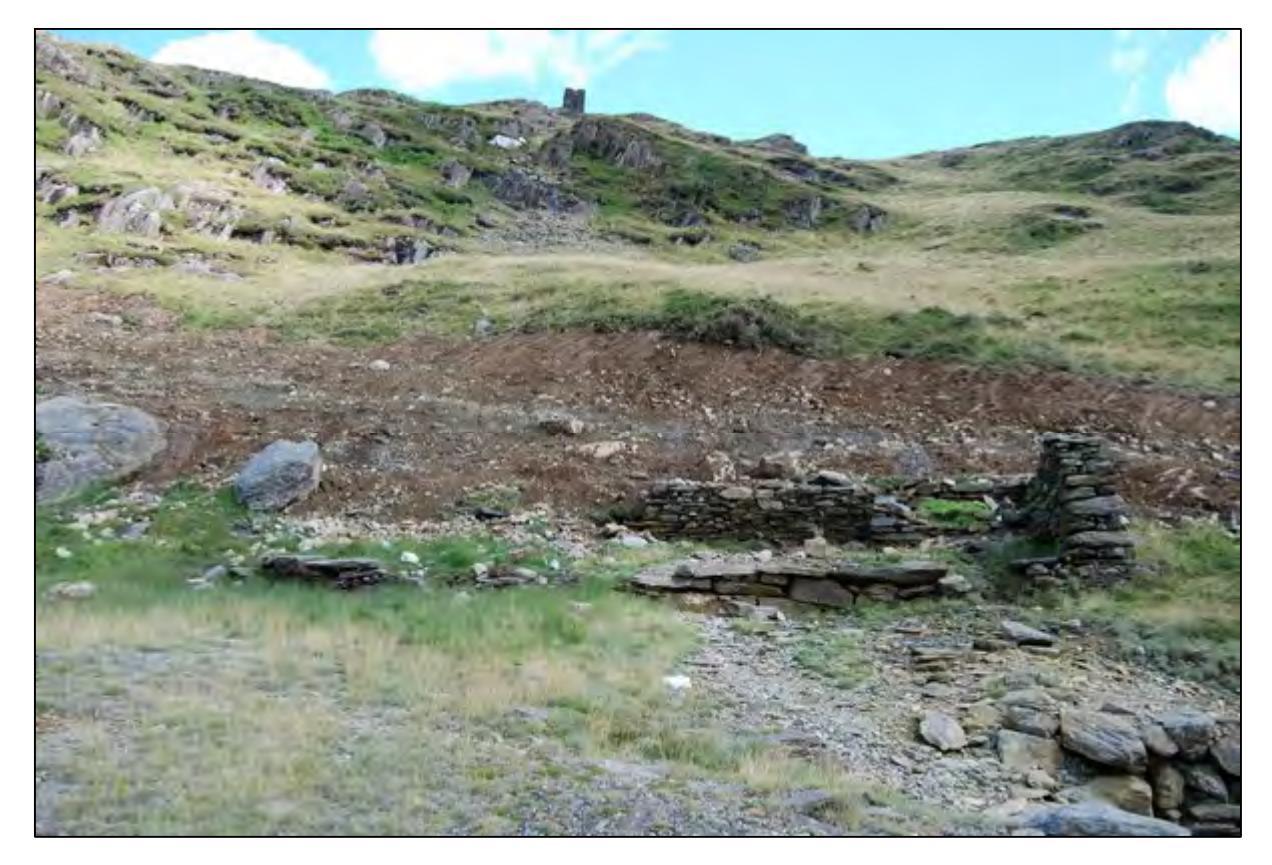
Between SH 62220 51982 and SH 62146 52023 the pipeline and the haul road cut through the tail of a large spoil heap (Plate 14). The digging of the haul road exposed a section approximately 32 m long and up to 2.2 m high of angular stone block in a matrix of dark brown clayey silt. Originally this spoil heap had a smooth profile with its tail resting against the rear wall of the building in the south eastern corner of the working platform associated with the copper mill. This building contained the presumed terminus for a cableway marked by a drum house on the skyline (Plate 15). It would seem likely that the build-up of spoil may be related to this method of transporting ore from the mountainside and Hafod v Llan mine itself to the works. Other possible interpretations are that the spoil heap may be the result of the dumping of the excess spoil from the creation of the working platform or the remains of a denuded incline feeding the copper mill from the mine high on the hillside.

Plate 15: Relationship of the spoil heap to the copper works and drum house in the landscape (after reinstatement)

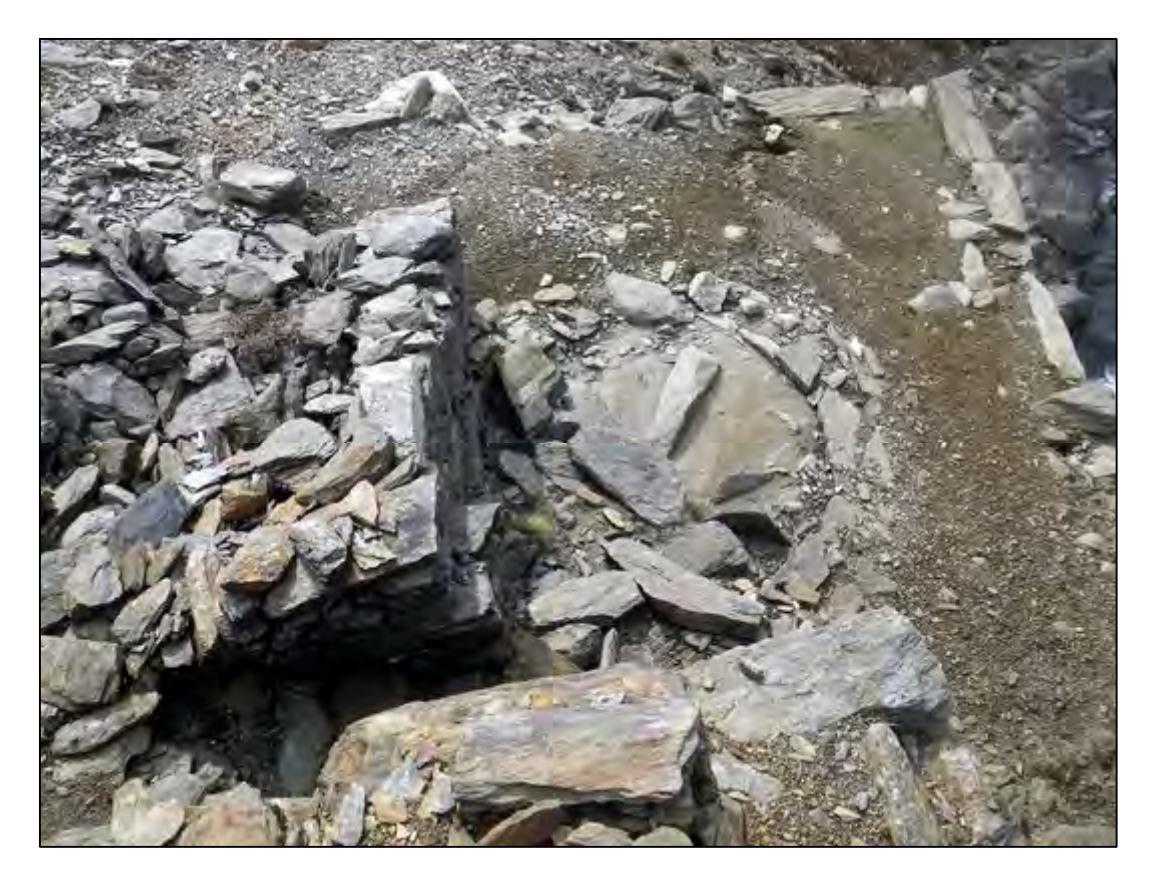
The construction of the haul road required the inclusion of drains in order to keep the road dry. Unfortunately these drains had their outfalls on the downhill side onto the working platform and waste tips associated with the copper mill. Some attempts were made to disperse the water by the use of straw bale filters, however some damage was done to the site by erosion. This was particularly noticeable within the waste tips to the south east of the working platform (Plate 16) where the fine deposits probably derived from the buddle (Plate 17) were remobilised. Also at the bottom of this slope the deposits were disturbed by turning a vehicle around leaving tracks across the deposits.

Plate 17: The possible buddle.

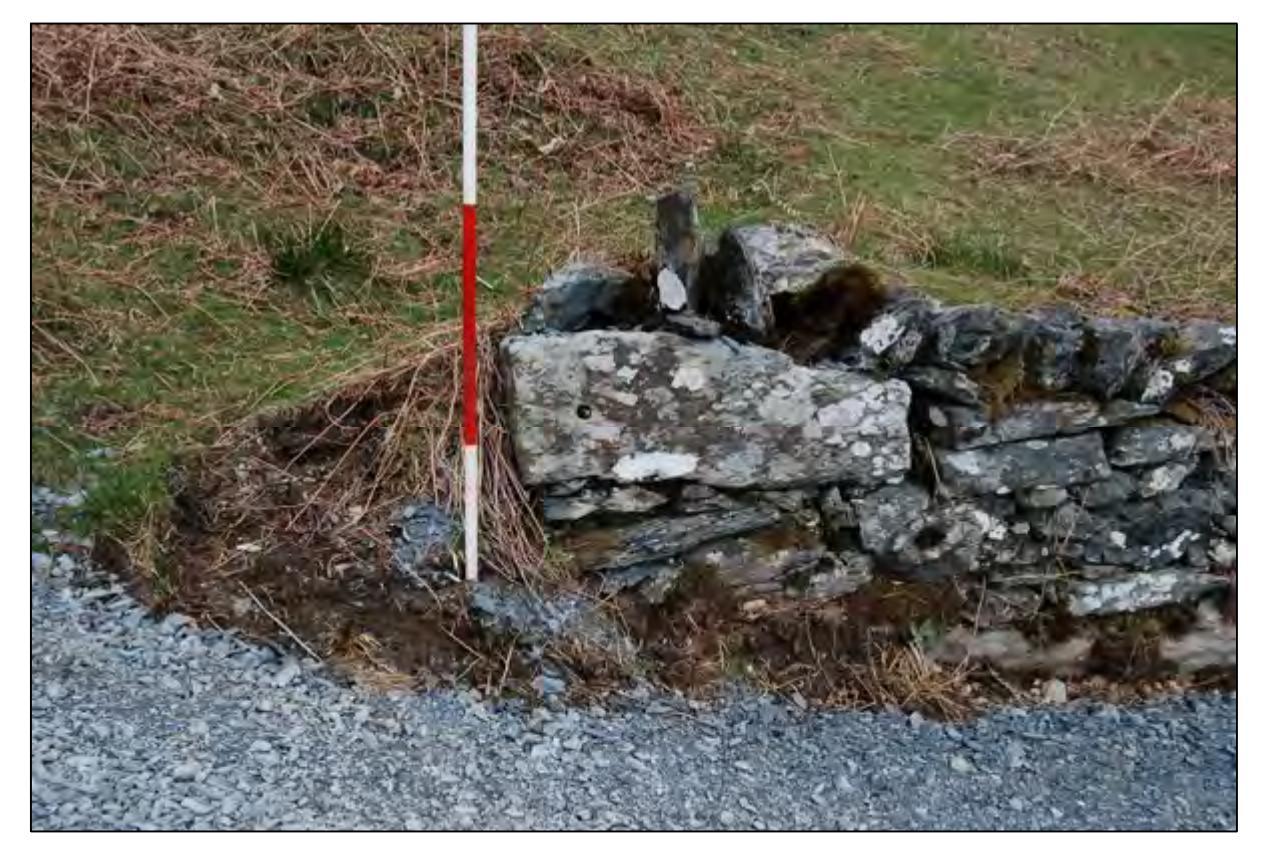
9). The size and preservation of these walls may suggest a possible nineteenth century date, they appear on the First Edition Ordnance Survey map published in 1889, however they are well built and are maintained suggesting they may be relatively late in the development of the landscape. Wall 3 (Plate 21) was recorded as NT PRN 45864 (Cooke and Evans 2011, 8). Surviving only up to 1 m high in places this wall differs from Walls 1 and 2 in that it is constructed of rounded stone boulders and is much less well preserved. It is somewhat intermittent, but tends to be better preserved to the south of the haul road where it is also pierced by one of the ditches from the peat cutting area to the west (see below). Wall 4 (Plate 22), (NT PRN 45863, Cooke and Evans 2011, 7) revetted the high side of the track way (NT PRN 45862) running from the river crossing of the Afon Cwm Llan. Only 0.7 m high, the wall has a break in its length at SH 62789 51442 which was probably a gateway. On the eastern side of this gap one of the stone block has a drilled hole in its surface. Whilst this may be a result of the quarrying process it is more likely that this hole was part of a "gate" or other means of blocking this gap.

Plate 22: Wall 4

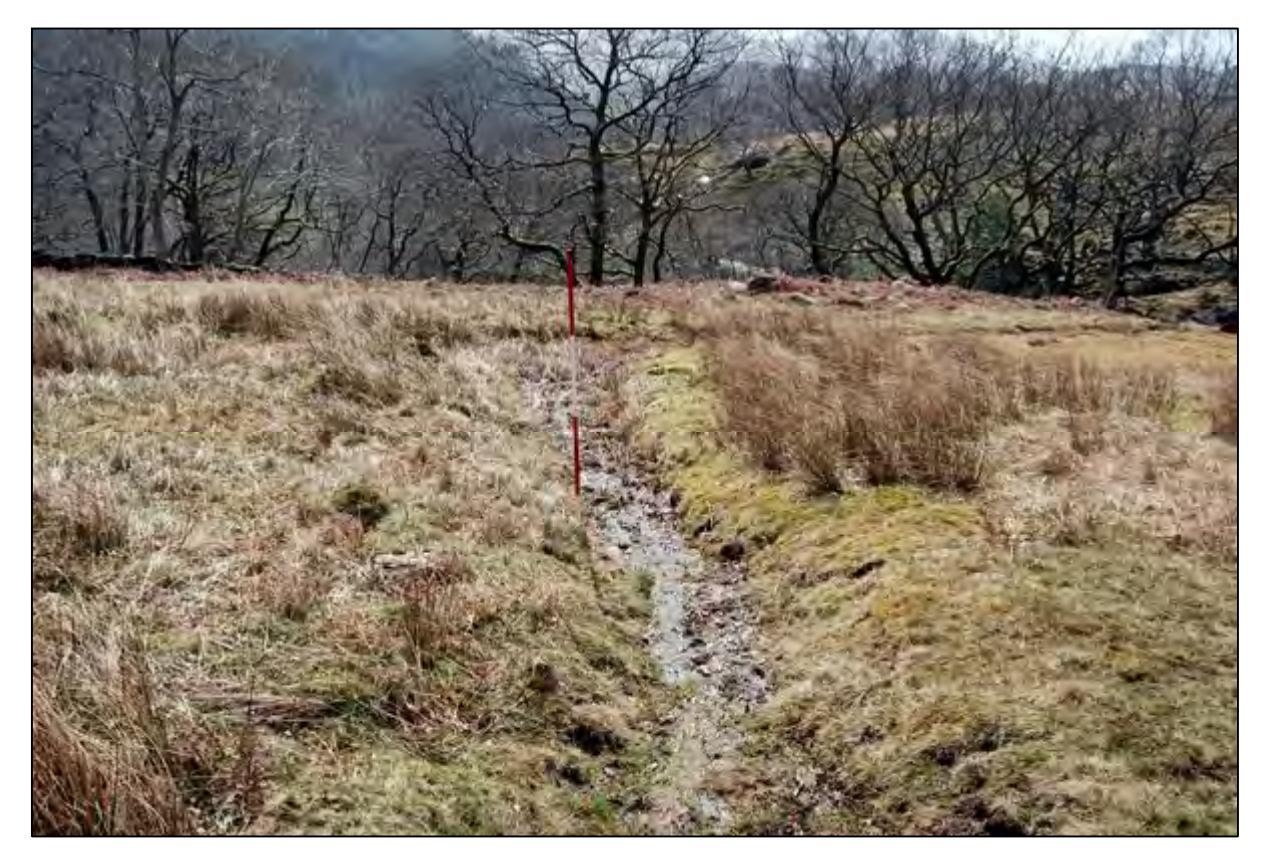
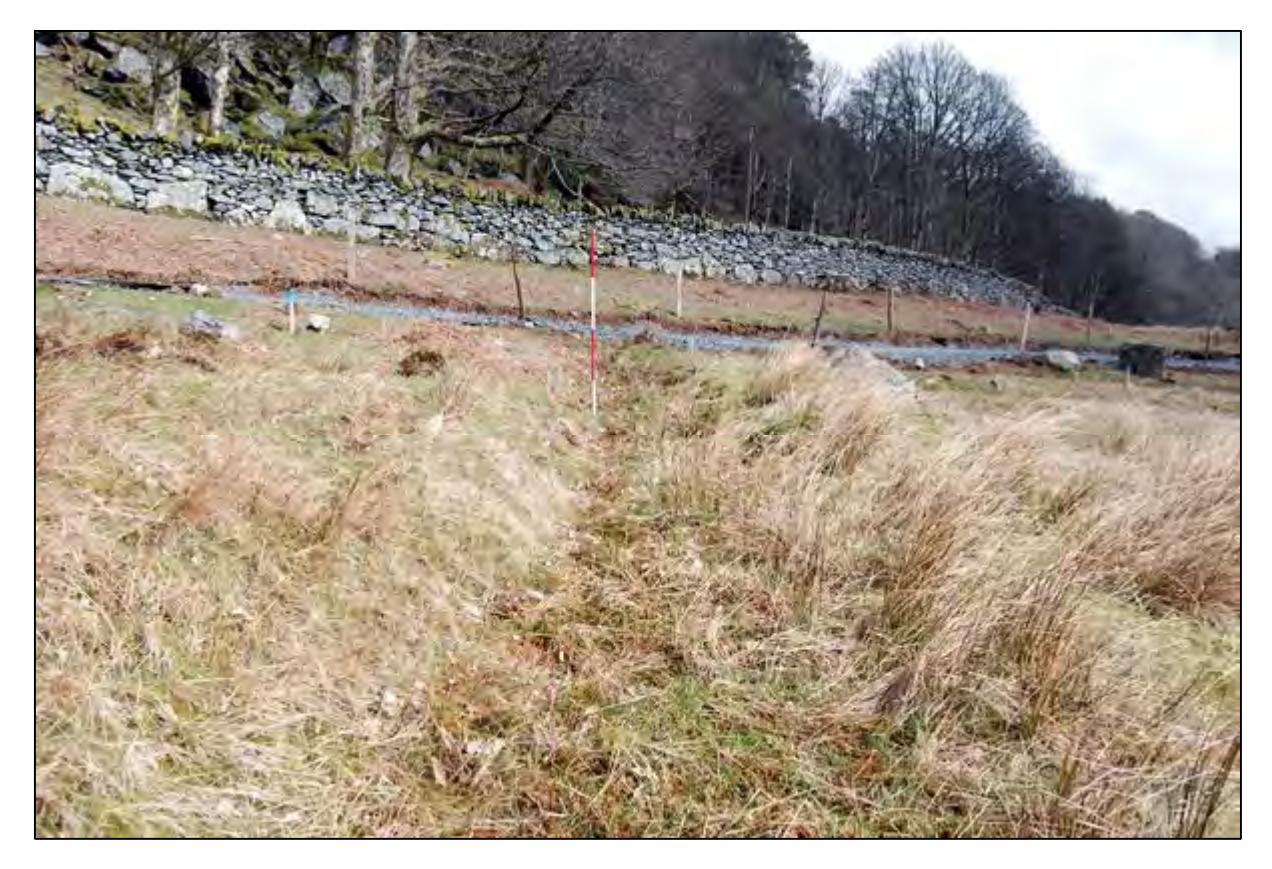
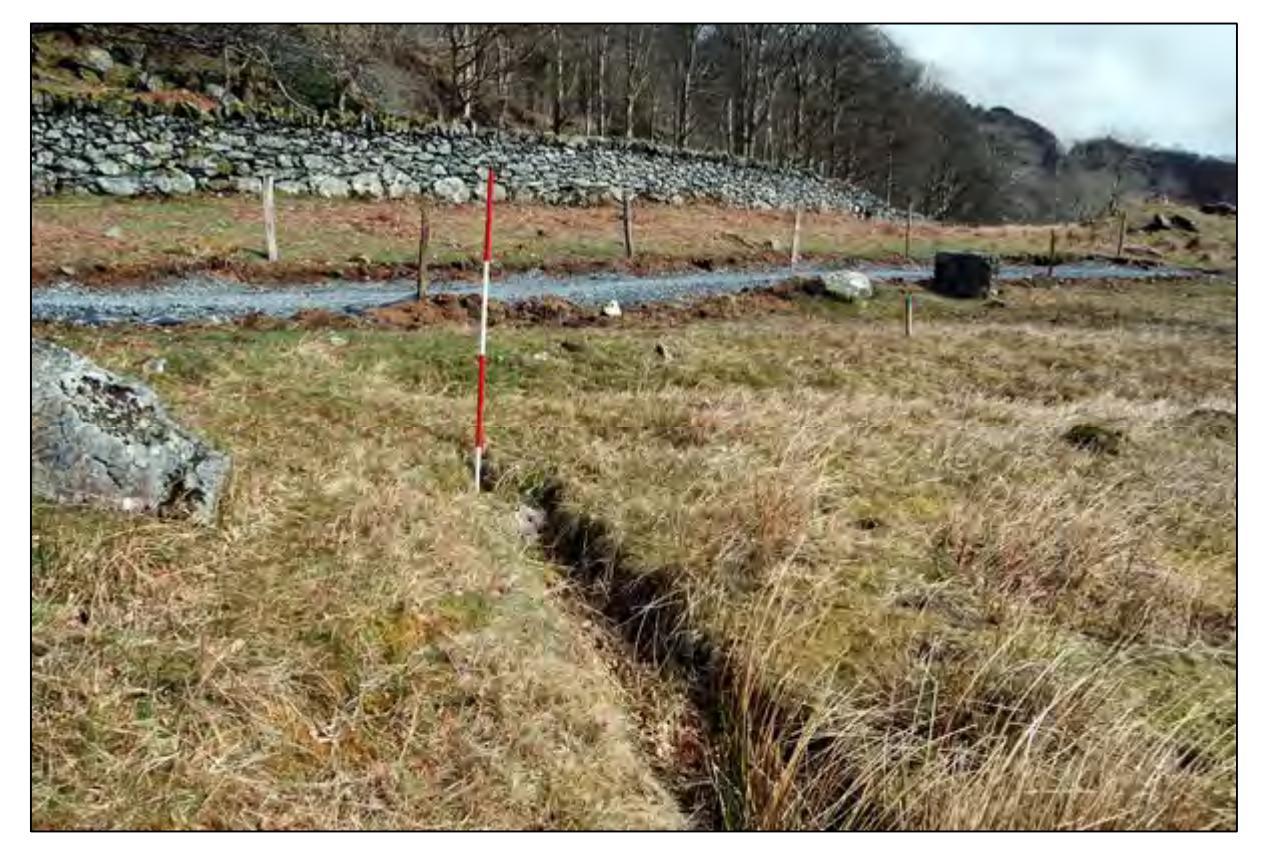
Slightly to the west of Wall 4 is an area of peat cutting (Plate 23) that was not recognised in the initial surveys of the pipeline. Extending over an area of 45 x 65 m there are a network of drainage ditches (Figure 4) cutting across an area of soft sediments (Plate 23). Each of the ditches (Plates 24-26) was up to 1.2 m wide and 0.4 m deep. They were cut through a layer of degraded peat up to 0.4 m thick (Context 1) which formed slight hummocks between each of the ditches (Plate 27). This layer sealed a layer of angular stones in a grey, slightly sandy, clay matrix up to 0.2 m thick (Context 2) which appear to be water lain, possibly an out wash layer. This in turn sealed a layer of amorphous peat up to 0.5 m thick (Context 3). These layers would suggest there has been at least two phases of peat cutting on the site. The top of Context 3 appears to have been truncated, however there was then a period of run off depositing Context 2 over the area. This period must have included considerable water flow with an area of exposed gravels above the area of the peat cutting. Peat, or at least organic rich soils, then regenerated on the site and it was these deposits which were

Plate 24: Drainage ditch within the area of peat cutting

Plate 25: Drainage ditch within the area of peat cutting

Plate 26: Drainage ditches within the area of peat cutting

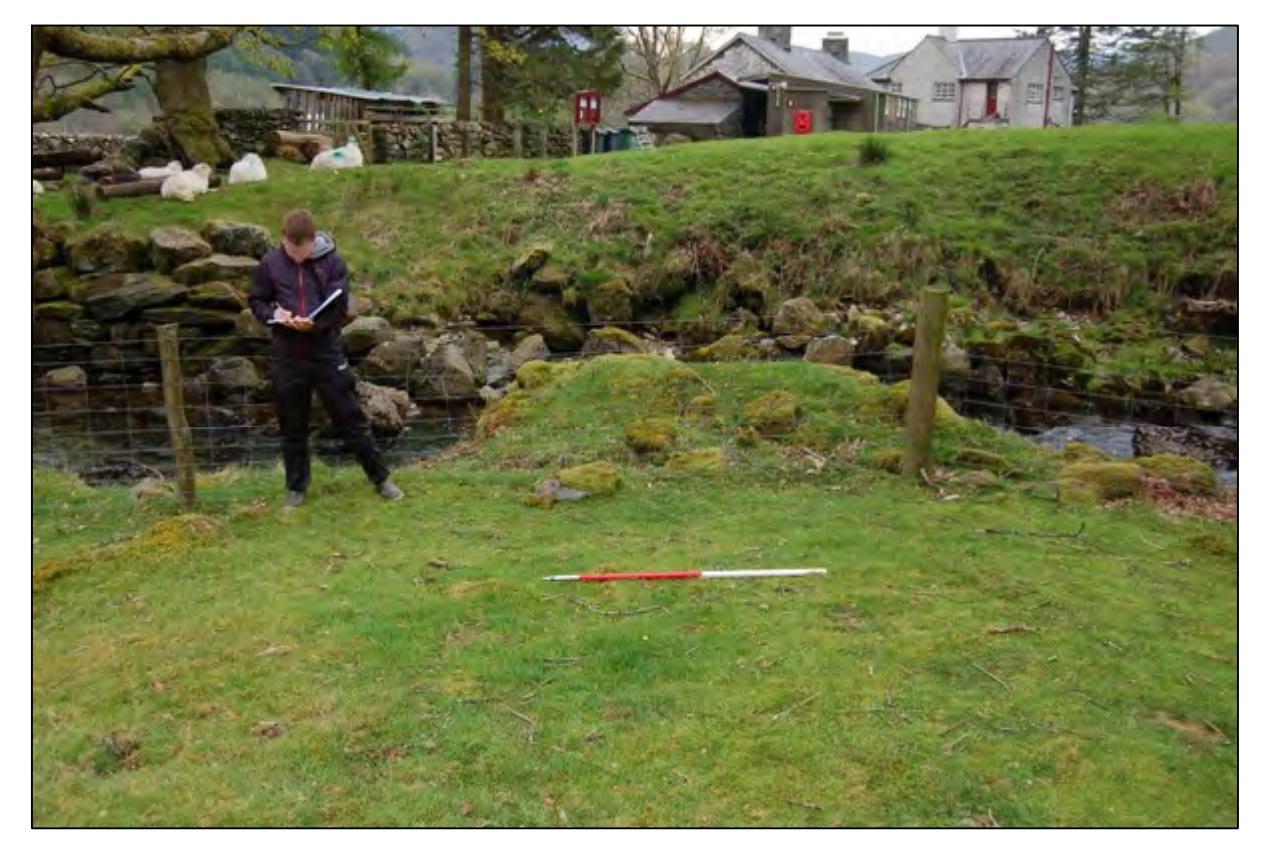
The location of the excavations for the turbine house were of some archaeological interest given their proximity to the bridge abutment located by K. Laws in her site visit of May 2012 (Plate 28). No signs of a formal track way leading from the bridge abutment was located, however, the pipe trench leading into the north western side of the turbine house was dug and backfilled without archaeological monitoring. The excavation for the Turbine House, however did give an opportunity to inspect the Pleistocene deposits in this part of the valley. There would appear to be a mixture of till and outwash gravels within the sections (Appendix 1, Plate 29). Given the large size of the water worn boulders within these deposits (up to $1.5 \ge 1.5 \ge 1.5 = 1.5$ relatively high energy regime occurred to move the stones whilst the clays associated with the till would suggest a much quieter period of deposition.

Plate 28: Bridge abutment (Source K. Laws, taken May 2012)
