**Porth Mawr, Caernarfon
Archaeological Assessment**

EAS Client report 2017/01

Porth Mawr, Caernarfon
Archaeological Assessment
Commissioned by
Donald Insall Associated for Cadw

Grid Reference:	SH 47901 62823
Listed Building No.	3869
Scheduled Monument reference number	CN034
NPRN	302416
PRN	3098

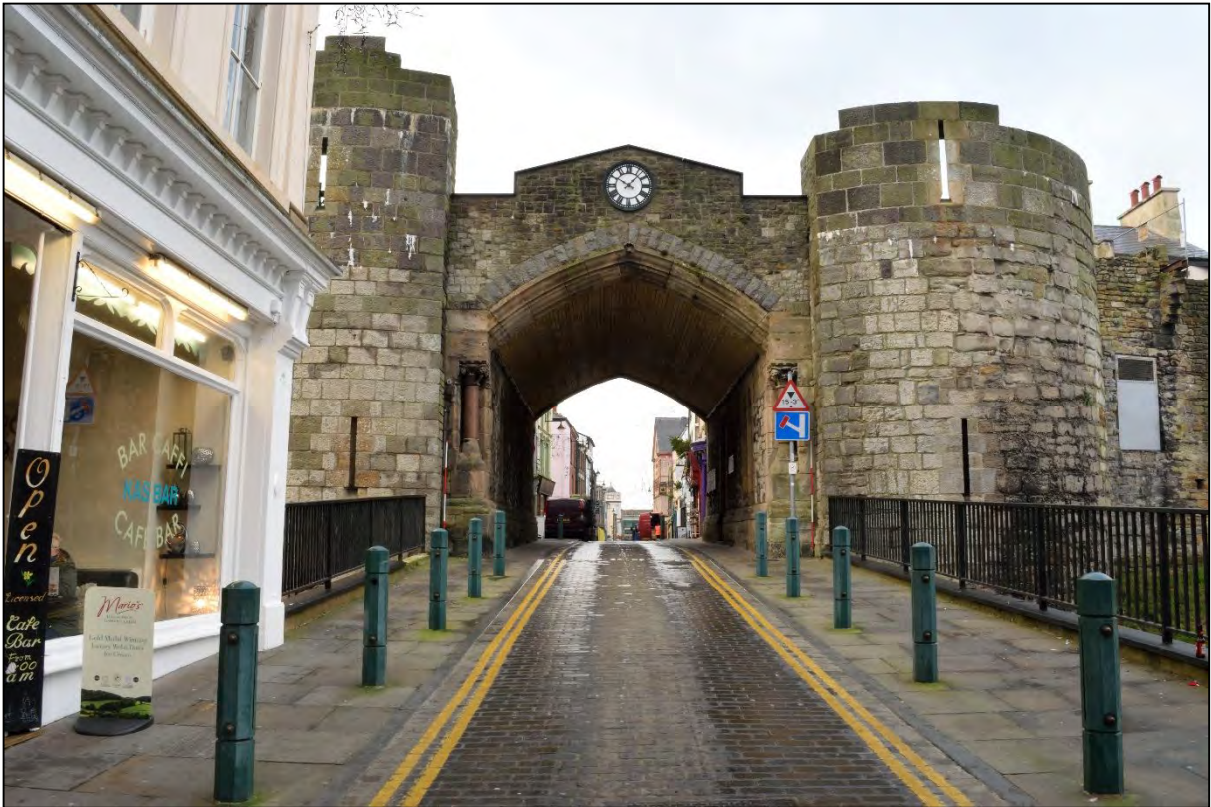
Plate 1: The Eastern approach

To the east (Plate 1, Figure 3), the gateway is approached over a bridge over Greengate Street/Cei Banc and has “D” shaped towers flanking the entrance passage. The northern tower (Plate 2) has a facing of fossil rich limestone and has two arrow slit openings facing. These openings have been restored with new surrounding blocks. A similar pattern is also recorded in the façade of the northern tower (Plate 3). Both of the towers extend down to the ground level of Greengate Street/Cei Banc, however the flanking town walls sit on top of a bank approximately 5.4 m high. Between these two towers is the bridge linking the gatehouse to Crown Street/Mill Lane (Plate 4). This has flanking walls defining the abutment (Plate 5) below the gate passageway.

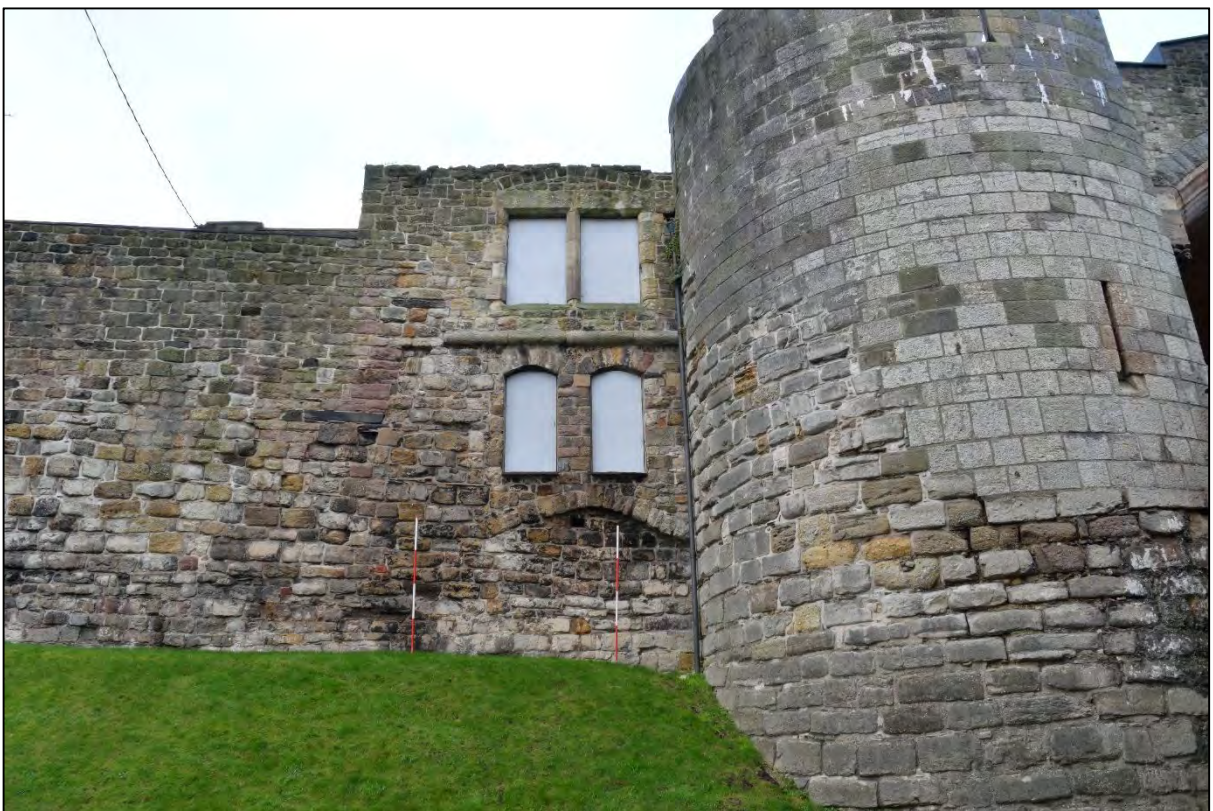
Plate 6: Eastern elevation of 3 Hole in the Wall Street

To the south the curtain wall of the town has been modified within the curtilage of 3 Hole in the Wall Street (Plate 6). There is a relieving arch at a height of 3.67 m above the current ground level, which probably related to the construction of buildings along the outside of the walls. Above this is two, arch topped windows with slate sills and segmented window heads. These are surmounted by a moulded string course with a “D” shaped profile. Above the string course is a two-pained widow with a stone mullion and stone lintels and sill. Above the lintel is a depressed relieving arch. These features appear to be in a re-built section of the town wall, presumably relating to the insertion of the windows. The slight pink staining to the south of the windows is probably related to heat damage from the fireplaces of the now lost buildings built in front of the wall.

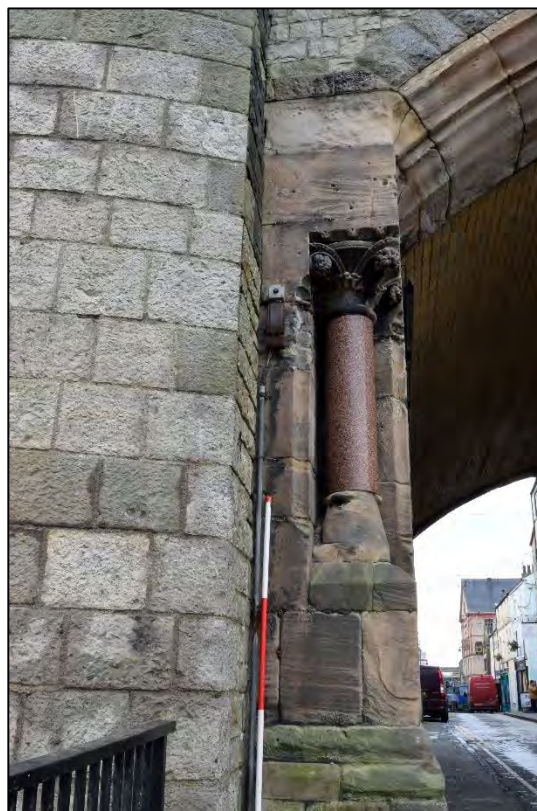
Plate 8: Decorative column on the south side of the entrance passage

The entrance passage is flanked by short decorative columns each of which are inset with, half-height shafts of polished pink granite, (Plate 8) drum bases and capitals decorated with foliage. The bases and capitals are of limestone. The columns sits within a façade of sandstone blocks which rises into a segmental moulded arch with a course of granite blocks above. Above these blocks is a coped parapet, with raised gabled central portion containing a clock face (Plate 11). The ceiling of the passageway consists of yellow bricks (Plate 12) arranged in a “English Garden Wall” bond (Plate 13) with four rows of stretcher bricks separated by a single row of headers. Bricks of this colour are likely to have been made in the local Sieont Brick Company, however similar coloured brick have also been recorded at the disused hospital building of Bryn Sieont which were made at the Aston Brick Company in Flintshire (Brooks forthcoming).

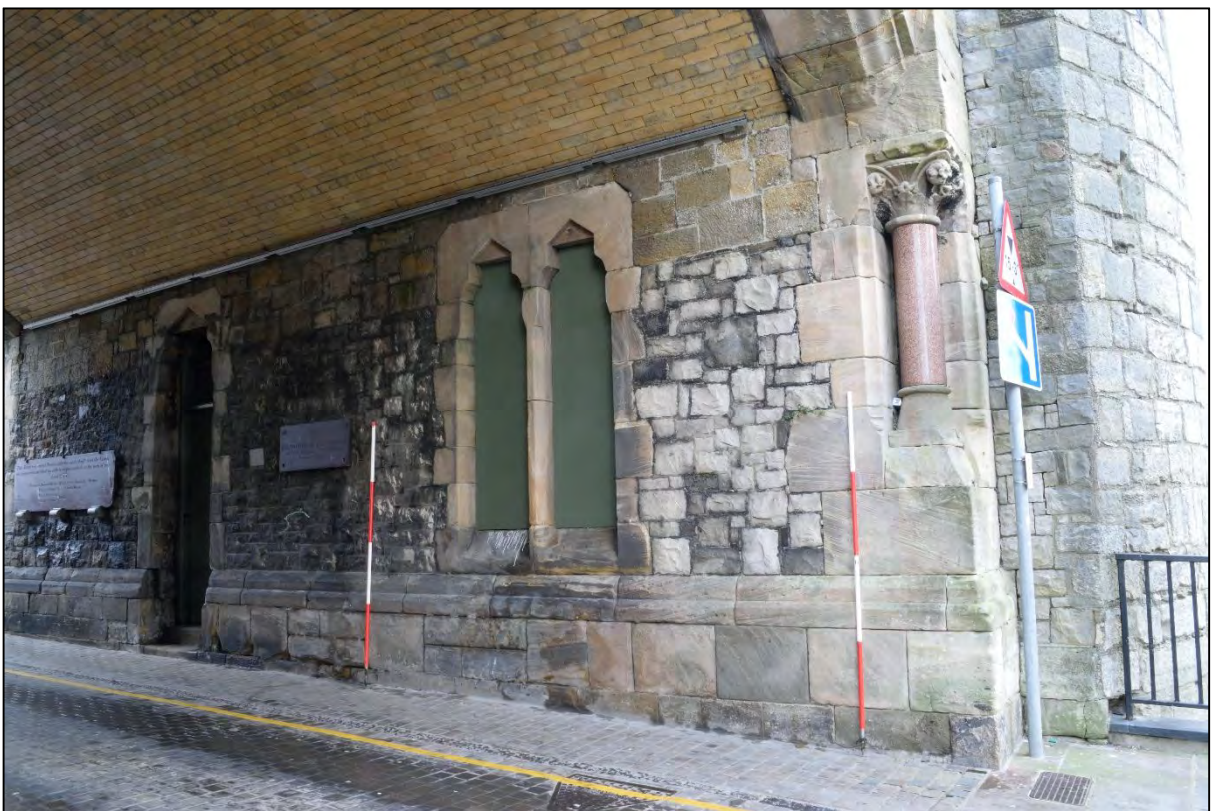
Plate 14: The northern side of the passageway

The northern elevation of the passageway (Plate 14, Figure 5) has a plinth of dressed sandstone blocks over which the walling is of random, squared limestone. At the top of the wall is a band of sandstone blocks arranged in a random pattern, with some rough rustication on their surfaces. There is a double window towards the eastern end of the wall (Plate 15), above the plinth. Both opening have Caernarvon arches and are separated by a chamfered,

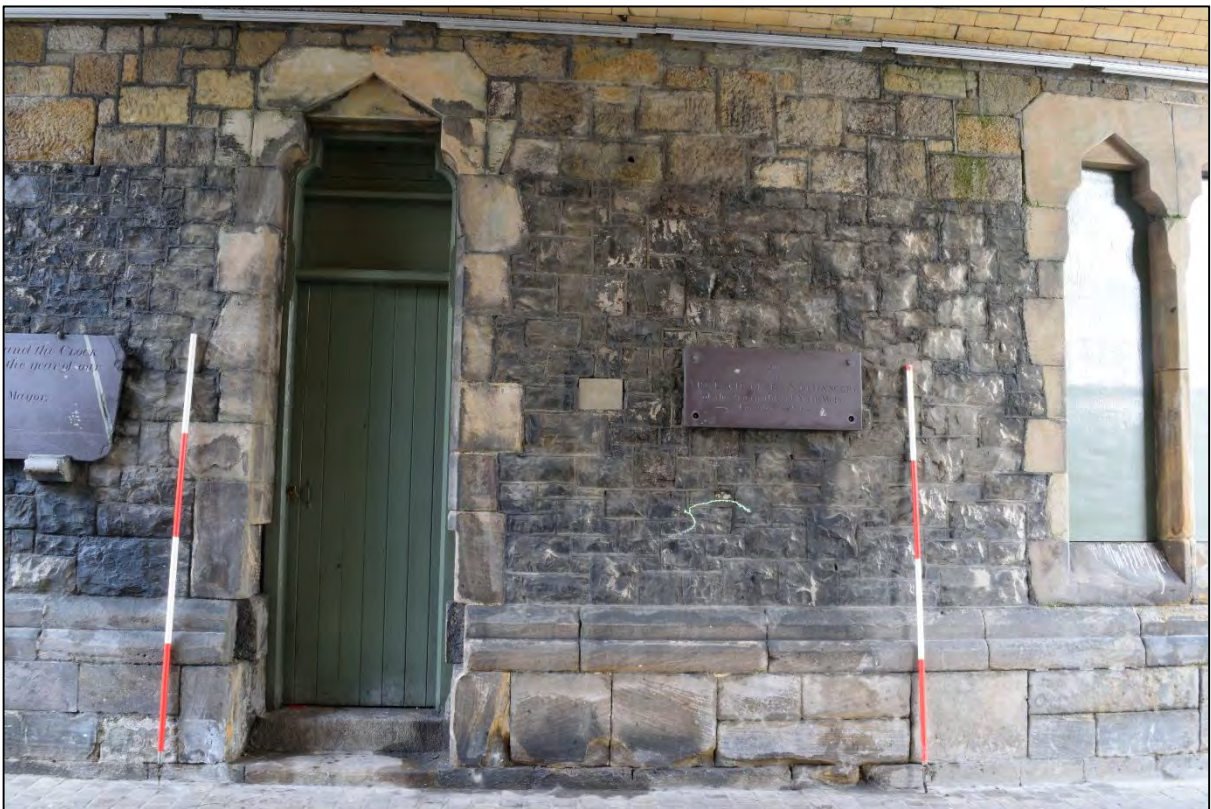
Plate 16: Door in the northern elevation of the passageway

sandstone, mullion and dressed sandstone jambs and quoins. More centrally placed is a doorway (Plate 16), also with a Caernarvon arch over and sandstone jambs and quoins. It is likely that this was originally a window which has been modified into a doorway at a later date. Either side of the doorway are slate plaques attached to the wall. That to the east (Plate 17) includes the inscription:

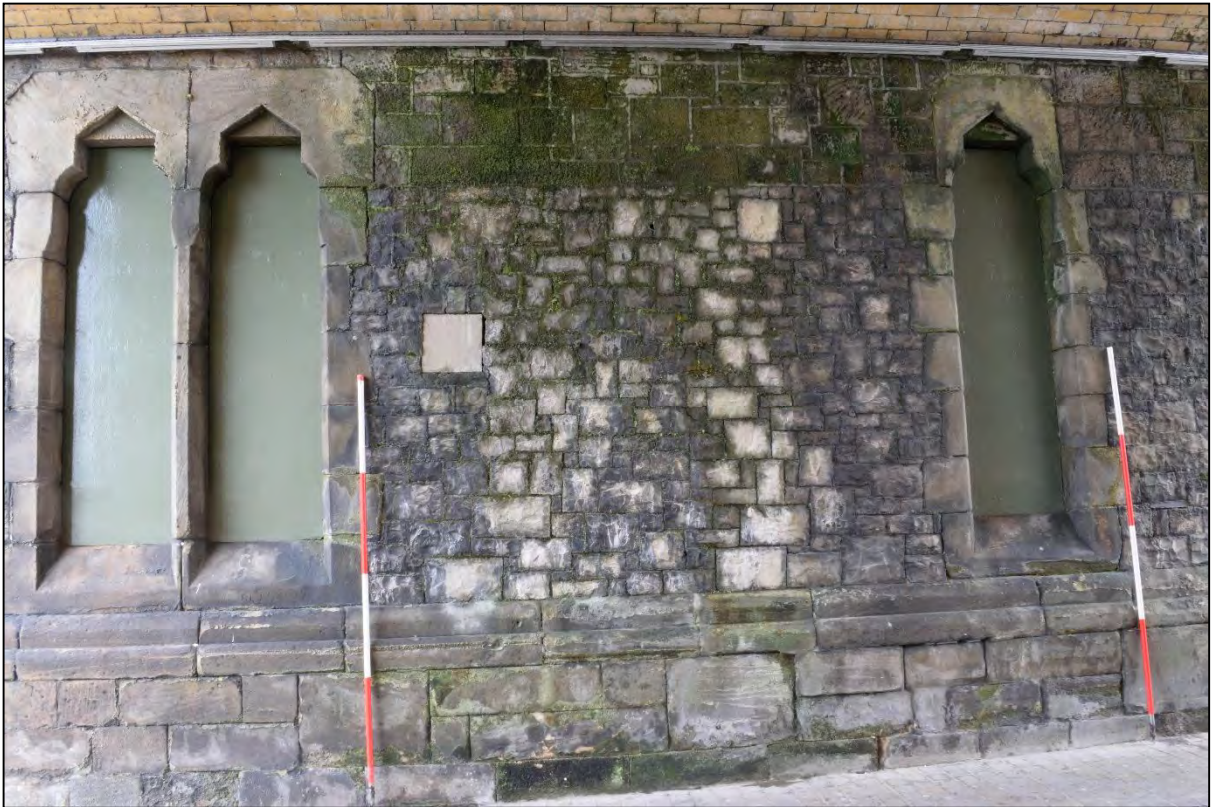
The southern elevation of the passageway mirrors that on the northern side (Plate 19, Figure 6), however there are no slate plaques and the single window has not been converted into a door.

Plate 19: Windows in the south face of the passageway

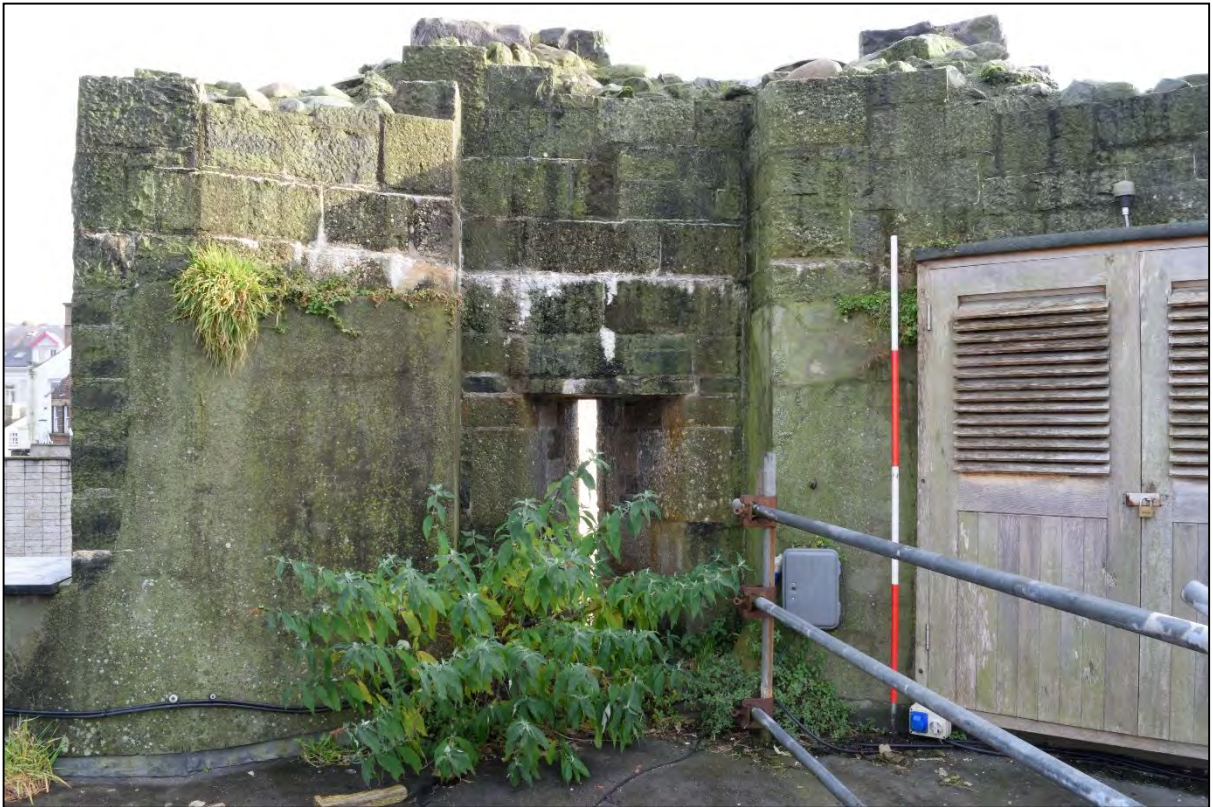
this cabinet is the remains of an arrow slot which is part of structure of the bastion (Plate 33). Similar arrow slots are also to be found in the north east (Plate 34) and south west (Plate 35) areas of the gatehouse roof. On the northern side of the gatehouse the brick parapet hides a chimney stack (Plate 36) which runs down the northern side of the wall of the gatehouse suggesting the presence of an attached building immediately to the north.

Plate 33: Arrow slot in the south-eastern corner of the gatehouse roof

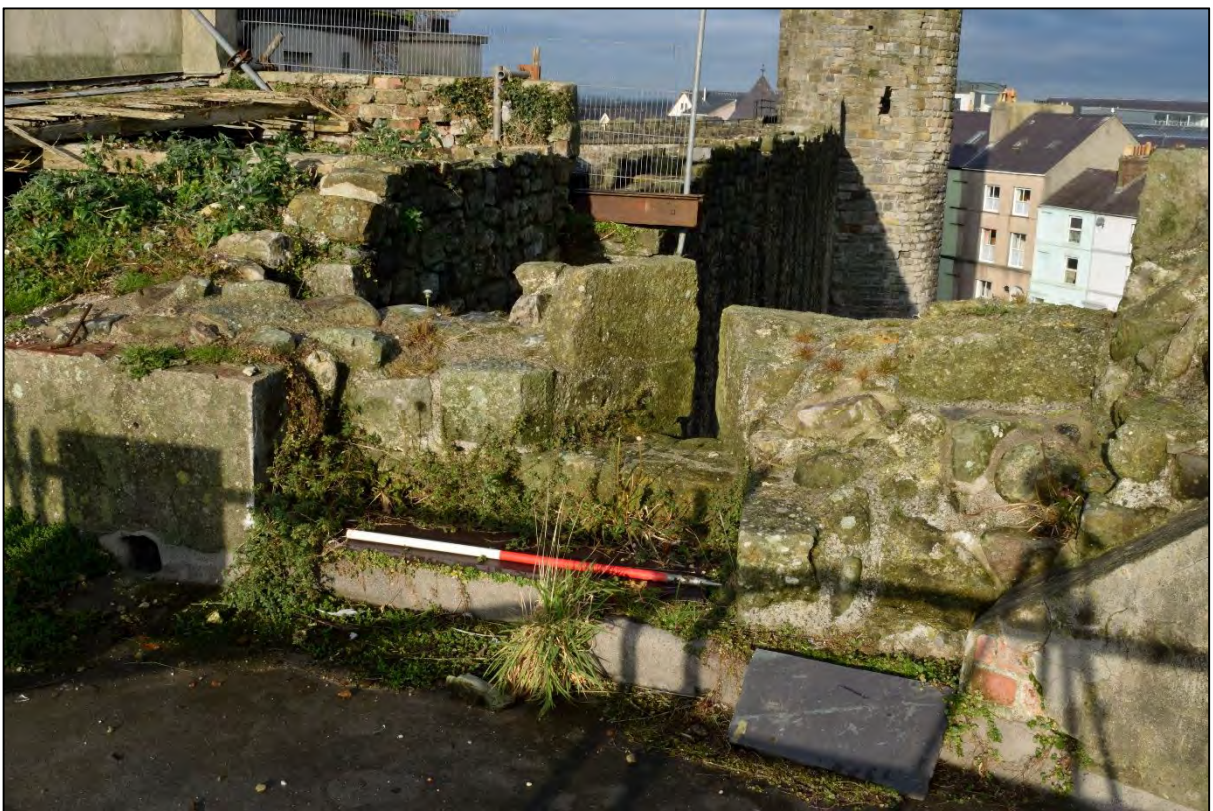
Plate 34: Arrow slot on the northern side of the gatehouse roof

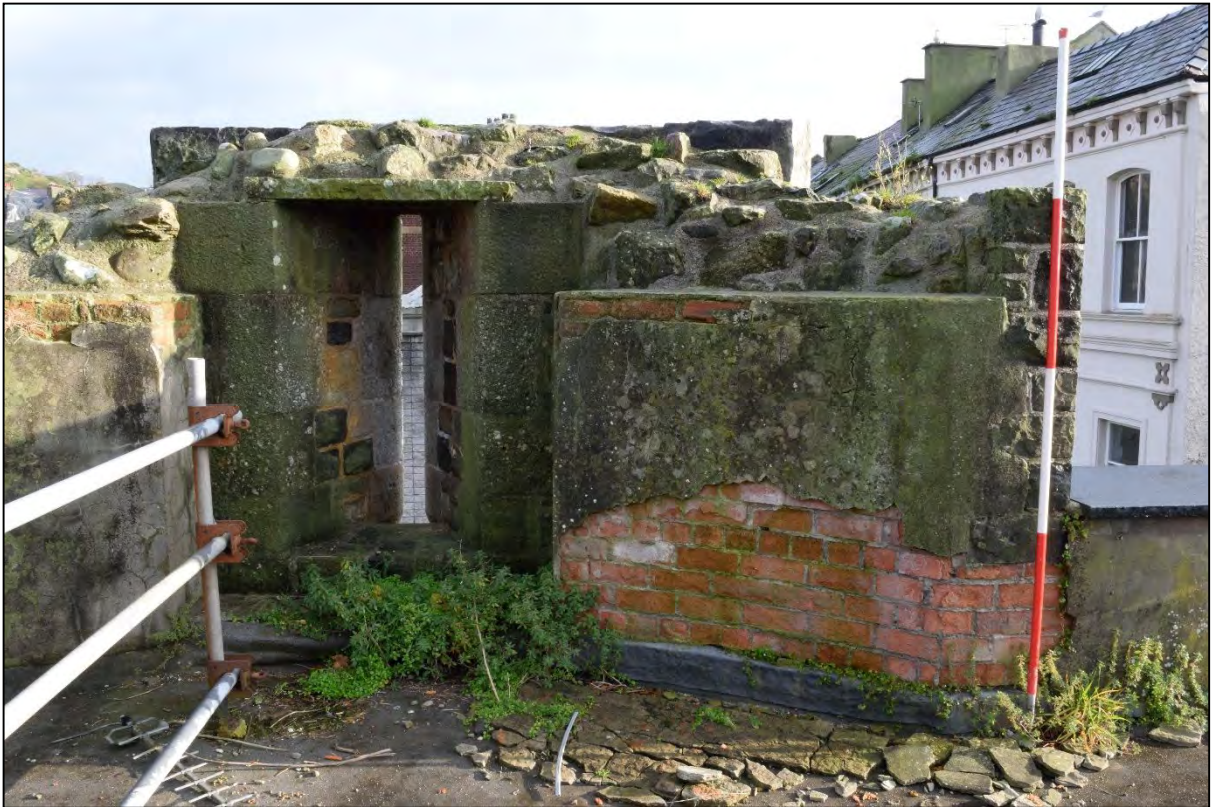
Plate 35: Arrow slot in the south-western corner of the gatehouse roof

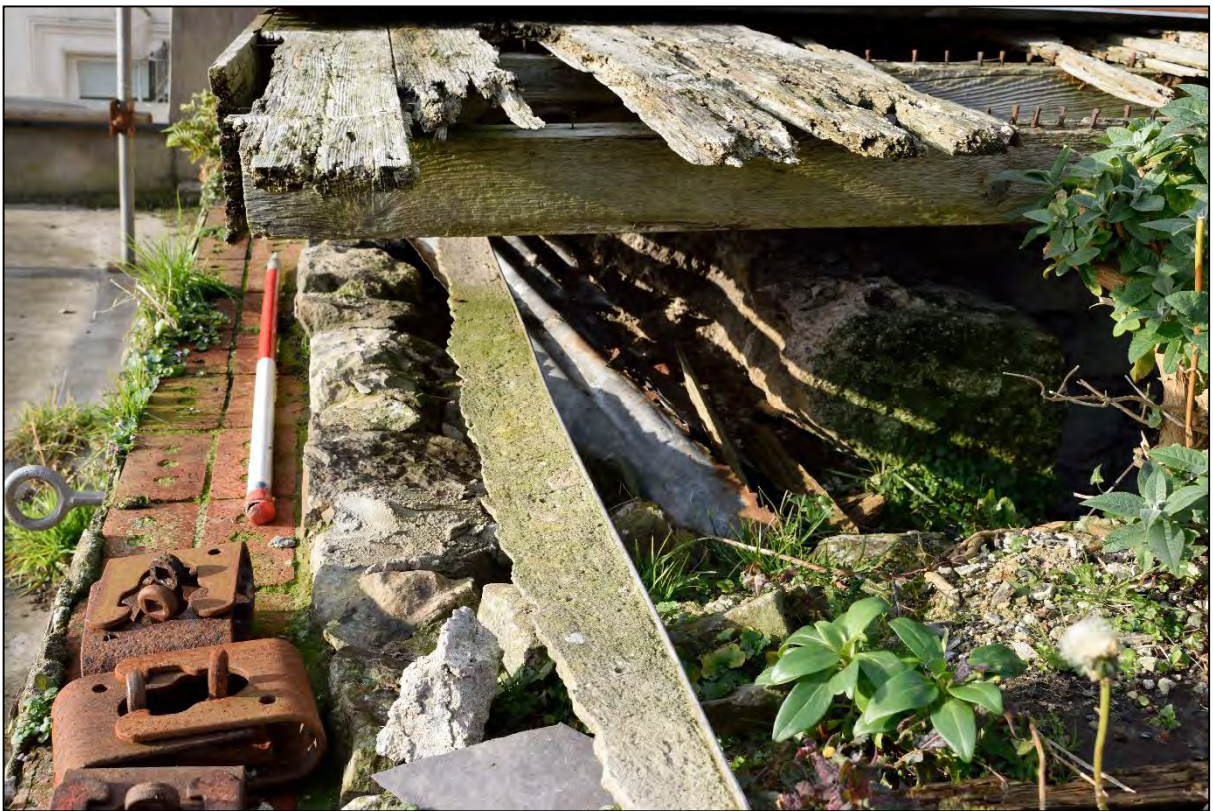
Plate 36: Chimney stack on the northern side of the gatehouse roof

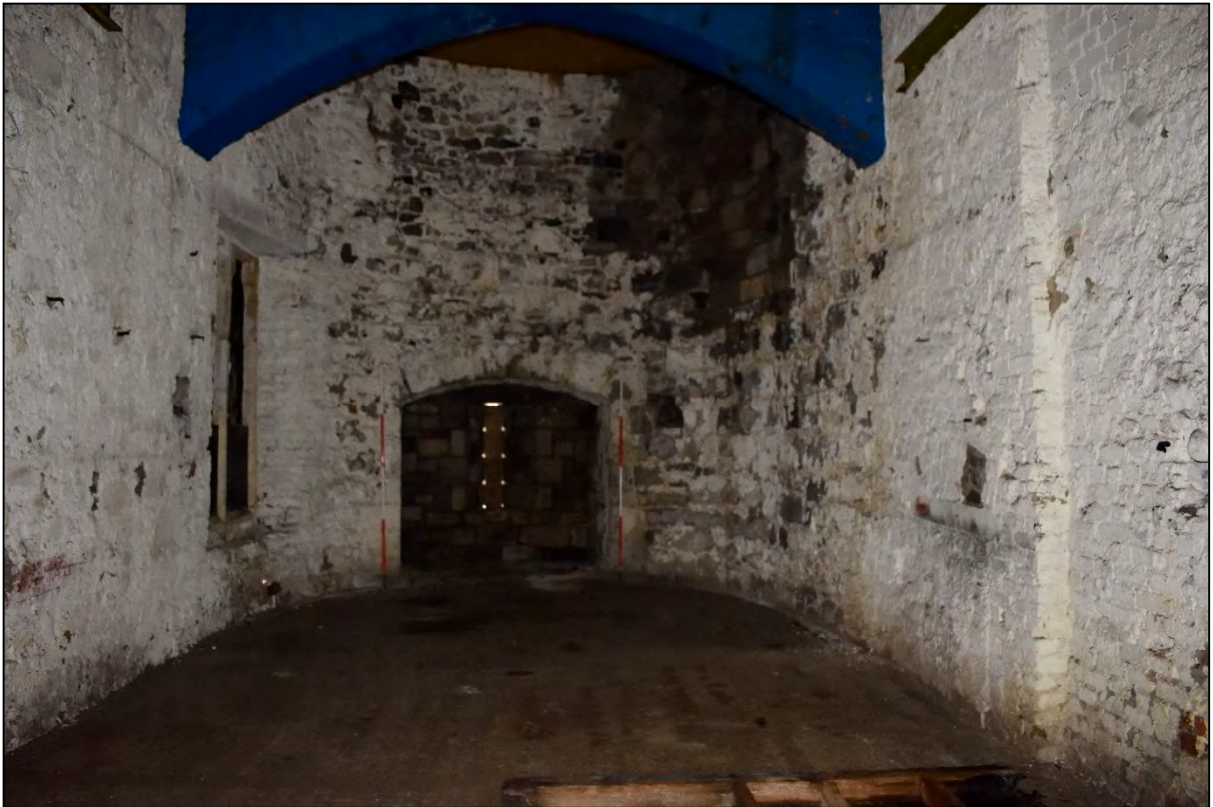
The southern gatehouse, itself, consists of a room with an apsidal eastern end (Plate 37) in which there is the embrasure for an arrow slot (Plate 38) This embrasure has been “restored” as has an area of the walling within the bastion, high on the southern side (Plate 39). Also adjacent to the embrasure, on the southern side, is a shaft within wall, approximately 0.4 m square which can be probed to a depth of 1.48 m. The function of this feature is unknown. Mid way along the southern wall of this chamber is a blocked opening, probably a fireplace, (Plate 40) which backs onto the blocked fireplace in the northern wall of 3 Hole in the Wall Street. The chimney breast for this feature also marks the change in the construction methods along this wall from relatively well coursed blocks to smaller rubble construction.

Plate 37: Southern gatehouse looking east

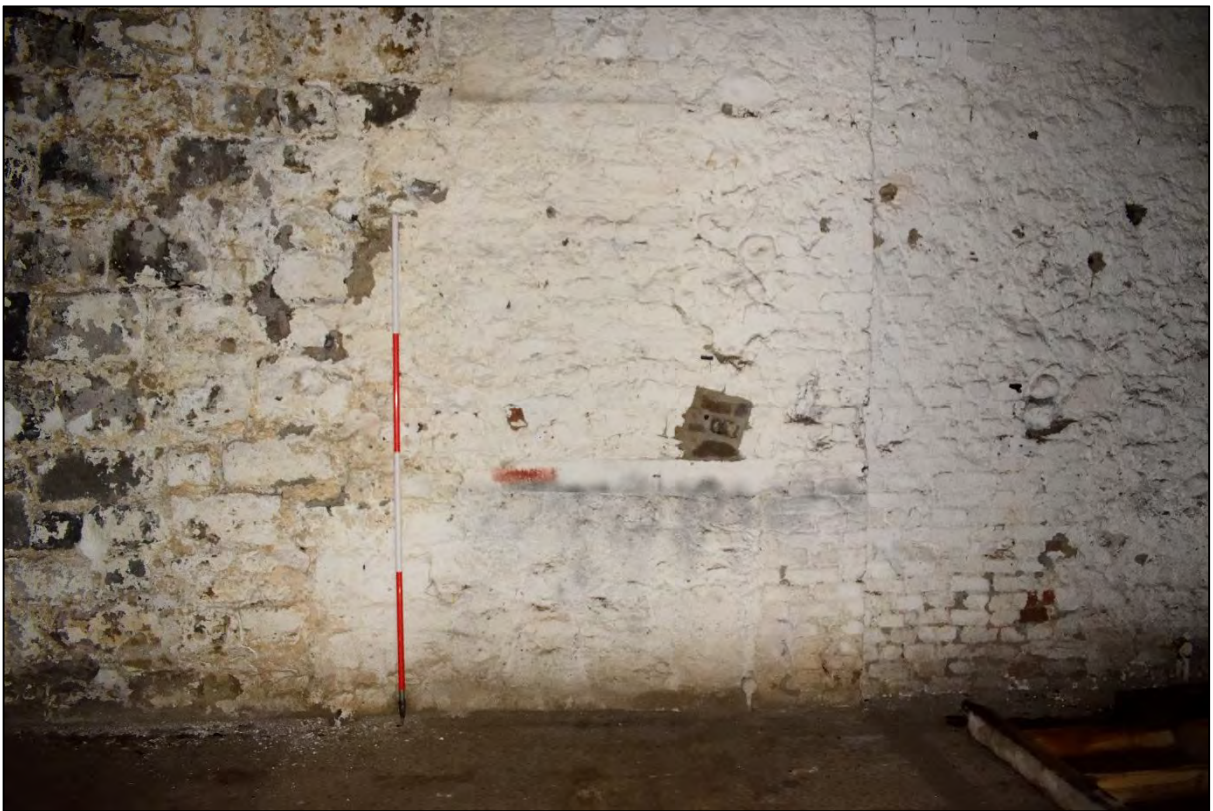
Plate 40: Blocked fireplace in southern gatehouse

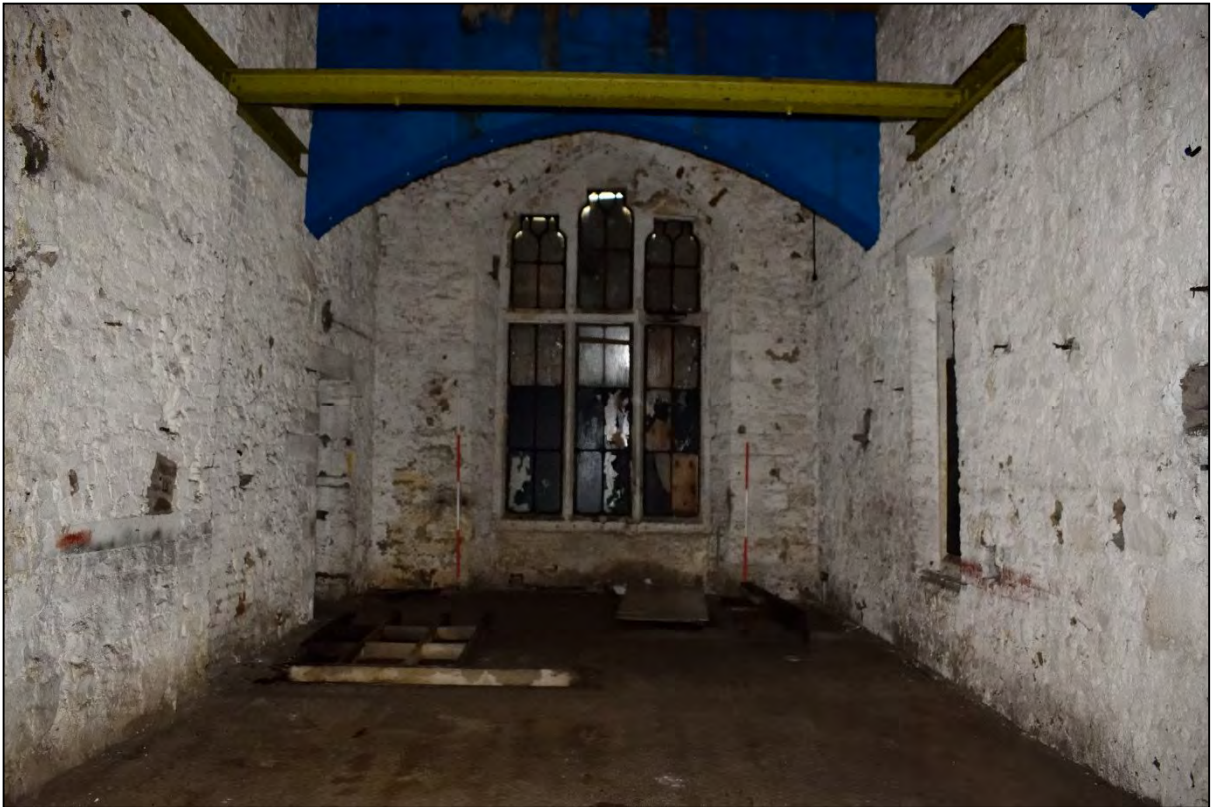
The western window (Plate 41) is the transomed and mullioned window with Caernarvon arches seen from outside, however the glazing is evident inside the building with lead comes dividing each of the lights into multiple panes. The two windows in the northern wall of the gatehouse reflect their appearances on the outside (Plates 42 and 43), however there is some evidence that the sill of the double window has been cut using a circular saw. The ceiling of the room is supported by two four centred arches made of brick (Plate 44) and there is a rolled steel joist providing stability to the upper section of the walling. This support is likely to have been inserted after 1963 when the structure on top of the gatehouse was demolished.

Plate 41: Southern gatehouse looking west

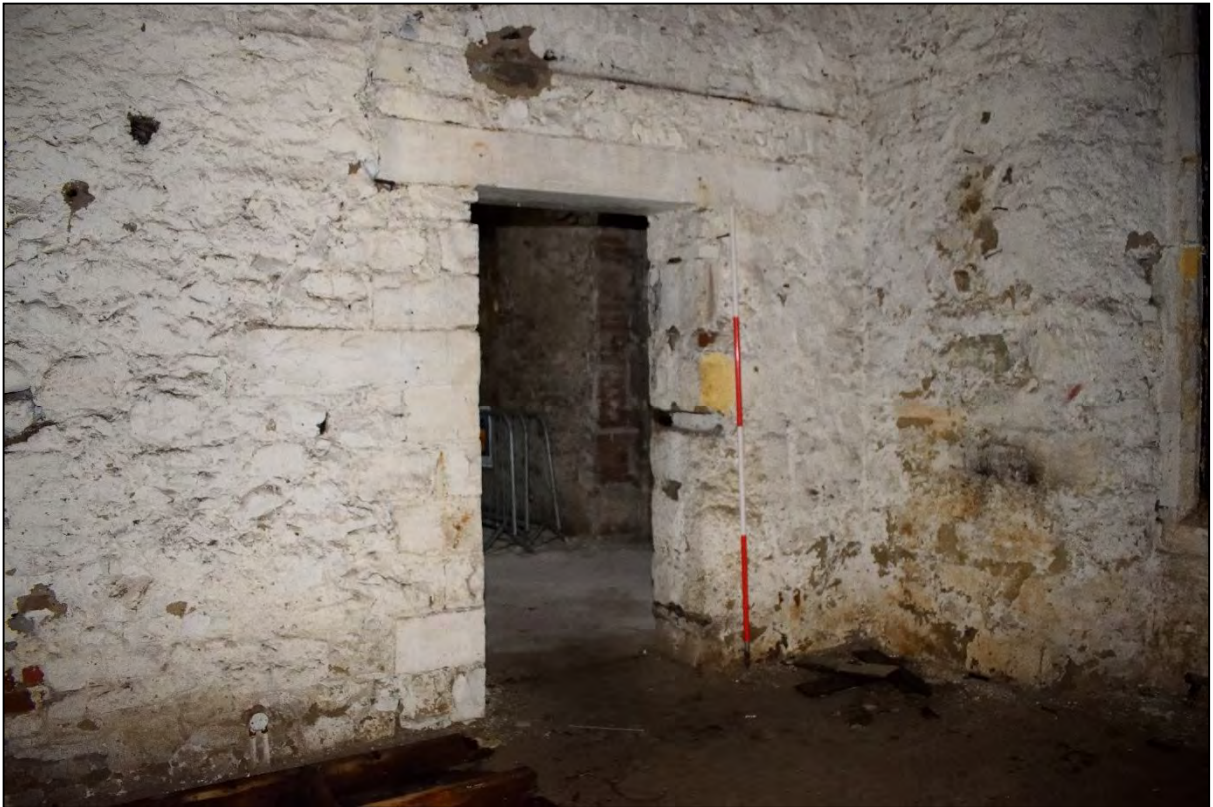
The southern gatehouse is linked to 3 Hole in the Wall Street by a doorway (Plate 45) with concrete lintel suggesting that it is a relatively recent feature, however, there is a low stone arch in the wall above the current lintel which may suggest that the current door has replaced an earlier opening. 3 Hole in the Wall Street is essentially a single room, however there is a half wall guarding the approach from the main door. This door (Plate 46) has a concrete lintel with brickwork infill above, however this very recent work also supports a higher level of brick infill suggesting a possible 19th century date for the opening. The doors and fittings are modern temporary partitions.

Plate 45: Doorway between the southern gatehouse and 3 Hole in the Wall Street

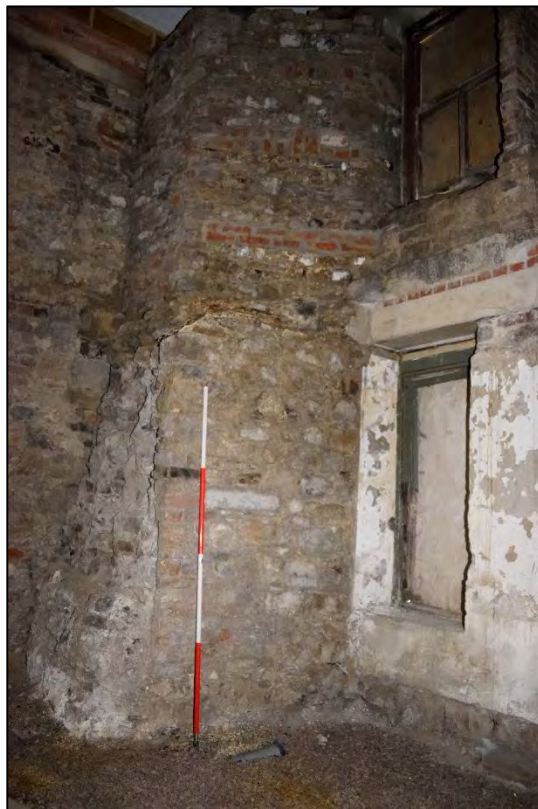
Brickwork also survives around the upper eastern window, particularly in the northern reveal, where at least three bands of brick have been recorded (Plate 48). Brick is also evident around both of the windows at this end of the building suggesting that they are later insertions. The sill of the upper window (Plate 49) also has circular saw marks suggesting it was cut in the 19th century. Further brickwork exists within the south wall (Plate 50) suggesting some repairs of this wall. Some of the brickwork, however is associated with the

Plate 48: the north reveal of the window in the eastern end of 3 Hole in the Wall Street

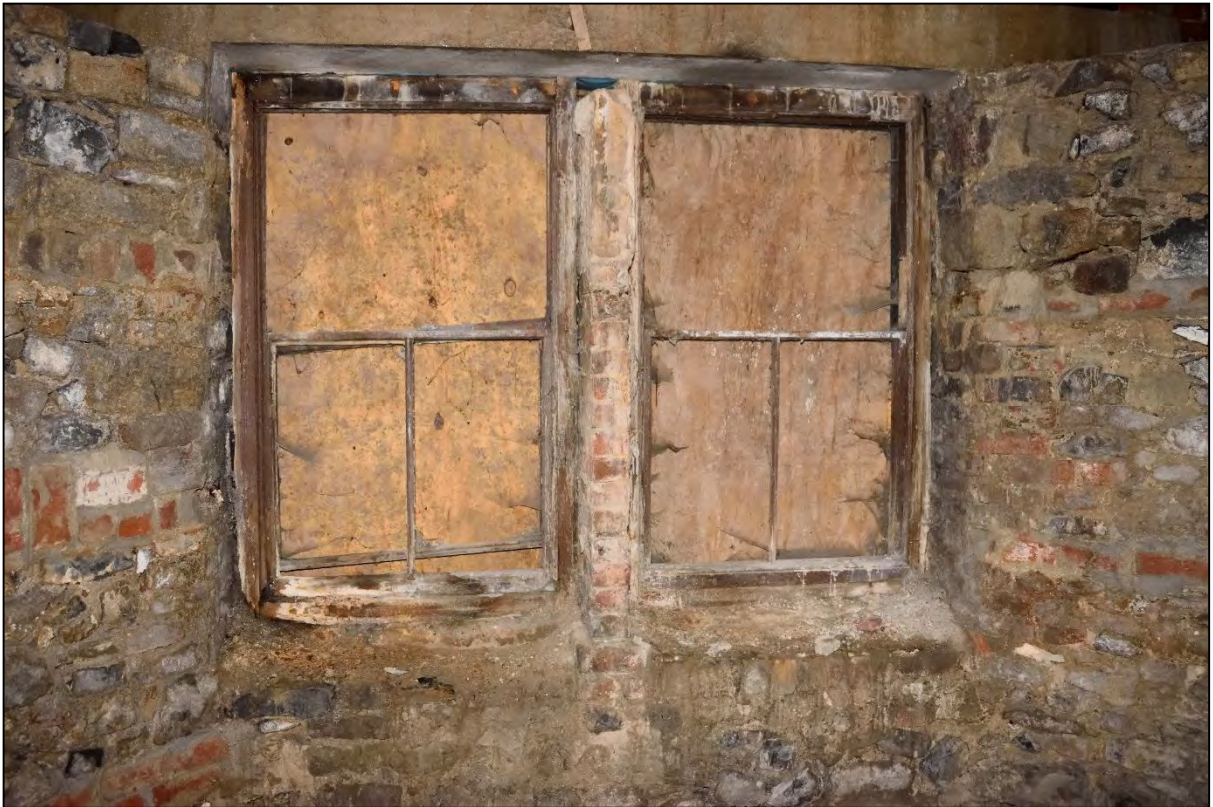
Plate 49: First floor window in the eastern end of 3 Hole in the Wall Street

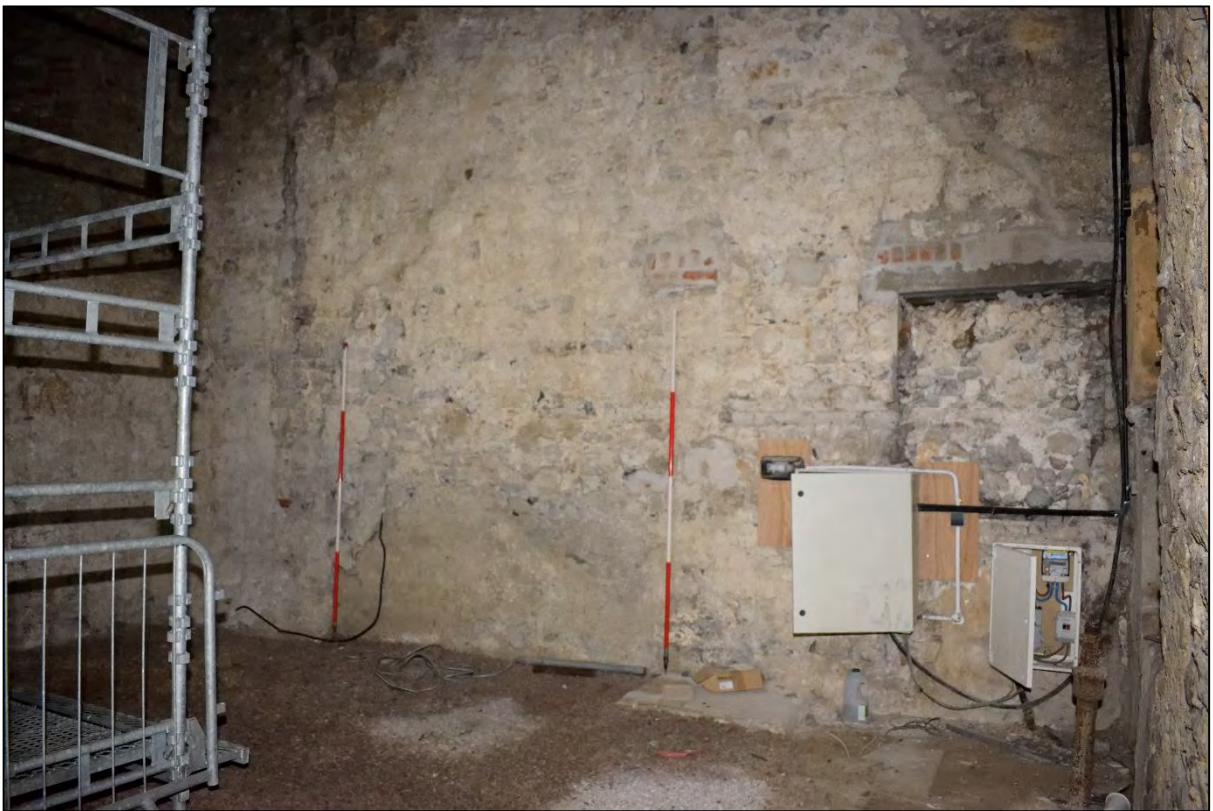
Plate 50: Southern wall of 3 Hole in the Wall Street

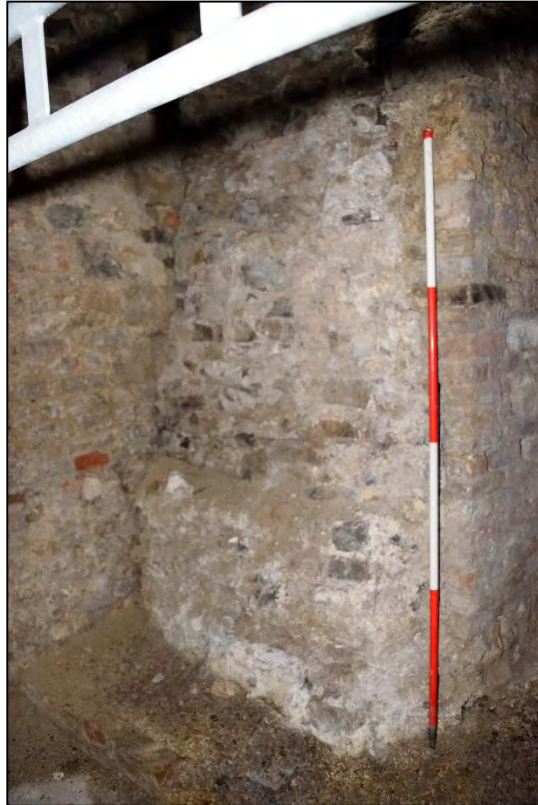
Two areas of more substantial stone walling have been recorded. Both of these are in the eastern section of the building (Plates 51 and 52), these are probably surviving remnant of the town wall and may therefore be Medieval in date.

Plate 51: Possible surviving town wall in the north-west corner of 3 Hole in the Wall Street

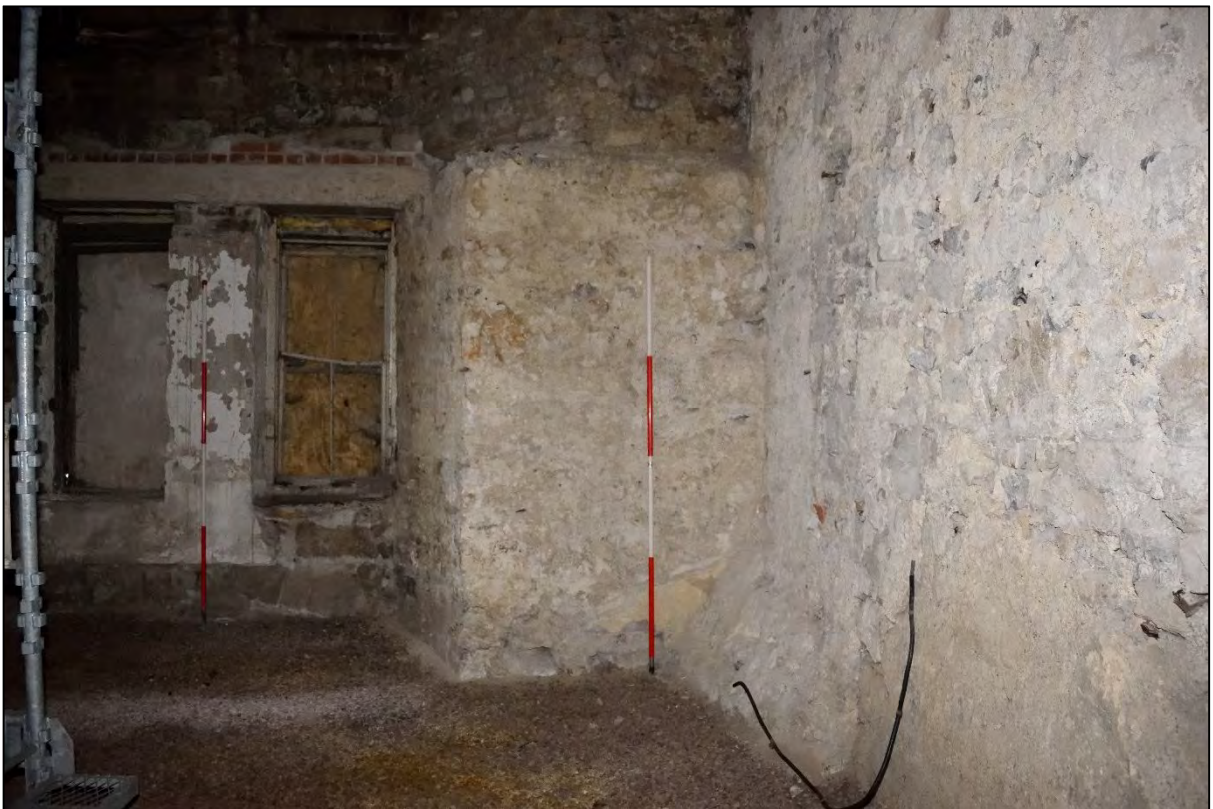
Plate 52: Possible surviving town wall in the north-east corner of 3 Hole in the Wall Street

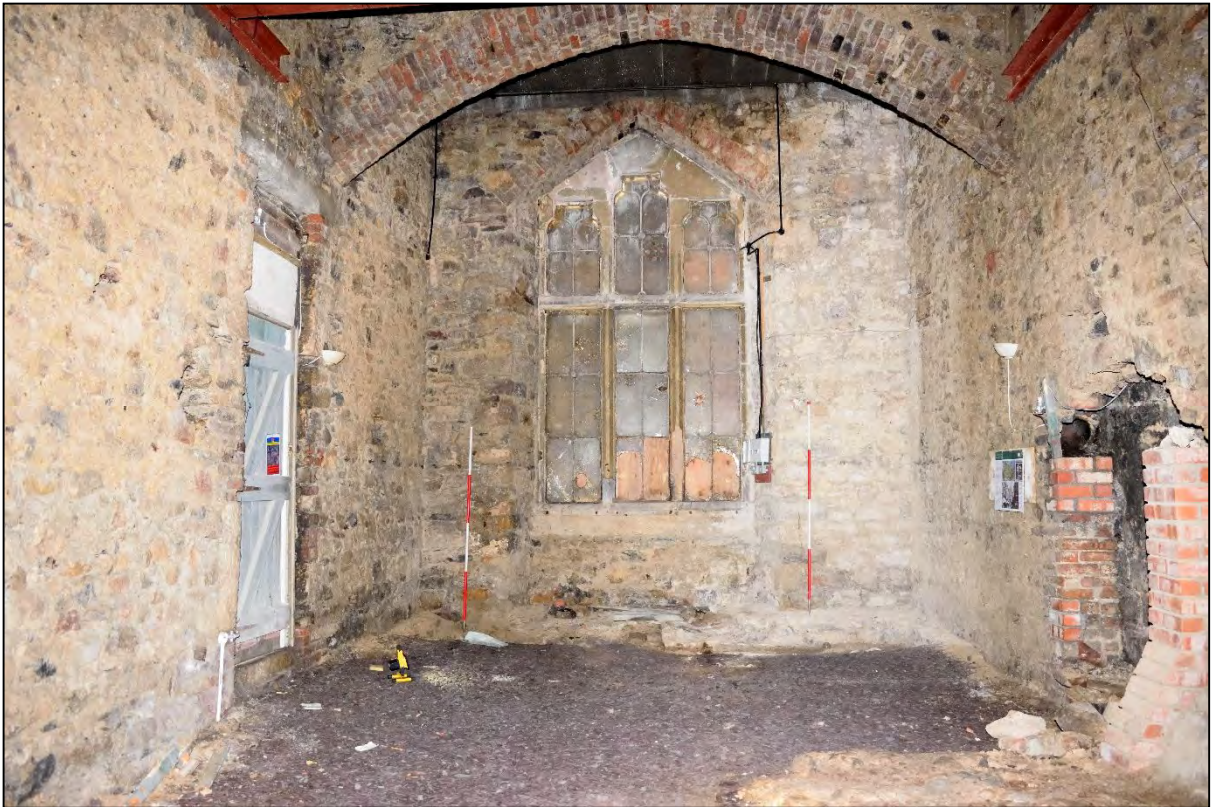
The norther gatehouse consists of a single room, now open to the roof level (Plate 53 and 54). The ceiling is supported by two brick arches (Plate 55) and consist of a series of concrete beams laid longitudinally. There is also a concrete wall plate around much of the building. The upper part of the gatehouse is supported by a rolled steel joist, presumably inserted to prevent the upper portion of the walls moving after the upper structure of the gatehouse was removed. Some modern repair in brick are also evident in the eastern end of the building (Plate 56). Further modern (20th century) repairs are evident to the embrasure and arrow slit (Plate 57).

The western wall of the gatehouse (Plate 53) contains the multi pained window with sandstone mullions and transoms and has Caernarvon arches over the top three lights. The lights are further divided into pains by lead comes. The sill of this window also has circular saw marks demonstrating that it is likely to be a 19th century feature. The arch over the window is of brick of a similar character to that used for the arches supporting the ceiling. The whole of the western wall would appear to have been inserted as there are straight joints with the both the northern and southern walls of the gatehouse. It would seem likely that the whole of this gable wall was replaced when the window was replaced, thereby suggesting a 19th century date for this phase of activity, possibly the major re-building which took place in 1872-3.

Plate 53: Northern gatehouse looking west

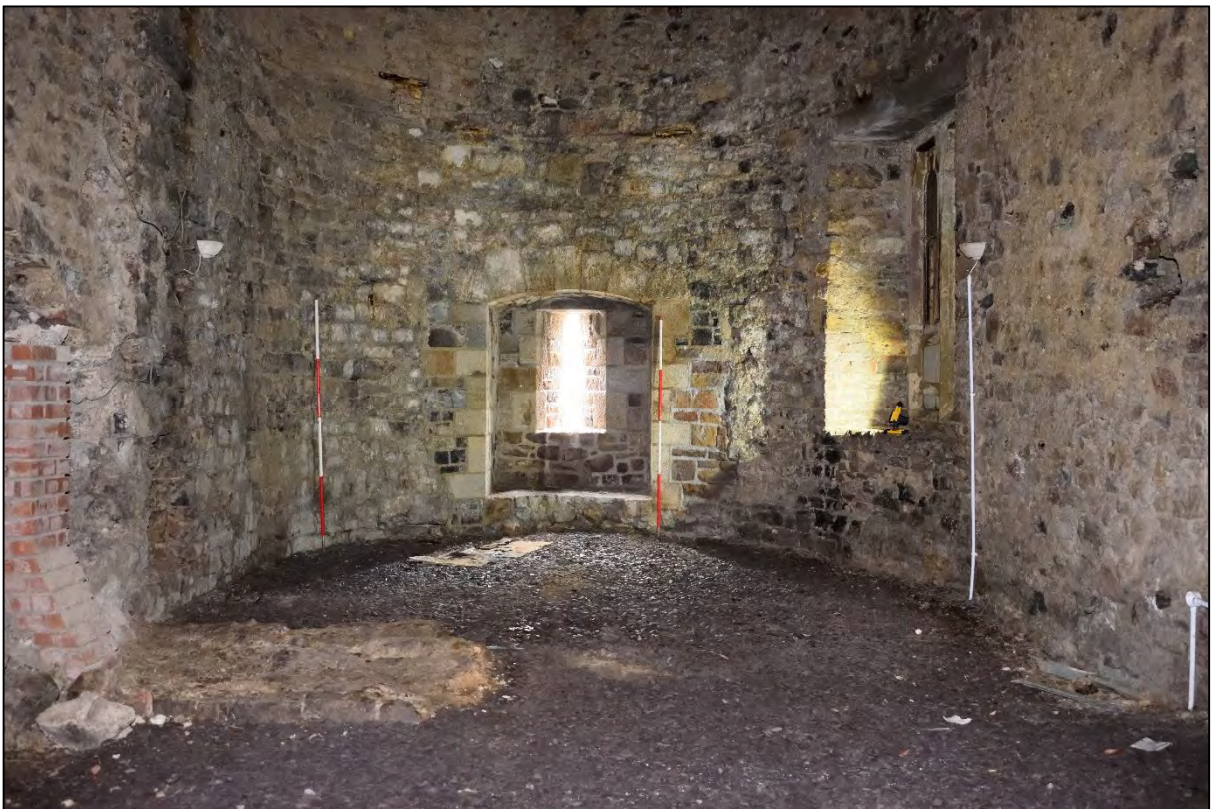
Plate 54: Northern gatehouse looking east

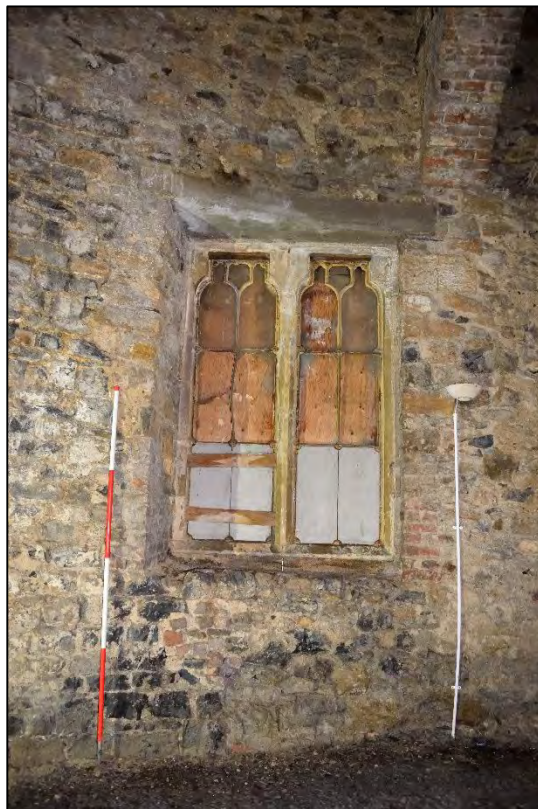
The northern wall incorporates the doorway and double window. The window (Plate 58) has sandstone mullions and frame. The sill of which has been clearly cut with a circular saw (Plate 59), assuming a similar development to the slate industry this means this sill must have been cut after the 1820's (Gwyn 2015, 115). The door (Plate 60) appears to have been modified from a single light window with brick used in the reveals and a sandstone block in the western jamb is possibly a re-used block from the original window. The door now has a concrete lintel which may relate to the last modification of the door recorded in a pencil inscription (Plate 61) on the back of the door itself which reads "Gwynfor Thomas 17.5.79".

Plate 58: The double window in the northern gatehouse
