**Porth Mawr, Caernarfon
Archaeological Assessment**

EAS Client report 2017/01

Porth Mawr, Caernarfon
Archaeological Assessment
Commissioned by
Donald Insall Associated for Cadw

Grid Reference:	SH 47901 62823
Listed Building No.	3869
Scheduled Monument reference number	CN034
NPRN	302416
PRN	3098

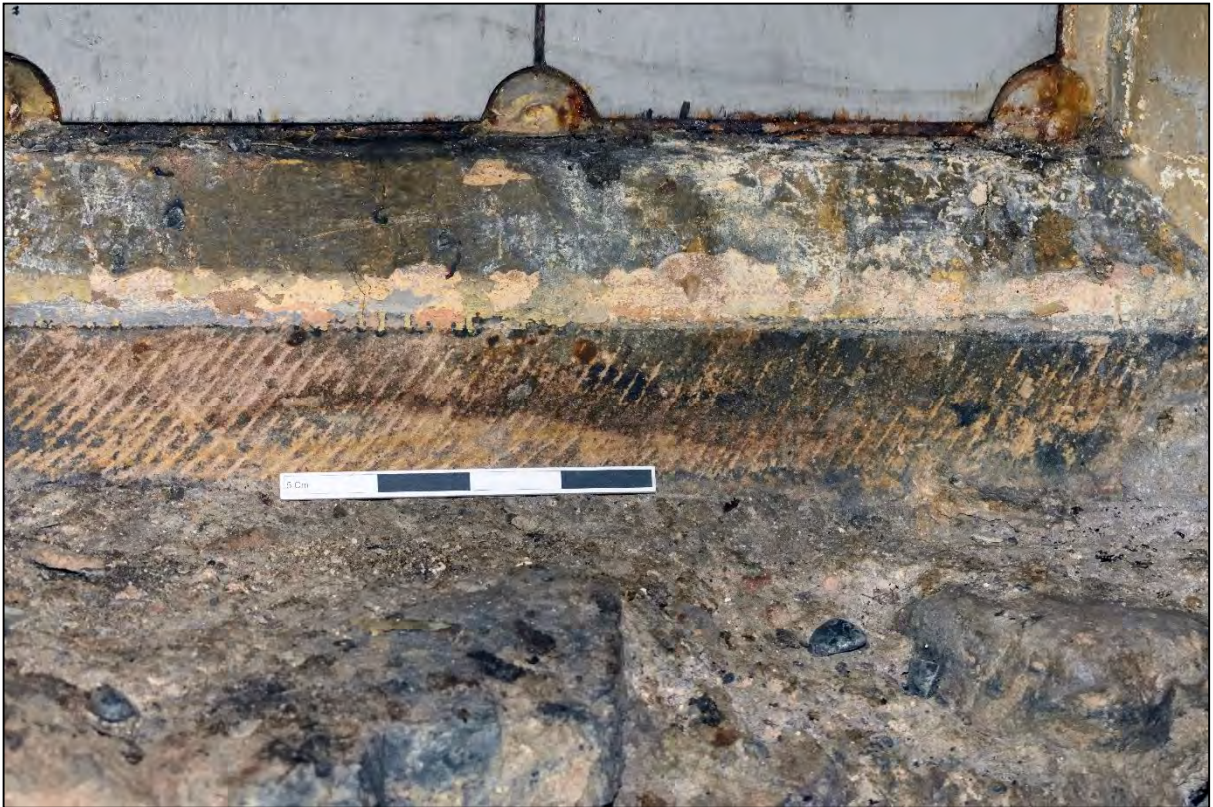
The northern wall incorporates the doorway and double window. The window (Plate 58) has sandstone mullions and frame. The sill of which has been clearly cut with a circular saw (Plate 59), assuming a similar development to the slate industry this means this sill must have been cut after the 1820's (Gwyn 2015, 115). The door (Plate 60) appears to have been modified from a single light window with brick used in the reveals and a sandstone block in the western jamb is possibly a re-used block from the original window. The door now has a concrete lintel which may relate to the last modification of the door recorded in a pencil inscription (Plate 61) on the back of the door itself which reads "Gwynfor Thomas 17.5.79".

Plate 59: Circular saw marks on the lintel of the double window in the north gatehouse
