Ty'r Wern, Llan Ffestiniog
Desk Top Study and Building Record

Commissioned by
Rhys Llwyd Davies

EAS Client Report 2023/05

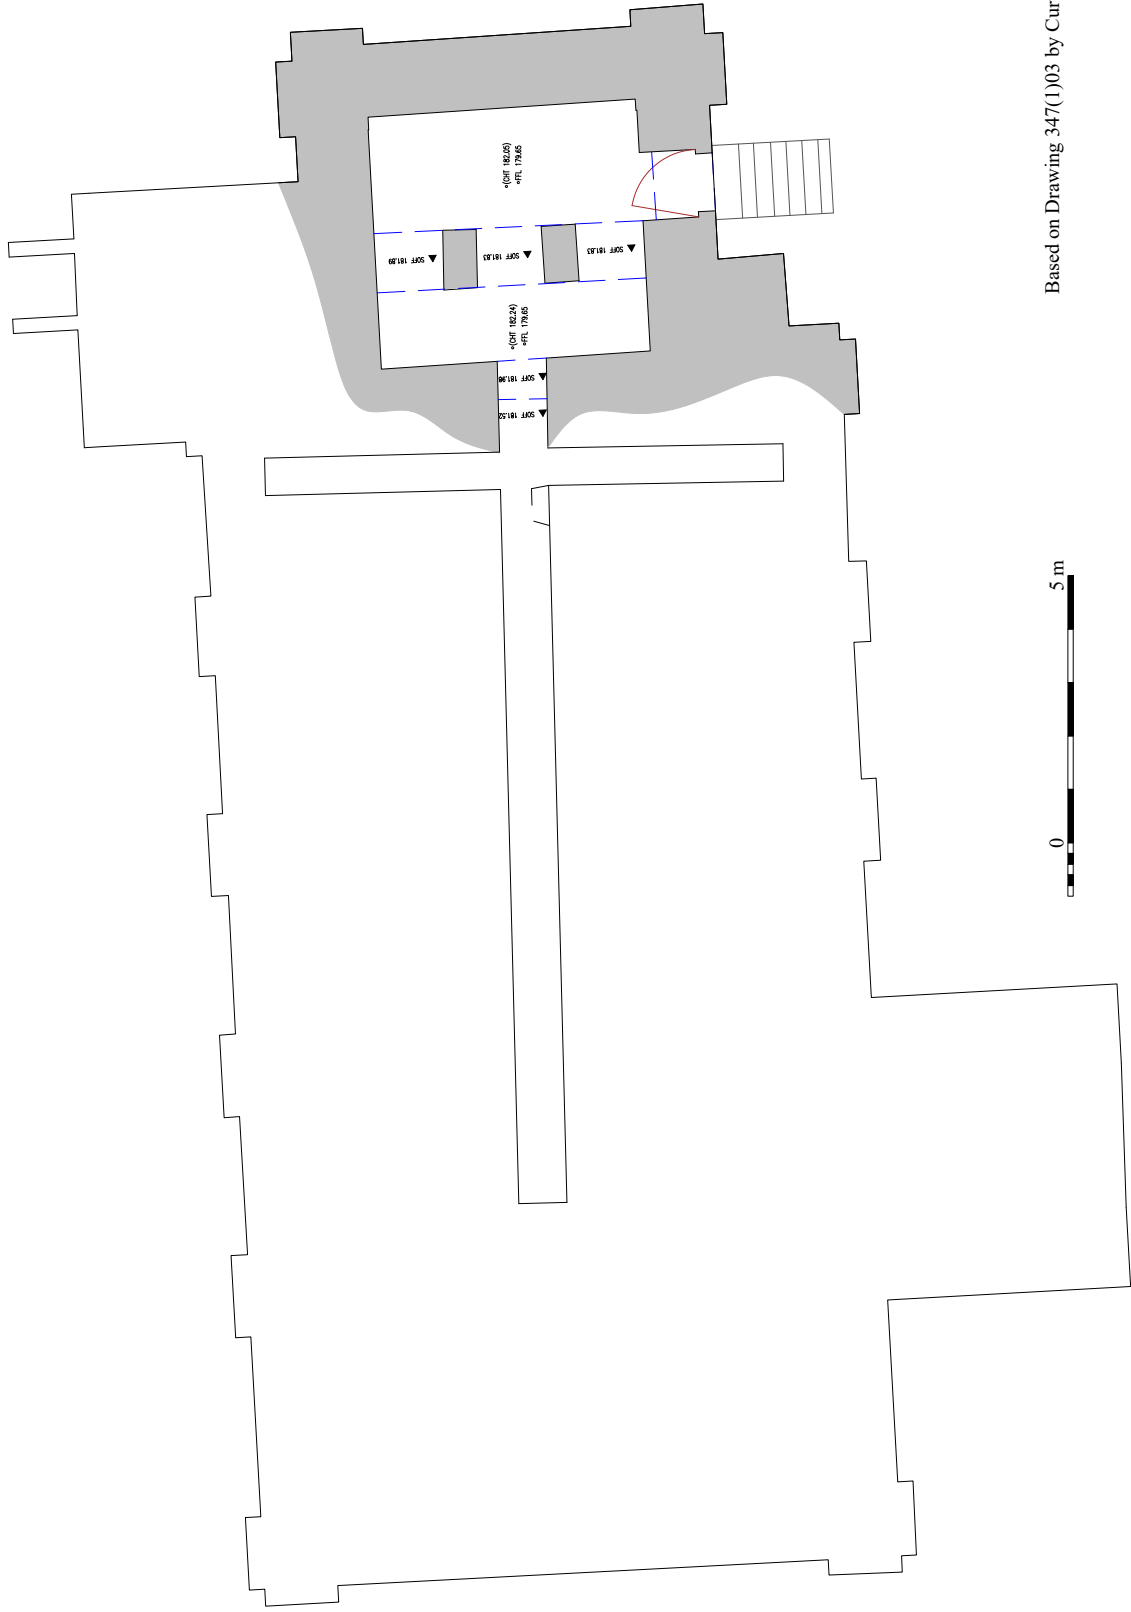
Figure 14: Cellar Plan
Scale 1:100

Extending from the western side of the cellar are three tunnels or passages (Figure 14, Plates 83 – 85). Originally up to 2 m high these passages are partially blocked with dumps of soil and building debris. The central passage runs along the centre line of the church and ends just below the eastern face of the gallery. The western end of the passage was not investigated, however plan 347(1)03 by Rhys Llwyd Davies (Figure 23) suggests there is a chamber at the other end of the passage. The roofs of the passages are generally of slate slabs, however there are bricks above the northern passage (Plate 86), presumably to support the raised floor in front of the chancel arch.

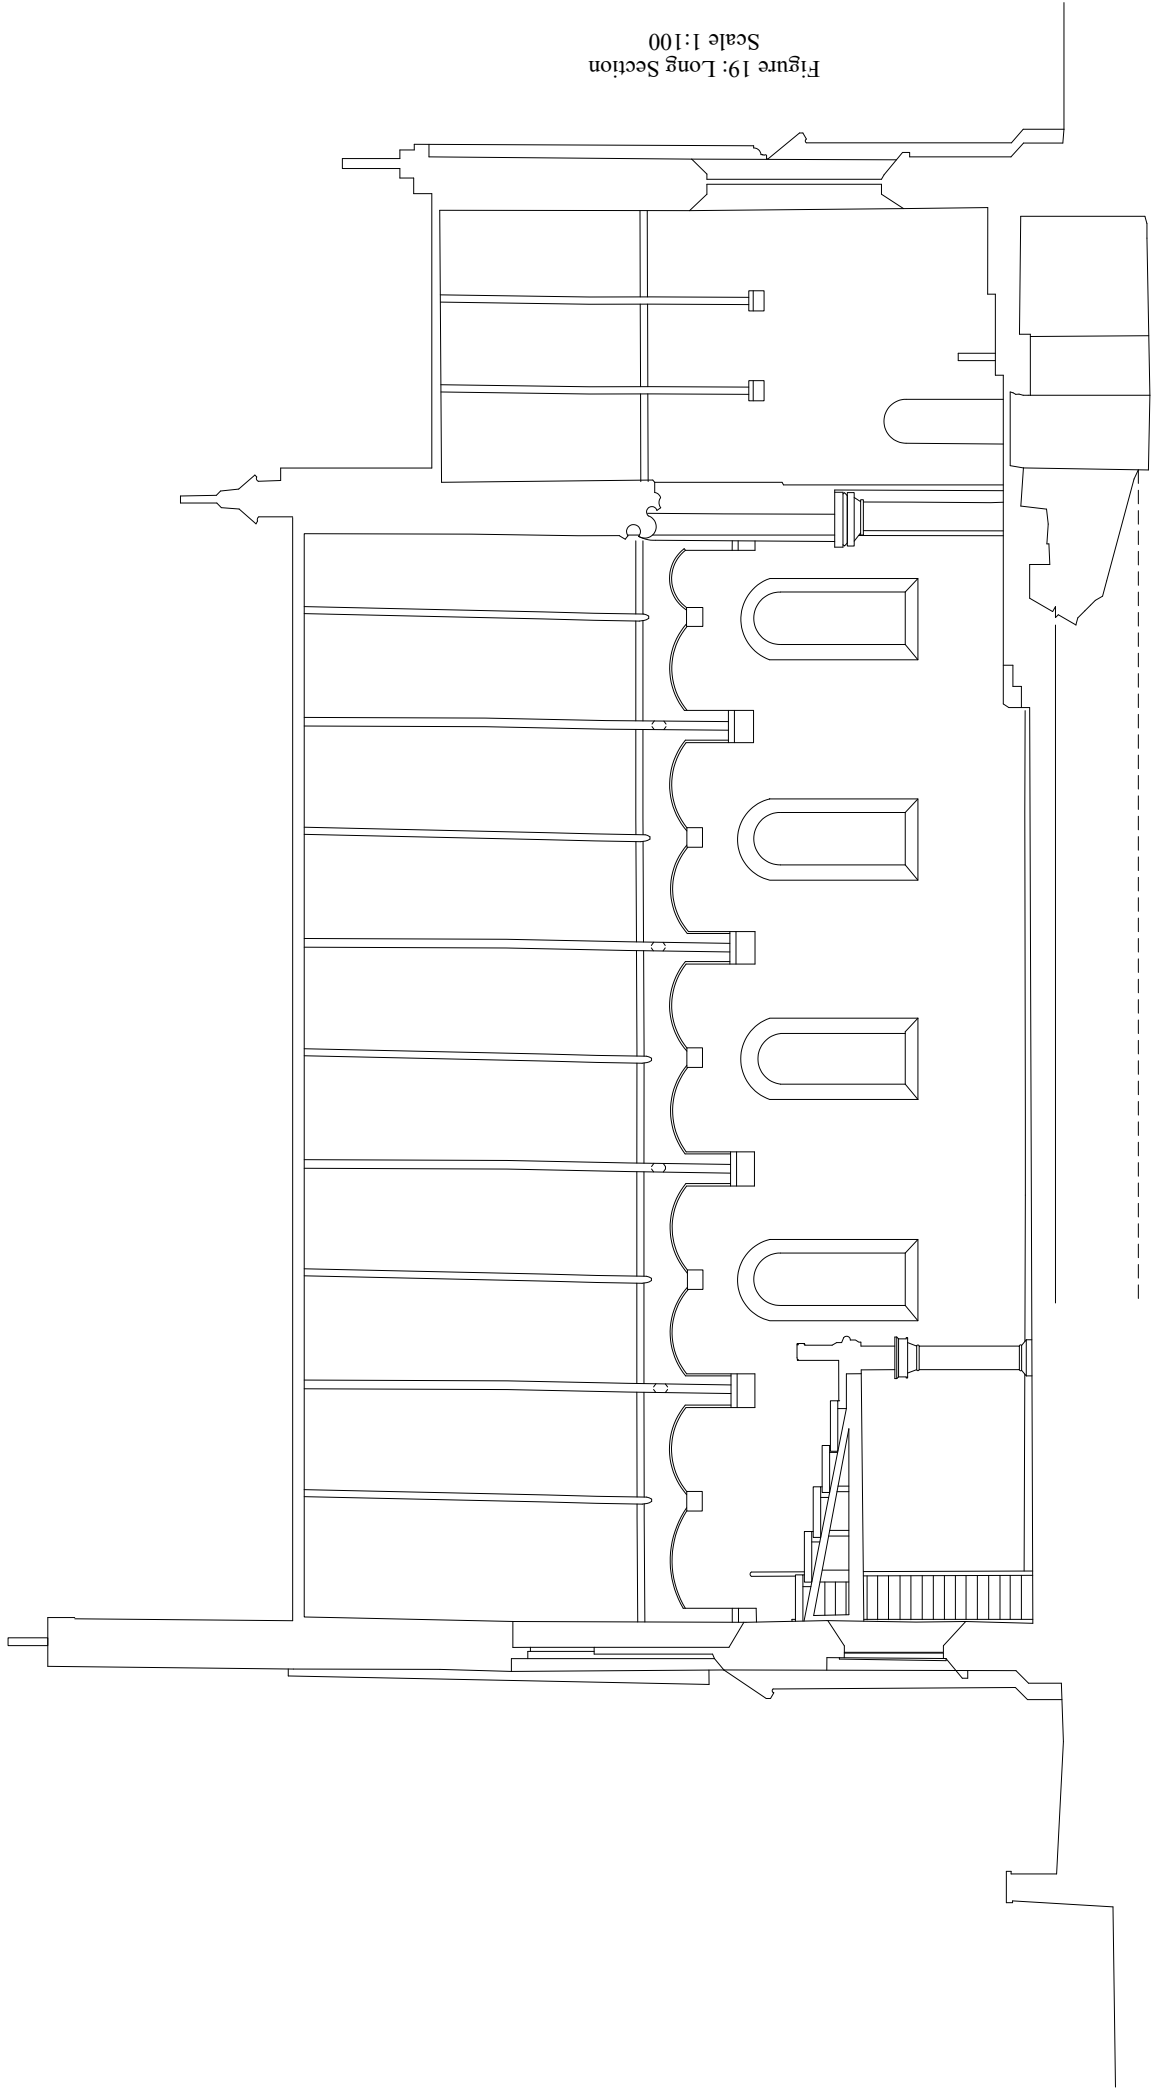
Figure 19: Long Section
Scale 1:100

The western end of the nave is dominated by the gallery (Figures 13, 19 and 20, Plate 36), the eastern end of which is supported by two pilasters (Plates 37 and 38) and a central column (Plate 39). The pilasters are rectangular in plan, whilst the central column is round. All the bases and capitals are undecorated, although there are square plan blocks above the capitals. The top of the capitals supports wooden, arching, braces, whilst the base of the gallery sits on the top of the block. The northern and southern sides of the gallery are supported by a series of rough corbels (Plate 40), whilst the western end has triangular, wooden brackets (Plate 41) which run the full length of the gallery. The gallery is accessed by a wooden staircase in the north west corner of the nave (Plate 42). The side of this is partly panelled with a series of graded arches. The panelling has been lost from the two larger openings, although it is probable that the largest, northern opening may have either held a door or was never filled, thereby giving access to the understairs space. Both the balusters and the newel post are plain (Plate 43) with a simple cushion cap to the newel. The gallery, itself, is raked with five broad steps leading down to the front rail. Only two of the pews were still in place, at the time of the survey, which show remarkably little space between them. It is assumed that the pews on the rest of the gallery were more openly spaced as the leg room between the surviving pews is very small indeed. Two ornate, brackets protrude from the base of the truss over the front of the gallery (Plates 46 and 47) which are assumed to have originally held some form of lighting. Consisting of a series three of scrolls this is unlike the Neo-Norman design of the rest of the church, possibly suggesting they are a later addition.

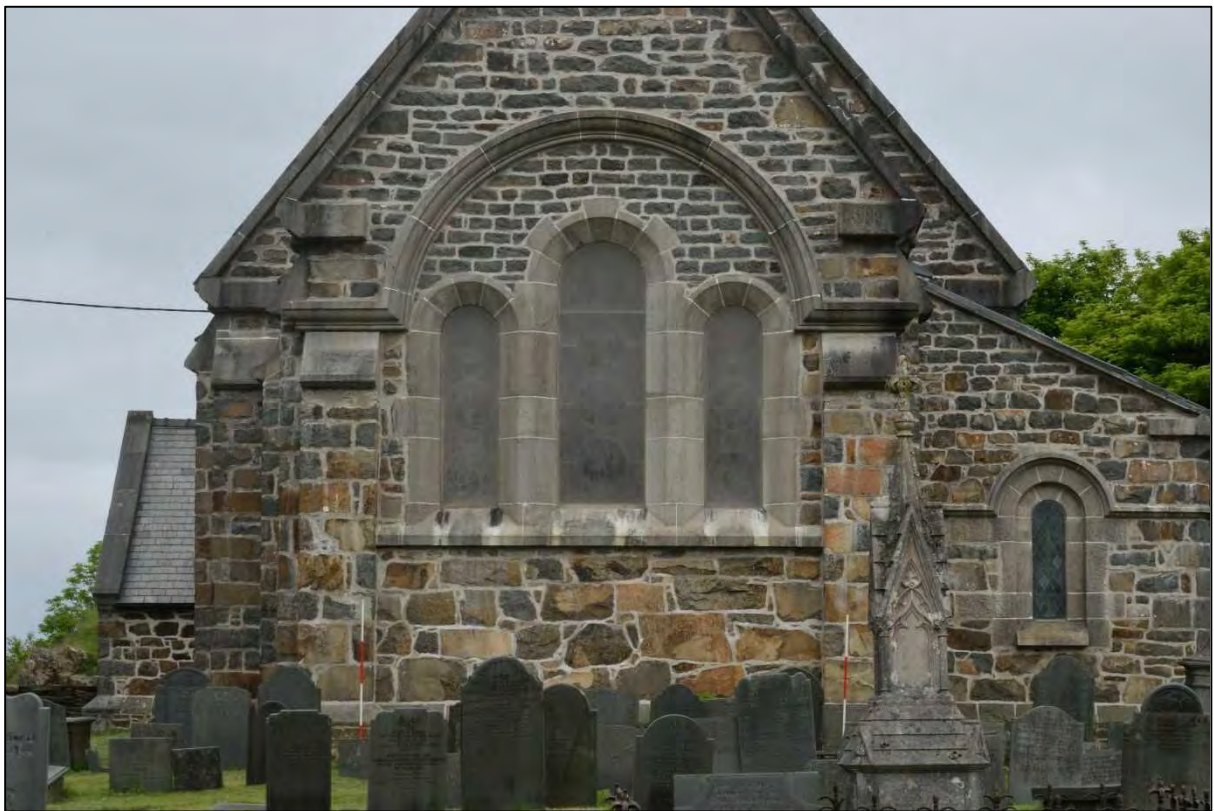
Plate 2: Detail of the eastern gable

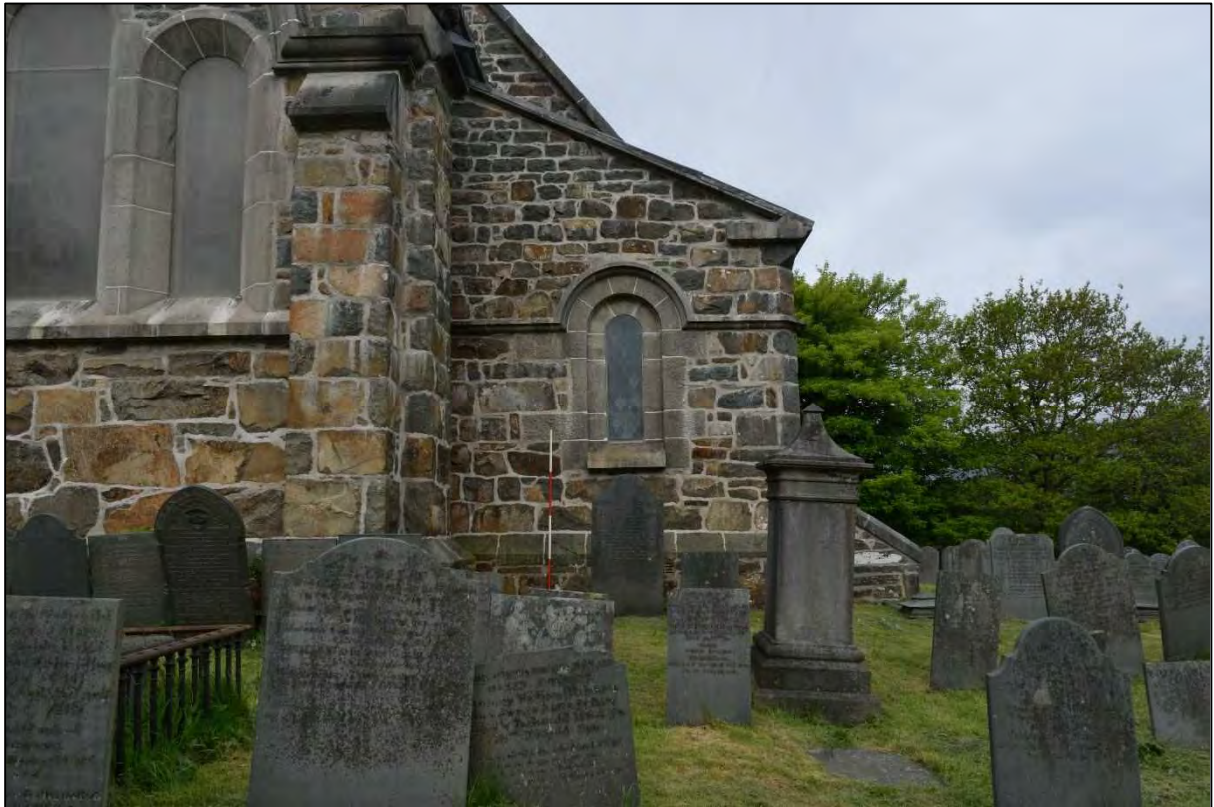
Plate 3: Eastern elevation of the vestry

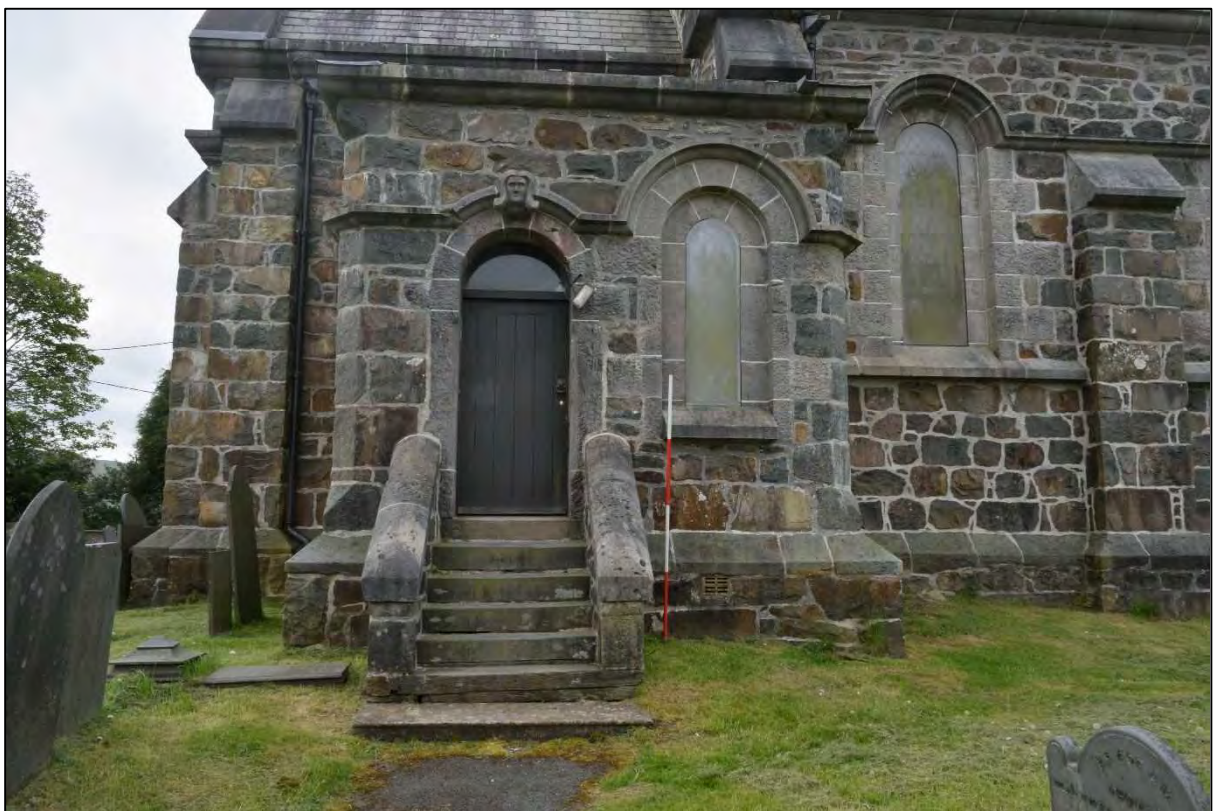
Plate 4: Northern elevation of the vestry

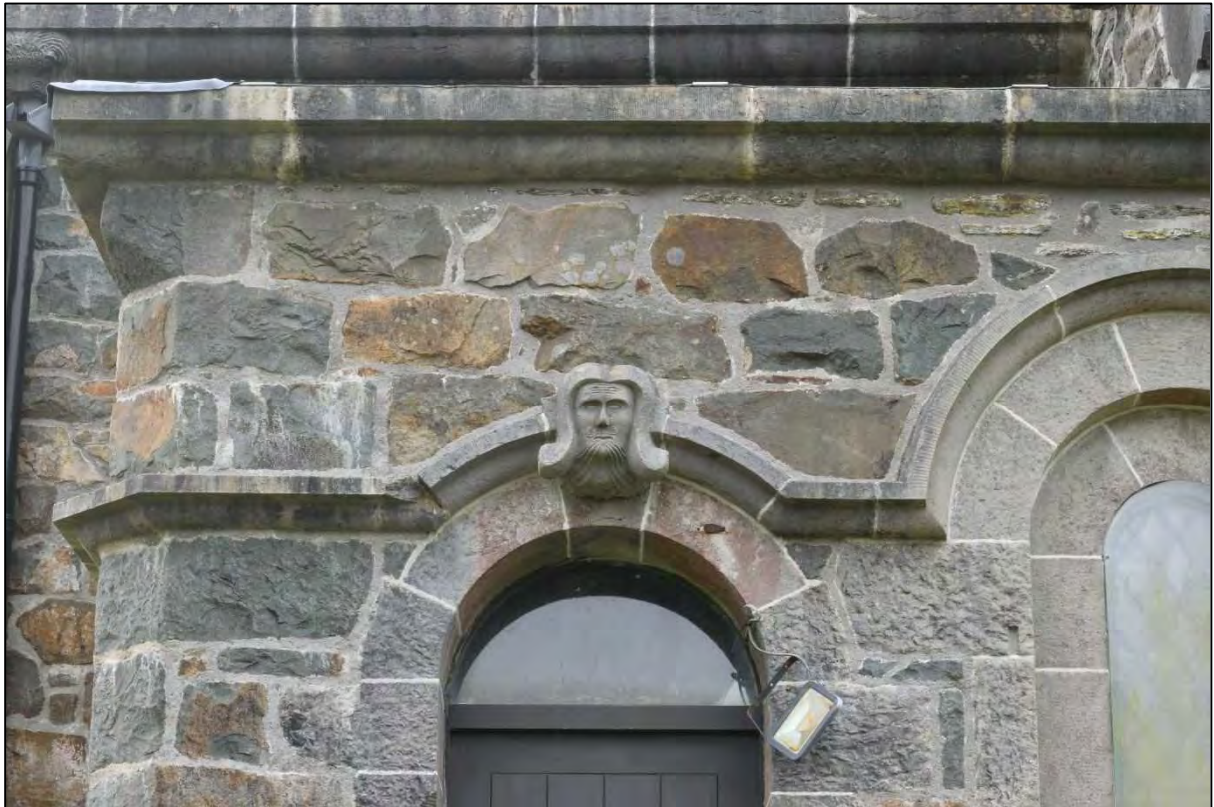
Plate 5: Carved head over the vestry door

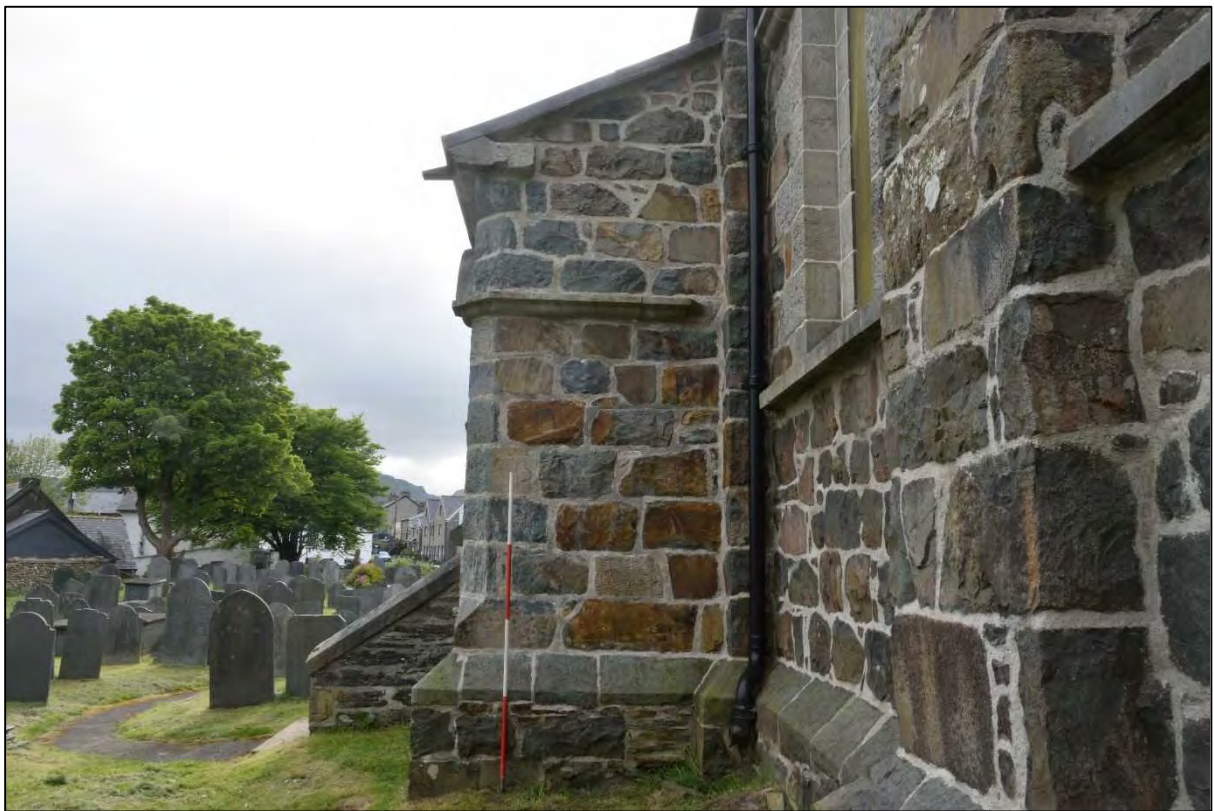
Plate 6: Western elevation of the vestry

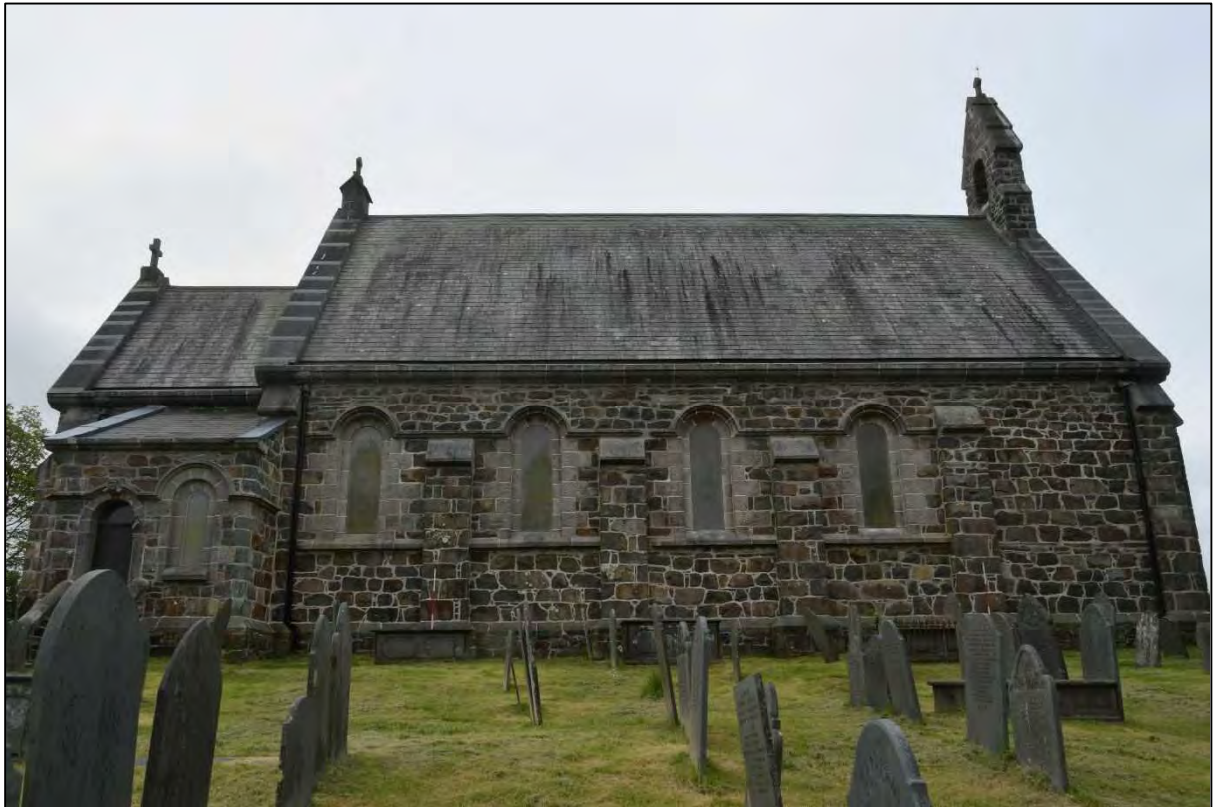
Plate 7: Northern elevation

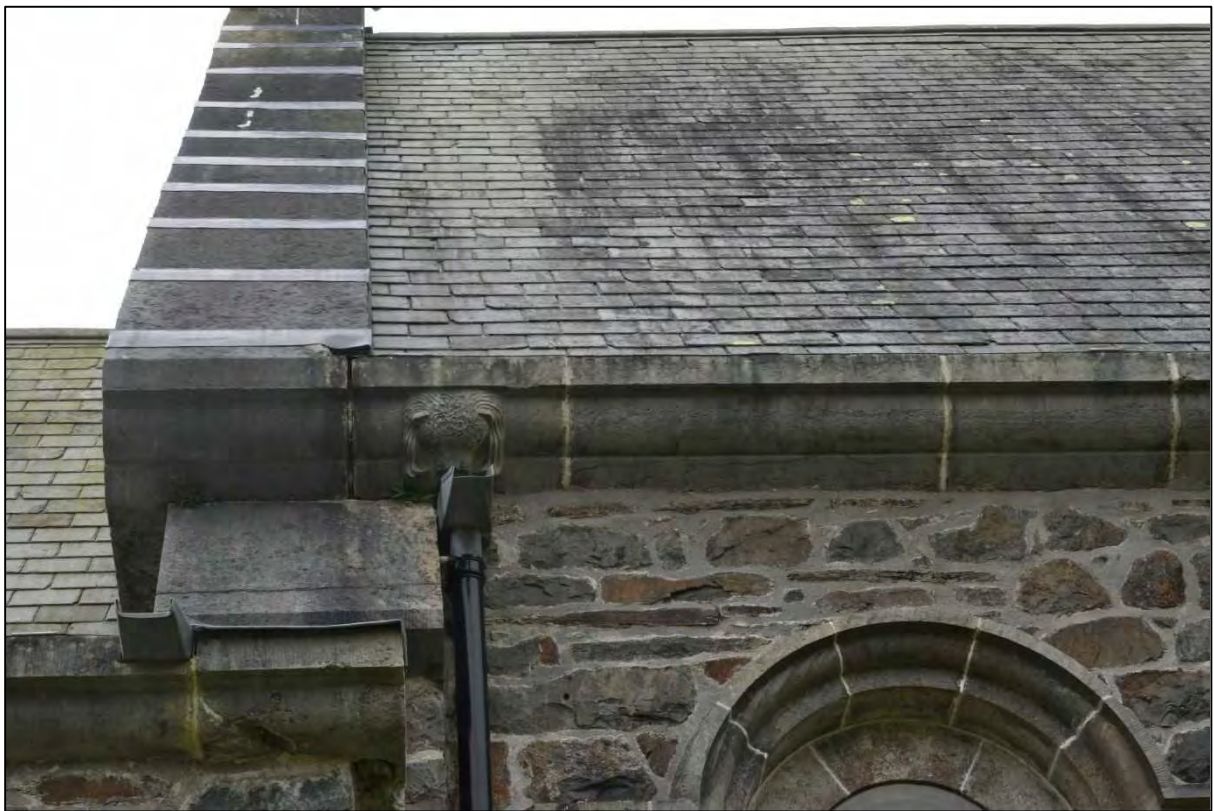
Plate 8: North-eastern gargoyle

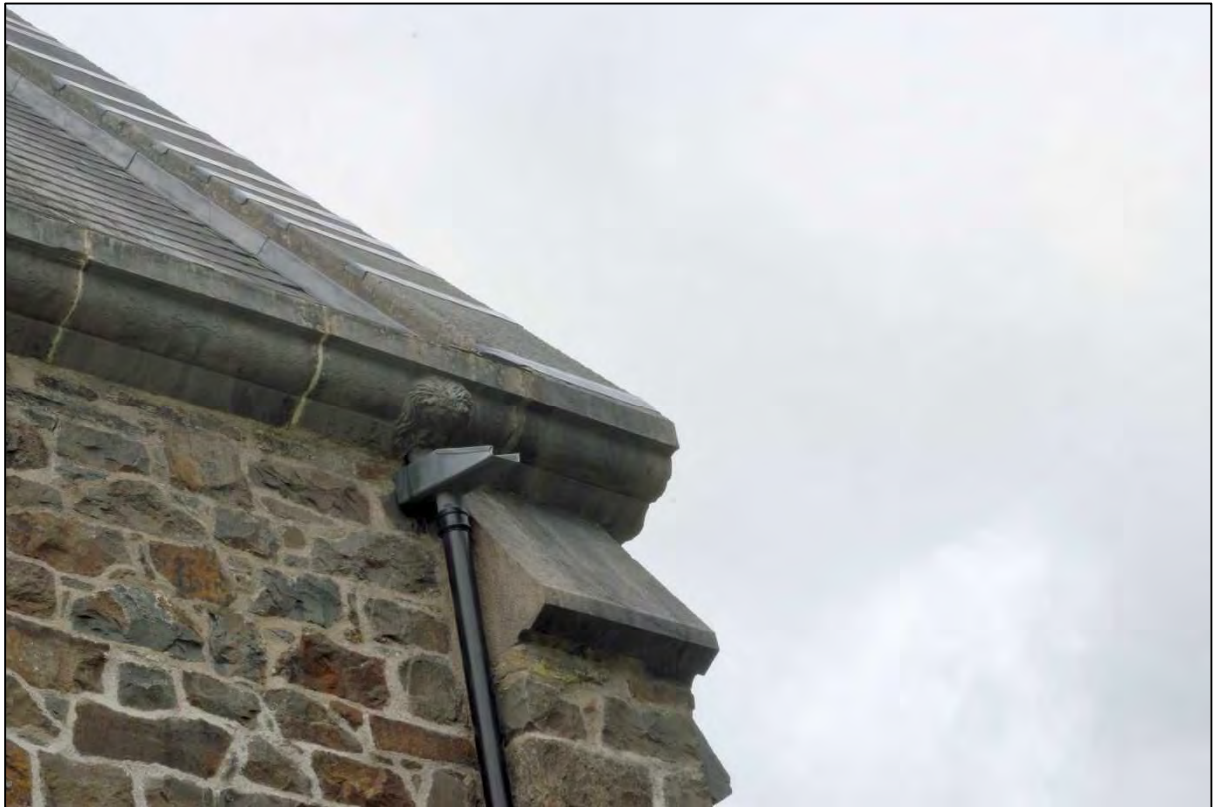
Plate 9: North-western gargoyle

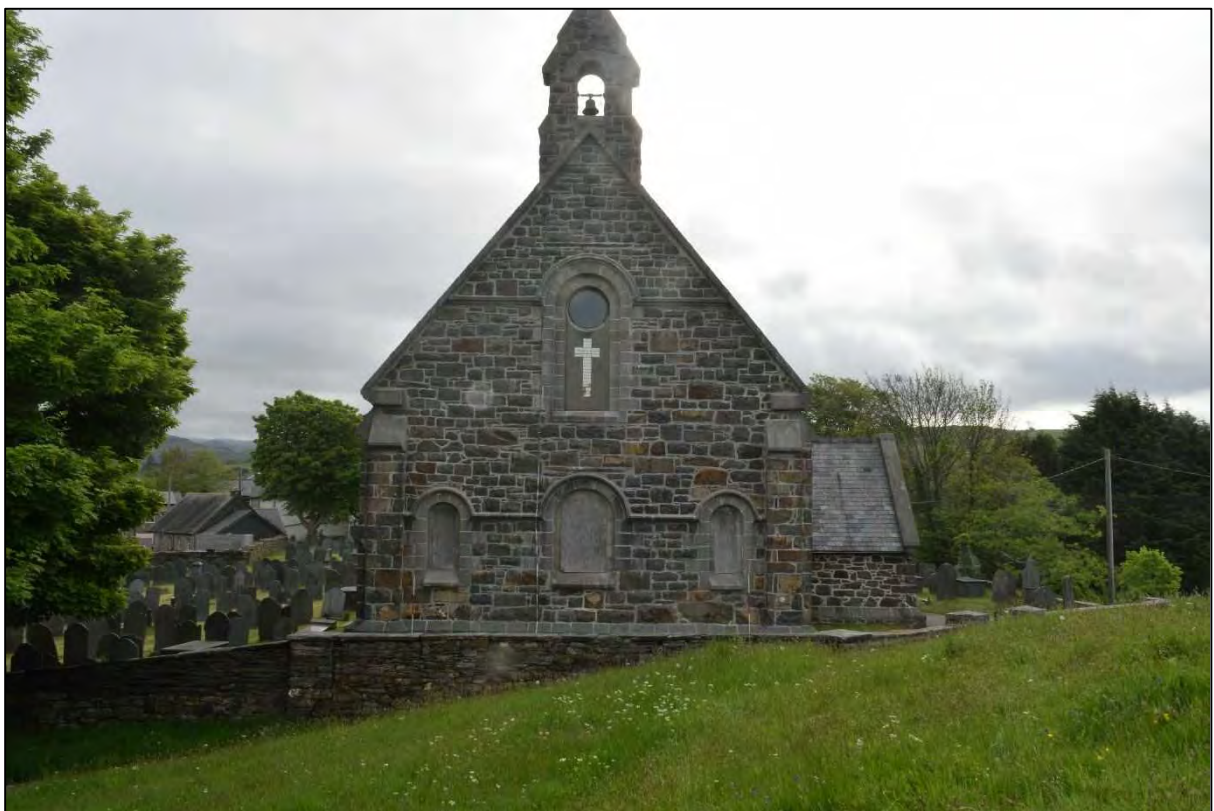
Plate 10: Western elevation

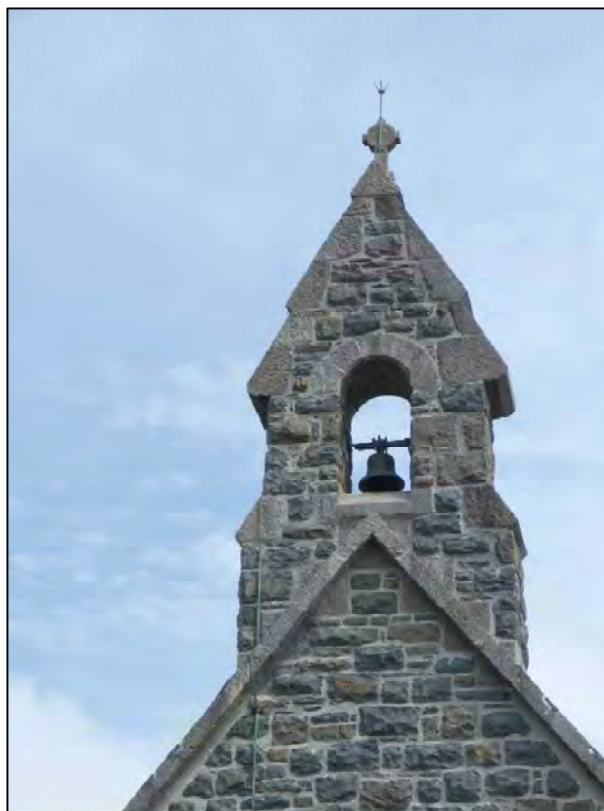
Plate 12: Bellcote

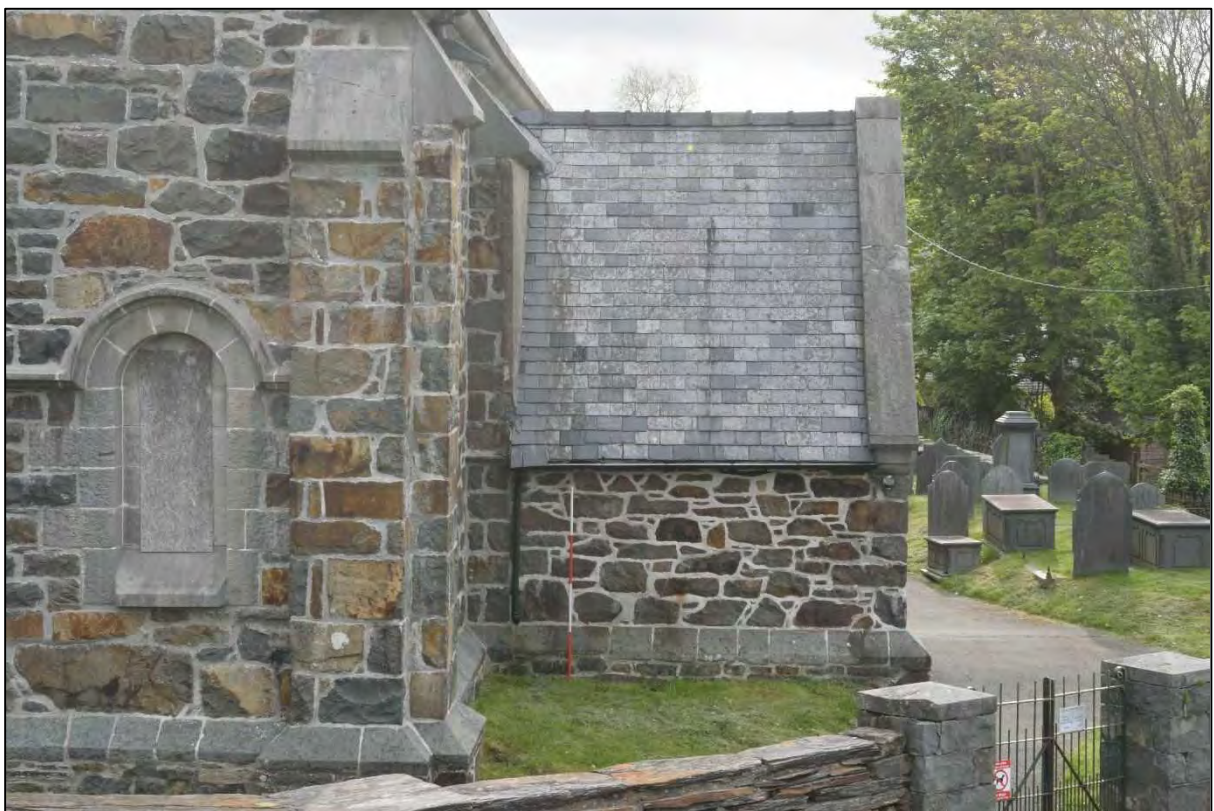
The south porch (Plates 14 – 16) is constructed of slightly smaller stone than the rest of the lower sections of the building, although of similar stones. There is the main door in the southern gable (Plate 15) and a single, semi-circular topped window in the eastern elevation (Plate 16). The door is set in a double chamfered opening, flanked by relatively slim columns with undecorated bases except for a torus separating the column from the base. The capitals (Plate 17) are quite starkly carved with what are assumed to be stylised leaves. Standing adjacent to the east face of the porch is a carved, stone cross (Plate 18). This is assumed to have been part of the 'mini-spire' which was replaced by the current bellcote in 1913.

Plate 14: Western elevation of the porch

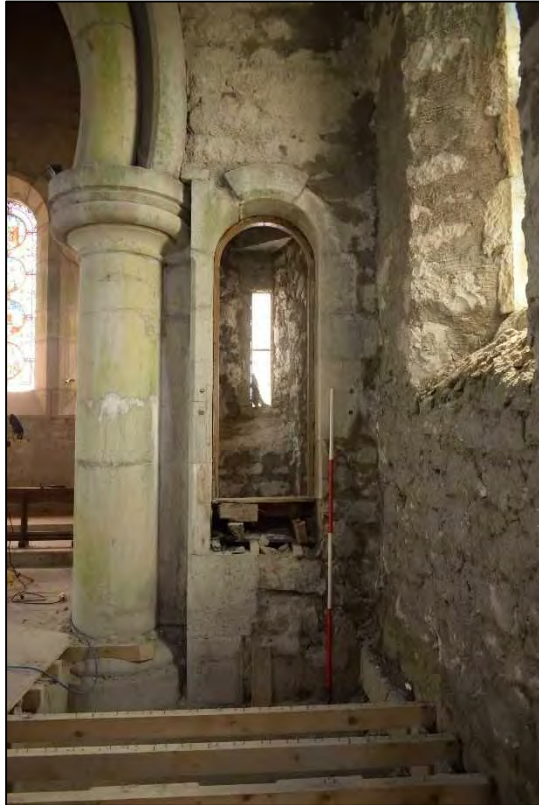
Plate 59: Southern column of the chancel arch and the pulpit doorway

Now displaced within the chancel, the pulpit (Plate 62) rests on three squat columns and has a wooden pulpit with oval decorative panels. It originally sat in front of its access doorway to the south of the chancel arch (Plate 59). Access to the pulpit was via a doorway in the south side of the chancel (Plate 63) with a short flight of stone steps through the chancel wall. Both doorways at the end of this short passage have heavily emphasised key stones (Plate 64) and the upper doorway (into the nave) retains its wooden frame for a door.

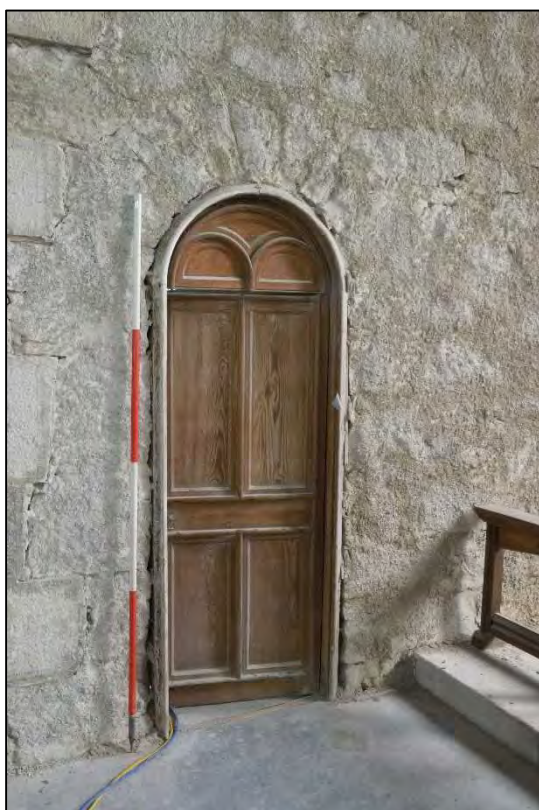
Plate 65: The vestry door from the chancel

In the south wall of the chancel is the vestry door (Plate 65) with a quarter panelled door within an arched doorway with a double arch design in the over panel. It is between the altar rail and the chancel arch. The altar rail (Plate 66) was only in position on the southern side of the chancel at the time of the survey. It is of relatively simple with the only decoration being a series of small roundels between the legs of the rail on the stretcher below the handrail. The eastern window (Plate 67) consists of a triple window, each with a series of roundels featuring biblical scenes.

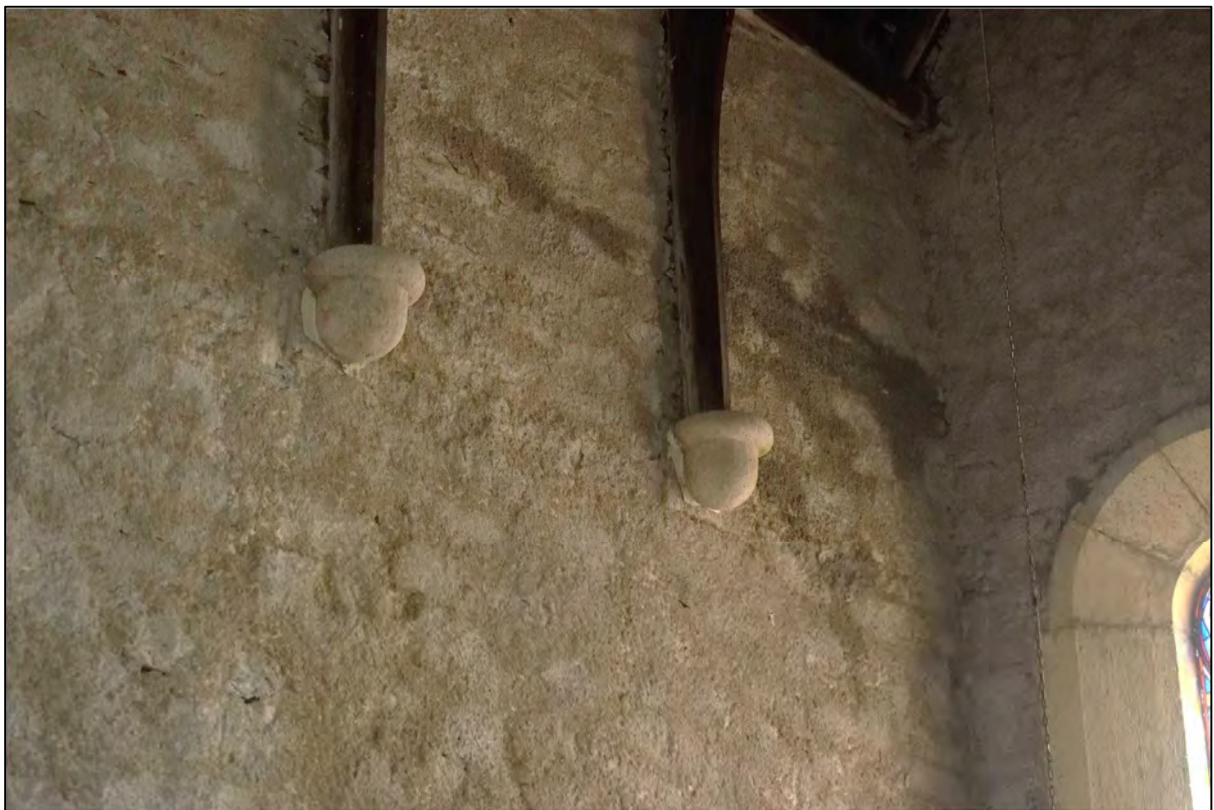
Plate 68: The corbels supporting the chancel roof

The trusses over the chancel are supported by corbels (Plate 68), which unlike those in the nave being a, well carved, "acorn" shape. They support two arch braced trusses which, in turn, supports a boards ceiling (Plate 69).

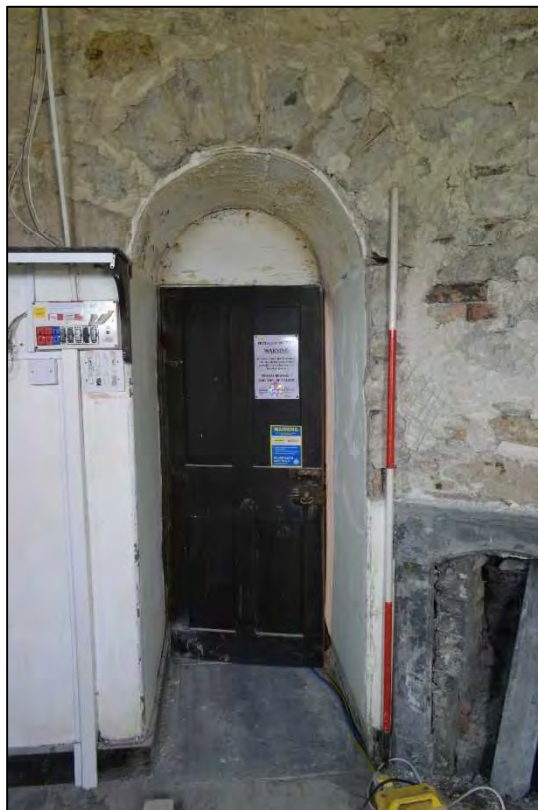
Plate 70: Inside of the door between the vestry and the chancel

The vestry is an addition to the original design, but was constructed before 1888 when it appears on the First Edition Ordnance Survey mapping. It has two doors, one from the chancel and the other an external door to the churchyard. That from the chancel (Plate 70) is cut through the wall of the chancel which is 0.89 m thick at this point. Just inside the inner door there is a fireplace, to the west, which had a plain, slate, fire surround (Plate 71). This must have been blocked off at some time as there is no chimney protruding from the roof above. It must also mean that the roof has been replaced at some time. Adjacent to the fireplace is recess which has been partly blocked with breeze blocks (Plate 72). The function of this recess is unknown.

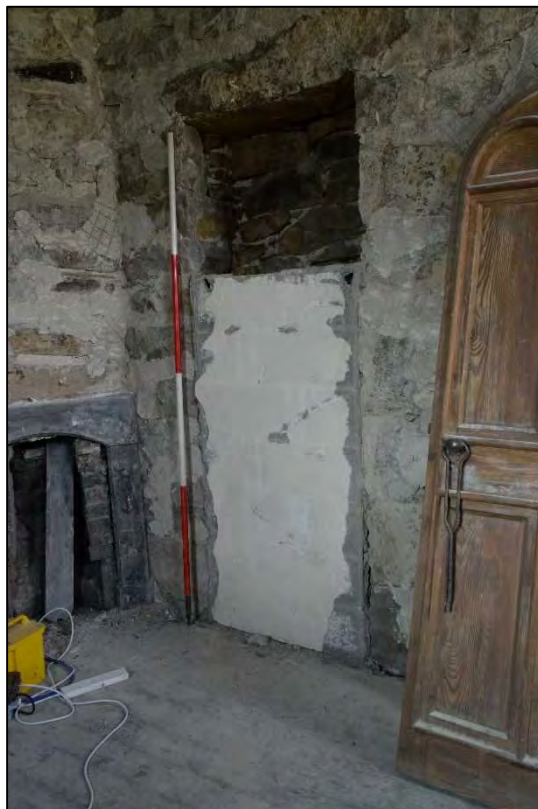
Plate 72: Partially blocked opening in the vestry

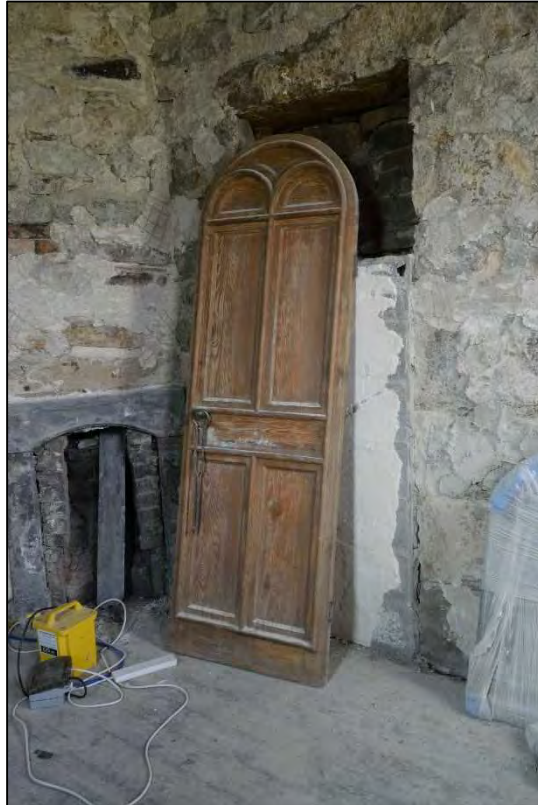
There is a detached wooden door in the vestry (Plate 73). This is 0.68 m wide and 2.11 m high with decorative panelling and an arched top. It is most likely that this door originally was at the top of the passage leading to the pulpit, fitting into the surviving wooden frame.

Plate 73: Displaced door from the pulpit passage

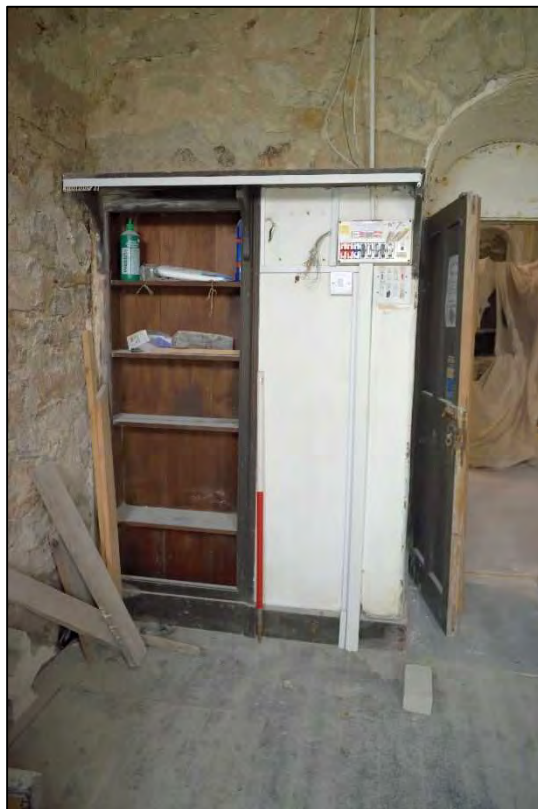
Plate 74: Vestry cupboard

On the other side of the inner door is the vestry cupboard (Plate 74). There is also a safe within the vestry (Plate 75) which has two doors each with a hand holding a rod which act as handles. There are

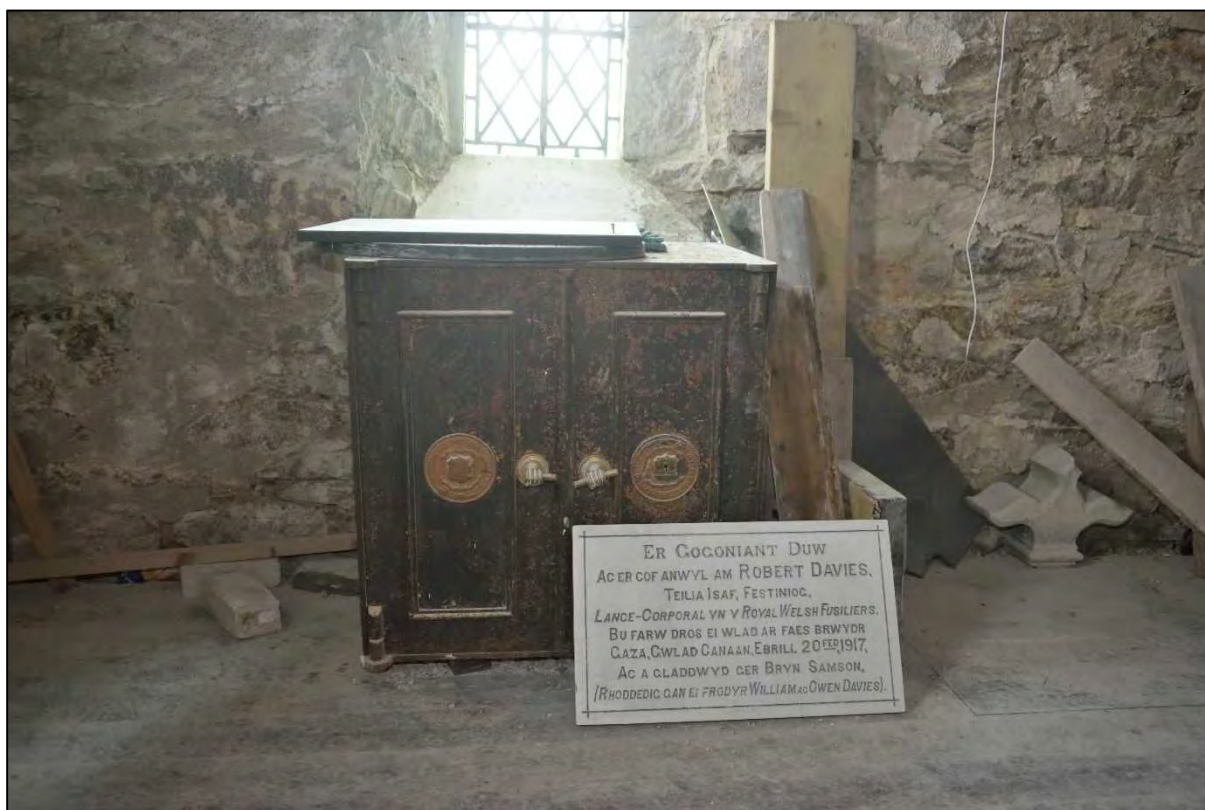
Plate 75: The safe

decorative roundels on each of the doors around which is the inscription “Impregnable Fire-proof Chest, Safe and Sound, Whitfield Yaren Birmingham.” One of these plates is upside down. There is also a door to the church yard on the northern side of the vestry with a panelled door (Plate 76) with a fanlight over.

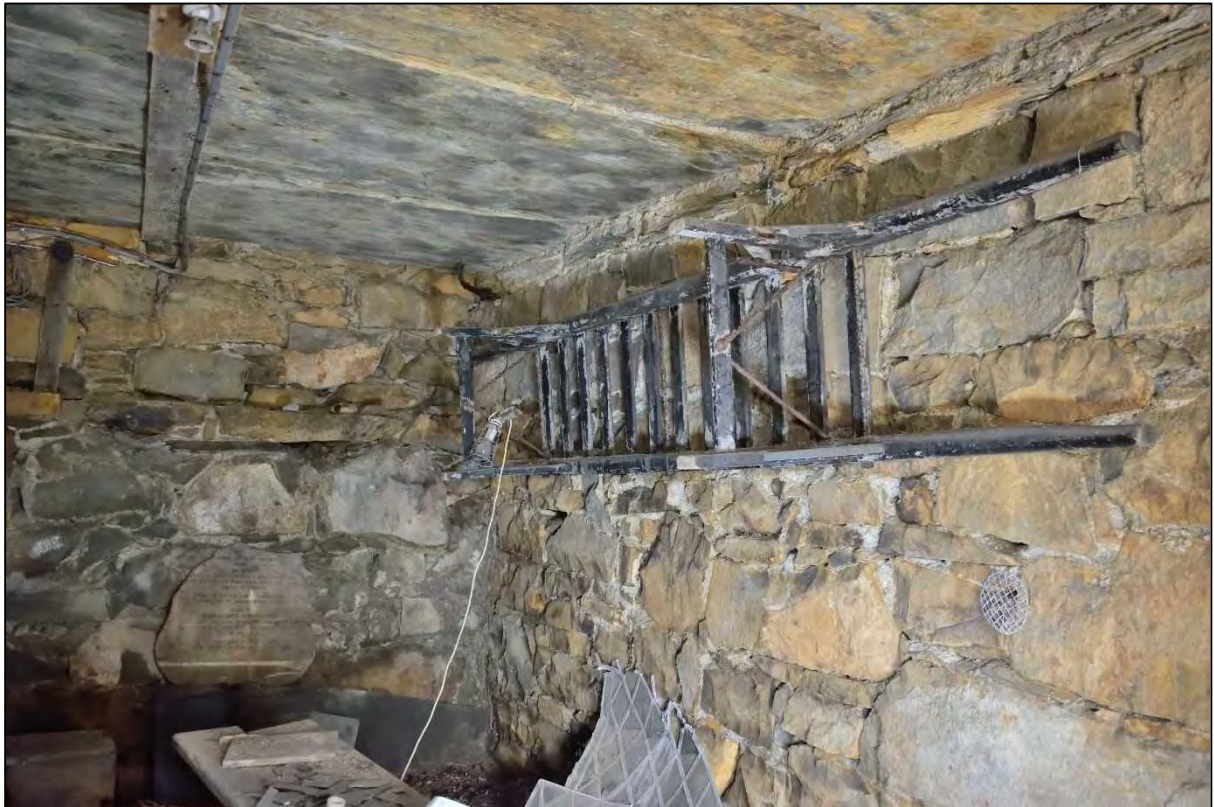
Directly below the chancel is a cellar access by the short flight of stone steps on the southern elevation (Plate 22). The cellar itself is 5.01 x 4.72 m and is divided into two spaces by a couple of stone piers supporting the roof. Hanging on the eastern wall is the village bier (Plate 77) and there is a four ink-hole school desk in this end of the cellar (Plate 78). Although this desk is missing its bench seat it has a lower shelf with a groove for pens and a cast iron frame. Along the northern side there is a box which appears to be a child sized coffin (Plate 76), although it is unknown if it is empty. The western side of the cellar has parts of the heating system (Plates 80 – 81) including the boiler from an earlier system. It is assumed that the iron pipe in the north-west corner was also part of the system, probably linking in to the chimney that must have been above the vestry.

Plate 77: The bier hanging on the cellar wall
